## status report

**customer:** Bank 11, Neuss  
**contract number:** 314375931  
**reference:**

#### Hyundai i30

| Vehicle identification number | <b>TMAD351AADJ021891</b> | mileage read: | <b>131320 km</b> |

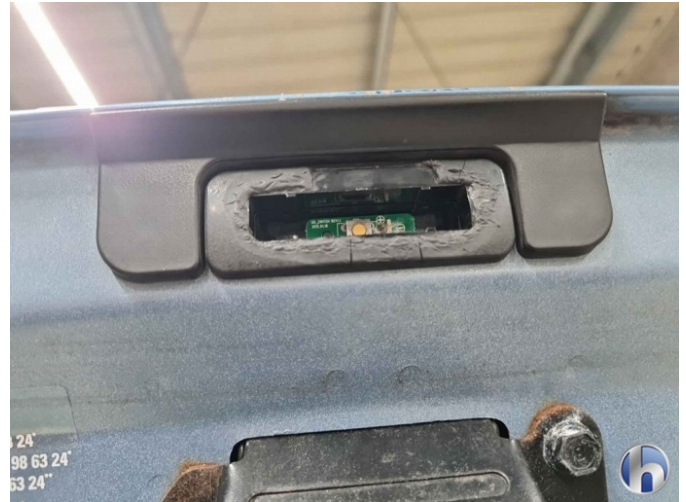
| component | Damage | Rep kind |
|---|---|---|
| 1. Heckklappentaster (Kofferraum nur von Innen über Notentriegelung zu öffnen) | Damaged | Replace |

1. Heckklappentaster (Kofferraum nur von Innen über Notentriegelung zu öffnen)

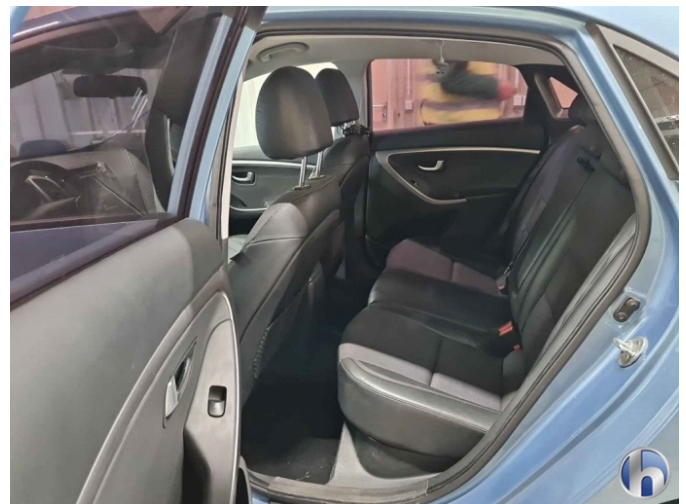
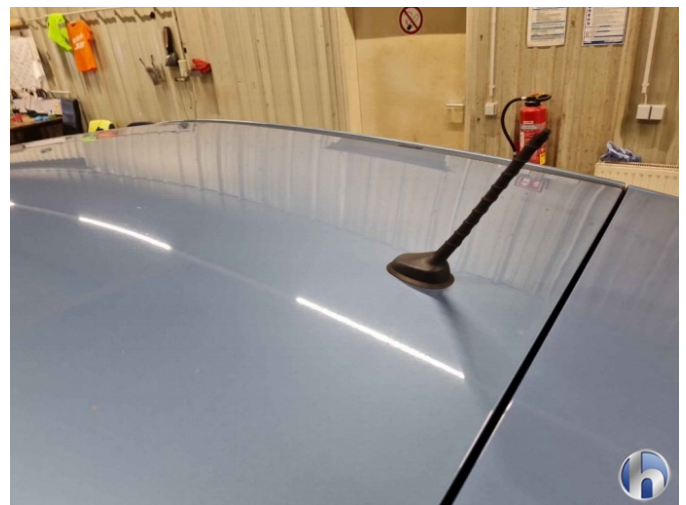
| component | Damage | Rep kind |
|---|---|---|
| 3. Kofferraum und Innenraum | Wear and tear | acceptable |

3. Kofferraum und Innenraum

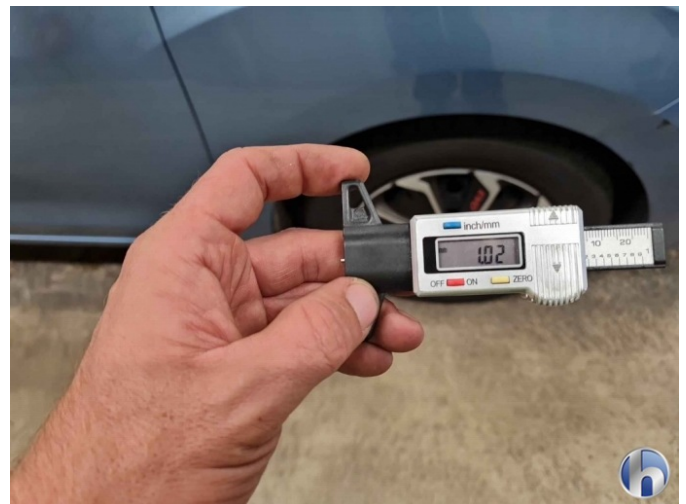
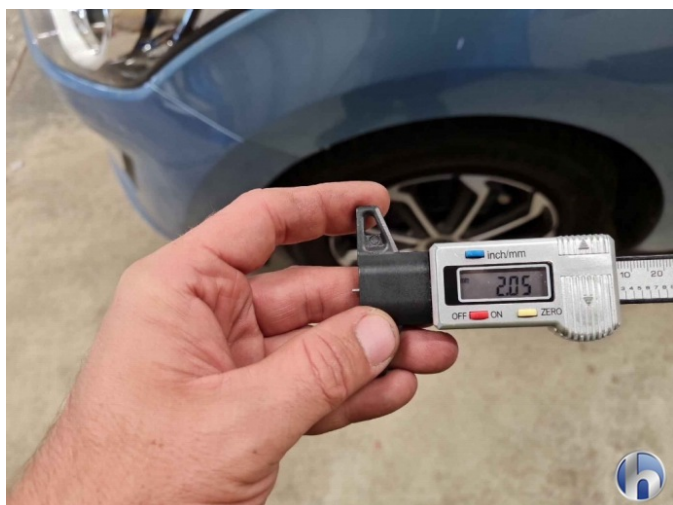
| 1st axis - right / states . | <b>Continental</b> | <b>195/65/R15/91T 1 mm</b> |

| component | Damage | Rep kind |
|---|---|---|
| 6. tire front - right | Worn | Replace |

6. tire front - right

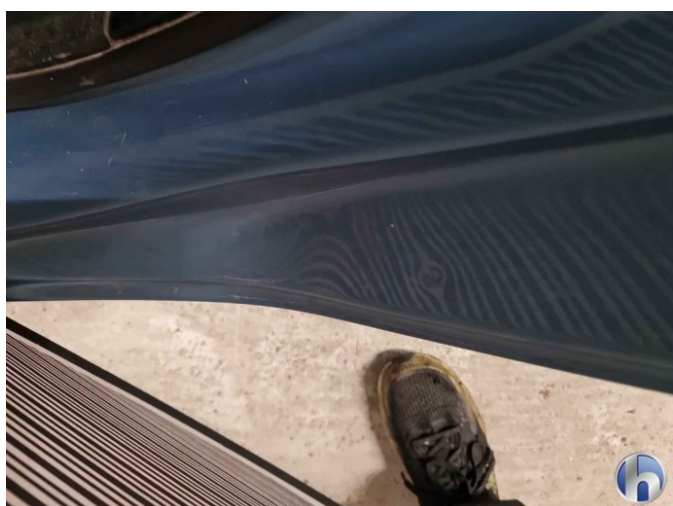
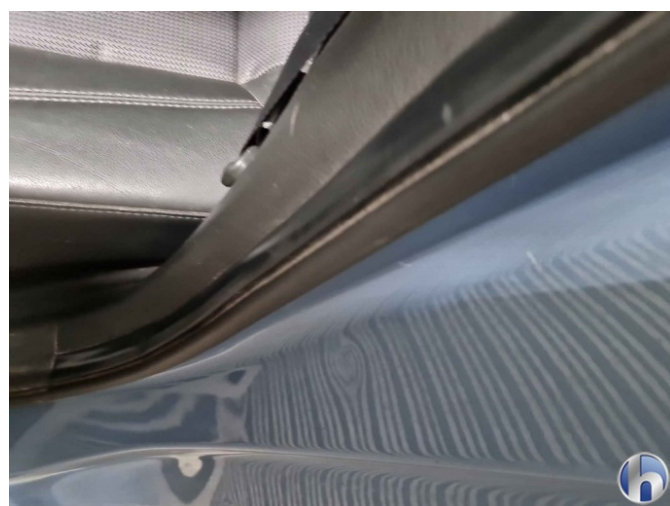
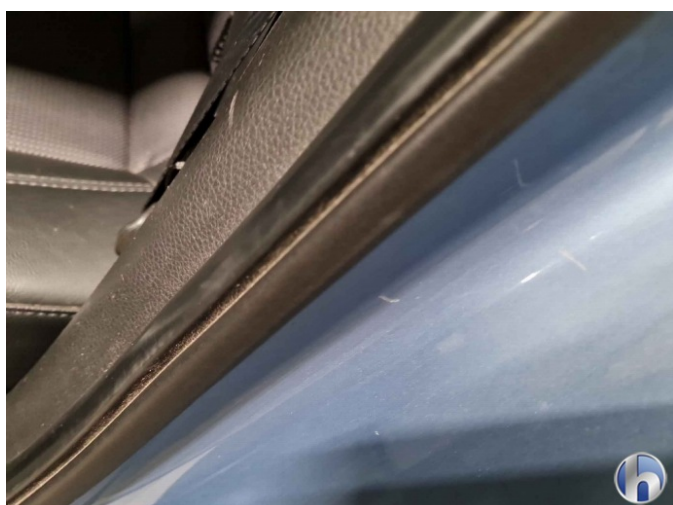
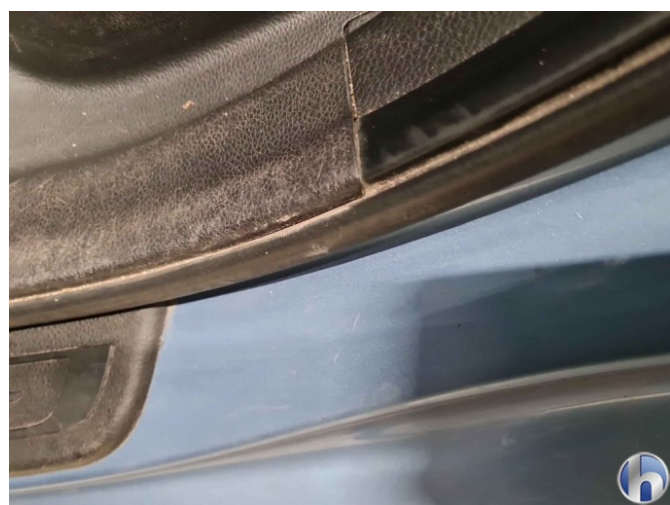
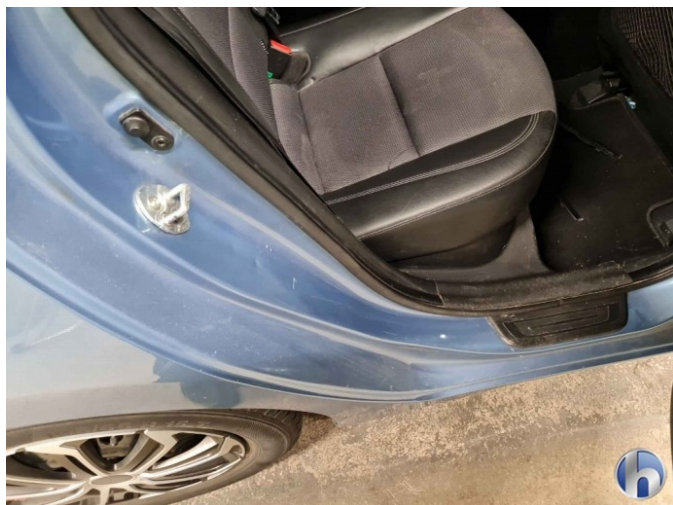
| component | Damage | Rep kind |
|---|---|---|
| 8. Türeinstieg Hinten - Links | Damaged | Refurbish and paint |

8. Türeinstieg Hinten - Links

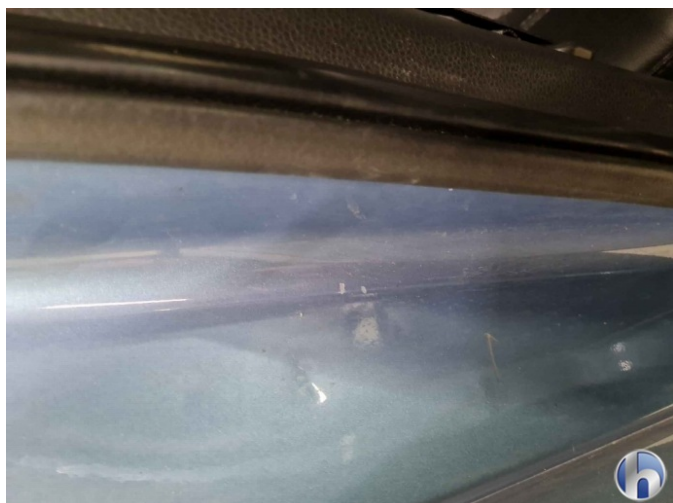
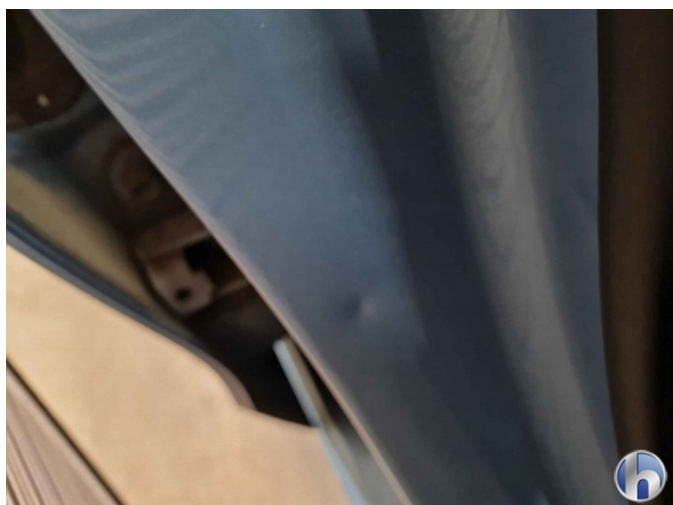
| component | Damage | Rep kind |
|---|---|---|
| 9. Türeinstieg Hinten - Rechts | Damaged | Refurbish and paint |

9. Türeinstieg Hinten - Rechts

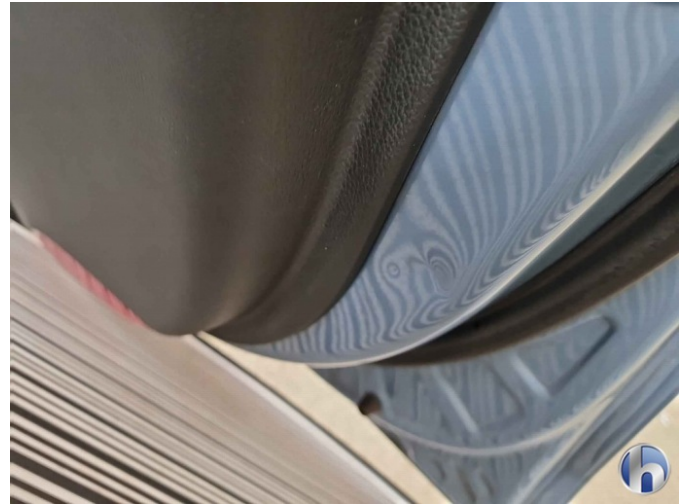
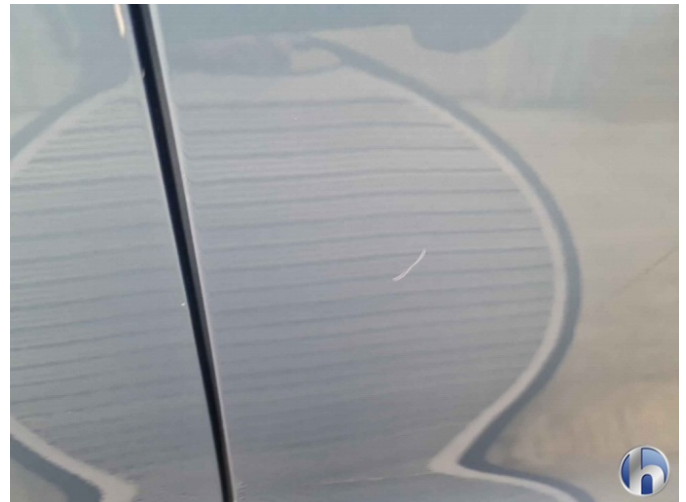
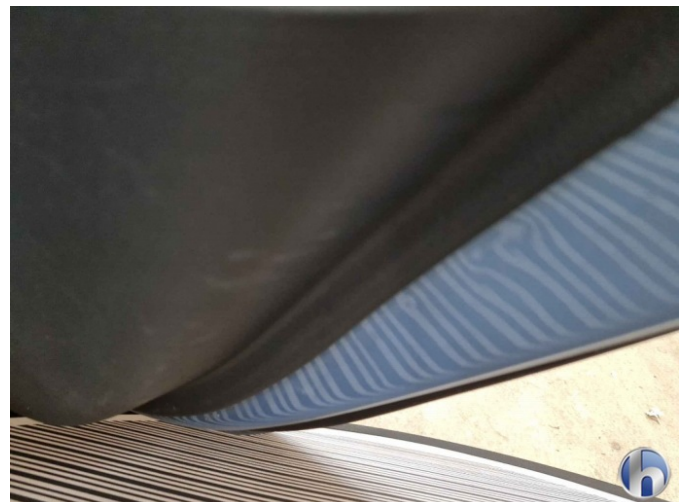
| component | Damage | Rep kind |
|---|---|---|
| 11. Front door - right | Damaged | Refurbish and paint |

11. Front door - right

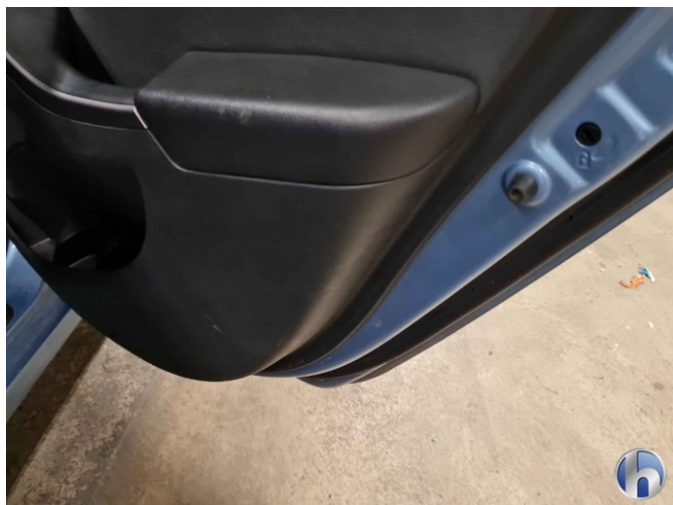
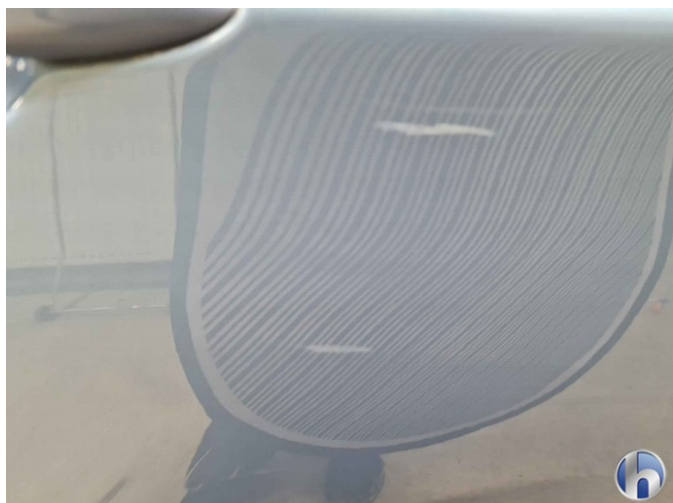
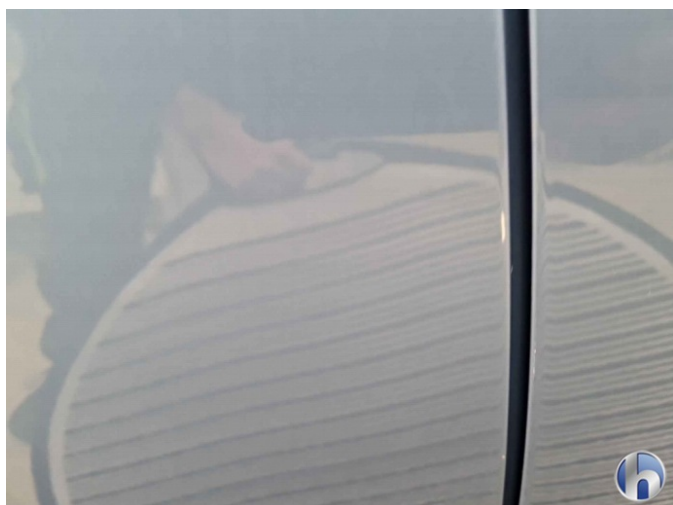
| component | Damage | Rep kind |
|---|---|---|
| 12. Door Rear - right | Damaged | Refurbish and paint |

12. Door Rear - right

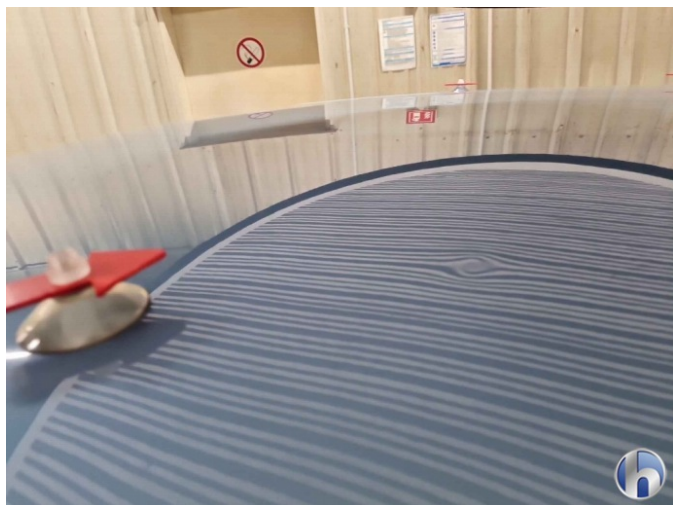
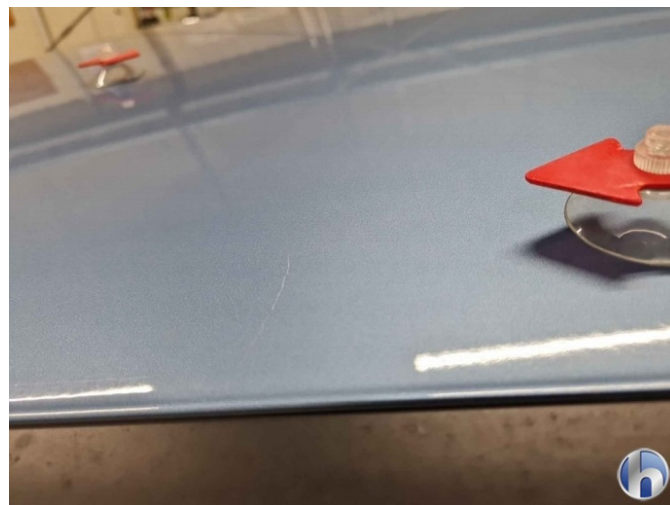
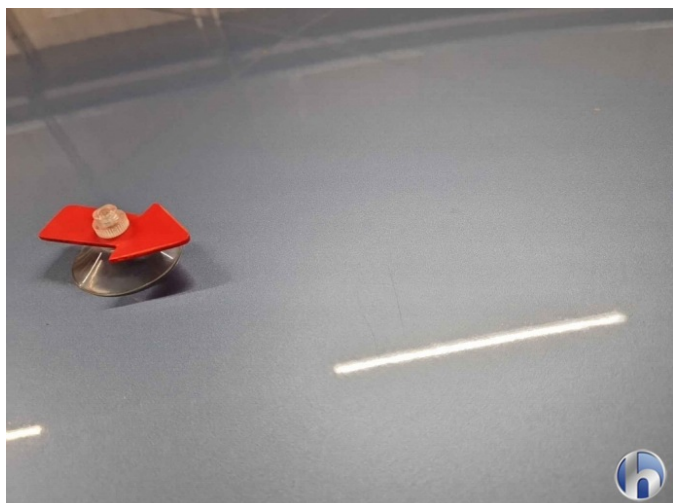
| component | Damage | Rep kind |
|---|---|---|
| 13. roof | Damaged | Refurbish and paint |

13. roof

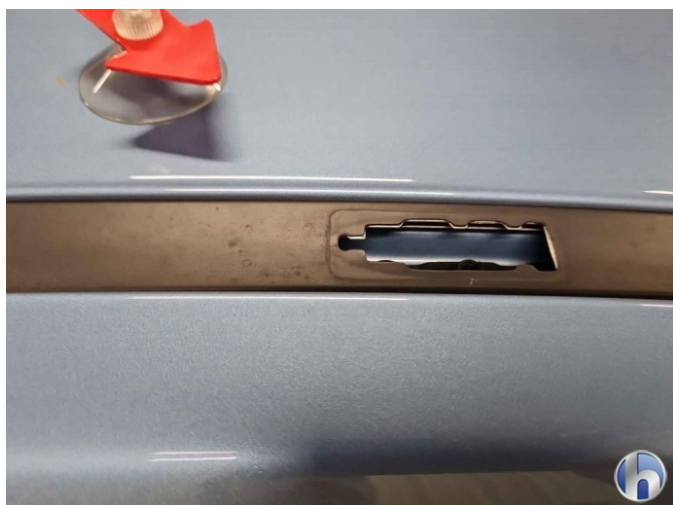
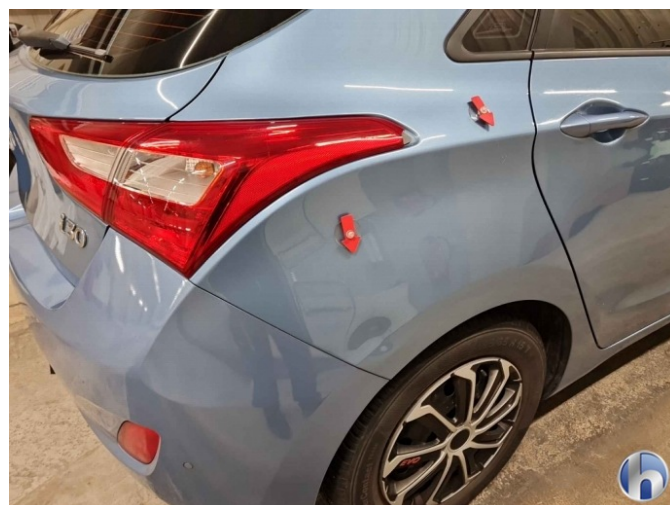
| component | Damage | Rep kind |
|---|---|---|
| 14. Dachleiste rechts: Abdeckkappe | Missing | Replace |

14. Dachleiste rechts: Abdeckkappe

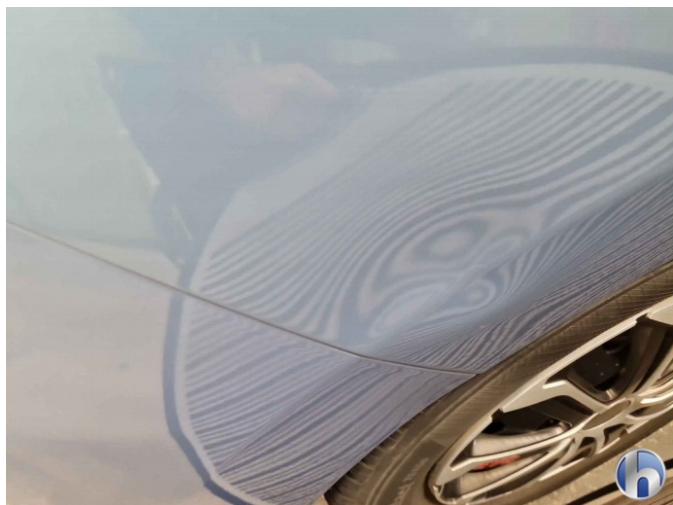
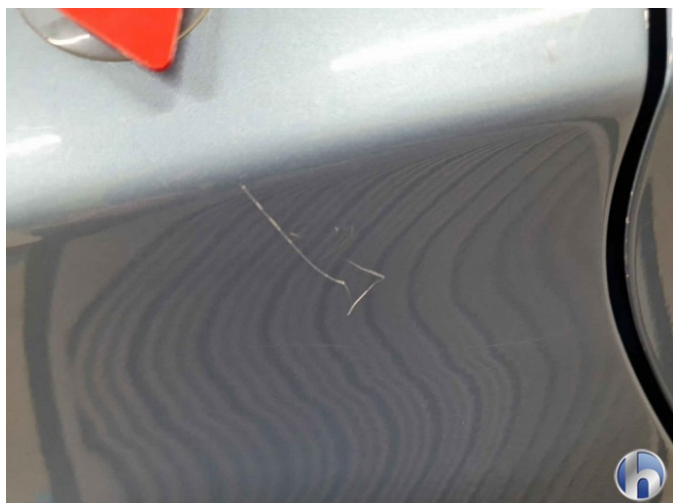
| component | Damage | Rep kind |
|---|---|---|
| 15. Sidewall - Rear - right | Damaged | Refurbish and paint |

15. Sidewall - Rear - right

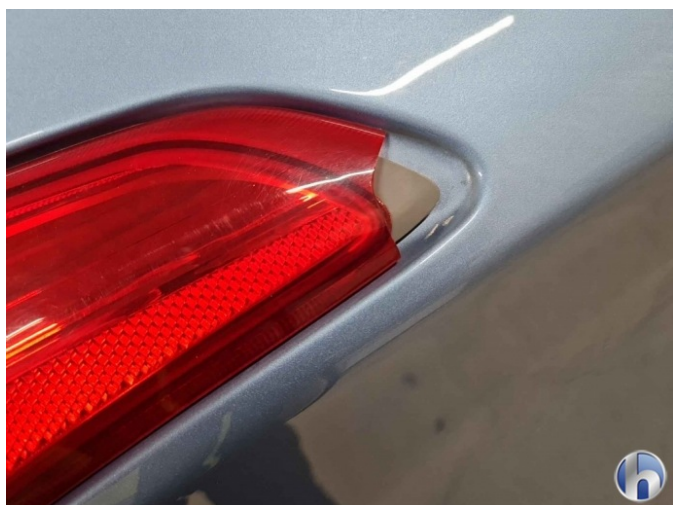
| component | Damage | Rep kind |
|---|---|---|
| 16. Taillight right | Damaged | Replace |

16. Taillight right

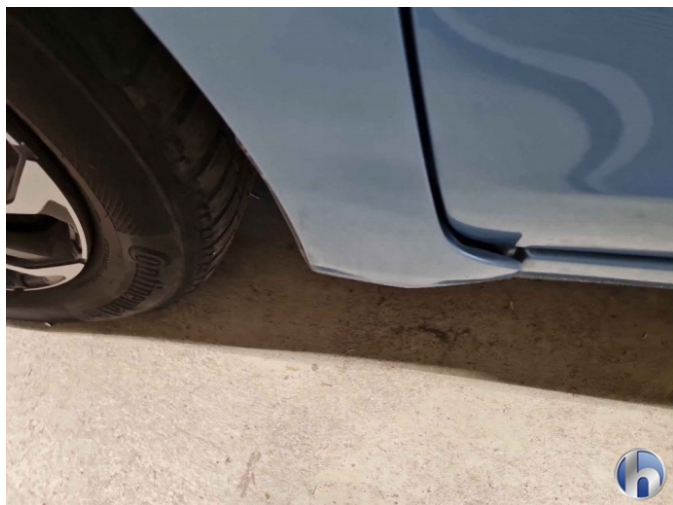
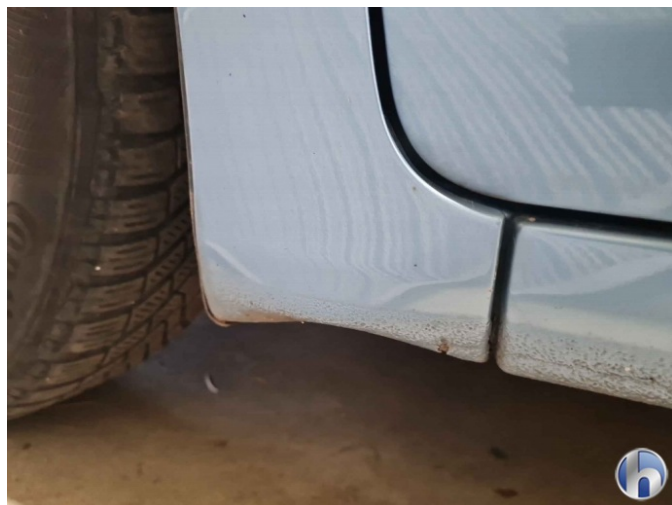
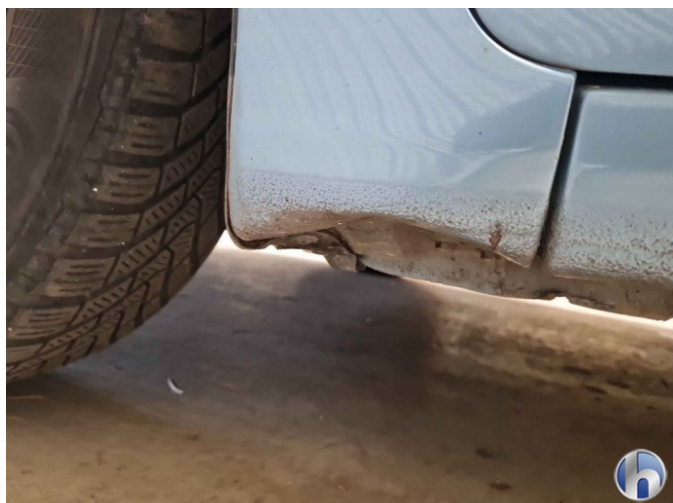
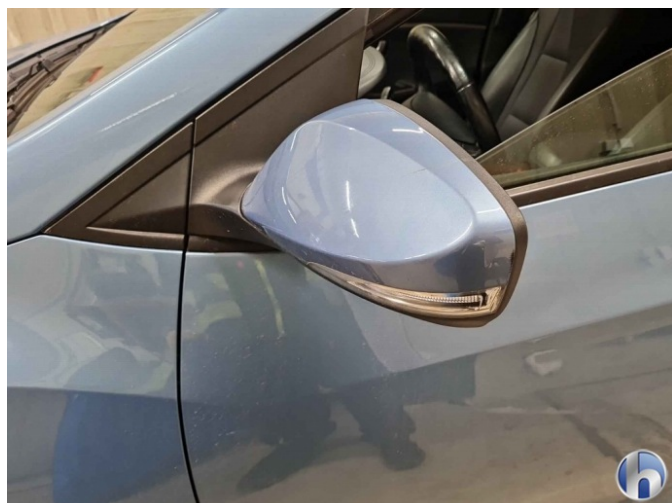
| component | Damage | Rep kind |
|---|---|---|
| 17. Front fender - left | Damaged | Refurbish and paint |

17. Front fender - left

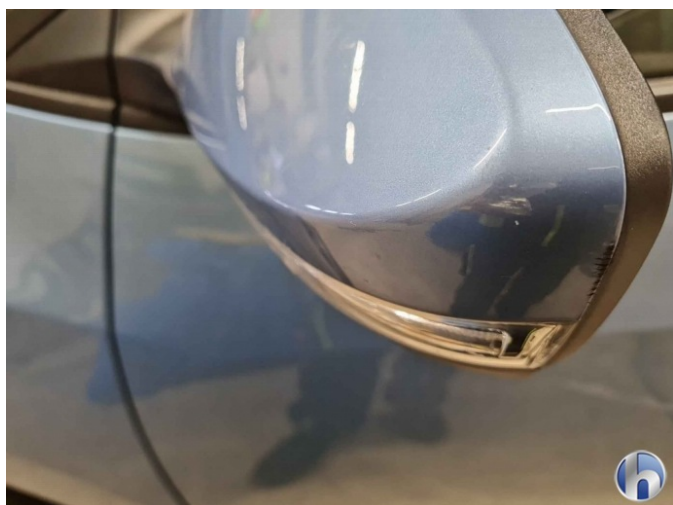
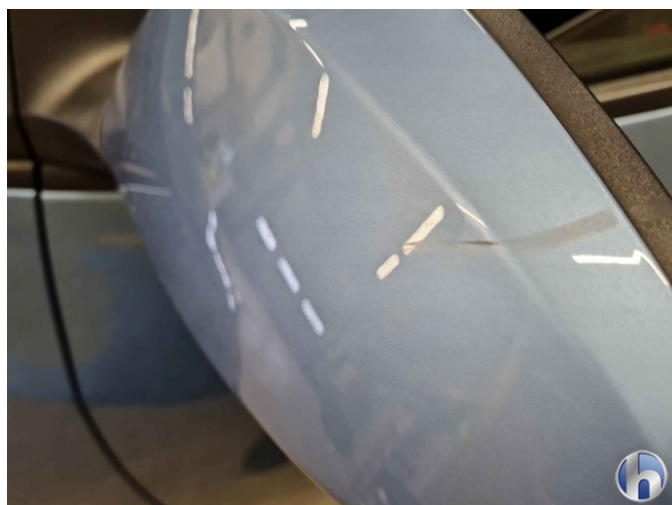
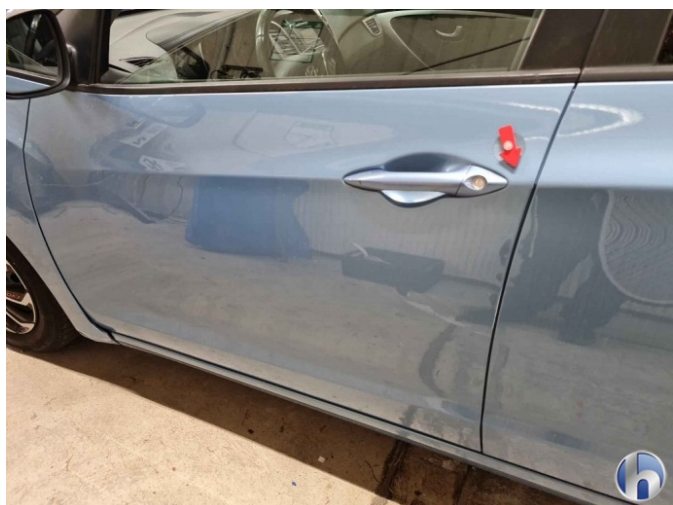
| component | Damage | Rep kind |
|---|---|---|
| 18. Outside mirror - left | Scrape | Paint |

18. Outside mirror - left

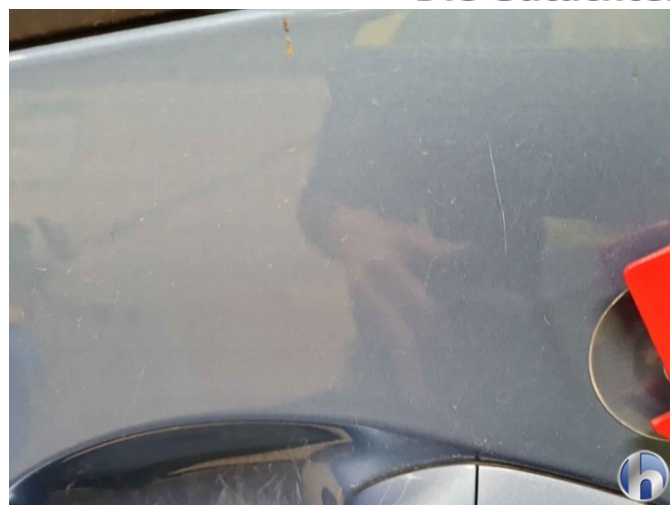
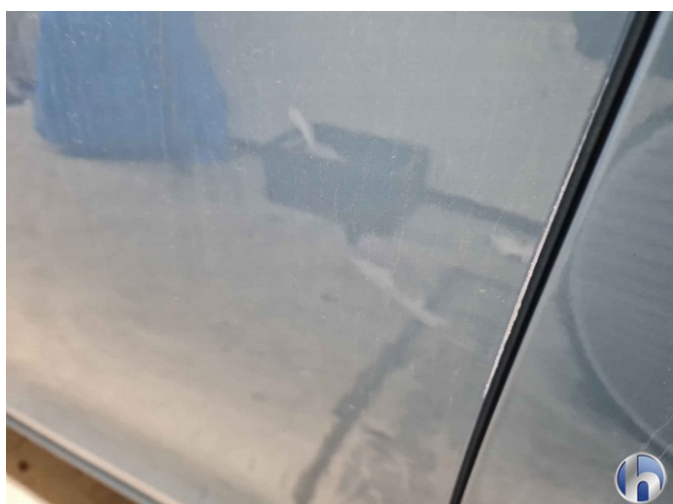
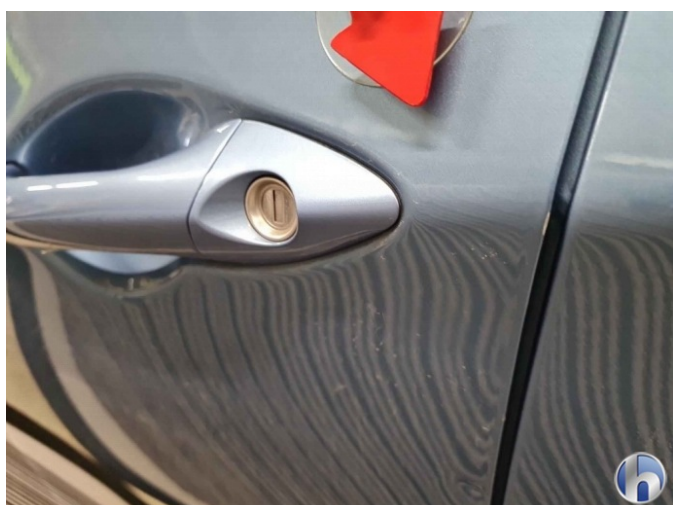
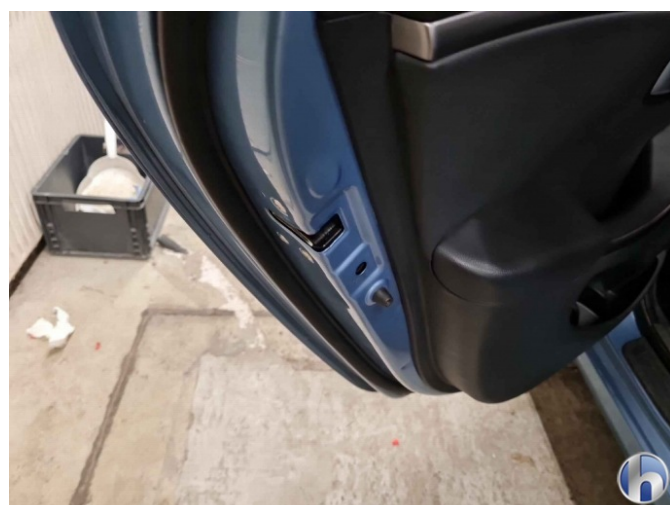
| component | Damage | Rep kind |
|---|---|---|
| 19. Front door - left | Damaged | Refurbish and paint |

19. Front door - left

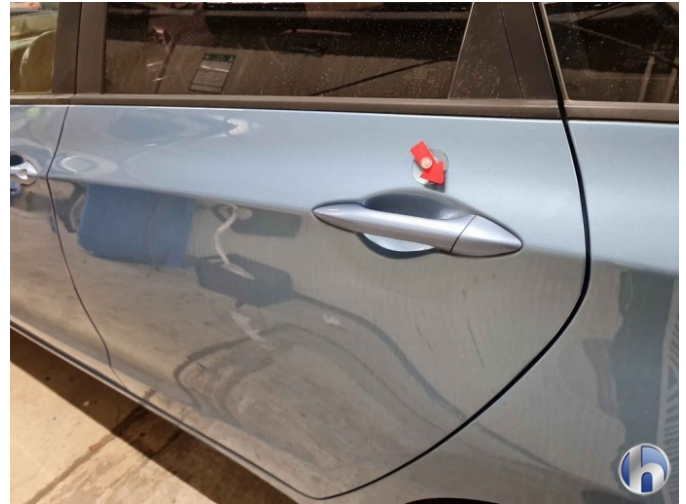
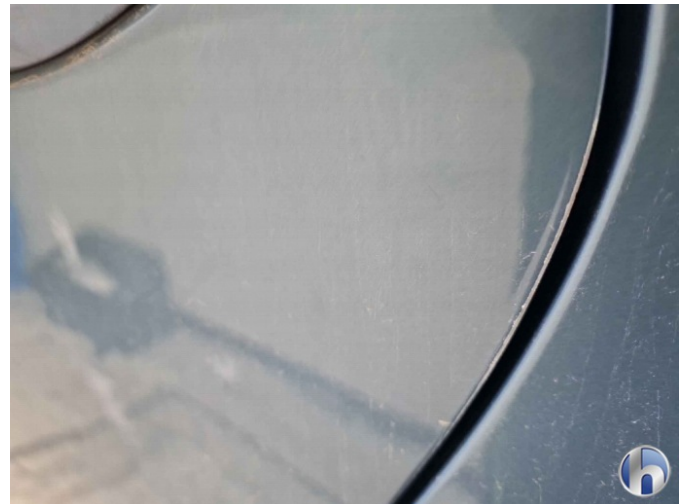
| component | Damage | Rep kind |
|---|---|---|
| 20. Rear door - left | Damaged | Refurbish and paint |

20. Rear door - left

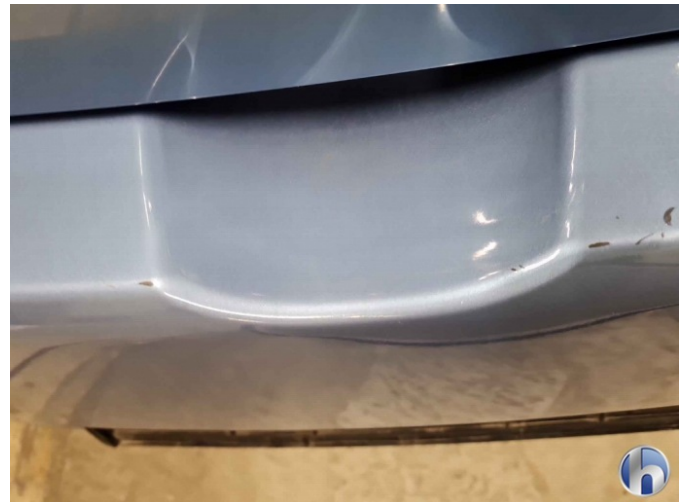
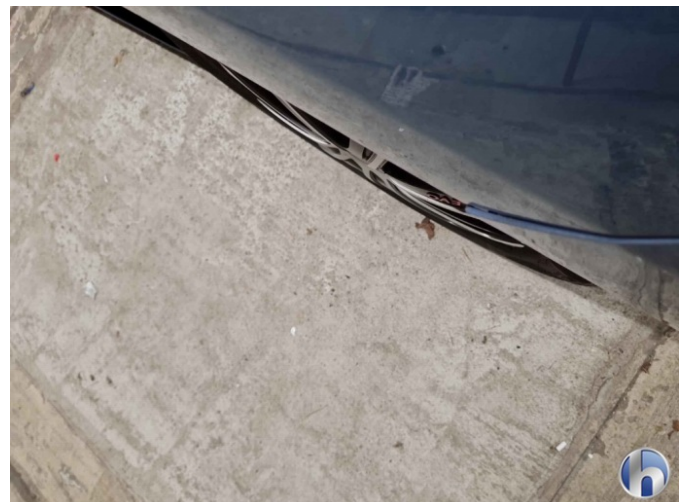
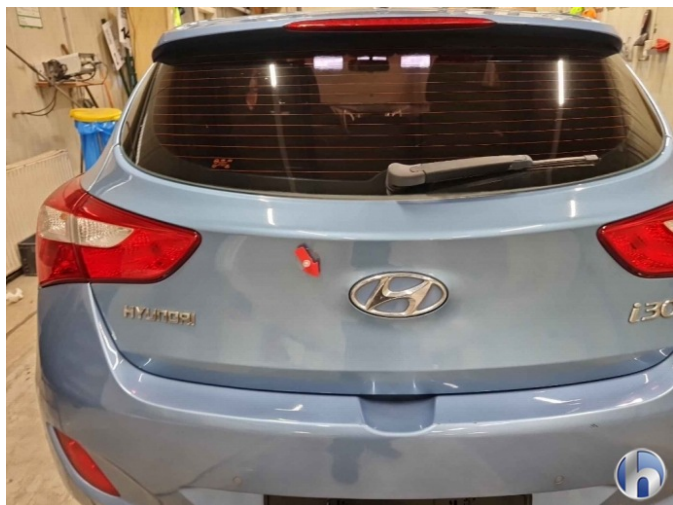
| component | Damage | Rep kind |
|---|---|---|
| 23. Rear bumper | Damaged | Refurbish and paint |

23. Rear bumper

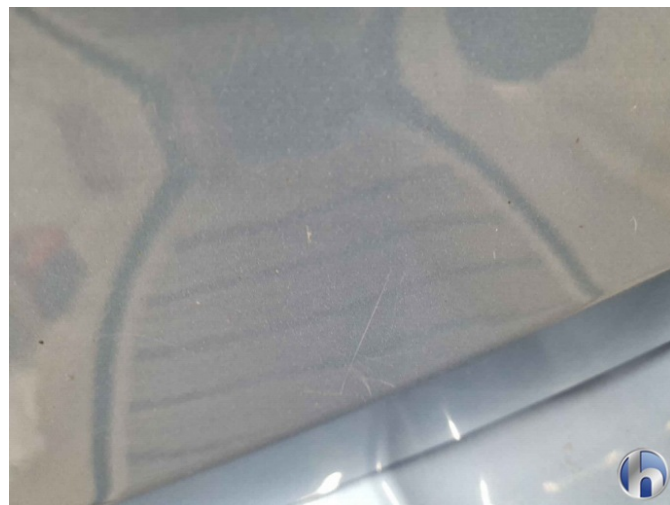
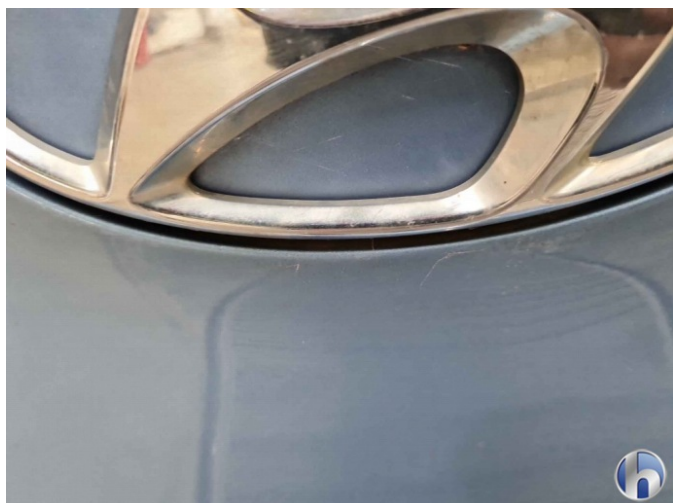
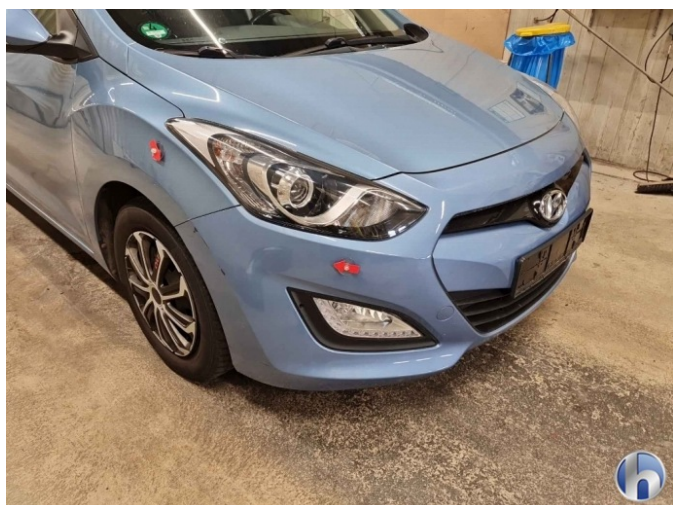
| component | Damage | Rep kind |
|---|---|---|
| 24. tailgate | Scratch(es) | Paint |

24. tailgate

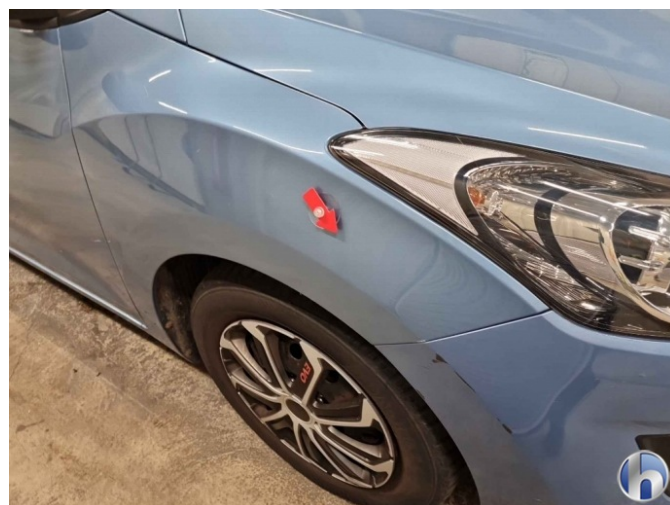
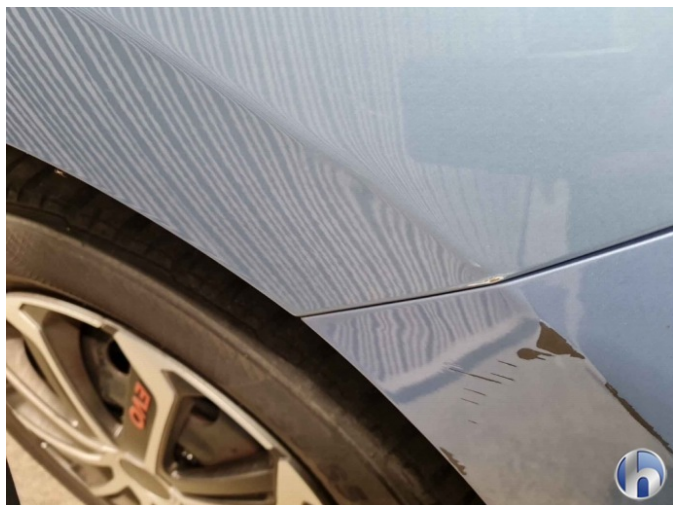
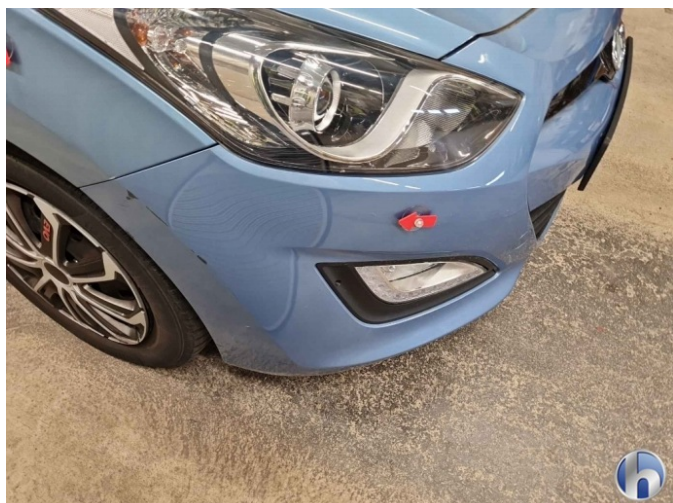
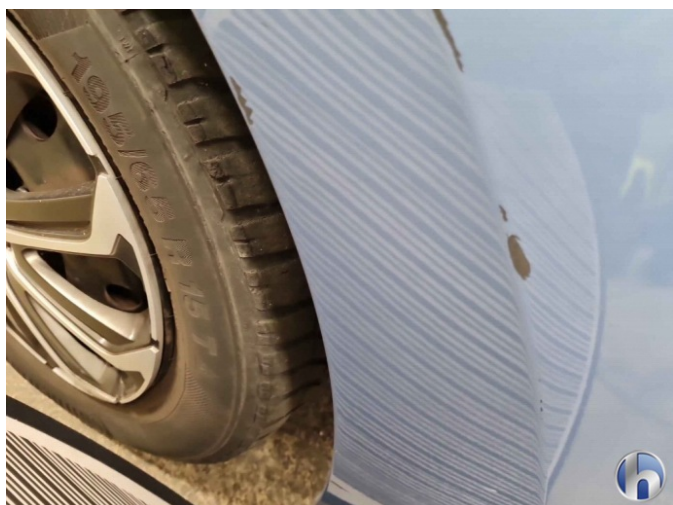
Fahrzeug mit bestehenden Unfallschaden, zur Schadensermittlung wurden keine Demontagearbeiten durchgeführt, verborgen gebliebene Schäden können nicht ausgeschlossen werden. Unfallschaden Kosten wurden überschlägig Kalkuliert, Kostenerweiterung möglich.

| component | Damage | Rep kind |
|---|---|---|
| 25. Fahrzeug vorn | Accident damage | Replace |

25. Fahrzeug vorn

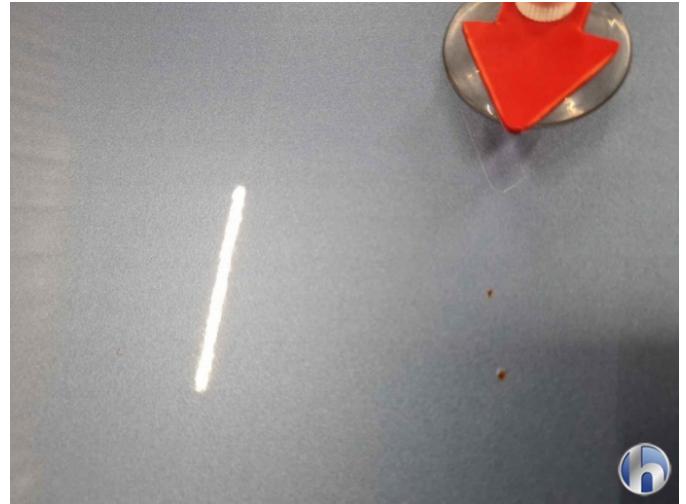
| component | Damage | Rep kind |
|---|---|---|
| 26. hood | Rust | Paint |

26. hood

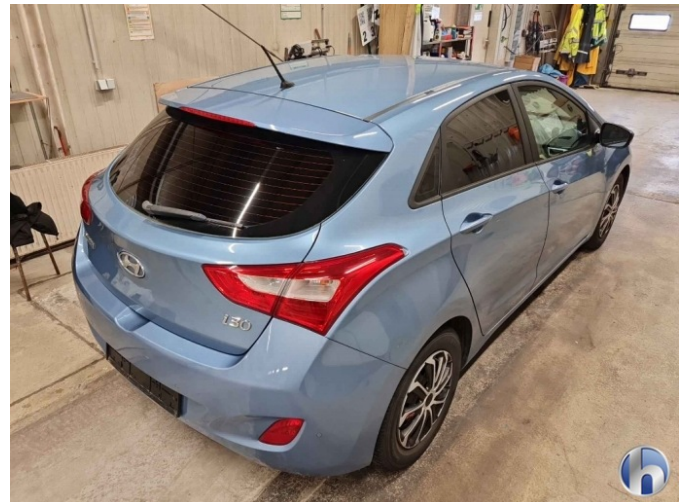
| component | Damage | Rep kind |
|---|---|---|
| 27. Fahrzeug (Kratzer, Harz-/Säureeinwirkung, Verschmutzungen) | Scratch(es) | |

27. Fahrzeug (Kratzer, Harz-/Säureeinwirkung, Verschmutzungen)

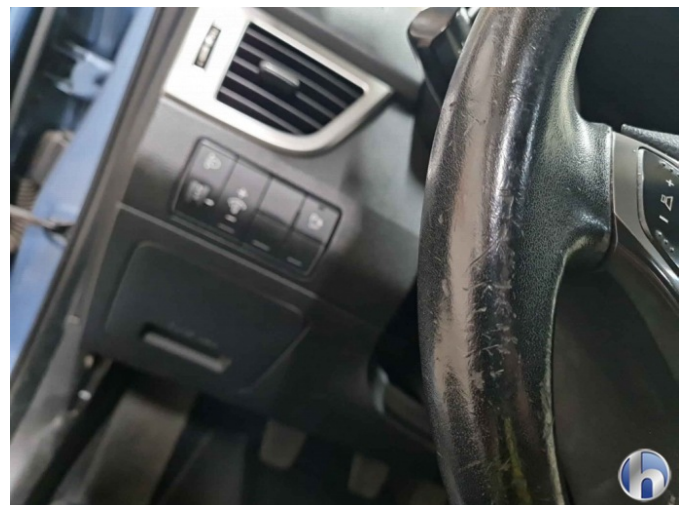
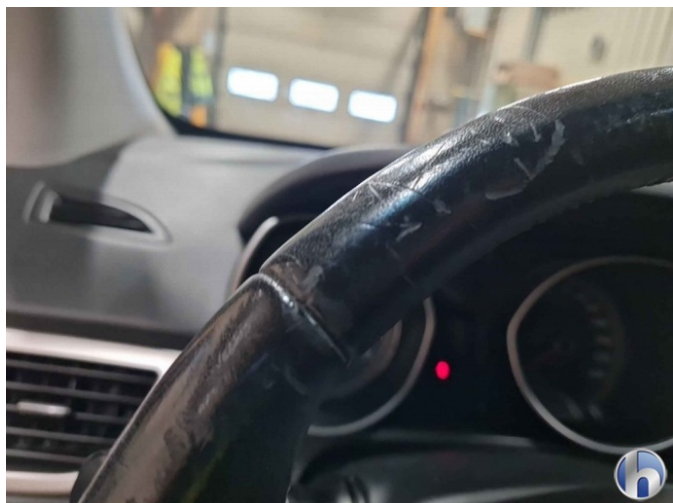
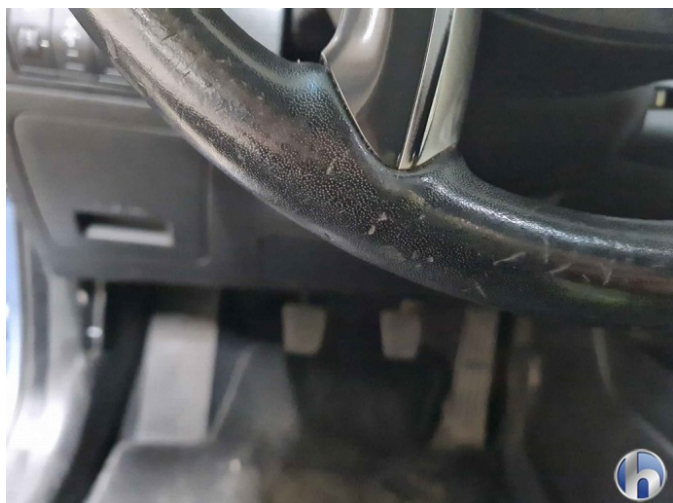
| component | Damage | Rep kind |
|---|---|---|
| 28. steering wheel | Material wear | Replace |

28. steering wheel

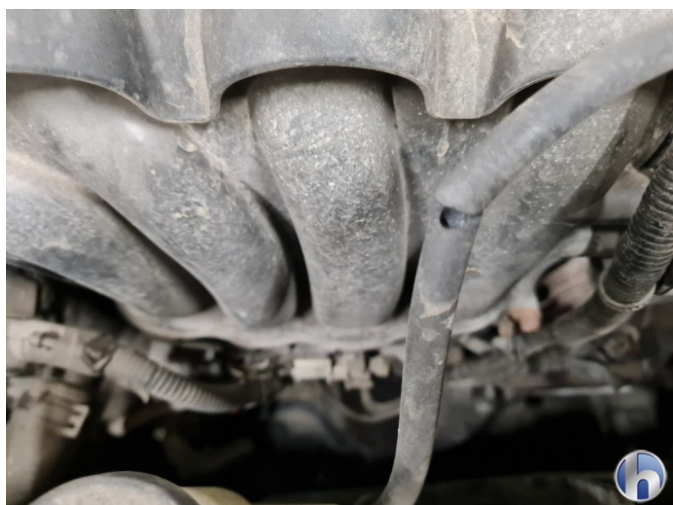
| component | Damage | Rep kind |
|---|---|---|
| 30. Kühlwasserschlauch | Damaged | Replace |

30. Kühlwasserschlauch
