## status report

**customer:** Bank 11, Neuss  
**contract number:** 84559031-INSO  
**reference:**

#### Hyundai I30

| Vehicle identification number | <b>TMAH2811ALJ065677</b> | mileage read: | <b>46195 km</b> |

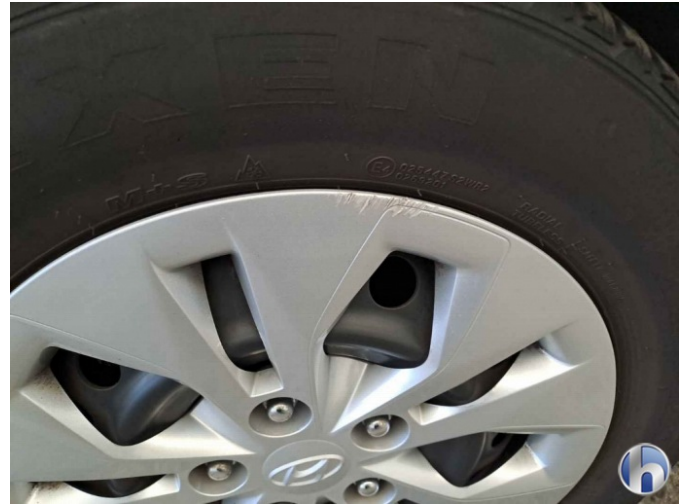
| component | Damage | Rep kind |
|---|---|---|
| 1. Radkappe - Vorne - Rechts | Scrape | Replace |

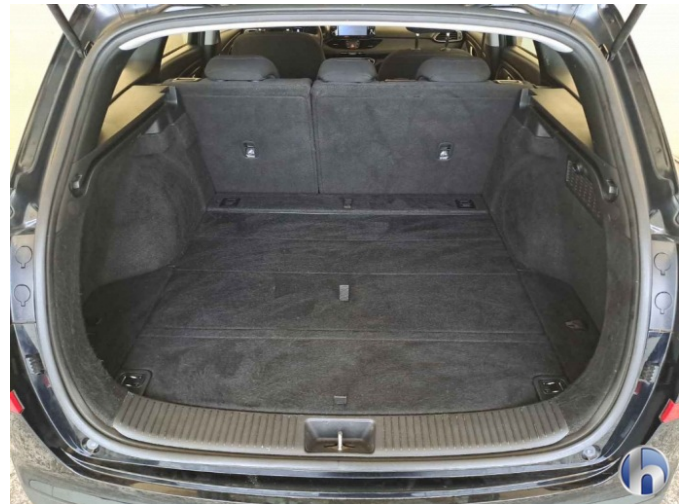
| component | Damage | Rep kind |
|---|---|---|
| 4. Cargo cover | Missing | Replace |

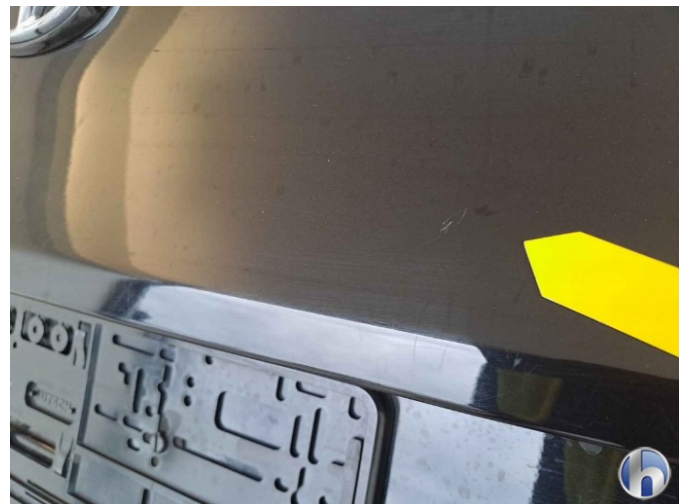
| component | Damage | Rep kind |
|---|---|---|
| 5. tailgate | Scratch(es) | Paint |

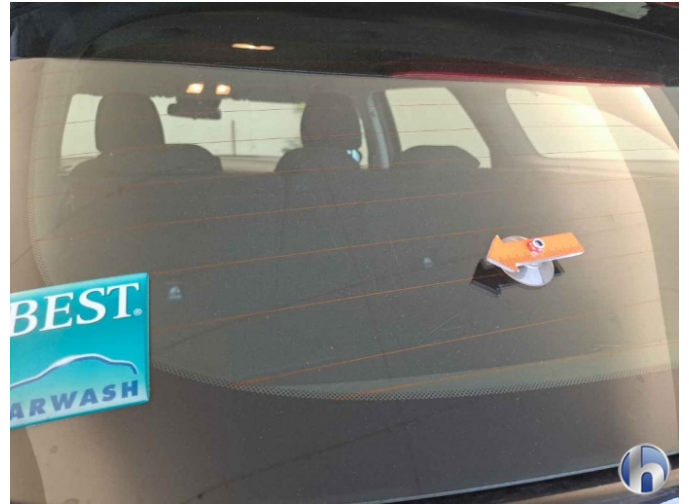
| component | Damage | Rep kind |
|---|---|---|
| 6. rear window | Scratch(es) | Replace |

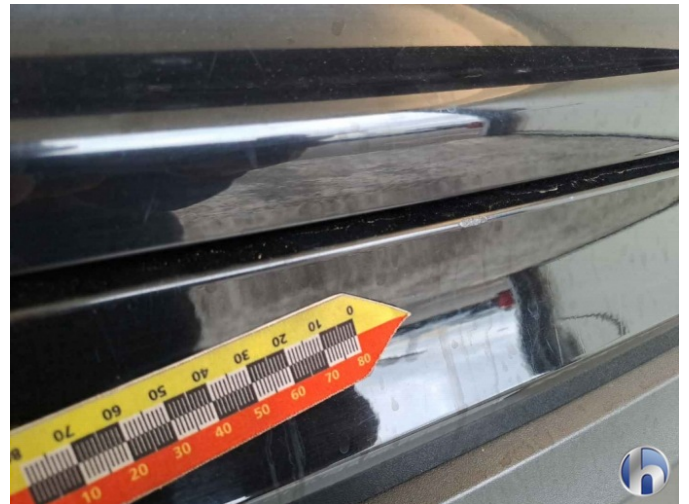
| component | Damage | Rep kind |
|---|---|---|
| 7. Rear bumper | Scratch(es) | Paint |

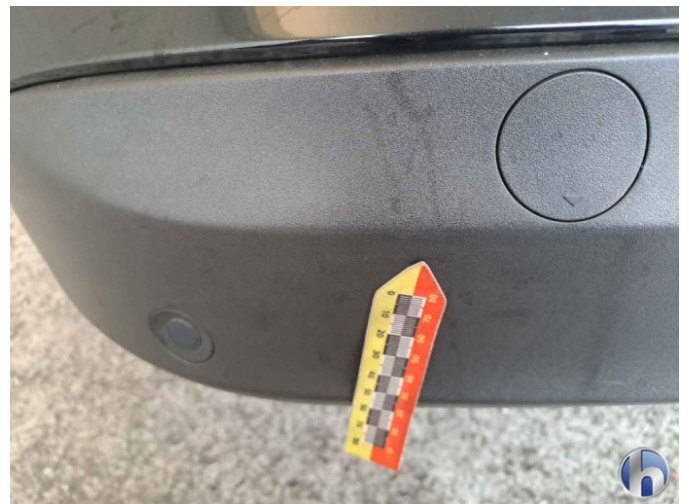
| component | Damage | Rep kind |
|---|---|---|
| 8. Diffusor | Scratch(es) | Replace |

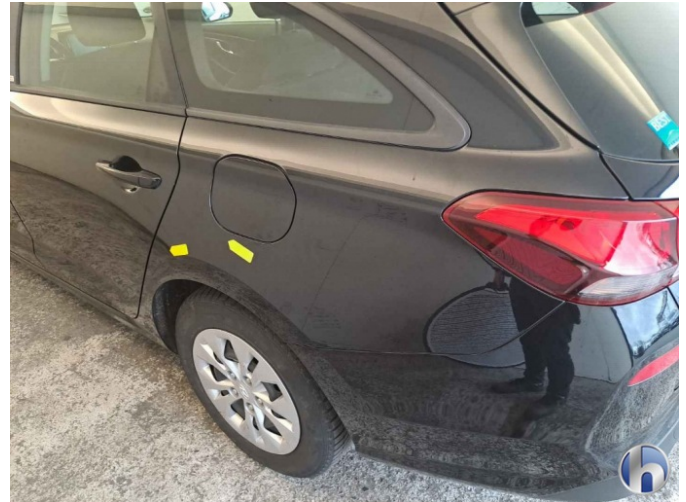
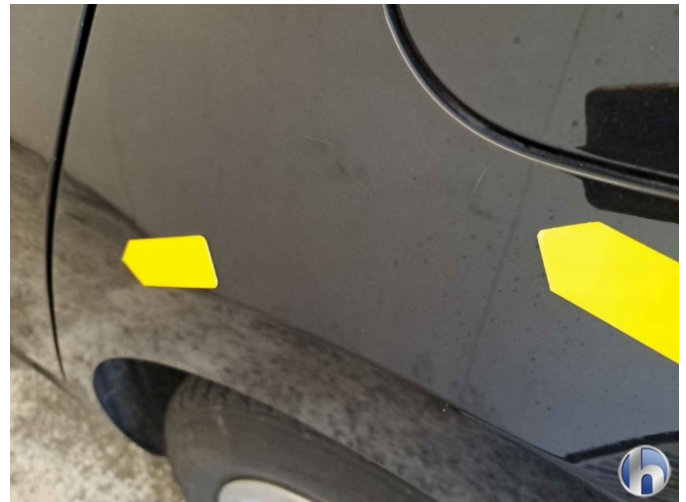
| component | Damage | Rep kind |
|---|---|---|
| 9. Sidewall - Rear - Left | Damaged | Refurbish and paint |

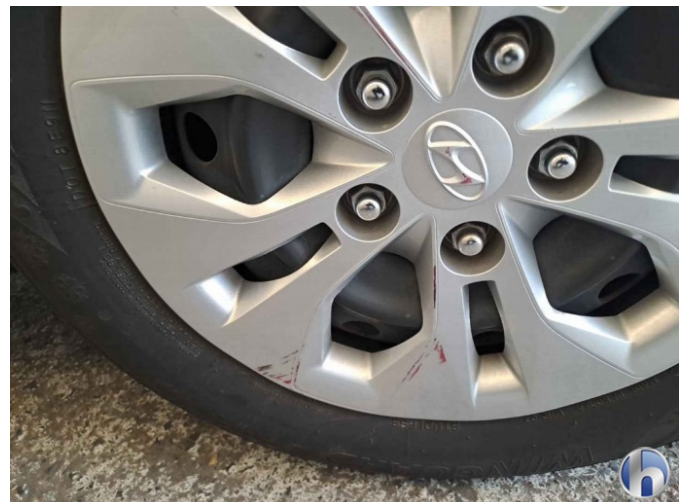
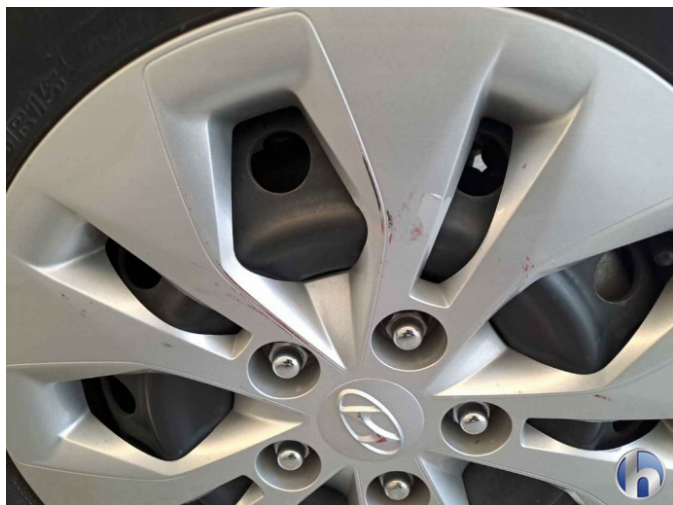
| component | Damage | Rep kind |
|---|---|---|
| 10. Radkappe - Hinten - Links | Damaged | Replace |

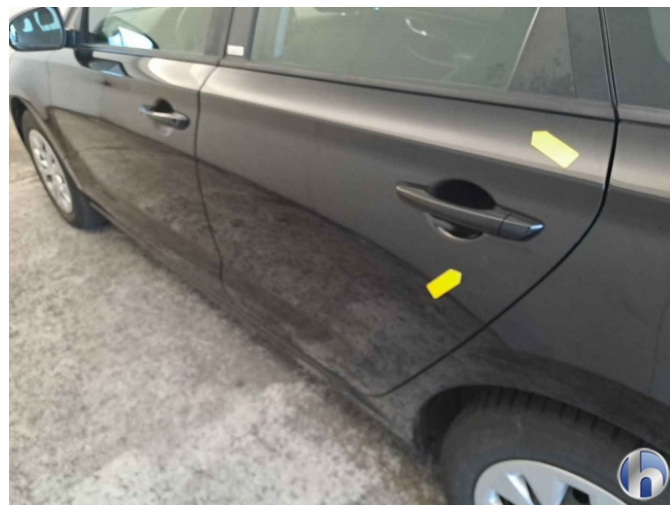
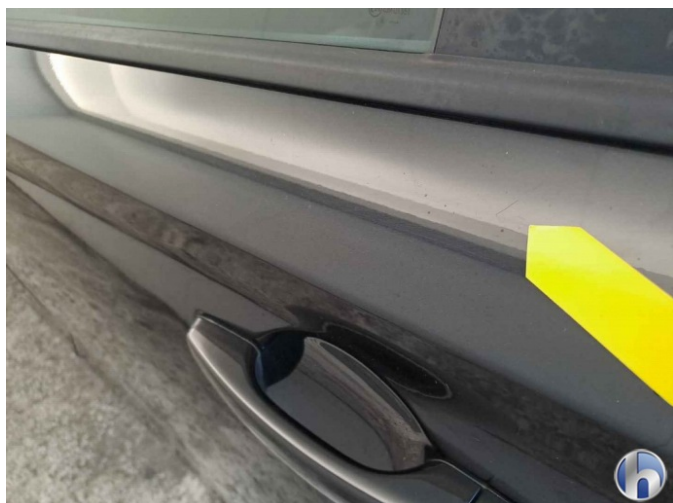
| component | Damage | Rep kind |
|---|---|---|
| 11. Rear door - left | Scratch(es) | Paint |

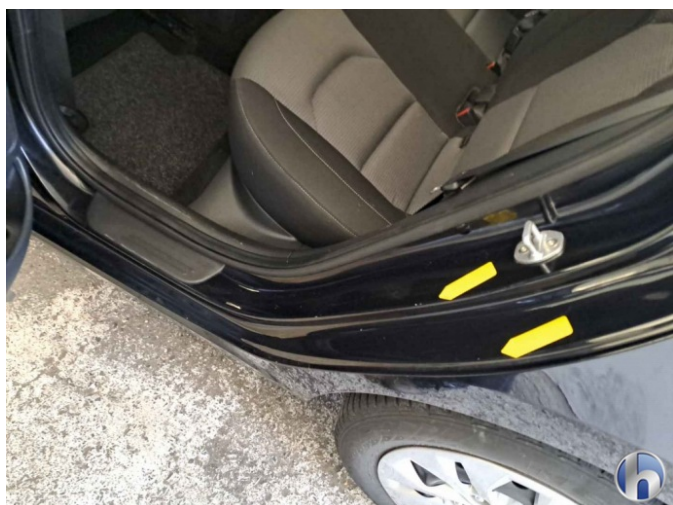
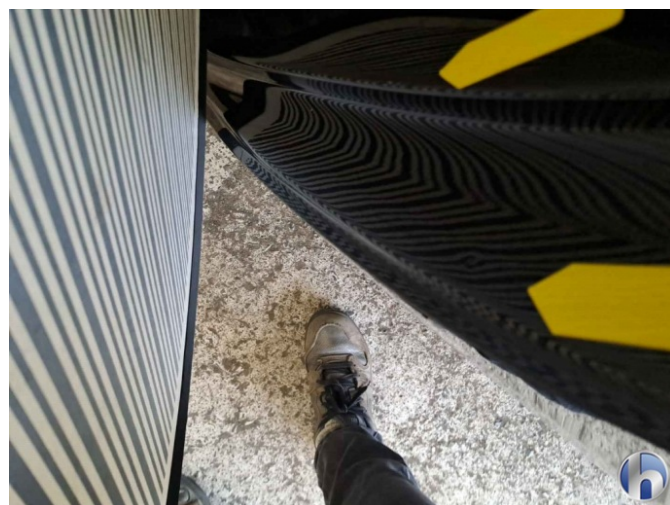
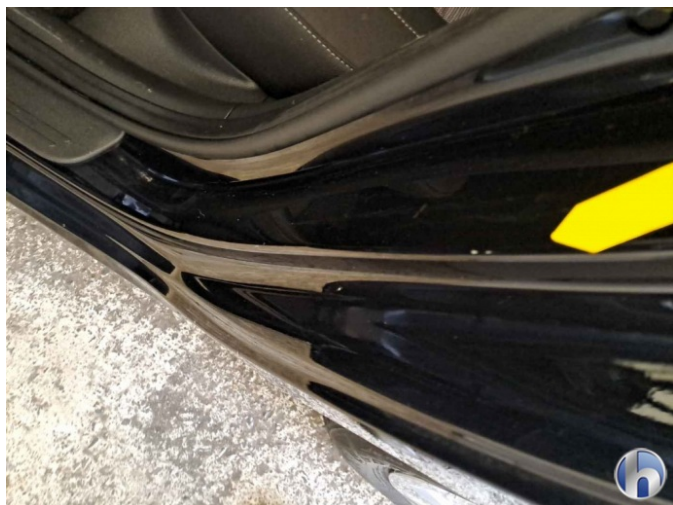
| component | Damage | Rep kind |
|---|---|---|
| 12. Türeinstieg Hinten - Links | Damaged | Refurbish and paint |

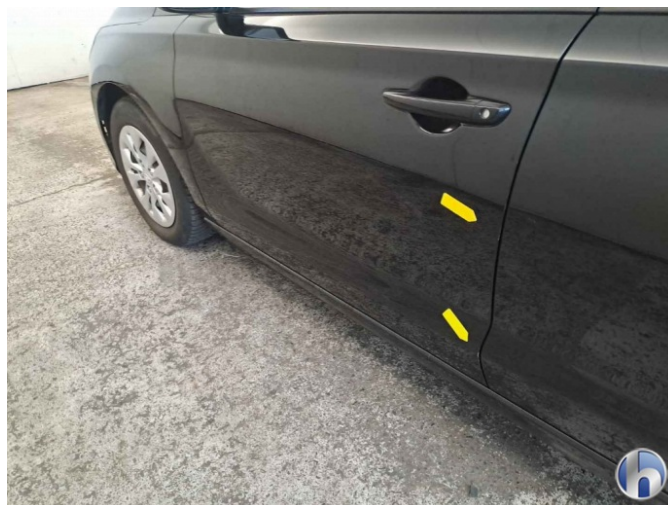
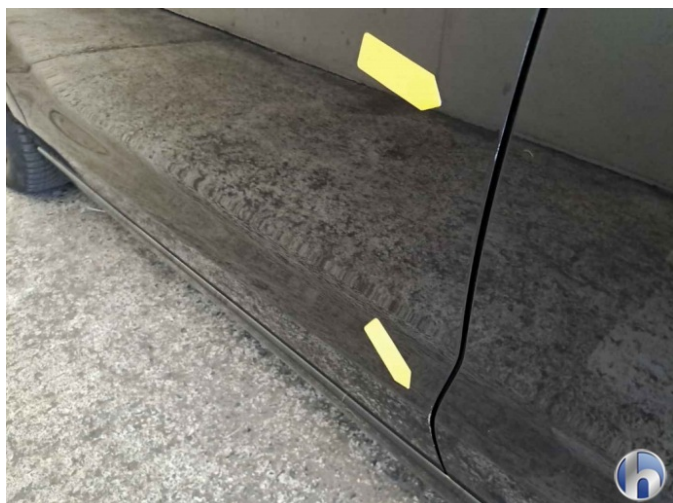
| component | Damage | Rep kind |
|---|---|---|
| 13. Front door - left | Scratch(es) | Paint |

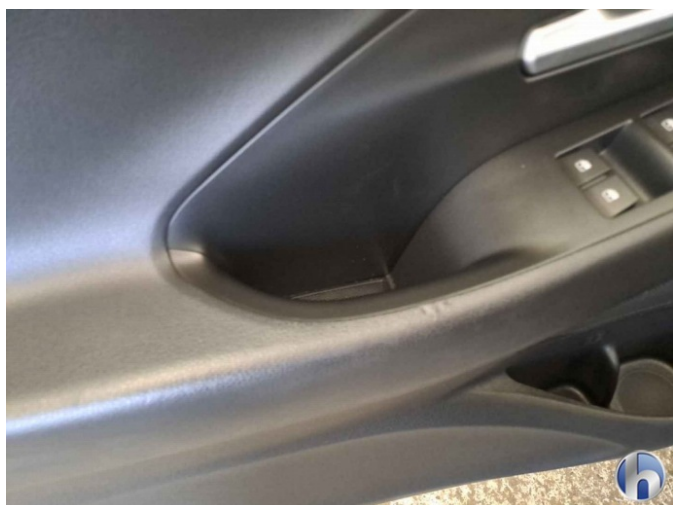
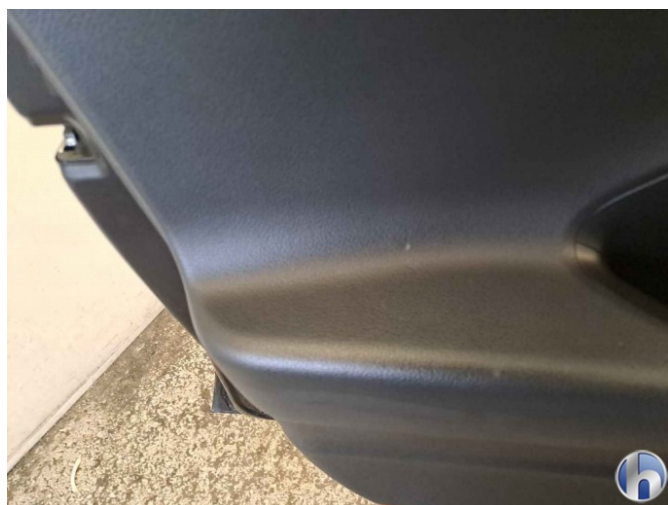
| component | Damage | Rep kind |
|---|---|---|
| 14. Front door trim - left | Damaged | Replace |

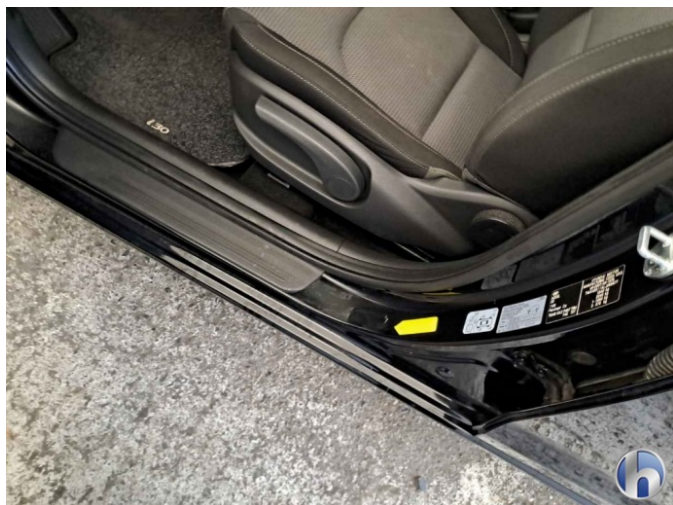
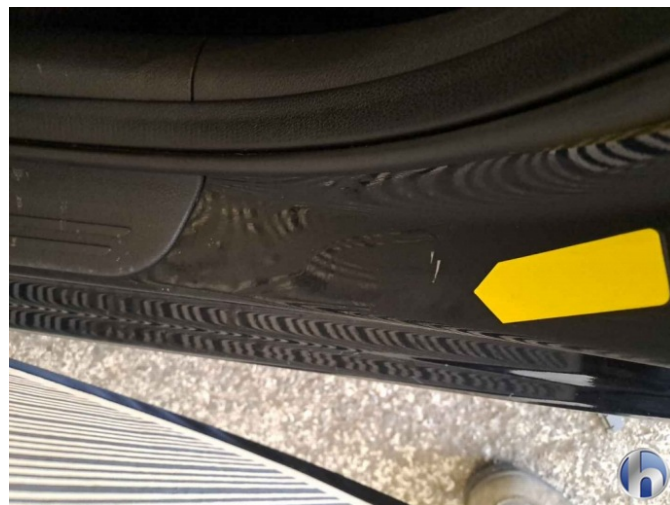
| component | Damage | Rep kind |
|---|---|---|
| 15. Türeinstieg Vorne - Links | Damaged | Refurbish and paint |

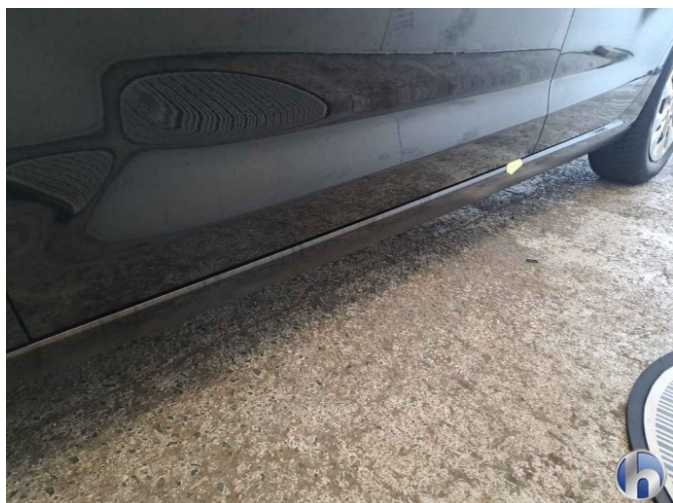
| component | Damage | Rep kind |
|---|---|---|
| 16. side skirt - left | Scratch(es) | Paint |

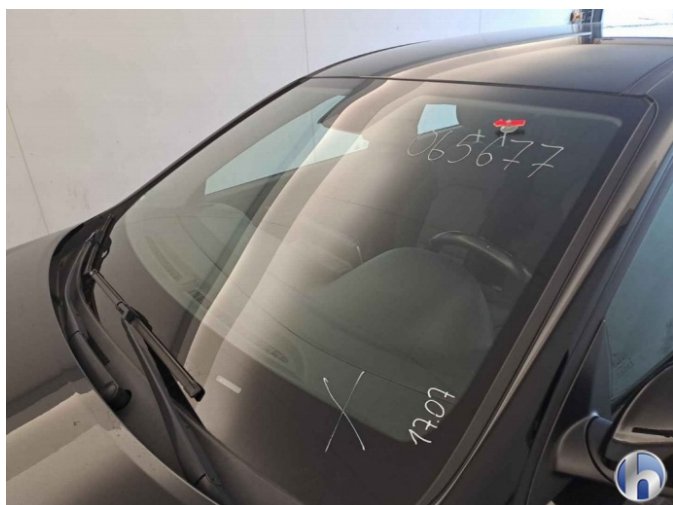
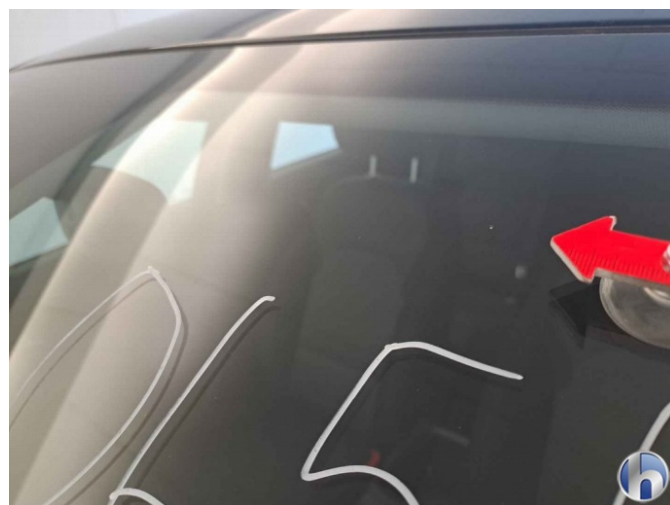
| component | Damage | Rep kind |
|---|---|---|
| 17. Windshield | Chipping from stones in field of view | Replace |

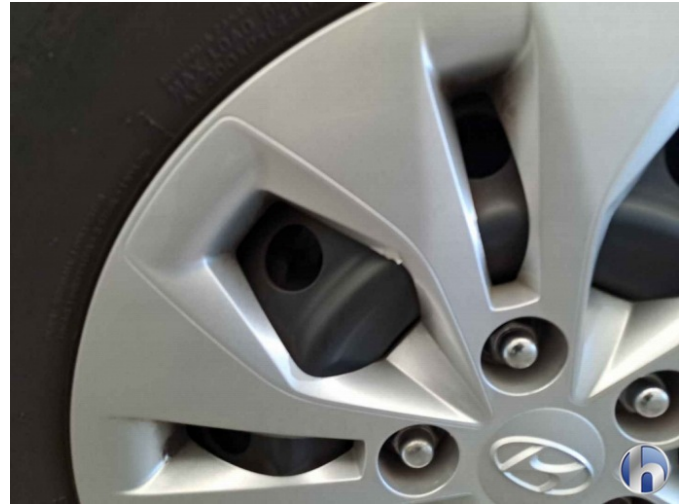
| component | Damage | Rep kind |
|---|---|---|
| 18. Radkappe - Vorne - Links | chipped paint | Replace |

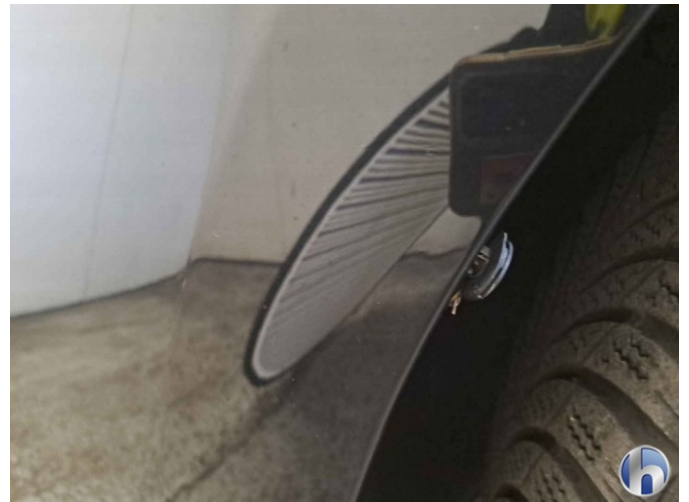
| component | Damage | Rep kind |
|---|---|---|
| 19. Front left wheel housing liner | Not okay | Replace |

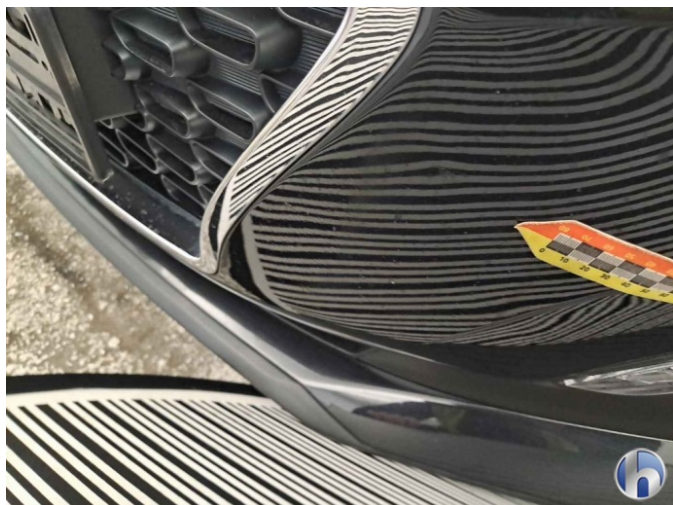
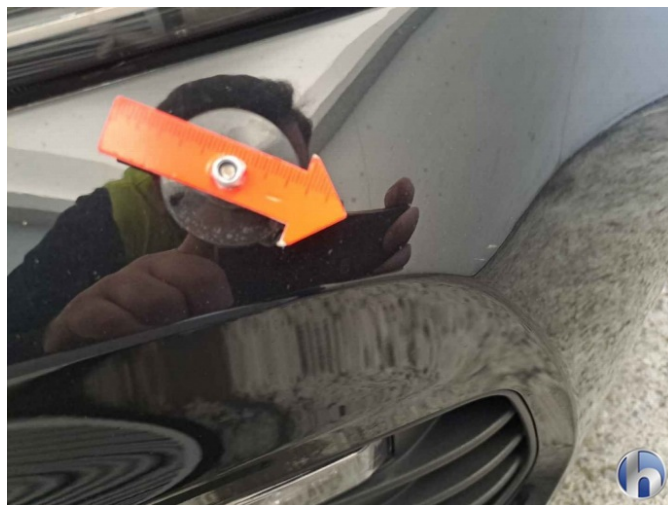
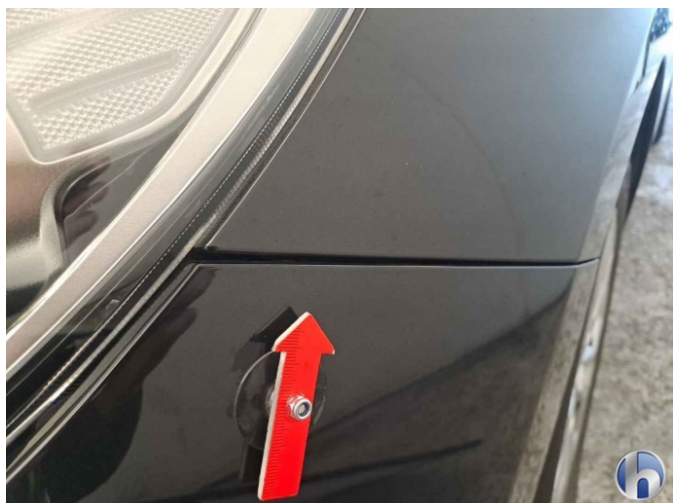
| component | Damage | Rep kind |
|---|---|---|
| 21. Front bumper | Damaged | Replace |

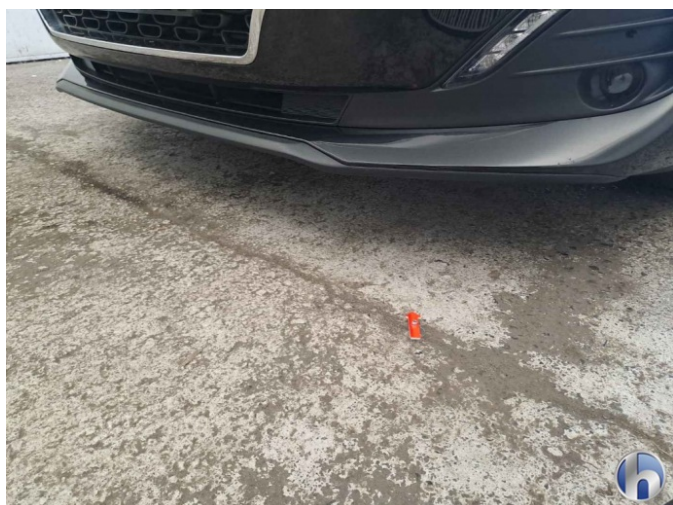
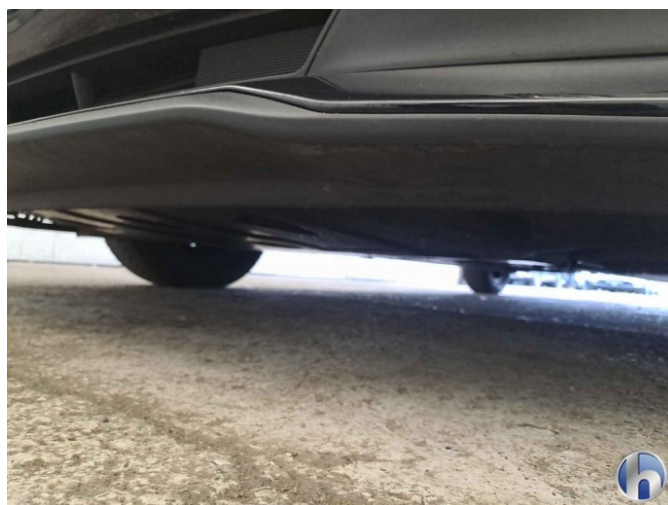
| component | Damage | Rep kind |
|---|---|---|
| 22. spoiler | Damaged | Replace |

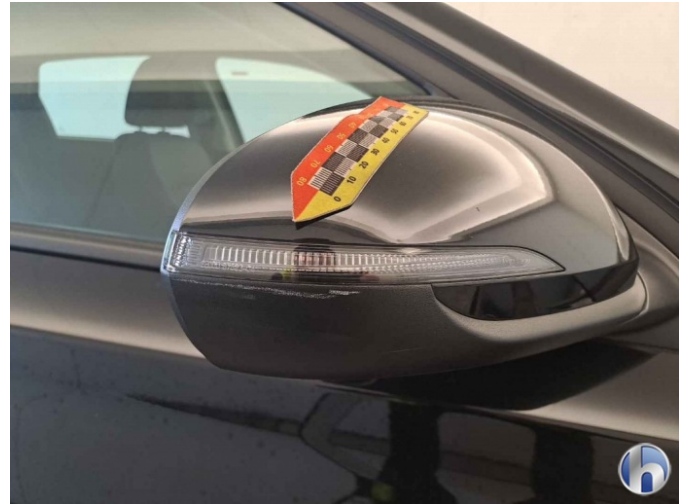
| component | Damage | Rep kind |
|---|---|---|
| 23. Outside mirror - right | Scrape | Smart repair |

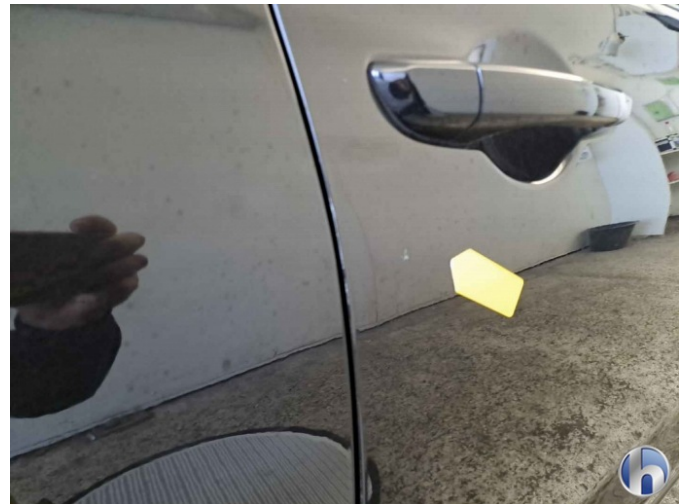
| component | Damage | Rep kind |
|---|---|---|
| 24. Front door - right | Scratch(es) | Paint |

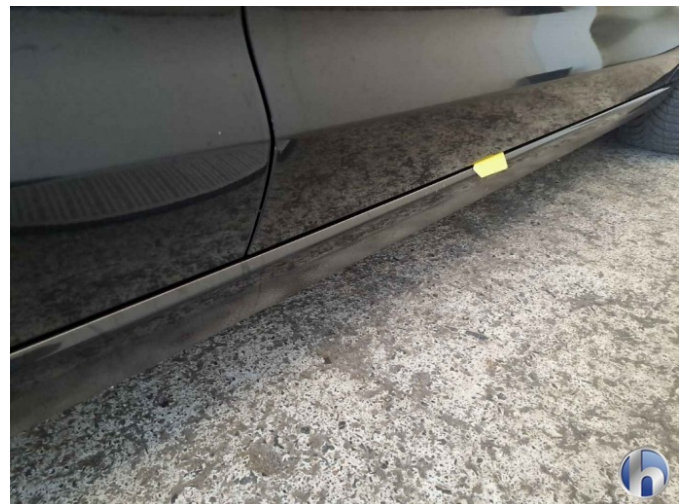
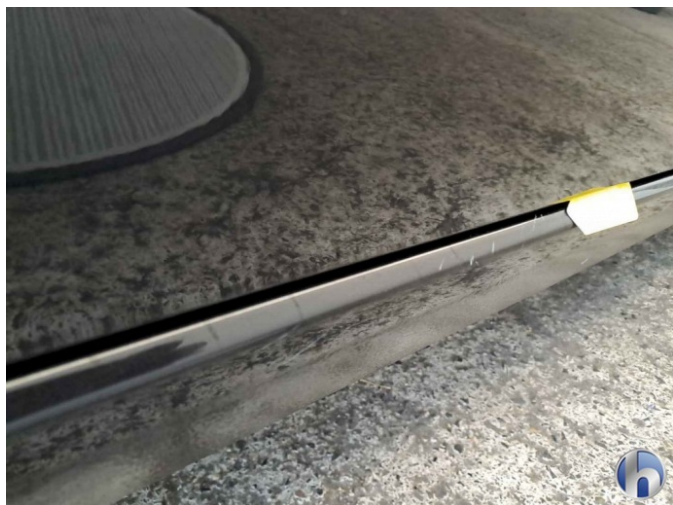
| component | Damage | Rep kind |
|---|---|---|
| 25. side skirt - right | Scratch(es) | Paint |

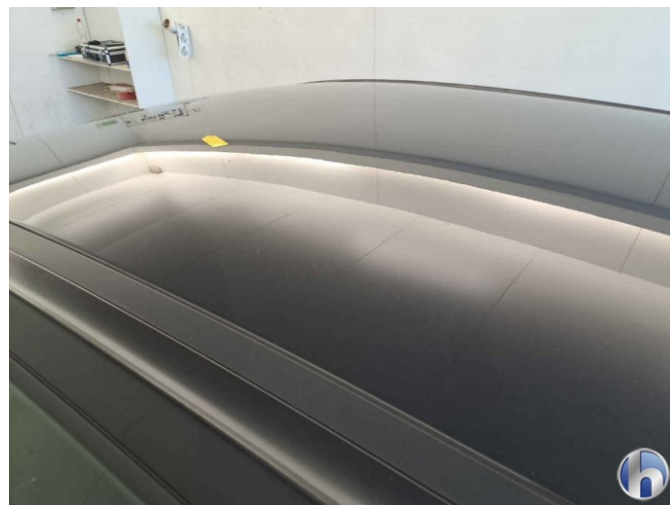
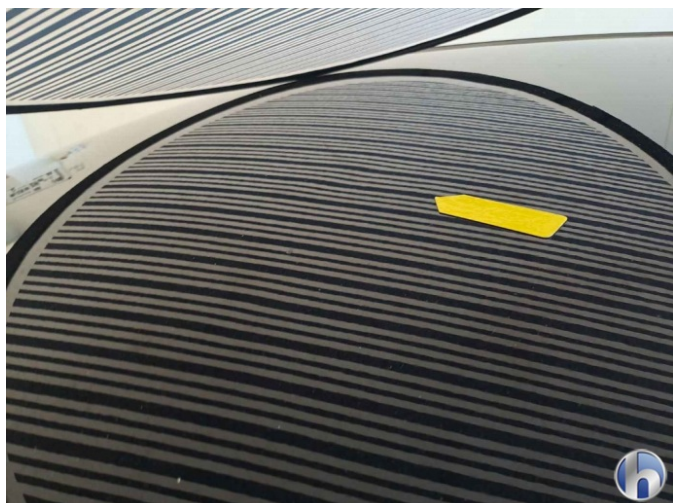
| component | Damage | Rep kind |
|---|---|---|
| 26. roof | Deformed | Refurbish and paint |

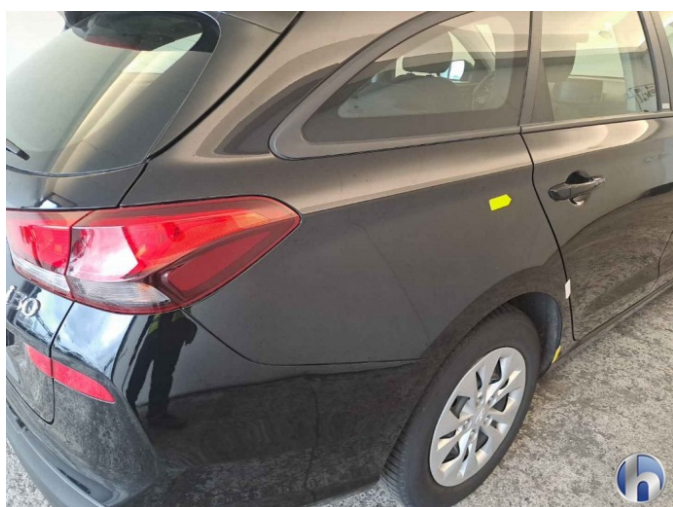
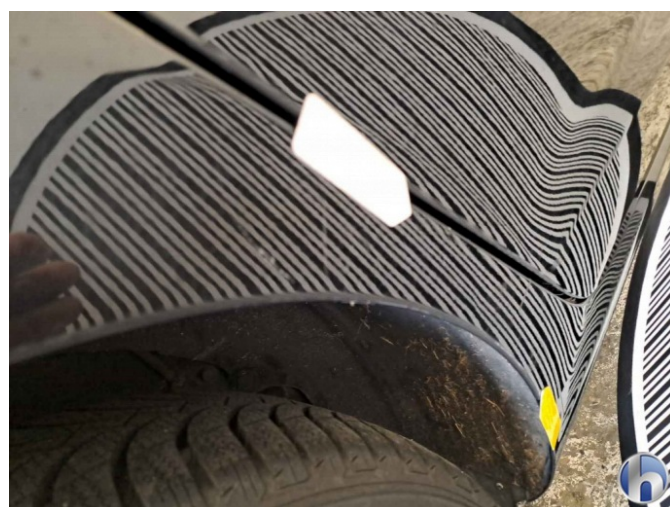
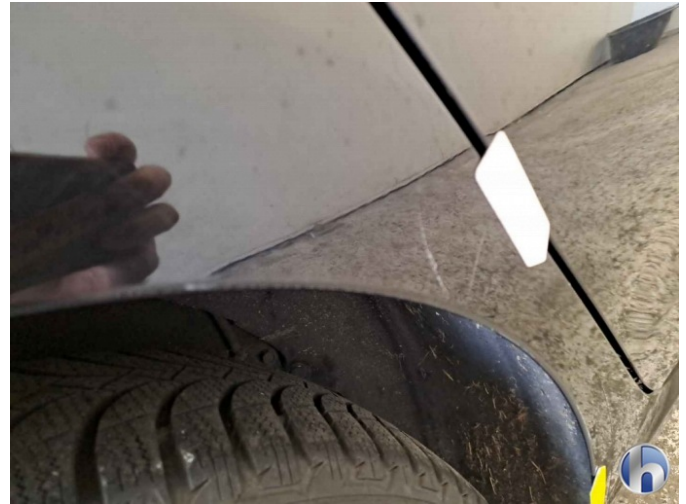
| component | Damage | Rep kind |
|---|---|---|
| 27. Sidewall - Rear - right | Damaged | Refurbish and paint |

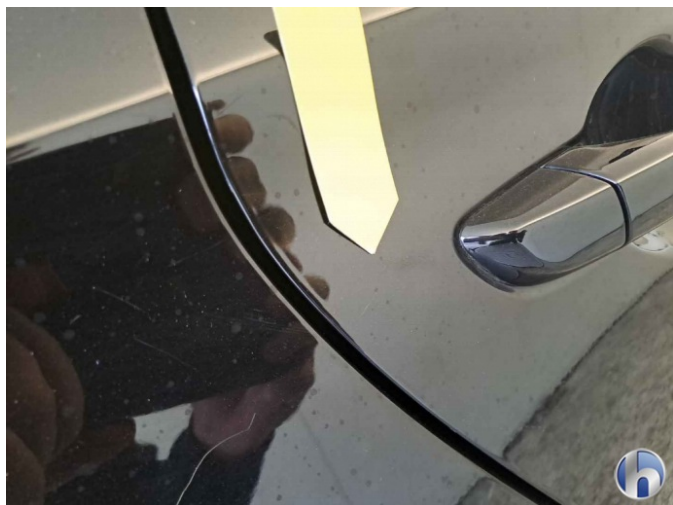
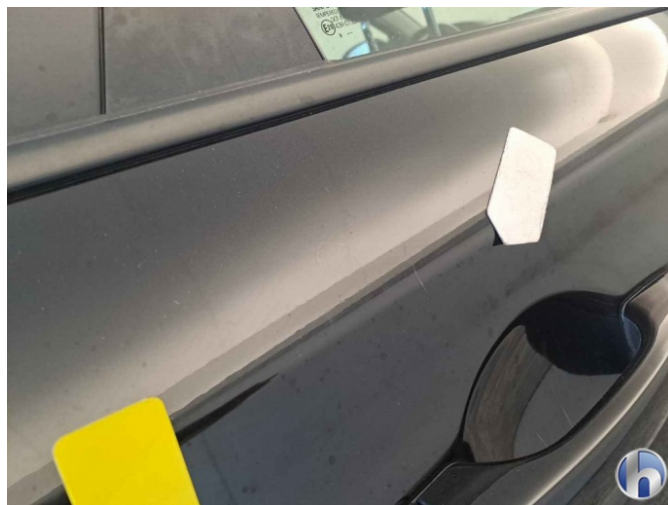
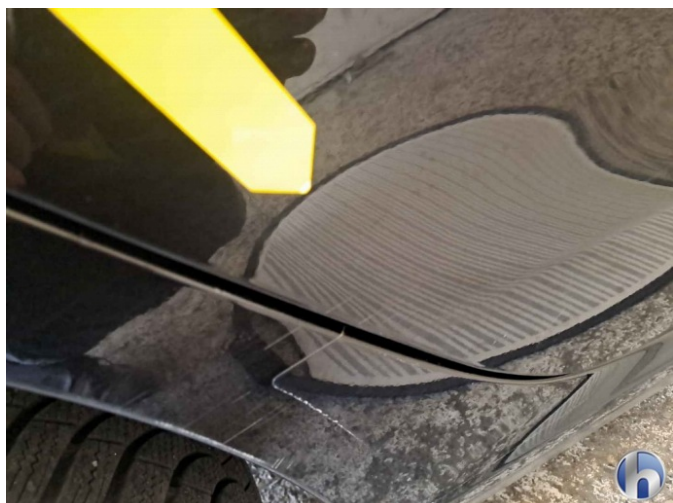
| component | Damage | Rep kind |
|---|---|---|
| 29. Door Rear - right | Scratch(es) | Paint |

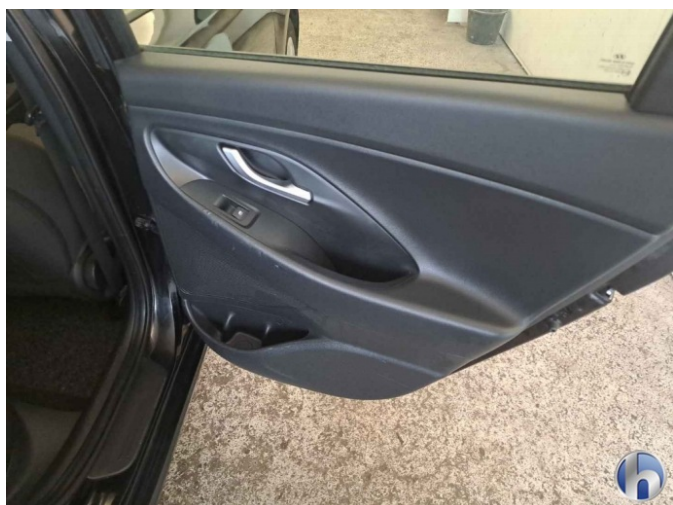
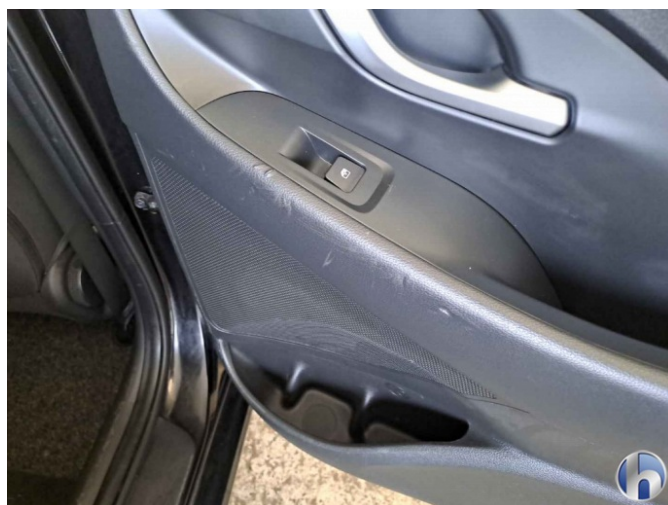
| component | Damage | Rep kind |
|---|---|---|
| 30. Door trim Rear - right | Damaged | Replace |

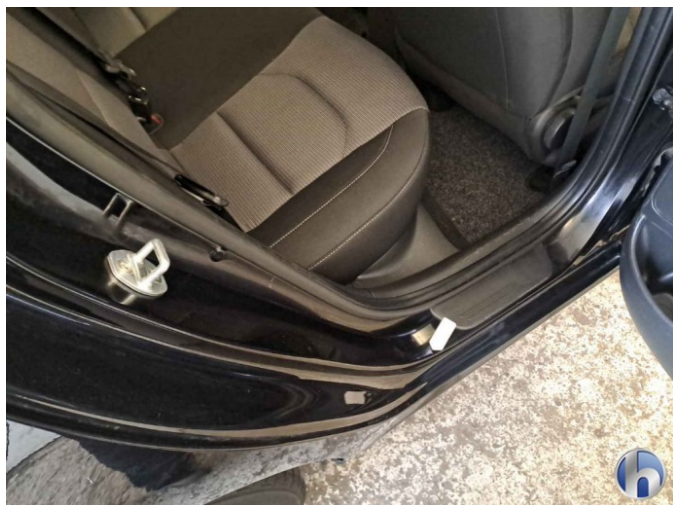
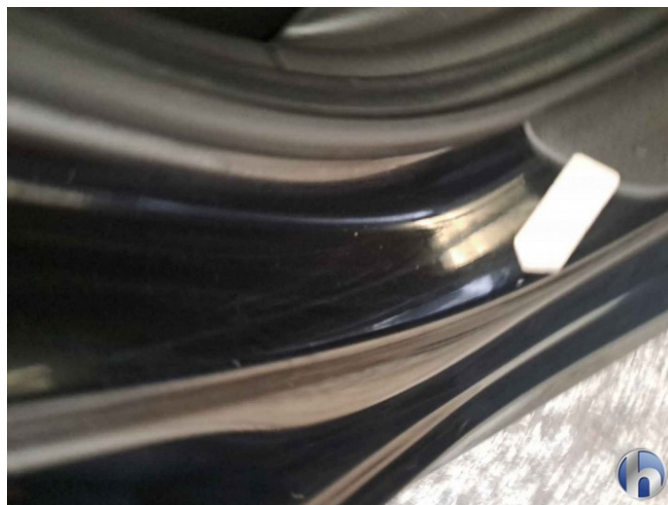
| component | Damage | Rep kind |
|---|---|---|
| 31. Türeinstieg Hinten - Rechts | Scratch(es) | Paint |

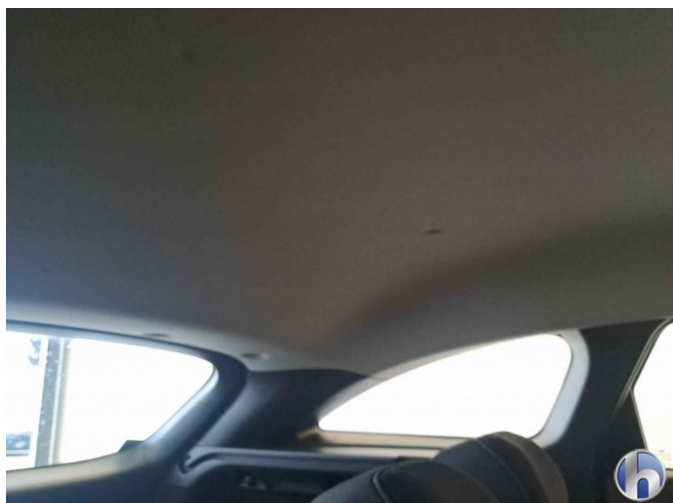
| component | Damage | Rep kind |
|---|---|---|
| 32. headlining | Damaged | Replace |

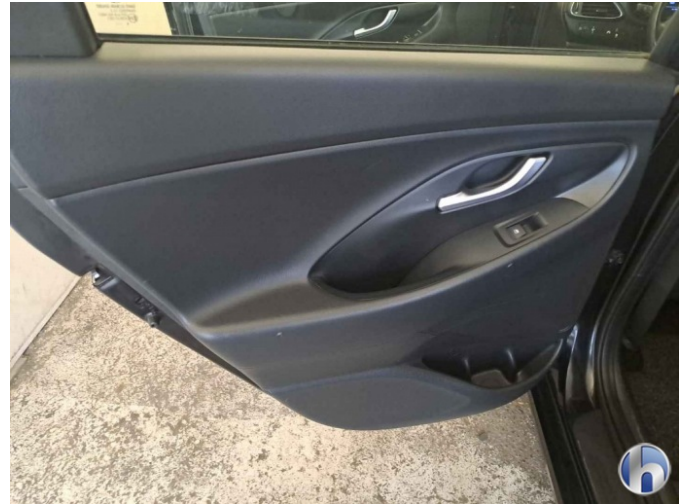
| component | Damage | Rep kind |
|---|---|---|
| 34. Rear door trim - left | Damaged | Replace |

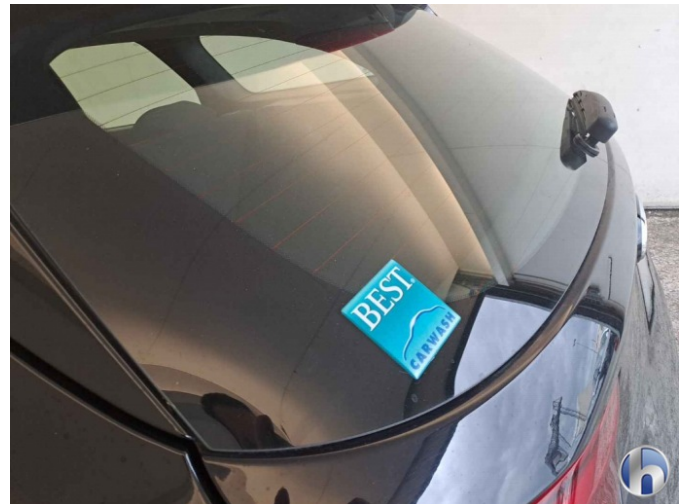
| component | Damage | Rep kind |
|---|---|---|
| 35. exterior body | Sticker | |

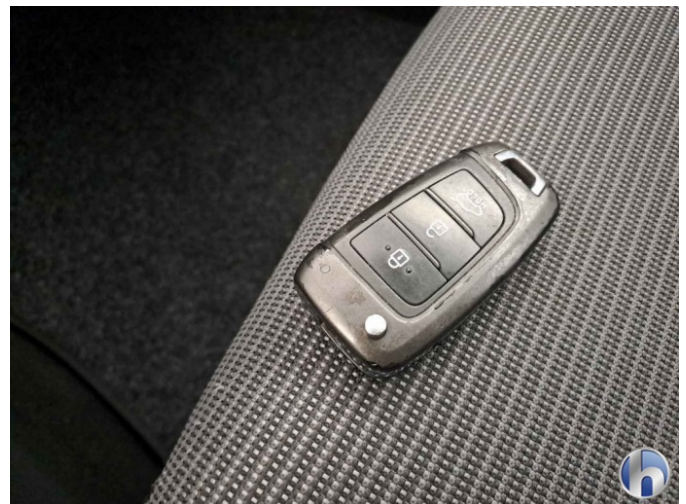
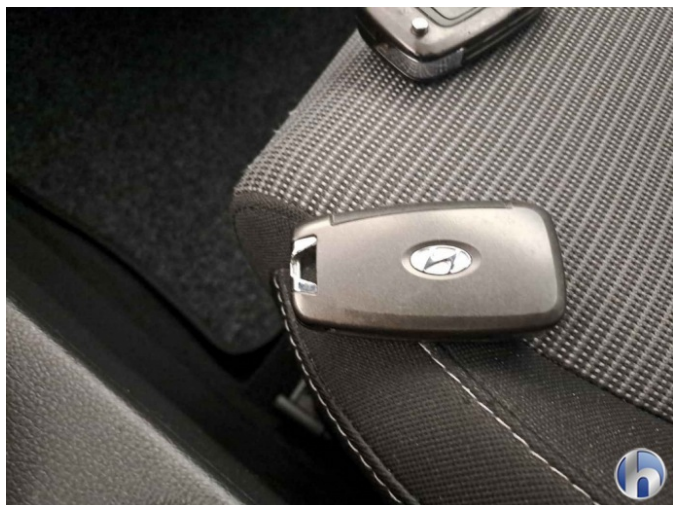
| component | Damage | Rep kind |
|---|---|---|
| 36. Key with remote control | Wear and tear | acceptable |
