## status report

| <b>customer:</b> | <b>Bank 11, Neuss</b> |

| vehicle data | | | |
|---|---|---|---|
| <b>Hyundai i30 N Performance</b> | | | |
| Vehicle identification number | <b>TMAHC51AALJ018670</b> | mileage read: | <b>120005 km</b> |

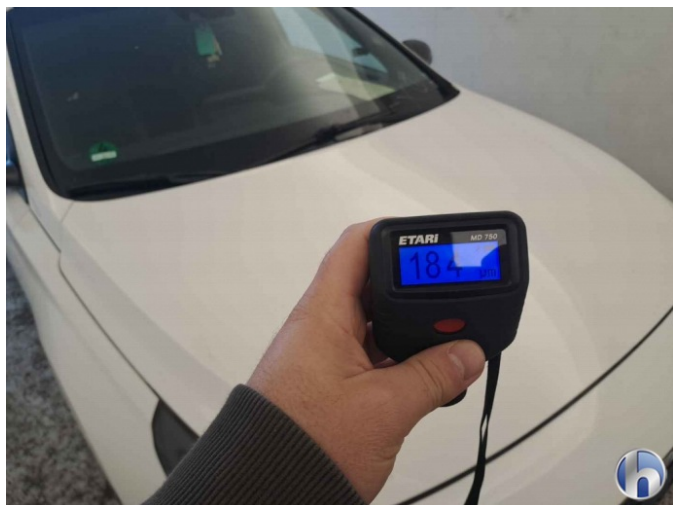
| component | Damage | Rep kind |
|---|---|---|
| 1. hood | Subsequently painted | acceptable |

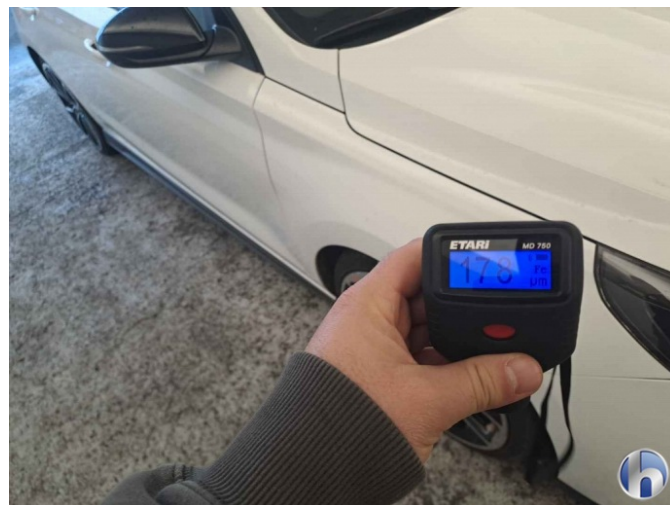
| component | Damage | Rep kind |
|---|---|---|
| 2. Front fender - right | Subsequently painted | acceptable |

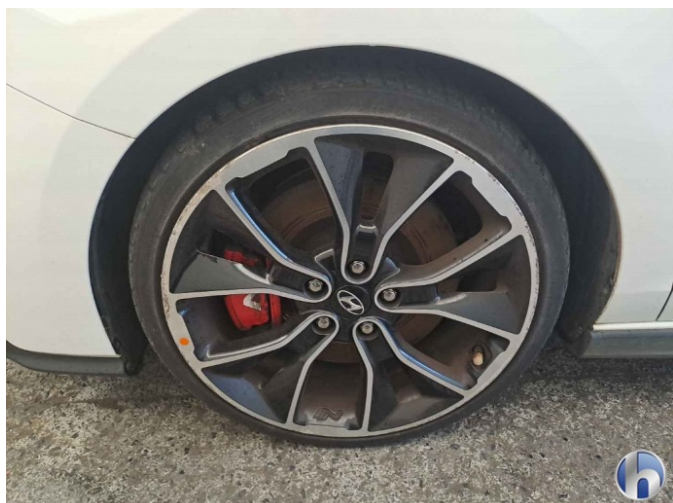
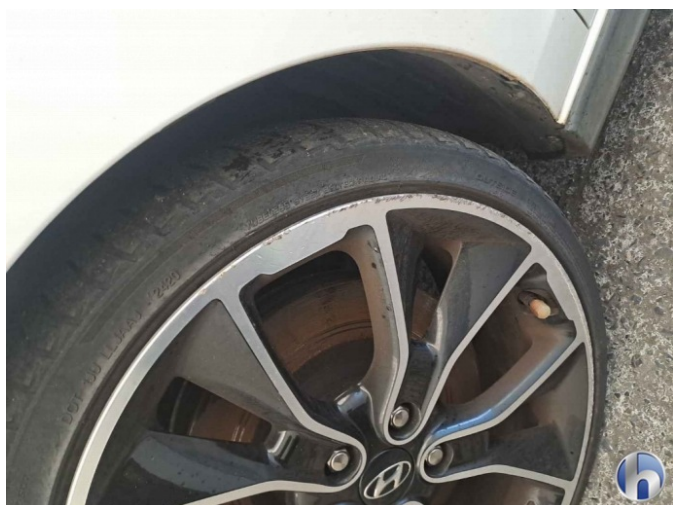
| component | Damage | Rep kind |
|---|---|---|
| 3. Rim front - left | Scratch(es) | Replace |

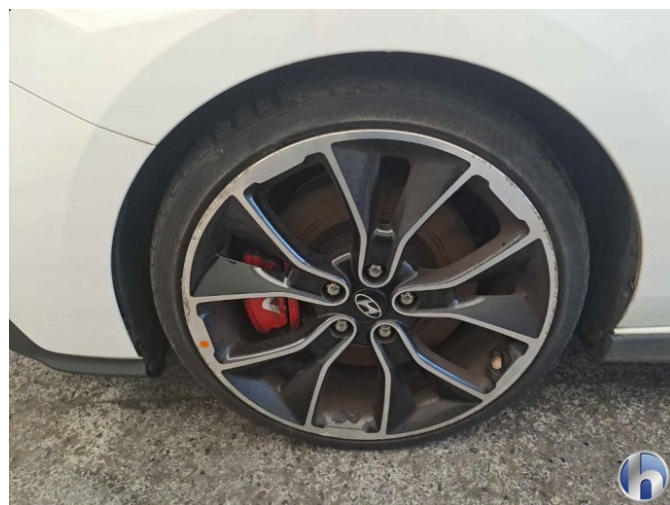
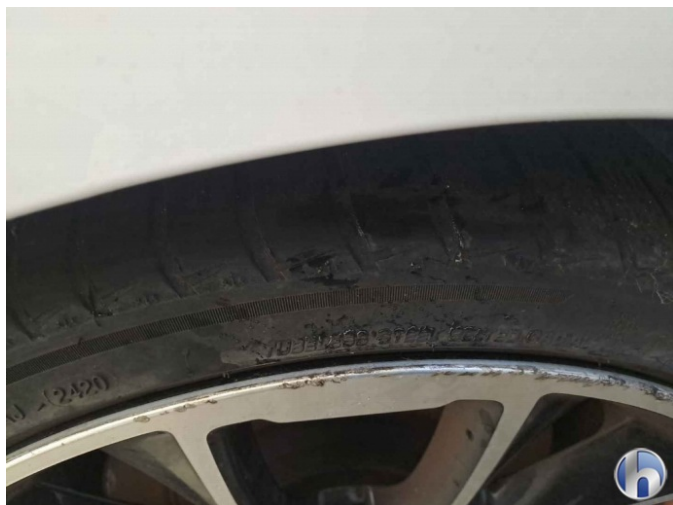
**Note Road Safe:** Reifen beschädigt.

| component | Damage | Rep kind |
|---|---|---|
| 4. tire front - left | Damaged | Replace |

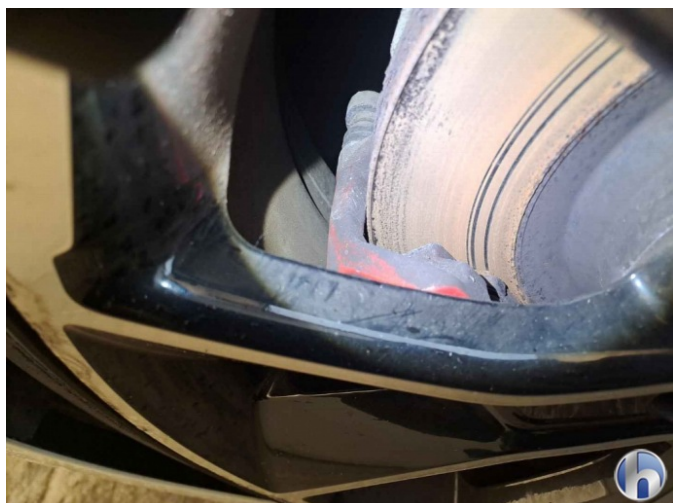
| component | Damage | Rep kind |
|---|---|---|
| 5. brake system | Worn | Replace |

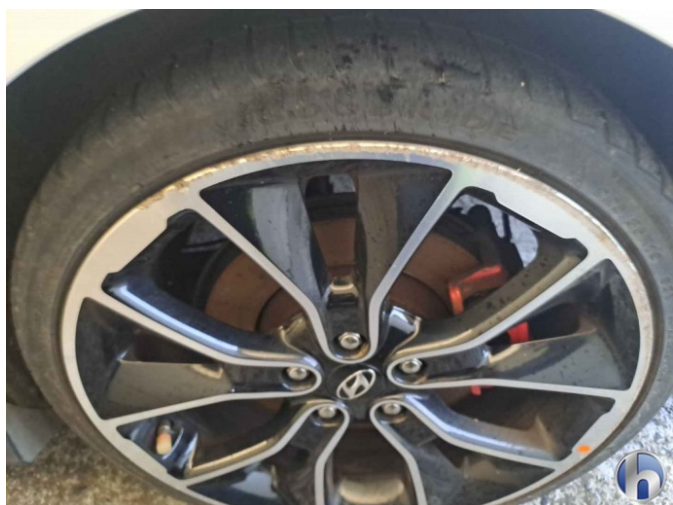
| component | Damage | Rep kind |
|---|---|---|
| 6. Rim rear - left | Scratch(es) | Replace |

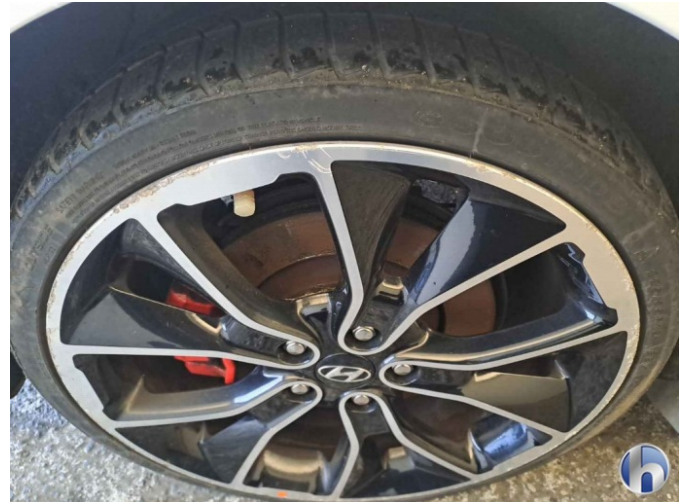
| component | Damage | Rep kind |
|---|---|---|
| 7. Rim rear - right | Scratch(es) | Replace |

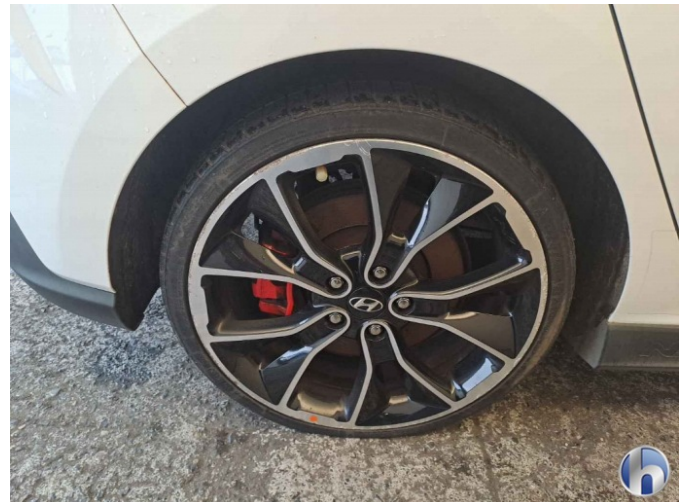
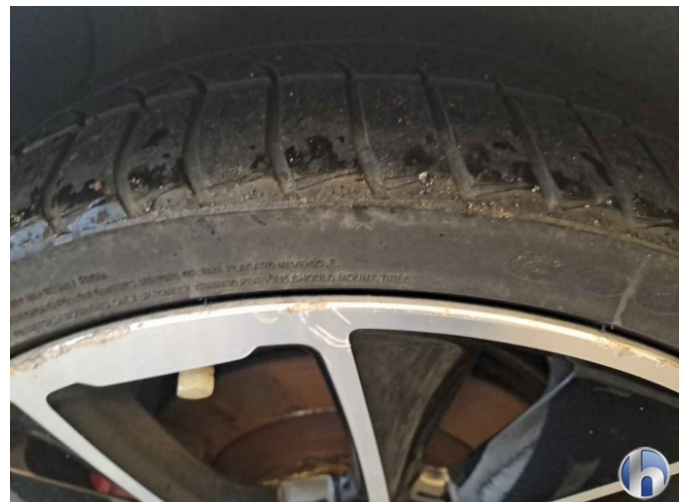
| component | Damage | Rep kind |
|---|---|---|
| 8. tire rear - right | Damaged | Replace |

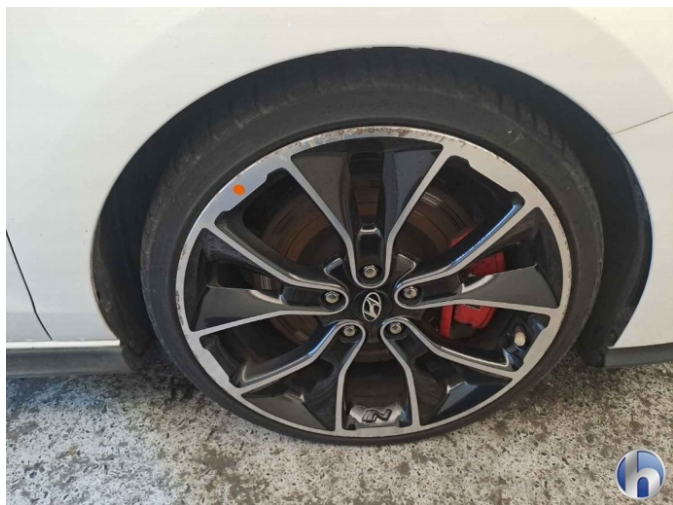
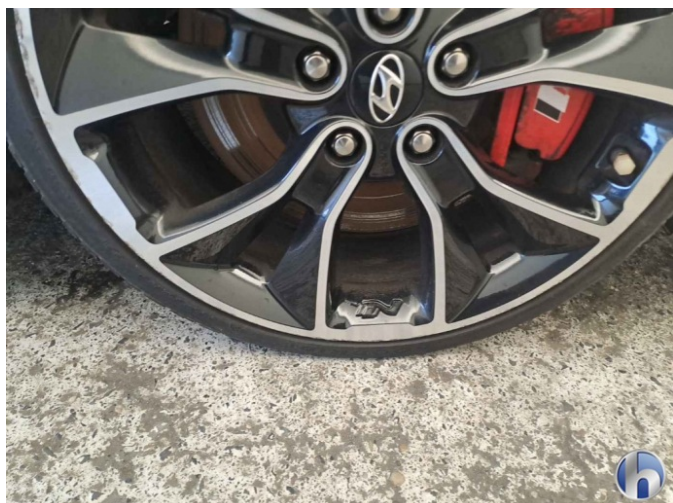
| component | Damage | Rep kind |
|---|---|---|
| 9. Rim front - right | Scratch(es) | Replace |

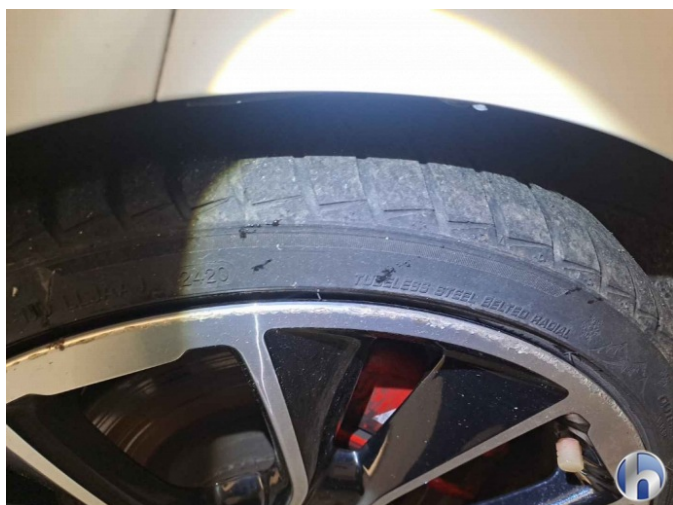
| component | Damage | Rep kind |
|---|---|---|
| 10. tire front - right | Worn | Replace |

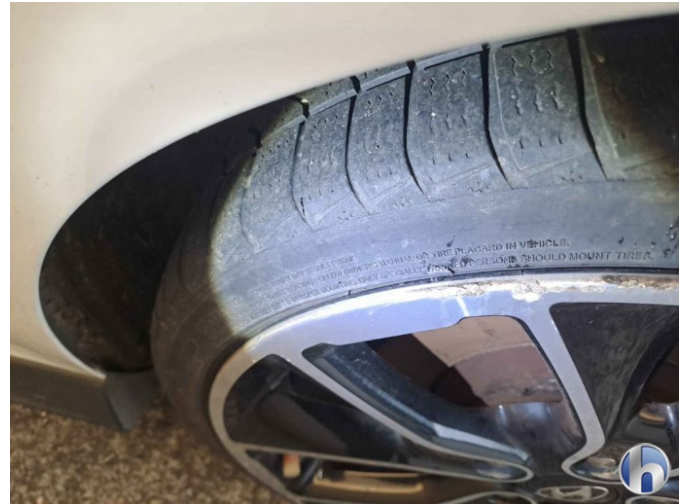
| component | Damage | Rep kind |
|---|---|---|
| 11. tire rear - left | Damaged | Replace |

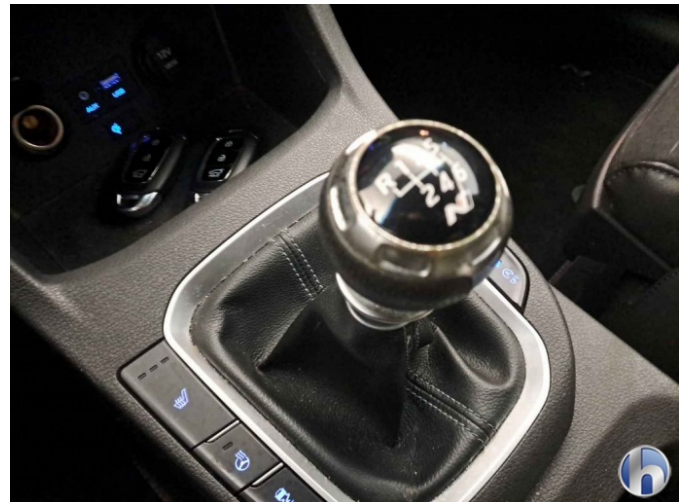
| component | Damage | Rep kind |
|---|---|---|
| 16. Schaltknauf | Damaged | Replace |

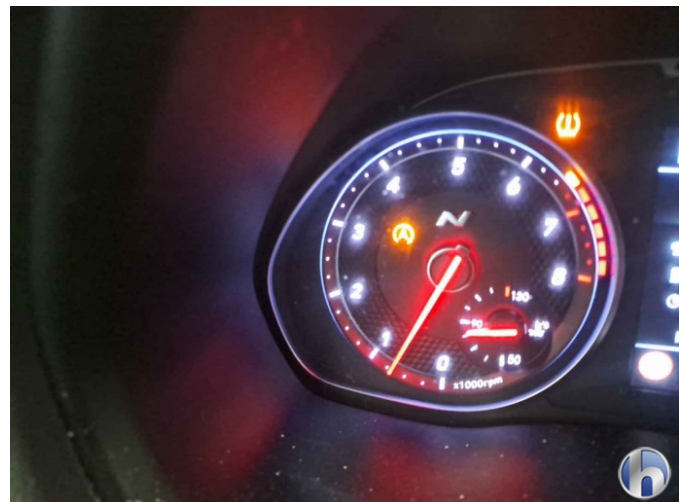
| component | Damage | Rep kind |
|---|---|---|
| 17. warning light | Error message | Carry out a fault diagnosis |

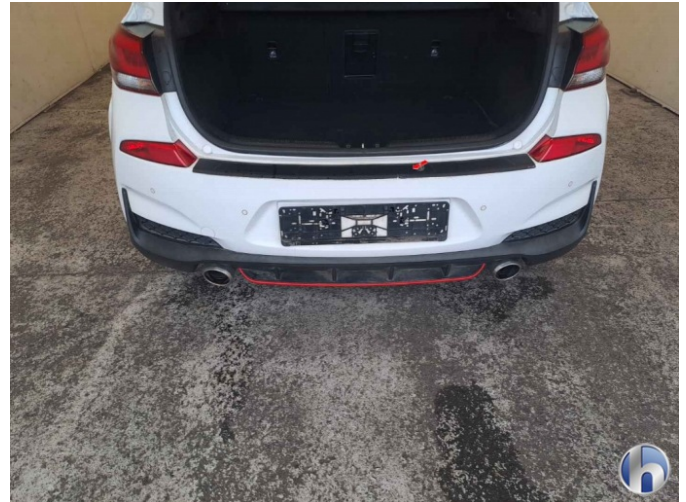
| component | Damage | Rep kind |
|---|---|---|
| 19. Rear bumper | Damaged | Replace |

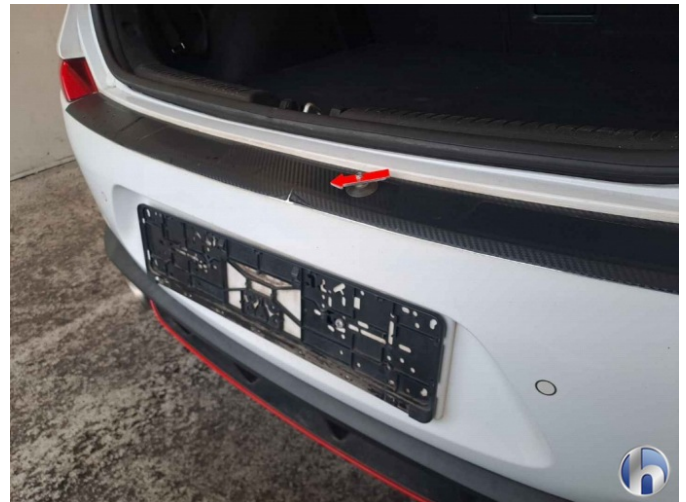
| component | Damage | Rep kind |
|---|---|---|
| 20. Laderaum Kantenschutz | Damaged | Replace |

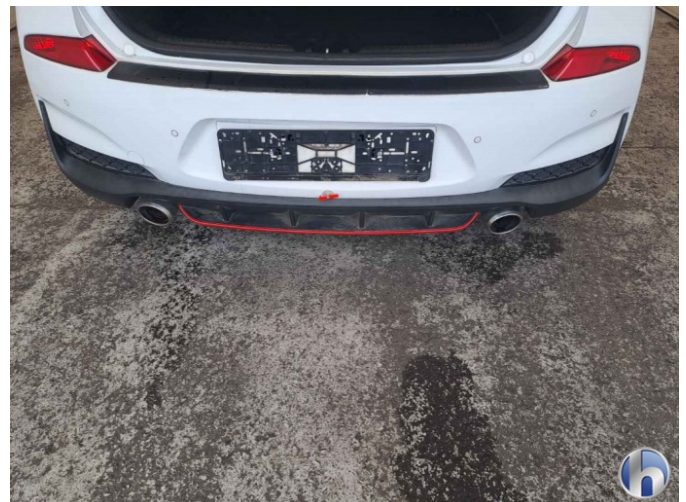
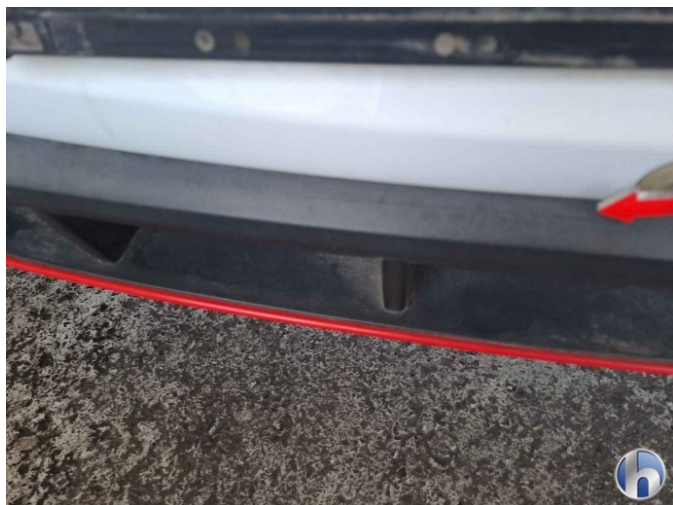
| component | Damage | Rep kind |
|---|---|---|
| 21. Diffusor | Scratch(es) | Replace |

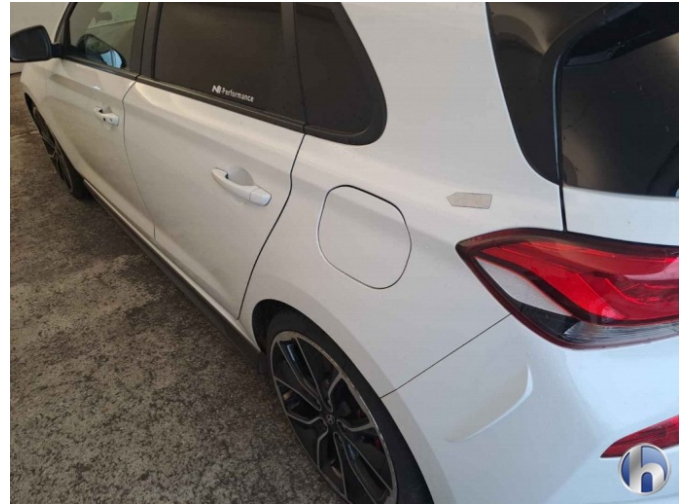
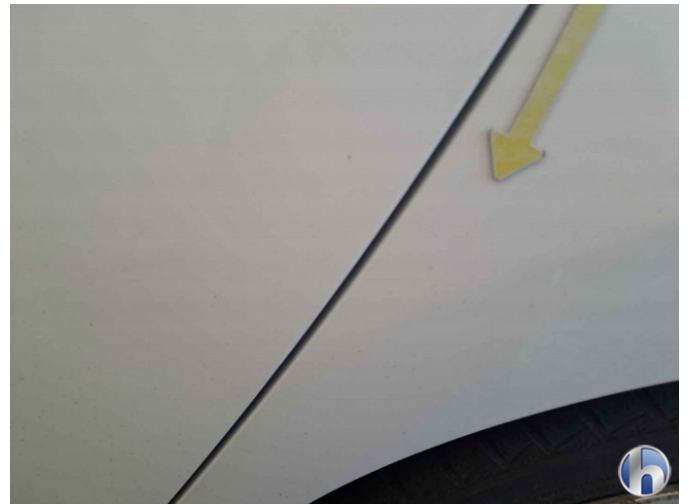
| component | Damage | Rep kind |
|---|---|---|
| 25. Sidewall - Rear - Left | Damaged | Refurbish and paint |

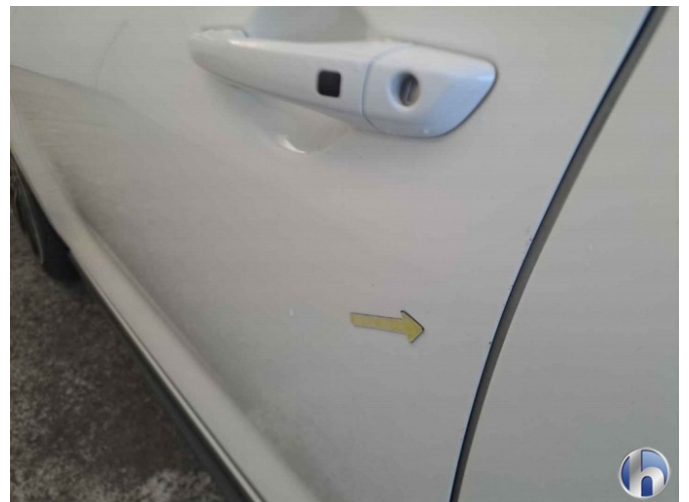
| component | Damage | Rep kind |
|---|---|---|
| 26. Front door - left | Scratch(es) | Paint |

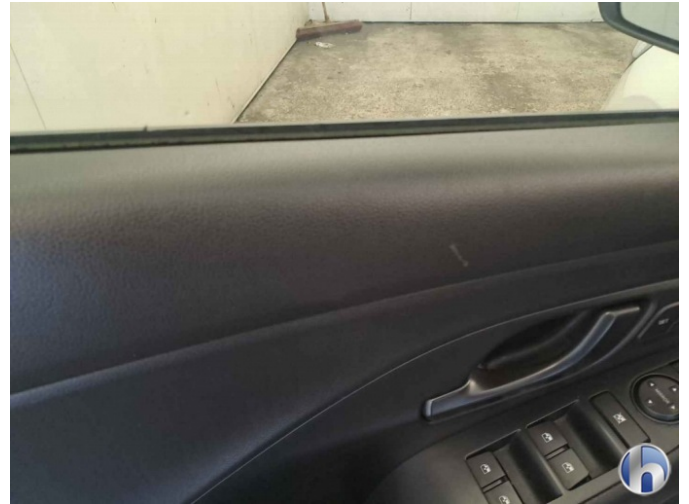
| component | Damage | Rep kind |
|---|---|---|
| 27. Front door trim - left | Scrape | Replace |

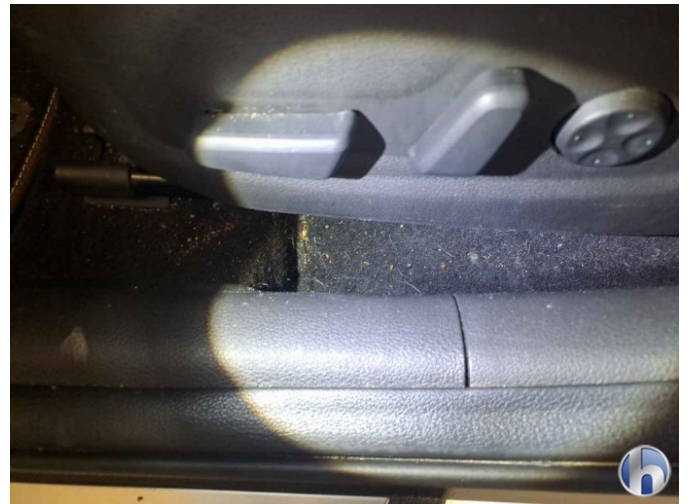
| component | Damage | Rep kind |
|---|---|---|
| 29. flooring | Burn hole | Replace |

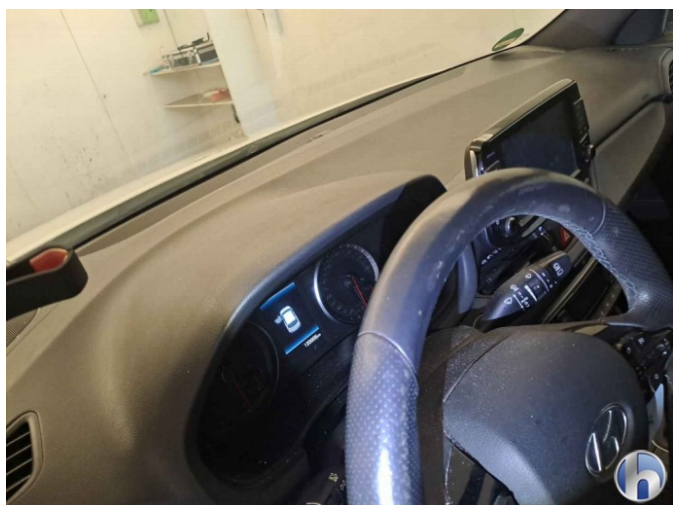
| component | Damage | Rep kind |
|---|---|---|
| 33. Steering wheel (leather) | Scrape | Replace |

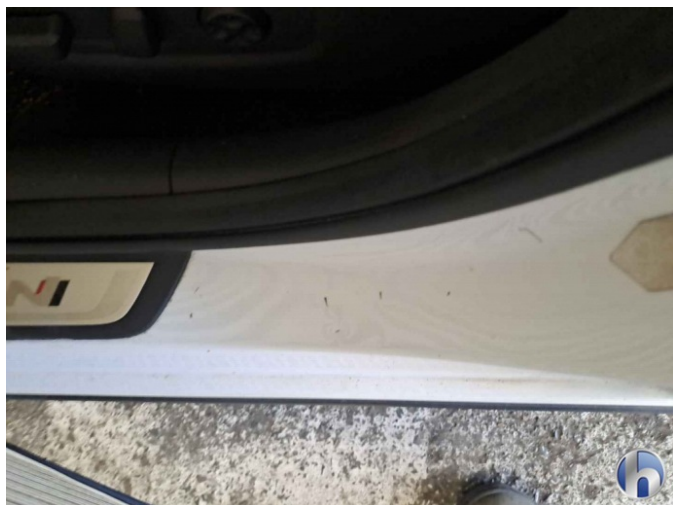
| component | Damage | Rep kind |
|---|---|---|
| 34. Türeinstieg Vorne - Links | Damaged | Refurbish and paint |

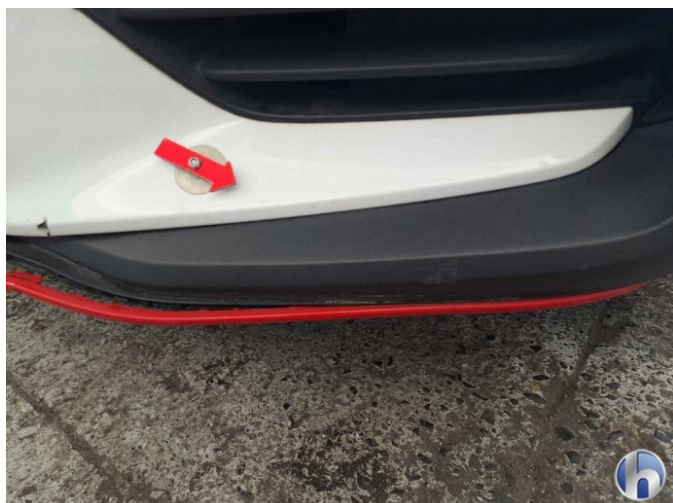
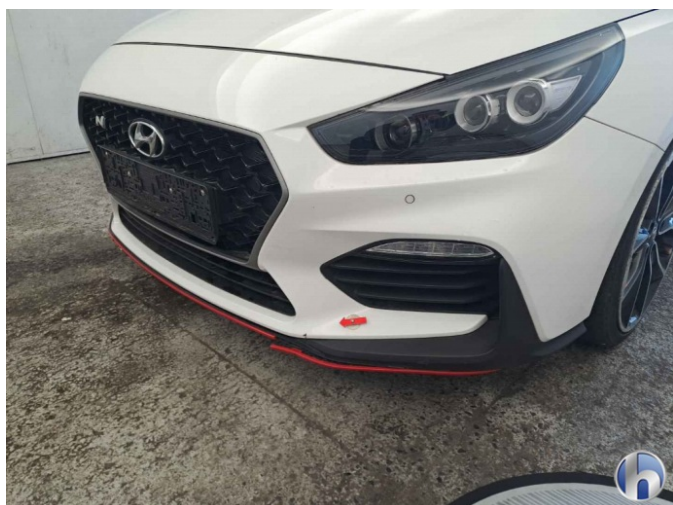
| component | Damage | Rep kind |
|---|---|---|
| 35. spoiler | Damaged | Replace |

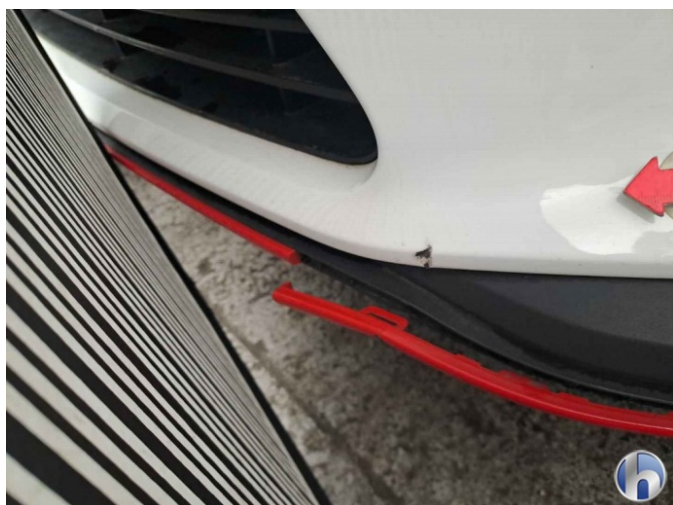
| component | Damage | Rep kind |
|---|---|---|
| 36. Front bumper | Damaged | Replace |

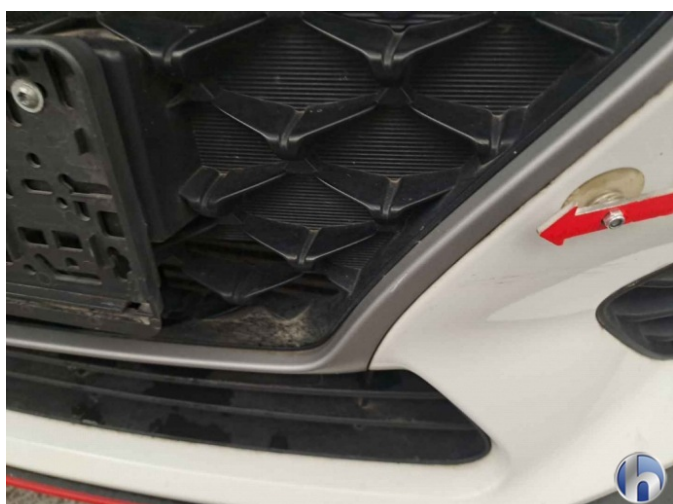
| component | Damage | Rep kind |
|---|---|---|
| 37. Front grille top | Scrape | Replace |

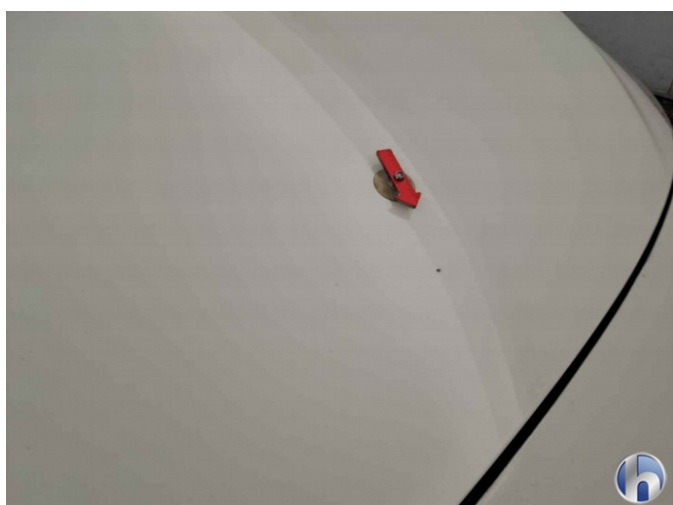
| component | Damage | Rep kind |
|---|---|---|
| 38. hood | Damaged | Refurbish and paint |

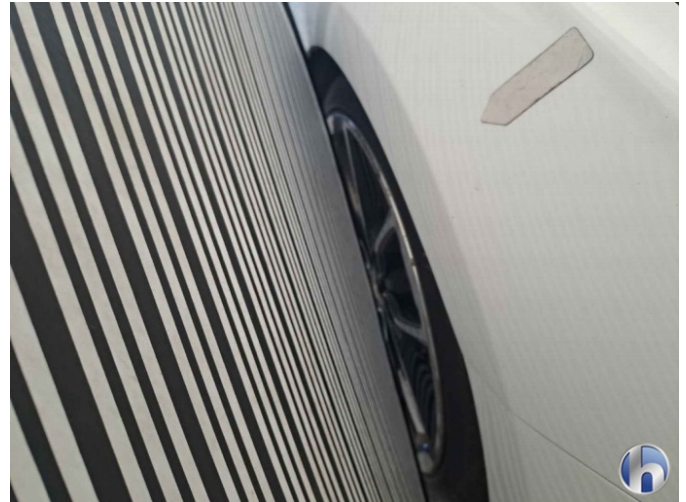
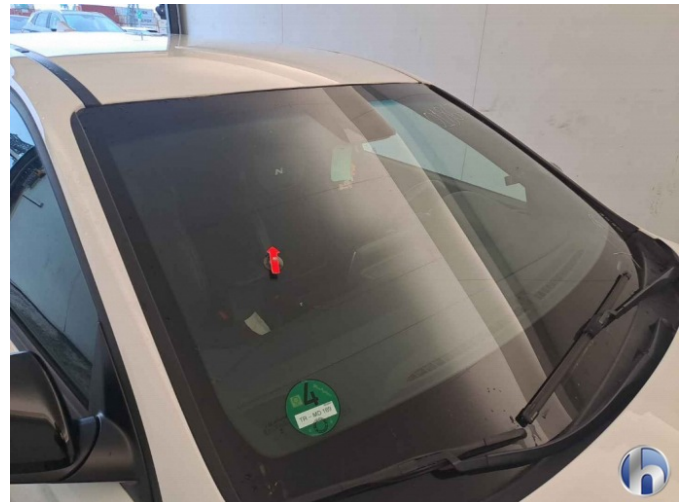
| component | Damage | Rep kind |
|---|---|---|
| 39. Front fender - right | Execution defect | Replace |

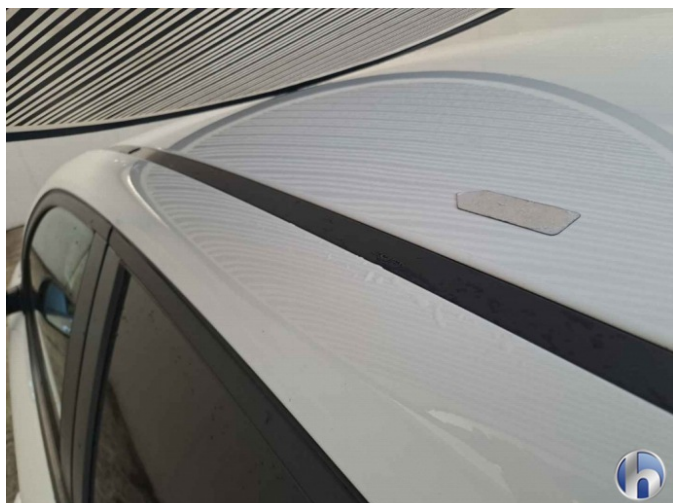
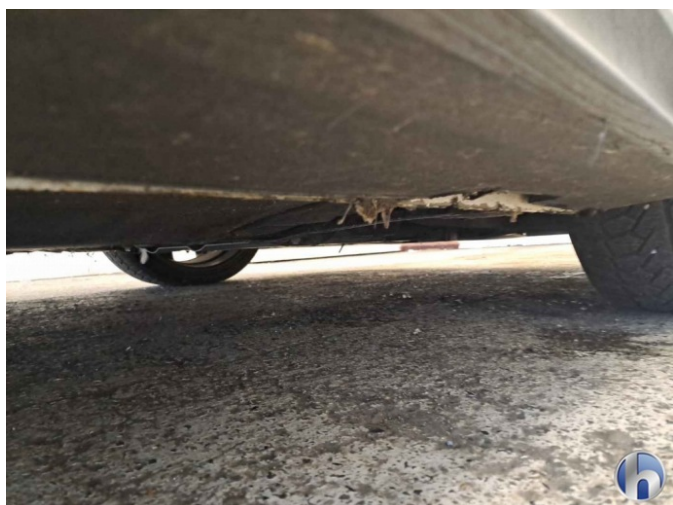
42. roof

| 42. | roof | Deformed | Refurbish and paint |

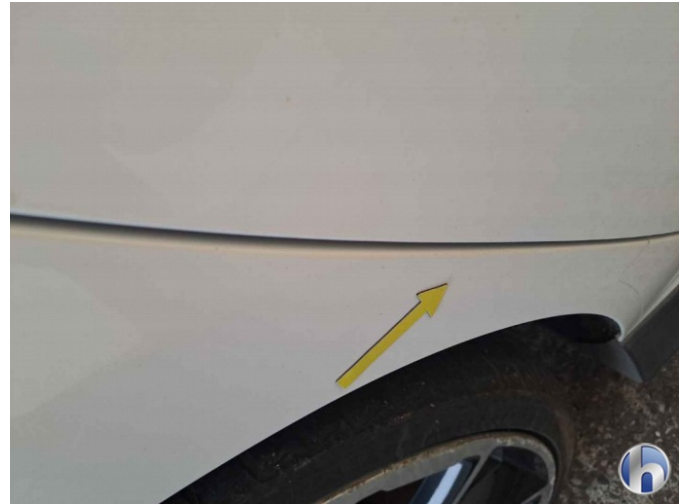
47. Sidewall - Rear - right

| 47. | Sidewall - Rear - right | Wear and tear | acceptable |

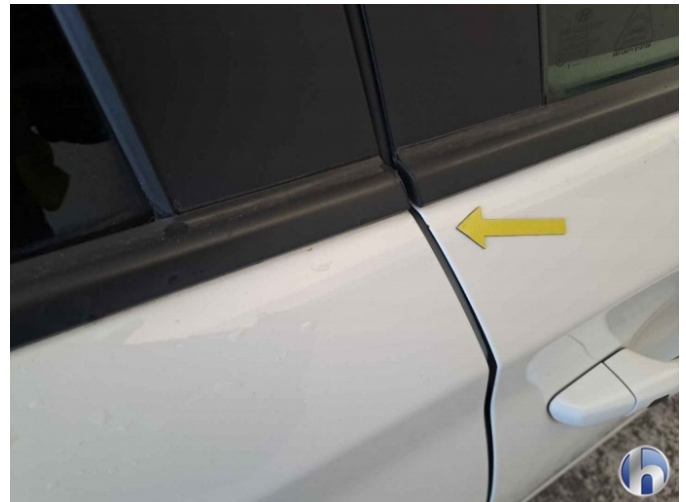
48. Front door - right

| 48. | Front door - right | Wear and tear | acceptable |

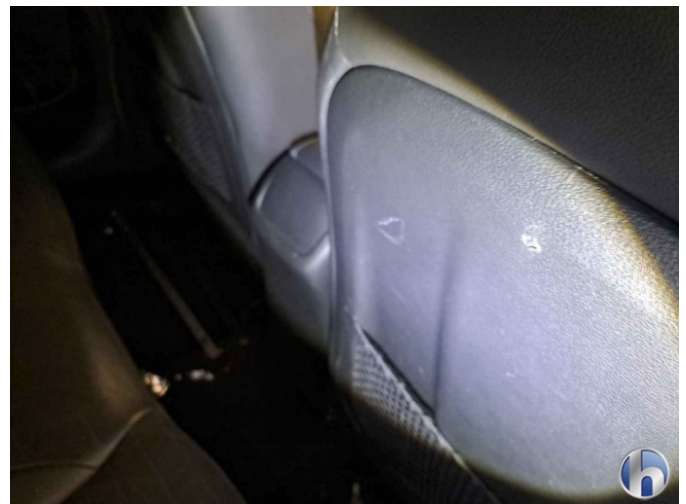
49. Sitz - Vorne - Rechts: Lehne (Verkleidung)

| 49. | Sitz - Vorne - Rechts: Lehne (Verkleidung) | Damaged | Replace |

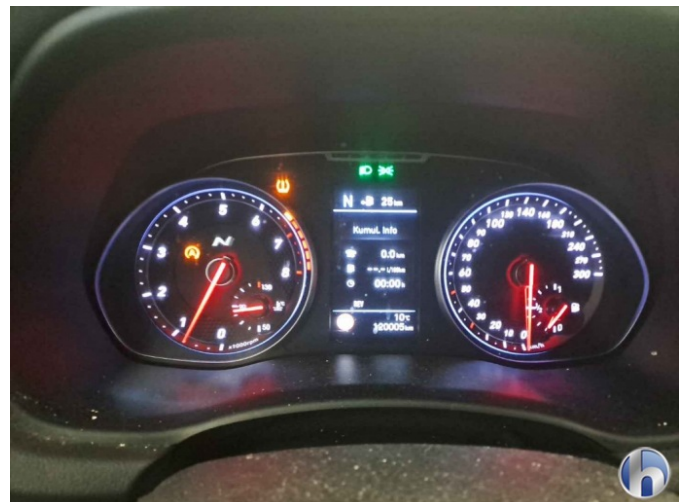
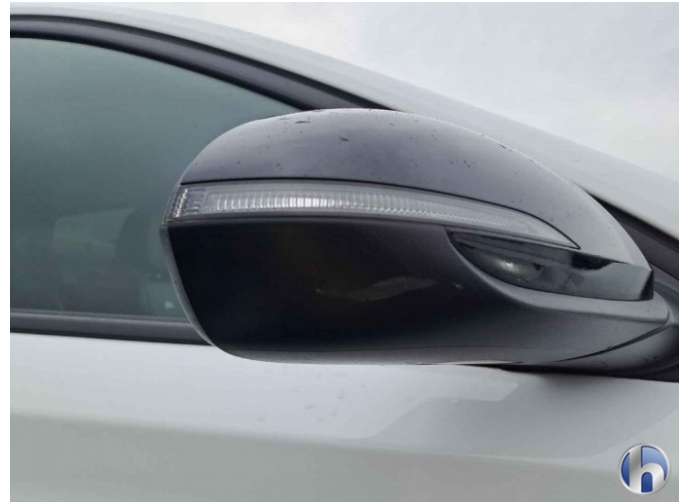
52. instrument cluster

| 52. | instrument cluster | Scratch(es) | Replace |

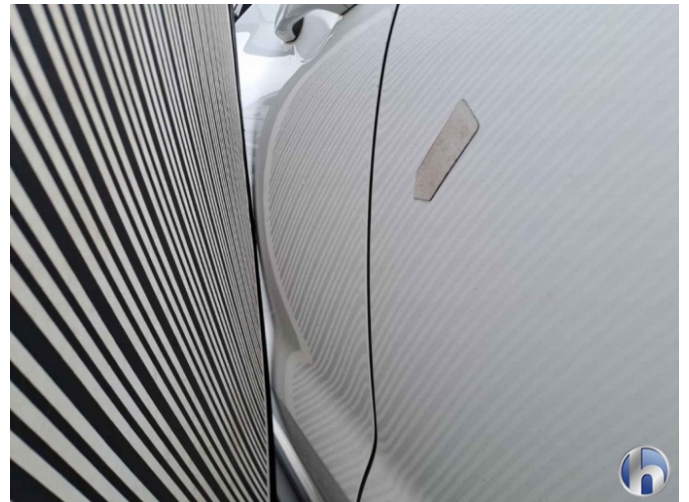
54. Rear door - left

| 54. | Rear door - left | Deformed | Refurbish and paint |

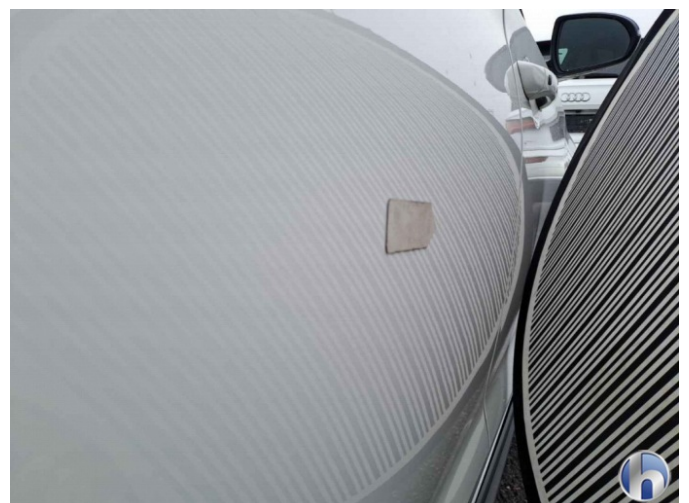
55. Door Rear - right

| 55. | Door Rear - right | Deformed | Refurbish and paint |

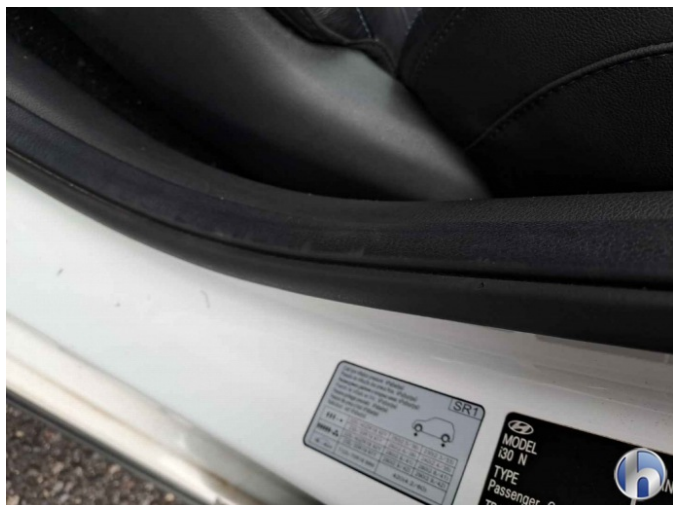
56. Front door seal - left

| 56. | Front door seal - left | Damaged | Replace |
