status report

Hyundai i30 N Project C

| Vehicle identification number | TMAHC51AALJ022948 | mileage read: | 36575 km |

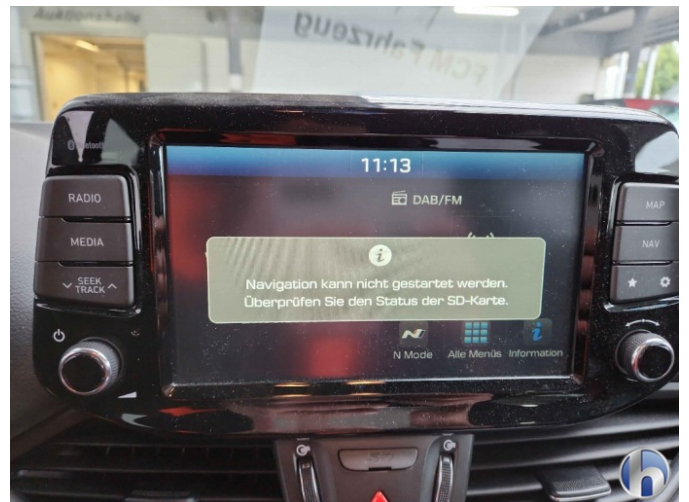
Navigation system

| reference: | *Navigation keine SD-Karte |

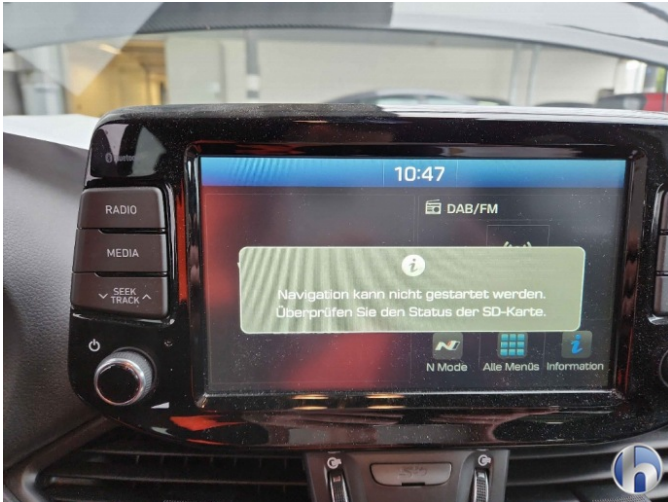
| component | Damage | Rep kind |
|---|---|---|
| 1. | Missing | Replace |

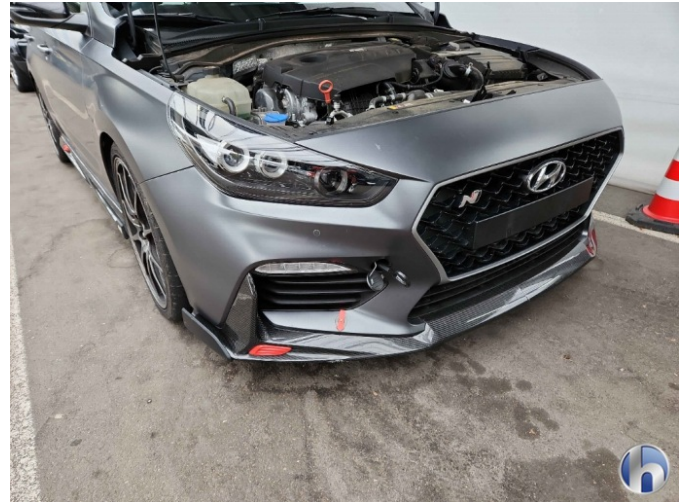
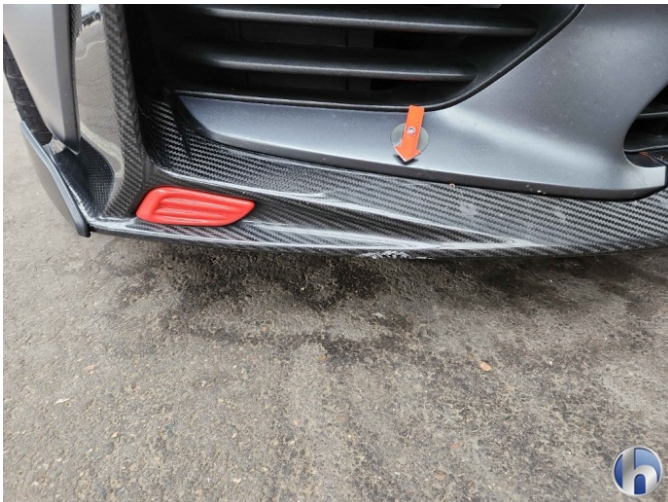
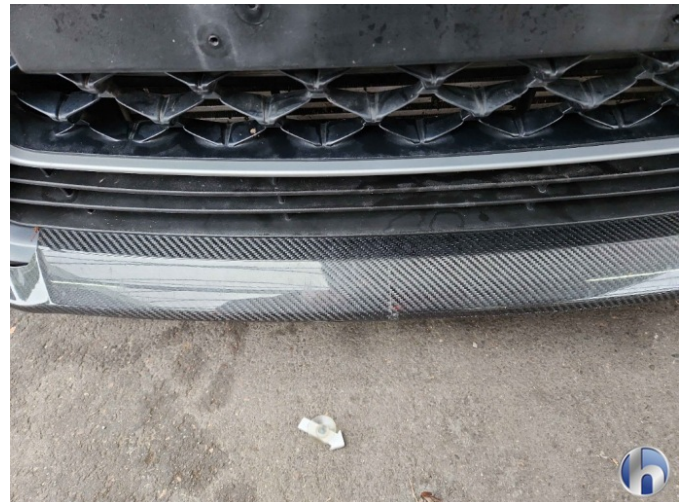
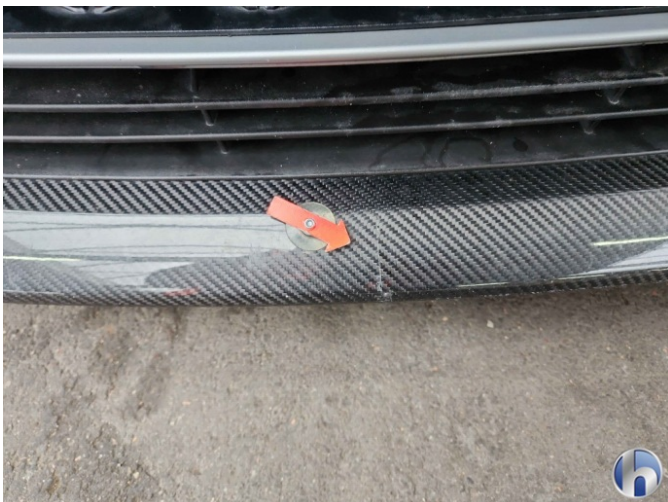
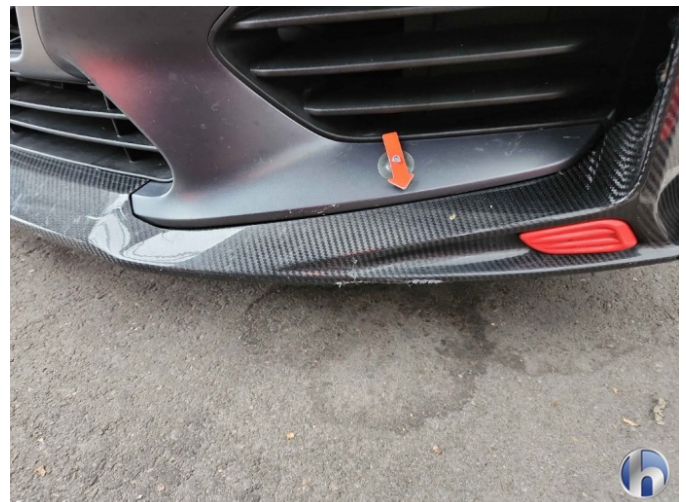
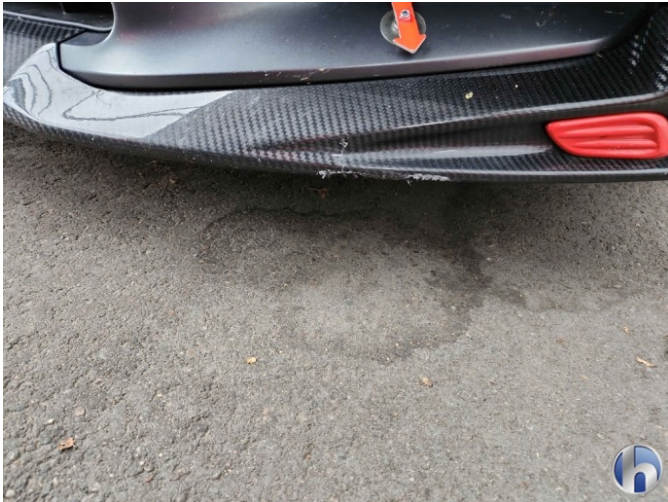
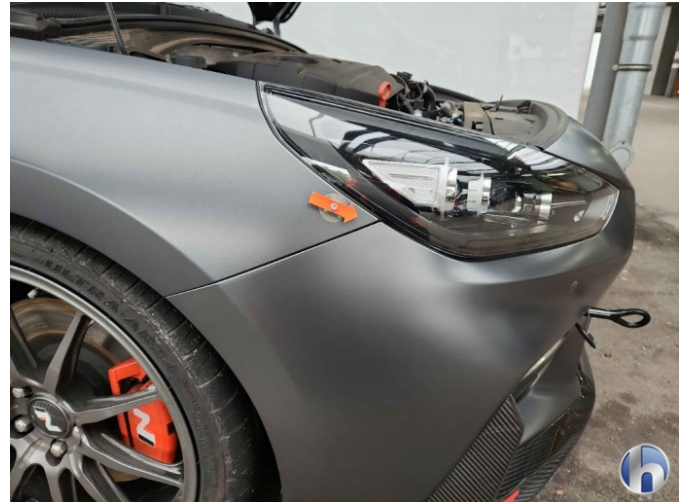
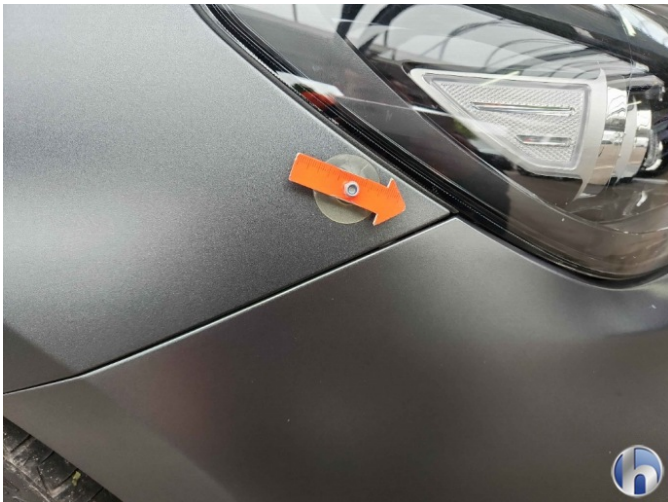
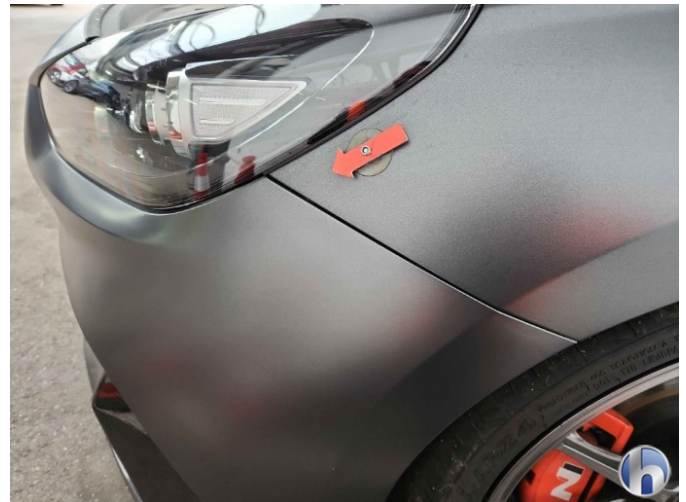
| component | Damage | Rep kind |
|---|---|---|
| 2. Front bumper | Damaged | Replace |

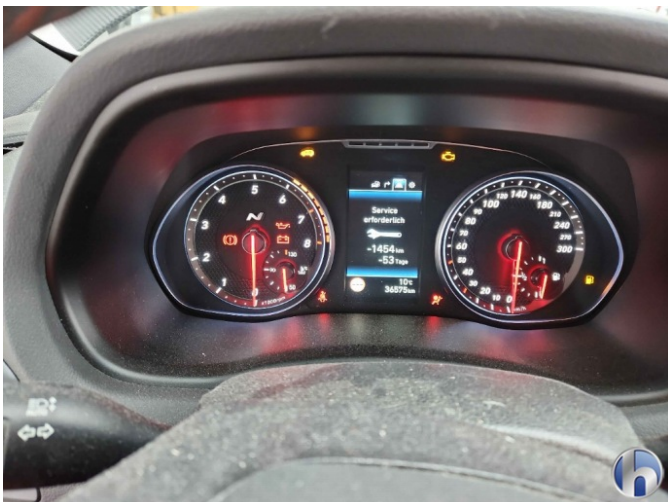
| component | Damage | Rep kind |
|---|---|---|
| 3. Service | Due | Replace |
