# HYUNDAI Tucson 2018 Diesel

## Tucson 1.6 crdi 48V NLine Safety&Sound Pack 2wd 13

VIN NO TMAJ3817GLJ124879  
Registration Number GD533HB

### Inspection Report Summary

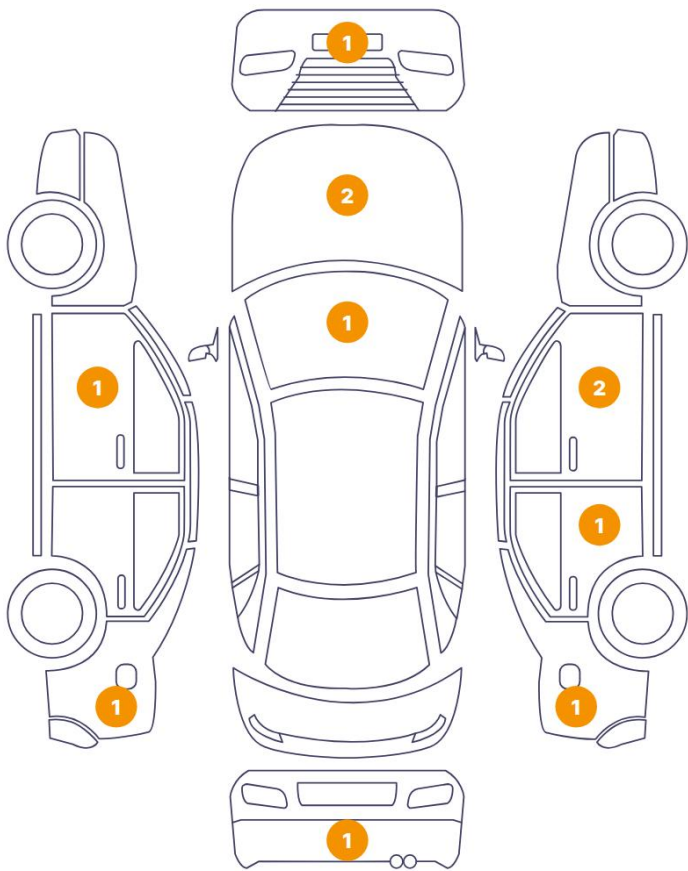
11 Danni

Component		Damage	Comments
1	Windshield / Front	Glass Break / Impact	
2	Bumper / Front	Paint / Chipping	
3	Door / Back Right	Bodywork / Poor Previous Repair	
4	Pillar / Front Right	Bodywork / Poor Previous Repair	
5	Door / Front Right	Bodywork / Poor Previous Repair	
6	Fender / Back Left	Bodywork / Poor Previous Repair	
7	Door / Front Left	Bodywork / Poor Previous Repair	
8	Hood	Paint / Chipping	
9	Fender / Back Right	Bodywork / Poor Previous Repair	
10	Bumper / Back	Paint / Scratch / Line	
11	Hood	Bodywork / Dent

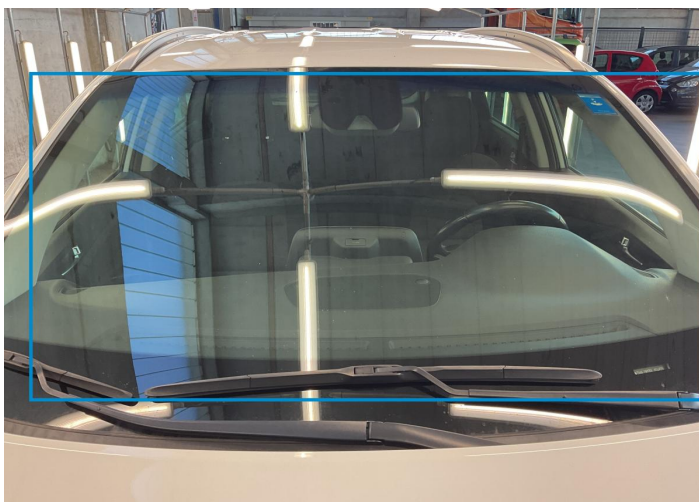
1. Windshield / Front  
Glass Break / Impact -

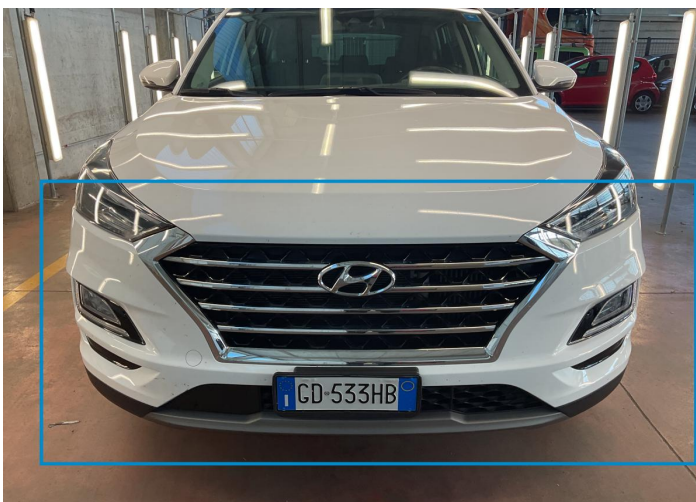
2. Bumper / Front  
Paint / Chipping -

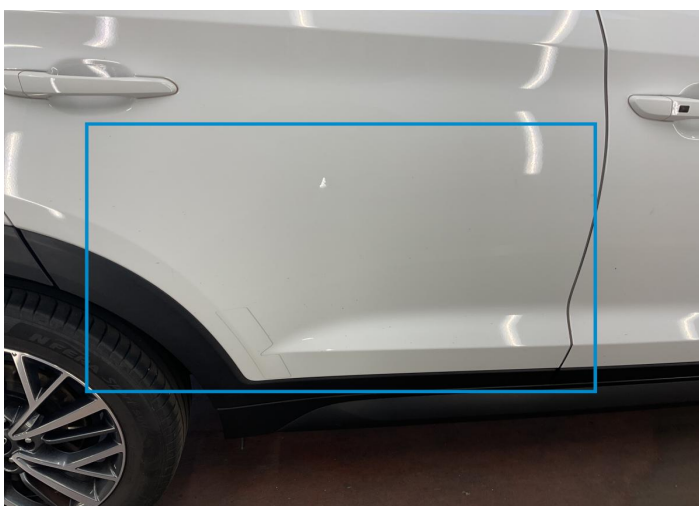
3. Door / Back Right  
Bodywork / Poor Previous Repair -

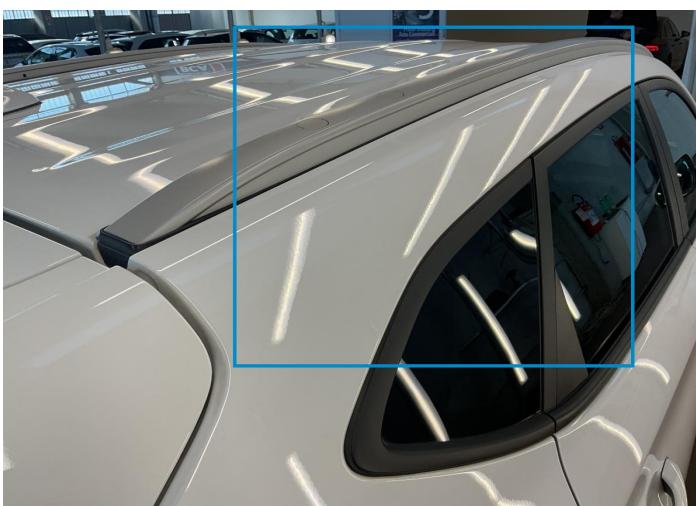
4. Pillar / Front Right  
Bodywork / Poor Previous Repair -

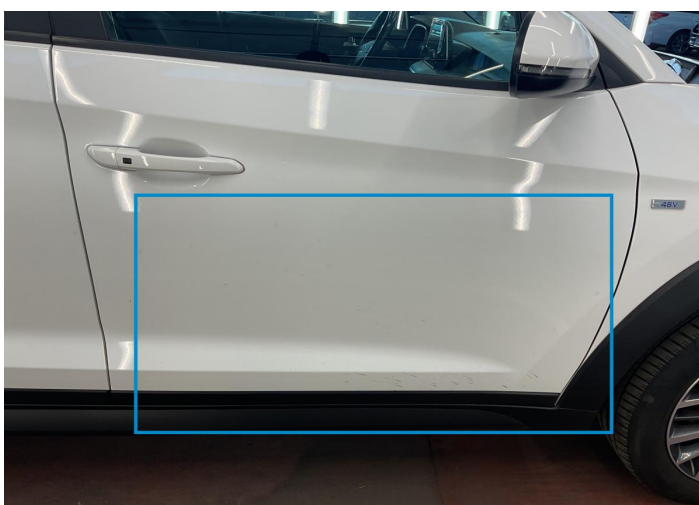
5. Door / Front Right  
Bodywork / Poor Previous Repair -

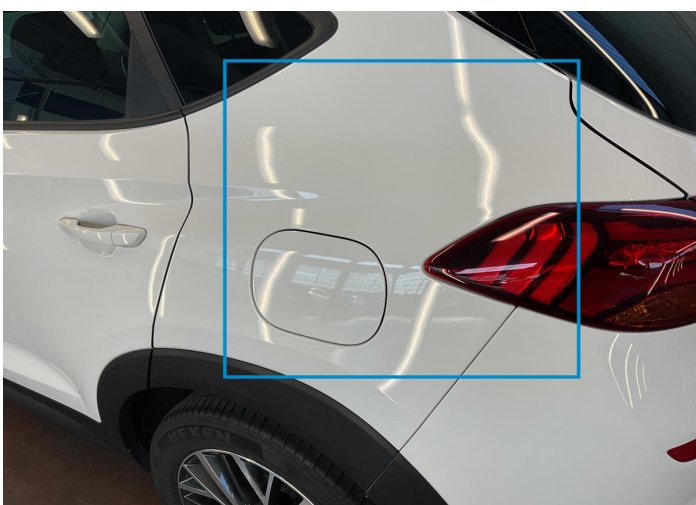
6. Fender / Back Left  
Bodywork / Poor Previous Repair -

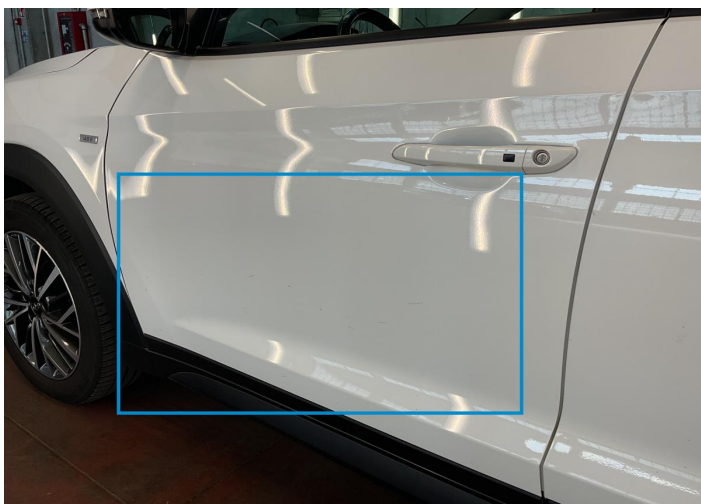
7. Door / Front Left  
Bodywork / Poor Previous Repair -

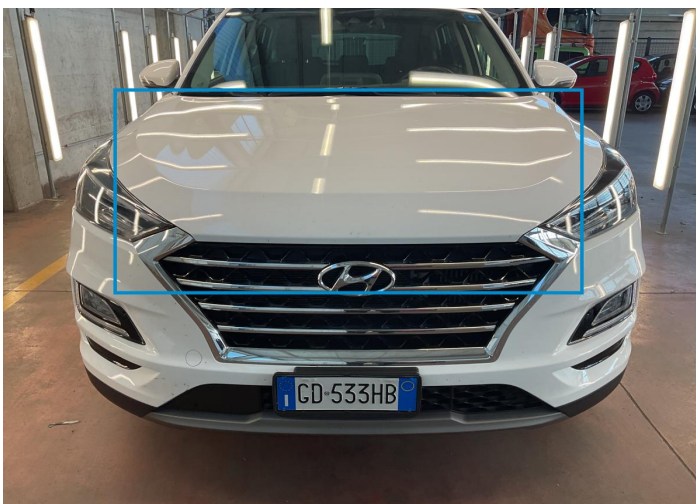
8. Hood  
Paint / Chipping -

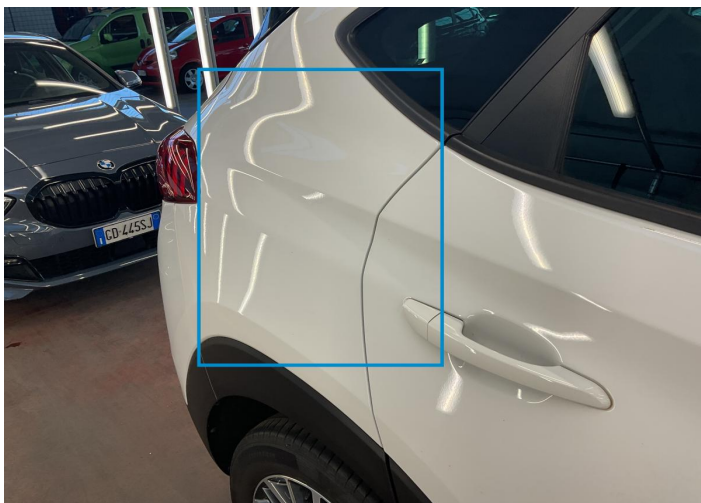
9. Fender / Back Right  
Bodywork / Poor Previous Repair -

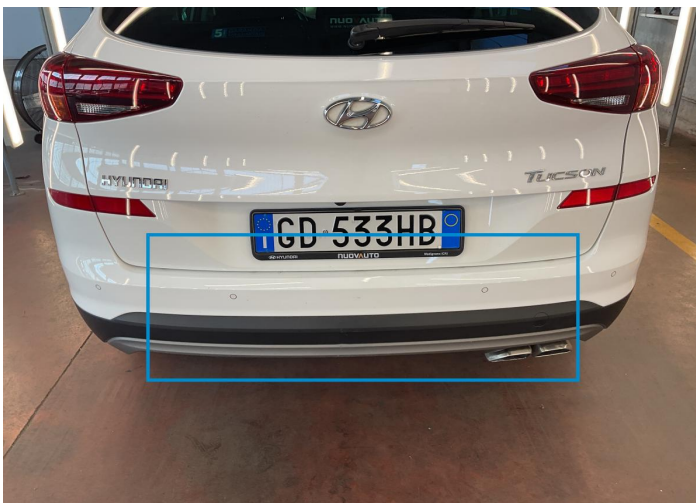
10. Bumper / Back  
Paint / Scratch / Line -

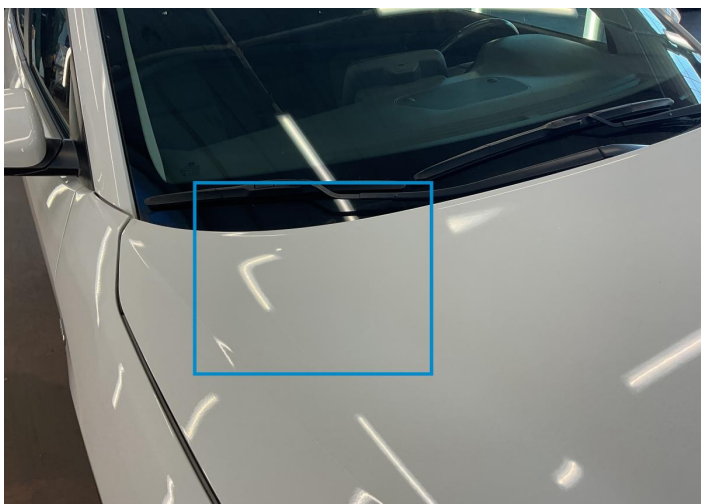
11. Hood  
Bodywork / Dent -
