HYUNDAI Tucson

Tucson 2.0 CRDi 4WD Automatik

Inspection Report Summary

Customer	BCA Online	Report Number	P20251001083853
Inspection Date / Place	2025-10-01 / ARS Altmann AG Riedstadt	Cosmetic Grade	3

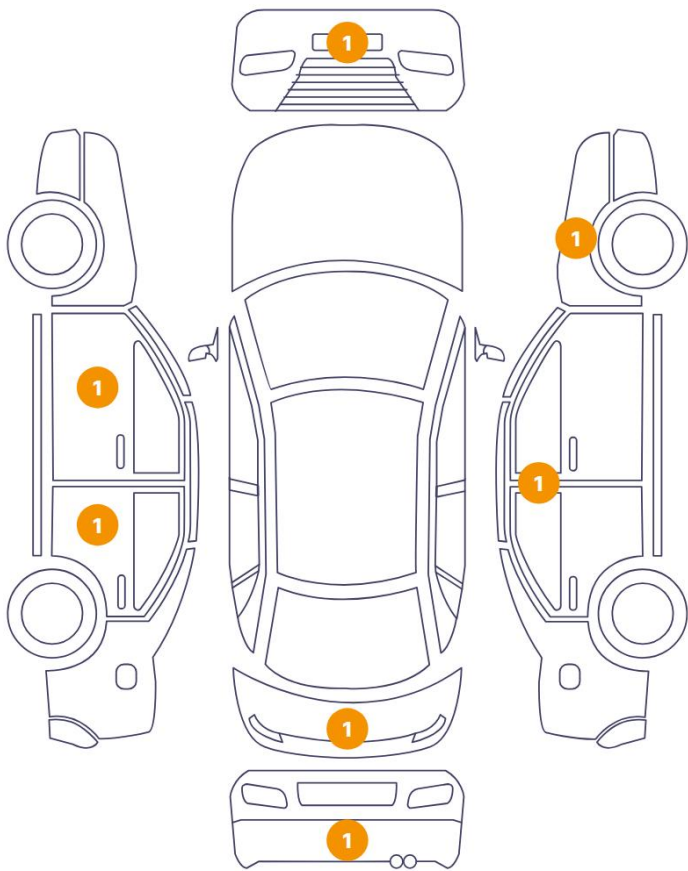
7 Schäden

Component	Damage	Comments
1 Bumper / Front	Paint / Scratch / Scuff	
2 Fender / Front Right	Paint / Scratch / Scuff	
3 B Pillar / Center Right	Bodywork / Dent / Dent	
4 Tailgate	Bodywork / Dent / Dent	
5 Bumper / Back	Bodywork / Dent / Dent	
6 Pillar / Back Left	Bodywork / Dent / Dent	
7 Door Joint / Front Left Middle	Bodywork / Breakage / Hole

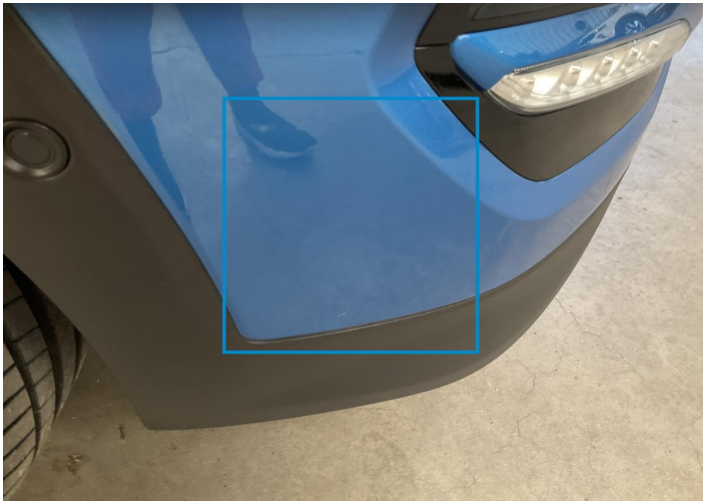
1. Bumper / Front
Paint / Scratch / Scuff -

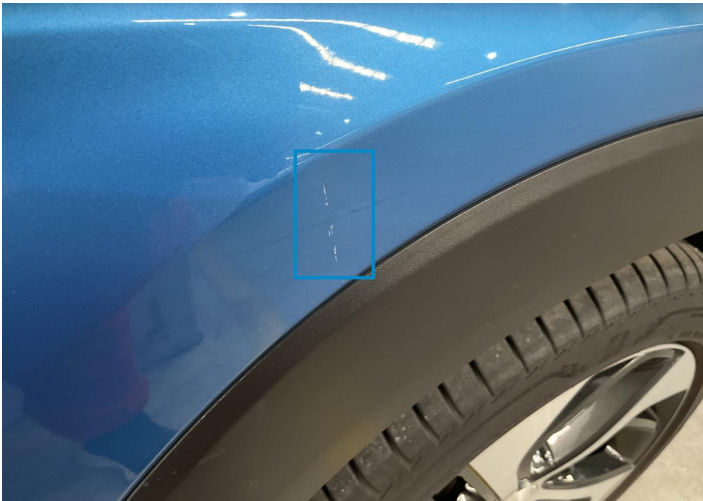
2. Fender / Front Right
Paint / Scratch / Scuff -

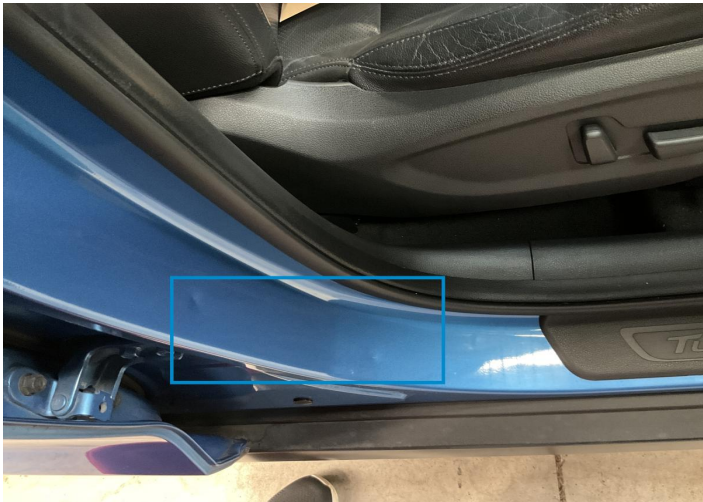
3. B Pillar / Center Right
Bodywork / Dent / Dent -

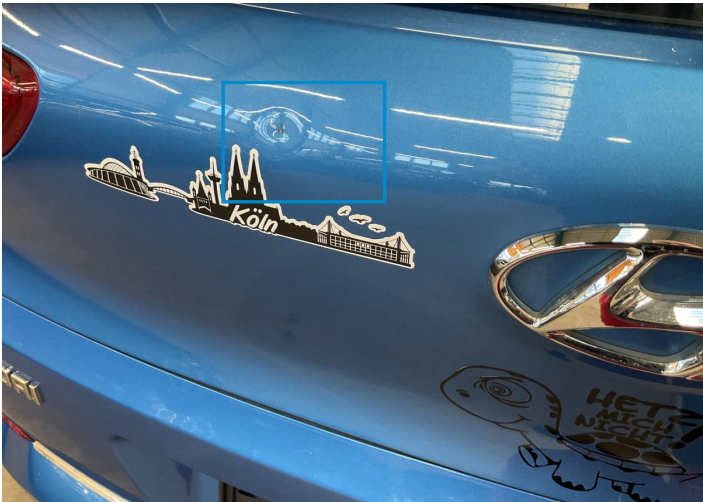
4. Tailgate
Bodywork / Dent / Dent -

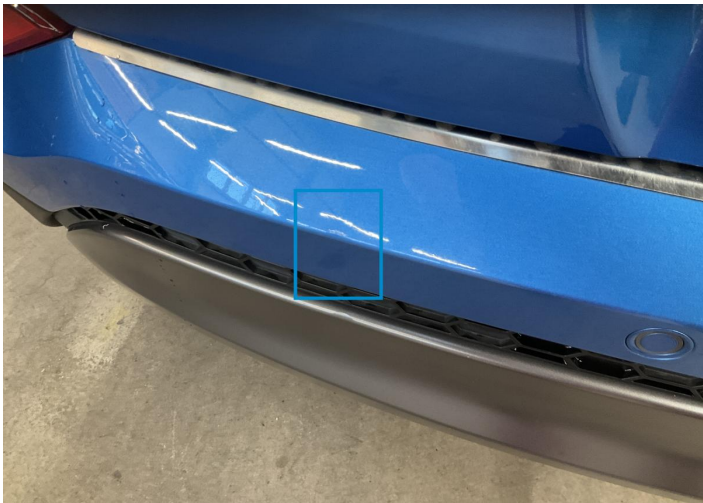
5. Bumper / Back
Bodywork / Dent / Dent -

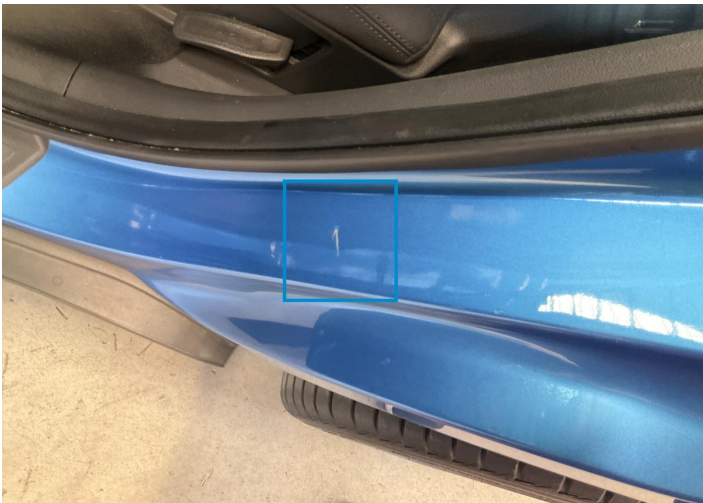
6. Pillar / Back Left
Bodywork / Dent / Dent -

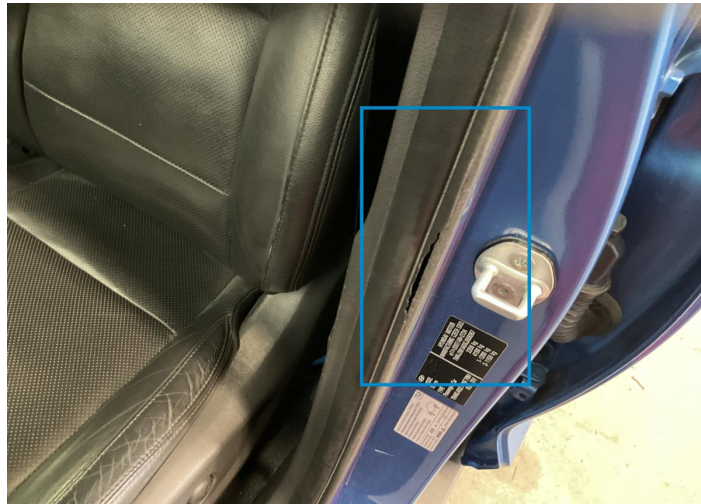
7. Door Joint / Front Left Middle
Bodywork / Breakage / Hole -
