HYUNDAI ix35

ix35 2.0 CRDi 4WD

VIN NO TMAJT81VCDJ465252
Registration Number VCDJ465252

Inspection Report Summary

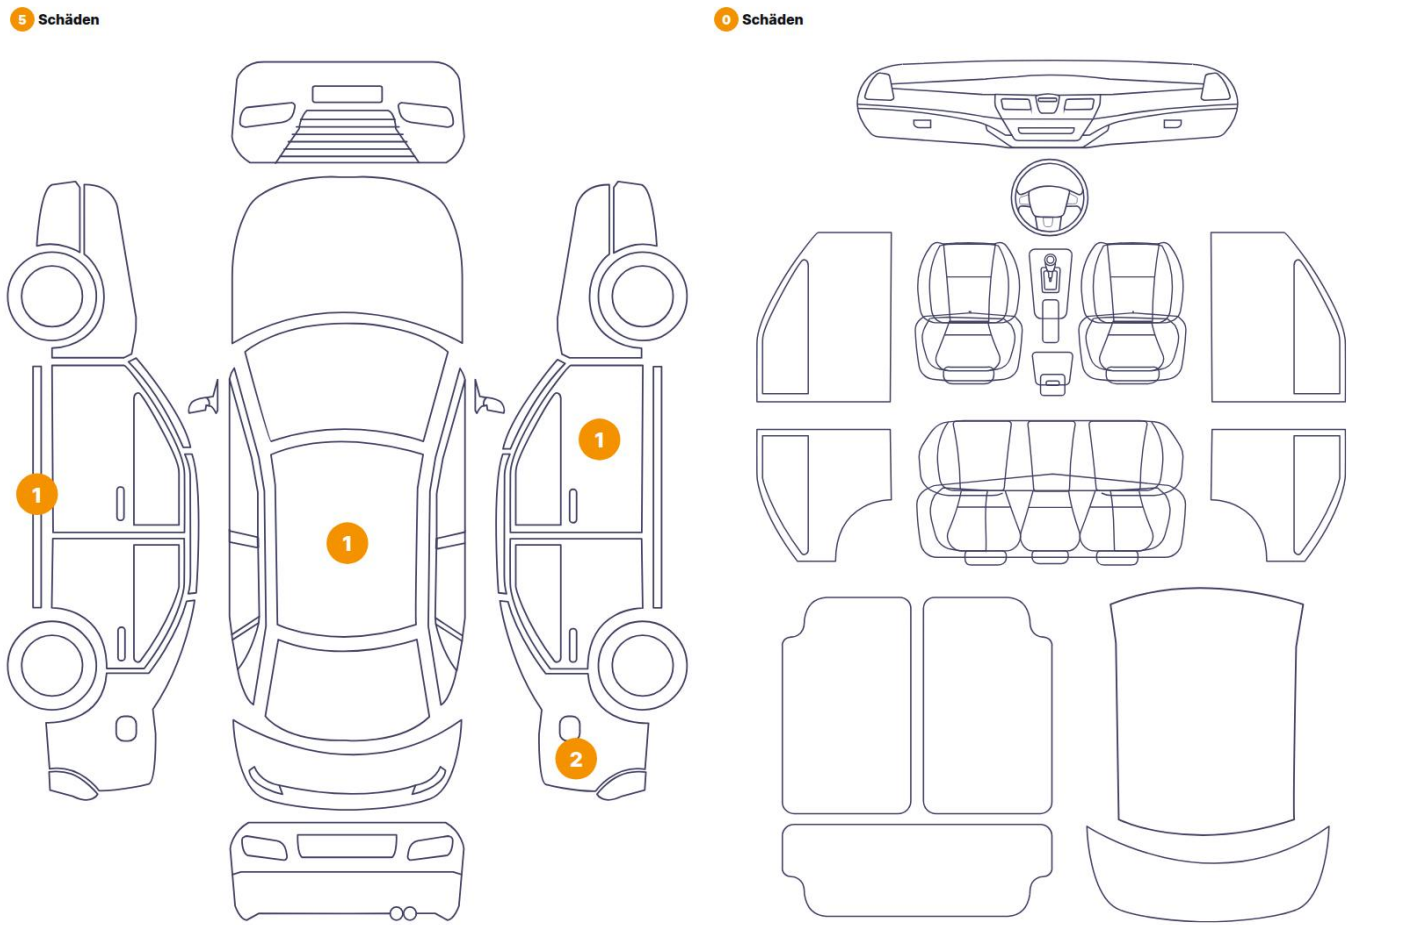
Cosmetic Damage

Component		Damage	Comments
1	Roof	Bodywork / Dent / Dent	
2	Fender / Back Right	Paint / Scratch / Scuff	
3	Fender / Back Right	Paint / Scratch / Scuff	
4	Mirror Repeater / Right	Glass Break	
5	Rocker Panel / Center Left	Bodywork / Dent / Dent

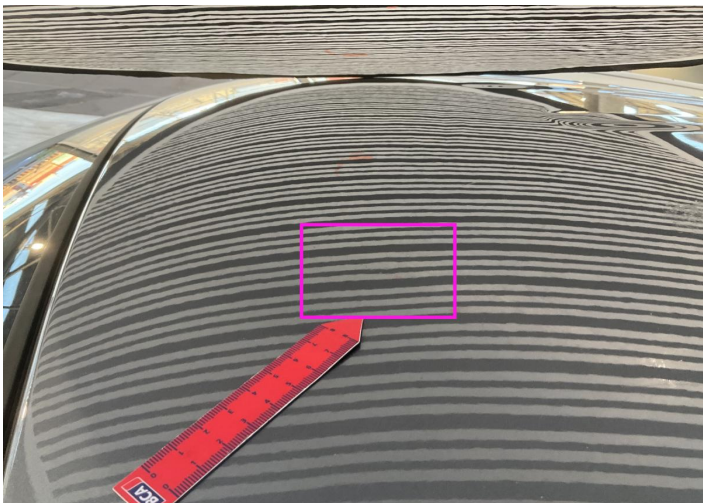
1. Roof
Bodywork / Dent / Dent -

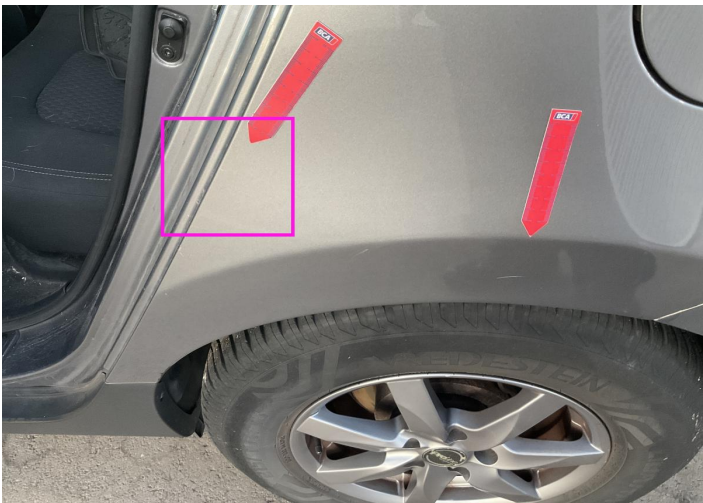
2. Fender / Back Right
Paint / Scratch / Scuff -

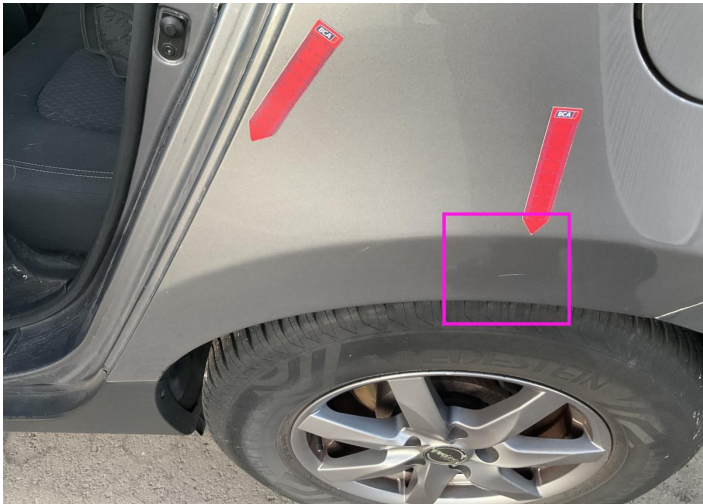
3. Fender / Back Right
Paint / Scratch / Scuff -

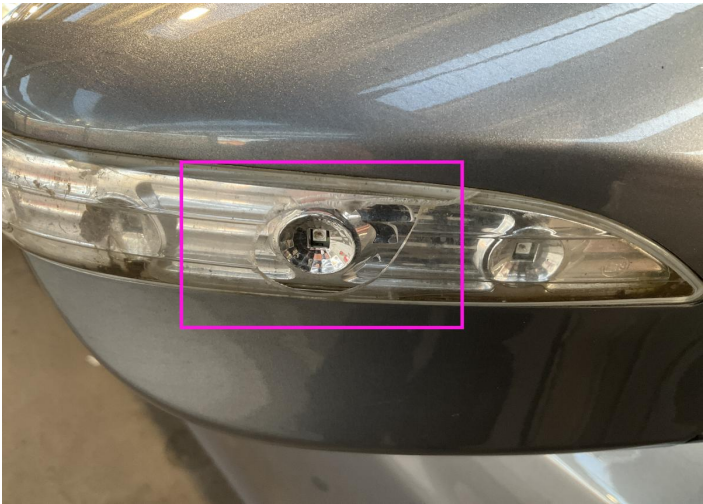
4. Mirror Repeater / Right
Glass Break -

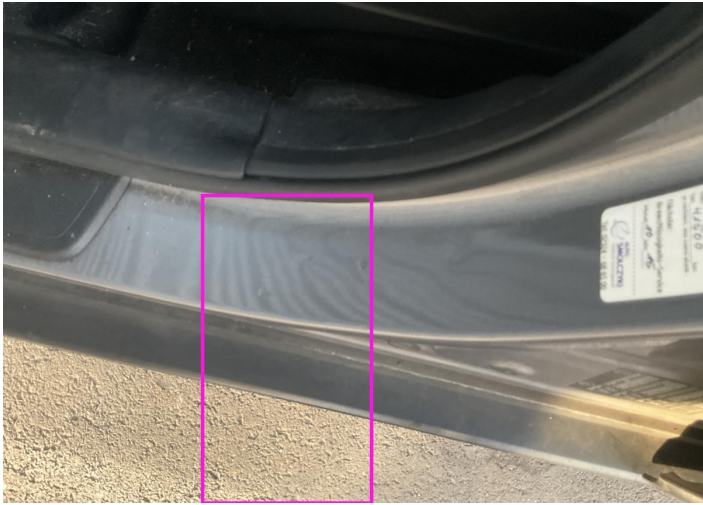
5. Rocker Panel / Center Left
Bodywork / Dent / Dent -
