# HYUNDAI ix35

## ix35 1.7 CRDi 2WD blue

### Inspection Report Summary

Customer	BCA Online	Report Number	P20250523122535
Inspection Date / Place	2025-05-23 / BCA Berlin	Cosmetic Grade	5

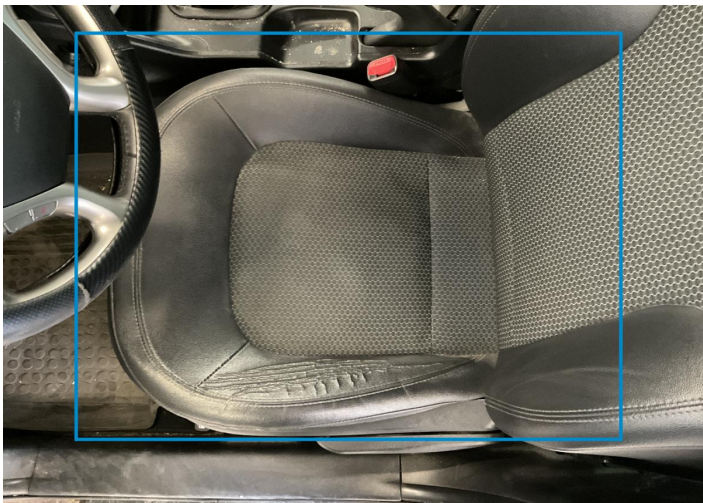
1. Seat / Front Left  
Interior / Broken -

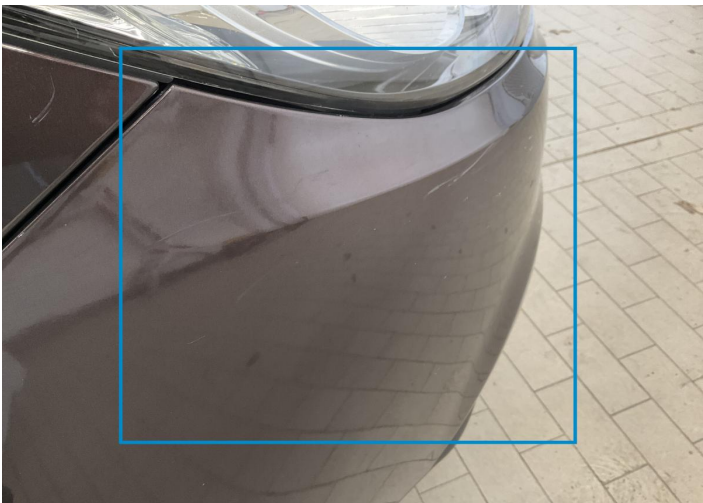
2. Bumper / Front  
Paint / Scratch / Scuff -

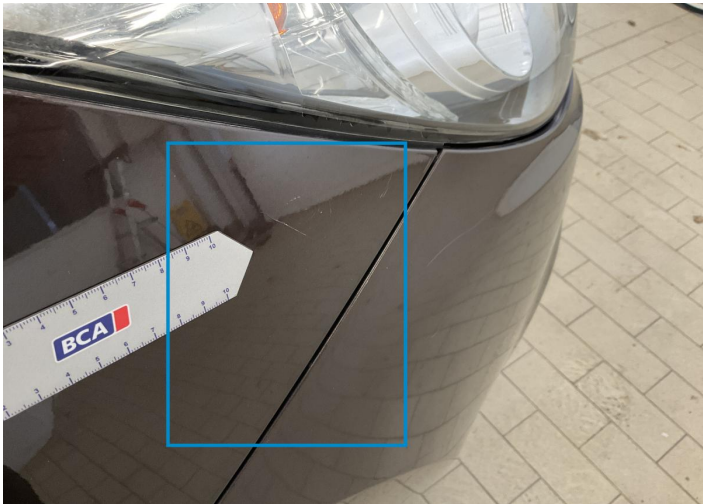
3. Fender / Front Right  
Paint / Scratch / Scuff -

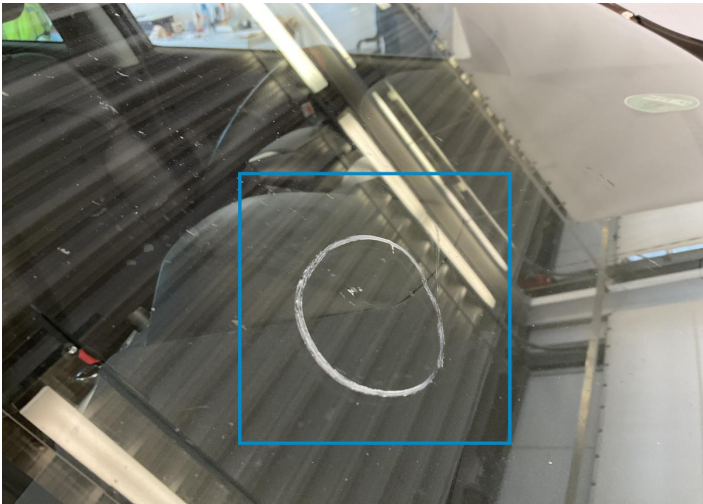
4. Windshield / Front  
Paint / Chipping -

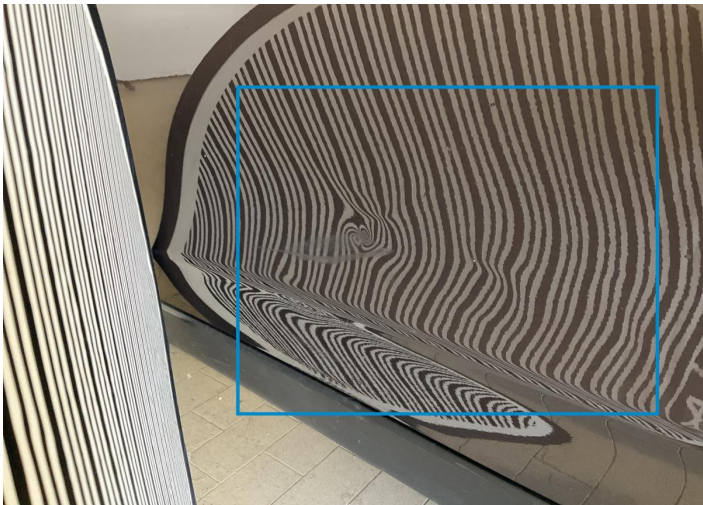
5. Door / Front Left  
Bodywork / Breakage / Crack -

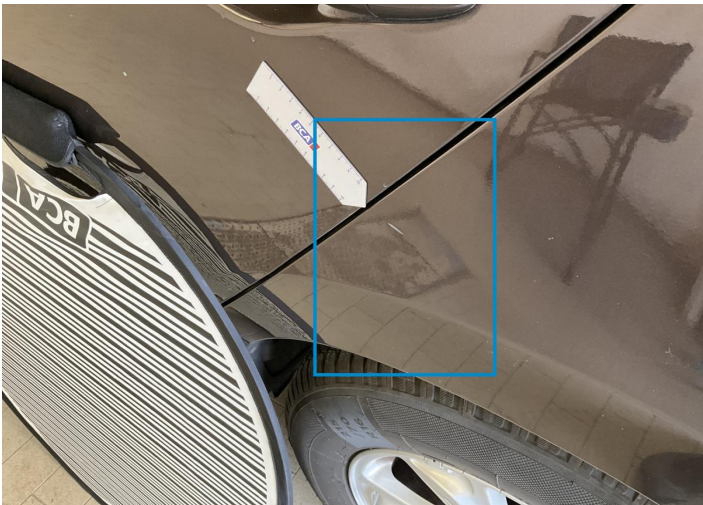
6. Side Panel / Back Left  
Paint / Scratch / Scuff -

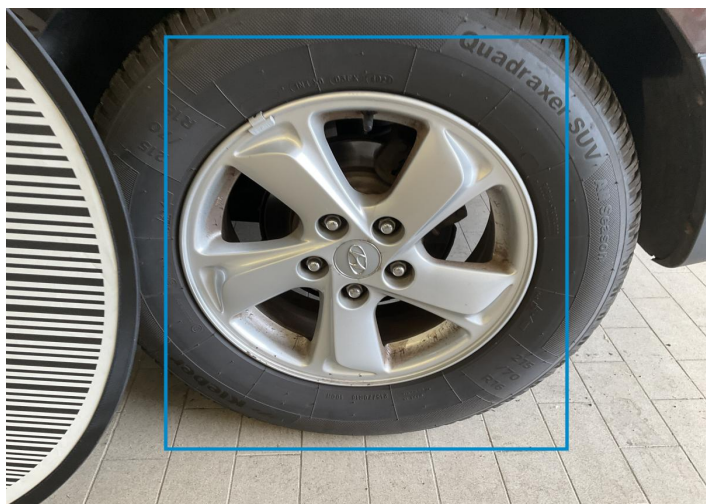
7. Rim / Back Left  
Out of Bodywork / Scratch -

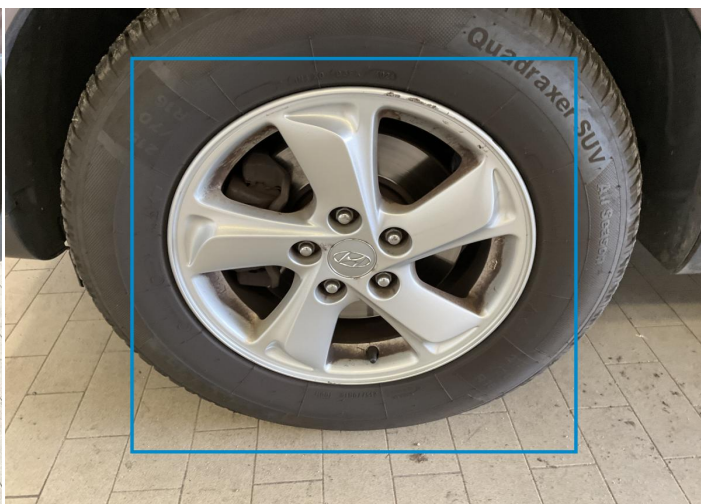
8. Rim / Front Left  
Out of Bodywork / Scratch -

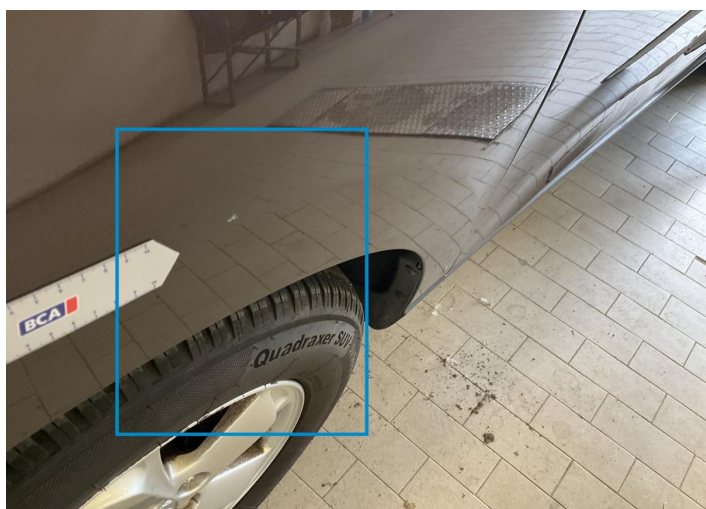
9. Fender / Front Left  
Paint / Scratch / Scuff -

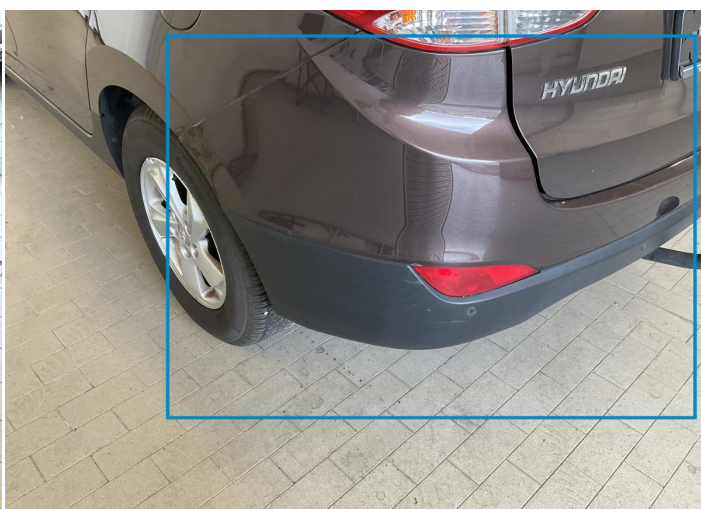
10. Bumper / Back  
Paint / Scratch / Scuff -

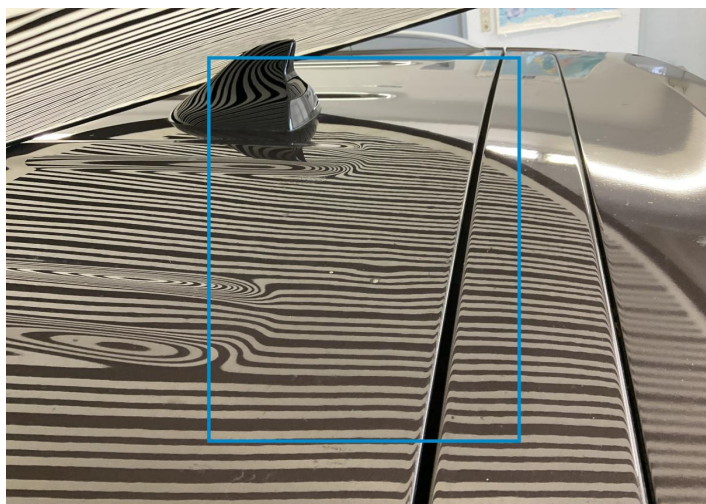
11. Roof  
Bodywork / Dent / Dent -

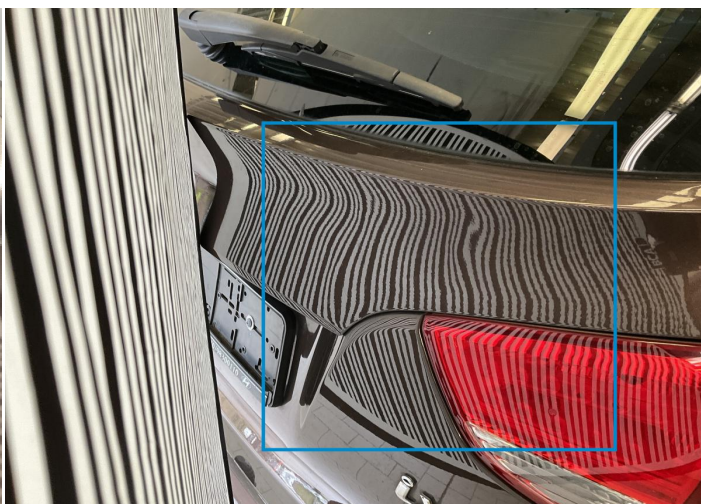
12. Tailgate  
Bodywork / Dent / Dent -

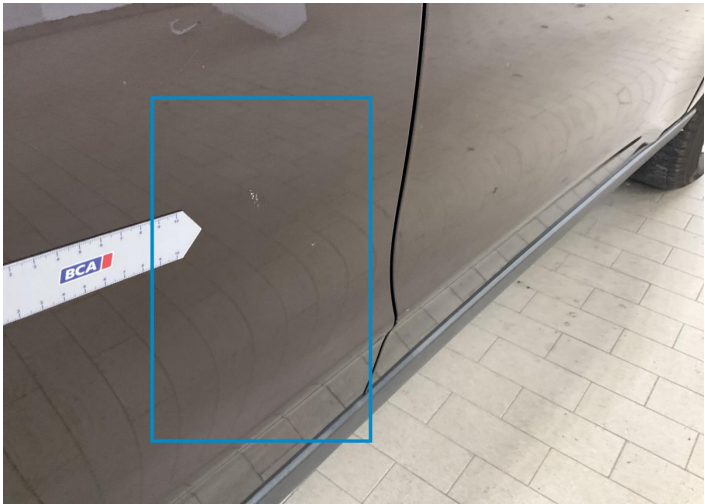
13. Door / Back Right  
Paint / Scratch / Scuff -

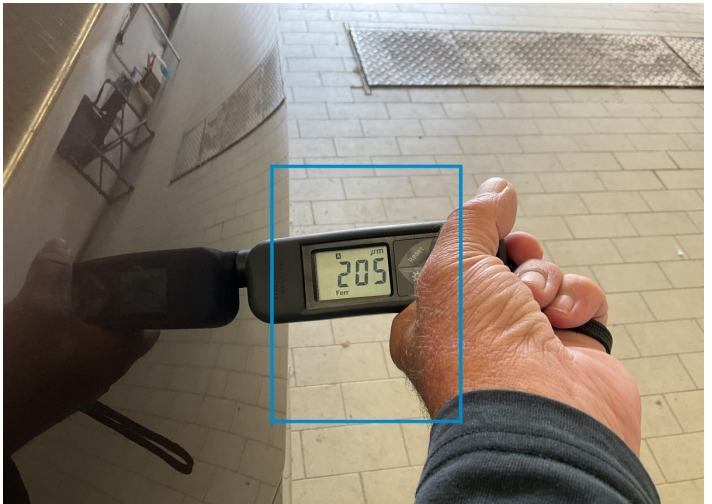
14. Fender / Front Left  
Paint / Poor Previous Repair -
