## status report

<b>Customer:</b>	<b>Allane SE HCBE</b>	<b>Off. Mark :</b>	<b>EN-BO 97E</b>
<b>Report number:</b>	<b>0000000807255-EN968</b>		
<b>reference number:</b>	<b>30835404</b>

#### Hyundai Kona (OS)(2017->) Select Elektro 2WD

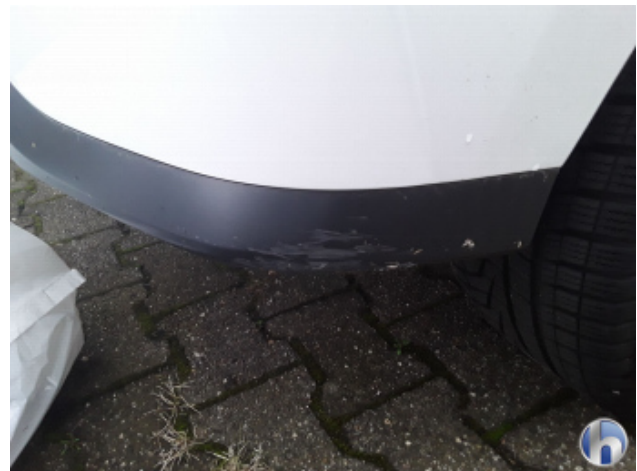
1. Rear Bumper  
Light scratch - Replace

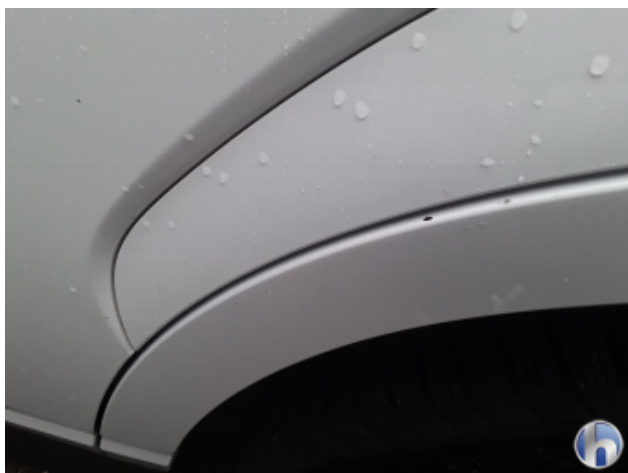
2. Sidewall - Rear - Left  
**Wear and tear - Without repair**

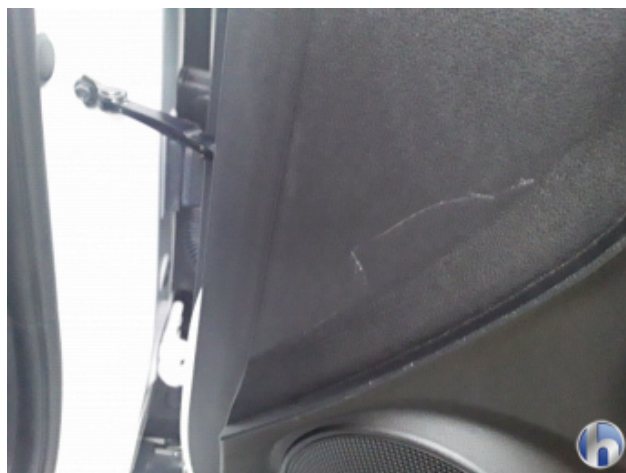
3. Door trim Front - right  
**Wear and tear - Without repair**

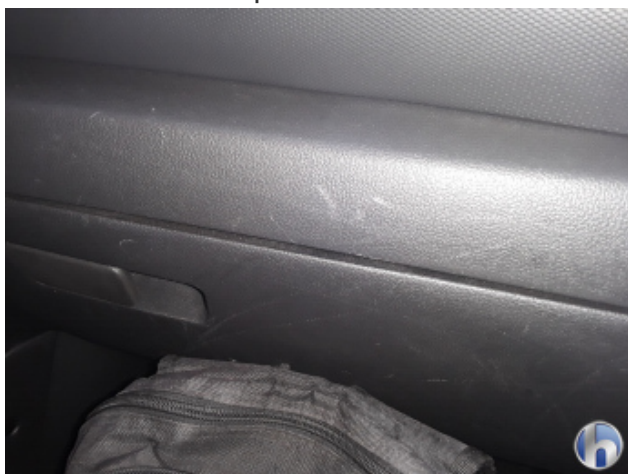
4. dashboard  
**Wear and tear - Without repair**
