## status report

| <b>Report number:</b> | <b>0000000788906-EN926</b> | | |

#### Hyundai Kona (OS)(2017->) Select Elektro 2WD

| Vehicle identification number .: | <b>TMAK281HFNJ055607</b> | mileage read: | <b>15632 km</b> |

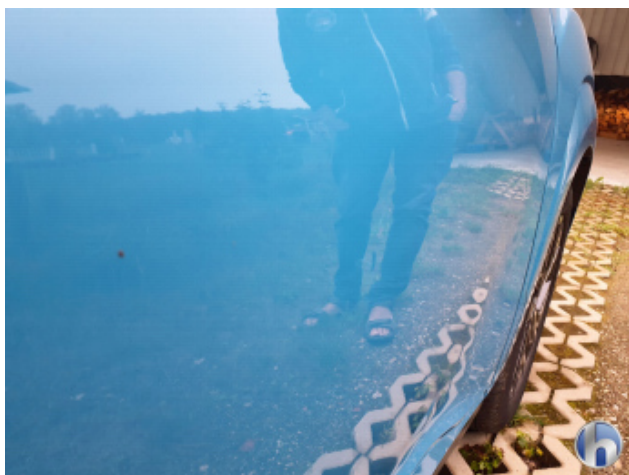
| | Component | Damage | Rep kind |
|---|---|---|---|
| 1. | Front door - right | 1 dent | Smart repair |

1. Front door - right  
**1 dent - Smart repair**
