status report

Customer:	Allane SE HCBE	Off. Mark :	Z-IM1803E
Report number:	0000000784974-EN926		
reference number:	30785228

Hyundai Kona (OS)(2017->) Basis Elektro 2WD

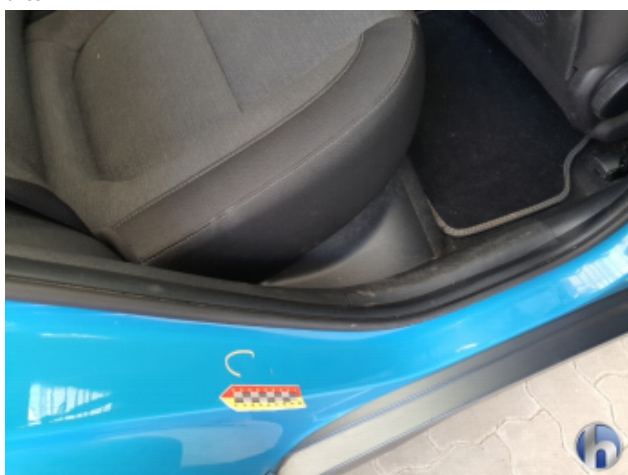
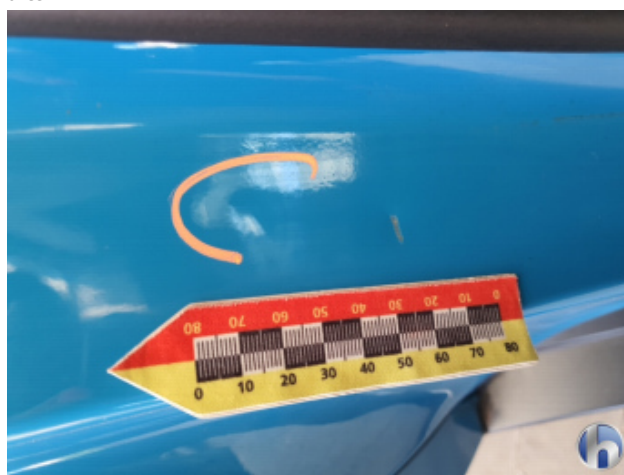
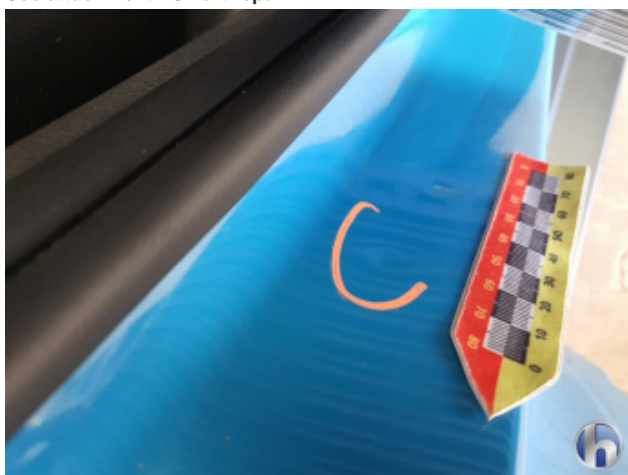
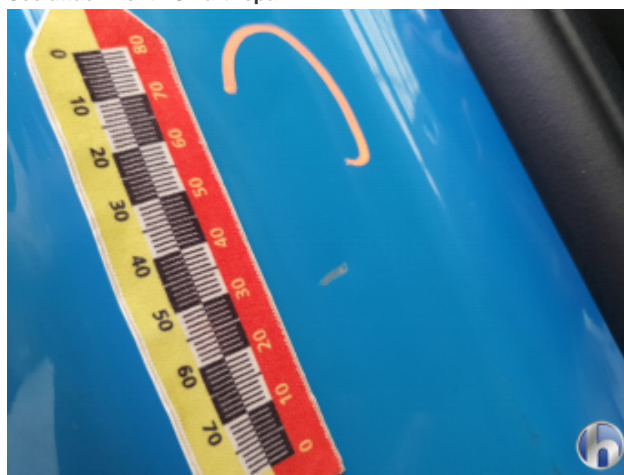
1. Türeinstieg Hinten - Rechts
 See attachment - Smart repair

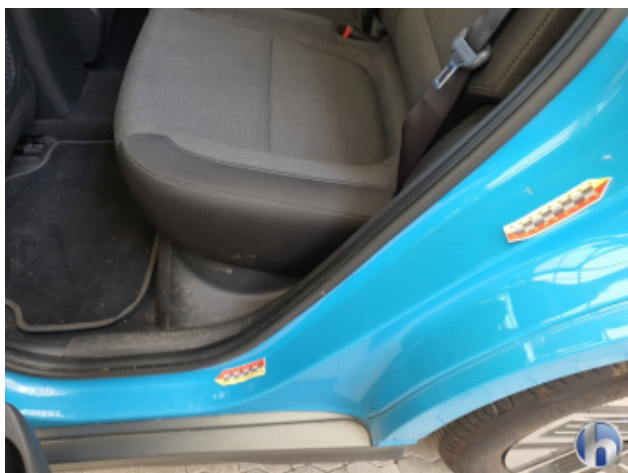
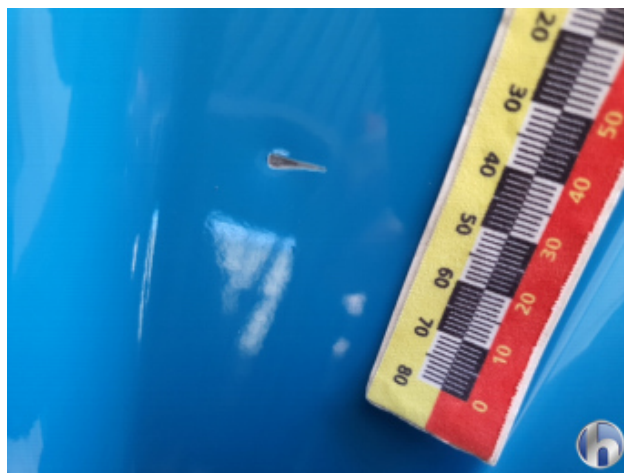
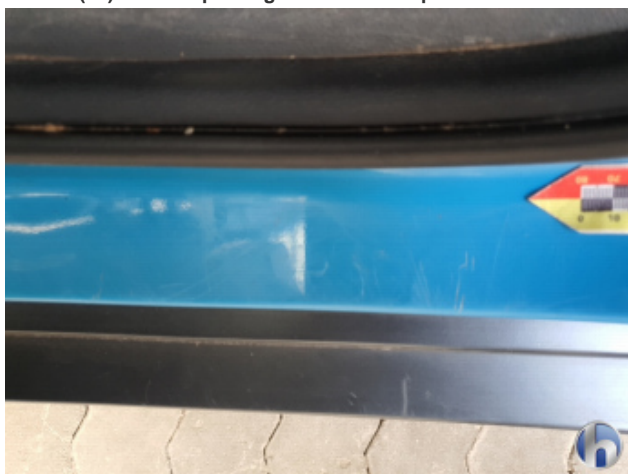
2. Türeinstieg Hinten - Links
Scratch(es) down to priming coat - Smart repair

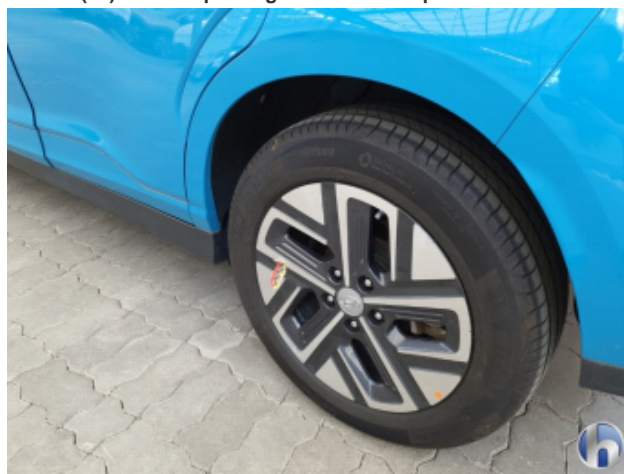
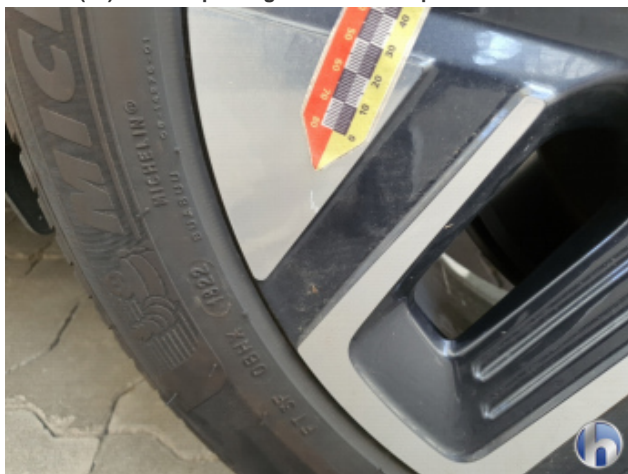
3. Rim rear - left
Deep scratch - Smart repair

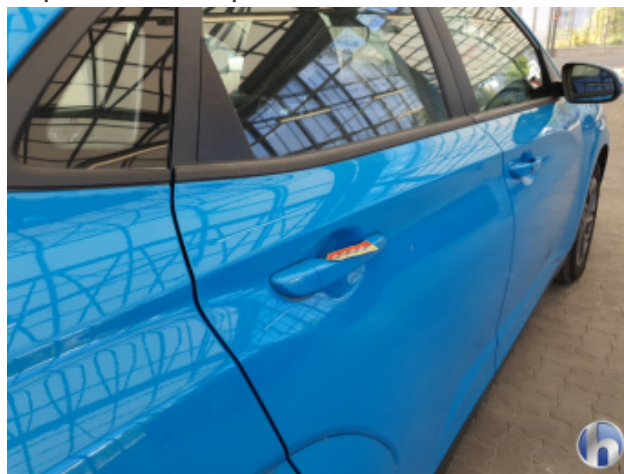
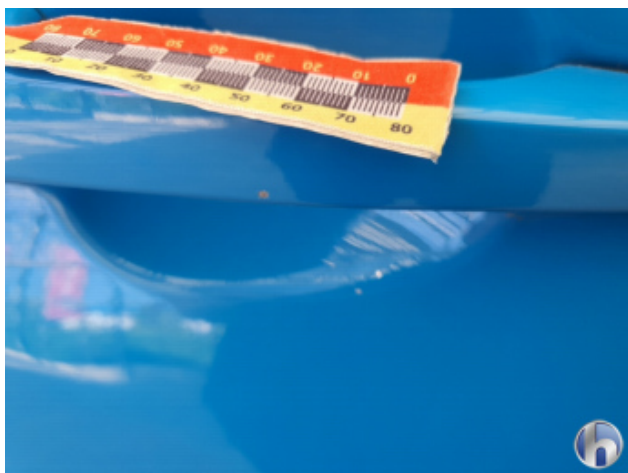
4. Outside Door Handle Rear - right
Deep scratch - Smart repair

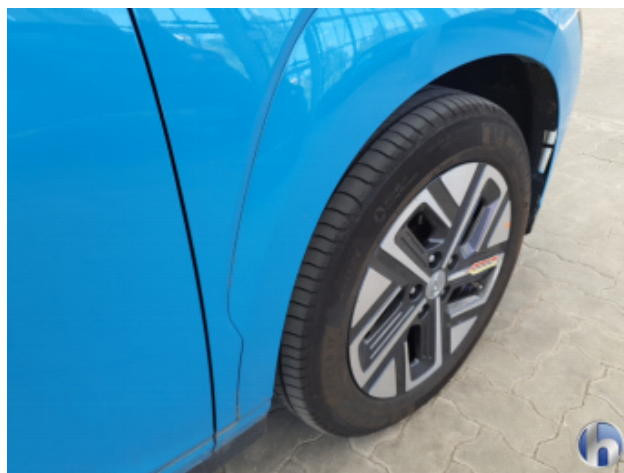
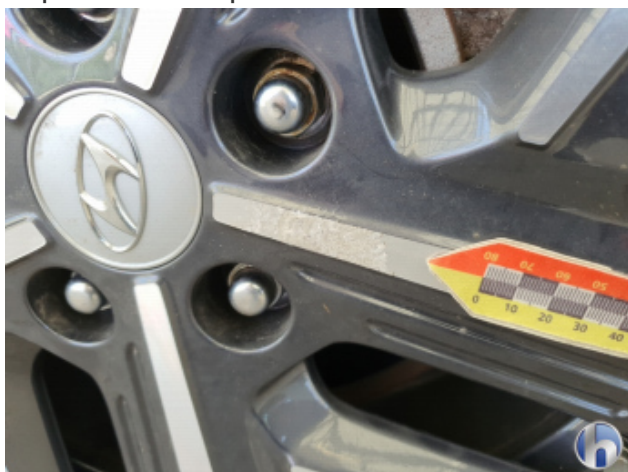
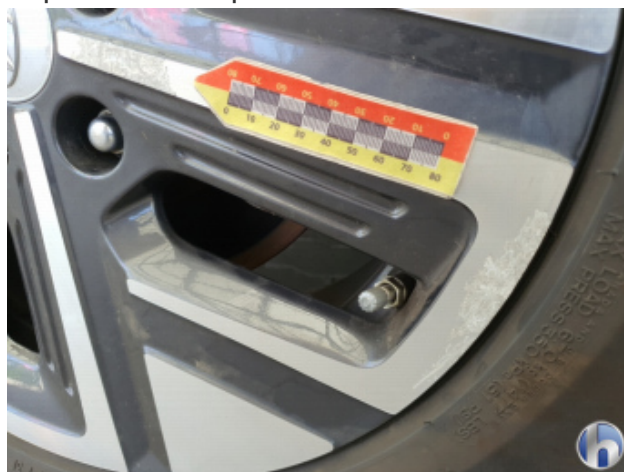
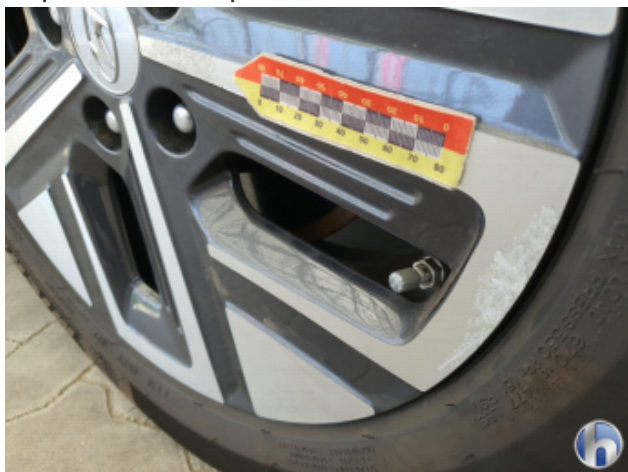
5. Rim front - right
Deep scratch - Smart repair

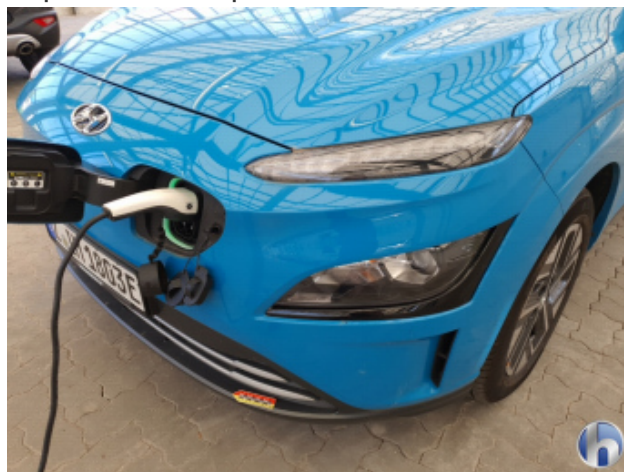
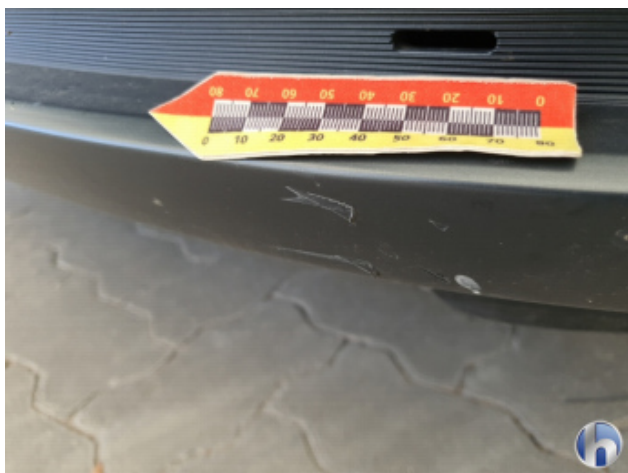
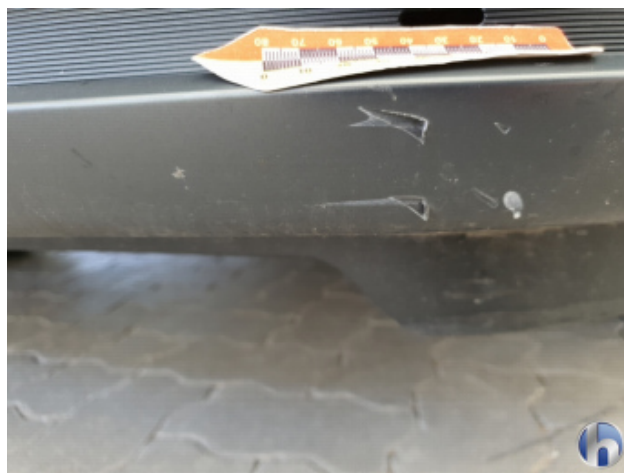
6. spoiler
Light scratch - Replace

6. spoiler
 Light scratch - Replace

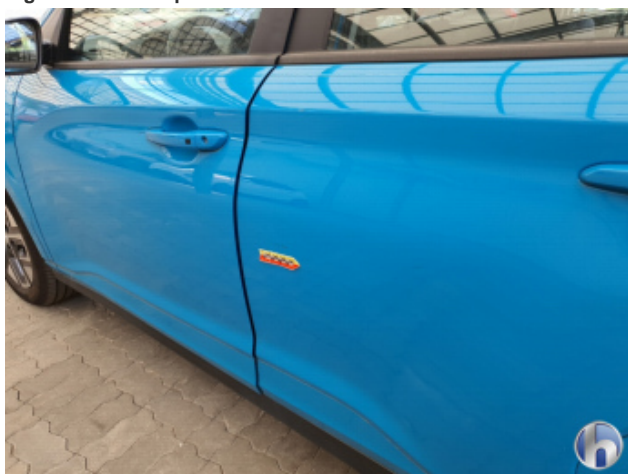
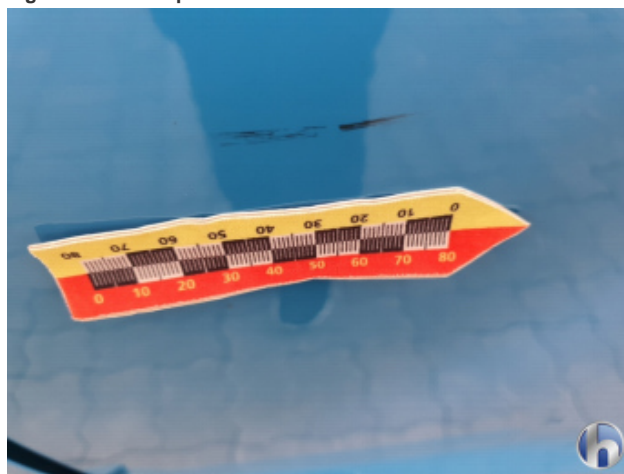
7. Rear door - left
 Surface scratch(es) - Condition/polish

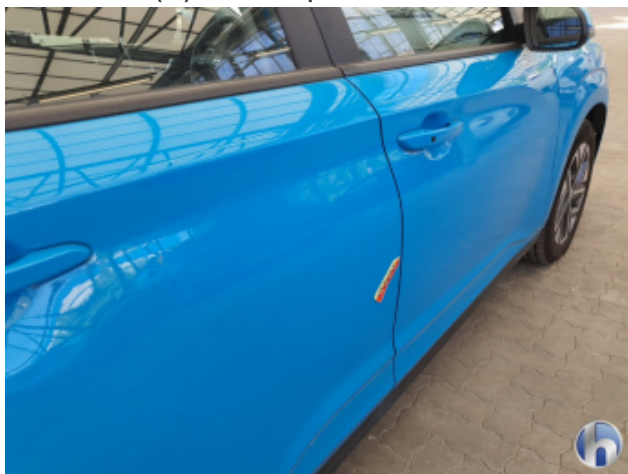
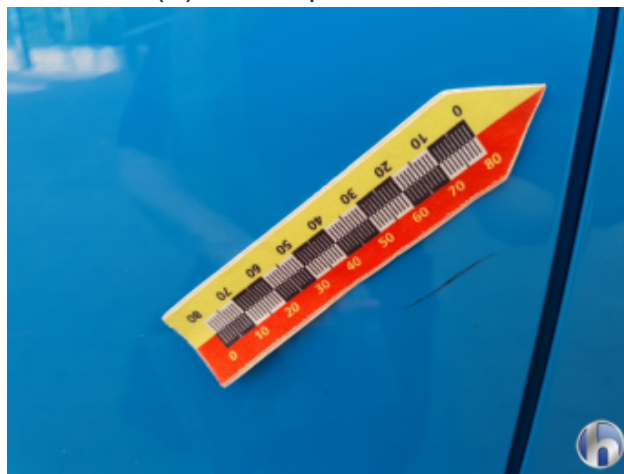
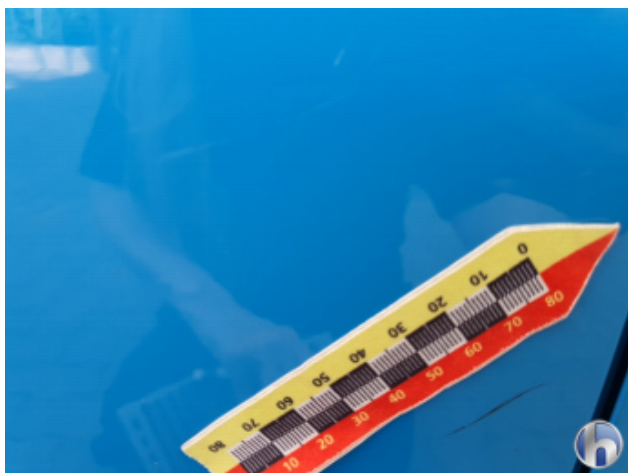
8. Rear Door - Right
 Surface scratch(es) - Condition/polish

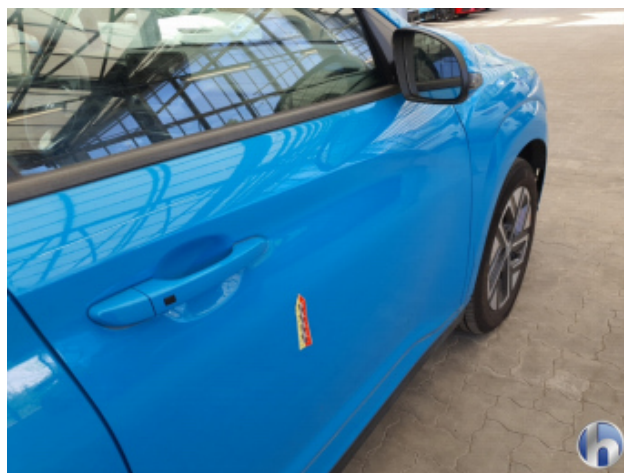
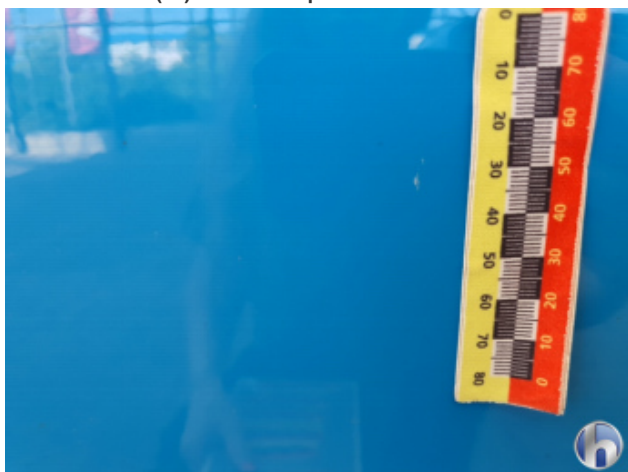
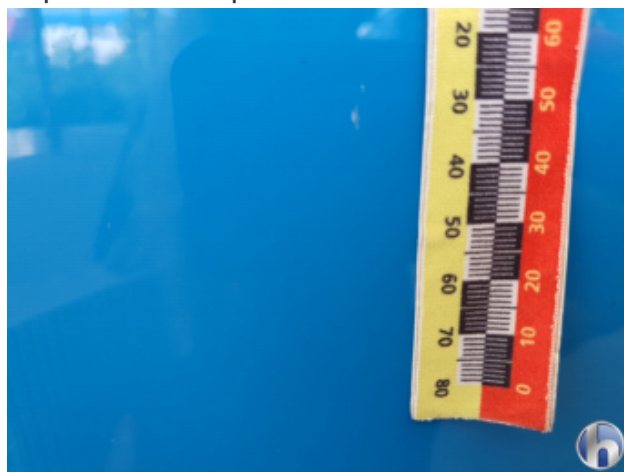
9. Front door - right
 Deep scratch - Smart repair

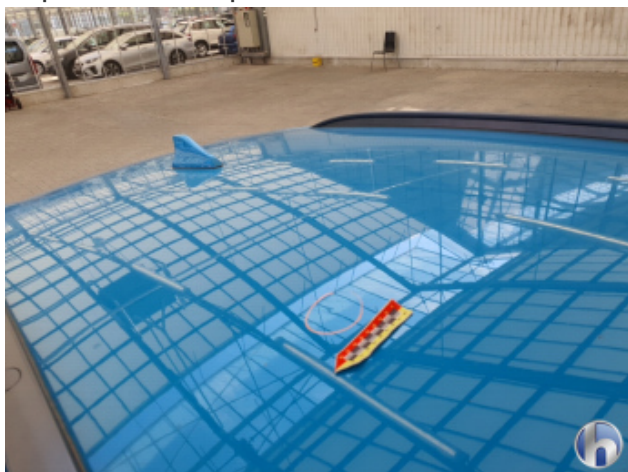
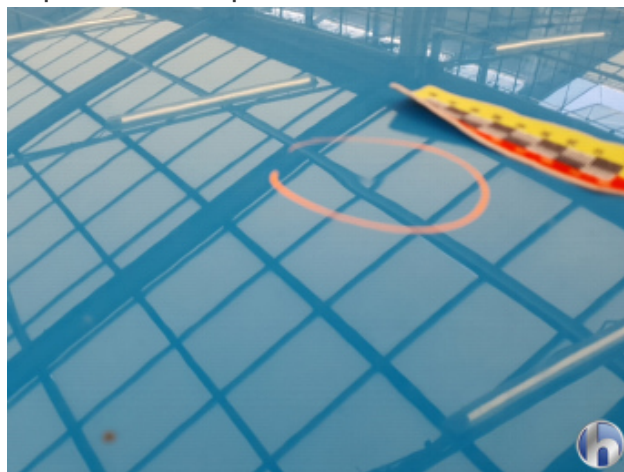
10. Roof
 1 dent - Gentle refurbishing

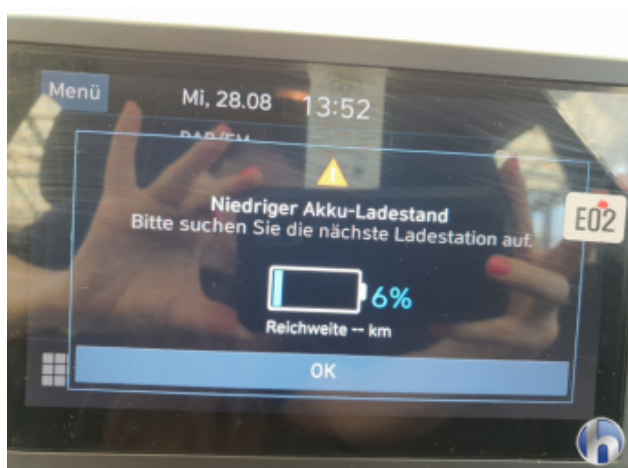
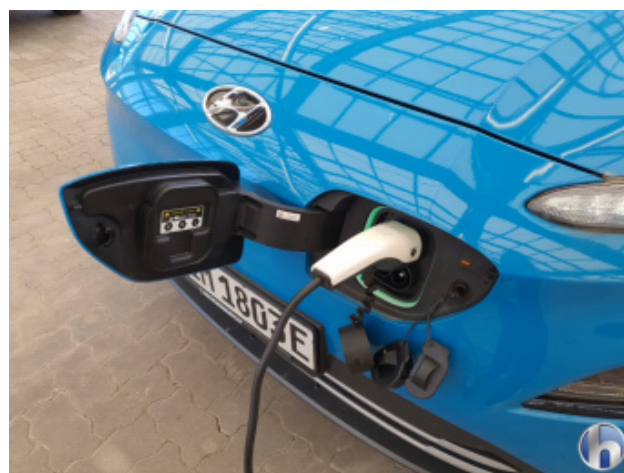
11. Akku Ladung
 Due - Replace
