status report

Customer:	Allane SE HCBE	Off. Mark :	B-MK 6010E
Report number:	0000000805901-EN968		
reference number:	30834465

Hyundai Kona (OS)(2017->) Select Elektro 2WD

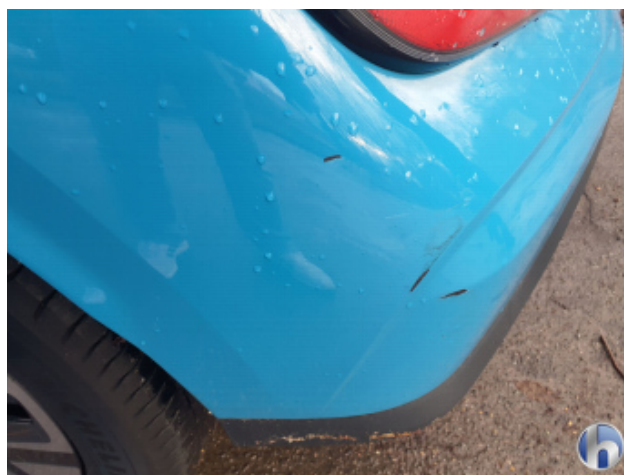
Component	Damage	Rep kind
1.	Rear Bumper	Light scratch	Paint

1. Rear Bumper
Light scratch - Paint
