status report

Report number:	0000000814397-EN968	Off. Mark :	NOR-DV 67E
reference number:	30849881

Hyundai Kona (OS)(2017->) Style Elektro 2WD

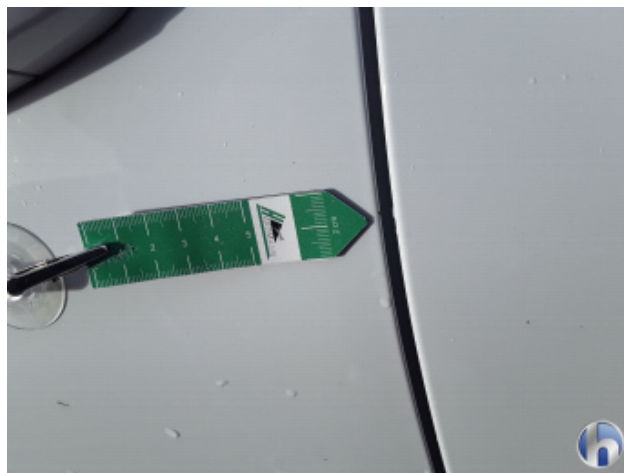
Component	Damage	Rep kind
1.	Front door - left	Wear and tear	Without repair
2.	Rim front - right	Wear and tear	Without repair
3.	Windshield	Wear and tear	Without repair

1. Front door - left
Wear and tear - Without repair

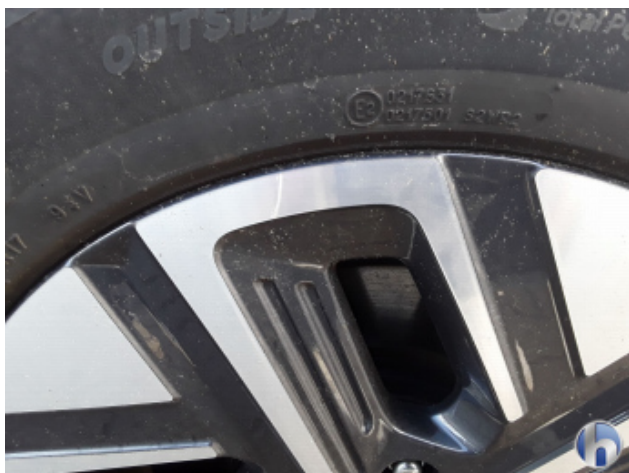
2. Rim front - right
Wear and tear - Without repair

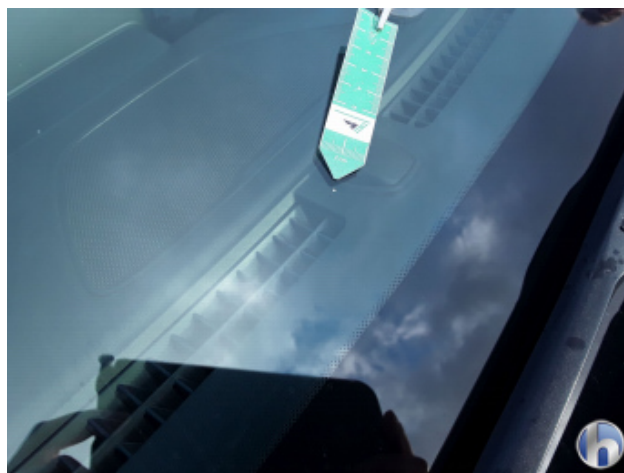
3. Windshield
Wear and tear - Without repair
