## status report

Customer:	Allane SE HCBE	Off. Mark :	MB-MR 604E
Report number:	0000000806347-EN968		
reference number:	30829568

#### Hyundai Kona (OS)(2017->) Trend Elektro 2WD

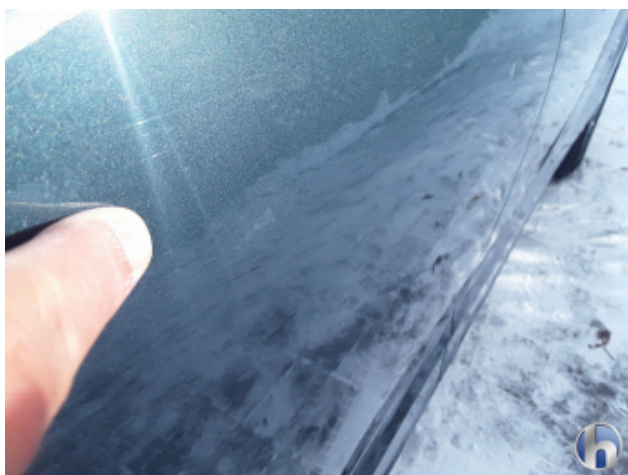
1. Rear Door - Right  
Dented - Gentle refurbishing

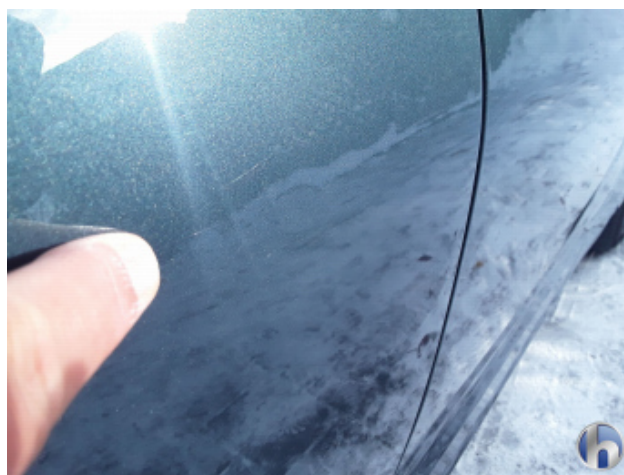
1. Rear Door - Right  
Dented - Gentle refurbishing

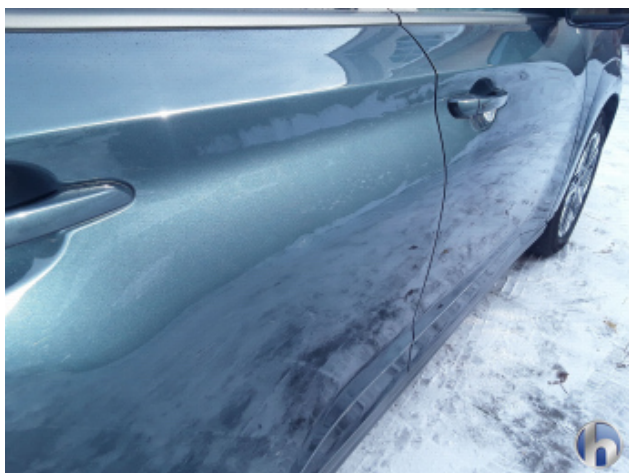
1. Rear Door - Right  
**Dented - Gentle refurbishing**

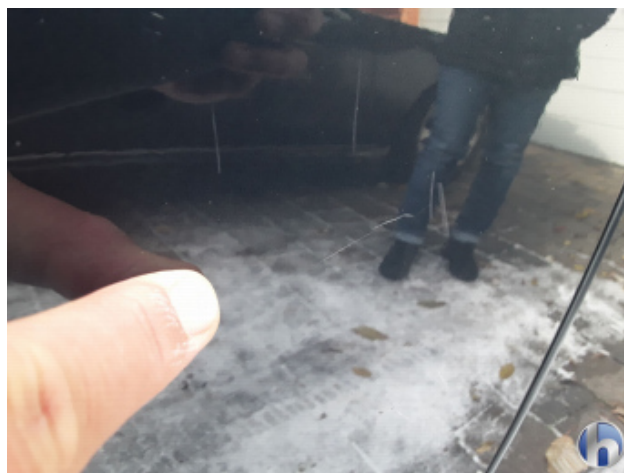
2. Front door - left  
**Deep scratch - Paint**
