HYUNDAI ix20 Diesel  
ix20 1.6 crdi Comfort

VIN NO TMAPU81SAEJ152240  
Registration Number EV940VT

Inspection Report Summary

| Customer | BCA Lodi | Report Number | P20251009111209 |

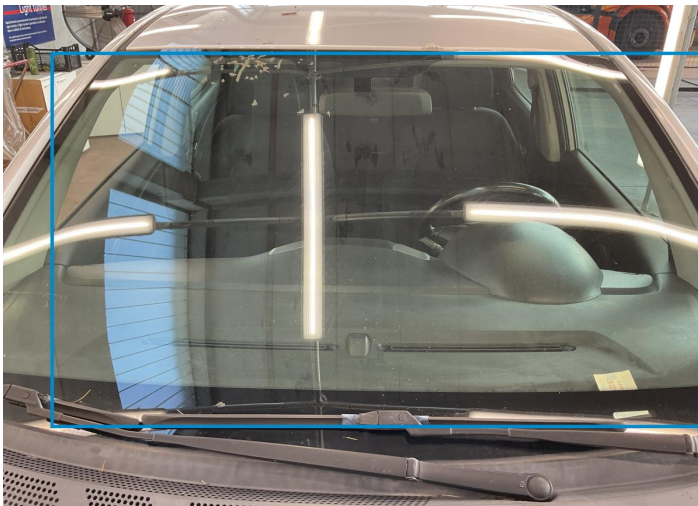
| Component | | Damage | Comments |
|---|---|---|---|
| 1 | Windshield / Front | Glass Break / Impact | |

1. Windshield / Front  
Glass Break / Impact -

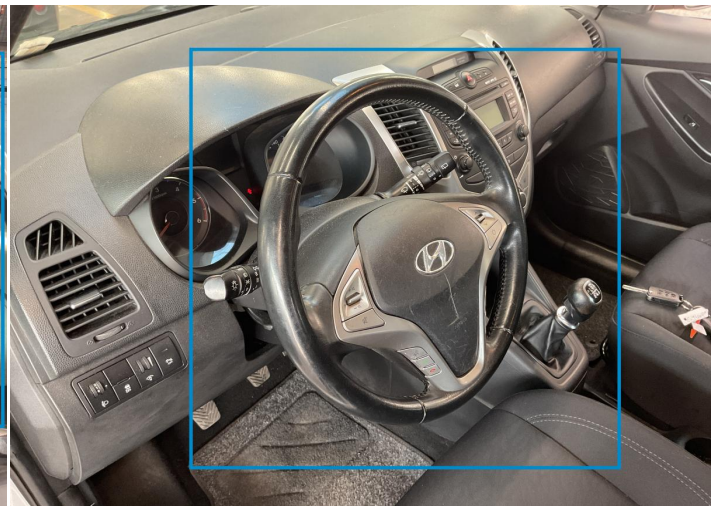
| Component | | Damage | Comments |
|---|---|---|---|
| 2 | Steering Wheel / Front | Interior / Worn - out | |

2. Steering Wheel / Front  
Interior / Worn - out -

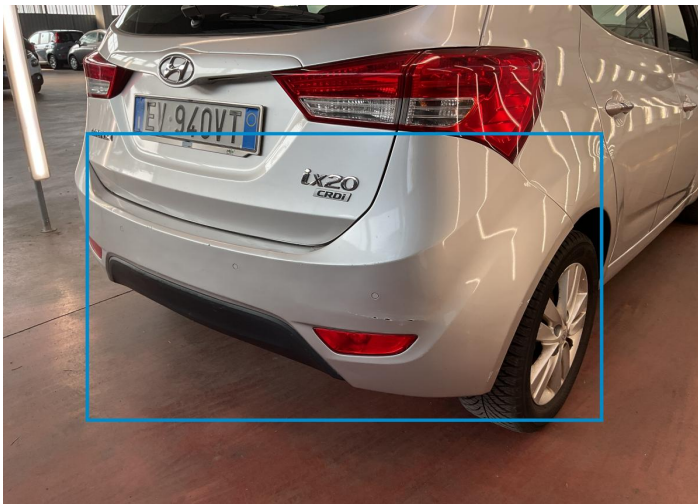
| Component | | Damage | Comments |
|---|---|---|---|
| 3 | Bumper / Back | Bodywork / Dent | |

3. Bumper / Back  
Bodywork / Dent -

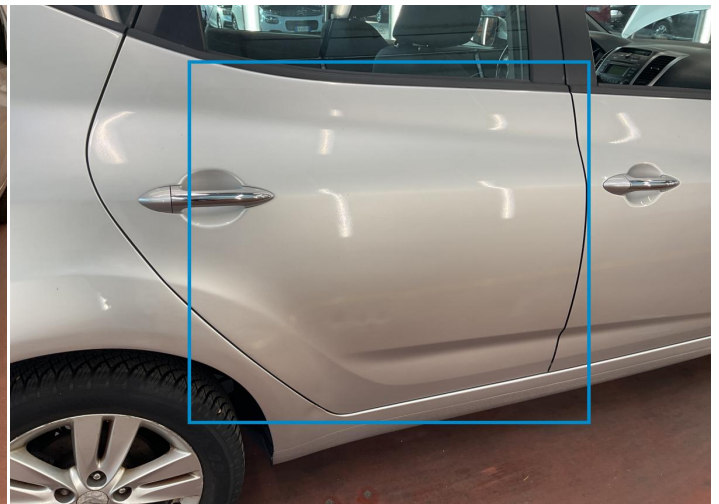
| Component | | Damage | Comments |
|---|---|---|---|
| 4 | Door / Back Right | Bodywork / Dent | |

4. Door / Back Right  
Bodywork / Dent -

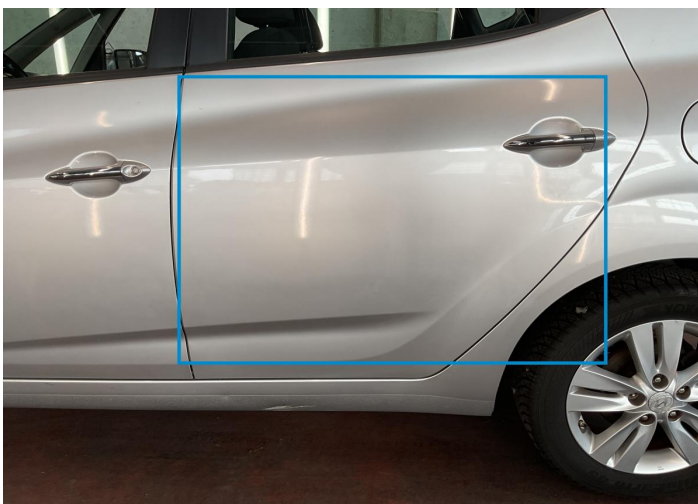
| Component | | Damage | Comments |
|---|---|---|---|
| 5 | Door / Back Left | Bodywork / Poor Previous Repair | |

5. Door / Back Left  
Bodywork / Poor Previous Repair -

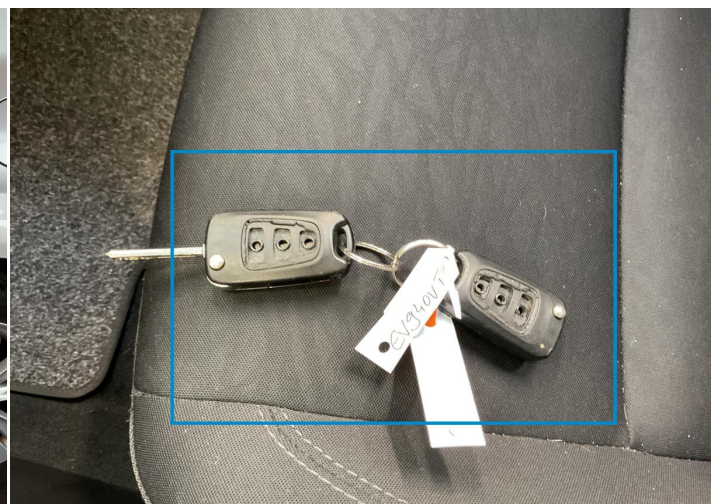
| Component | | Damage | Comments |
|---|---|---|---|
| 6 | Ignition Key | Interior / Broken | |

6. Ignition Key  
Interior / Broken -

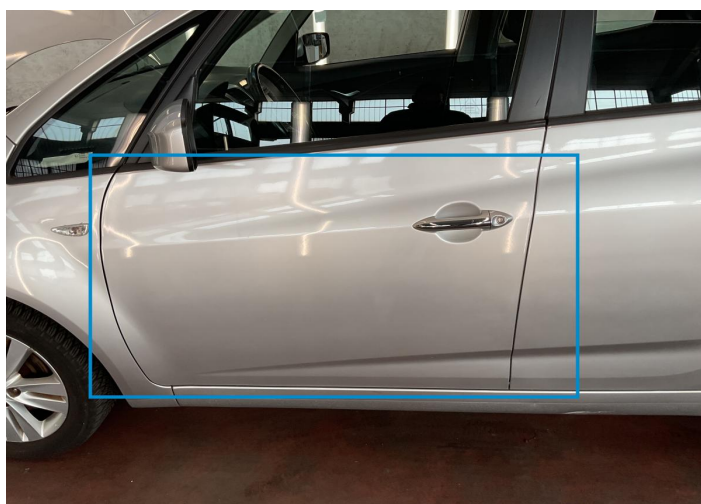
| Component | | Damage | Comments |
|---|---|---|---|
| 7 | Door / Front Left | Bodywork / Poor Previous Repair | |

7. Door / Front Left  
Bodywork / Poor Previous Repair -

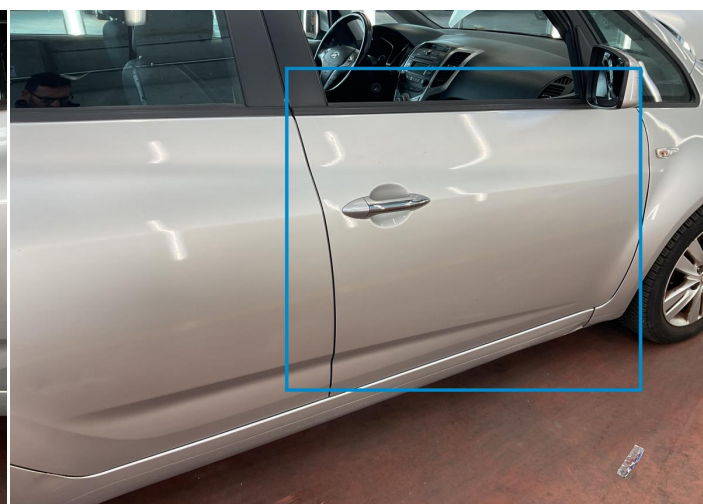
| Component | | Damage | Comments |
|---|---|---|---|
| 8 | Door / Front Right | Bodywork / Dent | |

8. Door / Front Right  
Bodywork / Dent -

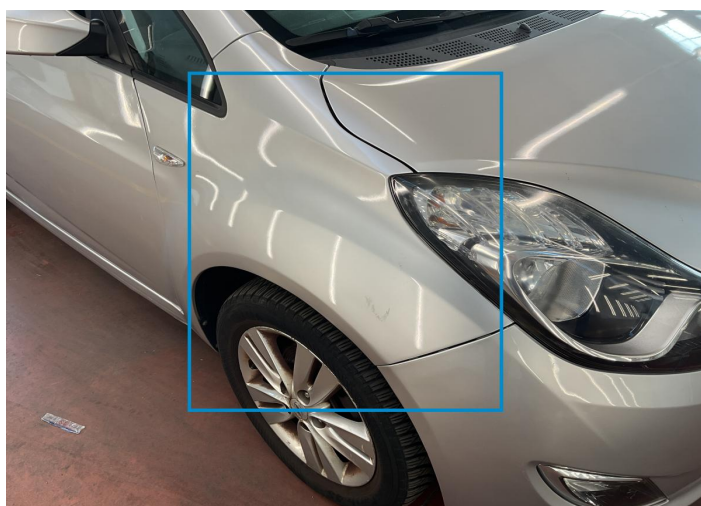
| Component | | Damage | Comments |
|---|---|---|---|
| 9 | Fender / Front Right | Bodywork / Poor Previous Repair | |

9. Fender / Front Right  
Bodywork / Poor Previous Repair -

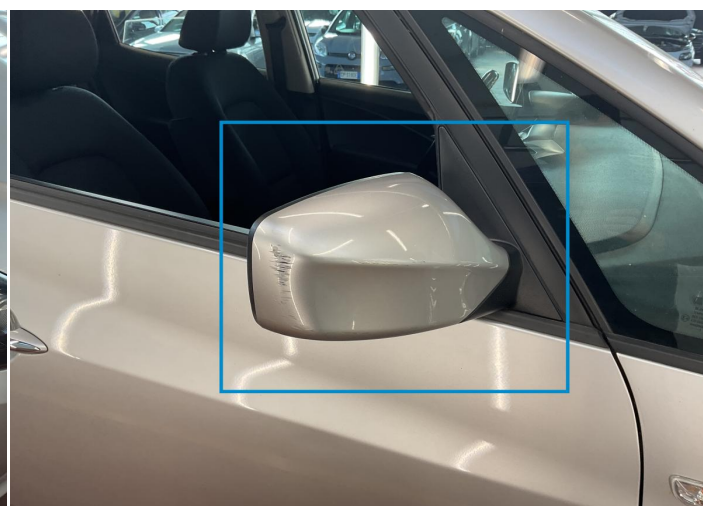
| Component | | Damage | Comments |
|---|---|---|---|
| 10 | Mirror Shell / Front Right | Paint / Scratch / Line | |

10. Mirror Shell / Front Right  
Paint / Scratch / Line -

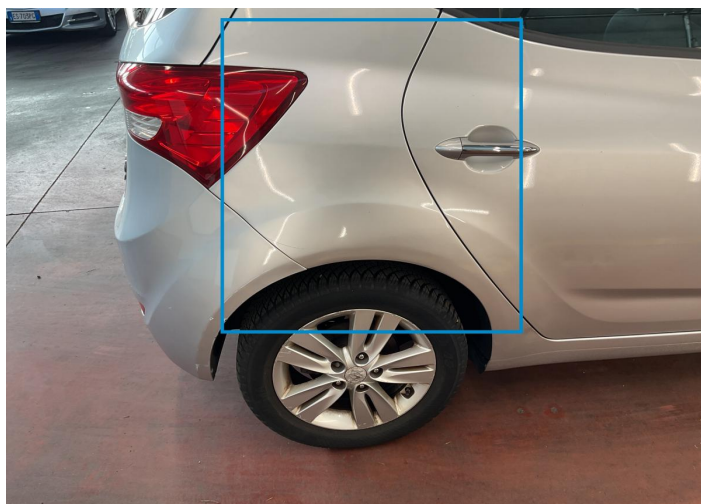
| Component | | Damage | Comments |
|---|---|---|---|
| 11 | Fender / Back Right | Bodywork / Dent | |

11. Fender / Back Right  
Bodywork / Dent -

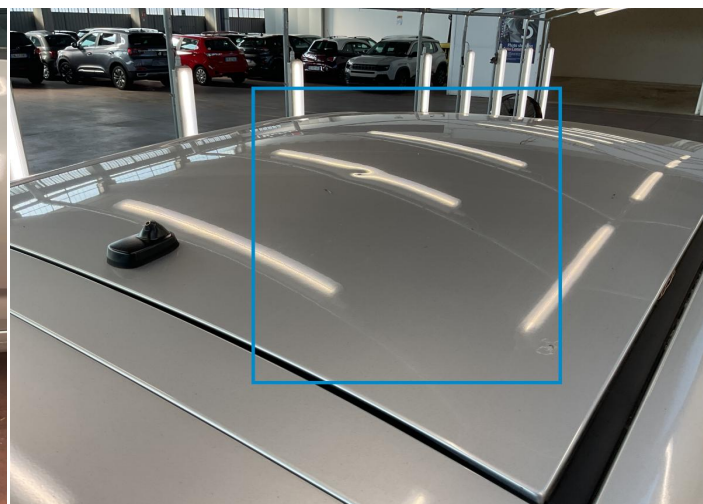
| Component | | Damage | Comments |
|---|---|---|---|
| 12 | Roof | Bodywork / Dent | |

12. Roof  
Bodywork / Dent -

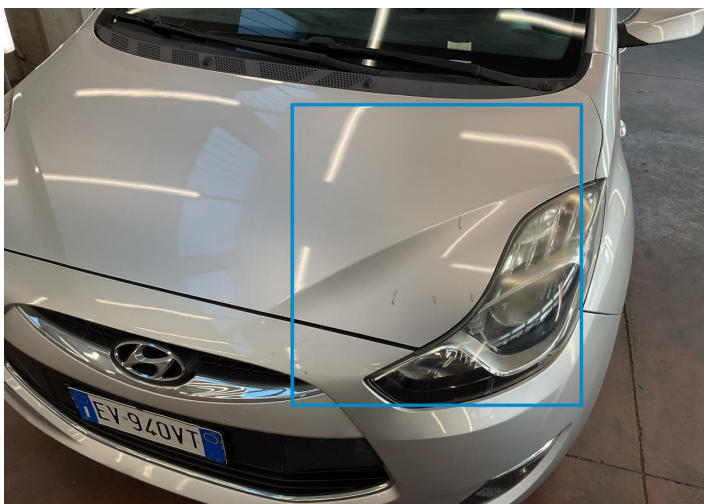
| 13 | Hood | Bodywork / Poor Previous Repair |

13. Hood  
Bodywork / Poor Previous Repair -

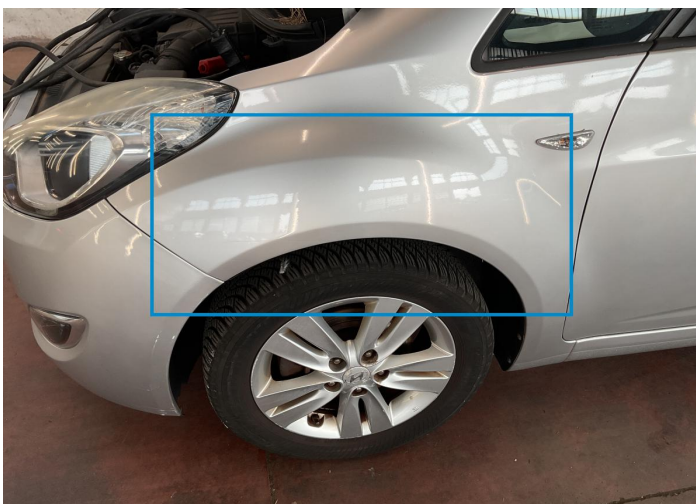
| 14 | Fender / Front Left | Bodywork / Poor Previous Repair |

14. Fender / Front Left  
Bodywork / Poor Previous Repair -

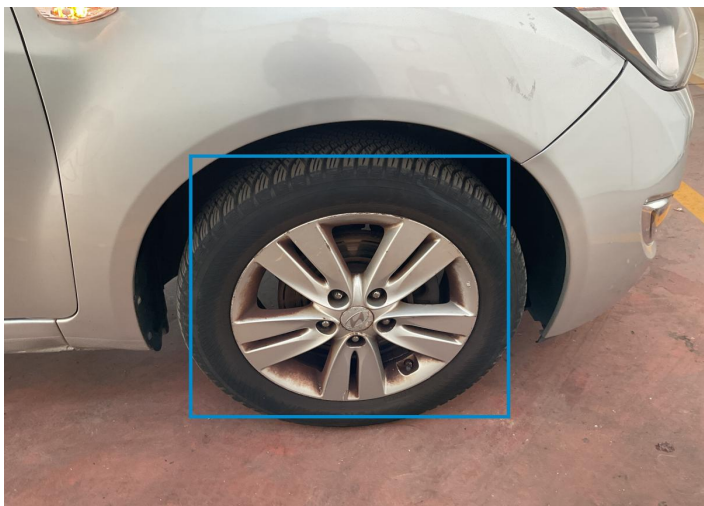
| 15 | Rim / Front Right | Out of Bodywork / Scratch |

15. Rim / Front Right  
Out of Bodywork / Scratch -

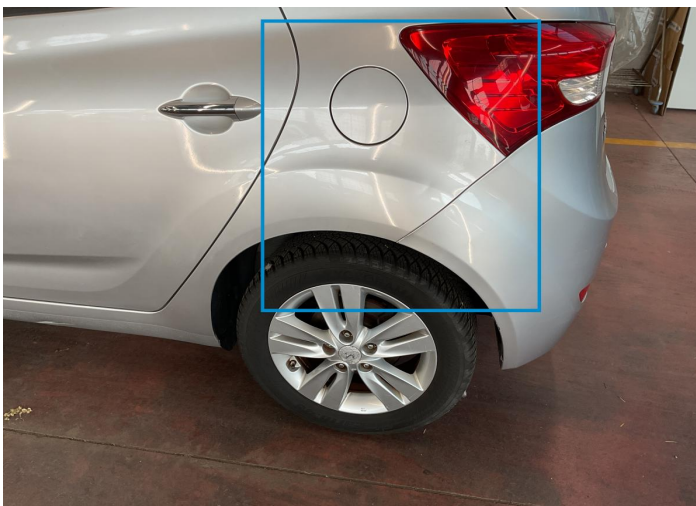
| 16 | Fender / Back Left | Bodywork / Dent |

16. Fender / Back Left  
Bodywork / Dent -

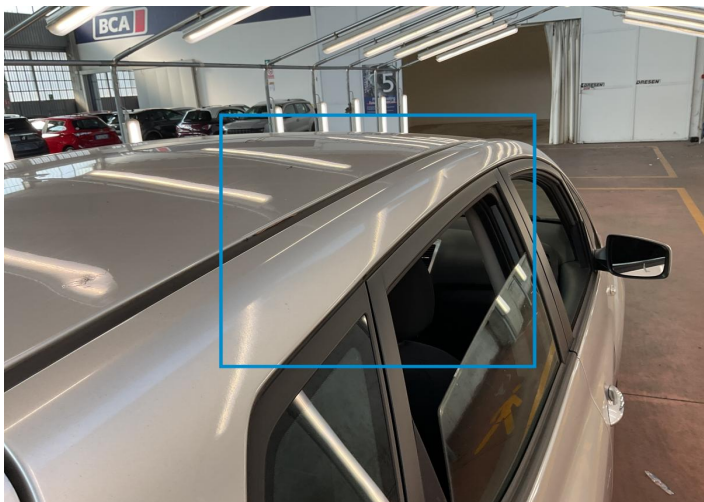
| 17 | Pillar / Front Right | Bodywork / Dent / Hail Area |

17. Pillar / Front Right  
Bodywork / Dent / Hail Area -

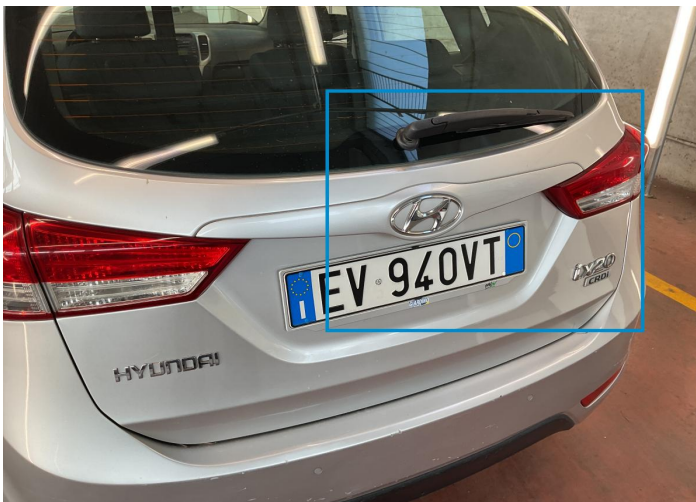
| 18 | Tailgate | Paint / Scratch / Line |

18. Tailgate  
Paint / Scratch / Line -

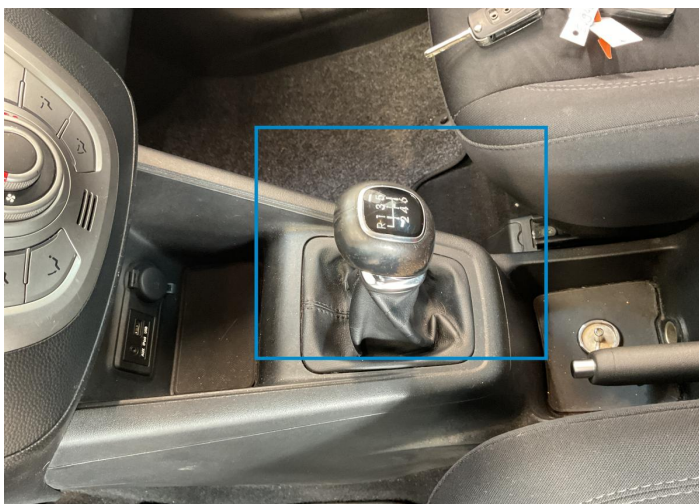
| 19 | Gear Knob | Interior / Worn - out |

19. Gear Knob  
Interior / Worn - out -

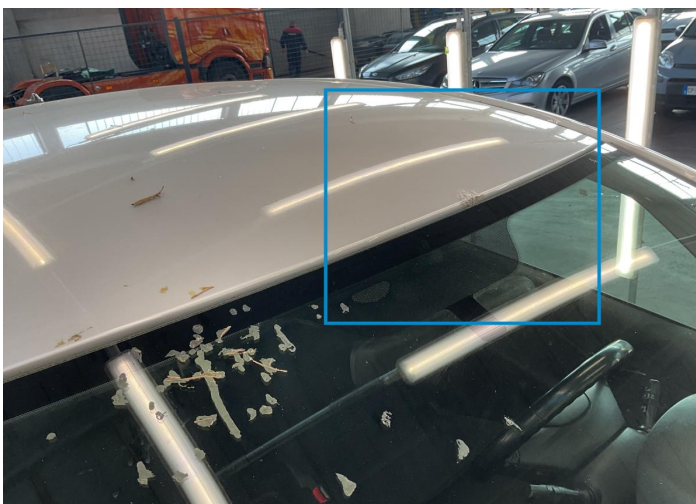
| 20 | Roof | Paint / Scratch / Line |

20. Roof  
Paint / Scratch / Line -

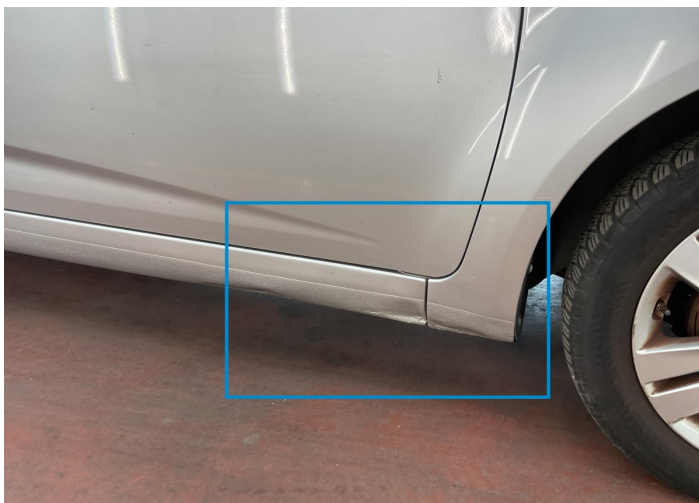
| 21 | Rocker Panel / Center Right | Bodywork / Dent |

21. Rocker Panel / Center Right  
Bodywork / Dent -

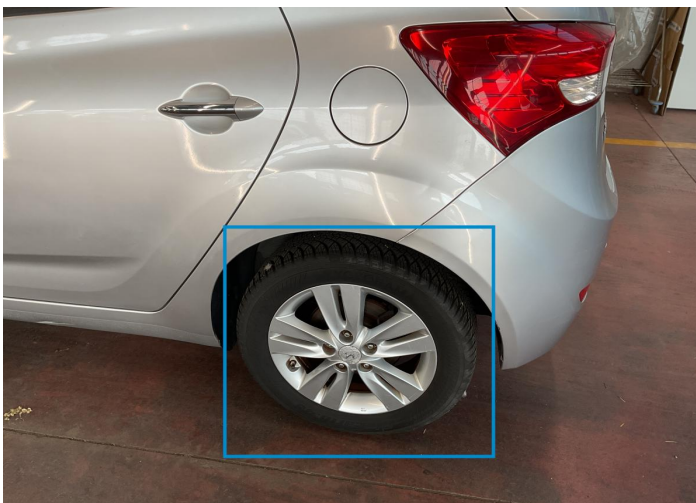
| 22 | Rim / Back Left | Out of Bodywork / Scratch |

22. Rim / Back Left  
Out of Bodywork / Scratch -

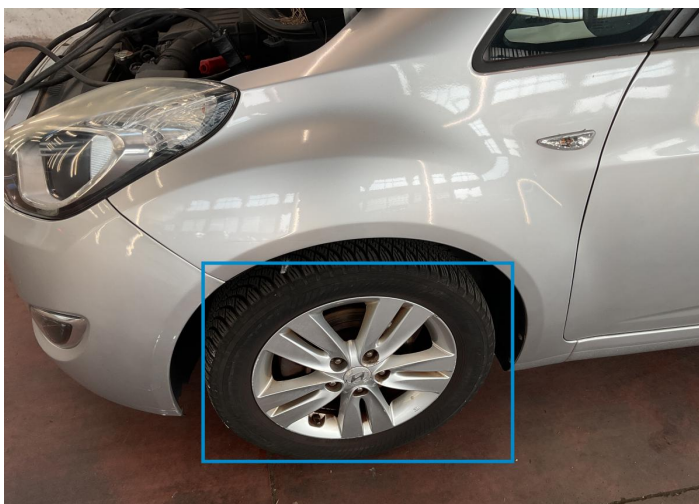
| 23 | Rim / Front Left | Out of Bodywork / Scratch |

23. Rim / Front Left  
Out of Bodywork / Scratch -

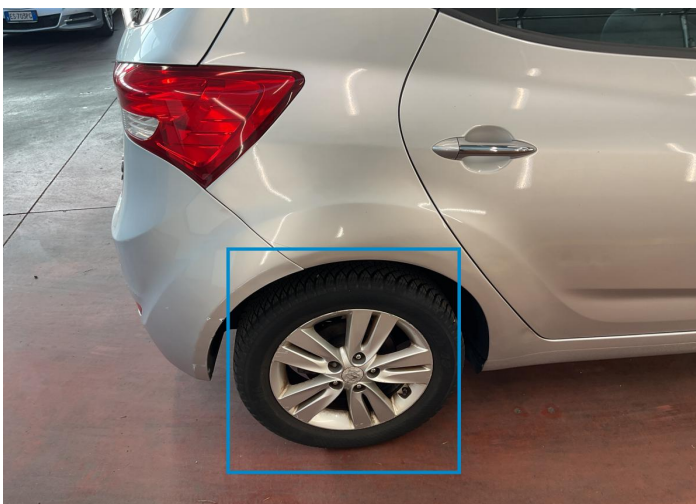
| 24 | Rim / Back Right | Out of Bodywork / Scratch |

24. Rim / Back Right  
Out of Bodywork / Scratch -

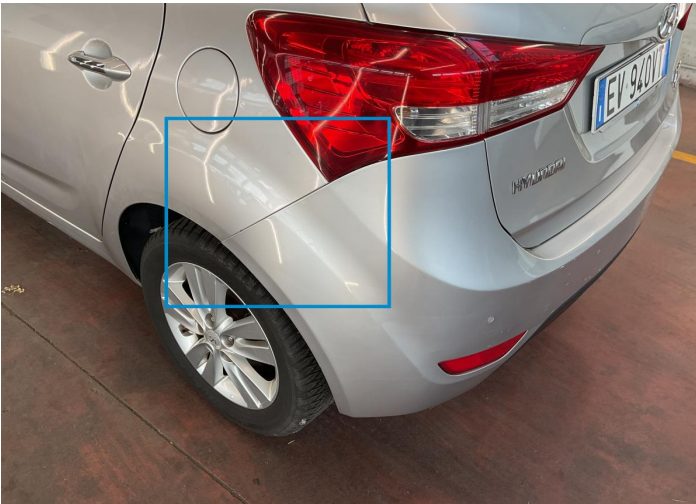
| 25 | Bumper / Back | Bodywork / Assembly |

25. Bumper / Back  
Bodywork / Assembly -

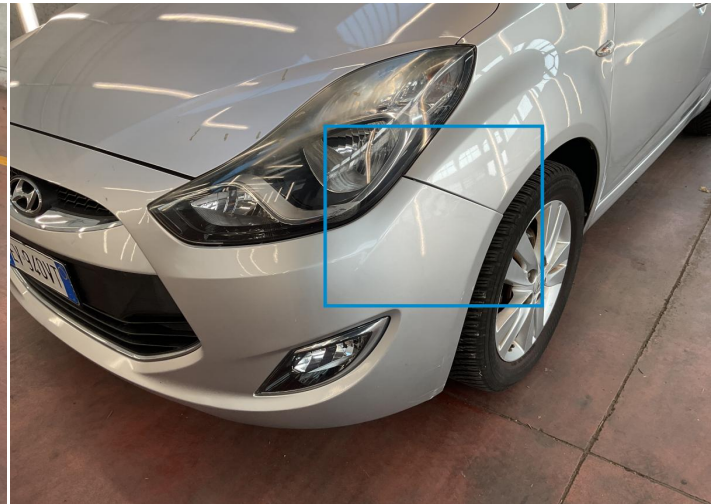
| 26 | Bumper / Front | Bodywork / Assembly |

26. Bumper / Front  
Bodywork / Assembly -

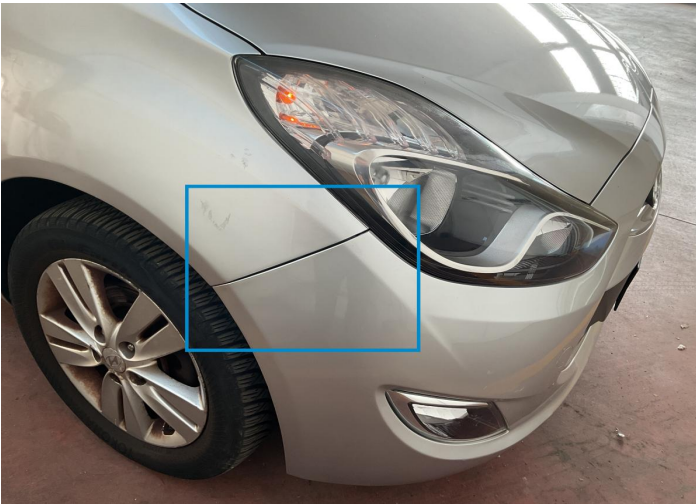
| 27 | Bumper / Front | Bodywork / Assembly |

27. Bumper / Front  
Bodywork / Assembly -

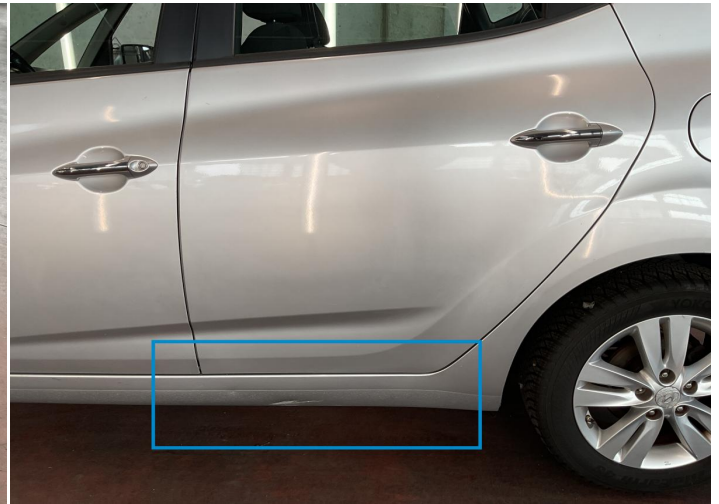
| 28 | Rocker Panel / Center Left | Bodywork / Dent |

28. Rocker Panel / Center Left  
Bodywork / Dent -

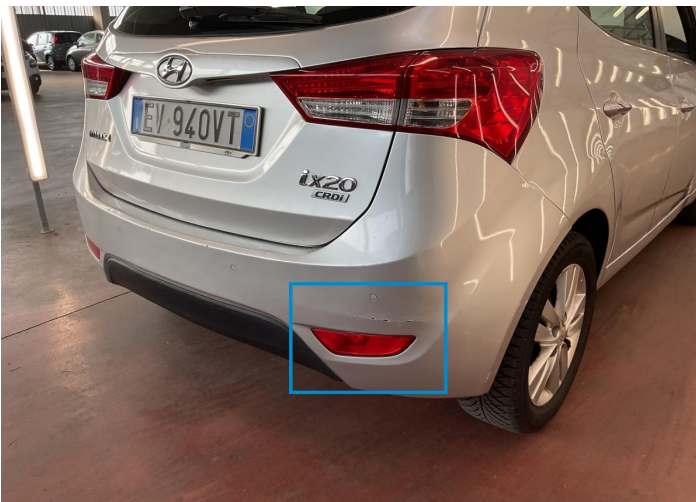
| 29 | Fog Light / Back Right | Glass Break |

29. Fog Light / Back Right  
Glass Break -
