## status report

#### Skoda Fabia Cool Edition

| Vehicle identification number | <b>TMBAC65J193091310</b> | mileage read: | <b>166265 km</b> |

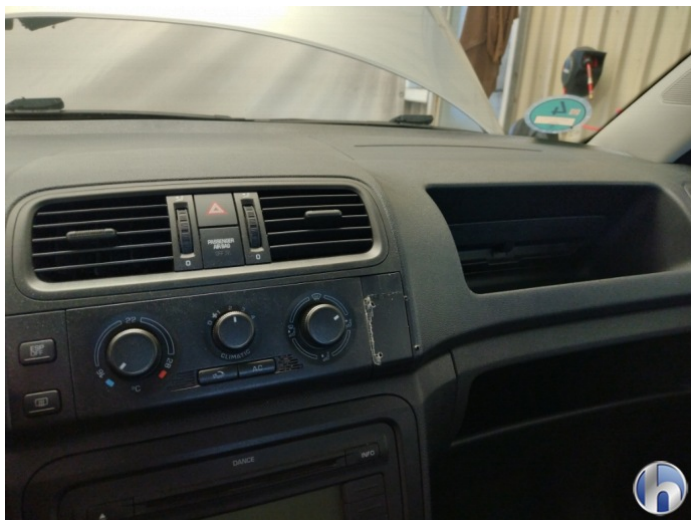
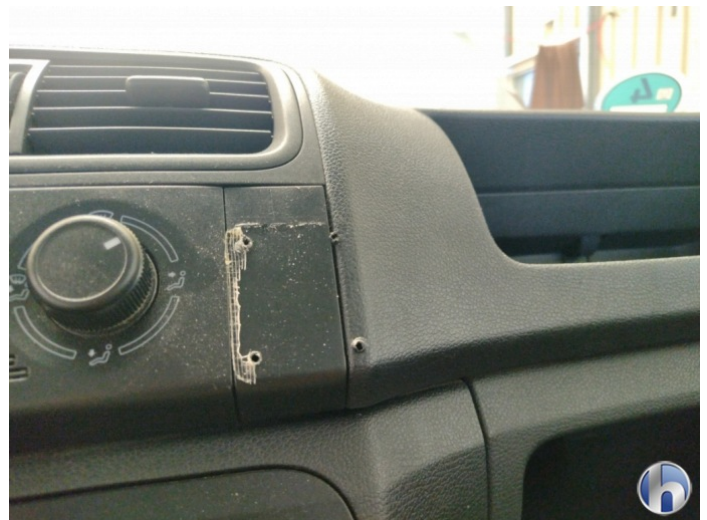
| component | Damage | Rep kind |
|---|---|---|
| 1. dashboard | | Replace |

1. dashboard

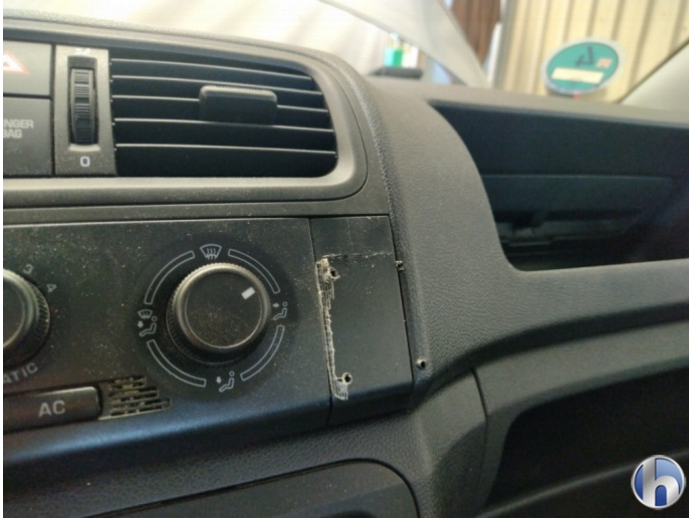
| component | Damage | Rep kind |
|---|---|---|
| 2. | Damaged | Replace |

2.

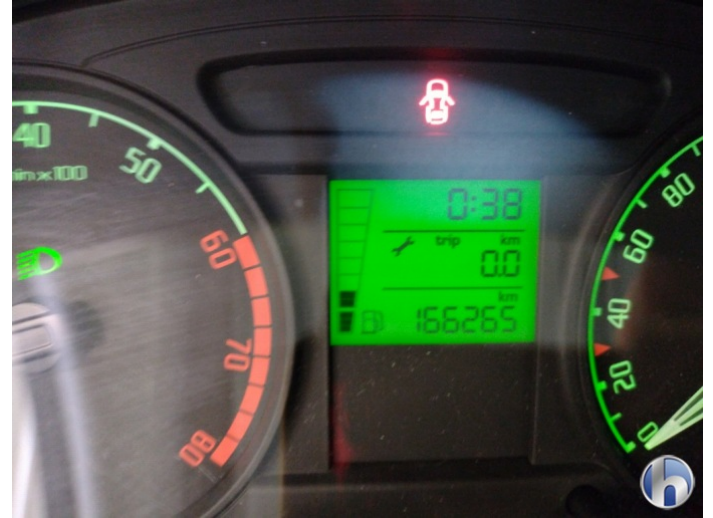
| component | Damage | Rep kind |
|---|---|---|
| 6. maintenance | Due | Replace |

6. maintenance

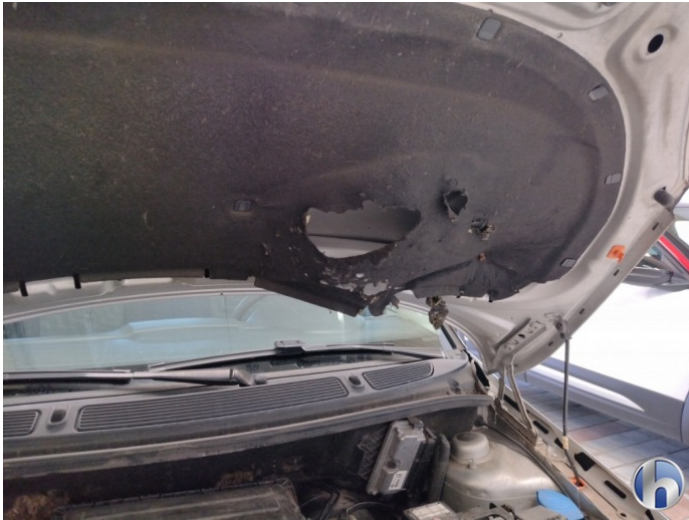
| component | Damage | Rep kind |
|---|---|---|
| 8. motor insulation | Damaged | Replace |

8. motor insulation

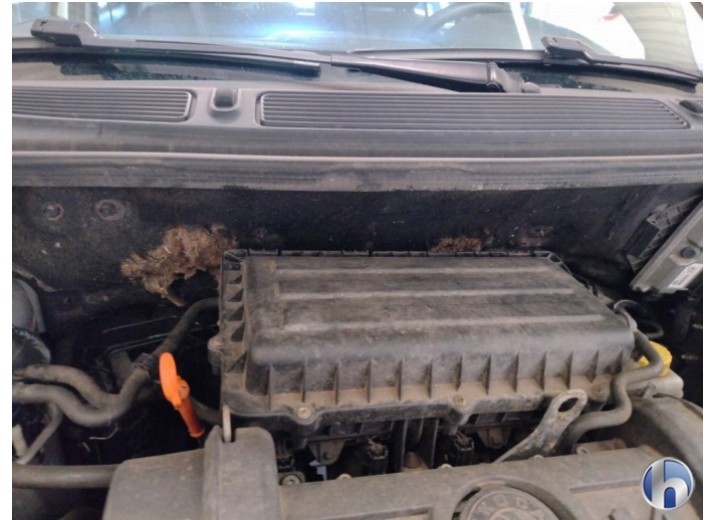
| component | Damage | Rep kind |
|---|---|---|
| 9. | Damaged | Replace |

9.

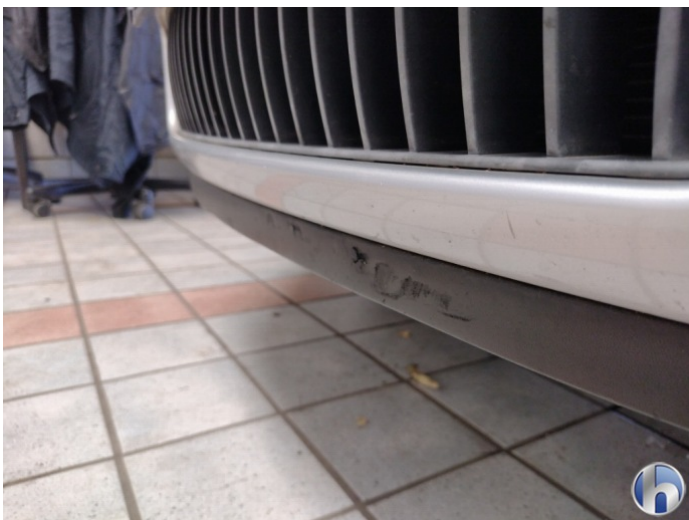
| component | Damage | Rep kind |
|---|---|---|
| 10. spoiler | Damaged | Replace |

10. spoiler

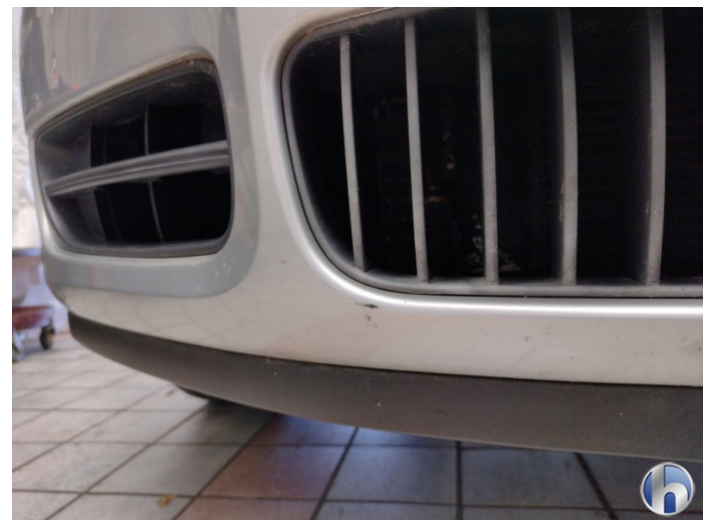
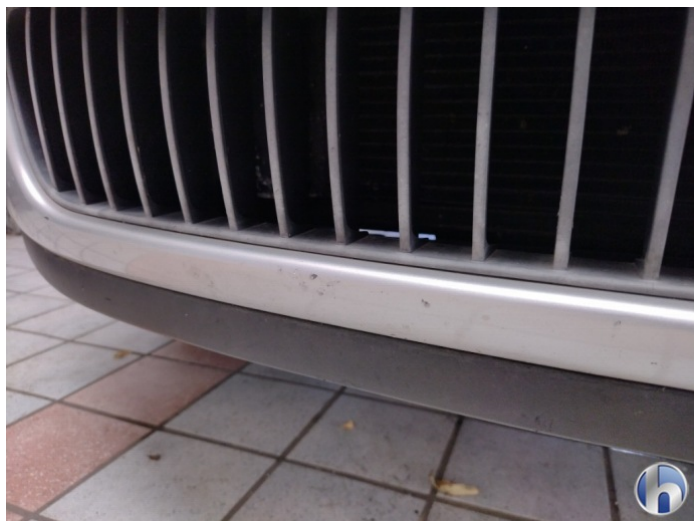
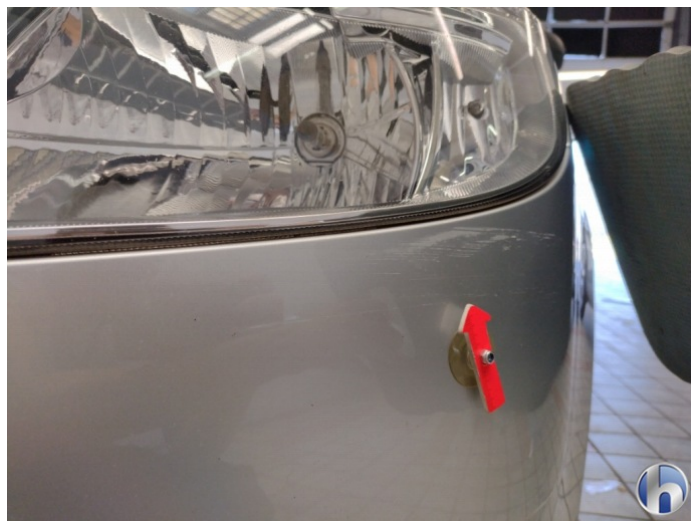
| component | Damage | Rep kind |
|---|---|---|
| 11. Front bumper | Scratch(es) | Paint |

11. Front bumper

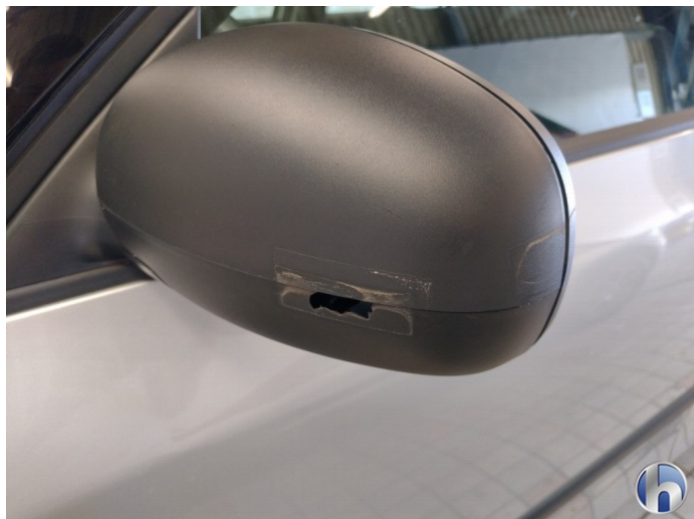
| component | Damage | Rep kind |
|---|---|---|
| 12. Outside mirror - left | Damaged | Replace |

12. Outside mirror - left

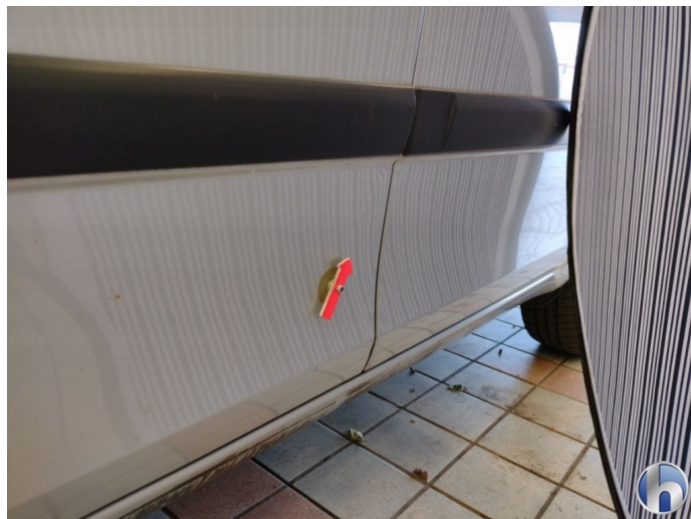
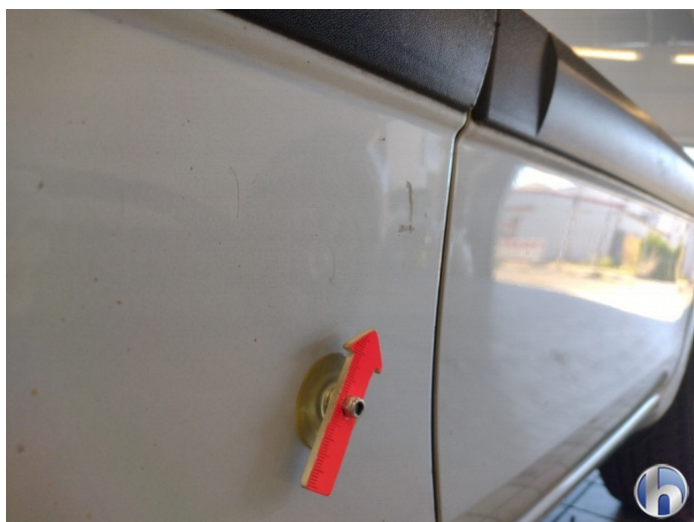
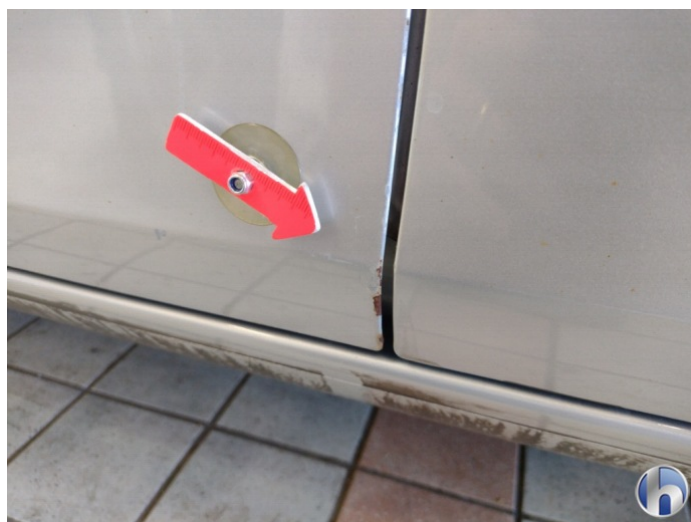
| component | Damage | Rep kind |
|---|---|---|
| 13. Front door - left | Damaged | Refurbish and paint |

13. Front door - left

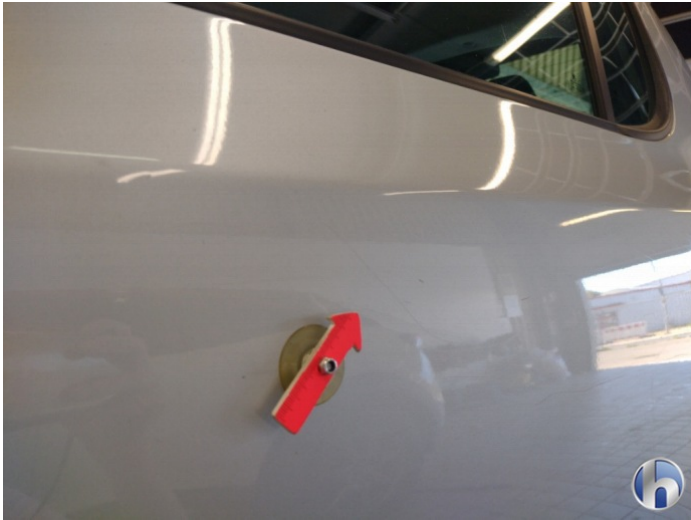
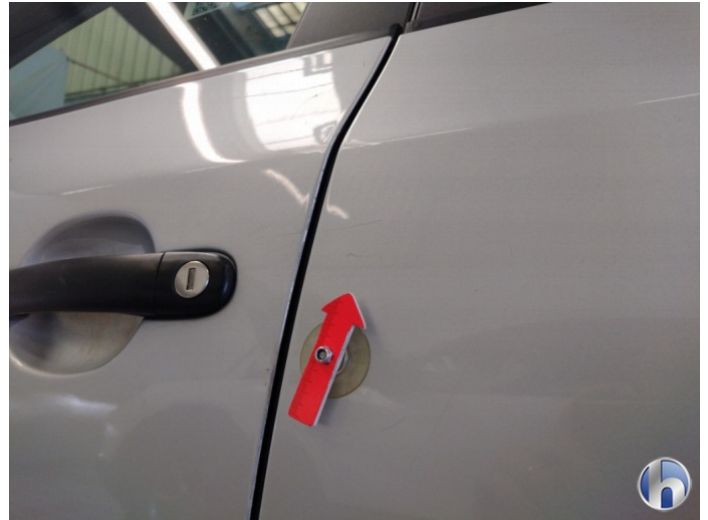
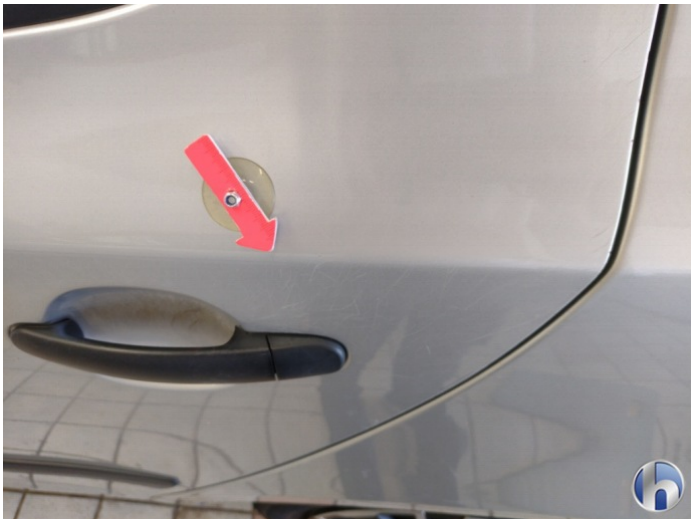
| component | Damage | Rep kind |
|---|---|---|
| 14. Rear door - left | Scratch(es) | Paint |

14. Rear door - left

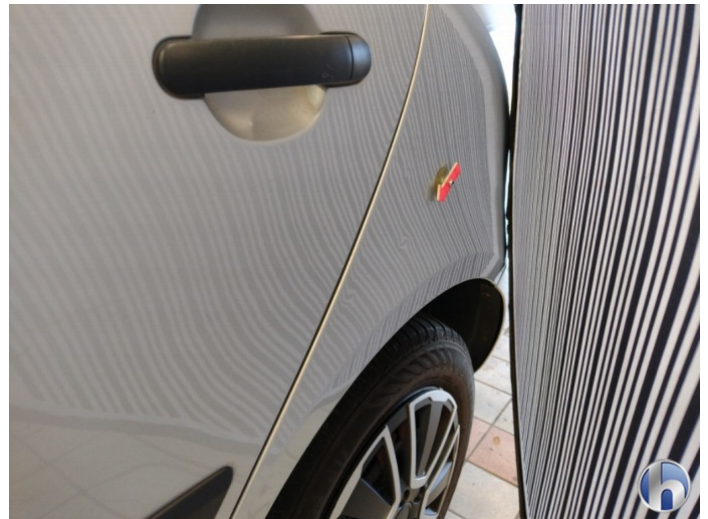
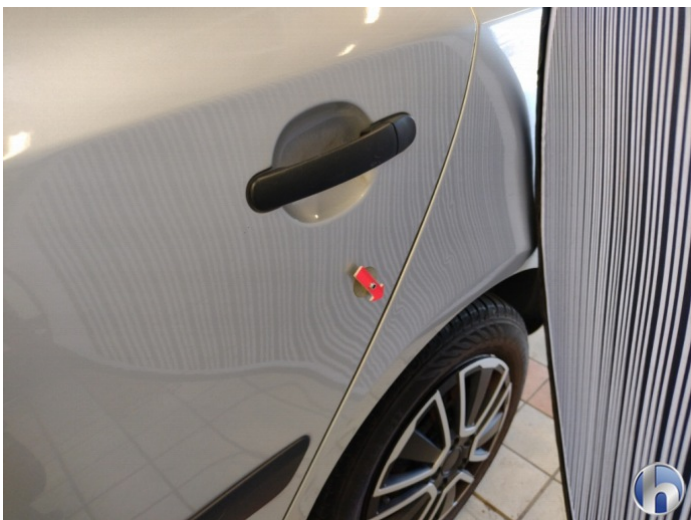
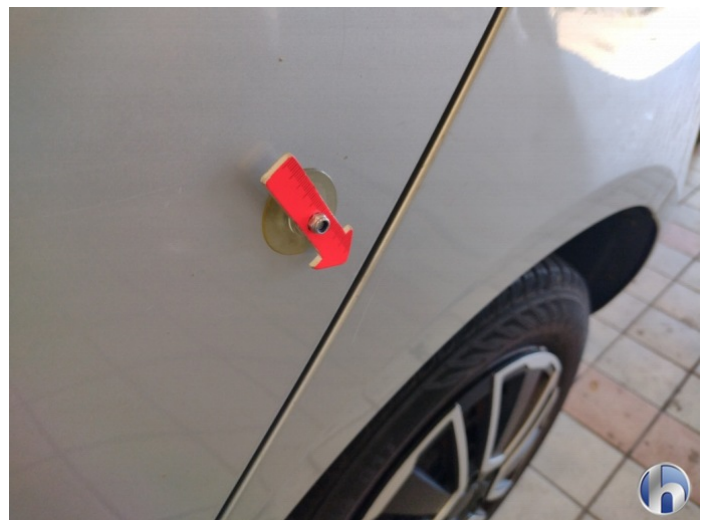
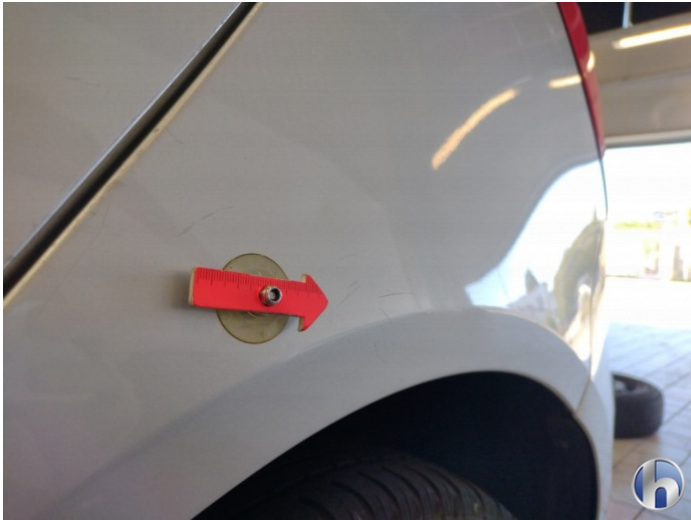
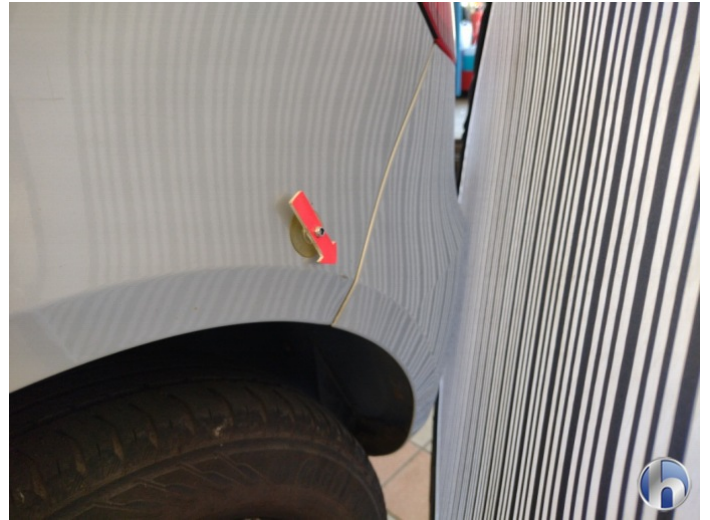
| component | Damage | Rep kind |
|---|---|---|
| 15. Sidewall - Rear - Left | Deformed | Refurbish and paint |

15. Sidewall - Rear - Left

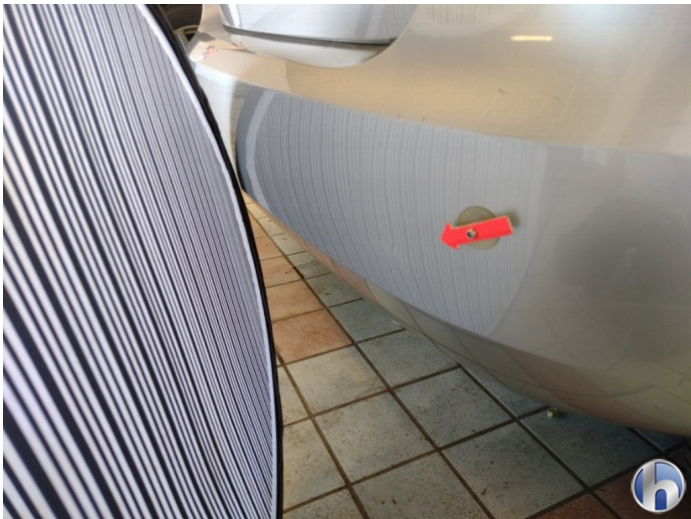
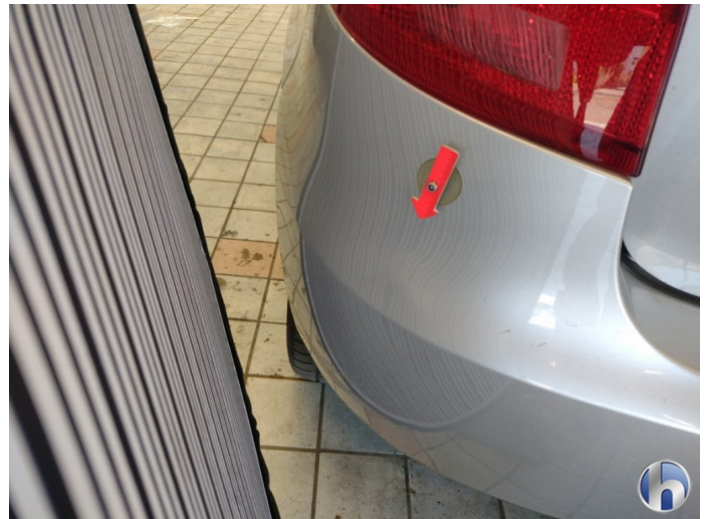
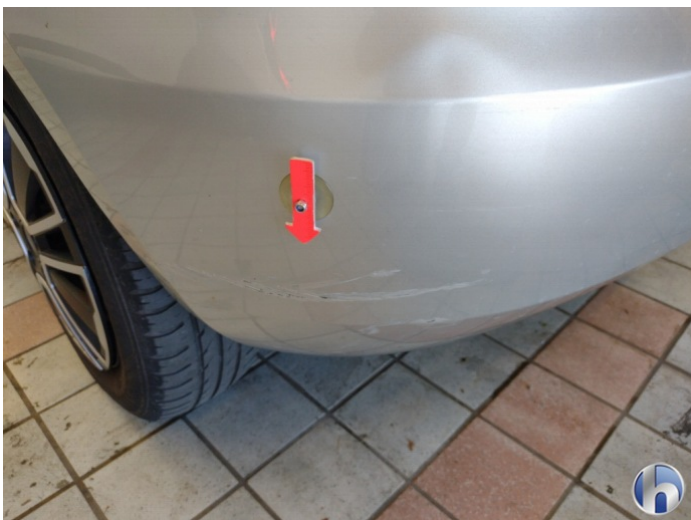
| component | Damage | Rep kind |
|---|---|---|
| 16. Rear bumper | Damaged | Refurbish and paint |

16. Rear bumper

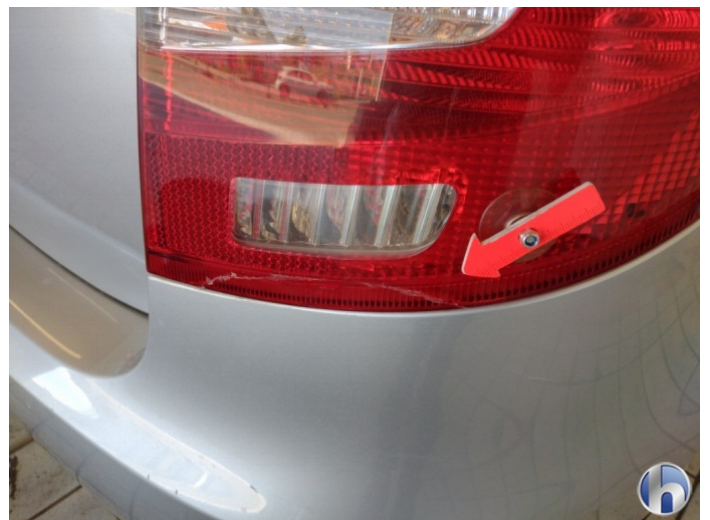
| component | Damage | Rep kind |
|---|---|---|
| 17. Taillight right | Breakage | Replace |

17. Taillight right

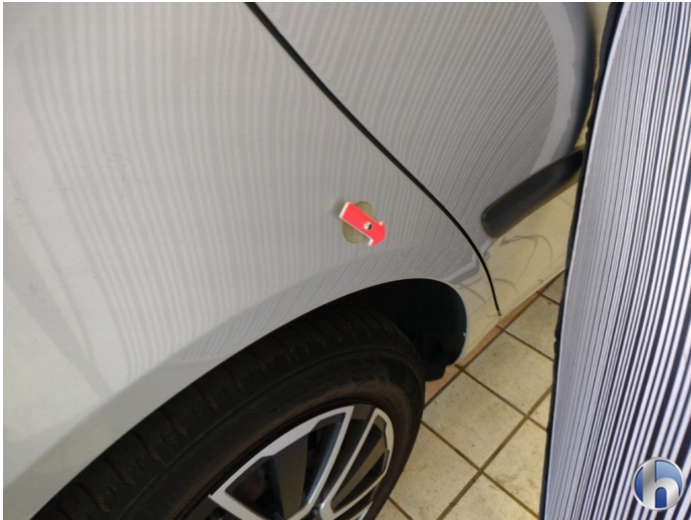
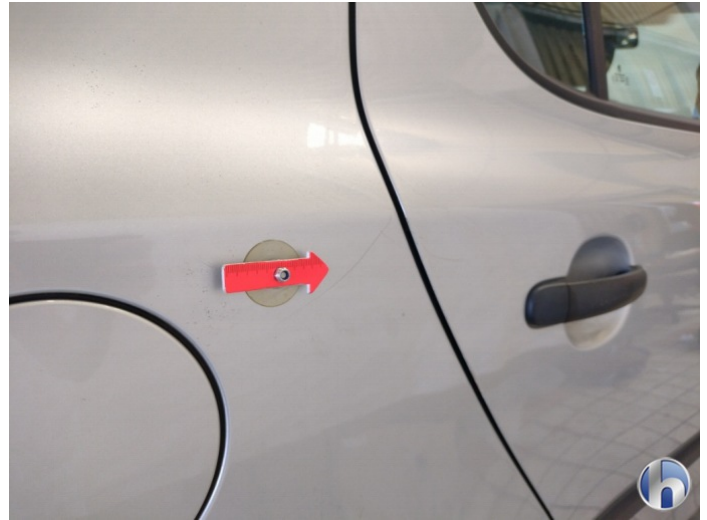
| component | Damage | Rep kind |
|---|---|---|
| 18. Sidewall - Rear - right | Delle | Smart repair |

18. Sidewall - Rear - right

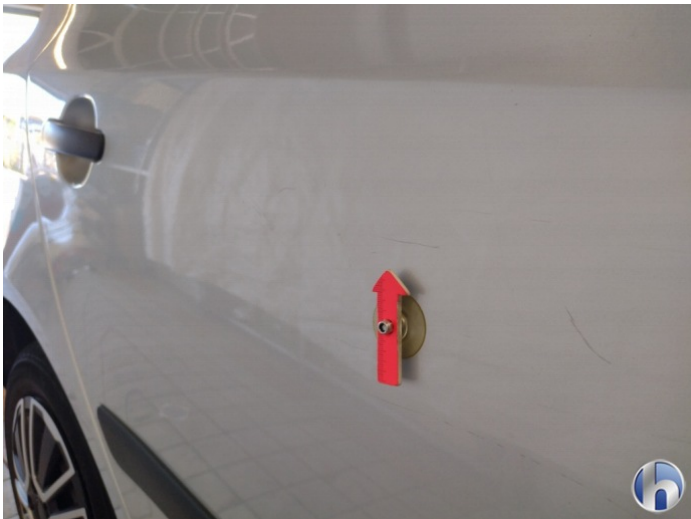
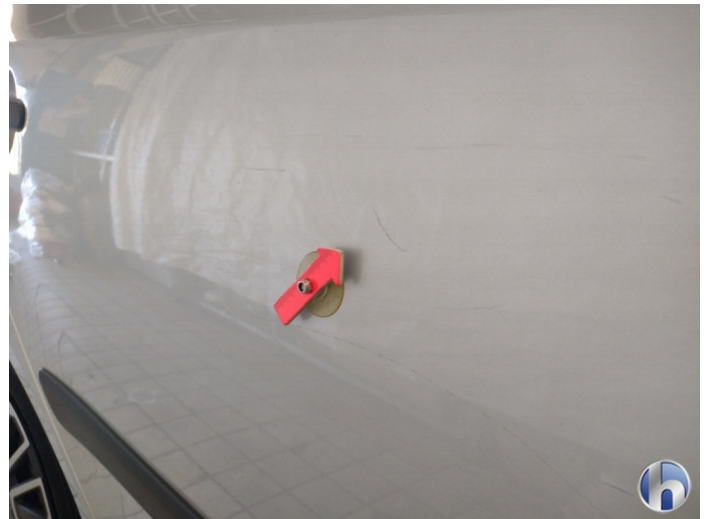
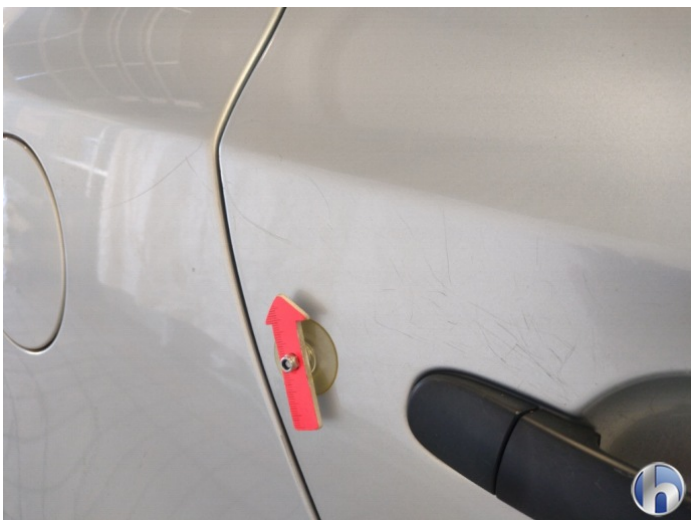
| component | Damage | Rep kind |
|---|---|---|
| 19. Door Rear - right | Scratch(es) | Paint |

19. Door Rear - right

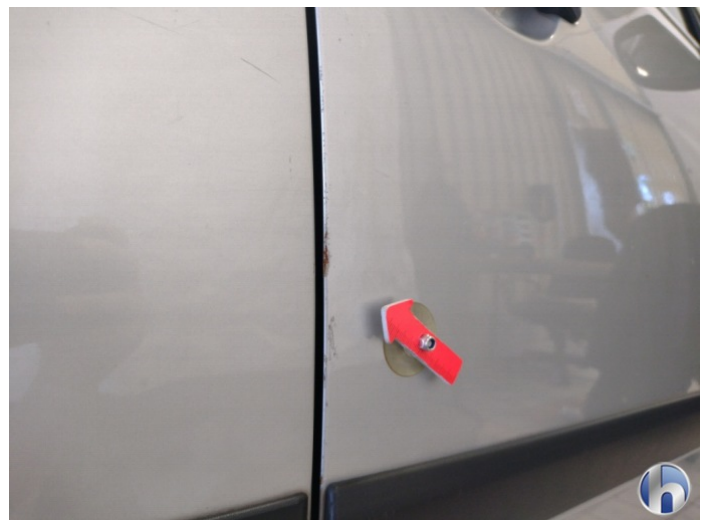
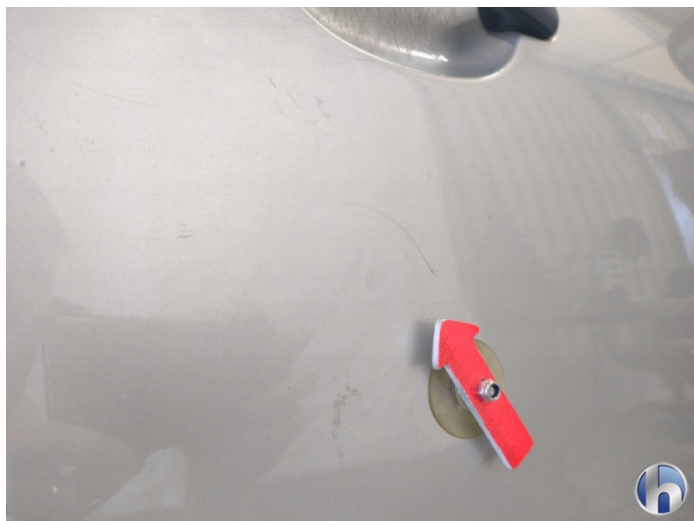
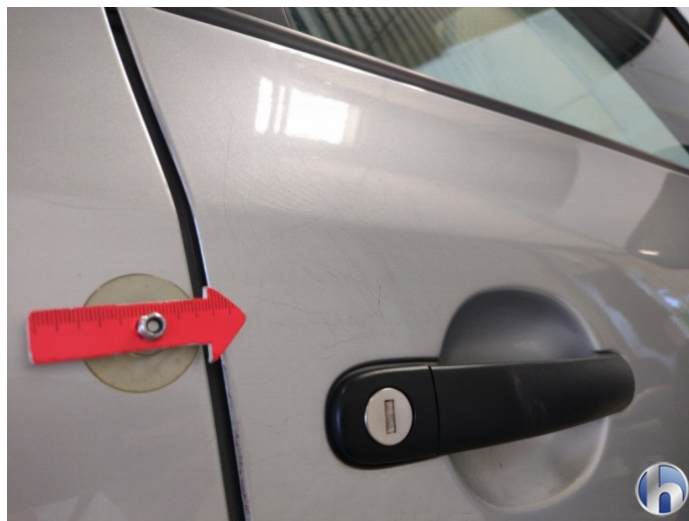
| component | Damage | Rep kind |
|---|---|---|
| 20. Front door - right | Scratch(es) | Paint |

20. Front door - right

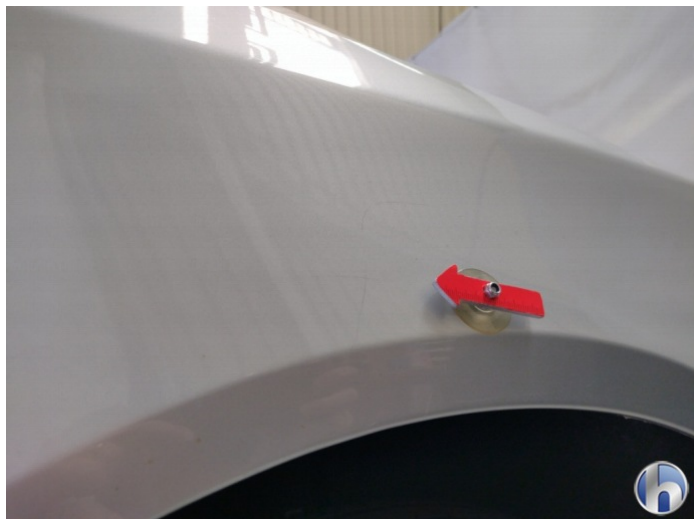
| component | Damage | Rep kind |
|---|---|---|
| 21. Front fender - right | Scratch(es) | Paint |

21. Front fender - right

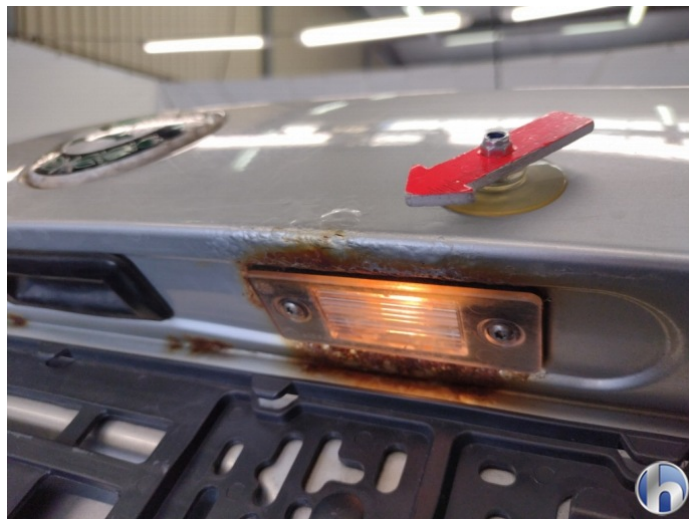
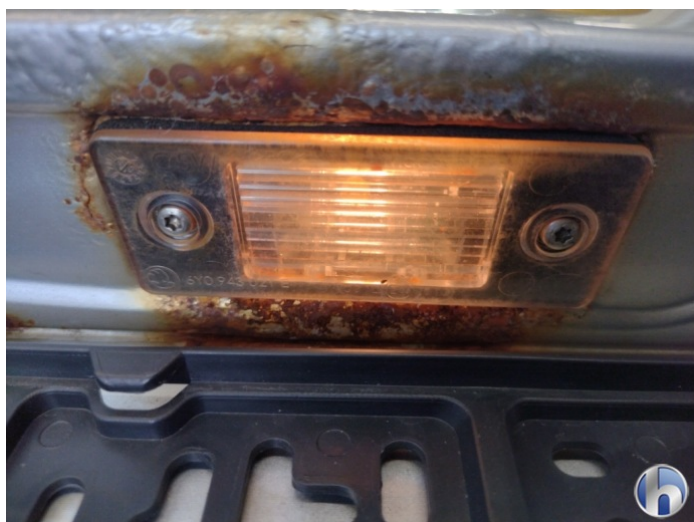
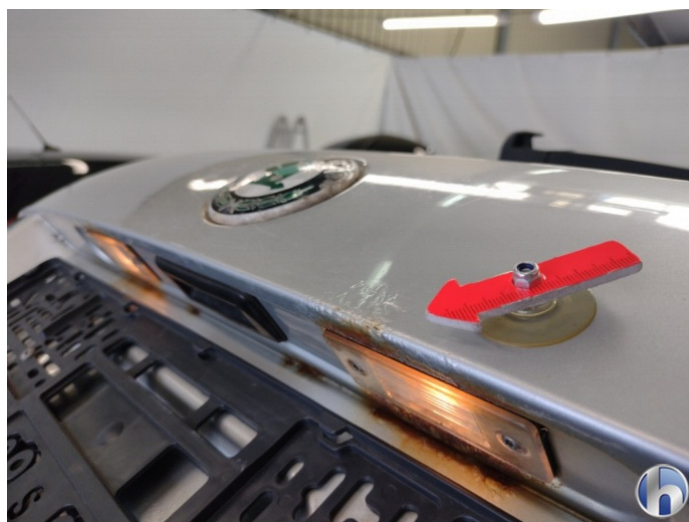
| component | Damage | Rep kind |
|---|---|---|
| 22. tailgate | Rust | Replace |

22. tailgate

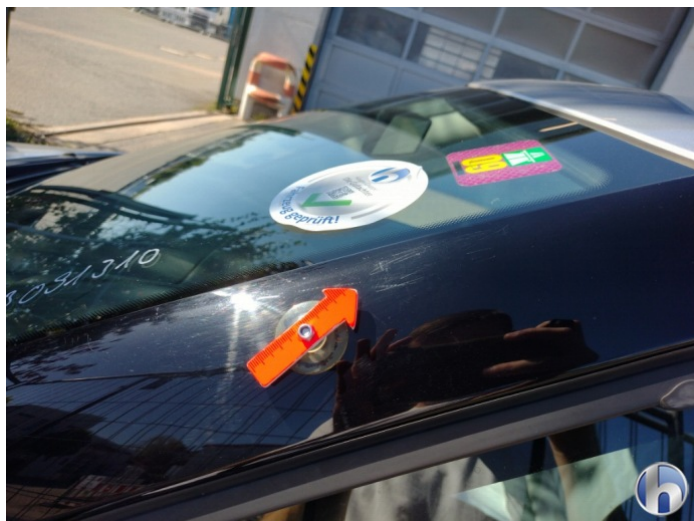
| component | Damage | Rep kind |
|---|---|---|
| 23. A-pillar Front - Left | Scratch(es) | |

23. A-pillar Front - Left
