Expertise

Protocol number: 39985637
Order No. / Reference: 24781070
Inspection date: 2 Jun 2025

Manufacturer: Skoda
VIN: TMBAJ7NP7L7035727

Model: Superb 2.0 TDI DSG Ambition

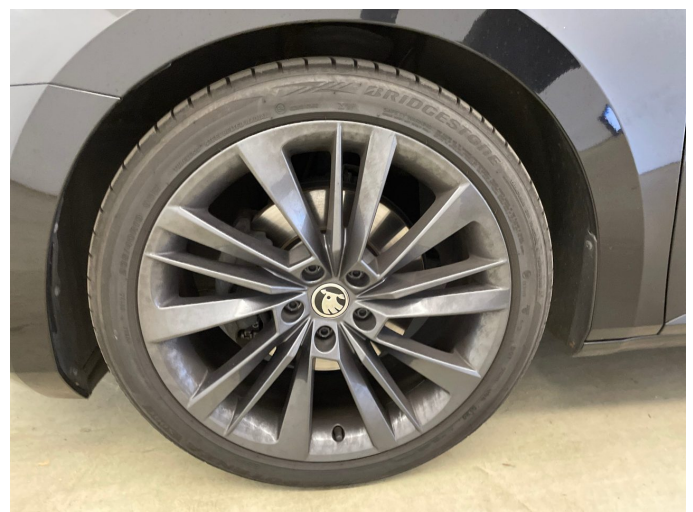
Figure 12: Mounted tyres

#	Tyre size	Type of tyre	Manufacturer	Tread depth
1)	235/40 R19 96W	Summer tyres on Light alloy	Bridgestone	4mm / 4mm
2)	235/40 R19 96W	Summer tyres on Light alloy	Bridgestone	4mm / 4mm

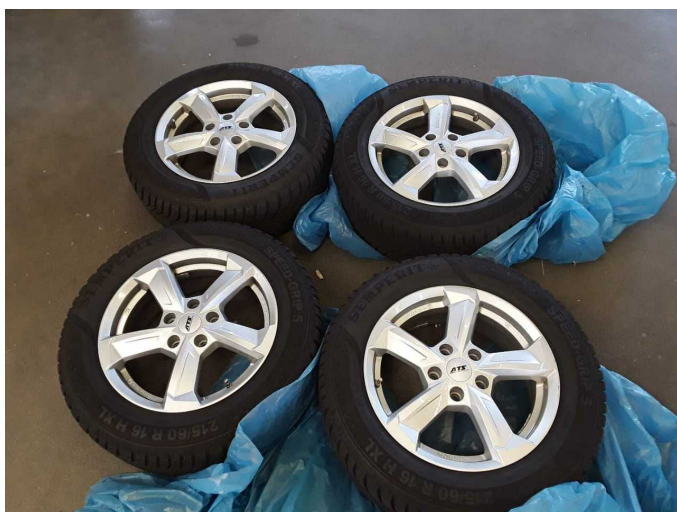
Figure 17: Additional tyres

#	Tyre size	Type of tyre	Manufacturer	Tread depth
1)	215/60 R16 99H	Winter tyres on Light alloy	Semperit	5mm / 5mm
2)	215/60 R16 99H	Winter tyres on Light alloy	Semperit	6mm / 6mm

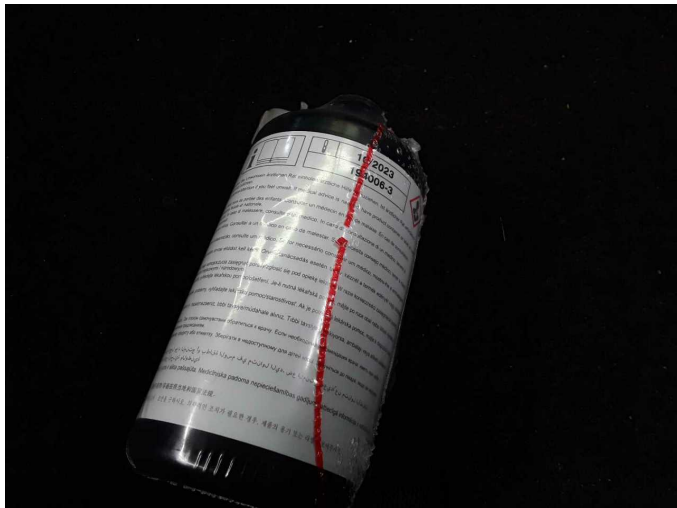
No.	Component group	Description
1	Equipment	Tirefit filler - Expired - Replace
2	Door - rear right side	Door - Scratch(es) - Smart repair
3	Door - front left side	Door - Scratch(es) - Smart repair
4	Bonnet	Bonnet (Vermehrte Steinschläge) - Stone chips - Paint
5	Vehicle glazing	Windscreen (Rissbildung) - Stone chips - repair according to calculation

Damage 1: Equipment: Tirefit filler - Expired - Replace

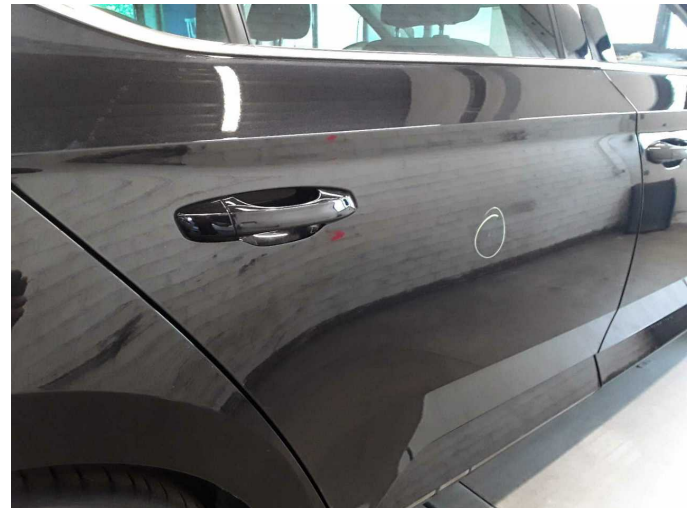
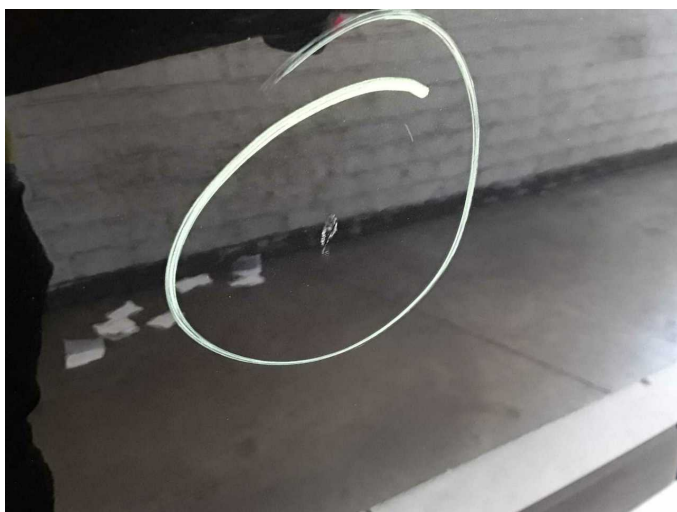
Damage 2: Door - rear right side: Door - Scratch(es) - Smart repair

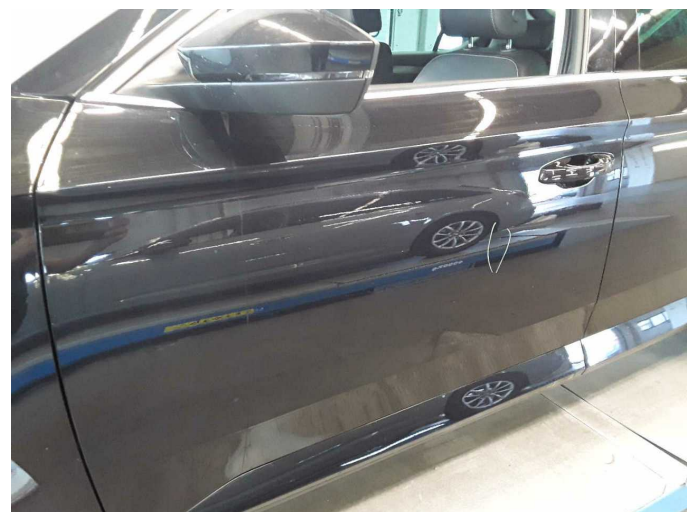
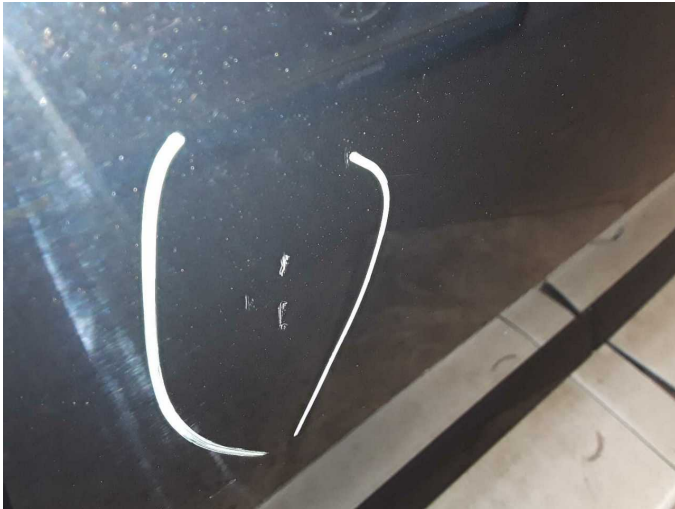
Damage 3: Door - front left side: Door - Scratch(es) - Smart repair

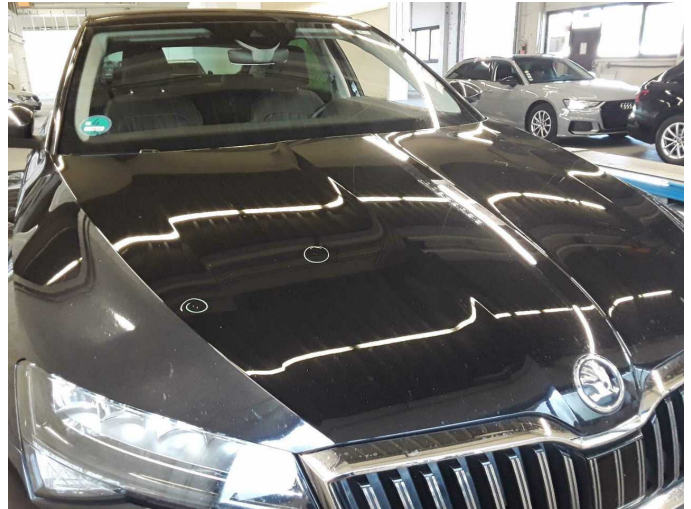
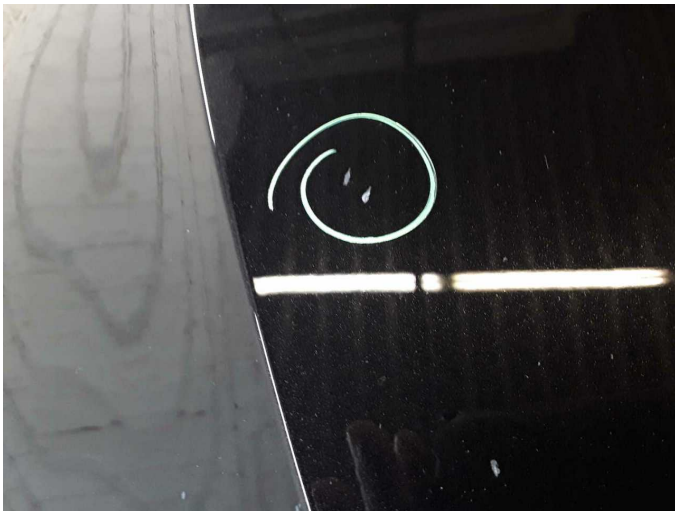
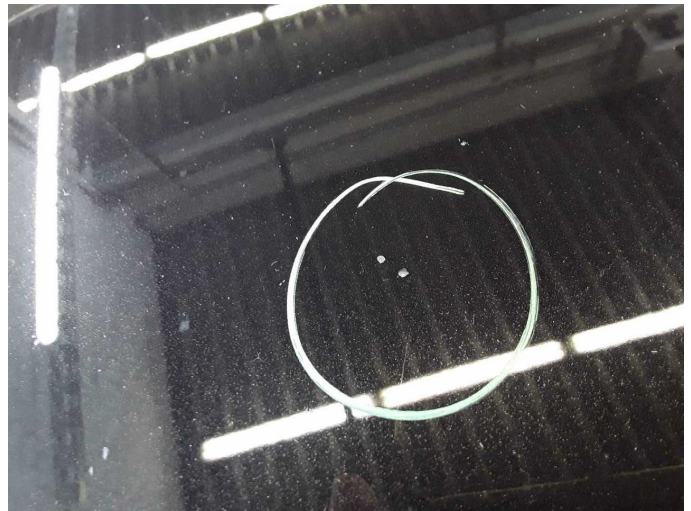
Damage 4: Bonnet: Bonnet (Vermehrte Steinschläge) - Stone chips - Paint

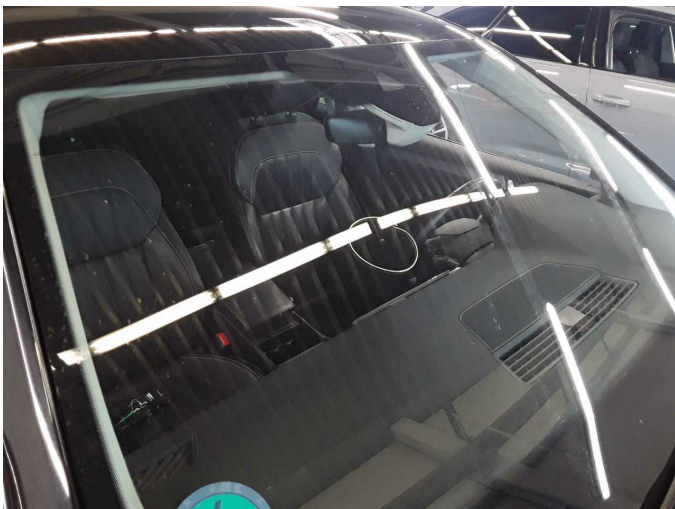
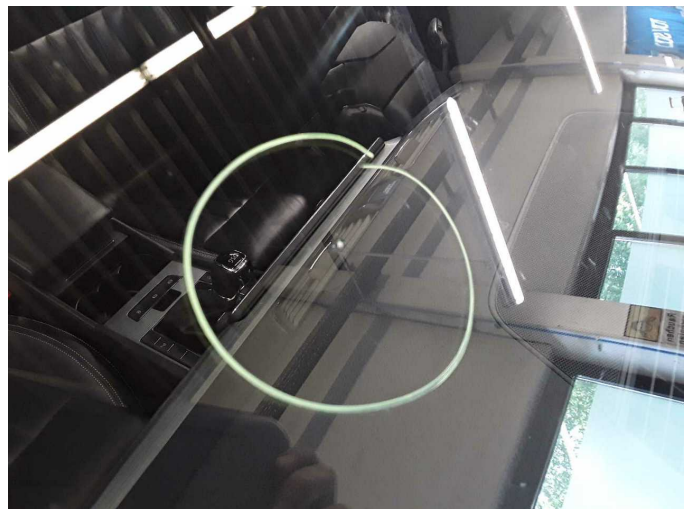
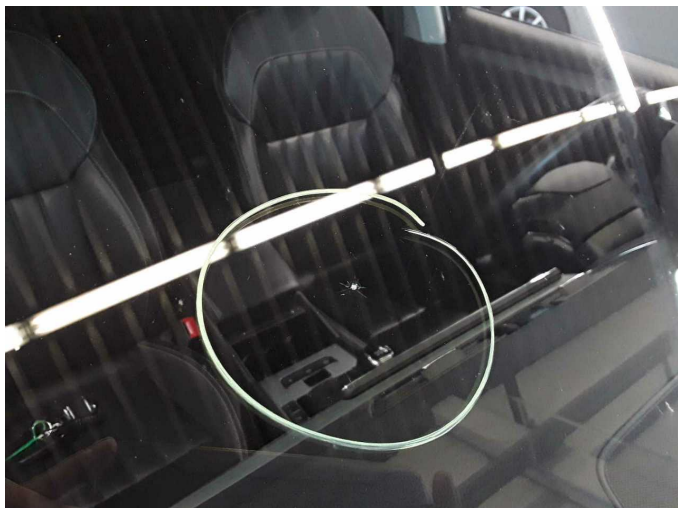
Damage 5: Vehicle glazing: Windscreen (Rissbildung) - Stone chips - repair according to calculation

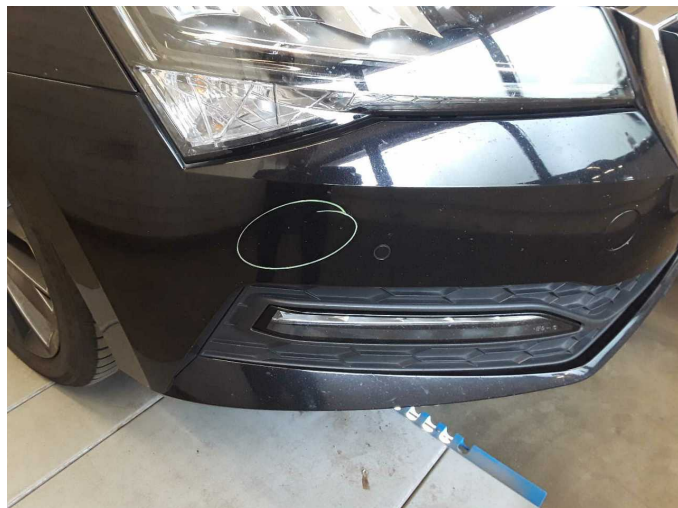
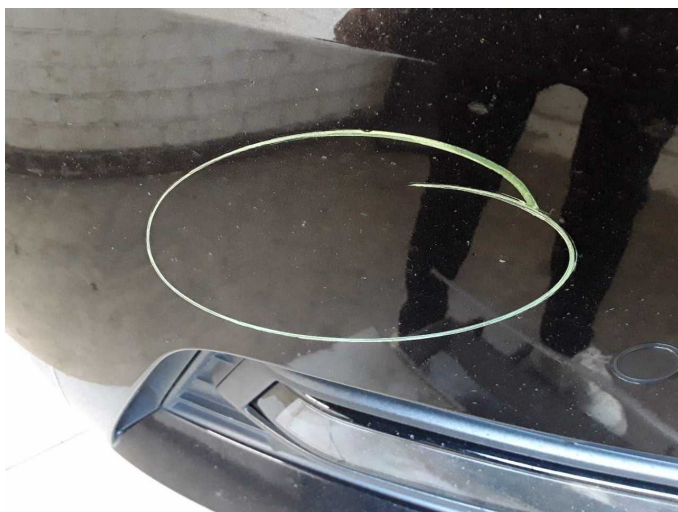
Wear and tear 1: Front bumper: Front bumper - Stone chips - No deduction

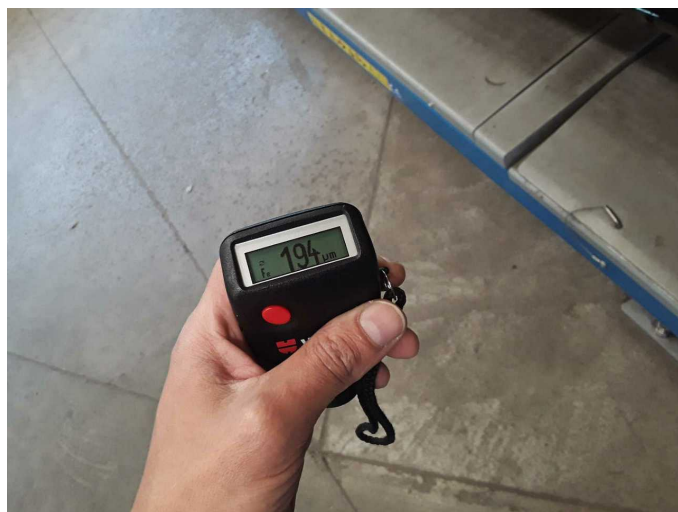
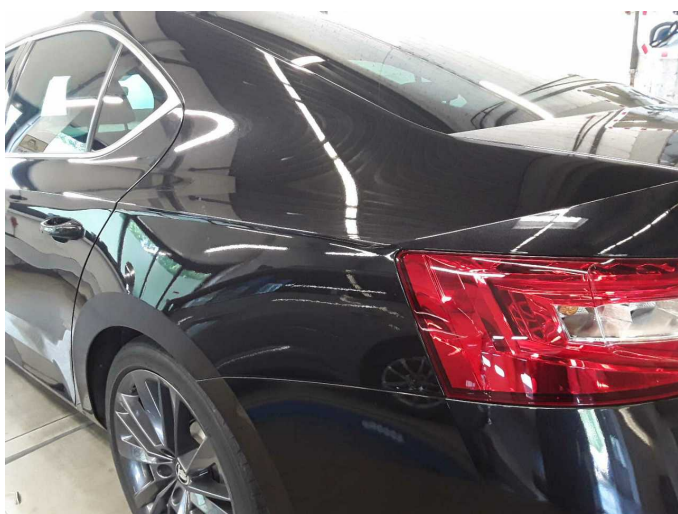
No.	Repainting
1	Door - rear left side, Professionally carried out, Invoice of repair done Non-existent

Repainting 1: Door - rear left side
