## status report

**customer:** Bank 11, Neuss  
**contract number:** 718773430  
**reference:**

#### Skoda Superb Lim. Style

| Vehicle identification number | <b>TMBAJ9NP7G7092477</b> | mileage read: | <b>259827 km</b> |

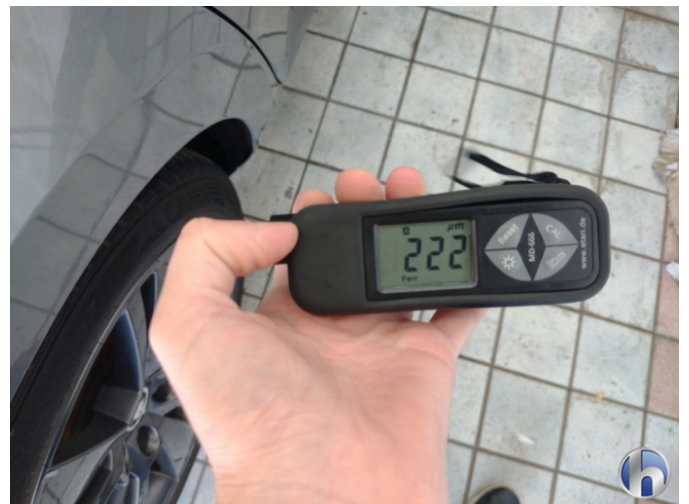
| component | Damage | Rep kind |
|---|---|---|
| 1. Sidewall - Rear - right | Subsequently painted | acceptable |

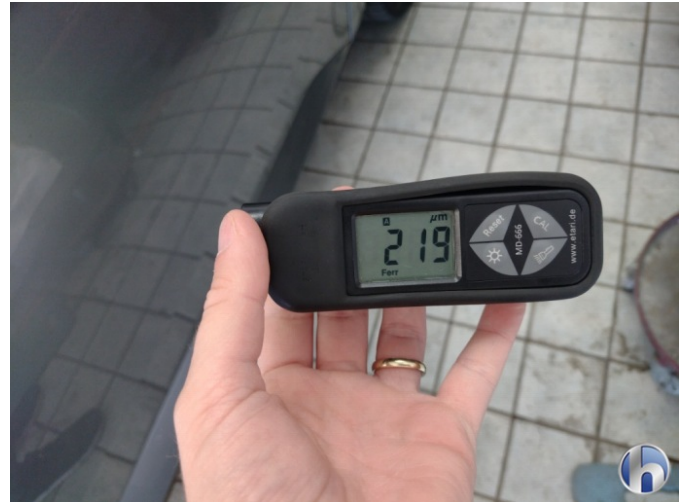
| component | Damage | Rep kind |
|---|---|---|
| 3. Front door - right | Subsequently painted | acceptable |

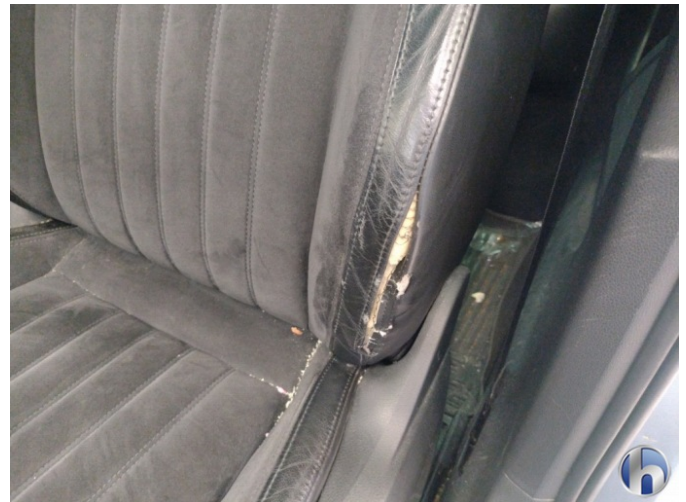
| component | Damage | Rep kind |
|---|---|---|
| 5. Sitz Vorne Links Lehne | Damaged | Replace |

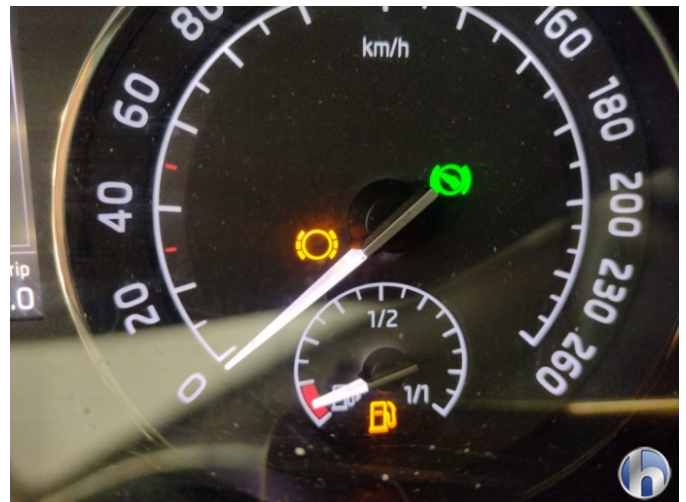
| component | Damage | Rep kind |
|---|---|---|
| 9. Bremsen | Worn | Replace |

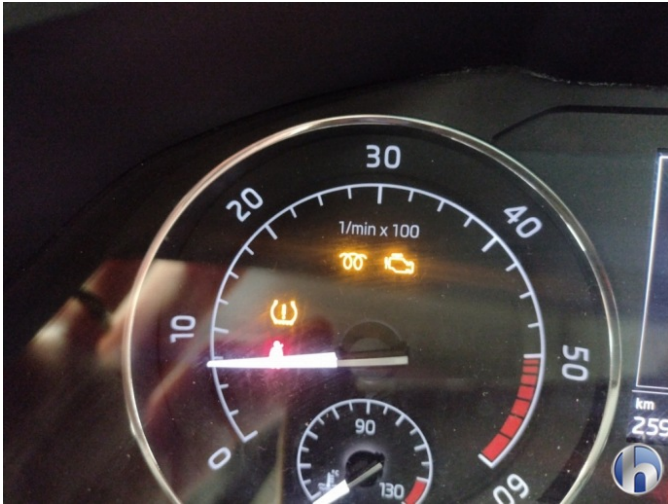
| component | Damage | Rep kind |
|---|---|---|
| 10. Vorglühanlage | Error message | Carry out a fault diagnosis |

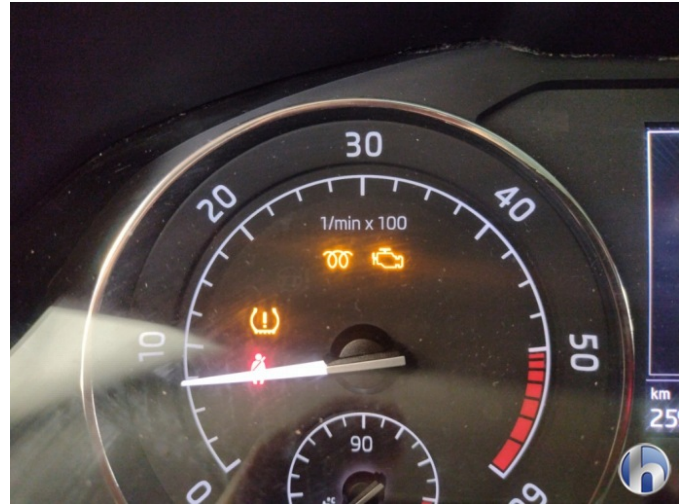
| Performed testing technology | |
|---|---|
| <b>engine running:</b> | A field test of the engine had to acoustic or visual defects for visiting time .<br>**Engine warning light. |

| component | Damage | Rep kind |
|---|---|---|
| 11. Motorkontrollleuchte | Error message | Carry out a fault diagnosis |

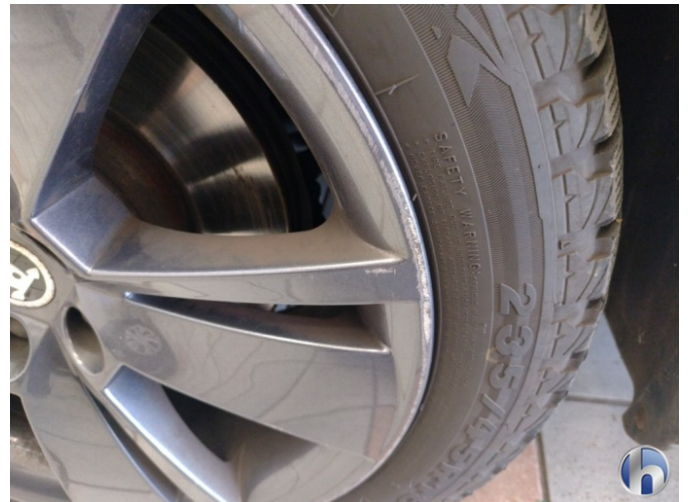
| component | Damage | Rep kind |
|---|---|---|
| 13. Rim front - left | Scratch(es) | Smart repair |

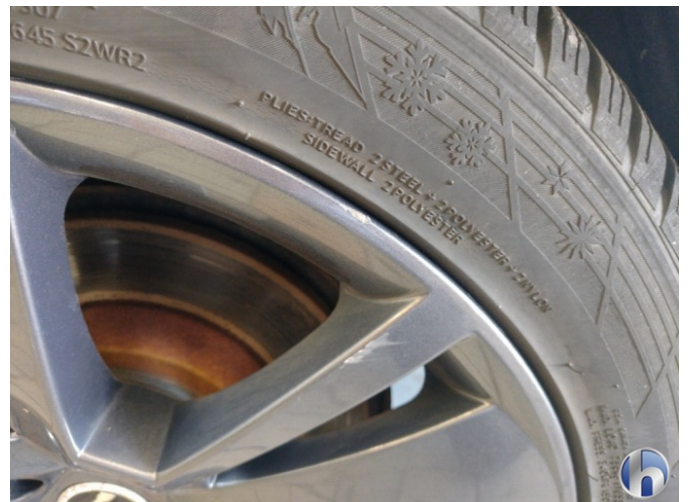
| component | Damage | Rep kind |
|---|---|---|
| 14. Rim rear - left | Scratch(es) | Smart repair |

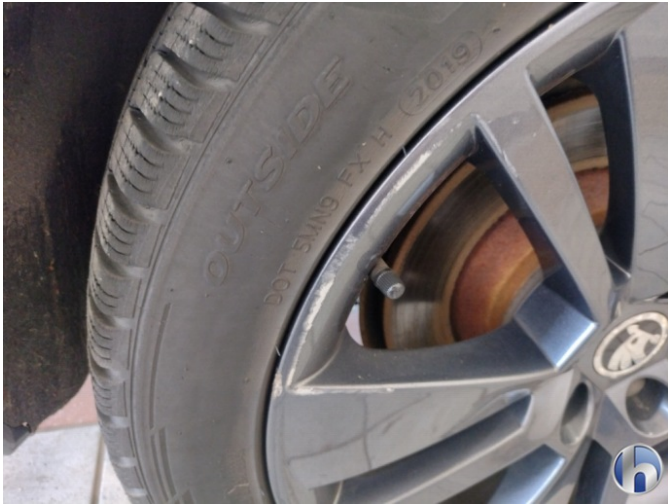
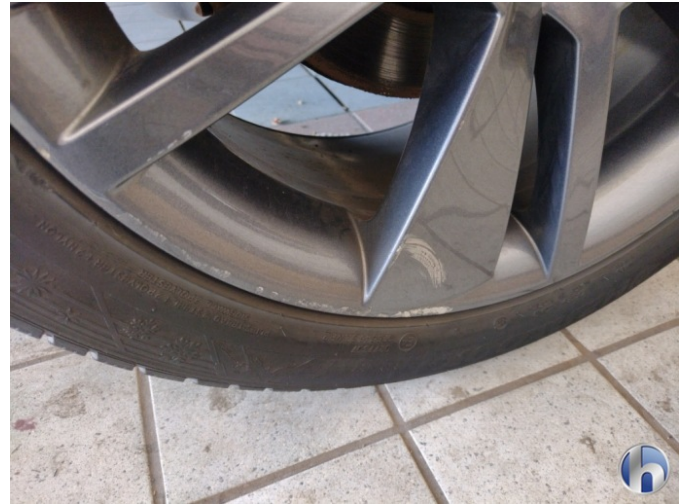
| component | Damage | Rep kind |
|---|---|---|
| 15. Rim rear - right | Scratch(es) | Smart repair |

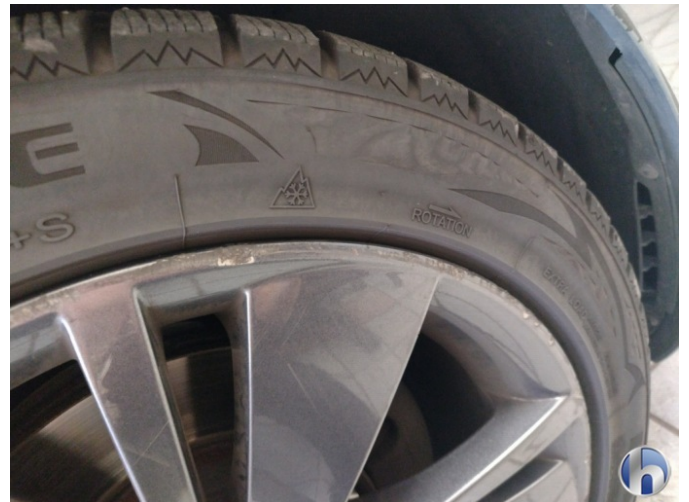
| component | Damage | Rep kind |
|---|---|---|
| 16. Rim front - right | Scratch(es) | Smart repair |

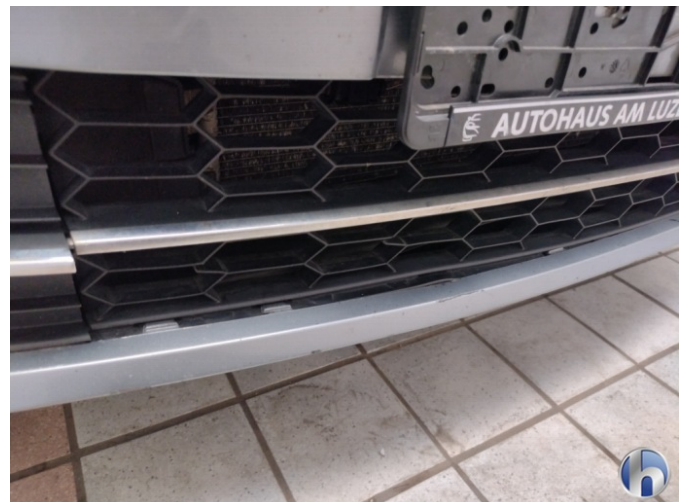
| component | Damage | Rep kind |
|---|---|---|
| 17. Front grill bumper Below | Damaged | Replace |

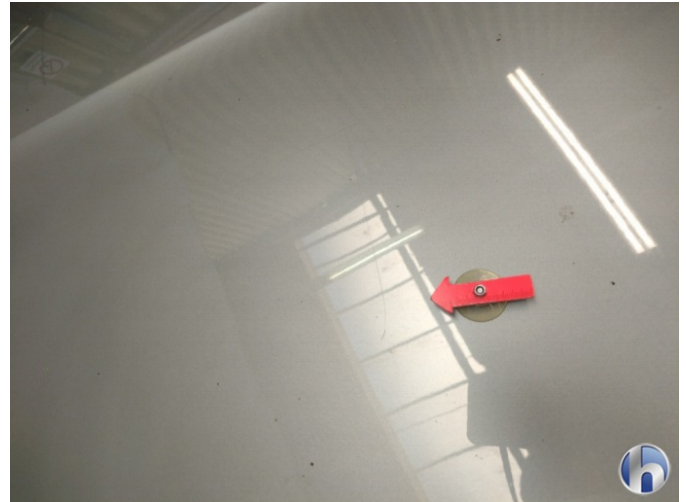
| component | Damage | Rep kind |
|---|---|---|
| 18. hood | Scratch(es) | Paint |

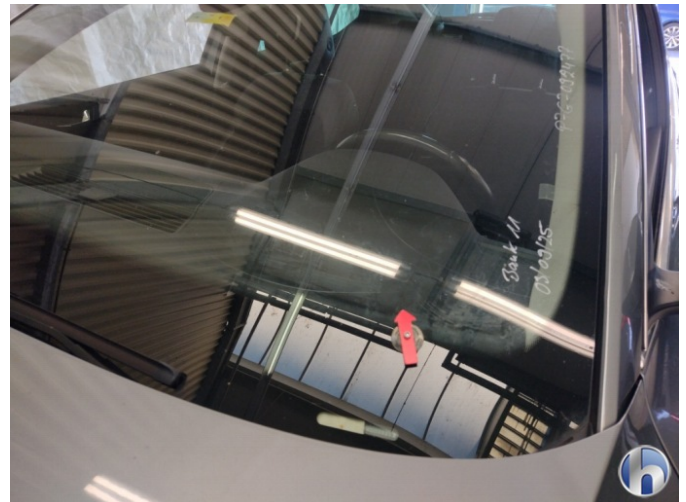
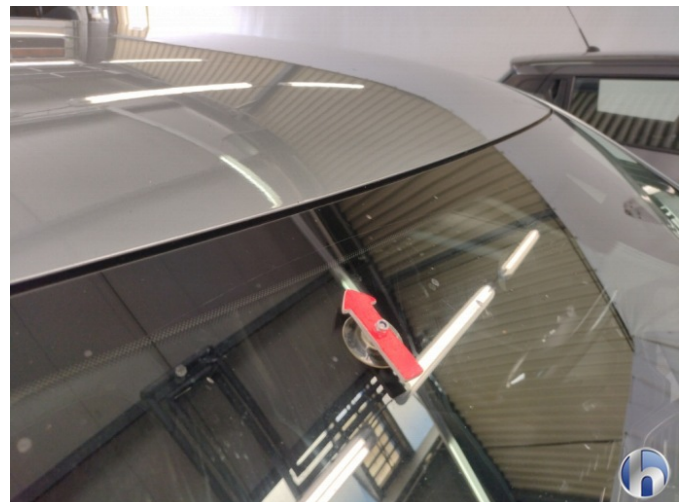
| component | Damage | Rep kind |
|---|---|---|
| 19. Windshield | Scratch(es) | Replace |

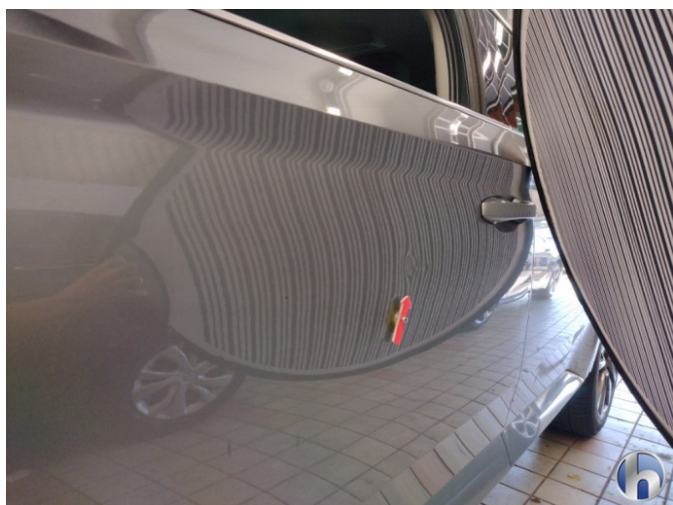
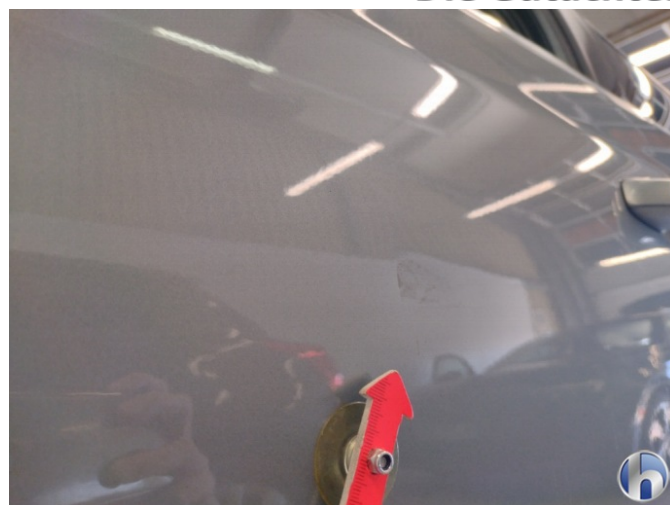
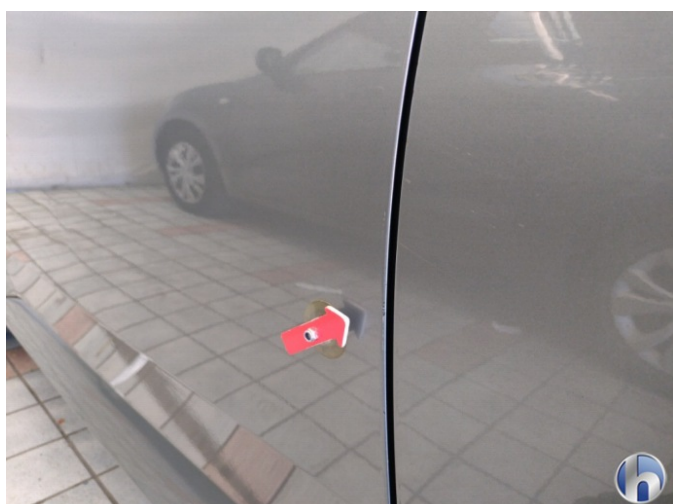
| component | Damage | Rep kind |
|---|---|---|
| 20. Front door - left | Damaged | Refurbish and paint |

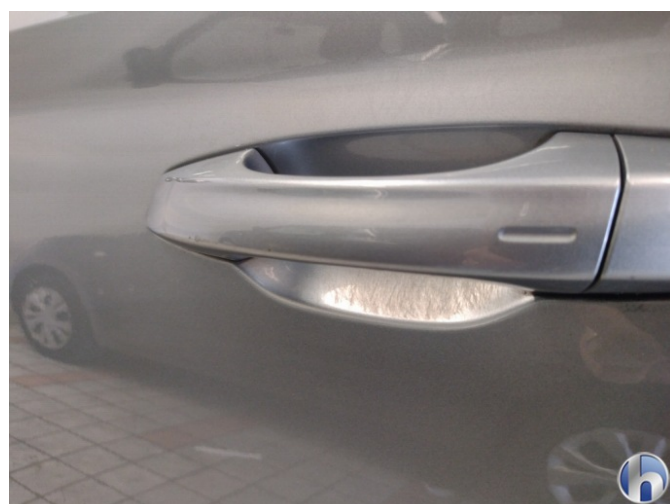
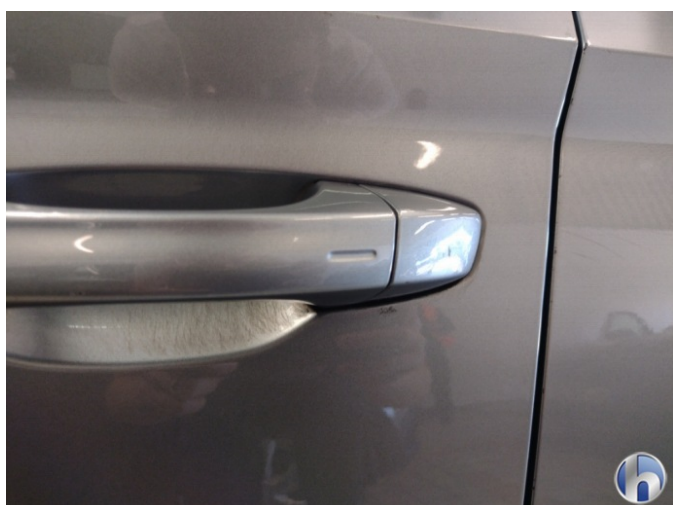
| component | Damage | Rep kind |
|---|---|---|
| 21. Outside Door Handle Front - Left | Scratch(es) | Paint |

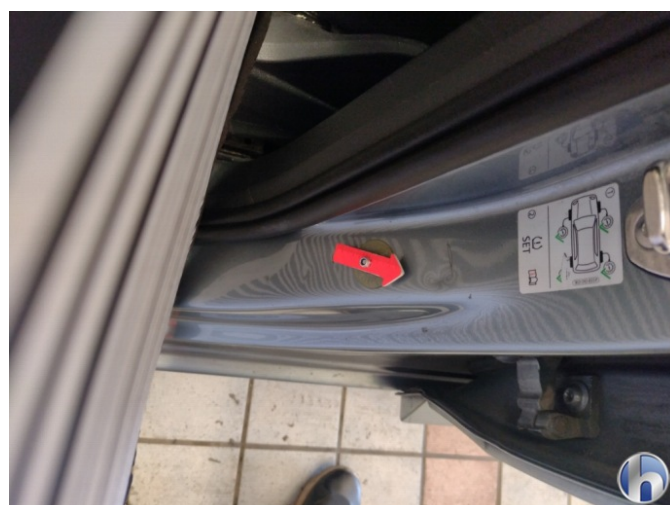
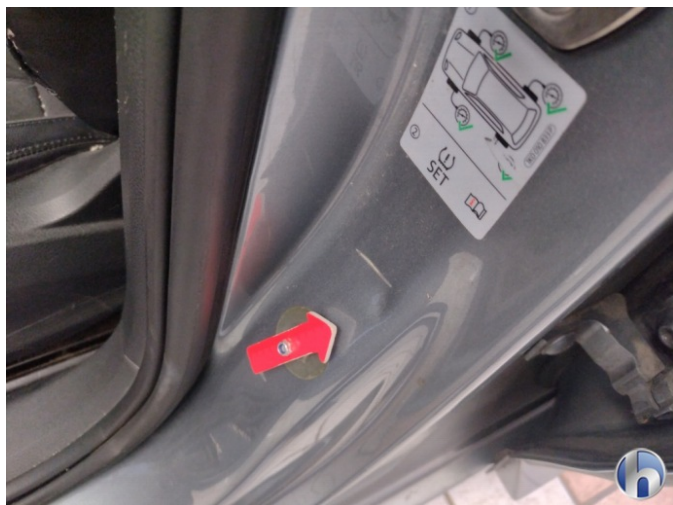
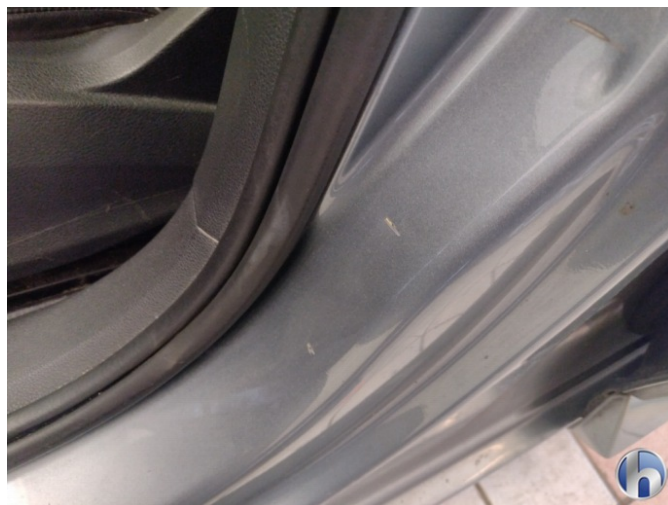
| component | Damage | Rep kind |
|---|---|---|
| 22. Türeinstieg Vorne - Links | Scratch(es) | Paint |

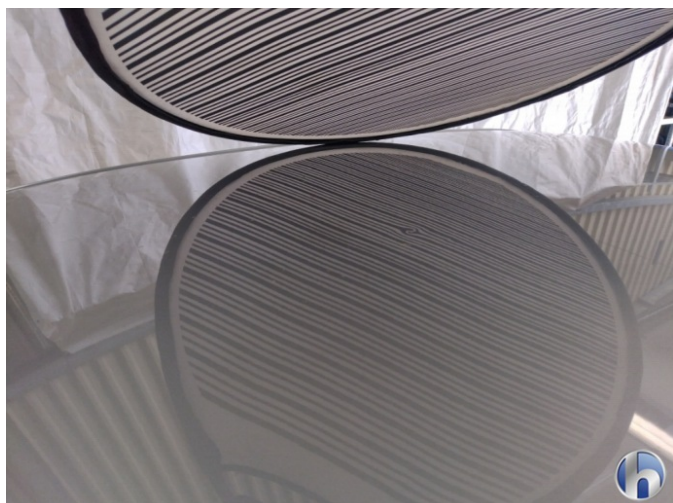
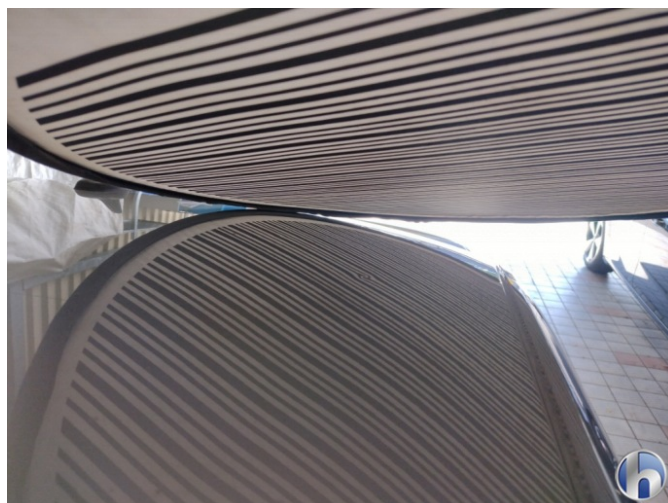
| component | Damage | Rep kind |
|---|---|---|
| 23. roof | | Smart repair |

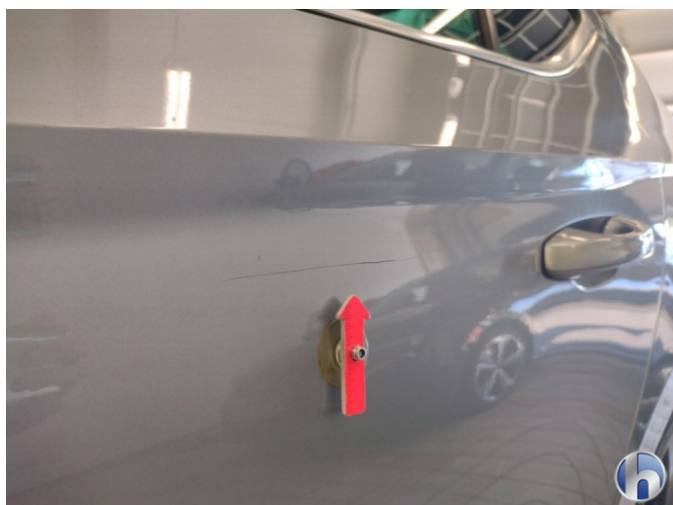
| component | Damage | Rep kind |
|---|---|---|
| 24. Rear door - left | Scratch(es) | Paint |

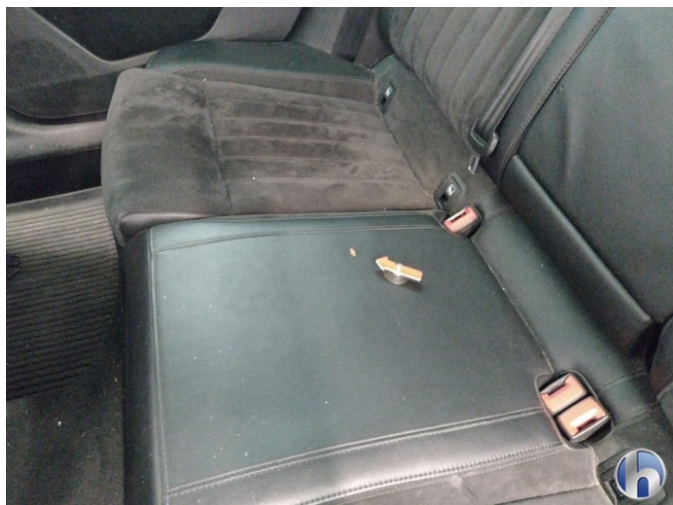
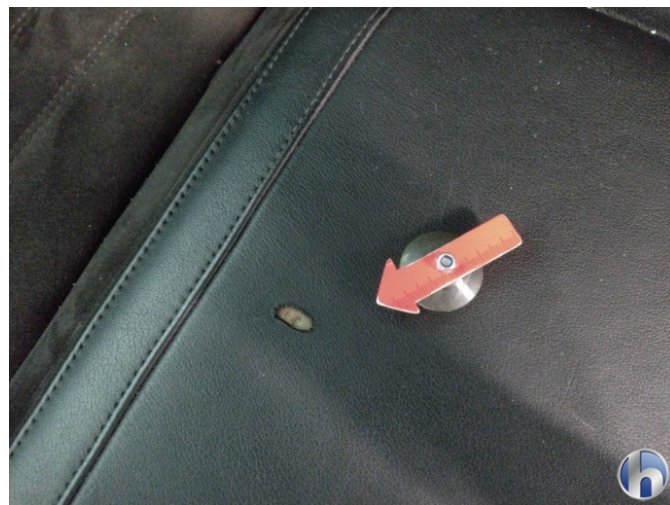
| component | Damage | Rep kind |
|---|---|---|
| 26. Sitz Hinten Mitte Kissen | Damaged | Replace |

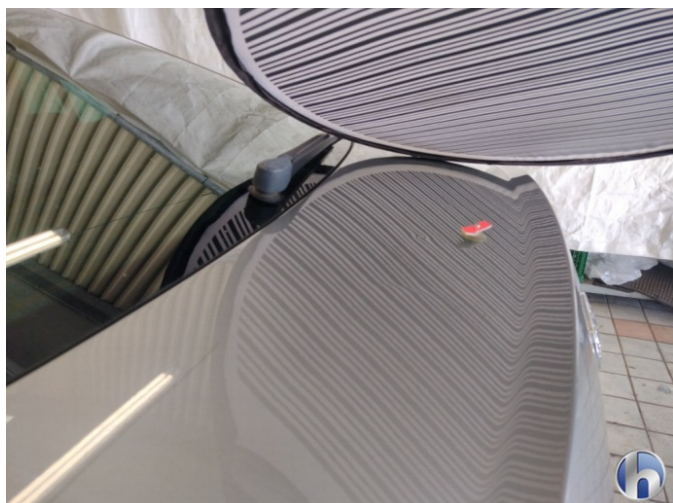
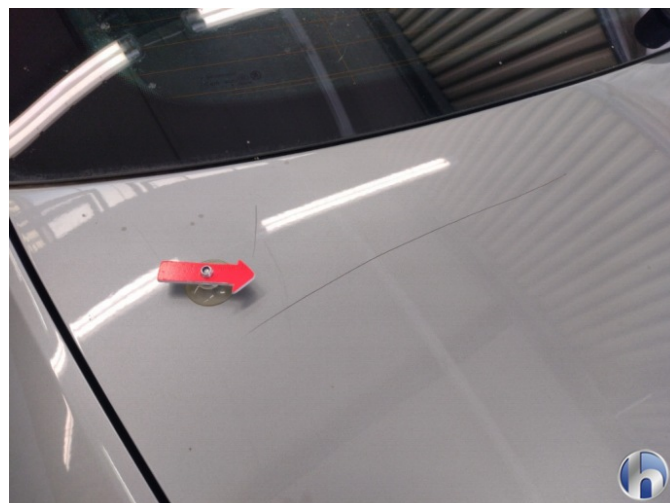
| component | Damage | Rep kind |
|---|---|---|
| 27. tailgate | Damaged | Refurbish and paint |

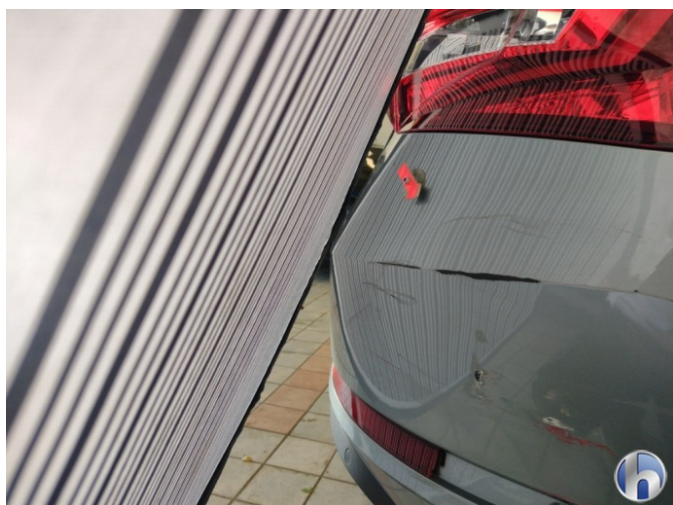
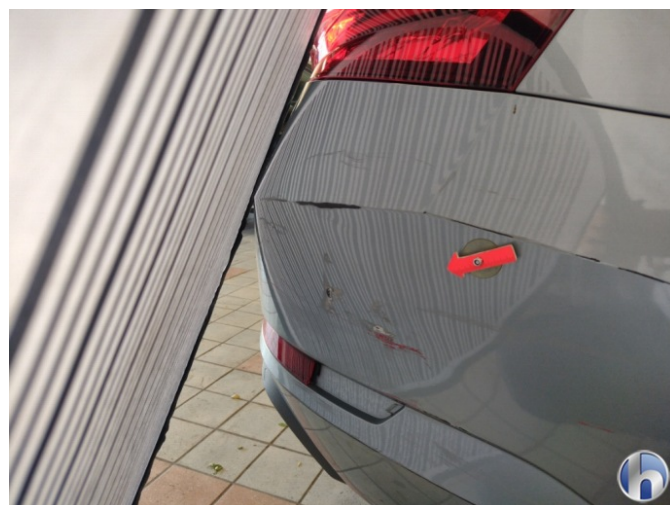
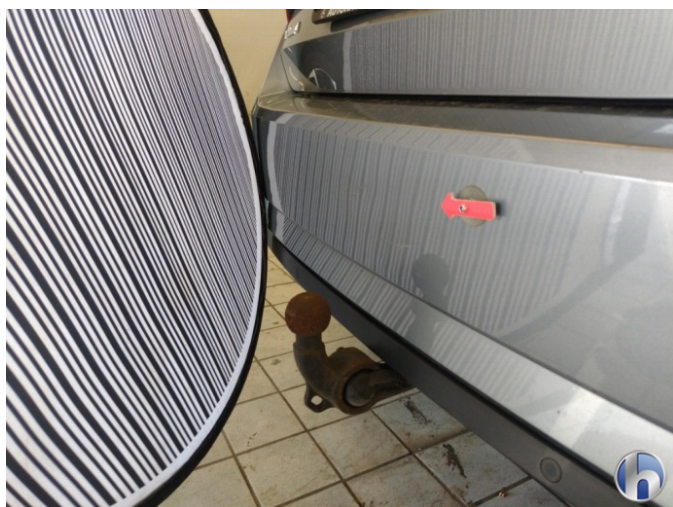
| component | Damage | Rep kind |
|---|---|---|
| 28. Rear bumper | Damaged | Refurbish and paint |

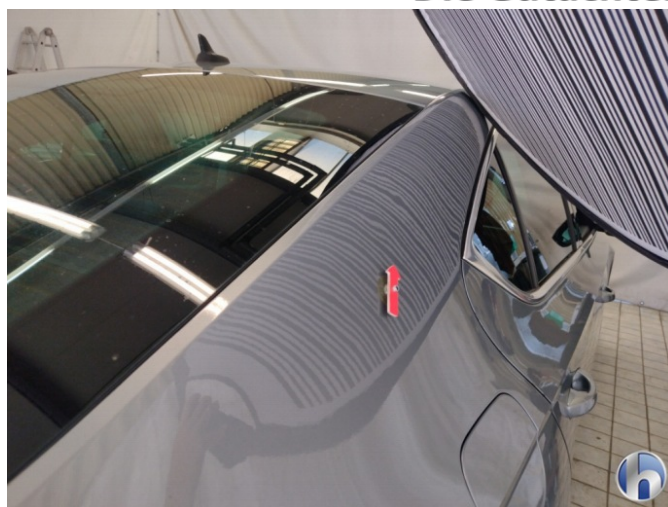
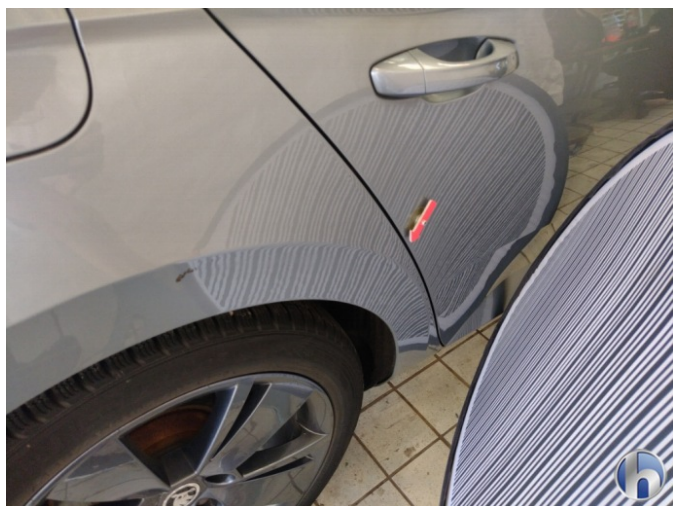
| component | Damage | Rep kind |
|---|---|---|
| 29. Sidewall - Rear - right | Damaged | Refurbish and paint |

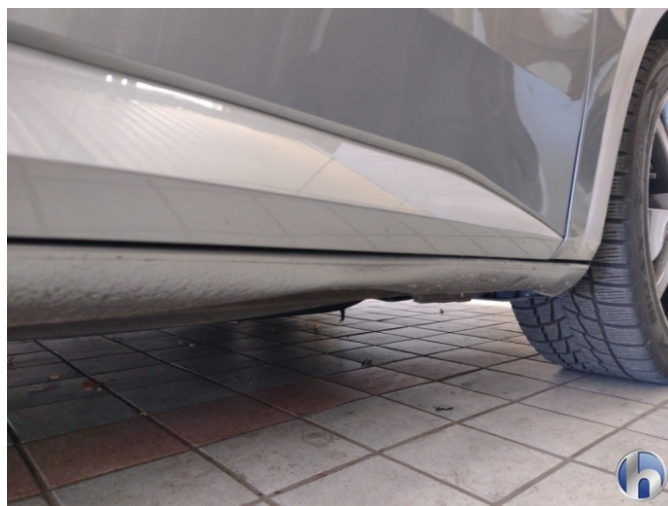
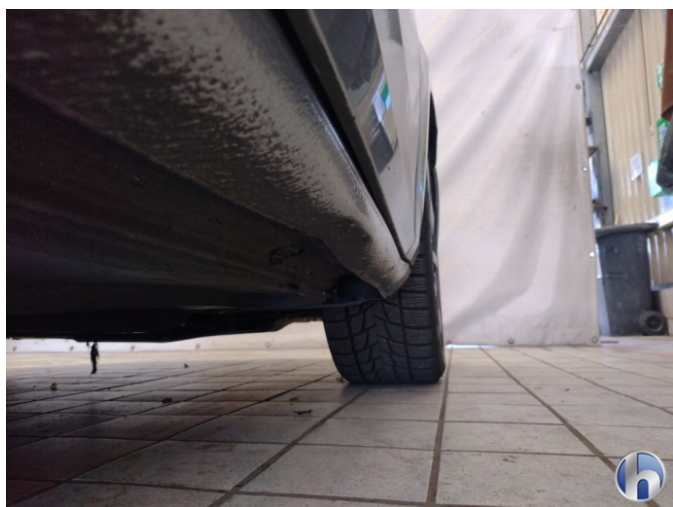
| component | Damage | Rep kind |
|---|---|---|
| 30. side skirt - right | Deformed | Refurbish and paint |

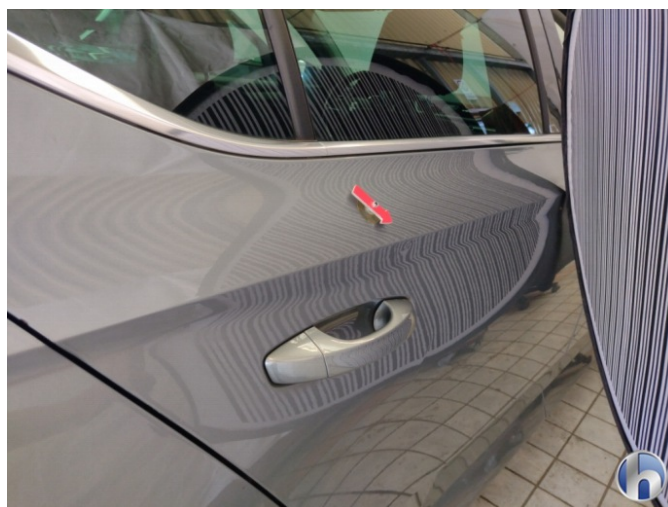
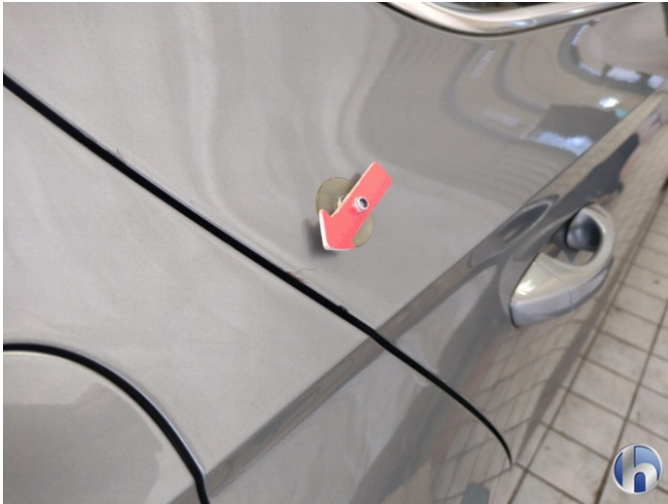
| component | Damage | Rep kind |
|---|---|---|
| 31. Door Rear - right | Damaged | Refurbish and paint |

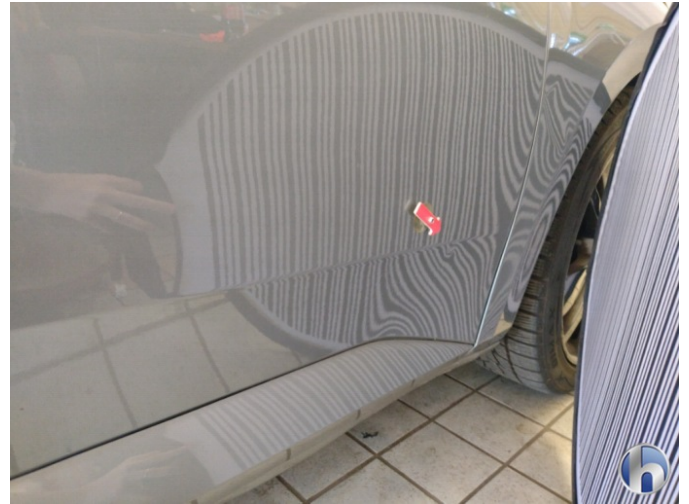
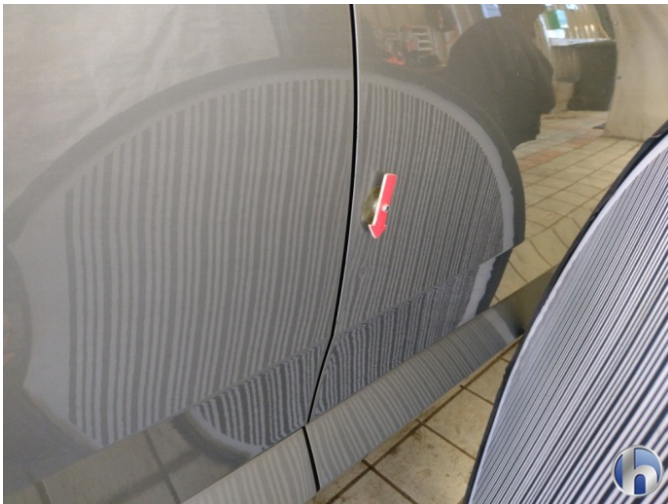
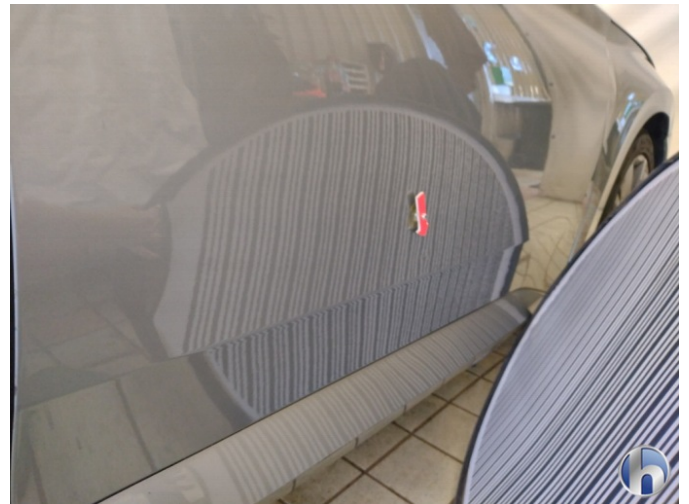
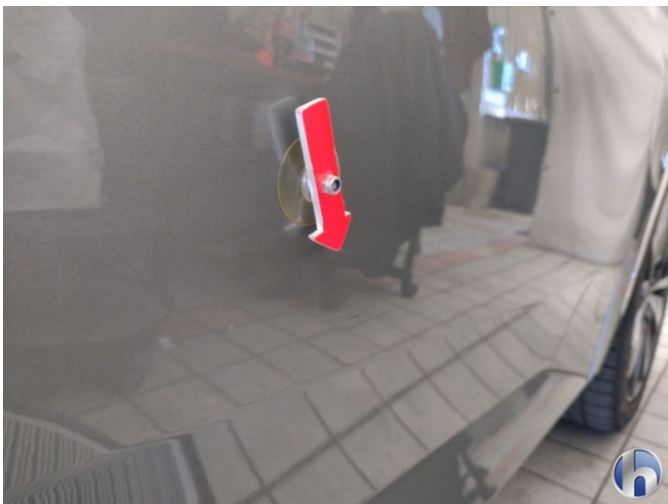
| component | Damage | Rep kind |
|---|---|---|
| 32. Front door - right | Deformed | Refurbish and paint |

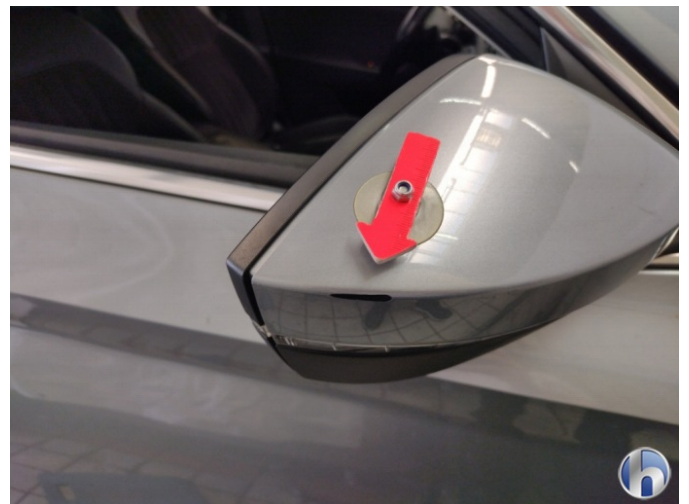
| component | Damage | Rep kind |
|---|---|---|
| 33. | Scrape | Paint |

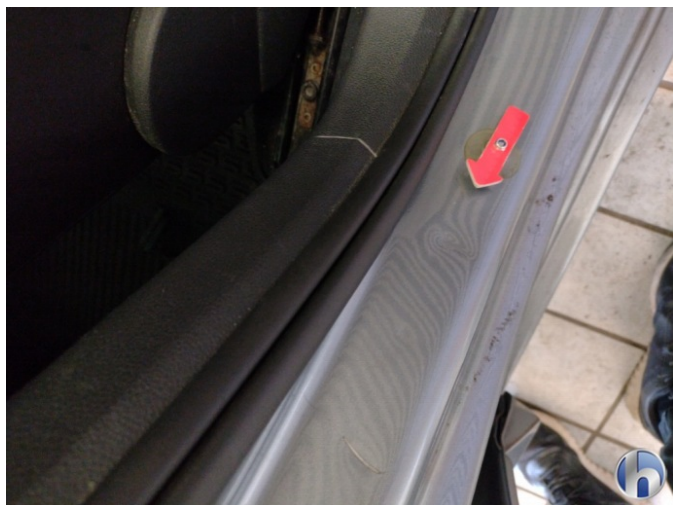
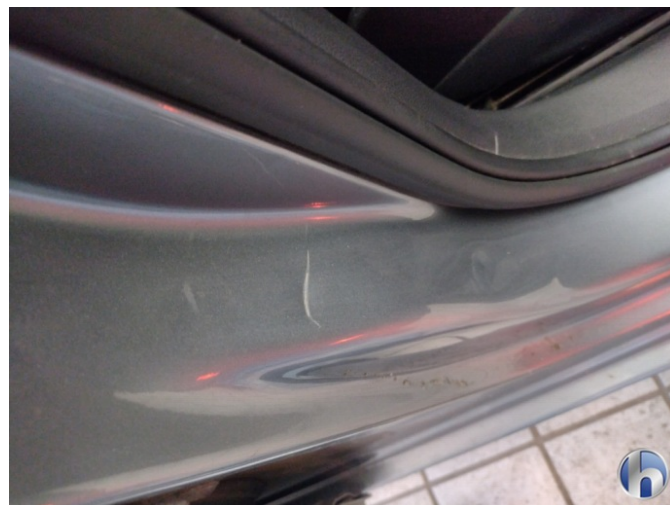
| component | Damage | Rep kind |
|---|---|---|
| 34. Türeinstieg Vorne - Rechts | Damaged | Refurbish and paint |

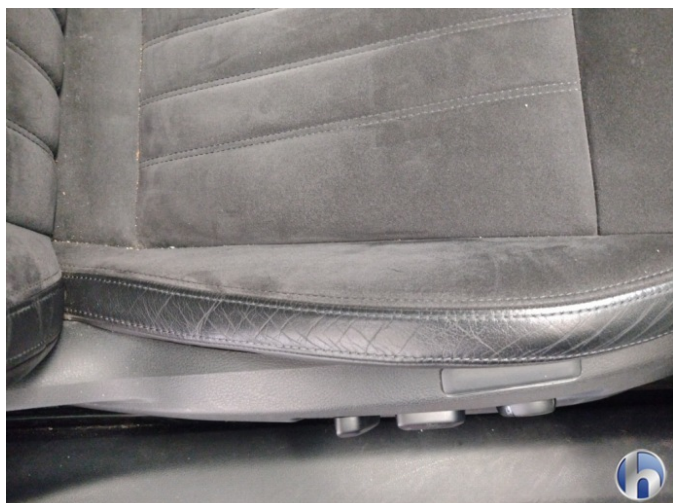
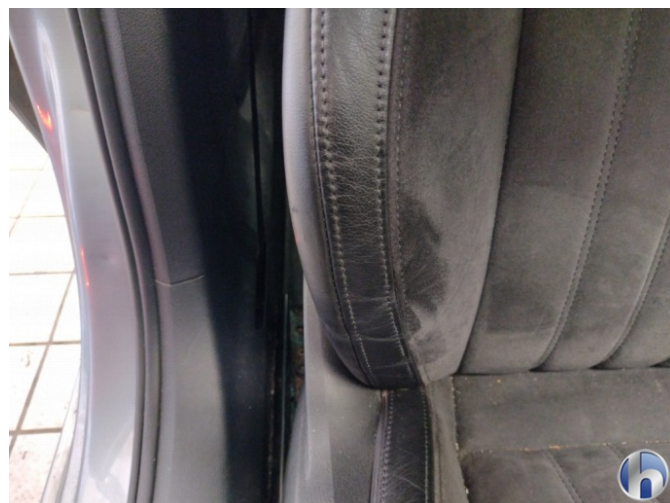
| component | Damage | Rep kind |
|---|---|---|
| 35. Sitz Vorne Rechts | Damaged | Smart repair |

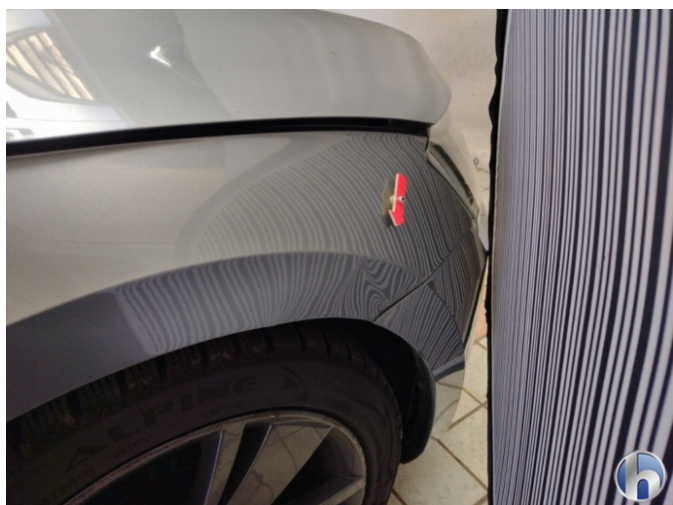
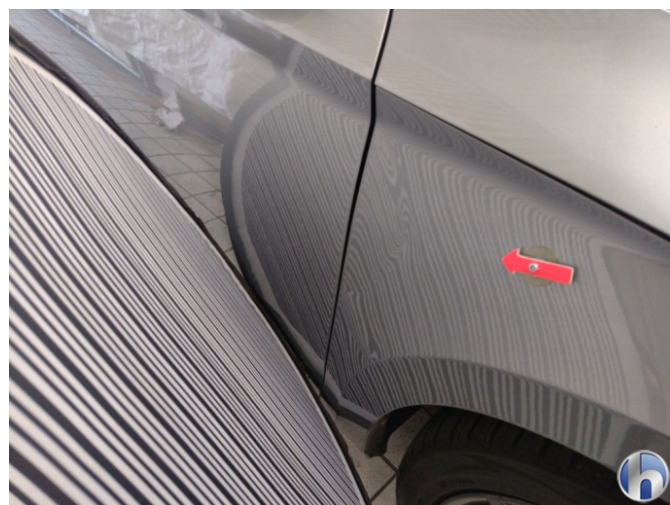
| component | Damage | Rep kind |
|---|---|---|
| 36. Front fender - right | Deformed | Refurbish and paint |

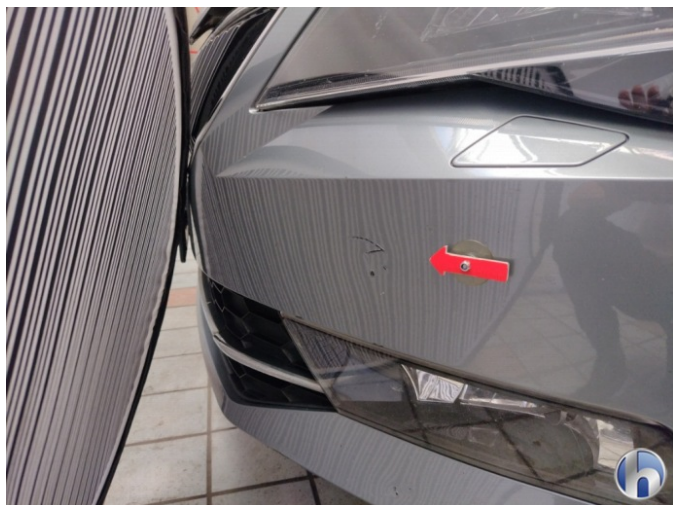
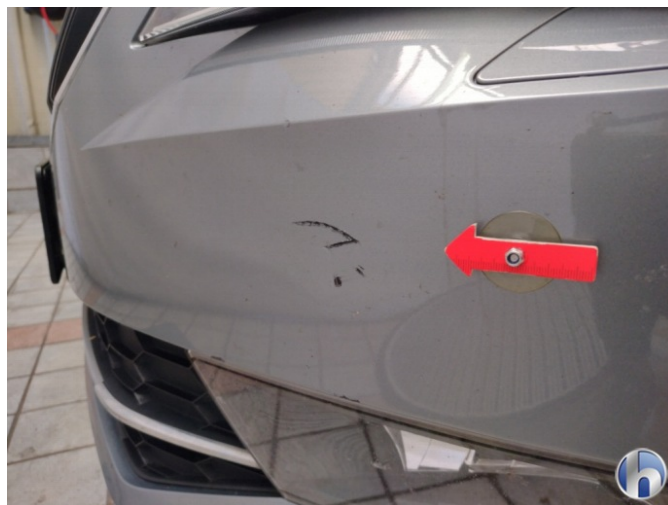
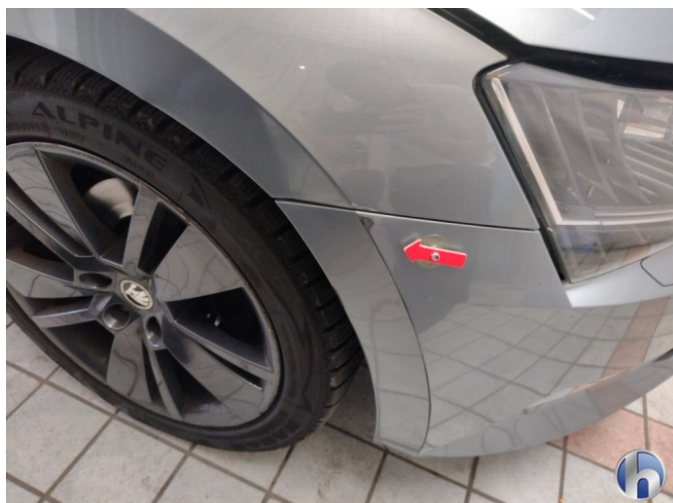
| component | Damage | Rep kind |
|---|---|---|
| 37. Front bumper | Damaged | Refurbish and paint |

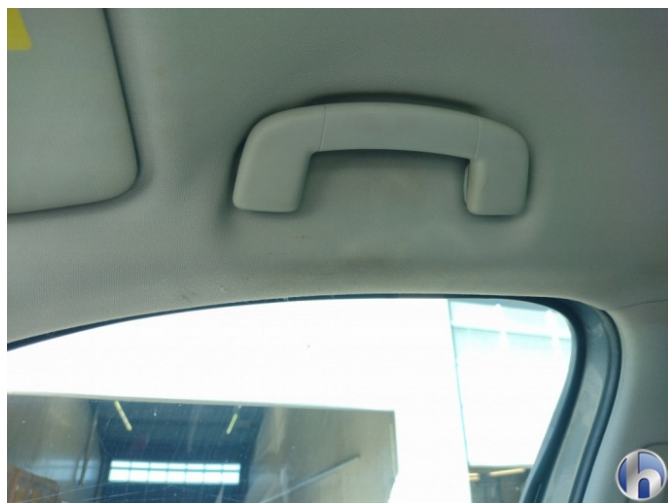
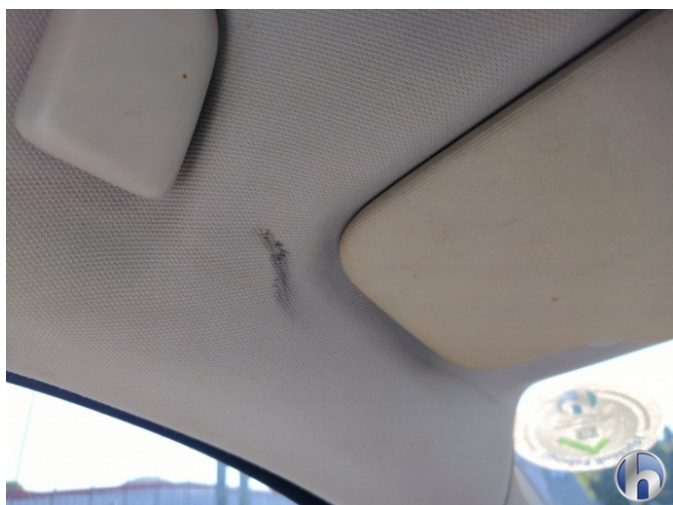
| component | Damage | Rep kind |
|---|---|---|
| 38. headlining | Dirty | |
