## status report

#### Skoda Rapid Ambition

| Vehicle identification number | <b>TMBAN6NH5F4020723</b> | mileage read: | <b>95093 km</b> |

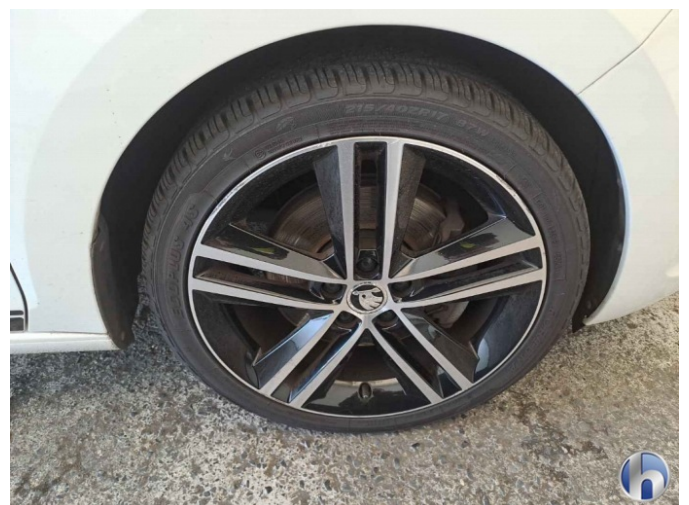
| component | Damage | Rep kind |
|---|---|---|
| 1. tire front - right | Worn | Replace |

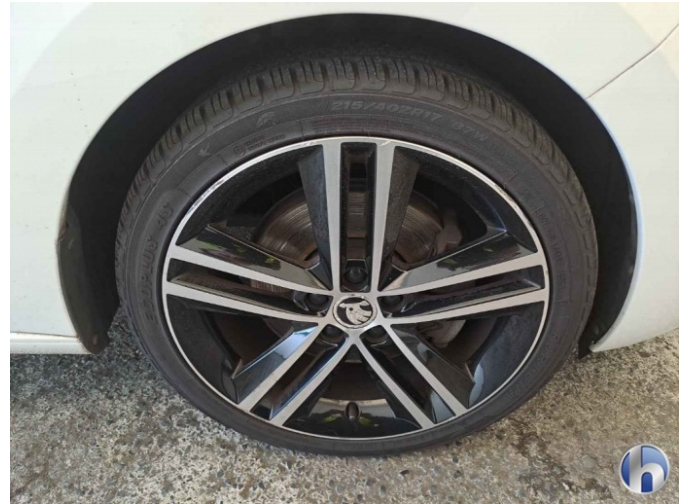
| component | Damage | Rep kind |
|---|---|---|
| 2. | Damaged | Replace |

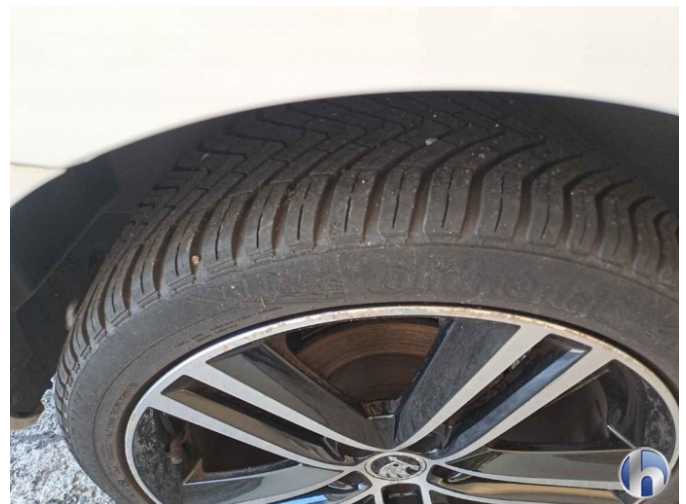
| component | Damage | Rep kind |
|---|---|---|
| 3. tire rear - right | Damaged | Replace |

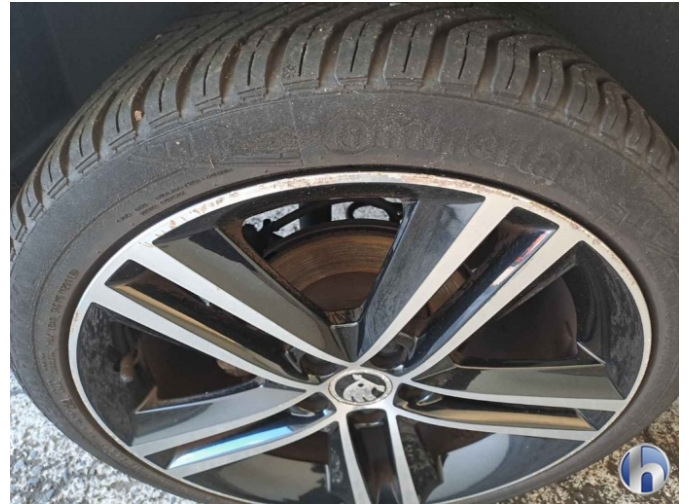
| component | Damage | Rep kind |
|---|---|---|
| 4. | Scratch(es) | Replace |

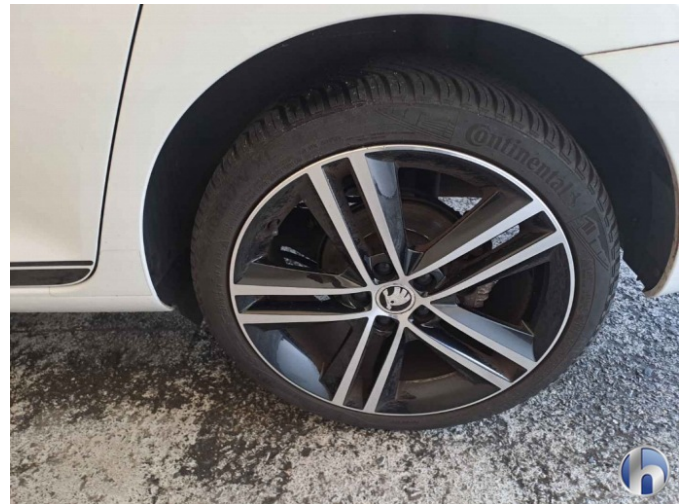
| component | Damage | Rep kind |
|---|---|---|
| 5. tire rear - left | Worn | Replace |

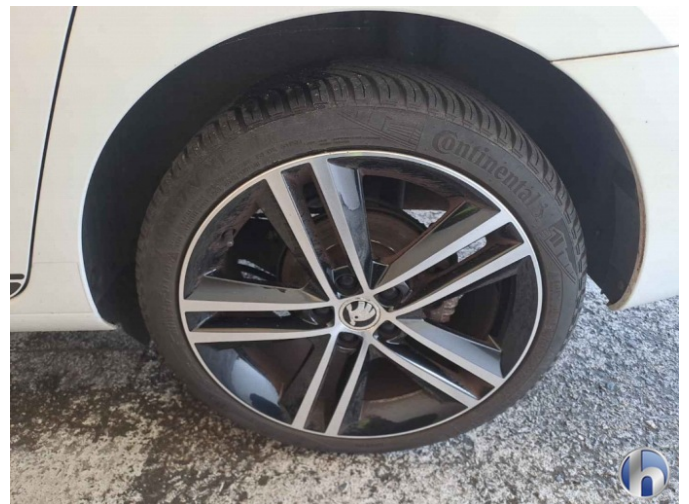
| component | Damage | Rep kind |
|---|---|---|
| 6. | Scratch(es) | Replace |

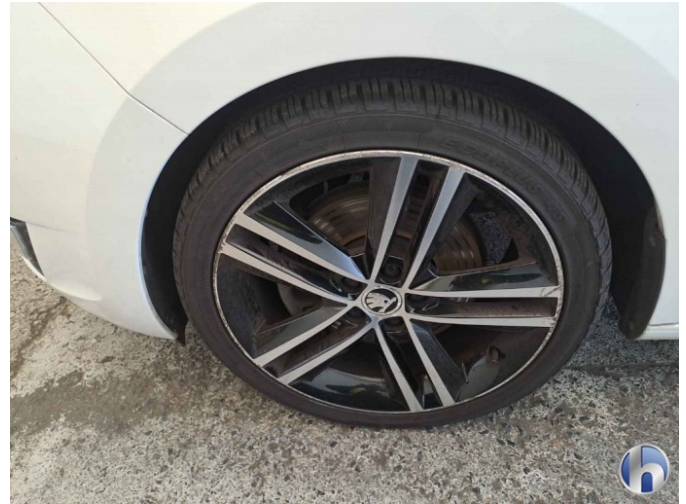
| component | Damage | Rep kind |
|---|---|---|
| 7. tire front - left | Worn | Replace |

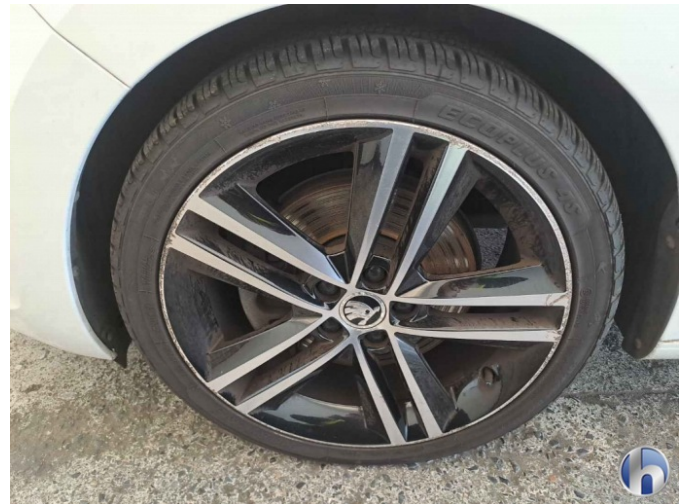
| component | Damage | Rep kind |
|---|---|---|
| 8. | Scratch(es) | Replace |

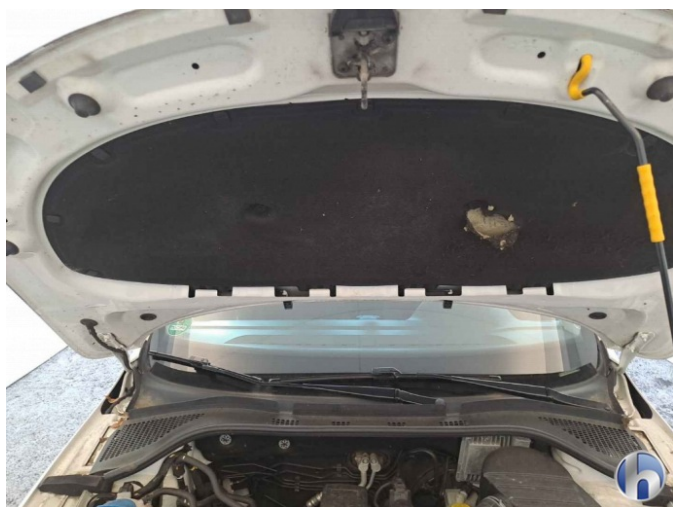
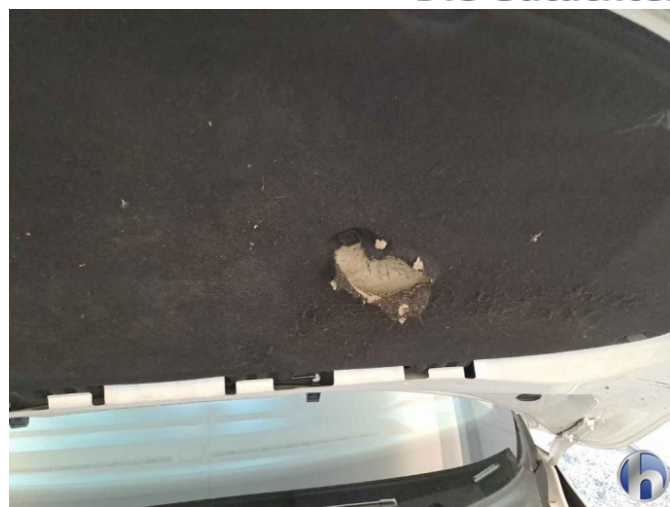
| component | Damage | Rep kind |
|---|---|---|
| 12. motor insulation | | Replace |

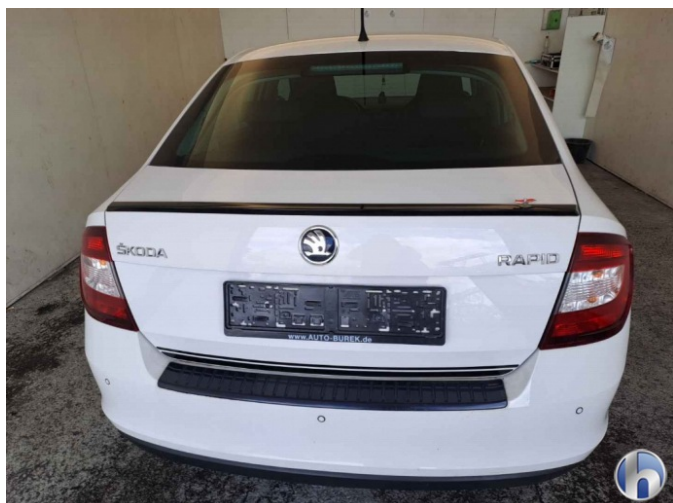
| component | Damage | Rep kind |
|---|---|---|
| 13. Rear spoiler | Scratch(es) | Paint |

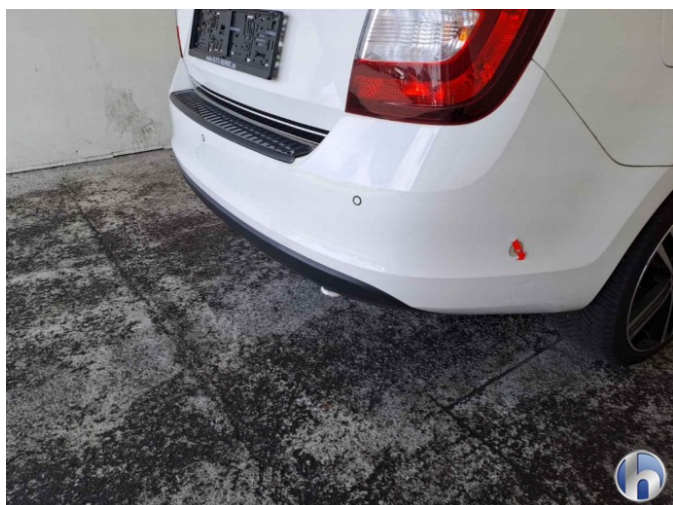
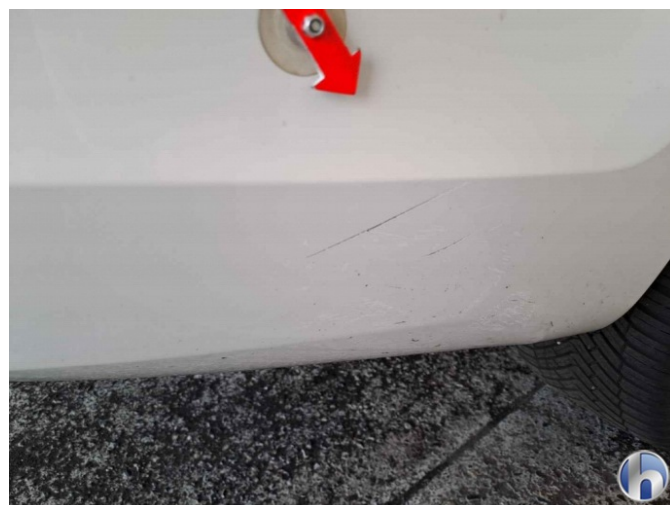
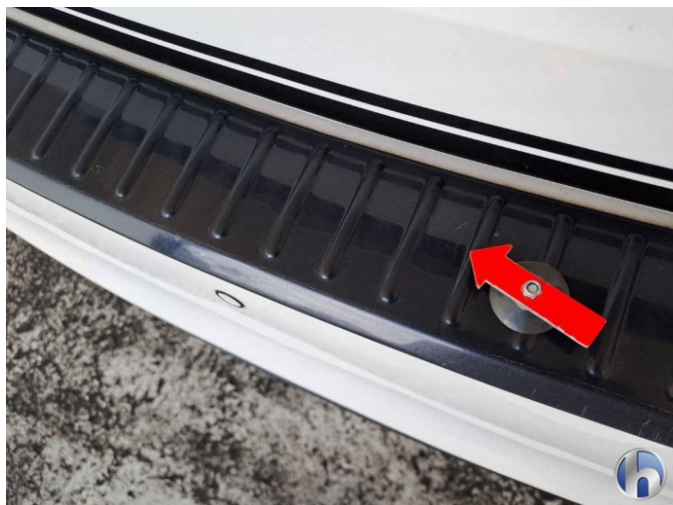
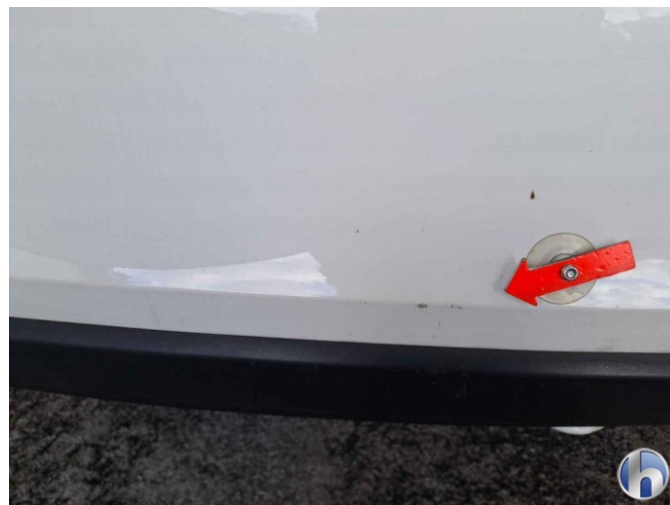
| component | Damage | Rep kind |
|---|---|---|
| 14. Rear bumper | Scratch(es) | Refurbish and paint |

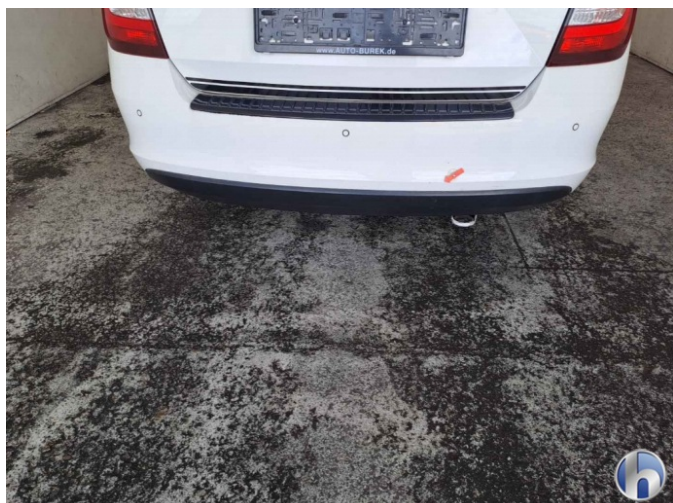
| component | Damage | Rep kind |
|---|---|---|
| 15. Diffusor | Scrape | Replace |

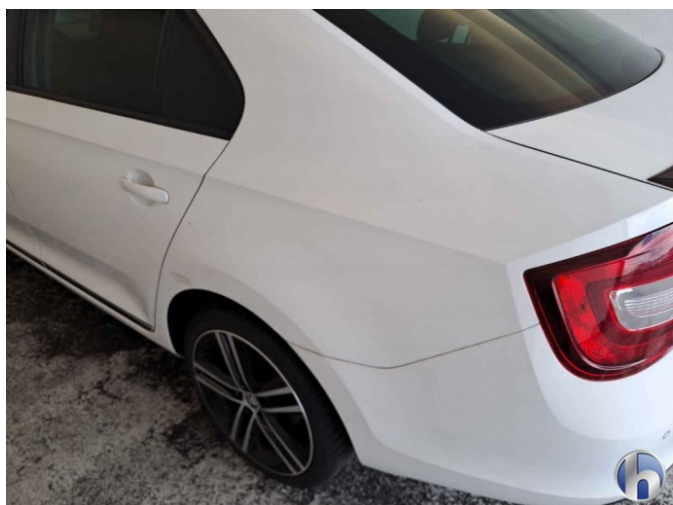
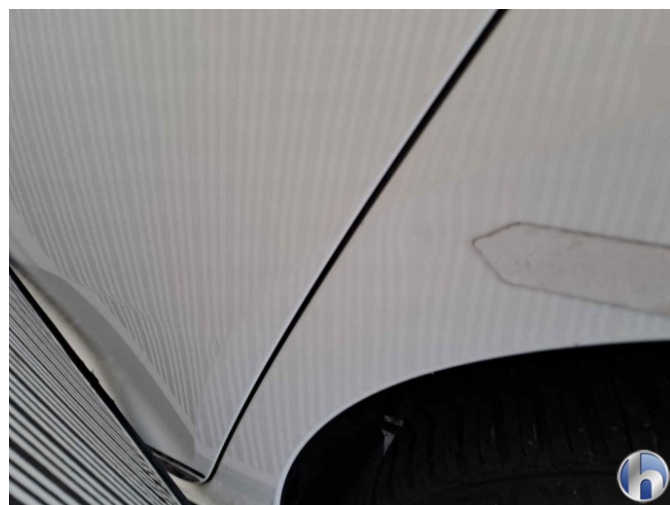
| component | Damage | Rep kind |
|---|---|---|
| 16. Sidewall - Rear - Left | Damaged | Refurbish and paint |

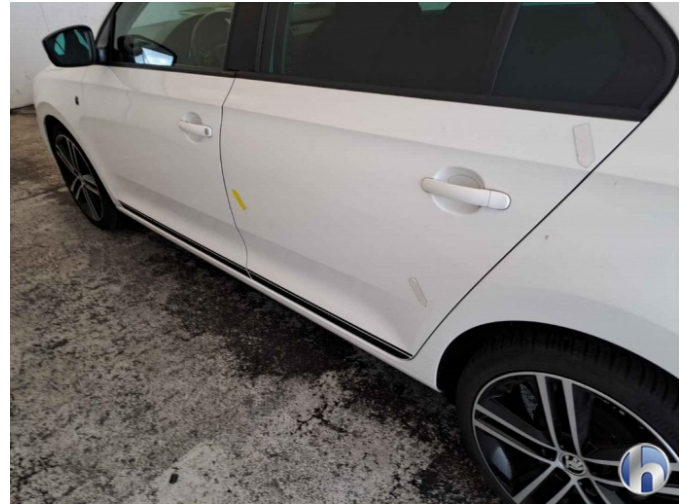
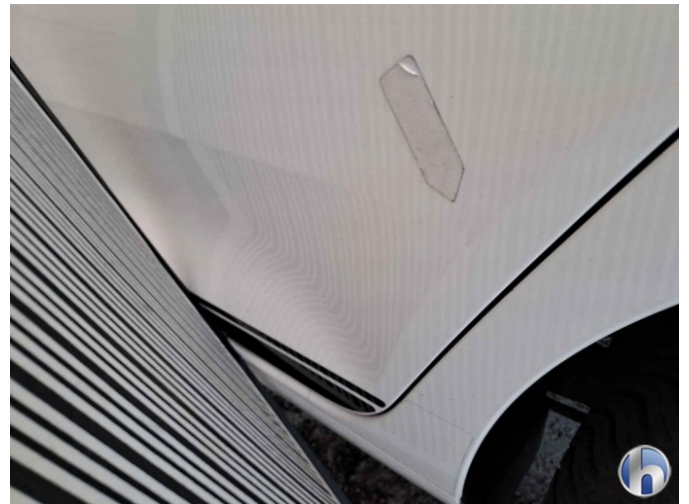
| component | Damage | Rep kind |
|---|---|---|
| 17. Rear door - left | Damaged | Refurbish and paint |

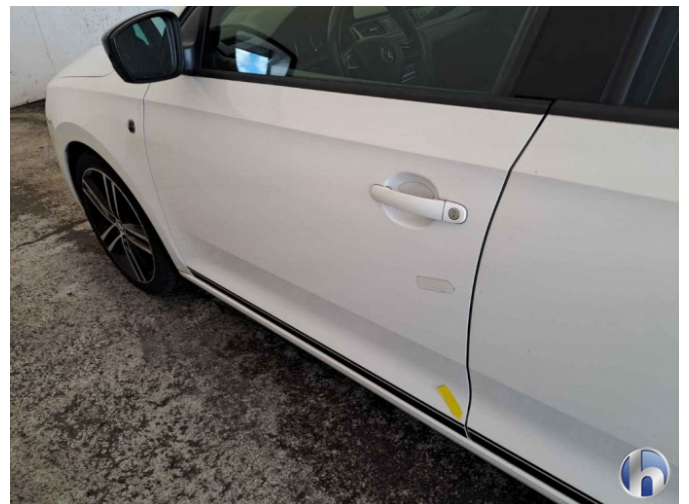
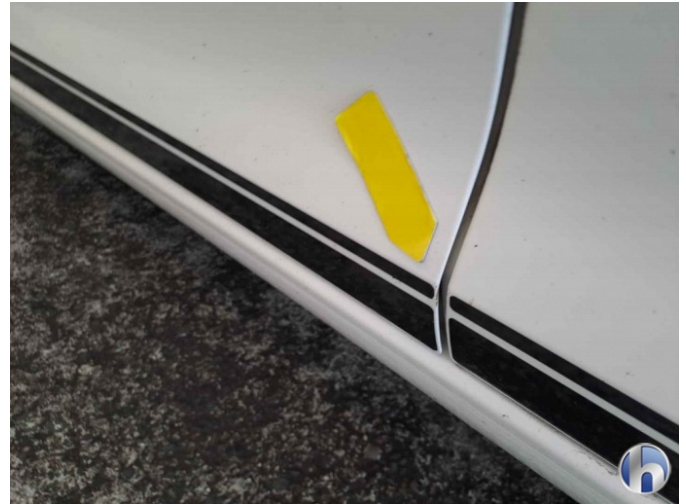
| component | Damage | Rep kind |
|---|---|---|
| 18. Front door - left | Scratch(es) | Paint |

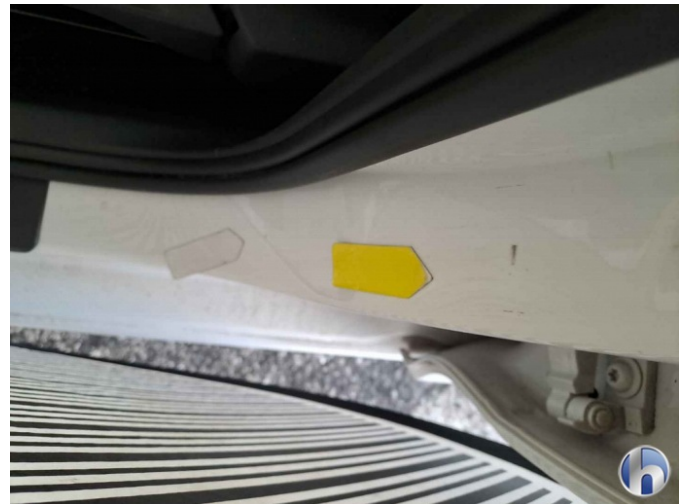
| component | Damage | Rep kind |
|---|---|---|
| 19. Türeinstieg Vorne - Links | Damaged | Refurbish and paint |

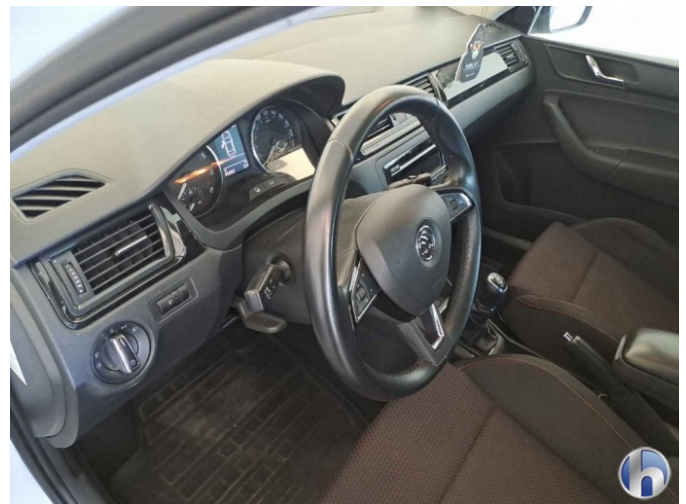
| component | Damage | Rep kind |
|---|---|---|
| 20. Steering wheel (leather) | Scratch(es) | Replace |

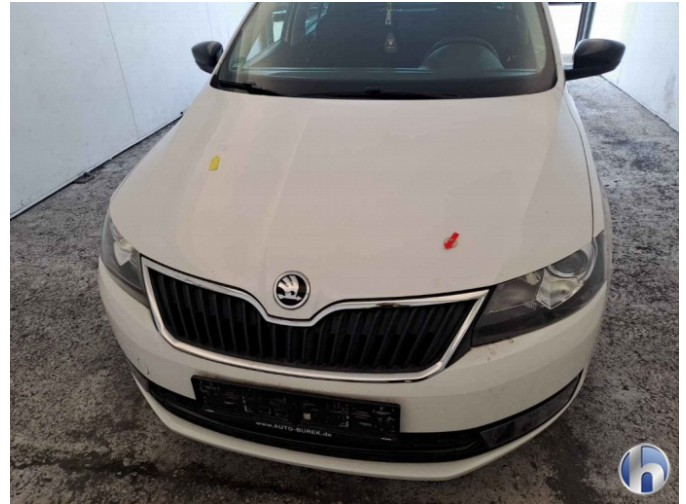
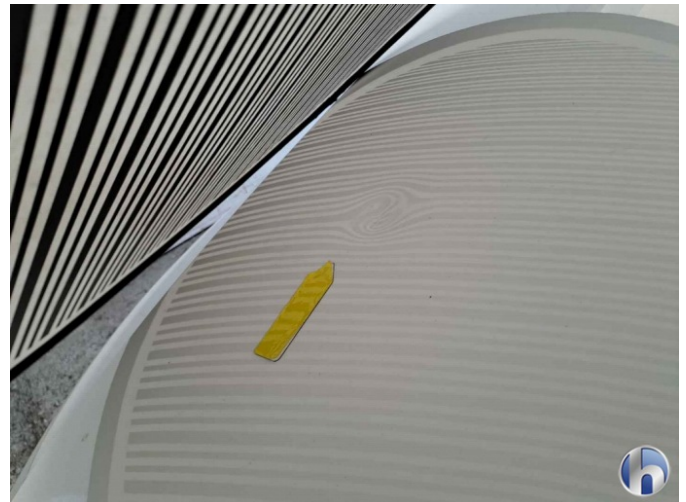
| component | Damage | Rep kind |
|---|---|---|
| 21. hood | Damaged | Refurbish and paint |

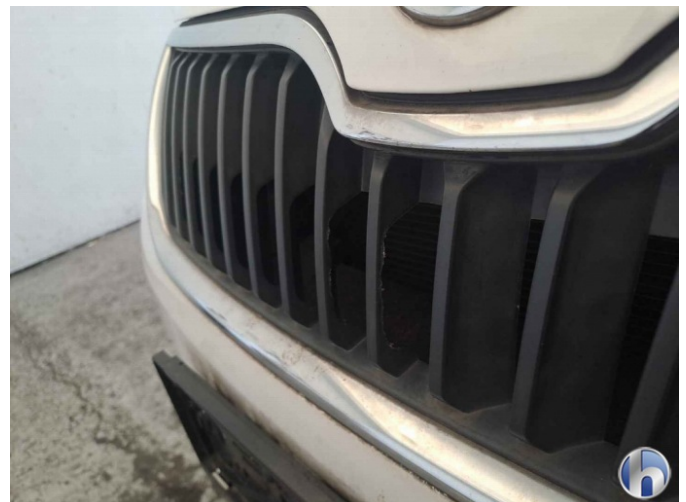
| component | Damage | Rep kind |
|---|---|---|
| 22. Front grille top | Damaged | Replace |

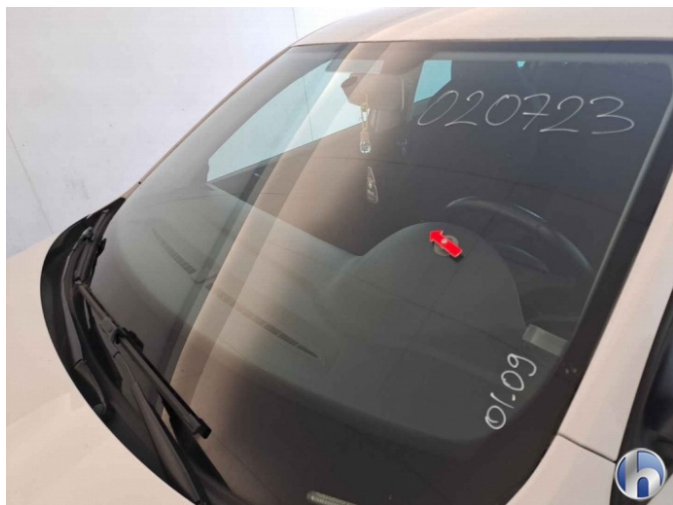
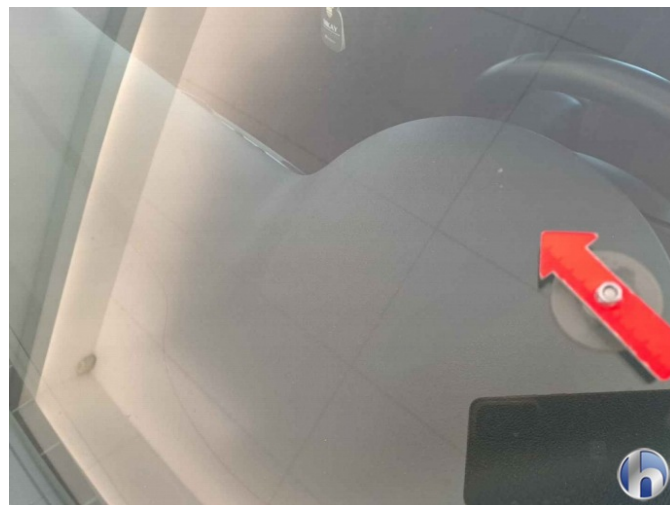
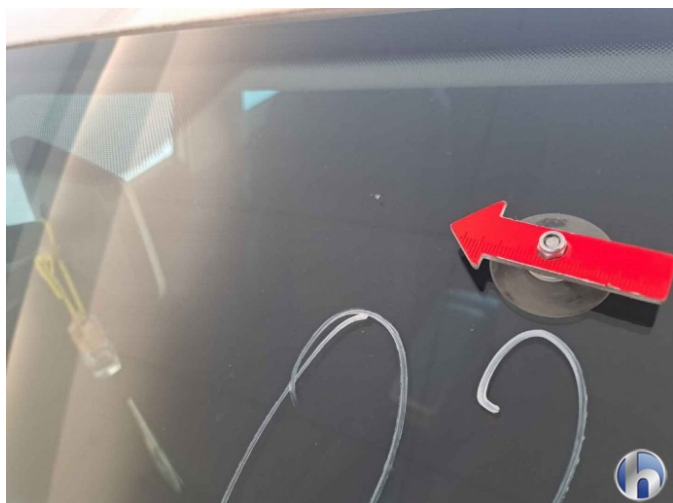
| component | Damage | Rep kind |
|---|---|---|
| 23. Windshield | Chipping from stones in field of view | Replace |

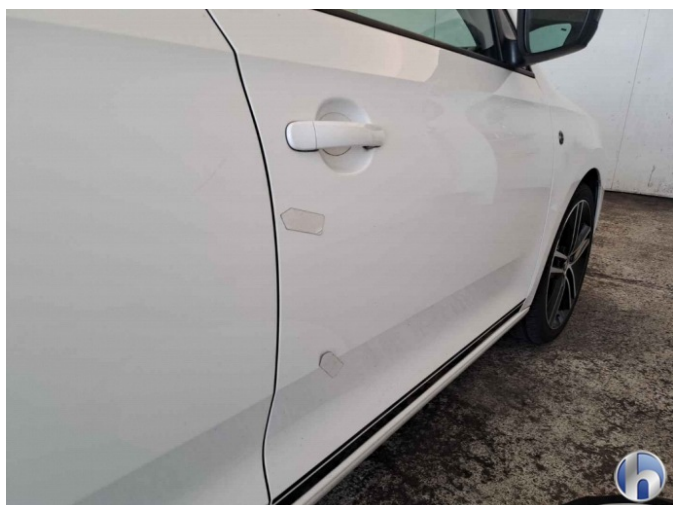
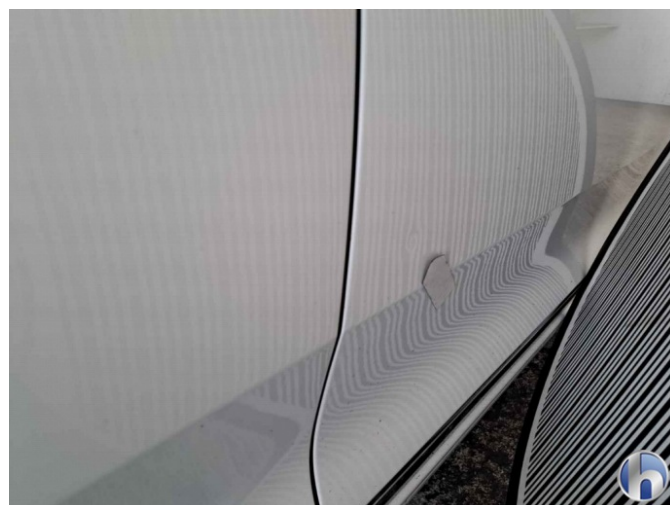
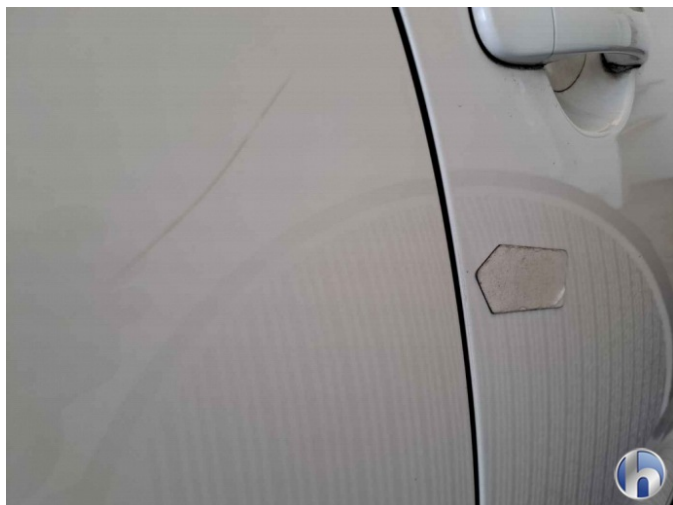
| component | Damage | Rep kind |
|---|---|---|
| 24. Front door - right | Damaged | Refurbish and paint |

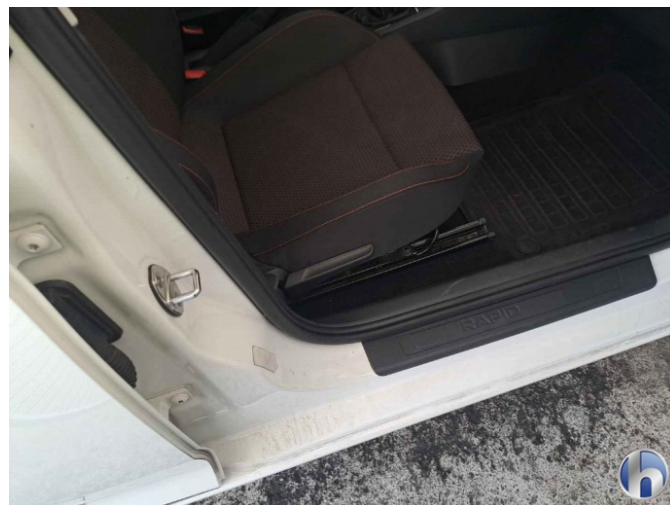
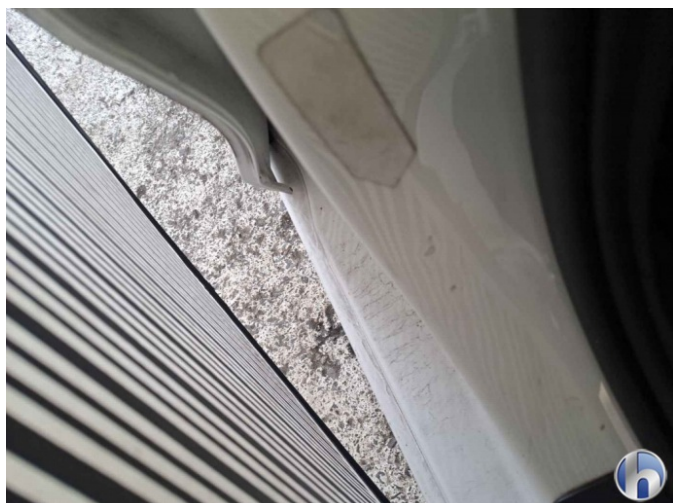
| component | Damage | Rep kind |
|---|---|---|
| 25. Türeinstieg Vorne - Rechts | Damaged | Refurbish and paint |

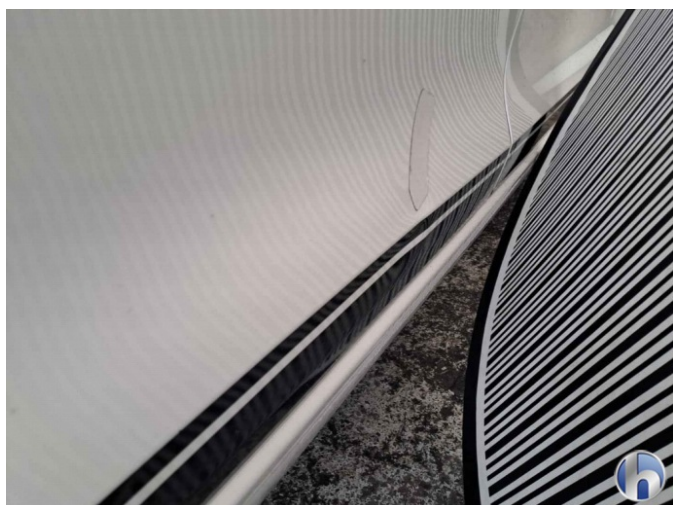
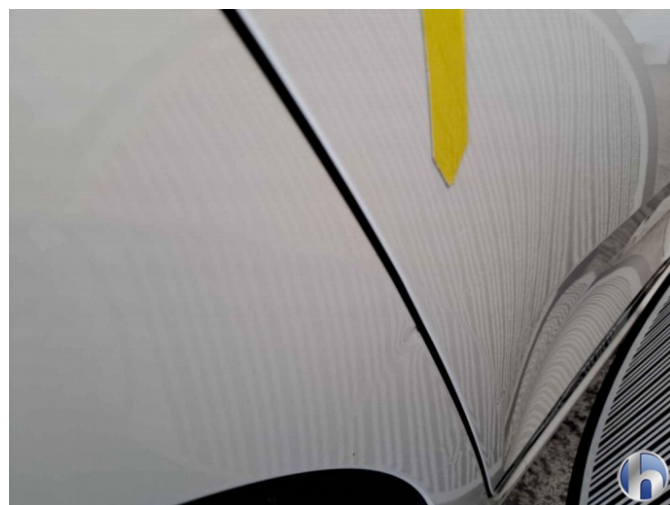
| component | Damage | Rep kind |
|---|---|---|
| 26. Door Rear - right | Damaged | Refurbish and paint |

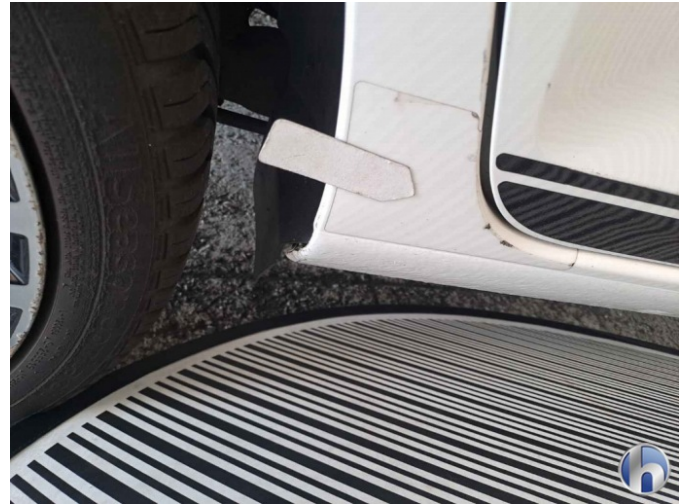
| component | Damage | Rep kind |
|---|---|---|
| 27. side skirt - right | Damaged | Refurbish and paint |

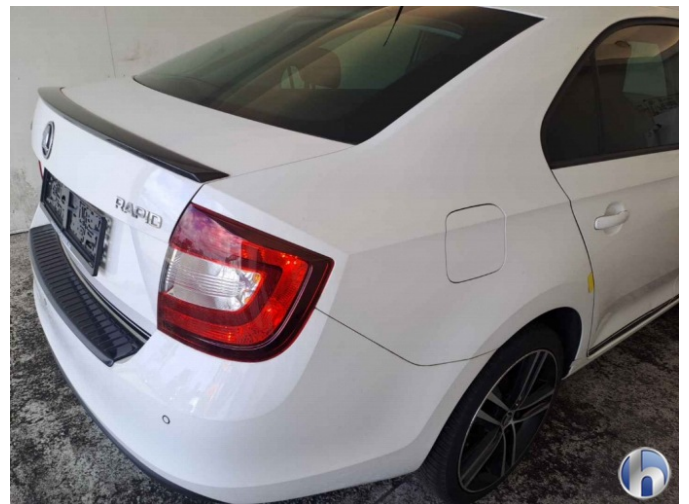
| component | Damage | Rep kind |
|---|---|---|
| 29. Taillight right | Breakage | Replace |

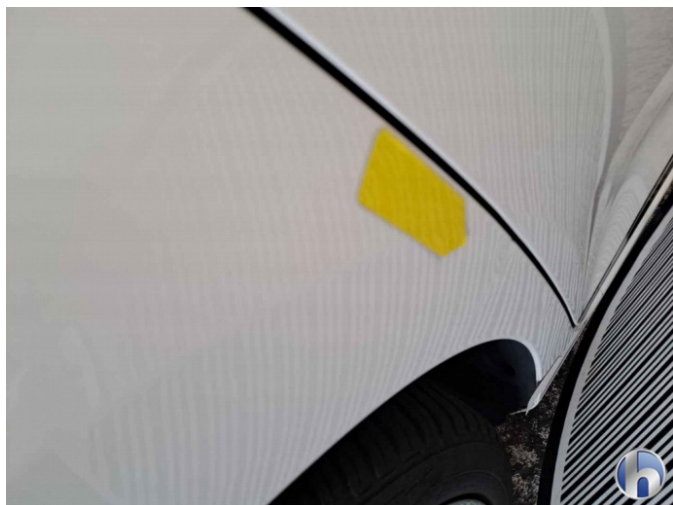
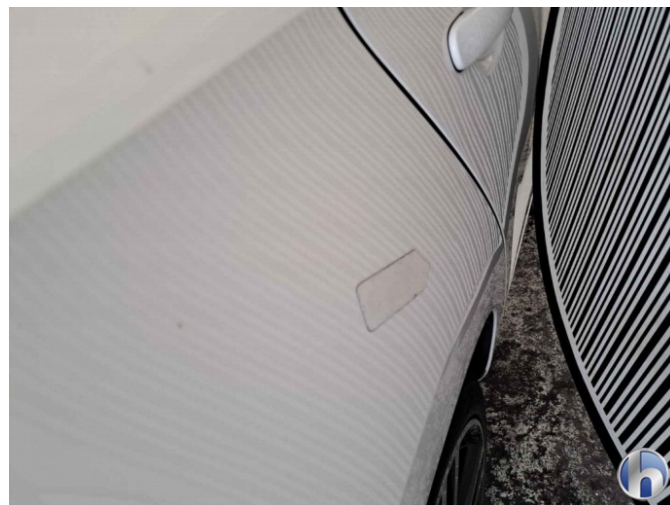
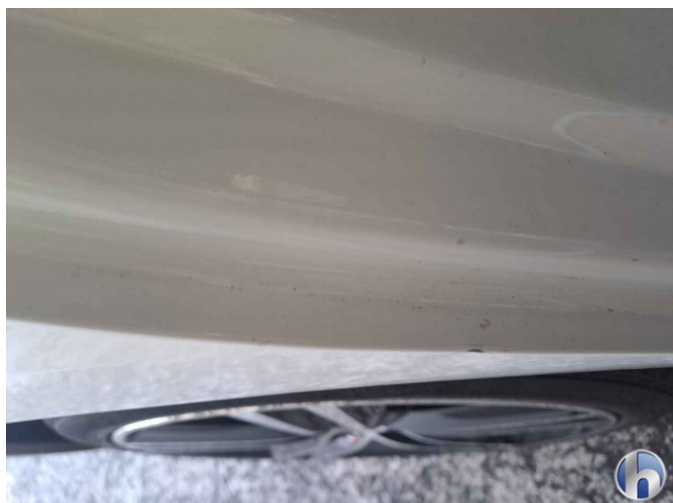
| component | Damage | Rep kind |
|---|---|---|
| 30. Sidewall - Rear - right | Damaged | Refurbish and paint |

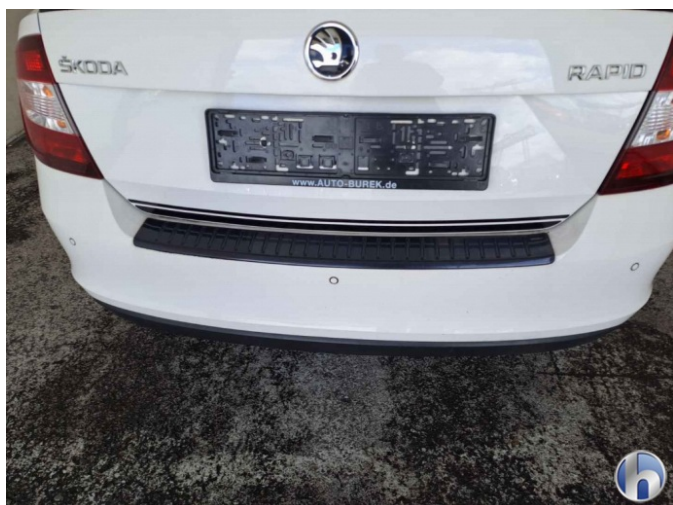
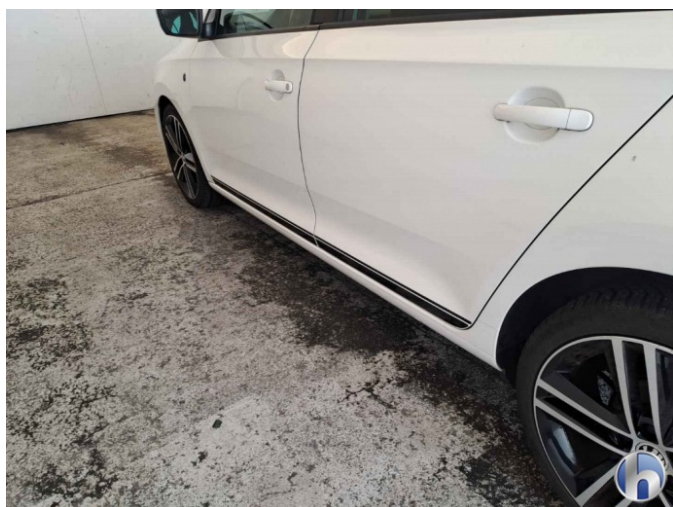
| component | Damage | Rep kind |
|---|---|---|
| 31. exterior body | Sticker | |

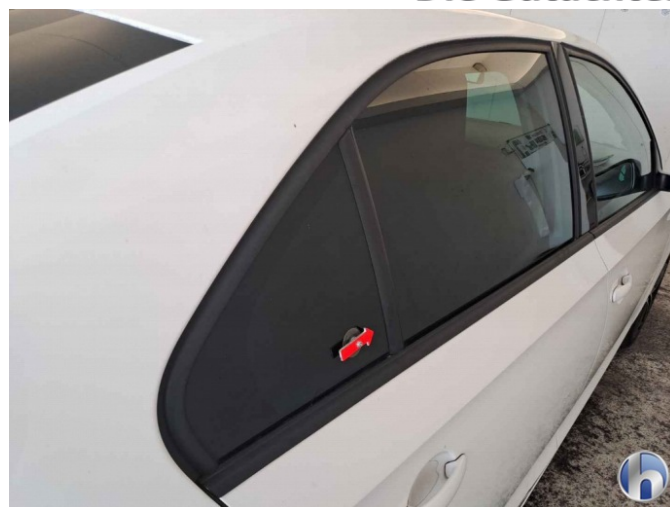
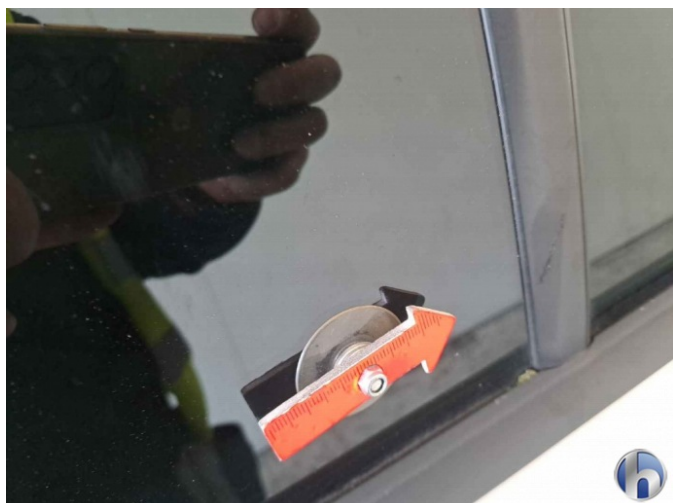
| component | Damage | Rep kind |
|---|---|---|
| 32. Seitenscheibe - Hinten - Rechts Dichtung | Damaged | Replace |

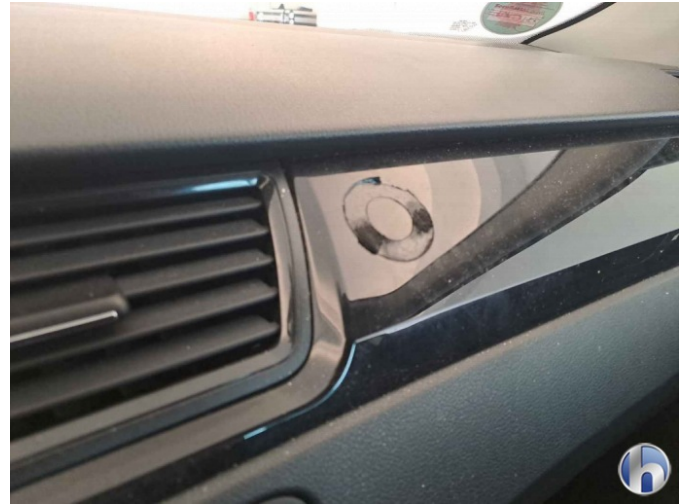
| component | Damage | Rep kind |
|---|---|---|
| 35. | Sticker | |

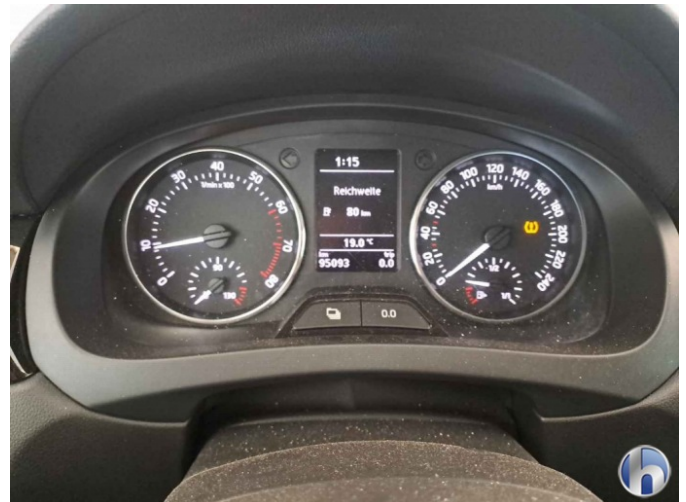
| component | Damage | Rep kind |
|---|---|---|
| 36. warning light | Error message | Carry out a fault diagnosis |

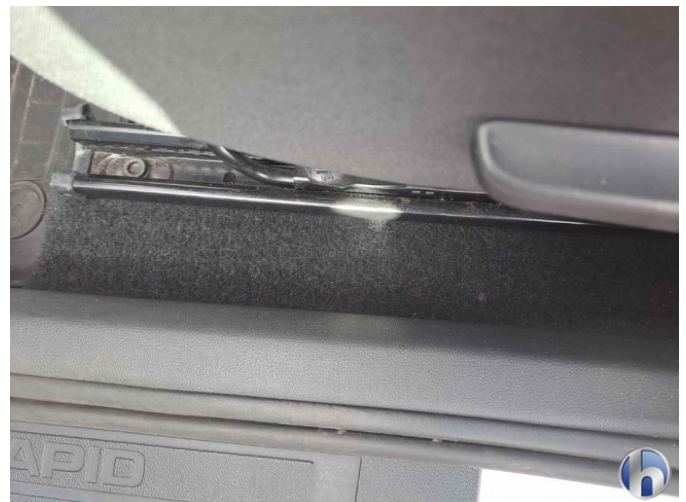
39. flooring

| 39. | flooring | Burn hole | Smart repair |

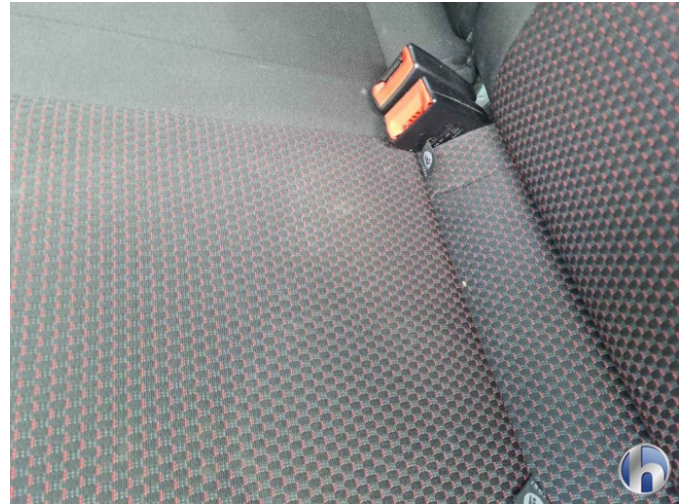
| 40. | | Burn hole | Replace |

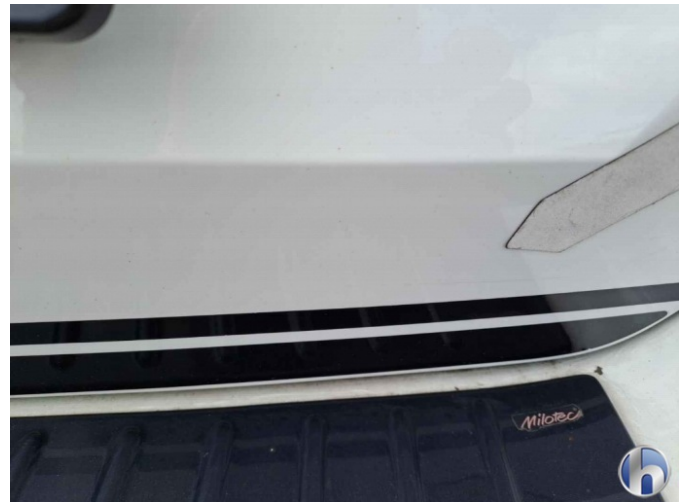
41. tailgate

| 41. | tailgate | Scratch(es) | Paint |

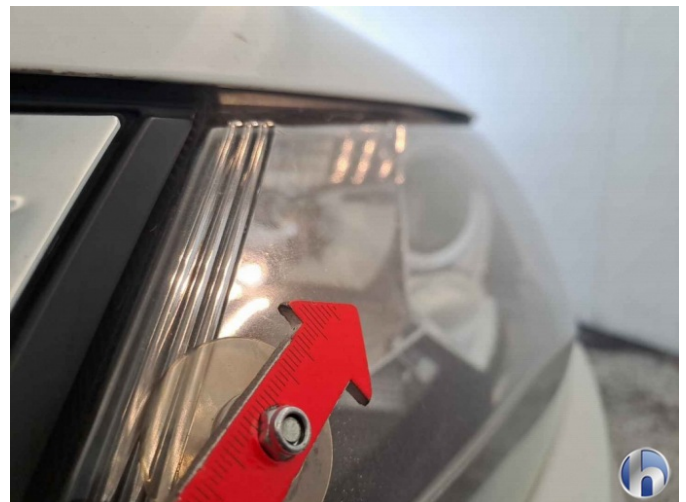
42. Xenon headlights - left

| 42. | Xenon headlights - left | Damaged | Replace |

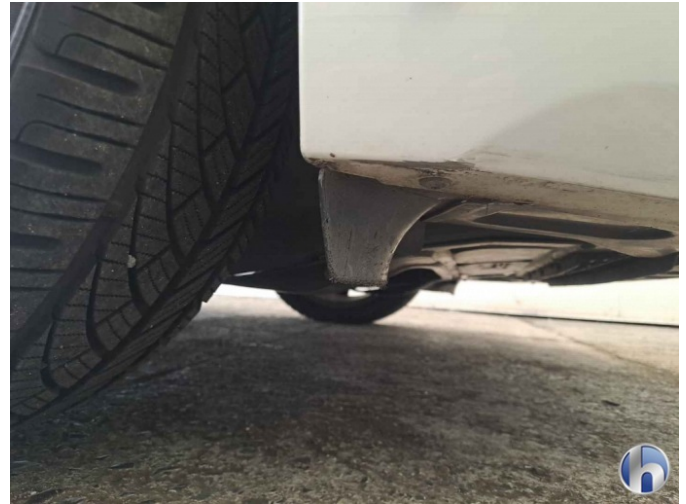
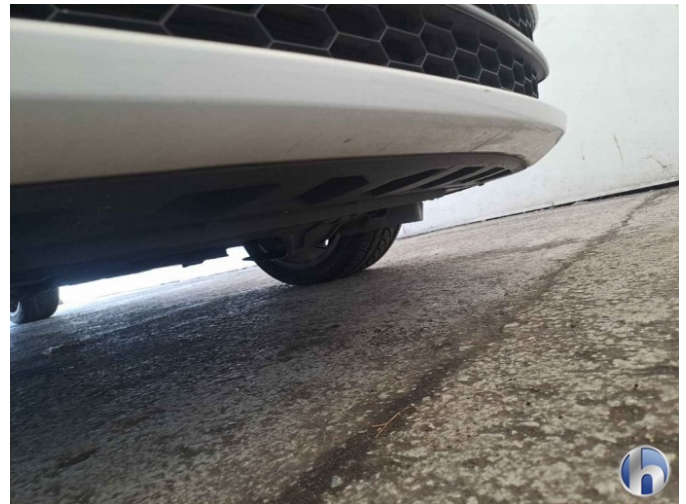
43. Front bumper

| 43. | Front bumper | Scrape | Refurbish and paint |

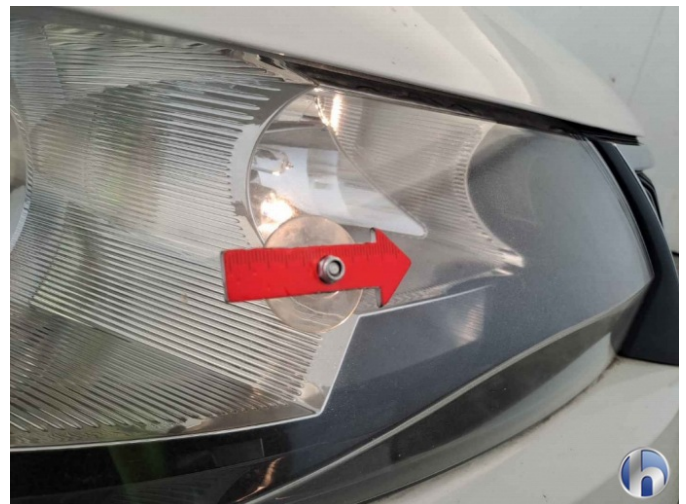
44. Xenon headlights - right

| 44. | Xenon headlights - right | Damaged | Replace |
