# SKODA Octavia

## Octavia 1.4 TSI iV DSG

VIN NO TMBAW8NX4PY012185  
Registration Number X4PY012185

### Inspection Report Summary

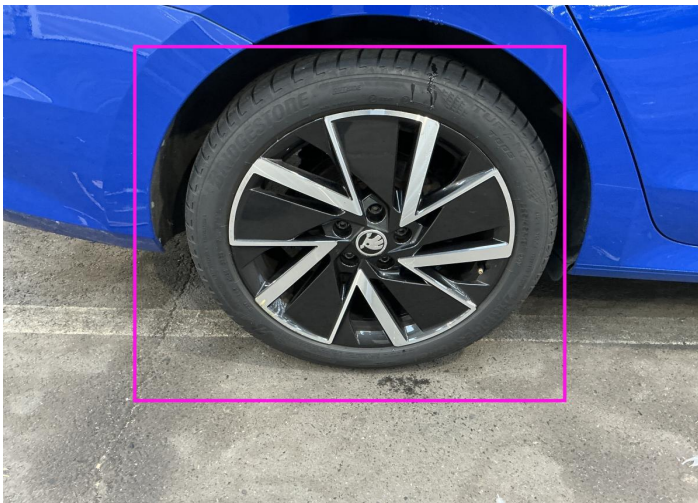
| Component | Damage | Comments |
|---|---|---|
| 1 Rim / Back Right | Out of Bodywork / Scratch | |

1. Rim / Back Right  
Out of Bodywork / Scratch -

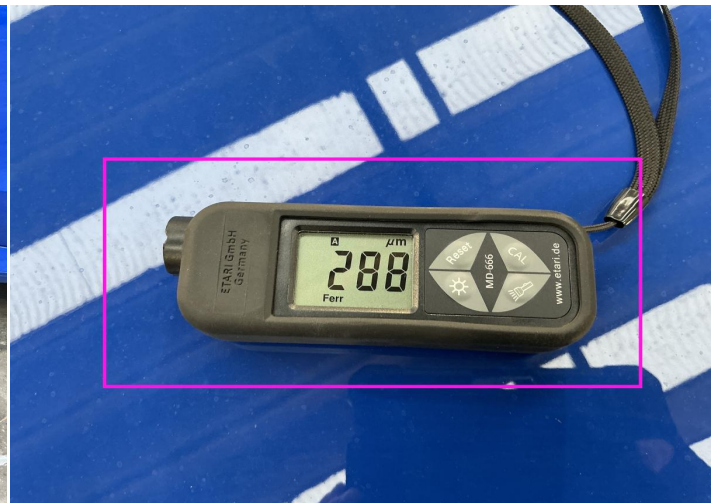
| Component | Damage | Comments |
|---|---|---|
| 2 Other | Paint / Poor Previous Repair | |

2.  
Paint / Poor Previous Repair -

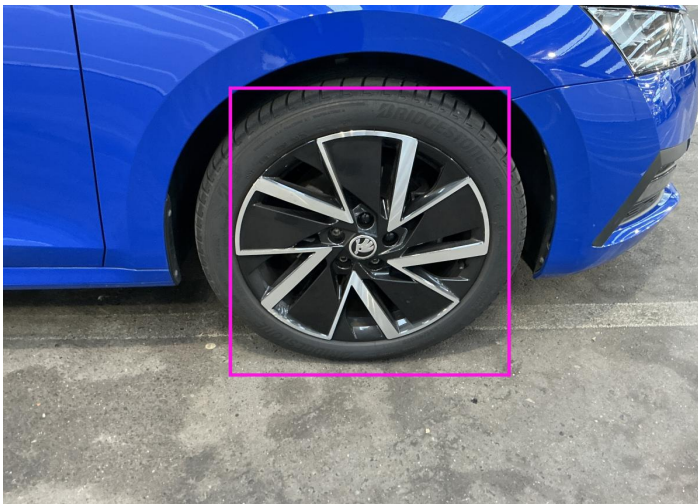
| Component | Damage | Comments |
|---|---|---|
| 3 Rim / Front Right | Out of Bodywork / Scratch | |

3. Rim / Front Right  
Out of Bodywork / Scratch -

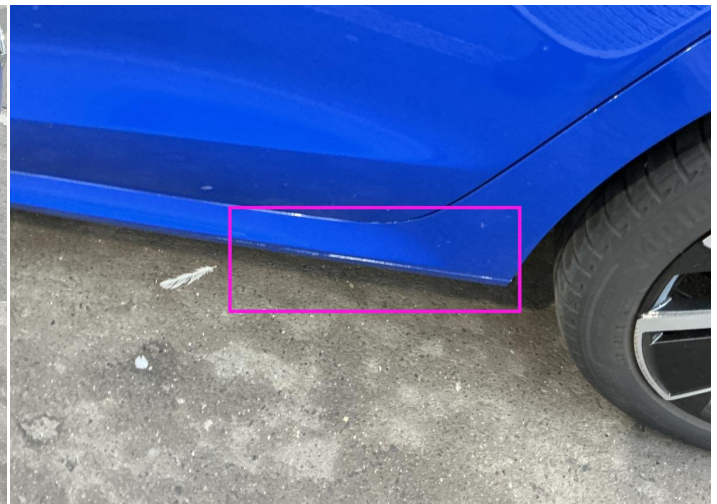
| Component | Damage | Comments |
|---|---|---|
| 4 Rocker Panel / Center Left | Paint / Scratch / Scuff | |

4. Rocker Panel / Center Left  
Paint / Scratch / Scuff -

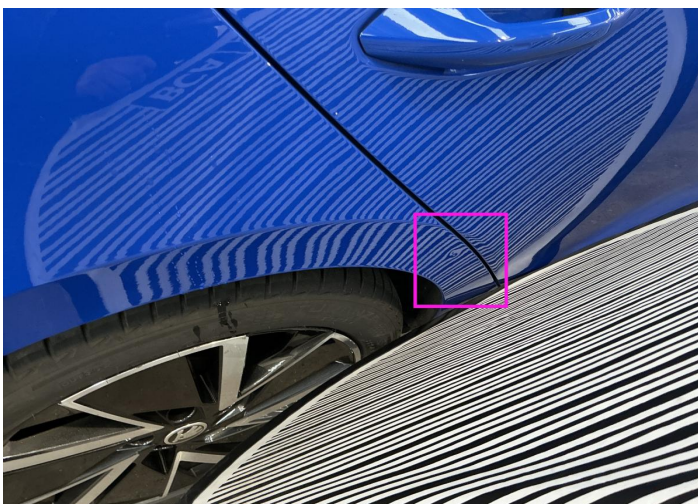
| Component | Damage | Comments |
|---|---|---|
| 5 Fender / Back Right | Bodywork / Dent / Dent | |

5. Fender / Back Right  
Bodywork / Dent / Dent -
