SKODA Octavia
Octavia 1.4 TSI iV DSG

VIN NO TMBAW8NX4PY012185
Registration Number X4PY012185

Inspection Report Summary

Customer	BCA Online	Report Number	P20251010083825
Inspection Date / Place	2025-10-10 / BCA Neuss	Cosmetic Grade	2

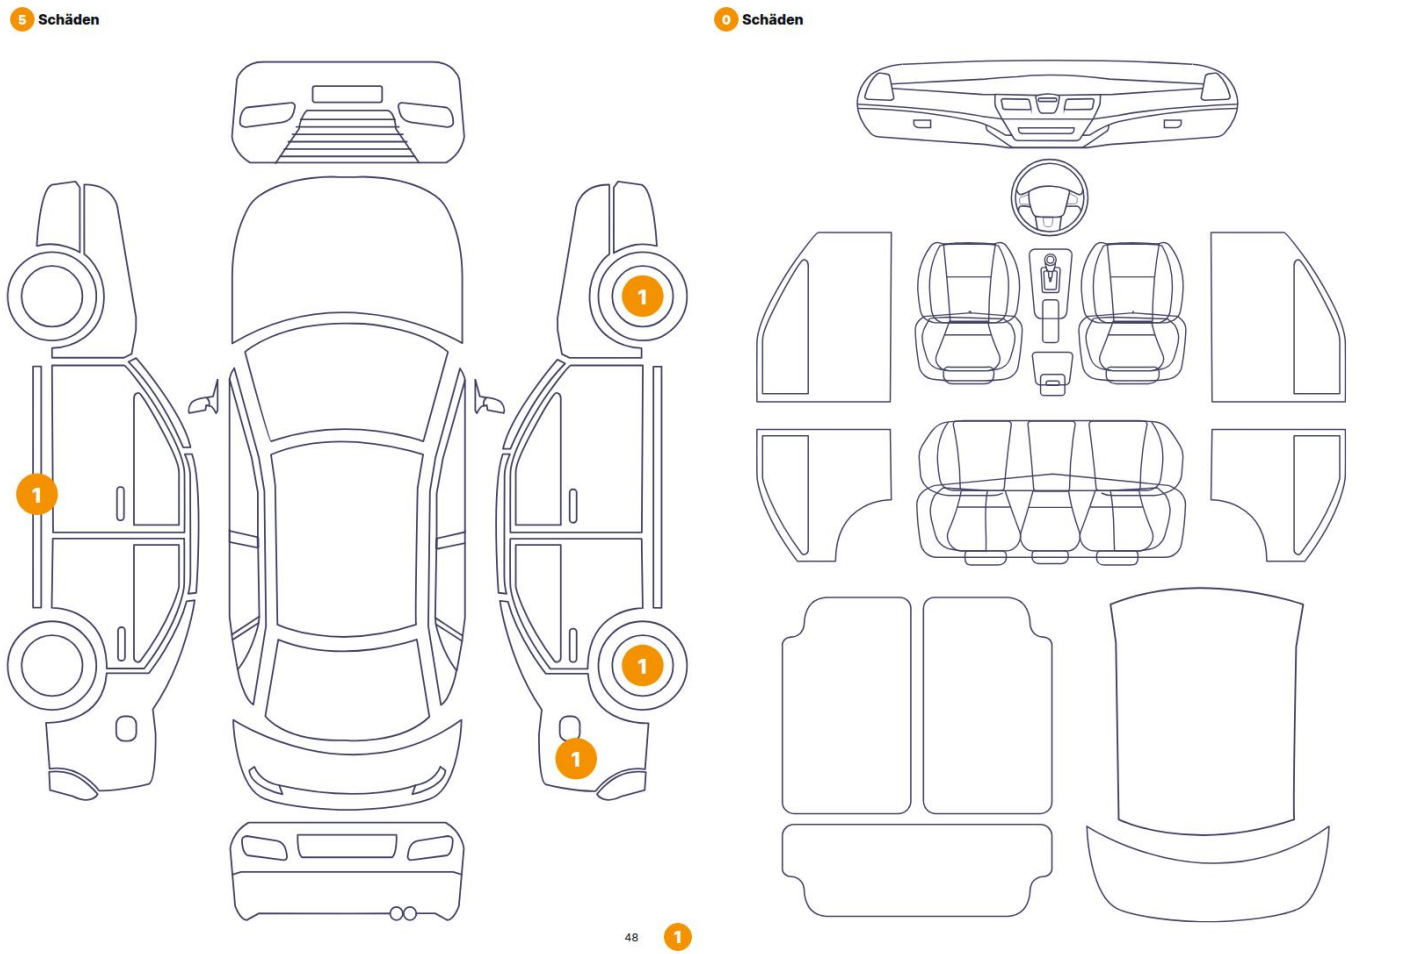
Cosmetic Damage

Component	Damage	Comments
1 Rim / Back Right	Out of Bodywork / Scratch	
2 Other	Paint / Poor Previous Repair	
3 Rim / Front Right	Out of Bodywork / Scratch	
4 Rocker Panel / Center Left	Paint / Scratch / Scuff	
5 Fender / Back Right	Bodywork / Dent / Dent
