# SKODA Octavia Octavia Combi 1.8 TSI

VIN NO TMBGK61Z6A2083707 Registration Number Z6A2083707

### **Inspection Report Summary**

Customer	BCA Online	Report Number	P20251010085049
Inspection Date / Place	2025-10-10 / BCA Oberndorf	Cosmetic Grade	4

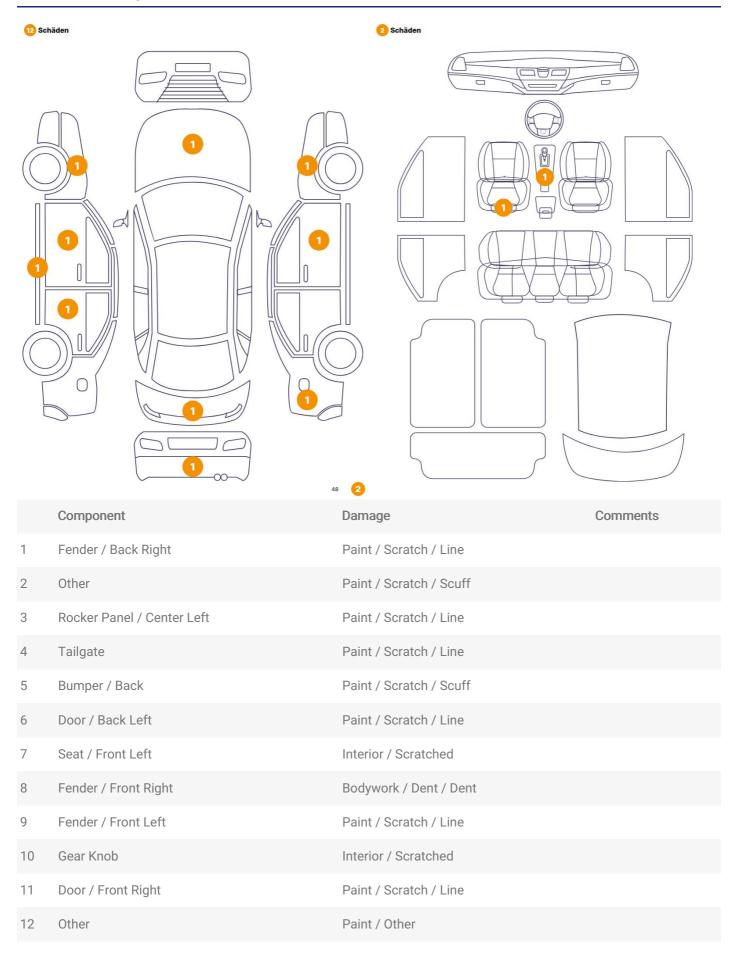
14 Hood Bodywork / Dent / Dent

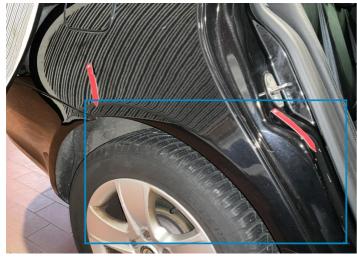
1. Fender / Back Right Paint / Scratch / Line -

2. Paint / Scratch / Scuff -

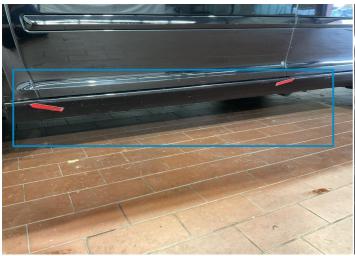
3. Rocker Panel / Center Left Paint / Scratch / Line -

4. Tailgate Paint / Scratch / Line -

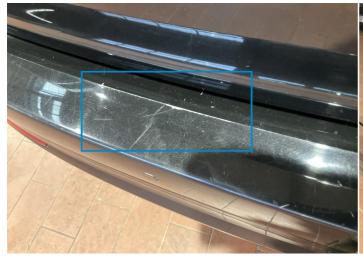
5. Bumper / Back Paint / Scratch / Scuff -

6. Door / Back Left Paint / Scratch / Line -

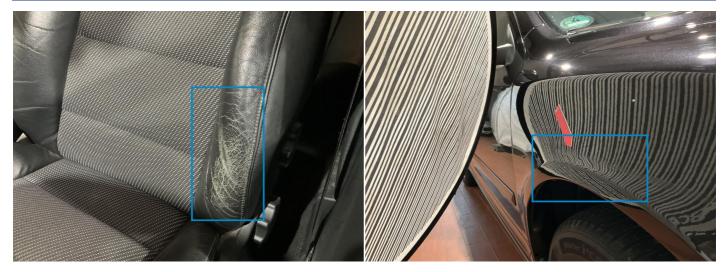
7. Seat / Front Left Interior / Scratched -

8. Fender / Front Right Bodywork / Dent -

9. Fender / Front Left Paint / Scratch / Line -

10. Gear Knob Interior / Scratched -

11. Door / Front Right Paint / Scratch / Line -

12. Paint / Other -

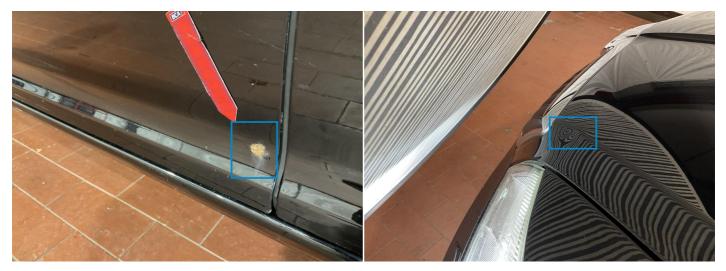
13. Door / Front Left Paint / Scratch / Line -

14. Hood Bodywork / Dent / Dent -
