## status report

**customer:** Bank 11, Neuss  
**contract number:** 868551730-INSO  
**reference:**

#### Skoda Kamiq Ambition

| Vehicle identification number | <b>TMBGP9NW8M3126090</b> | mileage read: | <b>90200 km</b> |

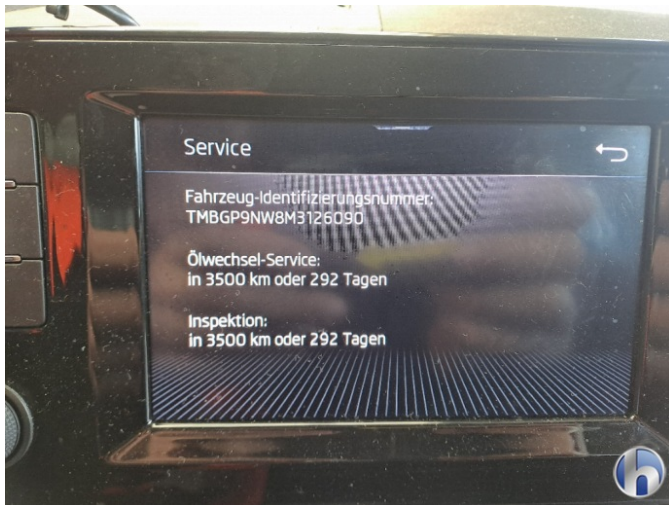
1. Wartung

| | component | Damage | Rep kind |
|---|---|---|---|
| 1. | Wartung | | Replace |

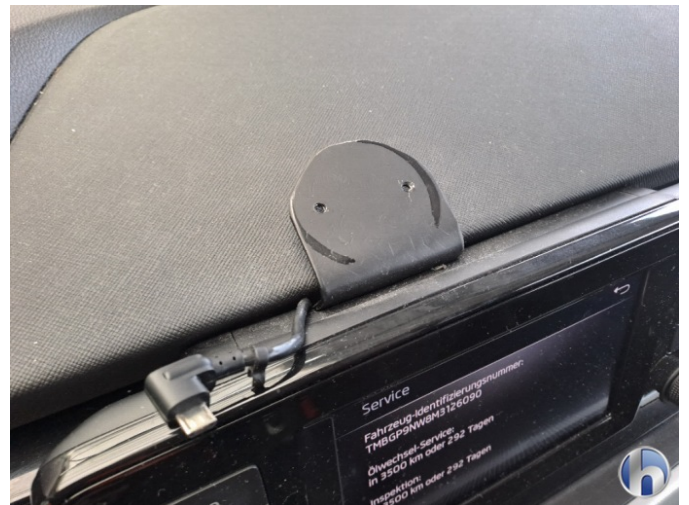
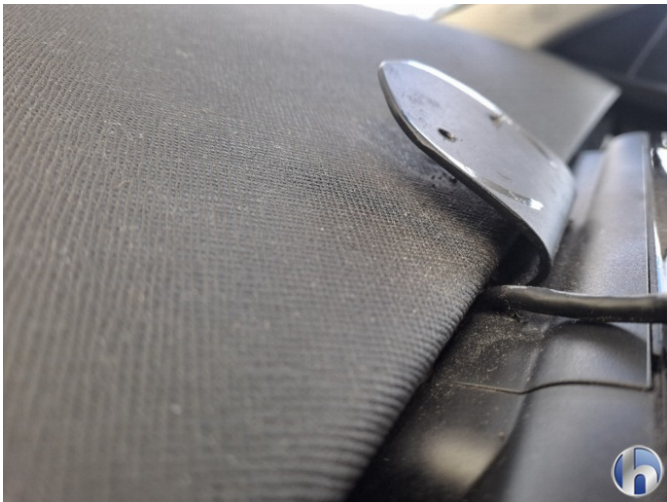
2. Amaturenbrett

| | component | Damage | Rep kind |
|---|---|---|---|
| 2. | Amaturen Brett | Delle | Replace |

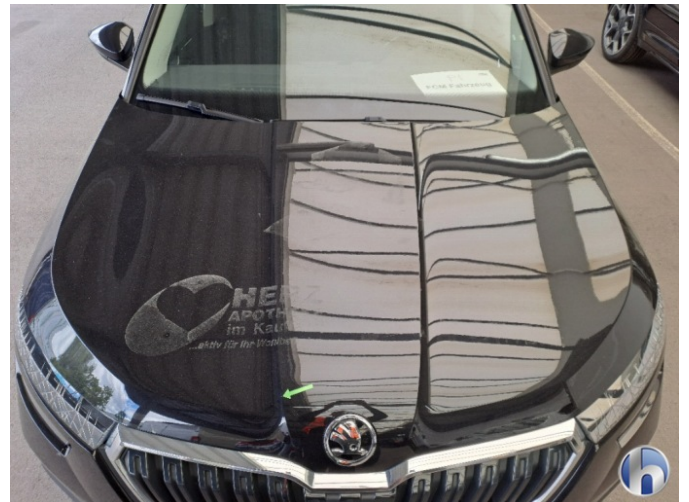
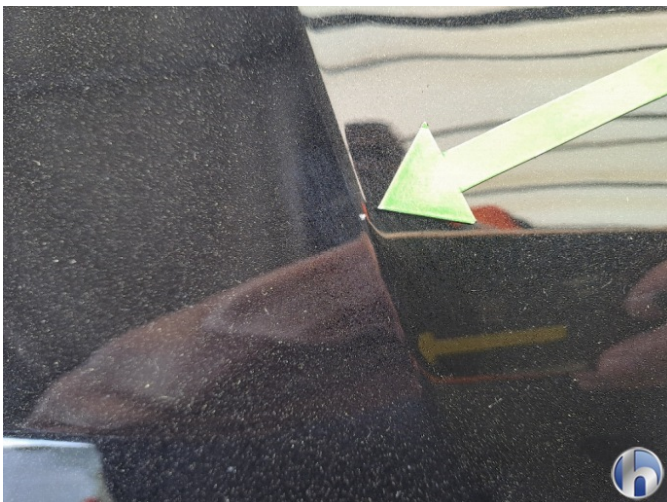
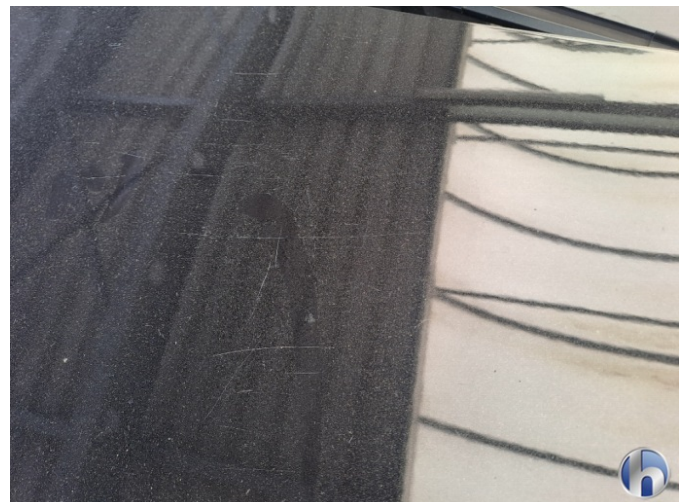
3. hood

| | component | Damage | Rep kind |
|---|---|---|---|
| 3. | hood | Scratch(es) | Smart repair |

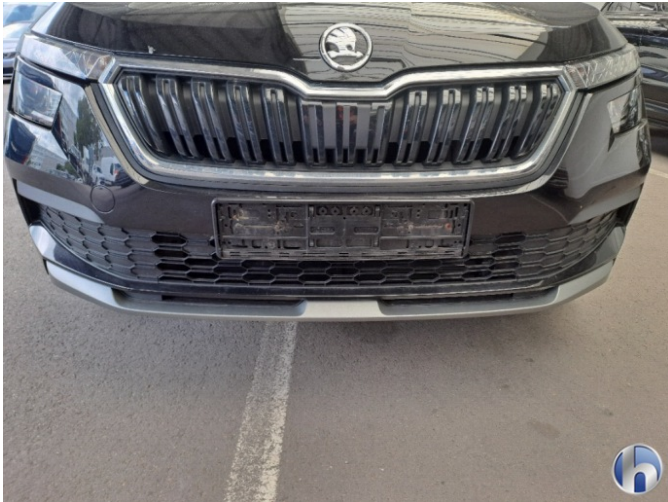
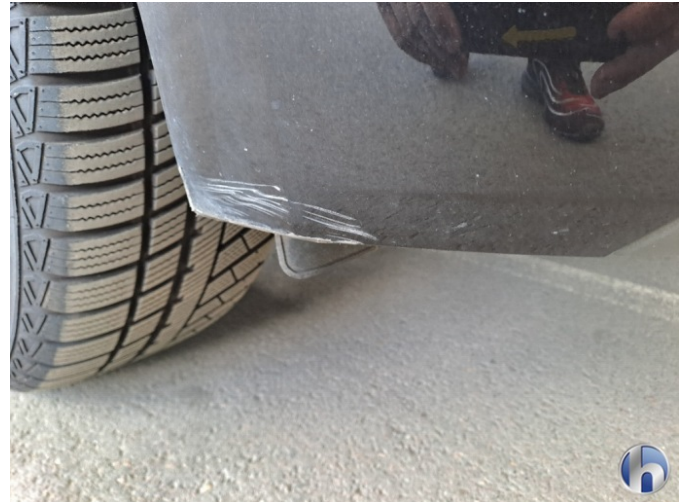
4. Front bumper

| | component | Damage | Rep kind |
|---|---|---|---|
| 4. | Front bumper | Scratch(es) | Paint |

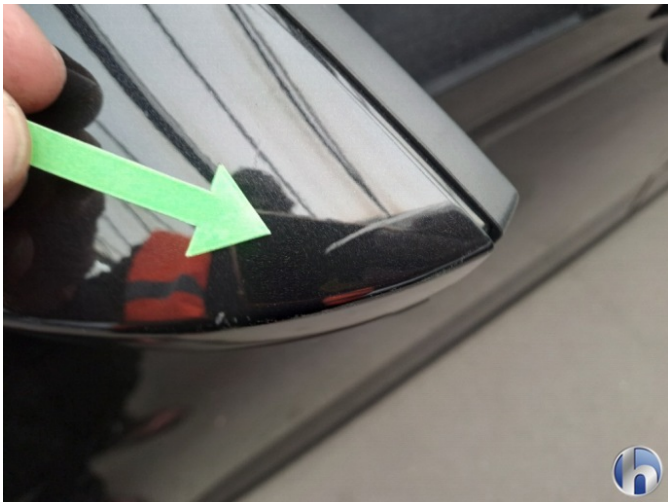
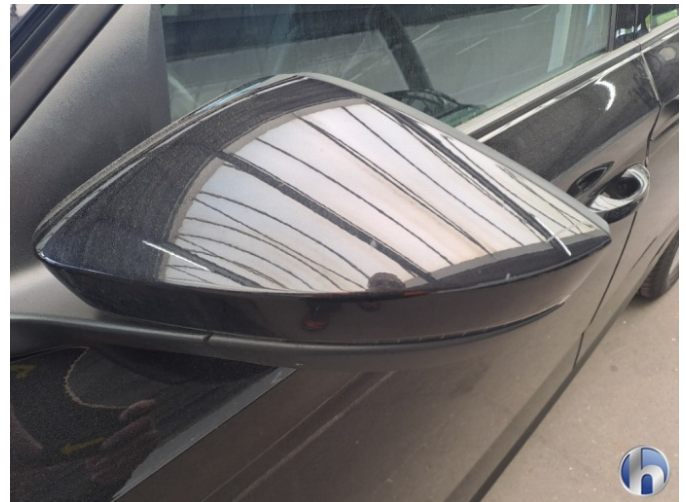
5. Spiegelkappe links

| | component | Damage | Rep kind |
|---|---|---|---|
| 5. | Spiegelkappe links | Scratch(es) | Smart repair |

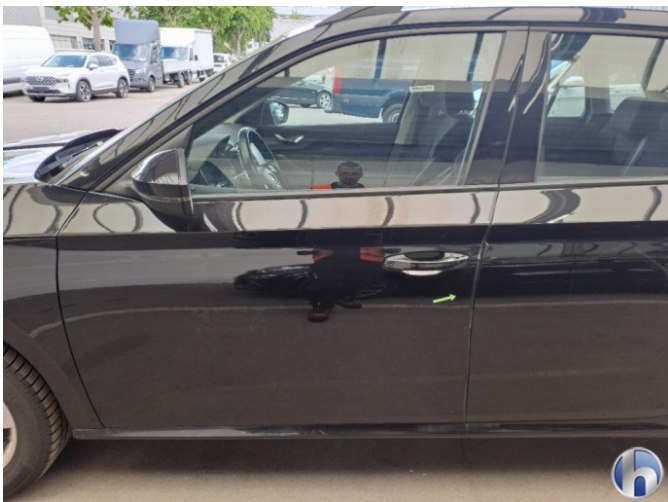
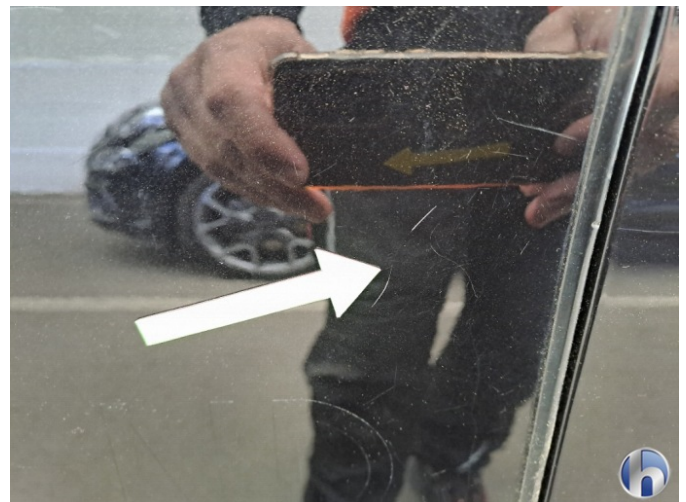
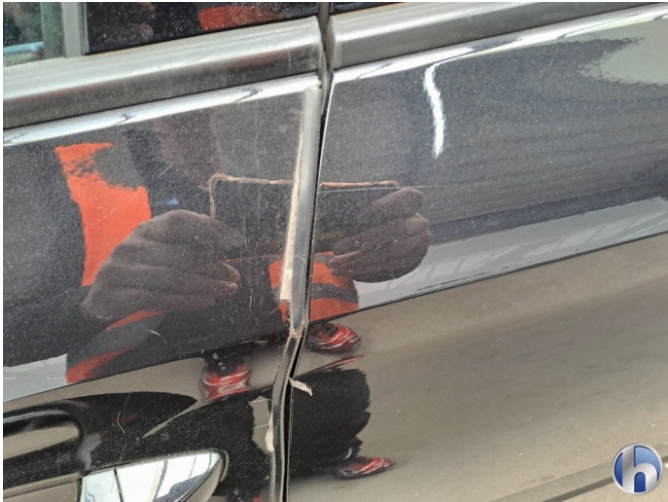
6. Front door - left

| | component | Damage | Rep kind |
|---|---|---|---|
| 6. | Front door - left | Scratch(es) | Smart repair |

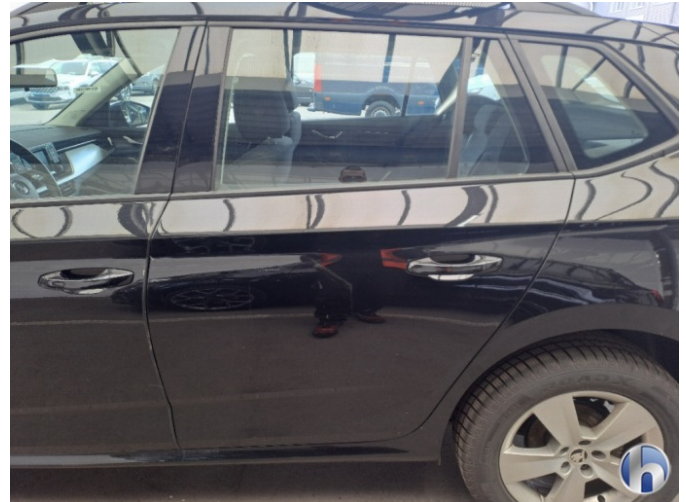
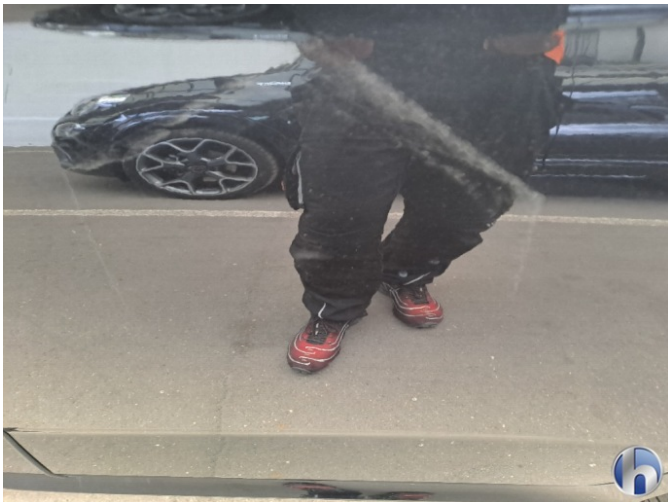
7. Rear door - left

| | component | Damage | Rep kind |
|---|---|---|---|
| 7. | Rear door - left | Sticker | |

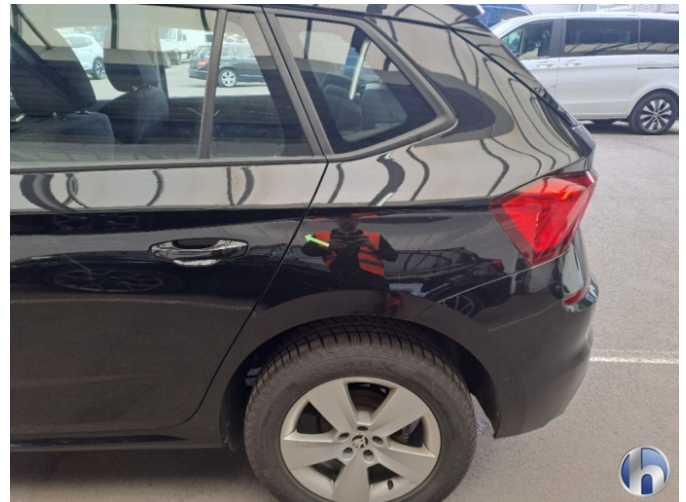
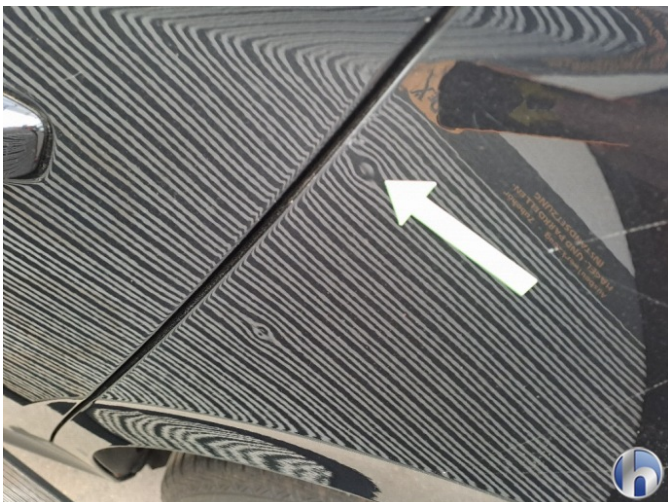
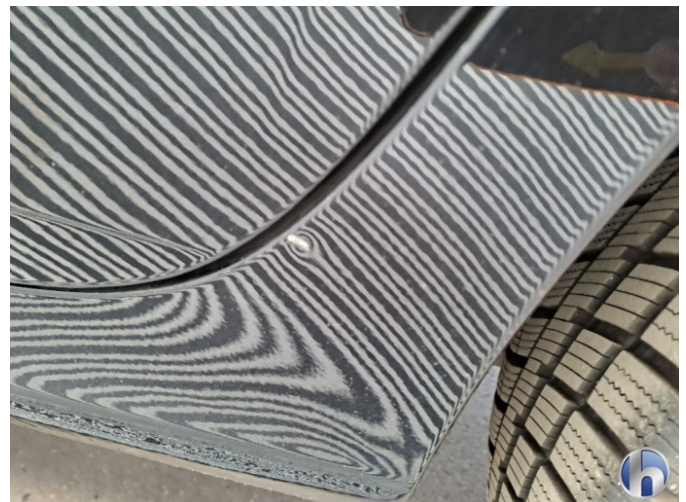
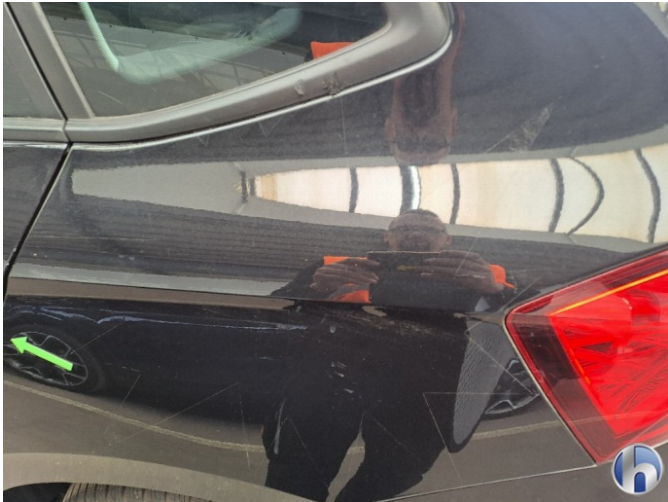
8. Sidewall - Rear - Left

| | component | Damage | Rep kind |
|---|---|---|---|
| 8. | Sidewall - Rear - Left | Deformed | Smart repair |

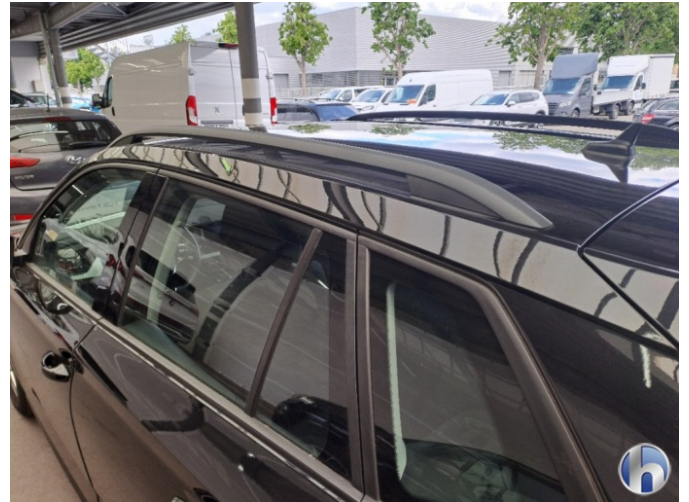
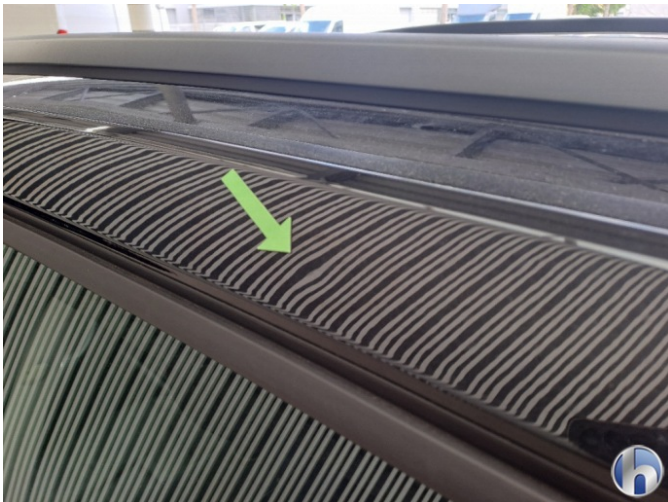
9. Roof frame - left

| | component | Damage | Rep kind |
|---|---|---|---|
| 9. | Roof frame - left | | Smart repair |

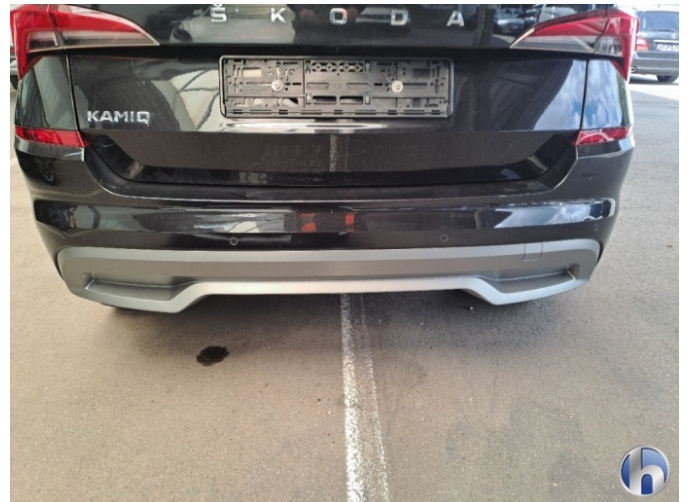
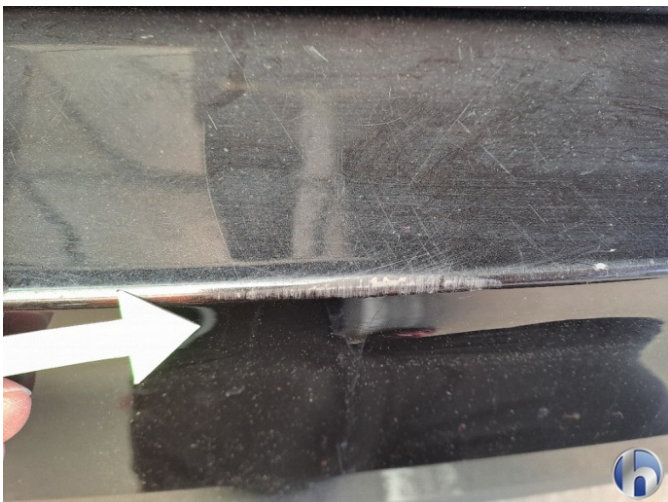
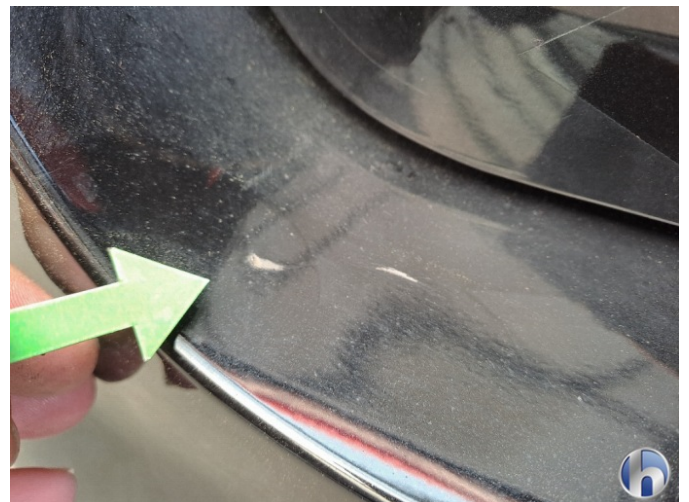
10. Rear bumper

| | component | Damage | Rep kind |
|---|---|---|---|
| 10. | Rear bumper | Scratch(es) | Paint |

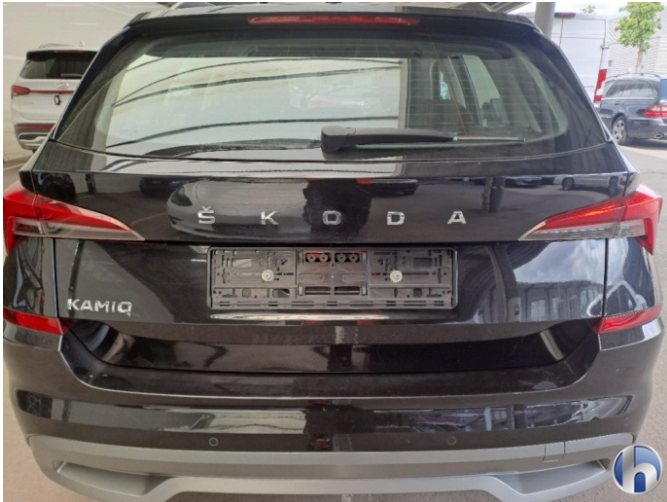
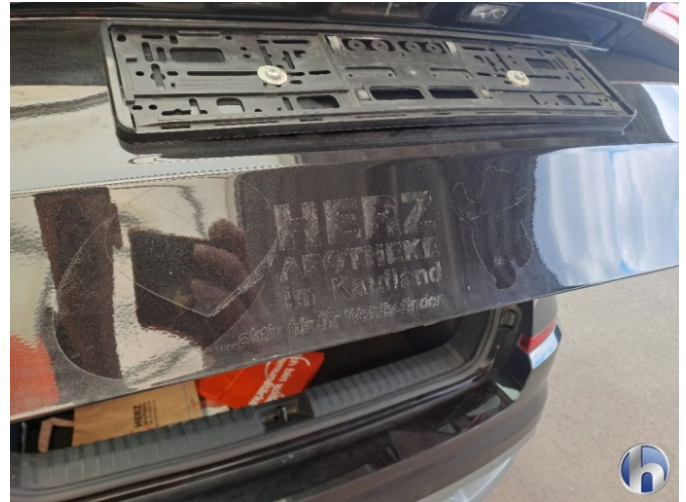
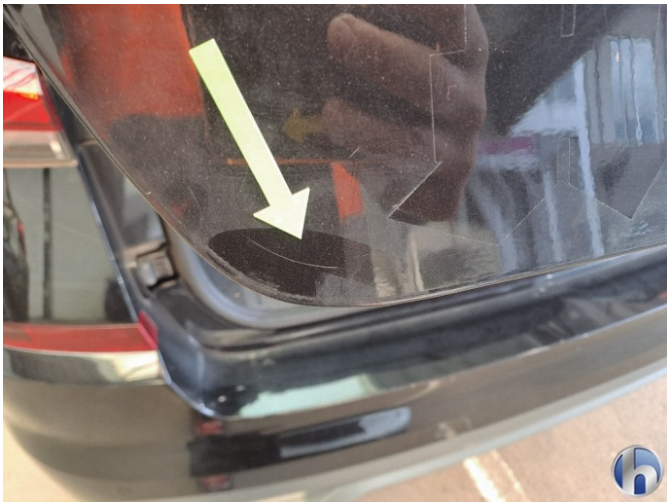
11. tailgate

| | component | Damage | Rep kind |
|---|---|---|---|
| 11. | tailgate | Scratch(es) | Smart repair |

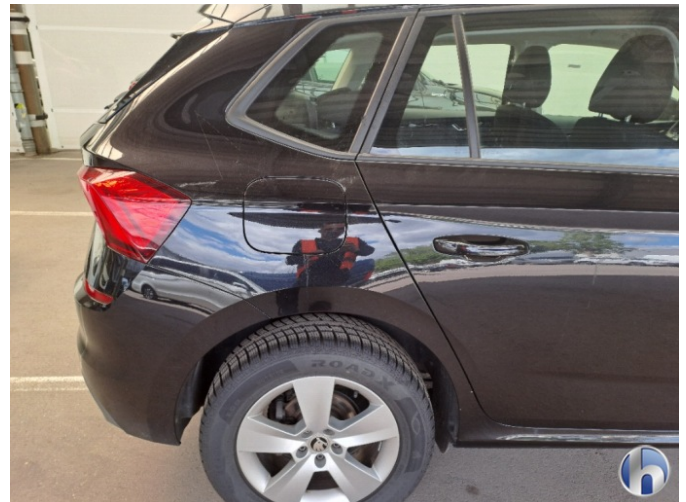
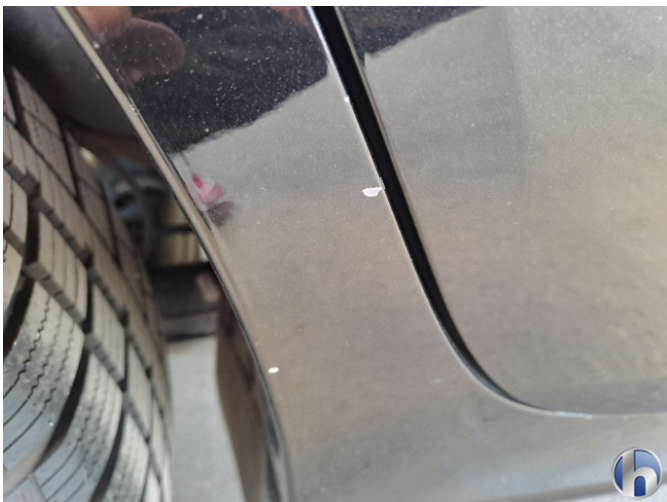
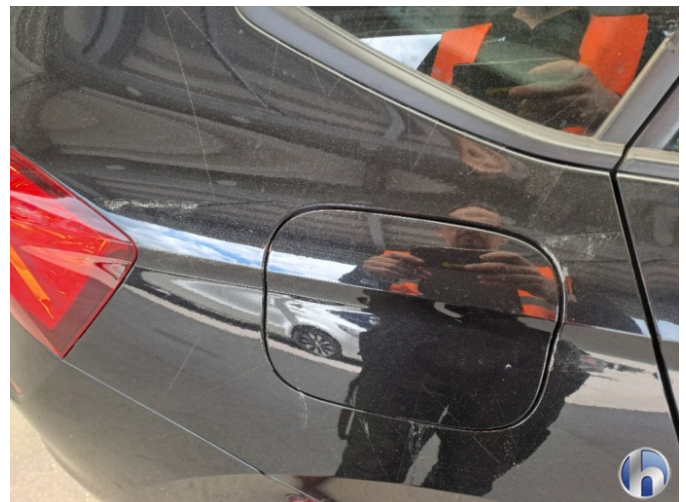
12. Sidewall - Rear - right

| | component | Damage | Rep kind |
|---|---|---|---|
| 12. | Sidewall - Rear - right | Deformed | Smart repair |

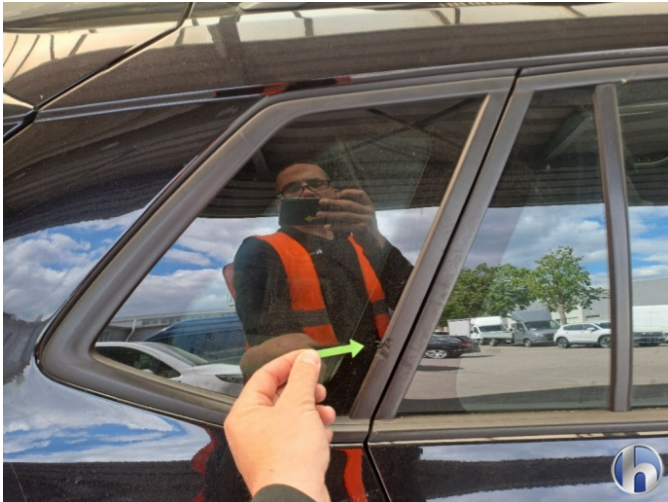
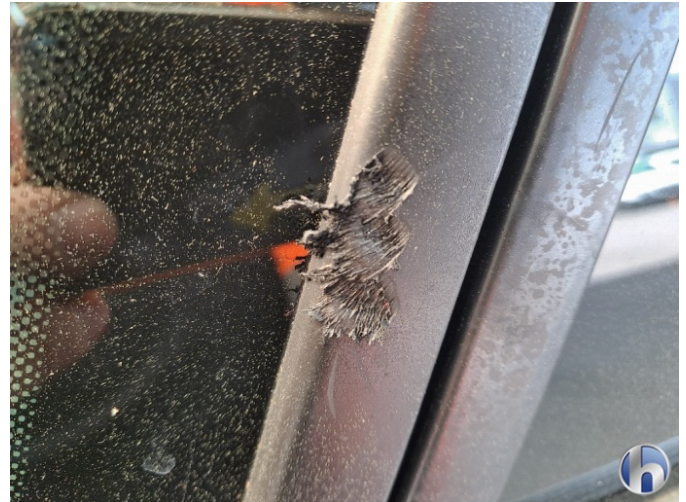
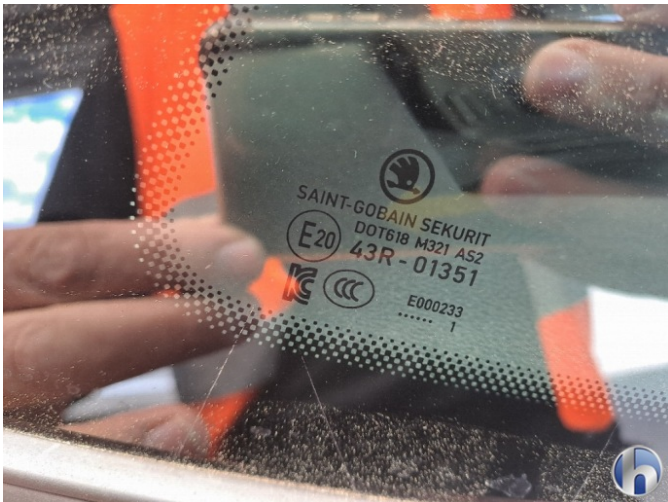
13. Side window - Rear - right

| | component | Damage | Rep kind |
|---|---|---|---|
| 13. | Side window - Rear - right | Damaged | Replace |

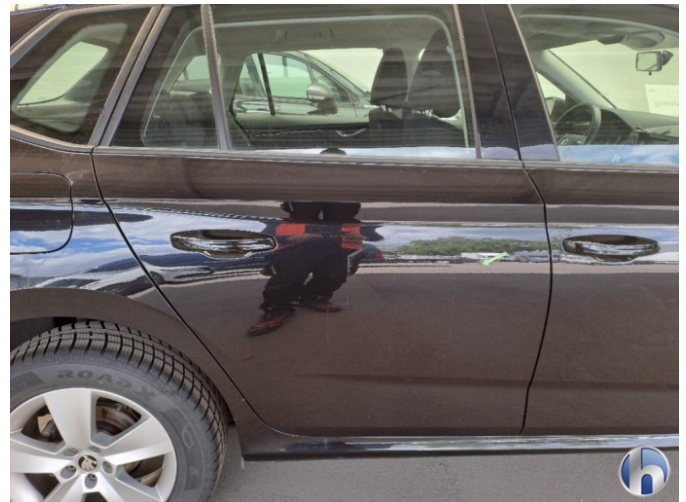
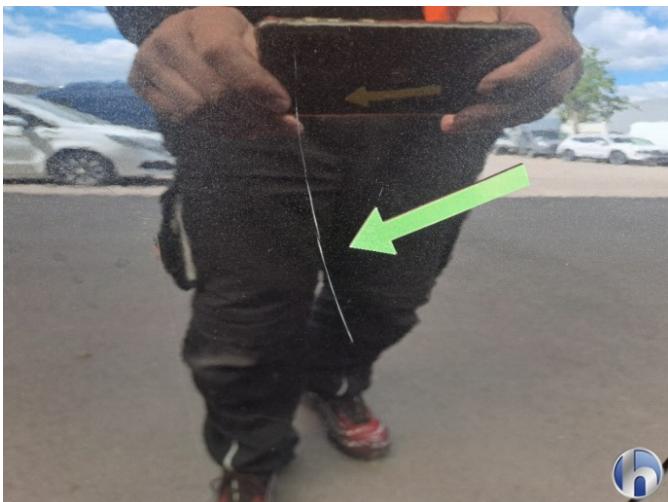
14. Door Rear - right

| | component | Damage | Rep kind |
|---|---|---|---|
| 14. | Door Rear - right | Scratch(es) | Paint |

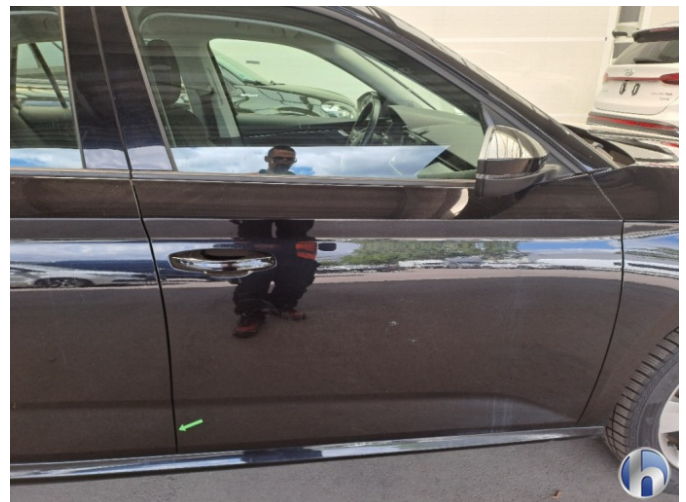
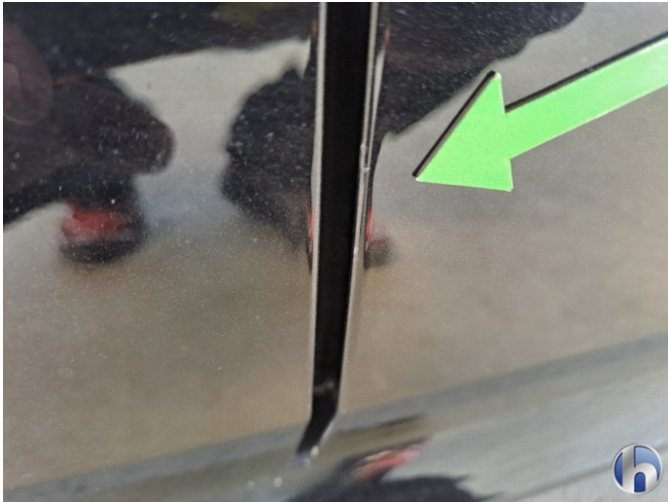
15. Front door - right

| | component | Damage | Rep kind |
|---|---|---|---|
| 15. | Front door - right | Scratch(es) | Smart repair |

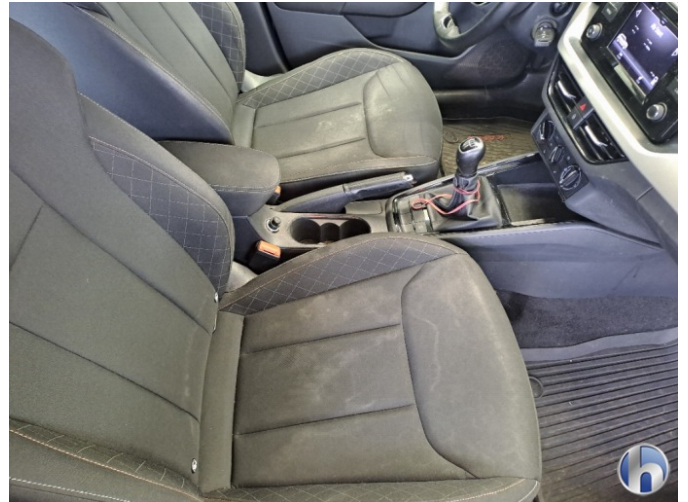
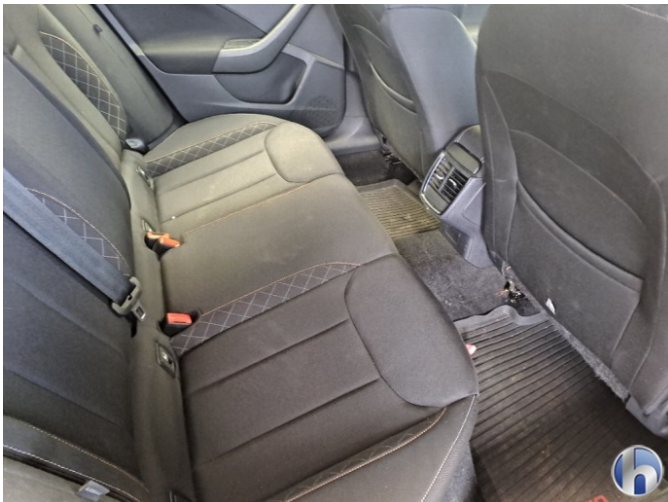
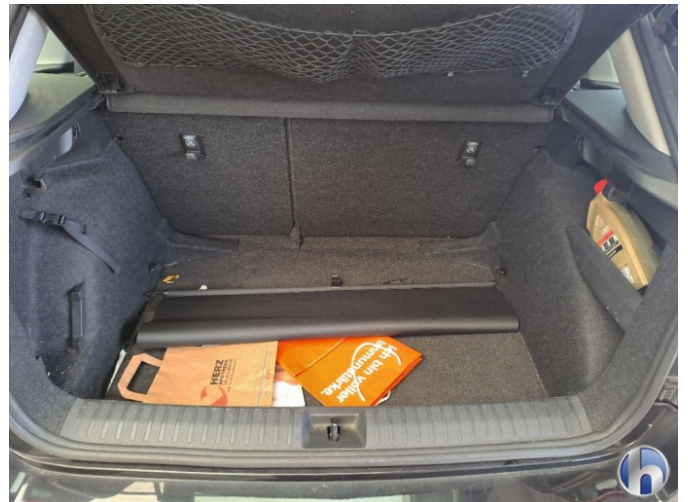
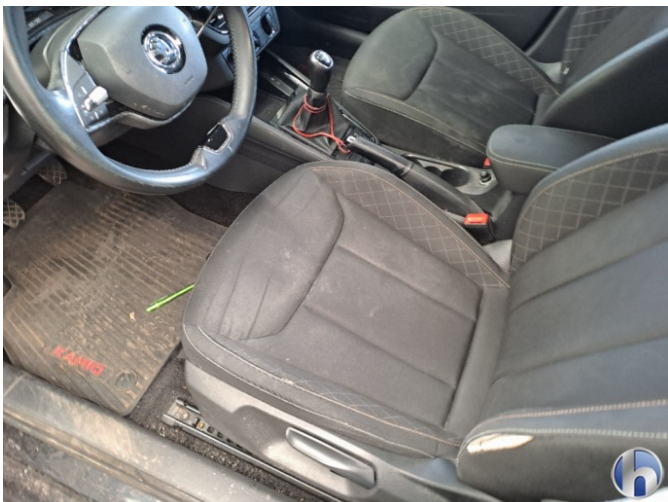
16. Innenraum

| | component | Damage | Rep kind |
|---|---|---|---|
| 16. | Innenraum | Dirty | |

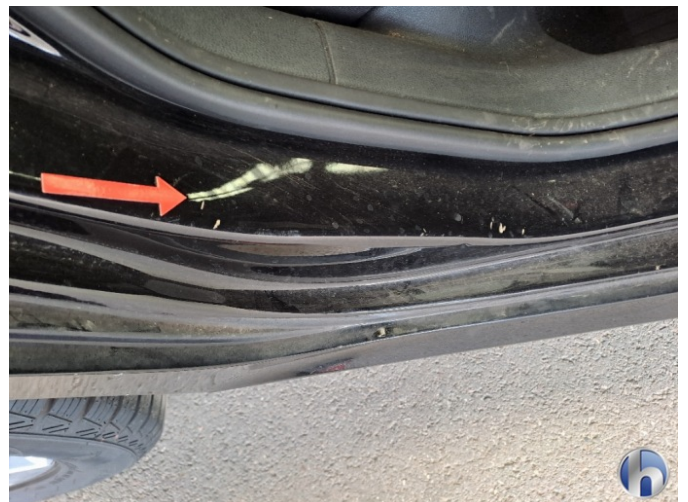
17. Türeinstieg Hinten rechts

| | component | Damage | Rep kind |
|---|---|---|---|
| 17. | Türeinstieg Hinten rechts | Scratch(es) | Smart repair |

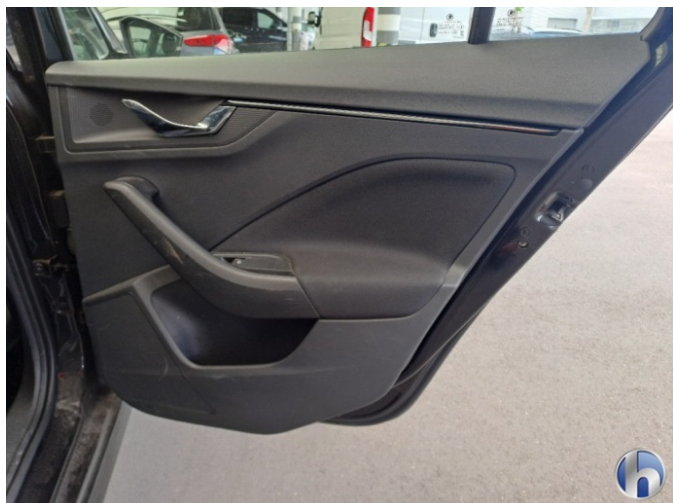
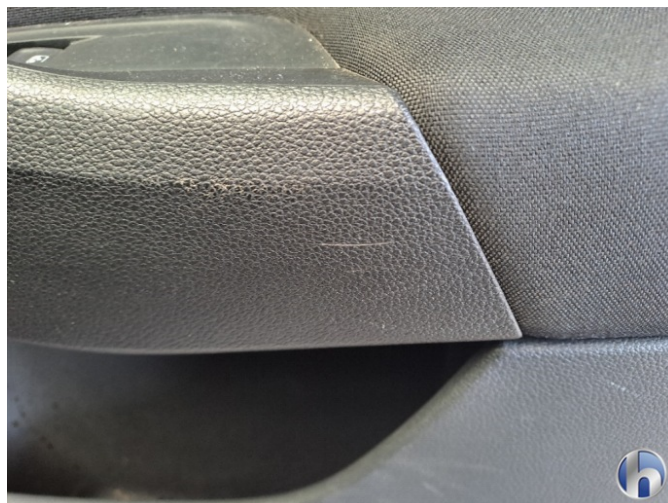
18. Türverkleidung Hinten rechts

| | component | Damage | Rep kind |
|---|---|---|---|
| 18. | Türverkleidung Hinten rechts | Scratch(es) | Smart repair |

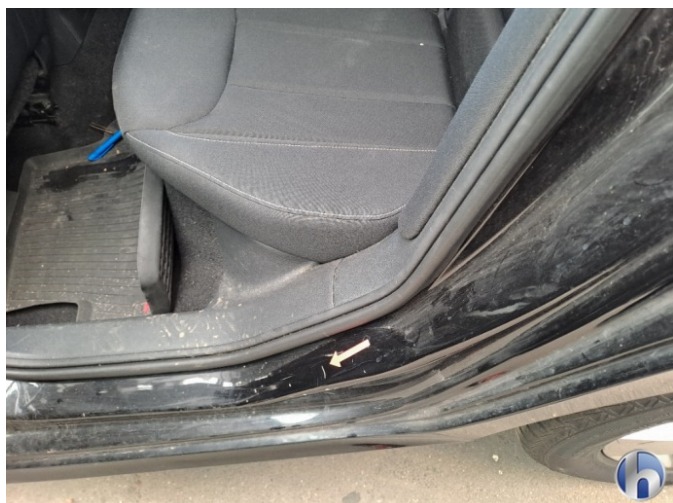
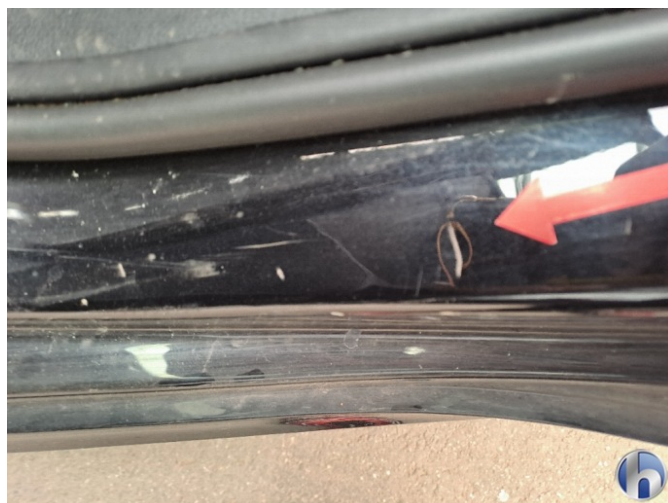
19. Türeinstieg Hinten links

| | component | Damage | Rep kind |
|---|---|---|---|
| 19. | Türeinstieg Hinten links | Scratch(es) | Smart repair |

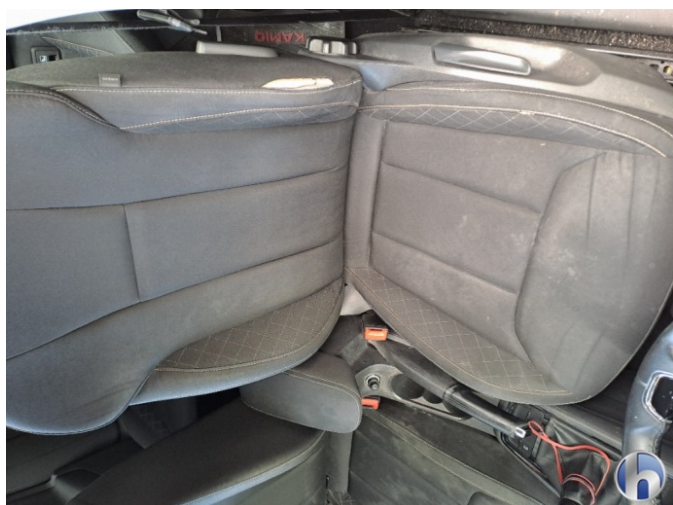
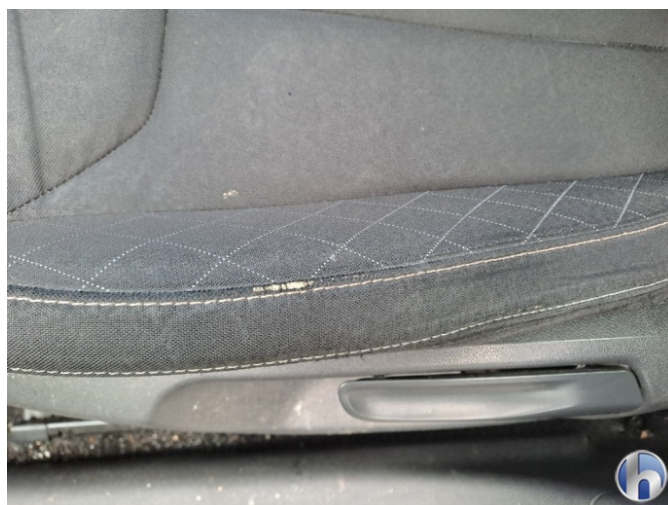
20. Fahrersitz Sitzposter

| | component | Damage | Rep kind |
|---|---|---|---|
| 20. | Fahrersitz Sitzposter | Scratch(es) | Smart repair |

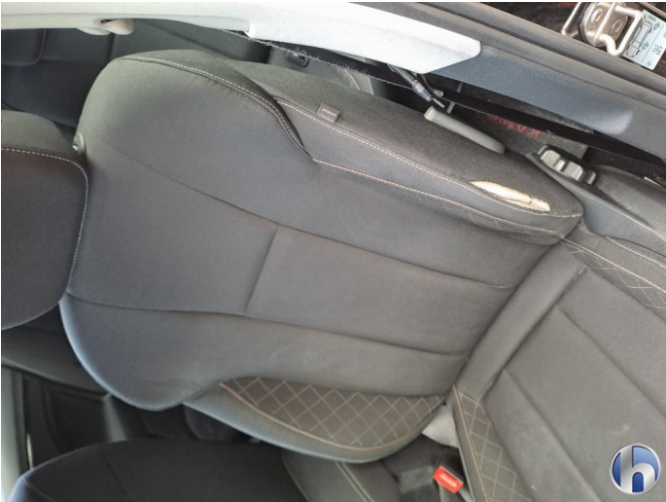
21. Fahrersitz Lehne

| | component | Damage | Rep kind |
|---|---|---|---|
| 21. | Fahrersitz Lehne | Crack | Replace |

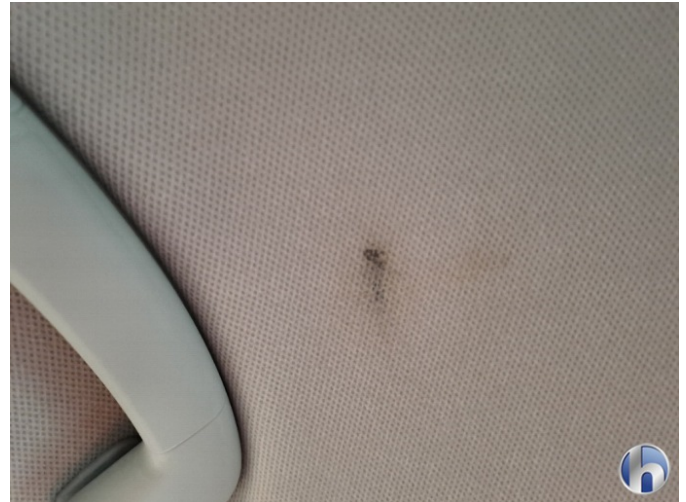
22. Dachhimmel

| | component | Damage | Rep kind |
|---|---|---|---|
| 22. | Dachhimmel | | Smart repair |

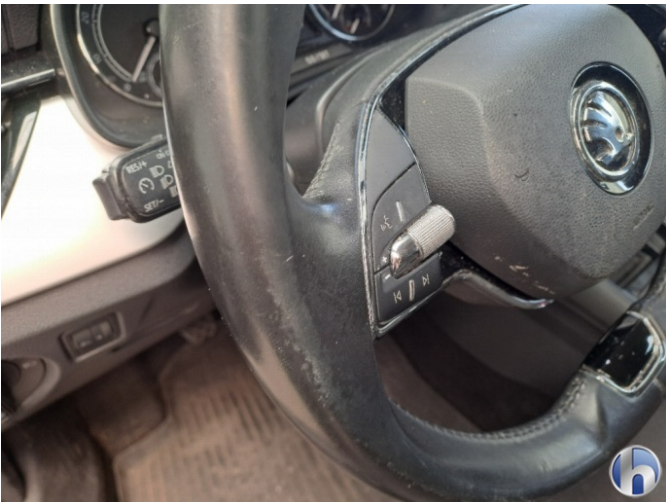
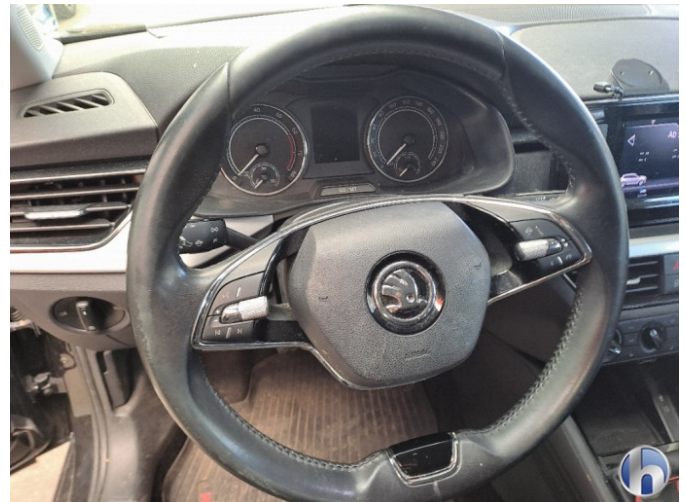
23. Leder Lenkrad

| | component | Damage | Rep kind |
|---|---|---|---|
| 23. | Leder Lenkrad | Scratch(es) | Smart repair |
