Expertise

Protocol number: 41449876  
Order No. / Reference: 25200889  
Inspection date: 9 Sept 2025

Manufacturer: Skoda	Model: Karoq 2.0 TDI SCR DSG Clever
VIN: TMBJF7NU0M5039283

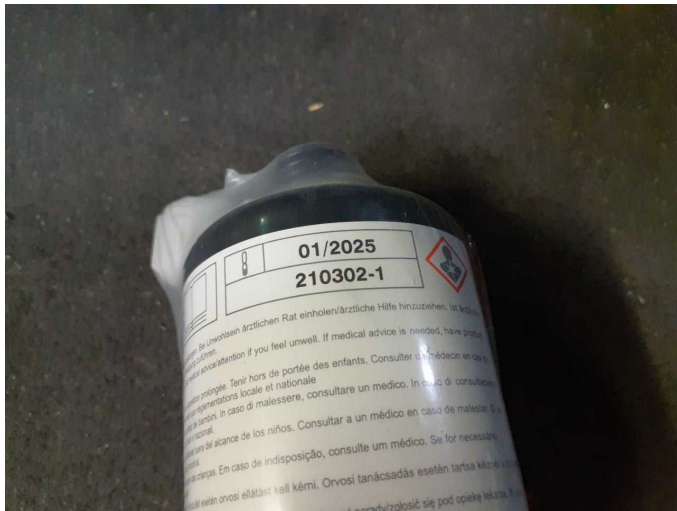
**Damage 1:** Equipment: Tirefit filler - Expired - Replace

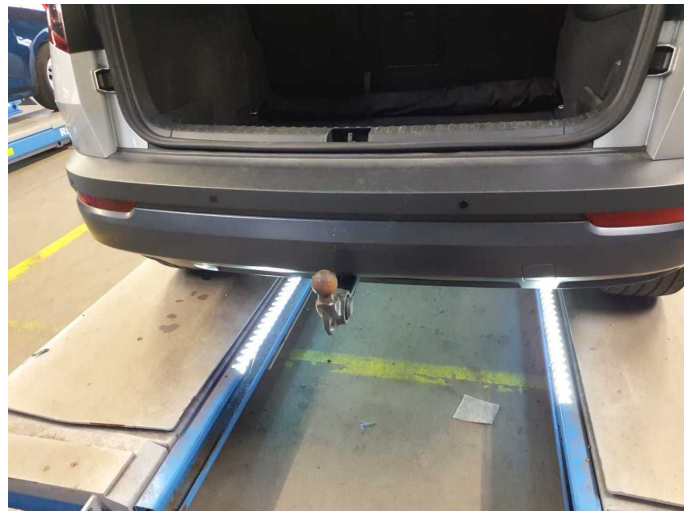
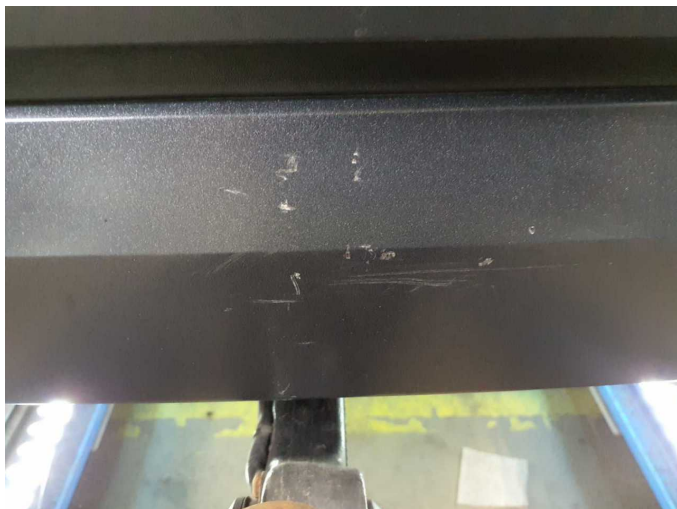
**Damage 2:** Rear bumper: Spoiler - Scratched - Loss in value

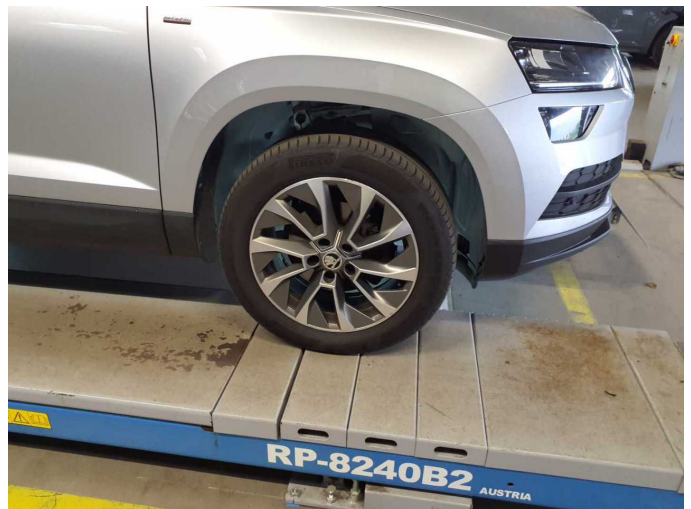
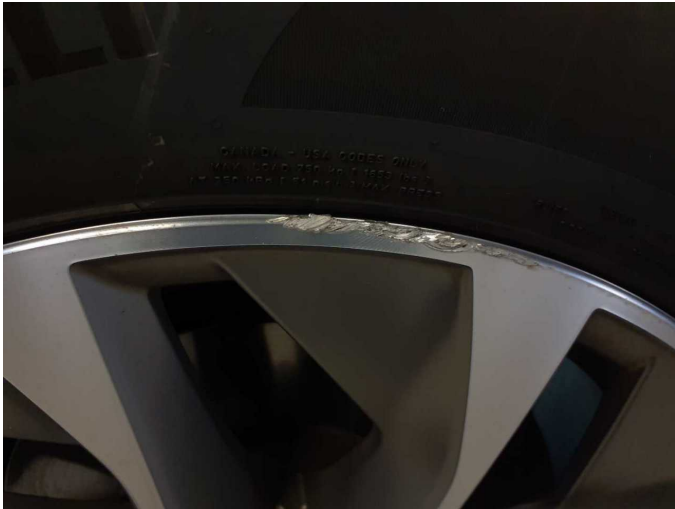
**Damage 3:** Wheel / tyres: Alloy rim - front right side (Materialabtrag) - Damaged - Replace

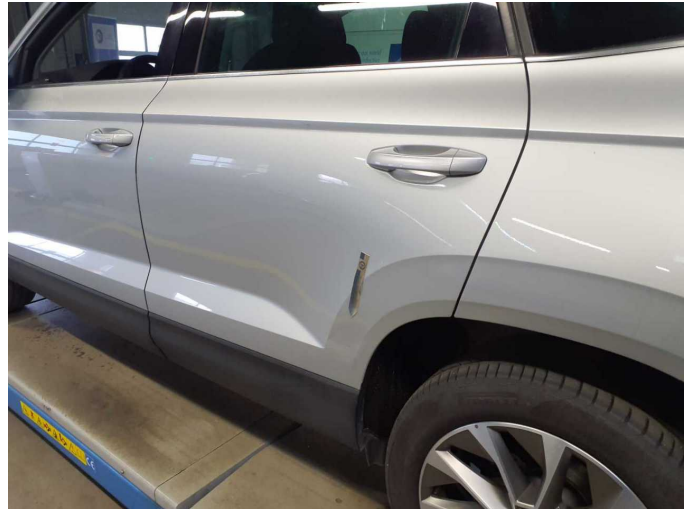
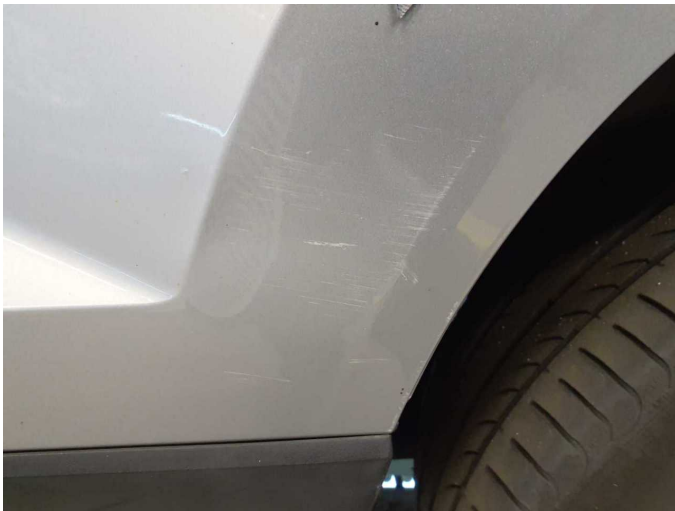
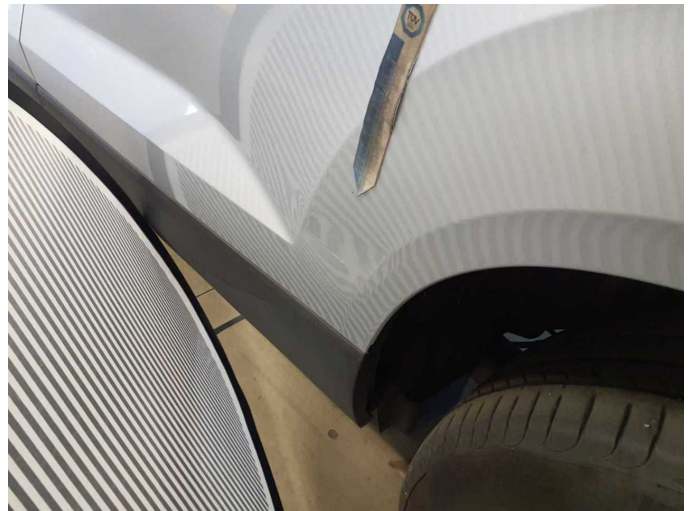
**Damage 4:** Door - rear left side: Door - Dent / paintcoat damage - Repair and paint

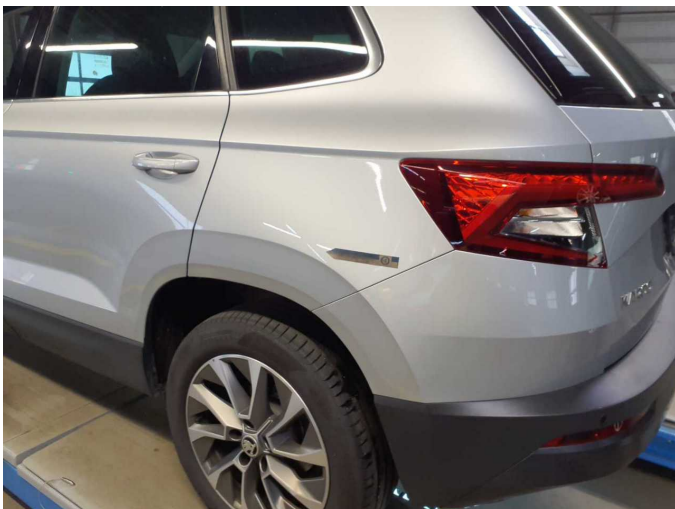
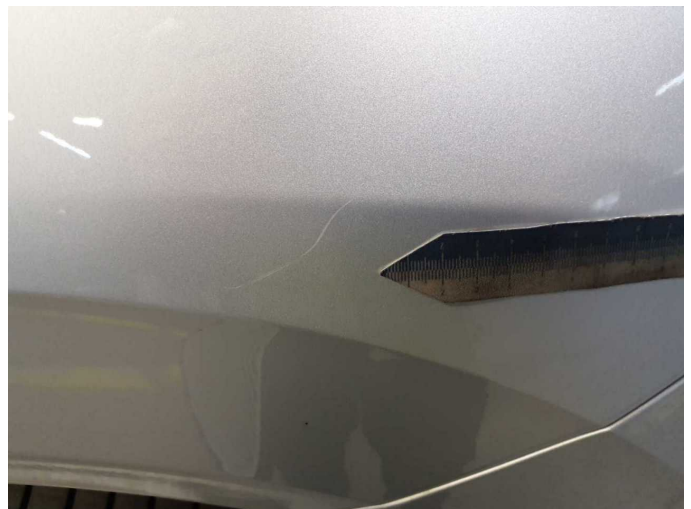
**Wear and tear 4:** Side panel - rear left side: Side panel - Scratch(es) - No deduction

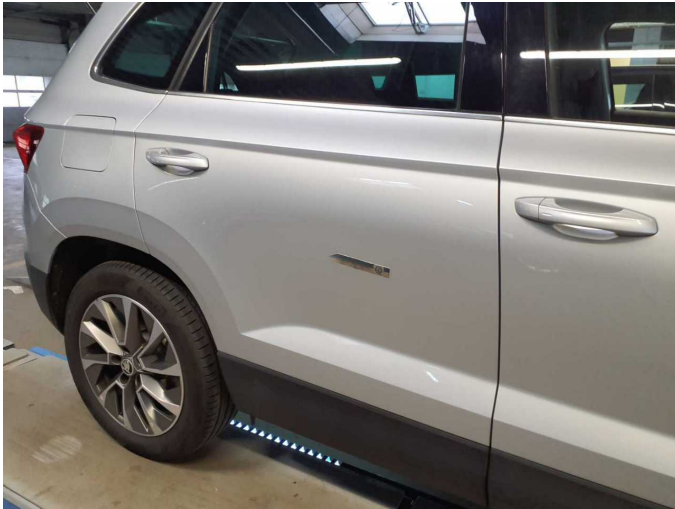
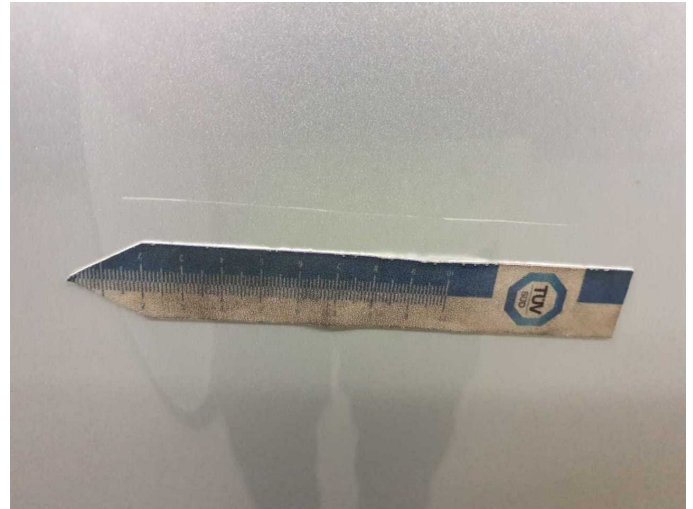
**Wear and tear 5:** Door - rear right side: Door - Scratch(es) - No deduction

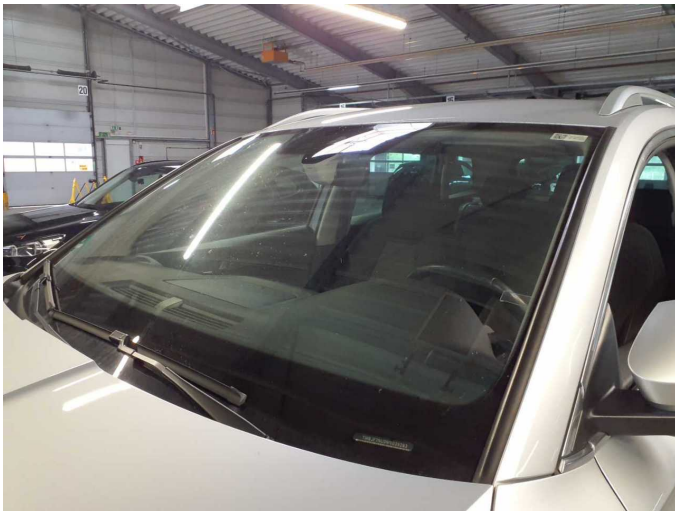
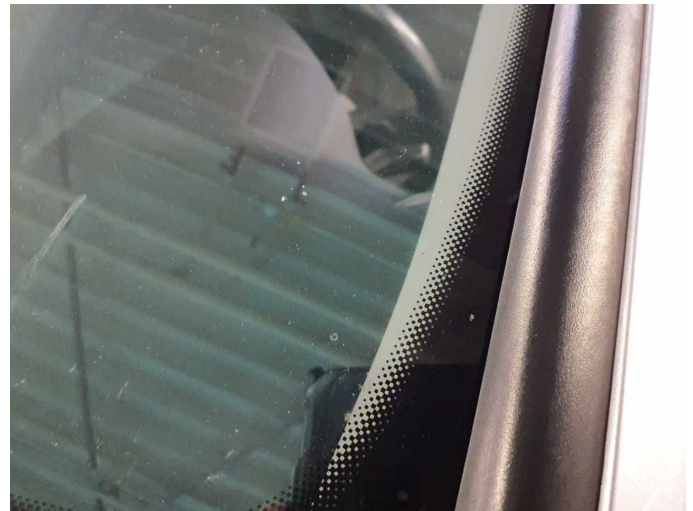
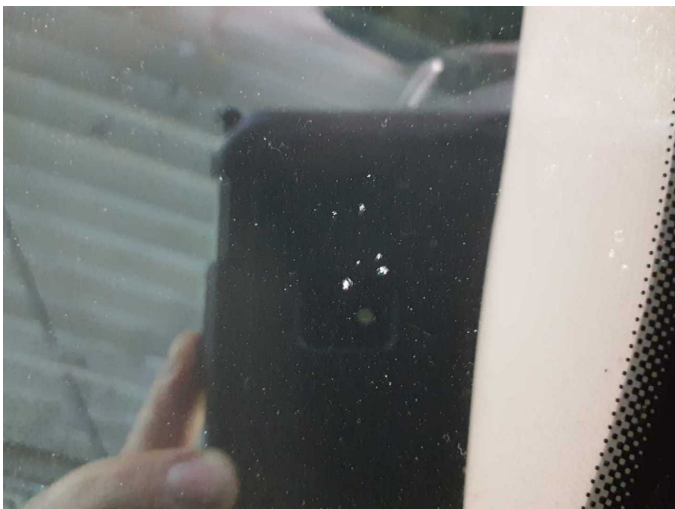
**Wear and tear 6:** Vehicle glazing: Windscreen with lane departure assistant (ohne Rissbildung) - Stone chips - No deduction
