Expertise

Protocol number: 40835372
Order No. / Reference: 24990710
Inspection date: 29 Jul 2025

Manufacturer: Skoda	Model: Karoq 2.0 TDI SCR DSG Clever
VIN: TMBJF7NU2M5050611

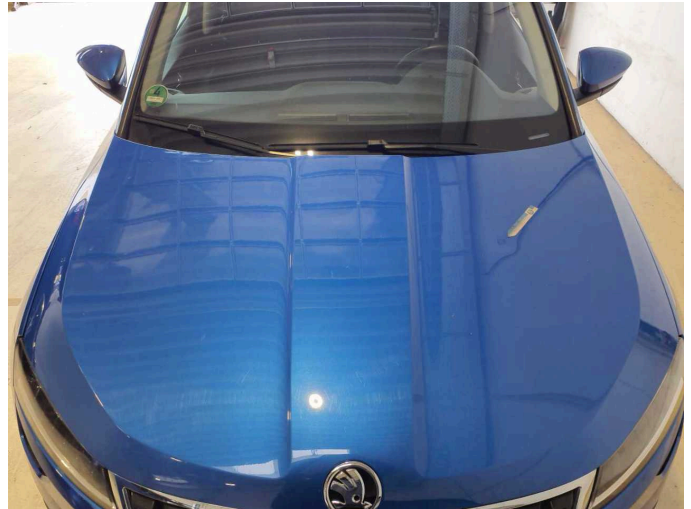
Damage 1: Bonnet: Bonnet - dent(s) - Smart repair

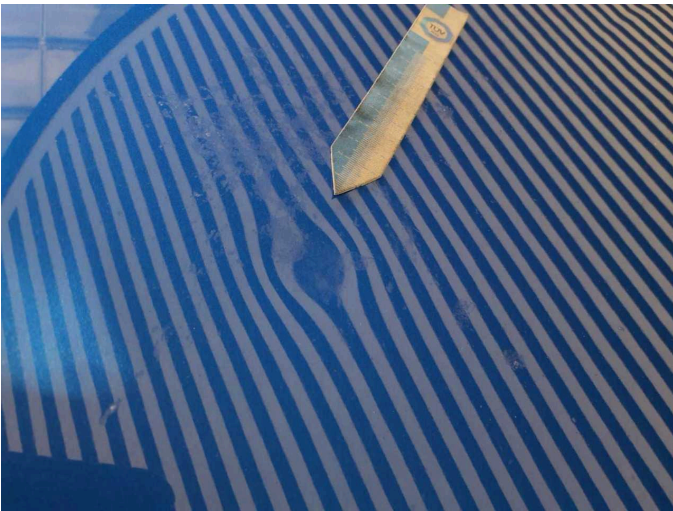
Damage 1: Bonnet: Bonnet - dent(s) - Smart repair

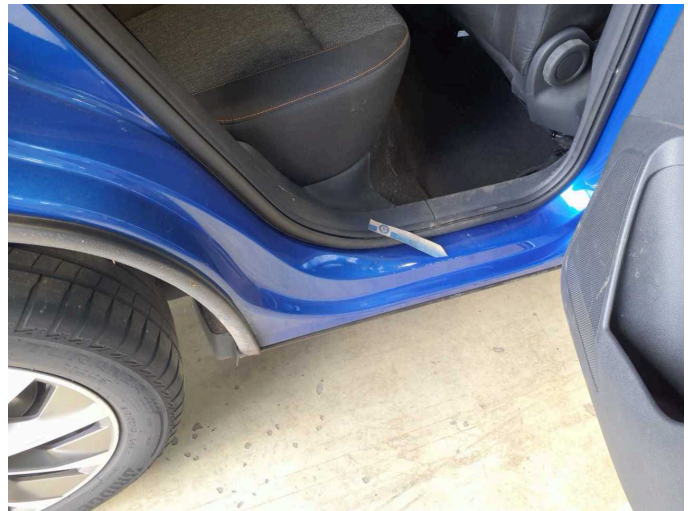
Damage 2: Side panel - rear right side: Sill - Scratch(es) - Smart repair

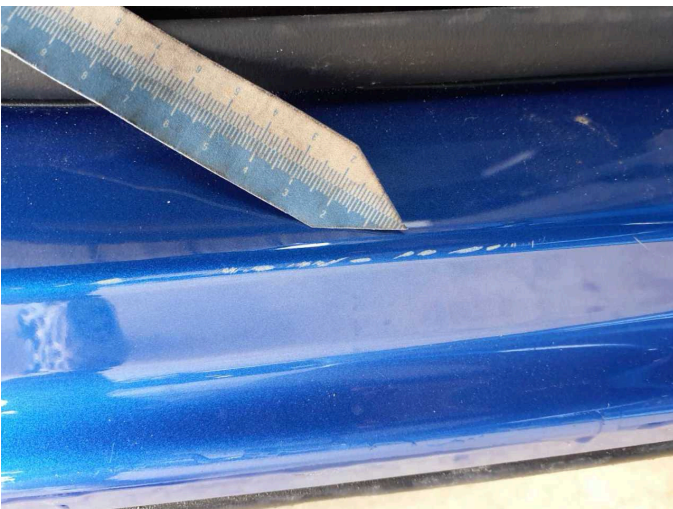
Damage 2: Side panel - rear right side: Sill - Scratch(es) - Smart repair

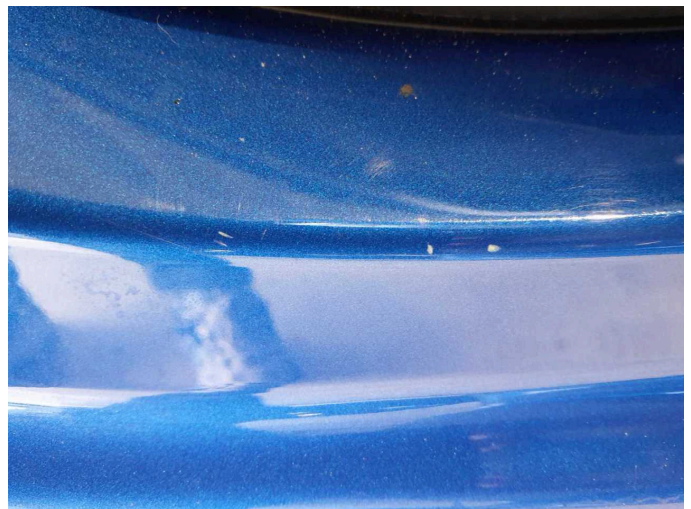
Damage 2: Side panel - rear right side: Sill - Scratch(es) - Smart repair

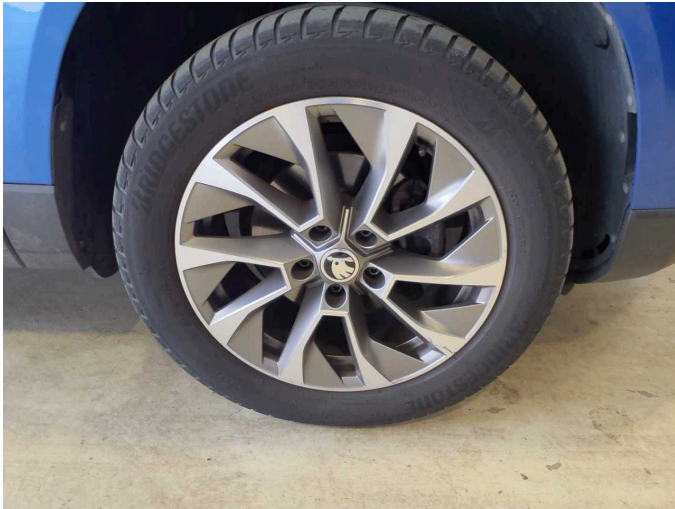
Damage 3: Wheel / tyres: Alloy rim - front right side - Scratch(es) - Loss in value

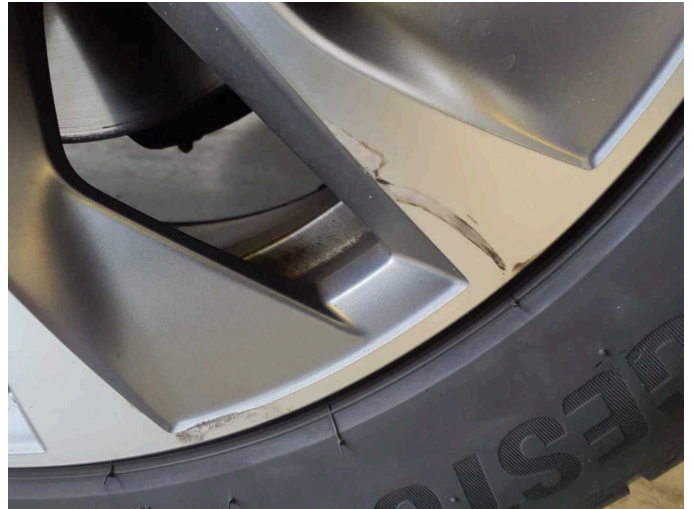
Damage 3: Wheel / tyres: Alloy rim - front right side - Scratch(es) - Loss in value

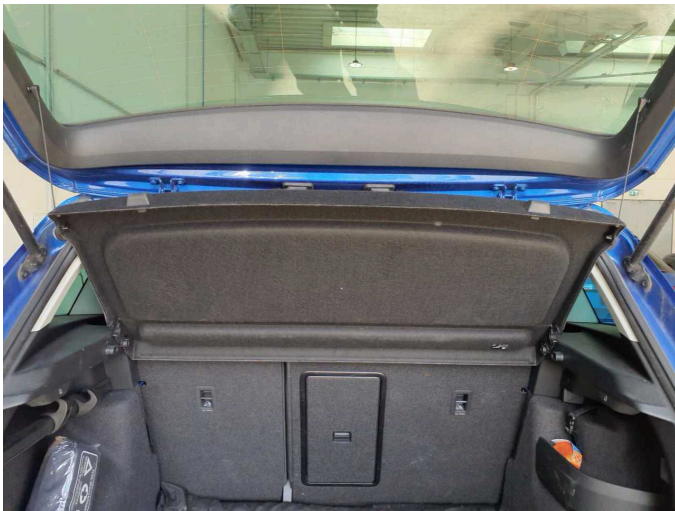
Damage 4: Interior: Boot cover / roller cover - Damaged - Replace

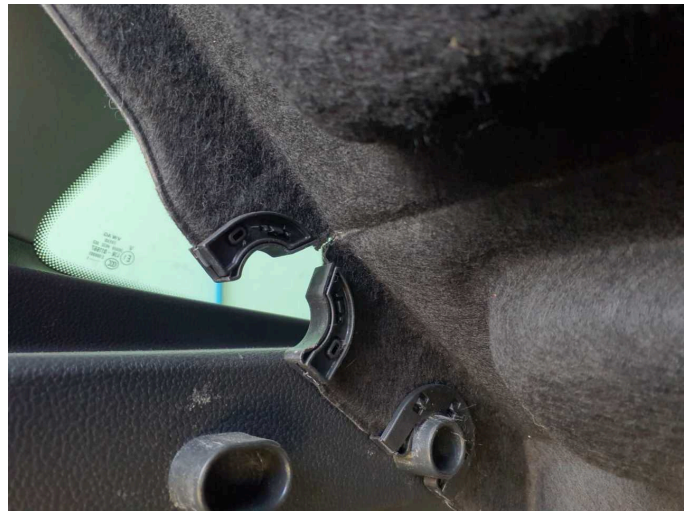
Damage 4: Interior: Boot cover / roller cover - Damaged - Replace

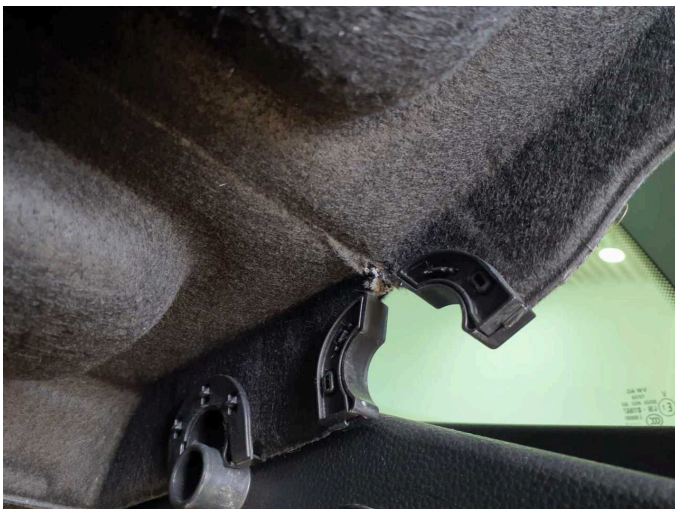
Damage 4: Interior: Boot cover / roller cover - Damaged - Replace

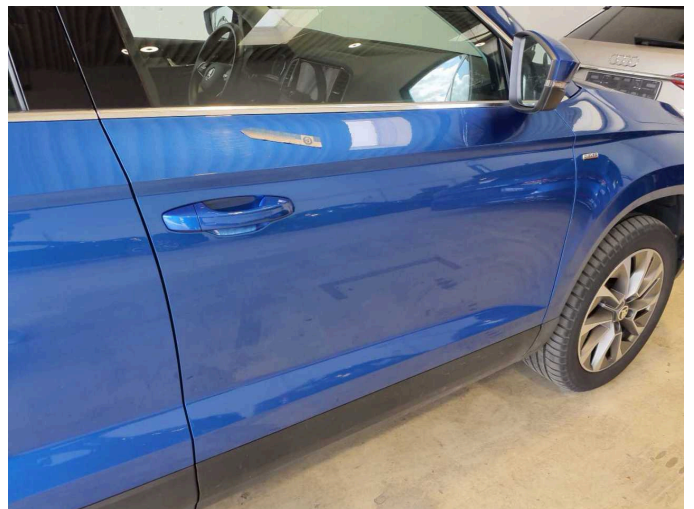
Damage 5: Door - front right side: Door - Scratch(es) - Paint

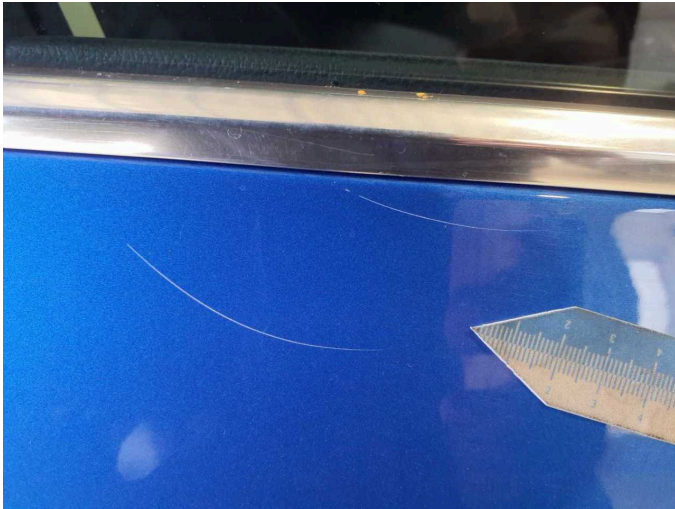
Damage 5: Door - front right side: Door - Scratch(es) - Paint

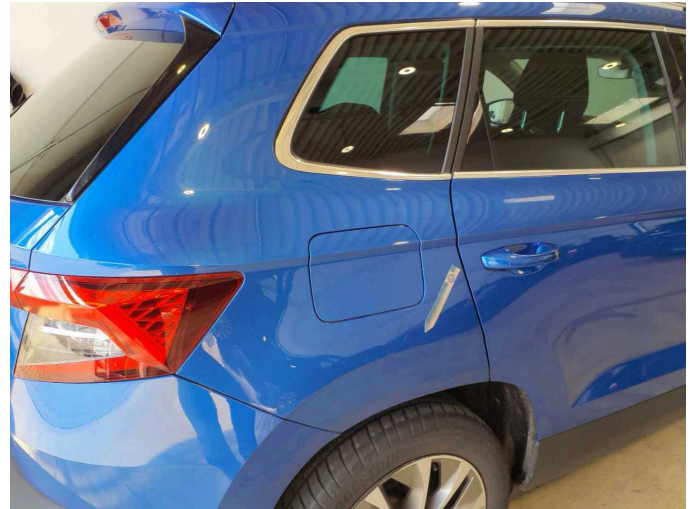
Damage 6: Side panel - rear right side: Side panel - Dent / paintcoat damage - Repair and paint

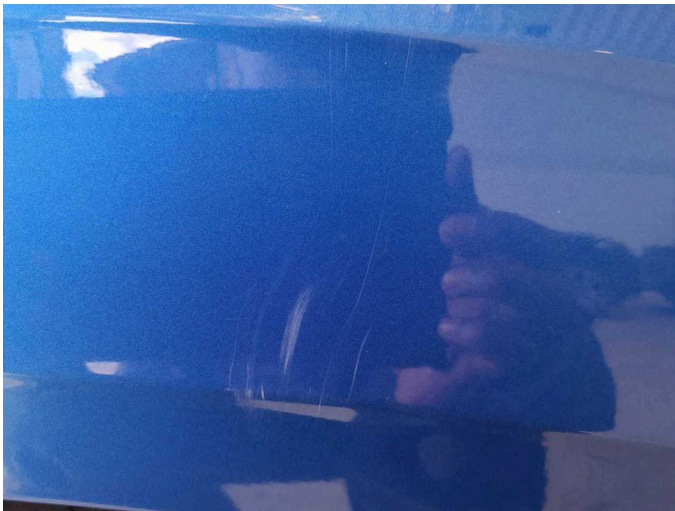
Damage 6: Side panel - rear right side: Side panel - Dent / paintcoat damage - Repair and paint

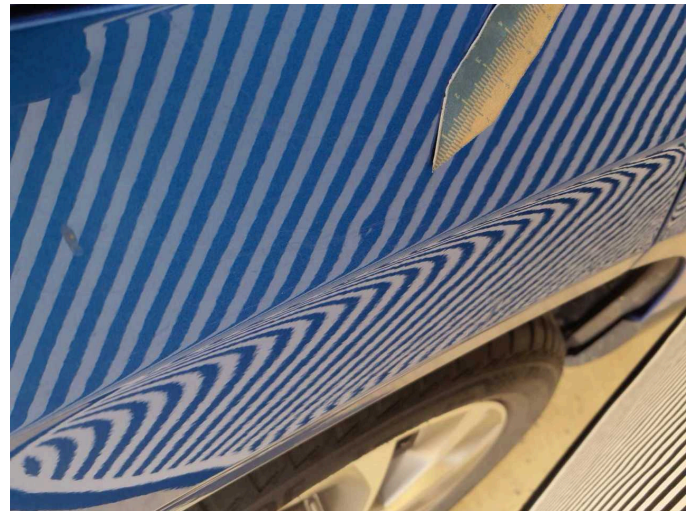
Damage 6: Side panel - rear right side: Side panel - Dent / paintcoat damage - Repair and paint

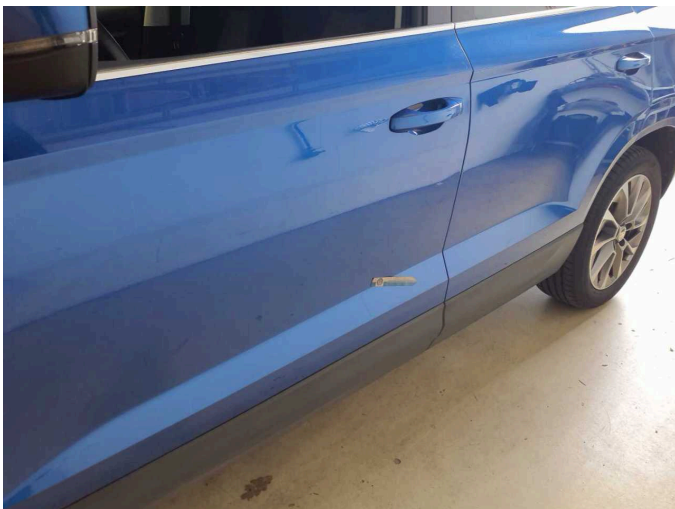
Wear and tear 1: Door - front left side: Door - dent(s) - No deduction

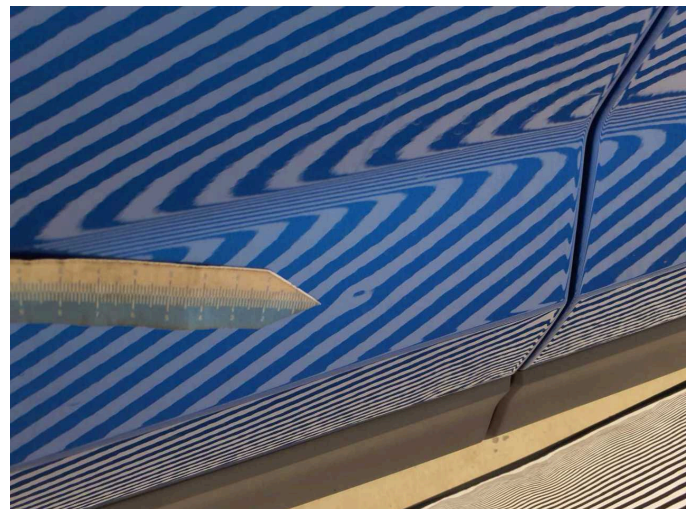
Wear and tear 1: Door - front left side: Door - dent(s) - No deduction

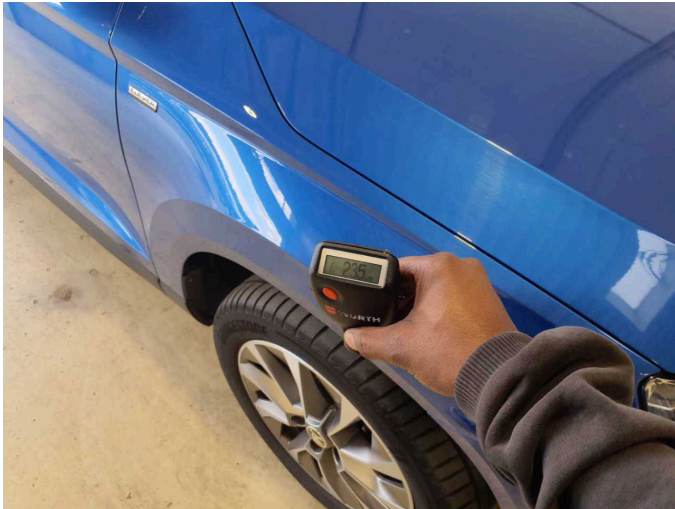
Repainting 1: Mudguard - right side

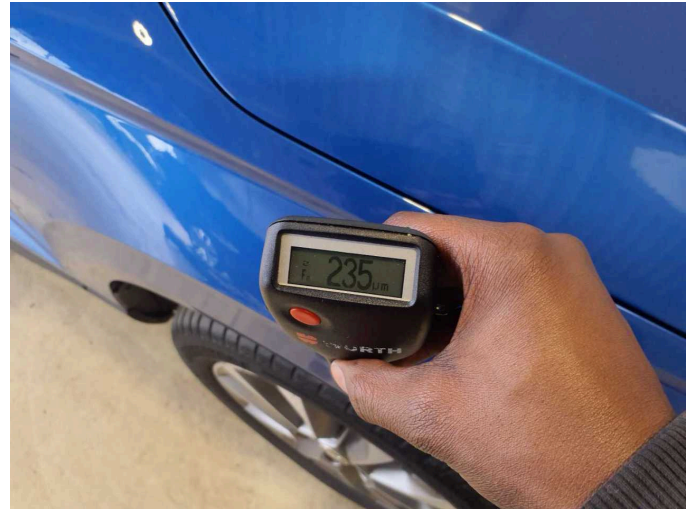
Repainting 1: Mudguard - right side

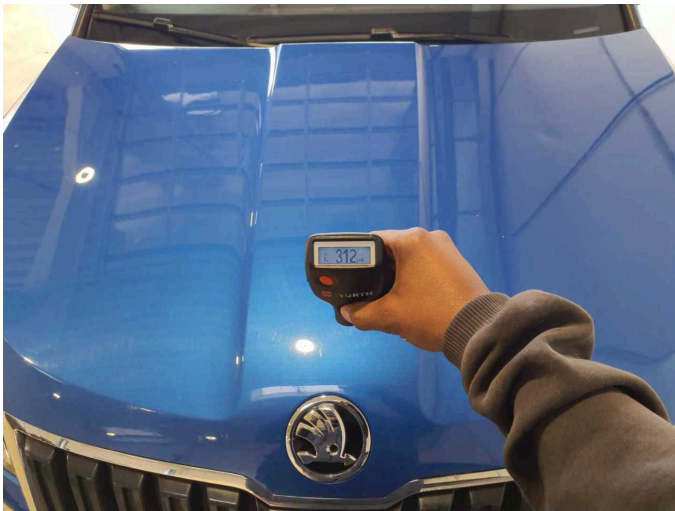
Repainting 2: Bonnet

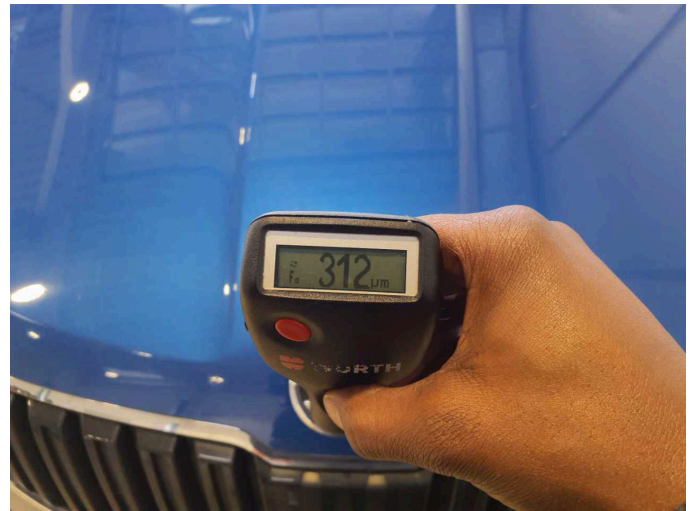
Repainting 2: Bonnet

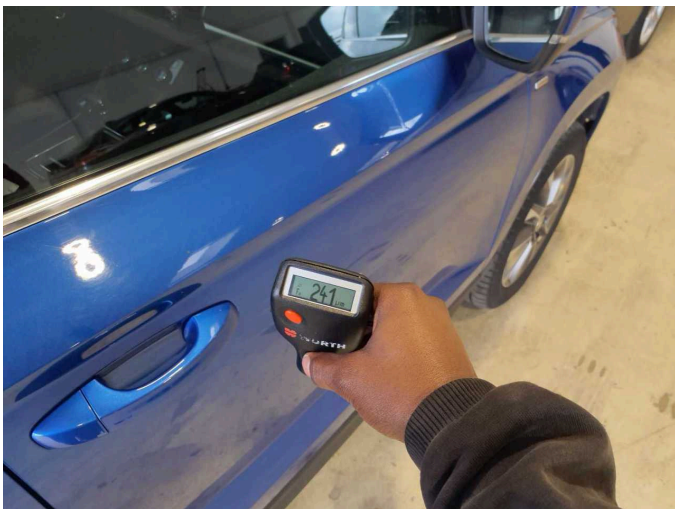
Repainting 3: Door - front right side

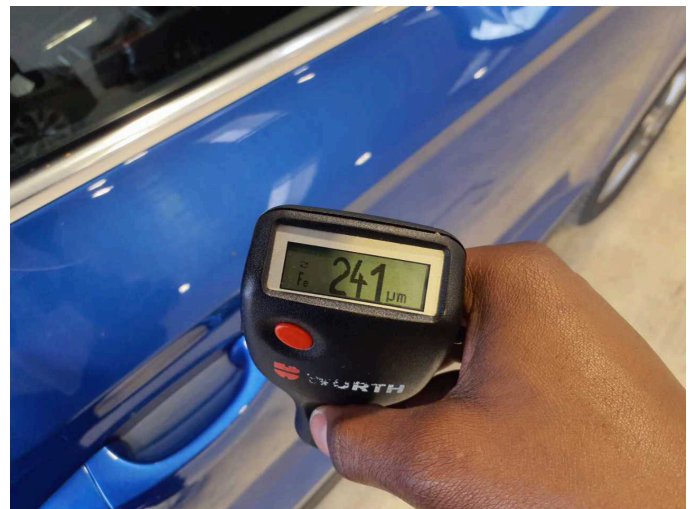
Repainting 3: Door - front right side
