Expertise

Protocol number: 41338547  
Order No. / Reference: 25104946  
Inspection date: 1 Sept 2025

Manufacturer: Skoda  
VIN: TMBJF7NUXMC205238

Model: Karoq Style 2,0TDI 85kW 7-Gang automat

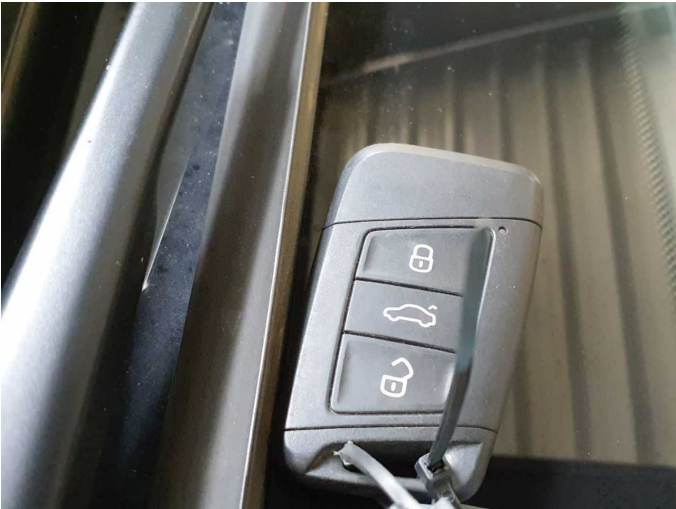
Damage 1: Equipment: Vehicle key - Non-operational - Perform diagnosis

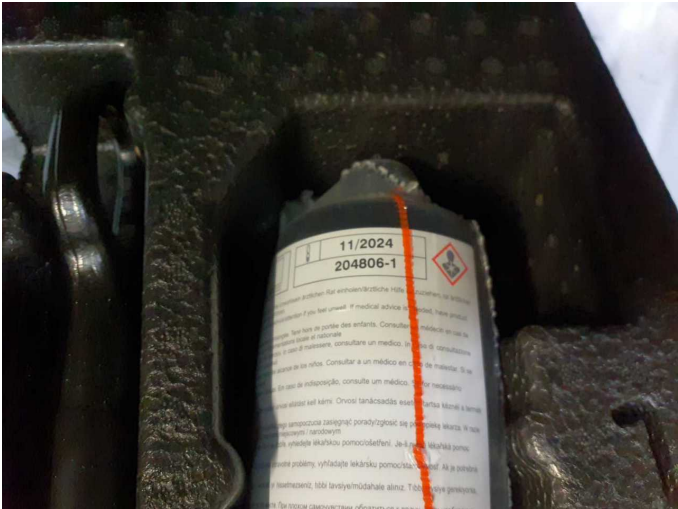
Damage 2: Equipment: Tirefit filler - Expired - Replace

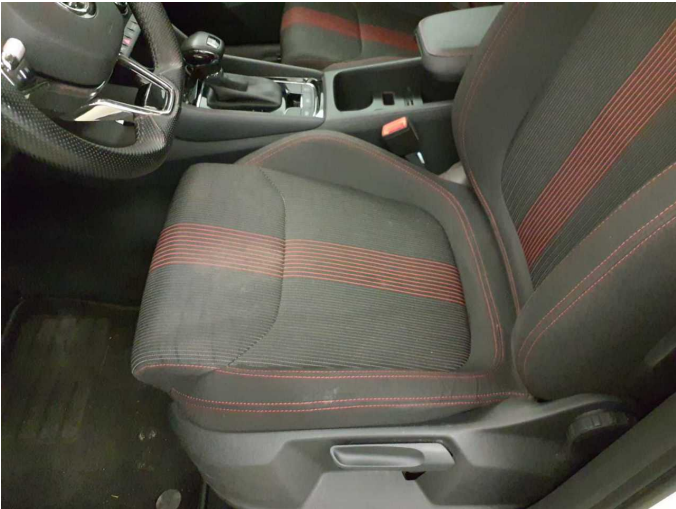
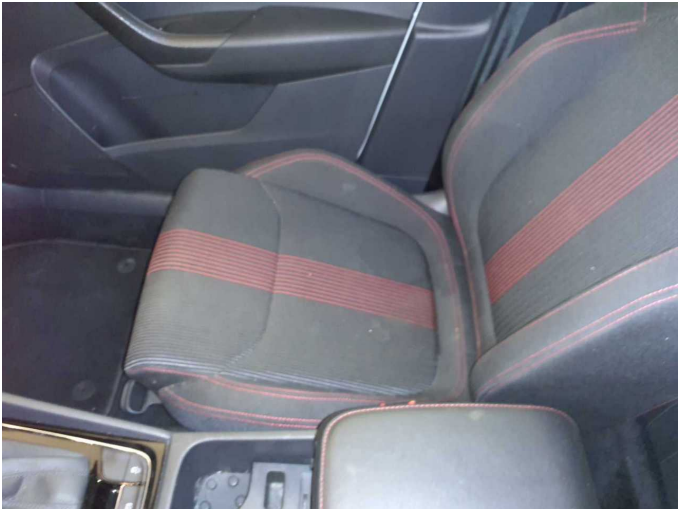
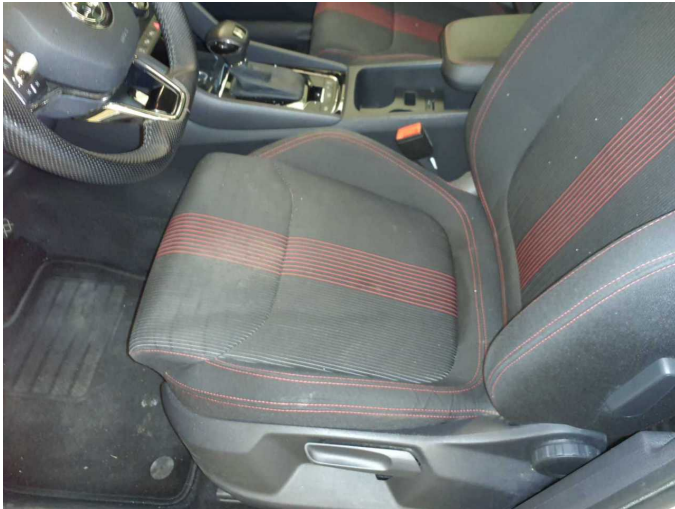
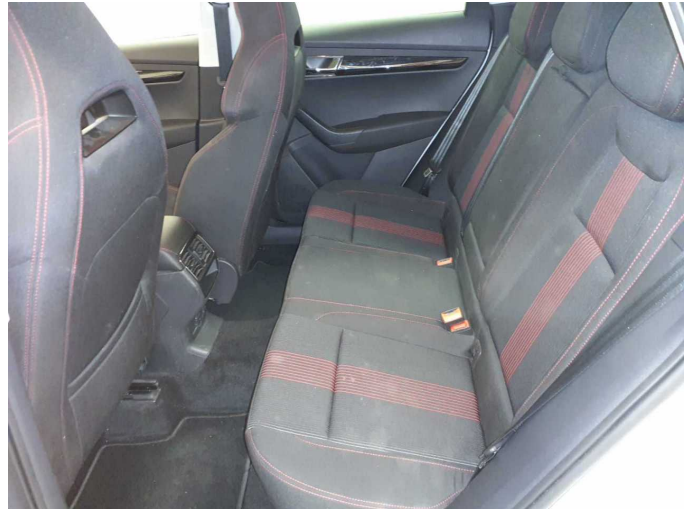
Damage 3: Interior: Interior - Soiled - Clean

**Damage 3:** Interior: Interior - Soiled - Clean

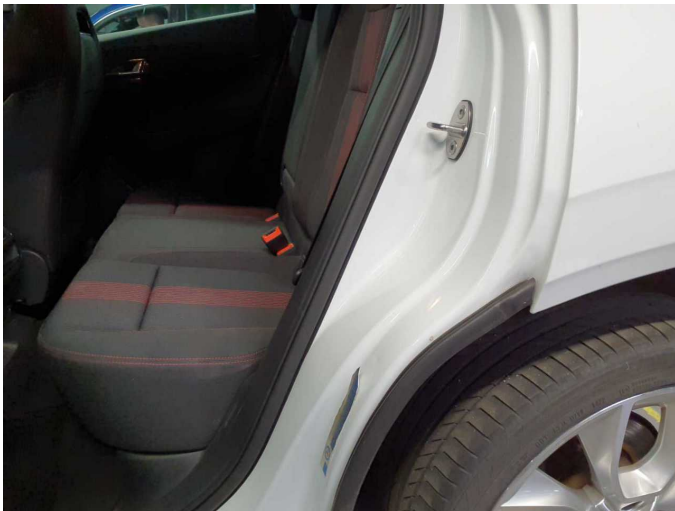
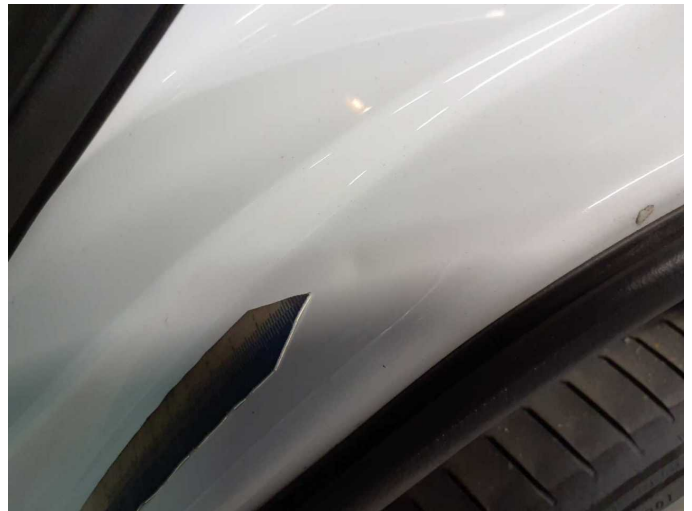
**Damage 4:** Side panel - rear left side: Sill - Dent / paintcoat damage - Smart repair

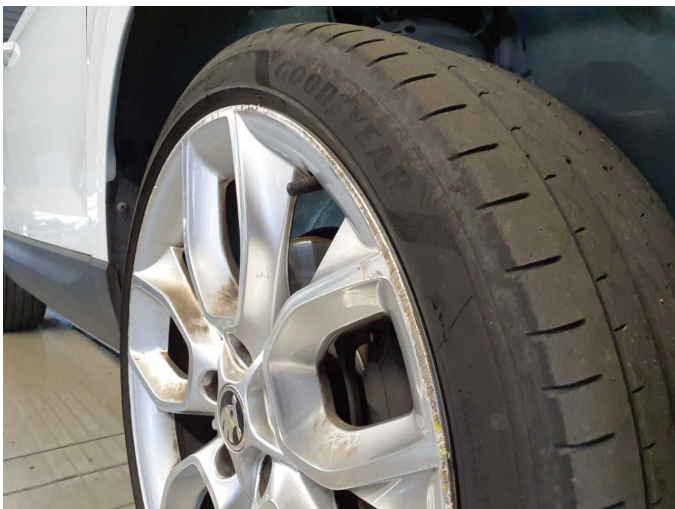
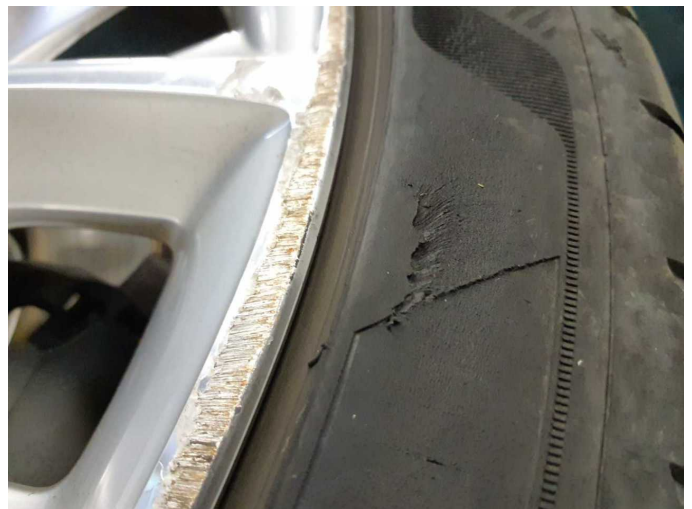
**Damage 5:** Wheel / tyres: Tyre - front right side - Porous / cracked - Replace

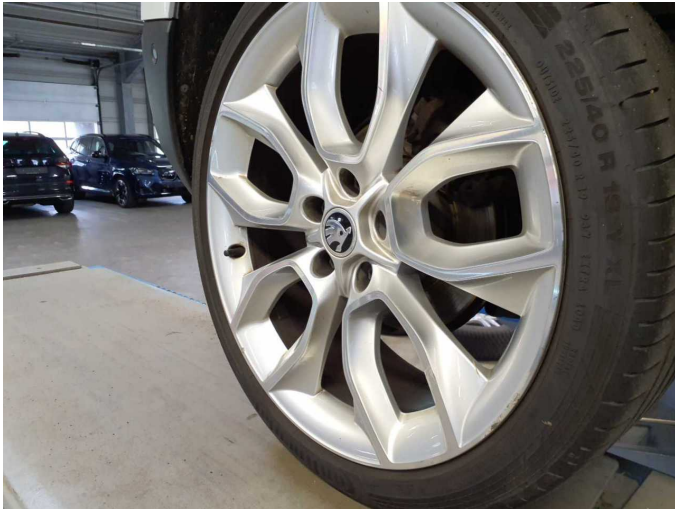
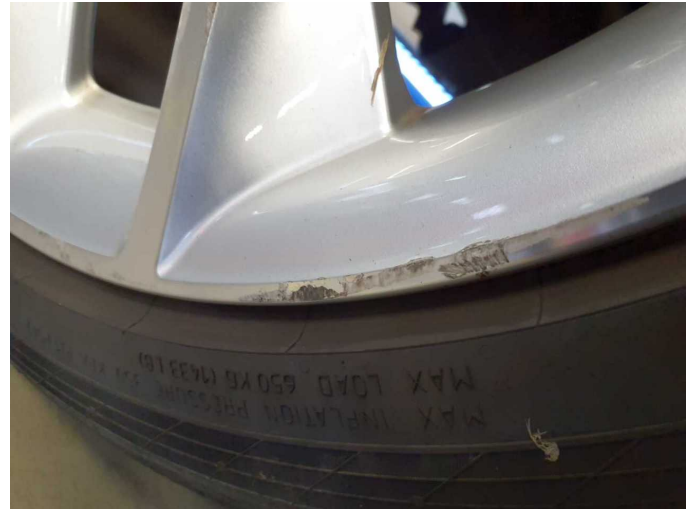
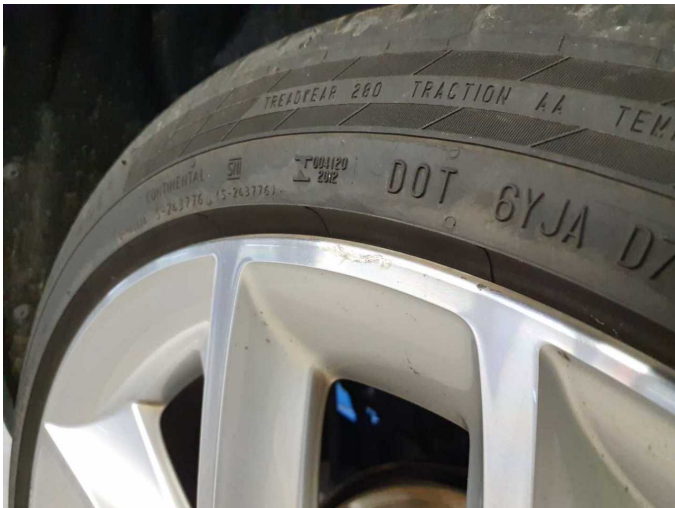
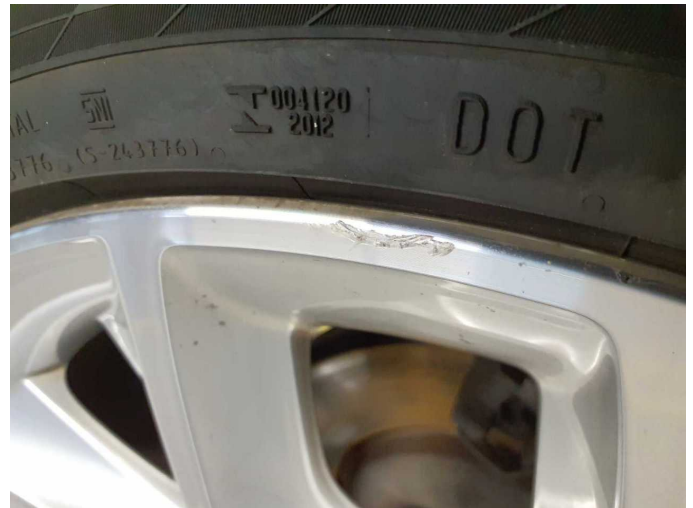
**Damage 6:** Wheel / tyres: Alloy rim - rear right side - Scratched - Loss in value

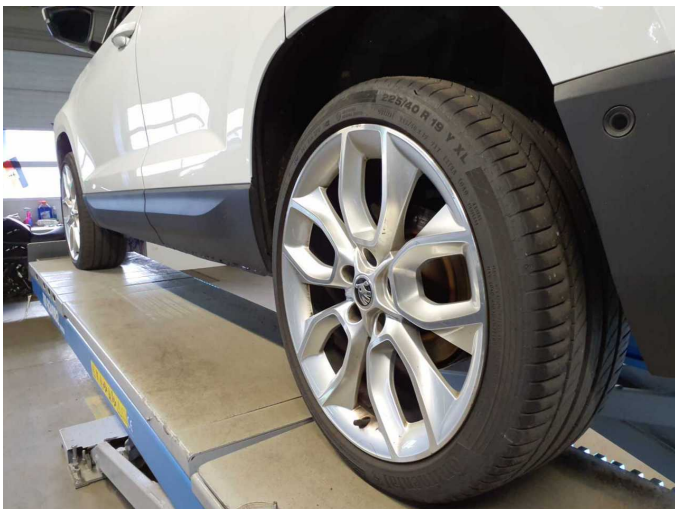
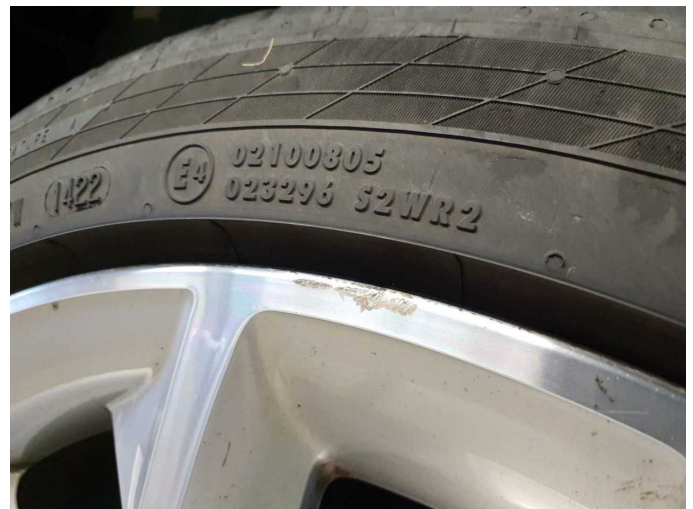
**Damage 7:** Wheel / tyres: Alloy rim - rear left side - Scratched - Loss in value

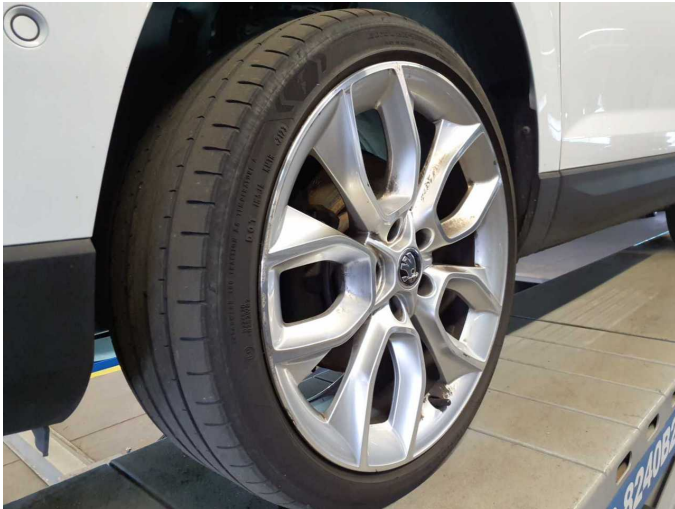
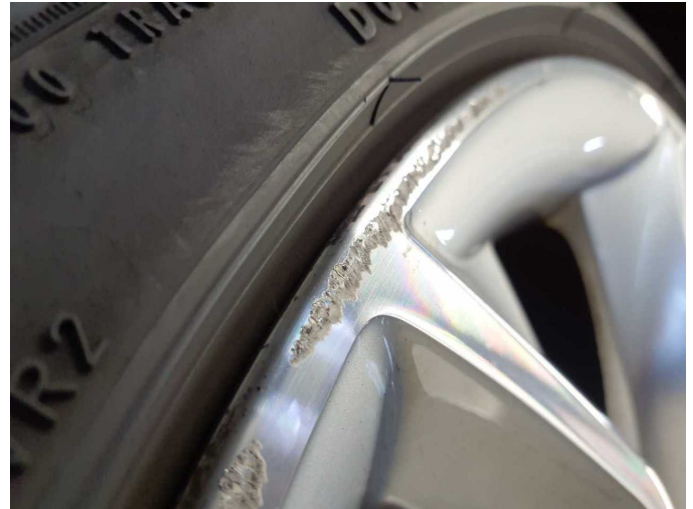
**Damage 8:** Wheel / tyres: Alloy rim - front left side (Materialabtrag) - Damaged - Loss in value

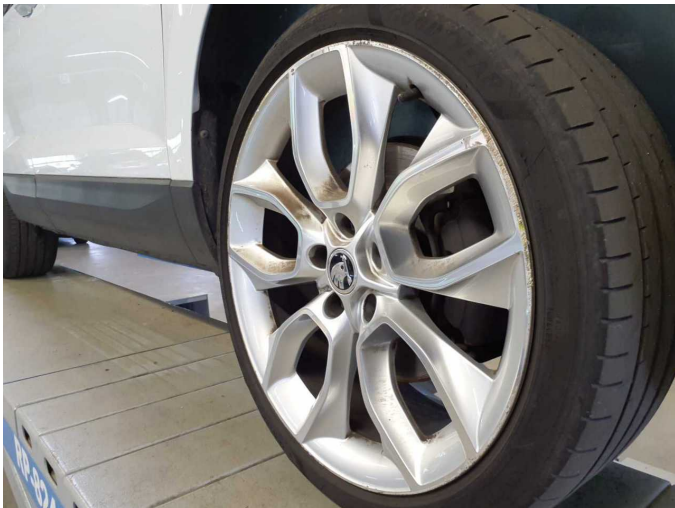
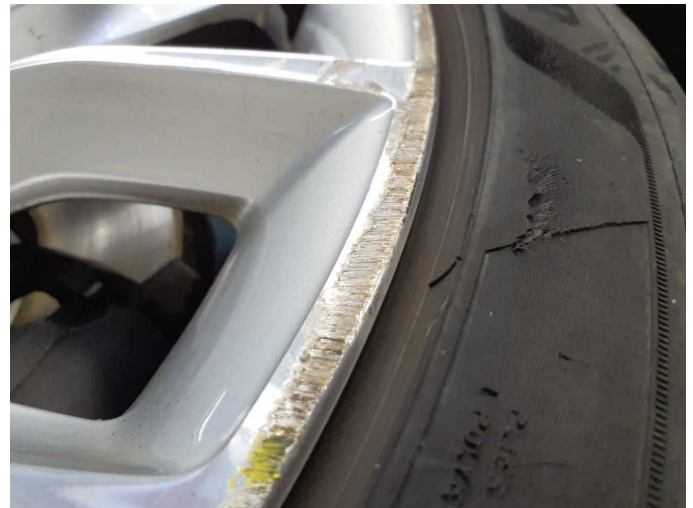
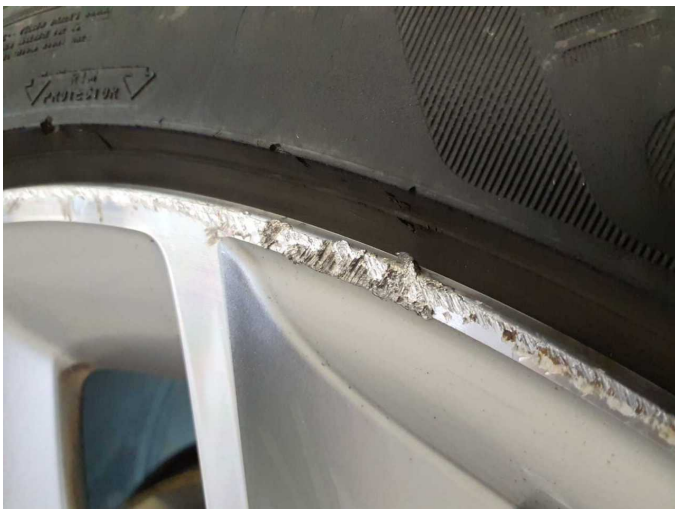
**Damage 9:** Wheel / tyres: Alloy rim - front right side (Materialabtrag) - Damaged - Loss in value

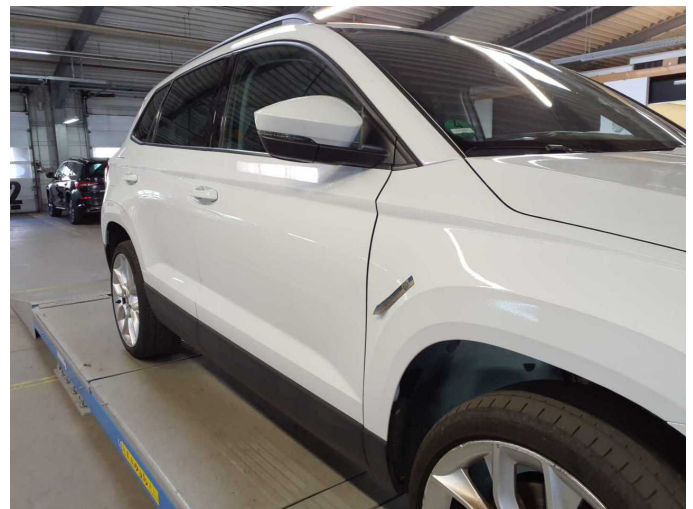
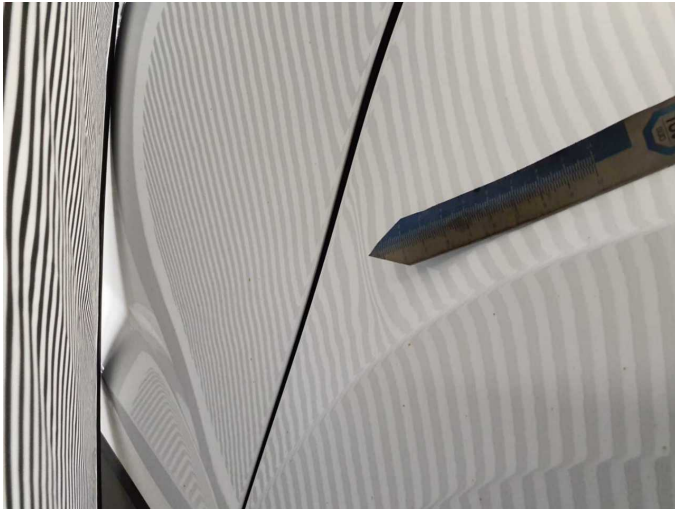
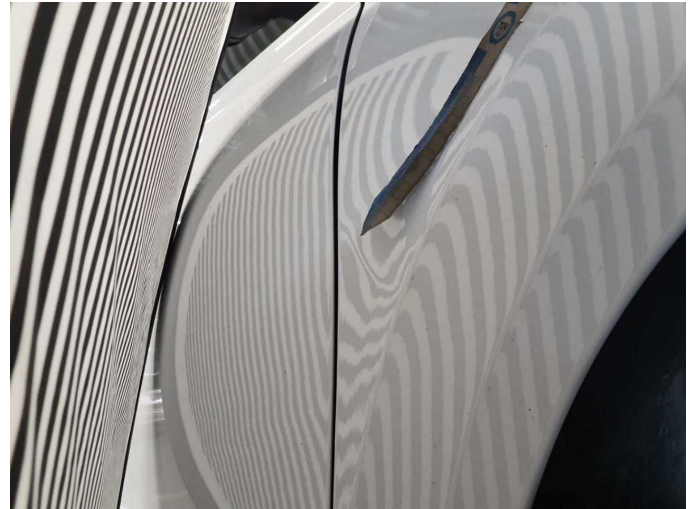
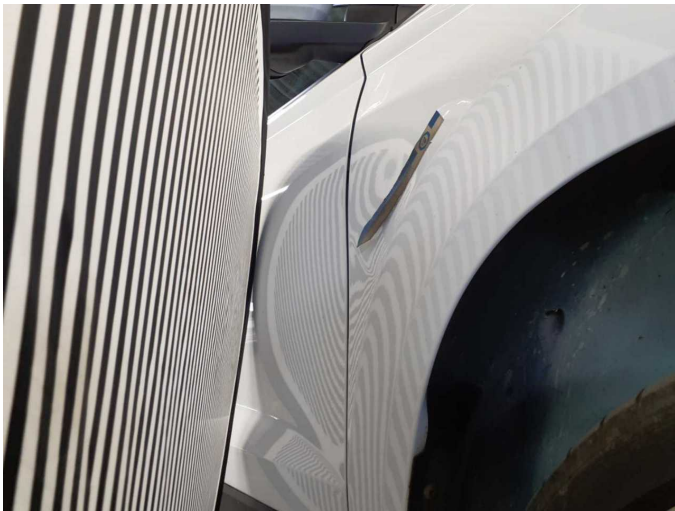
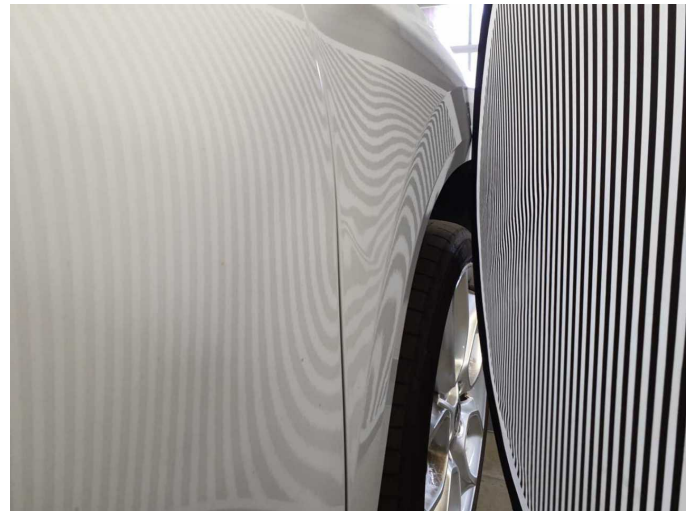
**Damage 10:** Mudguard - right side: Mudguard - right side - Deformed - Replace

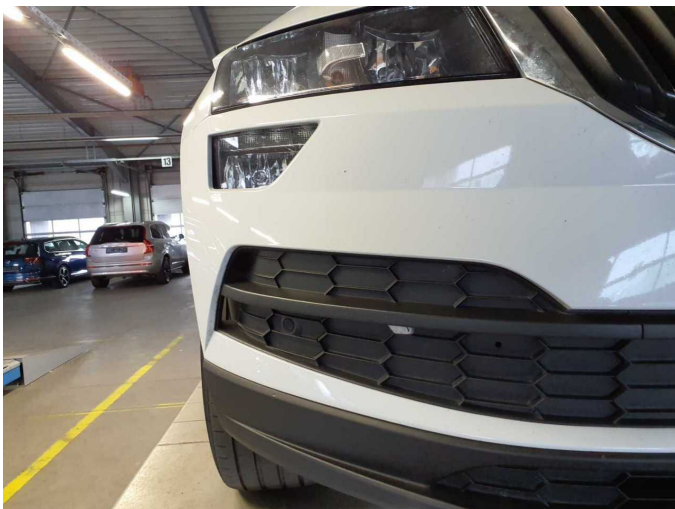
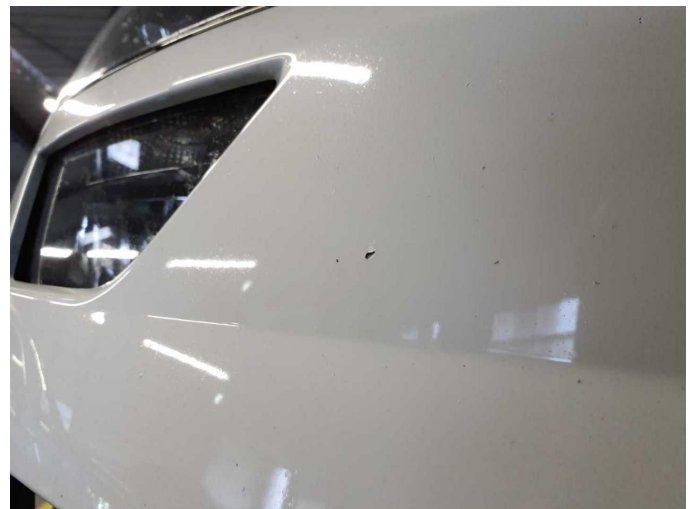
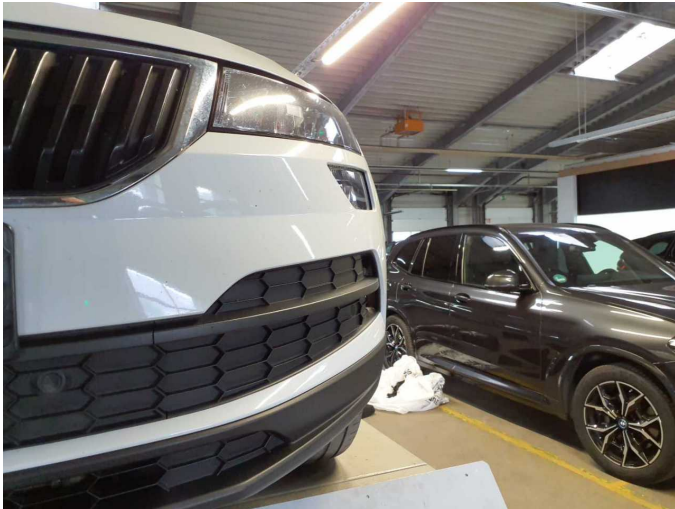
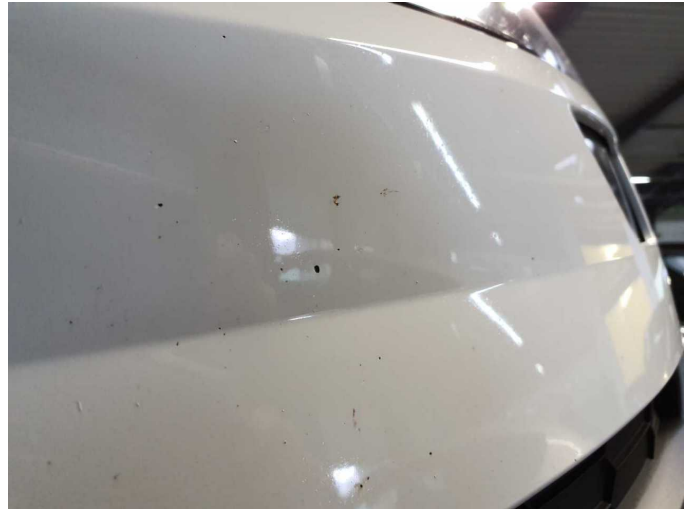
**Wear and tear 2:** Front bumper: Front bumper (Kratzer) - Stone chips - No deduction

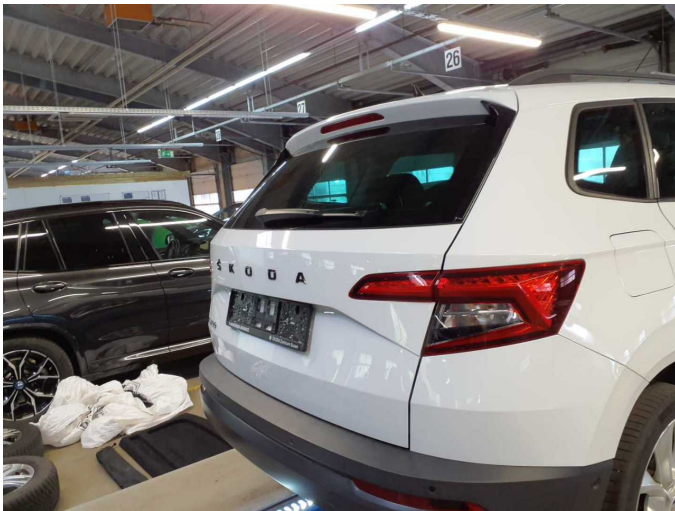
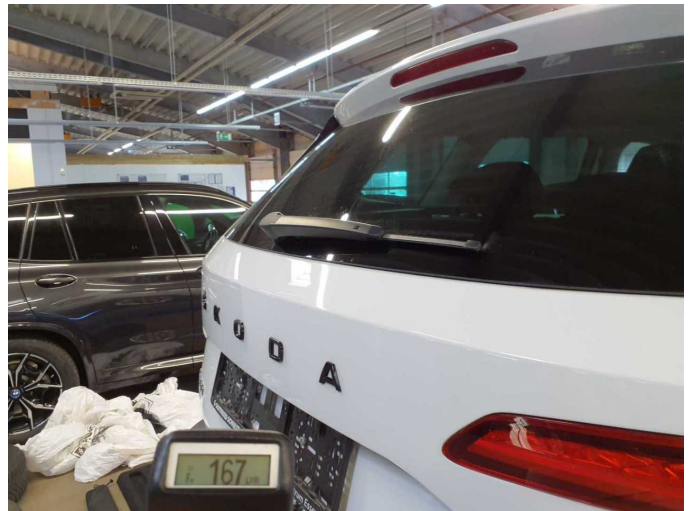
No.	Repainting
1	Boot lid / rear door, Professionally carried out, Invoice of repair done Non-existent
2	Side panel - rear left side, Professionally carried out, Invoice of repair done Non-existent

Boot lid / rear door	167 µm	Side panel - rear left side	161 µm
----------------------	--------	-----------------------------	--------

**Repainting 1:** Boot lid / rear door

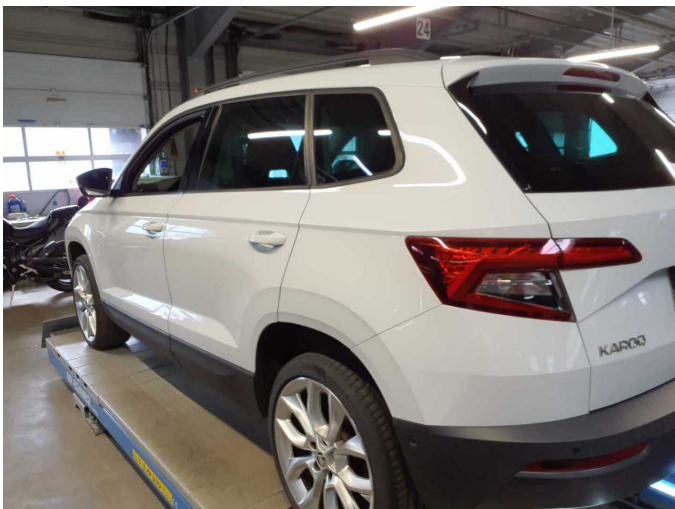
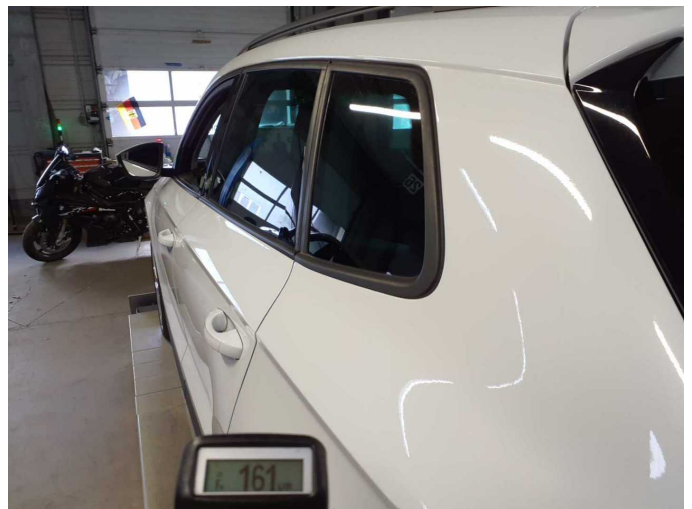
**Repainting 2:** Side panel - rear left side
