Expertise

Protocol number: 41001144
Order No. / Reference: 24998325
Inspection date: 5 Aug 2025

Manufacturer: Skoda Model: Superb Combi 2.0 TDI DSG Ambition

VIN: TMBJH7NP0N7021103

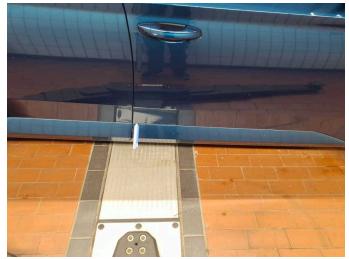
| No. | Component group | Description |
|---|---|---|
| 1 | Door - front right side | Brightware - lower - Scratch(es) - Smart repair |

Damage 1: Door - front right side: Brightware - lower - Scratch(es) - Smart repair

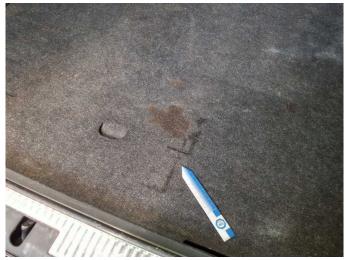
| No. | Component group | Description |
|---|---|---|
| 2 | Interior | Cargo area floor - Soiled - Clean |

Damage 2: Interior: Cargo area floor - Soiled - Clean

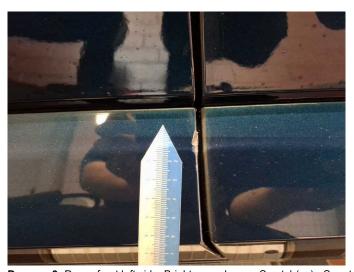
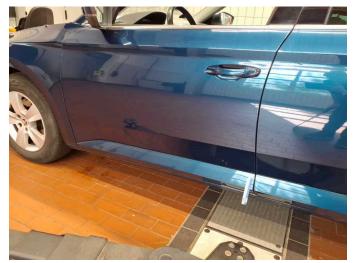
| No. | Component group | Description |
|---|---|---|
| 3 | Door - front left side | Brightware - lower - Scratch(es) - Smart repair |

Damage 3: Door - front left side: Brightware - lower - Scratch(es) - Smart repair

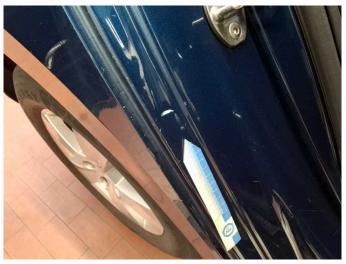
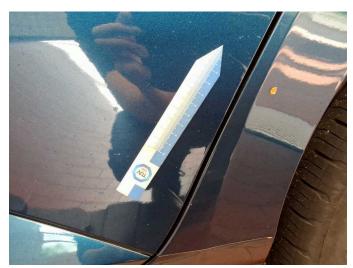
| No. | Component group | Description |
|---|---|---|
| 6 | Side panel - rear right side | Sill - Scratch(es) - Smart repair |

Damage 6: Side panel - rear right side: Sill - Scratch(es) - Smart repair

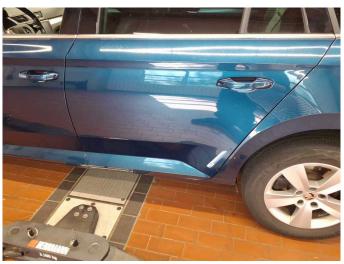
| No. | Component group | Description |
|---|---|---|
| 7 | Door - rear left side | Door - Scratch(es) - Smart repair |

Damage 7: Door - rear left side: Door - Scratch(es) - Smart repair

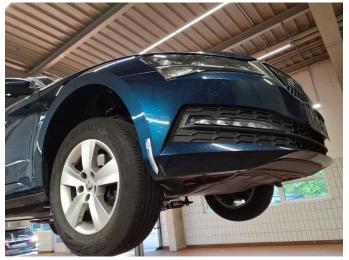
| No. | Component group | Description |
|---|---|---|
| 8 | Front bumper | Front bumper (unterhalb) - Scratched - Smart repair |

Damage 8: Front bumper: Front bumper (unterhalb) - Scratched - Smart repair

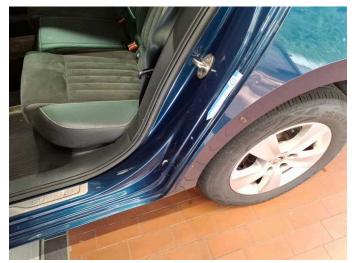
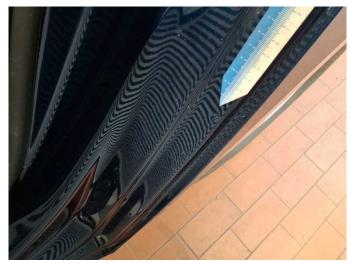
| No. | Component group | Description |
|---|---|---|
| 9 | Side panel - rear left side | Sill - Dent / paintcoat damage - Smart repair |

Damage 9: Side panel - rear left side: Sill - Dent / paintcoat damage - Smart repair

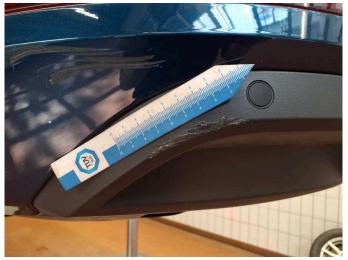
| No. | Component group | Description |
|---|---|---|
| 10 | Rear bumper | Spoiler - Scratched - Replace |

Damage 10: Rear bumper: Spoiler - Scratched - Replace

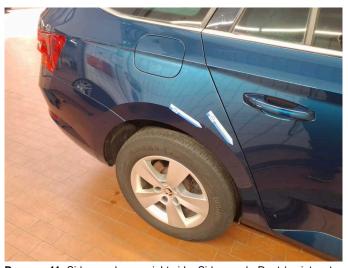
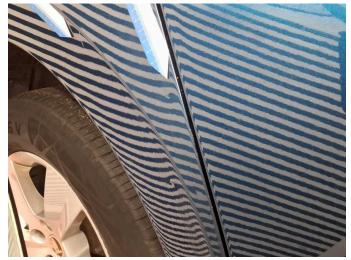
| No. | Component group | Description |
|---|---|---|
| 11 | Side panel - rear right side | Side panel - Dent / paintcoat damage - Repair and paint |

Damage 11: Side panel - rear right side: Side panel - Dent / paintcoat damage - Repair and paint

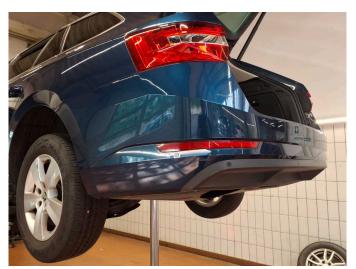
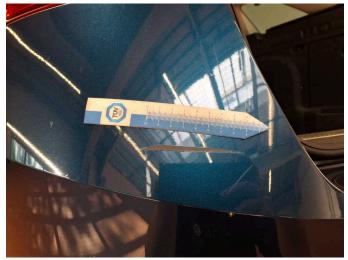
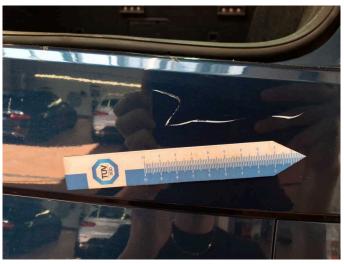
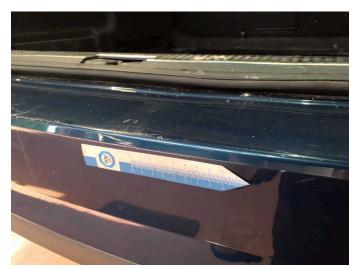
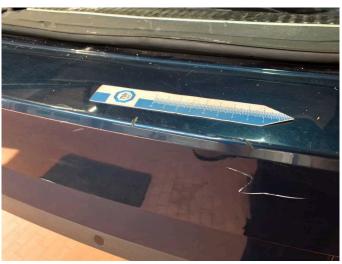
| No. | Component group | Description |
|---|---|---|
| 12 | Rear bumper | Rear bumper - Scratched - Paint |

Damage 12: Rear bumper: Rear bumper - Scratched - Paint

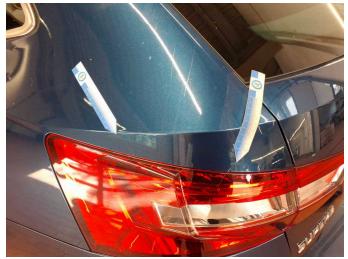
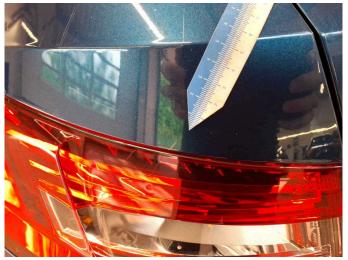
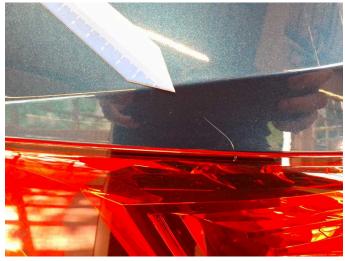
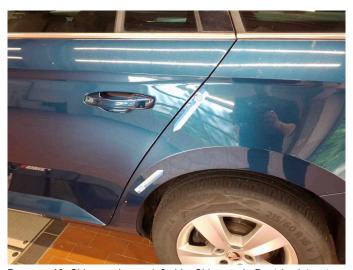
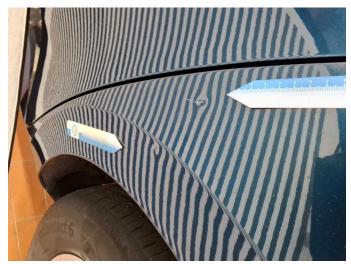
| No. | Component group | Description |
|---|---|---|
| 13 | Side panel - rear left side | Side panel - Dent / paintcoat damage - Repair and paint |

Damage 13: Side panel - rear left side: Side panel - Dent / paintcoat damage - Repair and paint

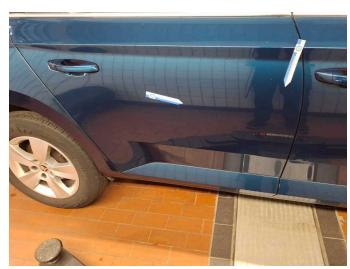
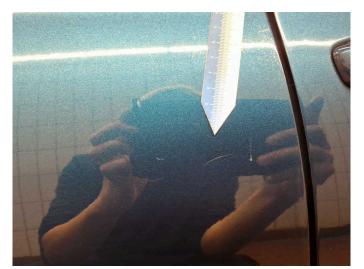
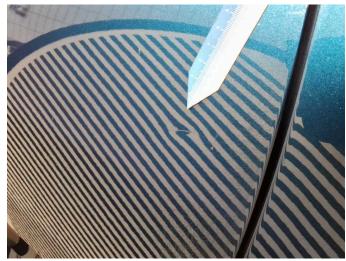
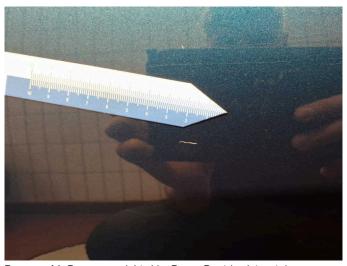
| No. | Component group | Description |
|---|---|---|
| 14 | Door - rear right side | Door - Dent / paintcoat damage - Paint |

Damage 14: Door - rear right side: Door - Dent / paintcoat damage - Paint

Damage 14: Door - rear right side: Door - Dent / paintcoat damage -

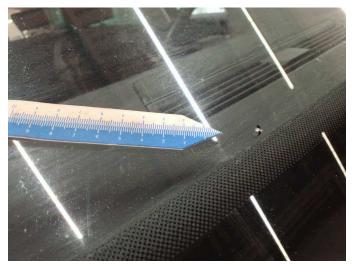
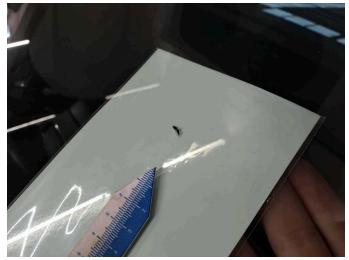
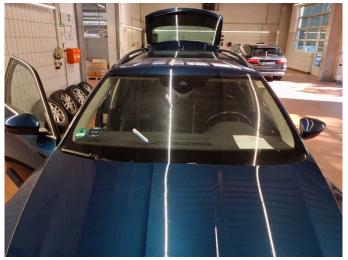
| No. | Component group | Description |
|---|---|---|
| 15 | Vehicle glazing | Windscreen - Stone chips - Replace |

Damage 15: Vehicle glazing: Windscreen - Stone chips - Replace
