Expertise

Protocol number: 41553571
Order No. / Reference: 25113544
Inspection date: 15 Sept 2025

Manufacturer: Skoda
VIN: TMBJH7NP4P7062689

Model: Superb Combi 2.0 TDI DSG Style

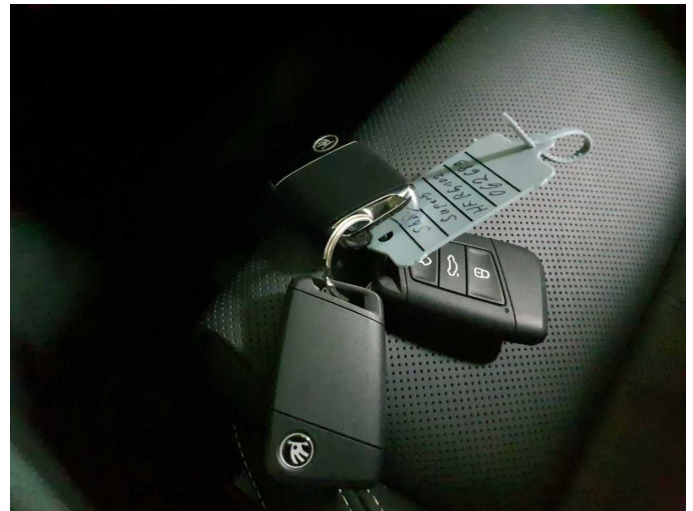
Damage 1: Equipment: Vehicle key (Batterie) - Empty - Replace

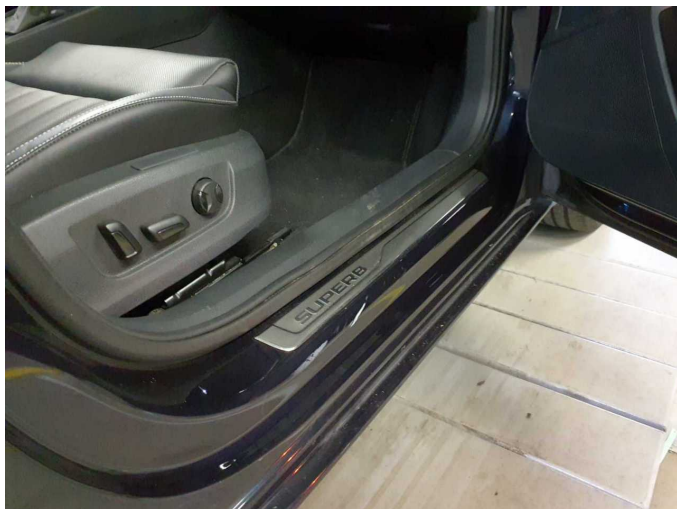
Damage 2: Sill - right side: Sill - Scratched - Smart repair

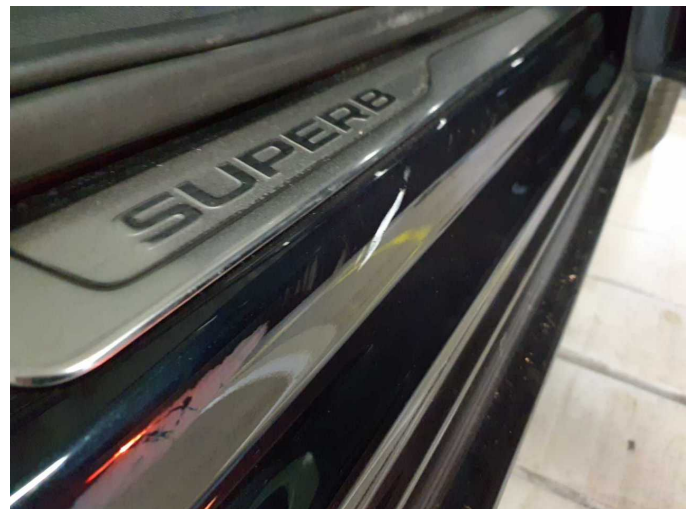
Damage 2: Sill - right side: Sill - Scratched - Smart repair

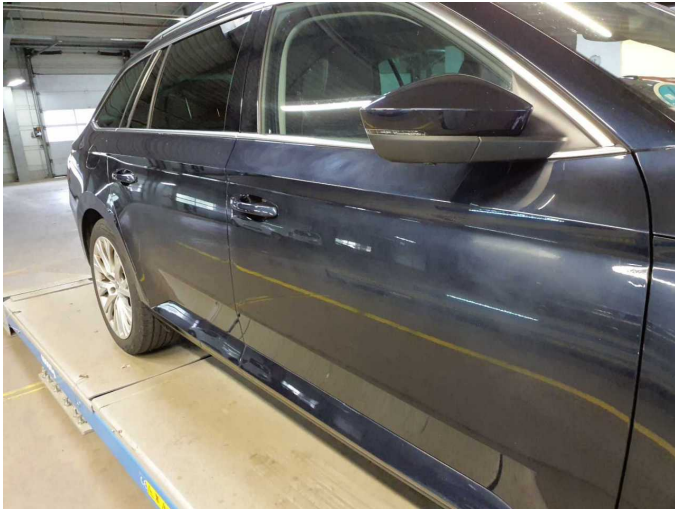
Damage 3: Door - front right side: Door - Scratched - Smart repair

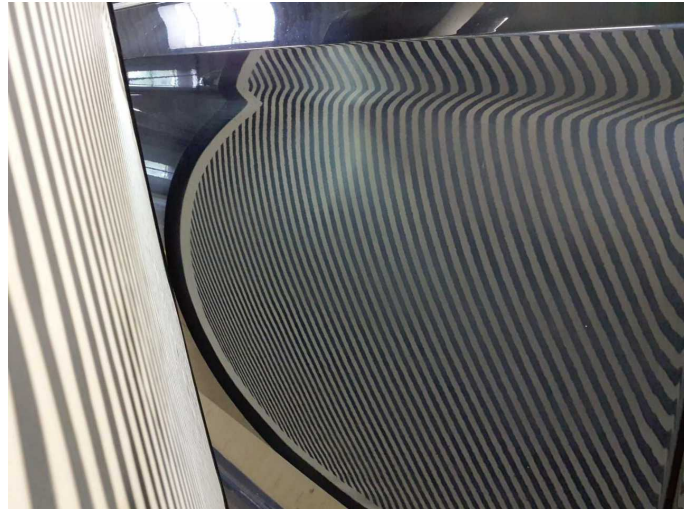
Damage 3: Door - front right side: Door - Scratched - Smart repair

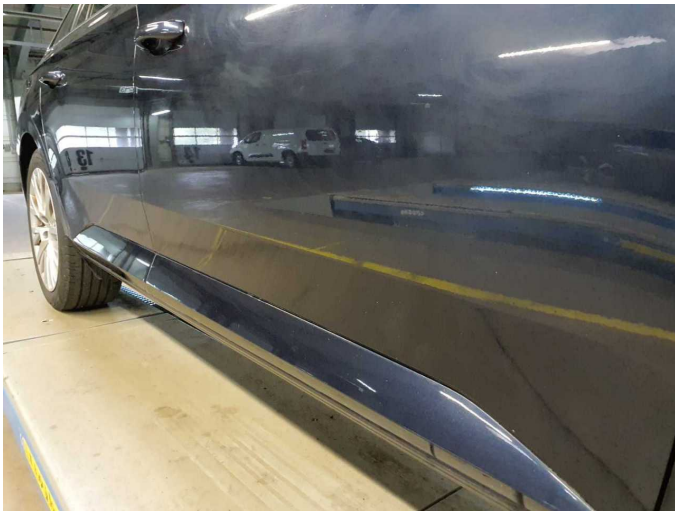
Damage 3: Door - front right side: Door - Scratched - Smart repair

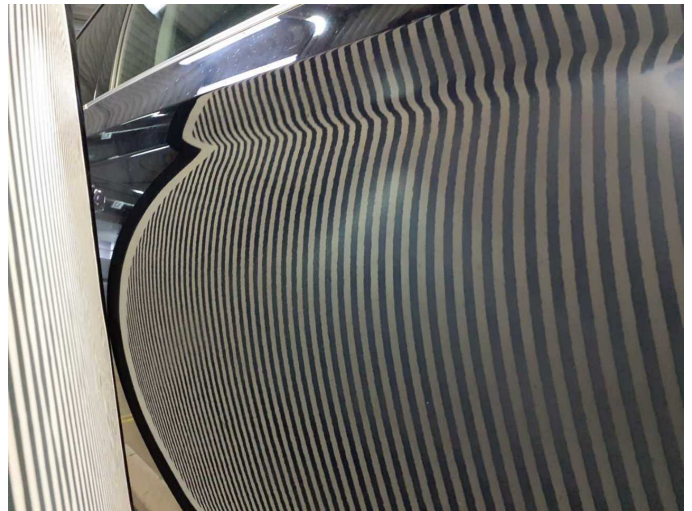
Damage 3: Door - front right side: Door - Scratched - Smart repair

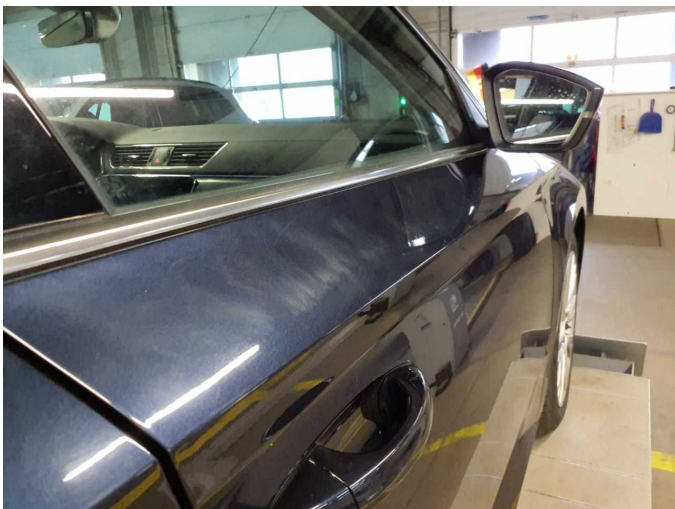
Damage 3: Door - front right side: Door - Scratched - Smart repair

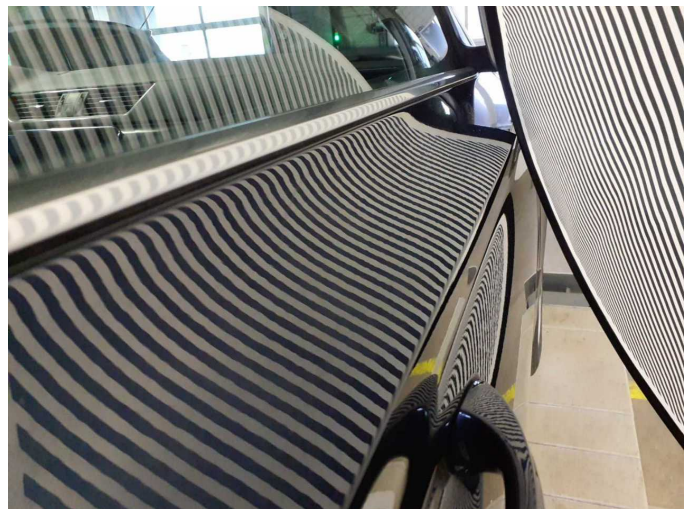
Damage 3: Door - front right side: Door - Scratched - Smart repair

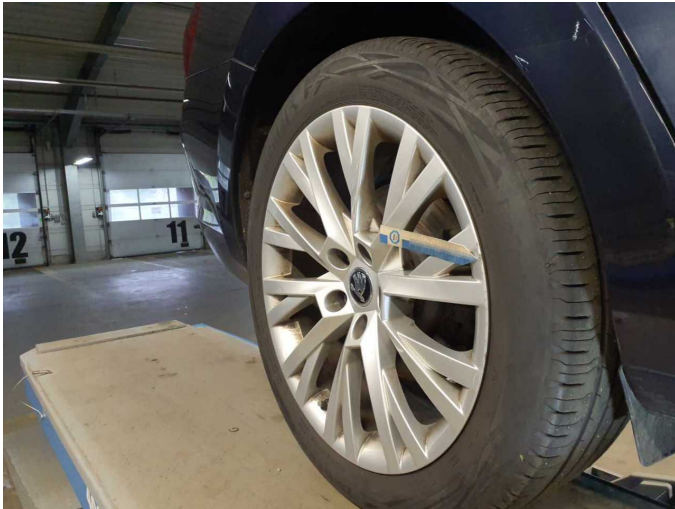
Damage 5: Wheel / tyres: Alloy rim - rear right side (Materialabtrag) - Damaged - Loss in value

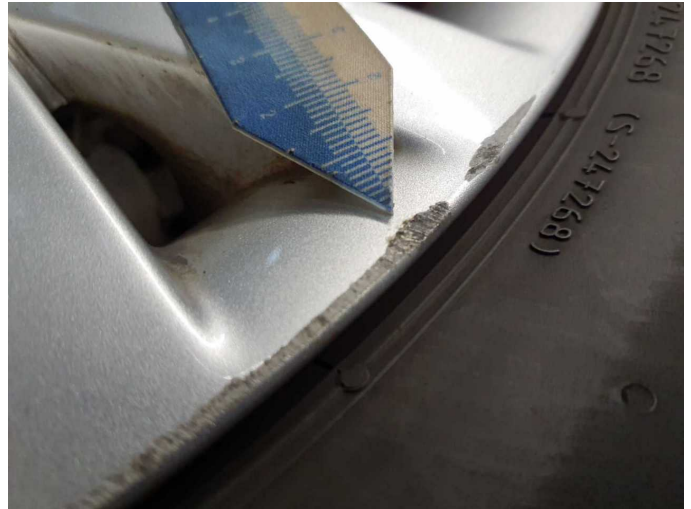
Damage 5: Wheel / tyres: Alloy rim - rear right side (Materialabtrag) - Damaged - Loss in value

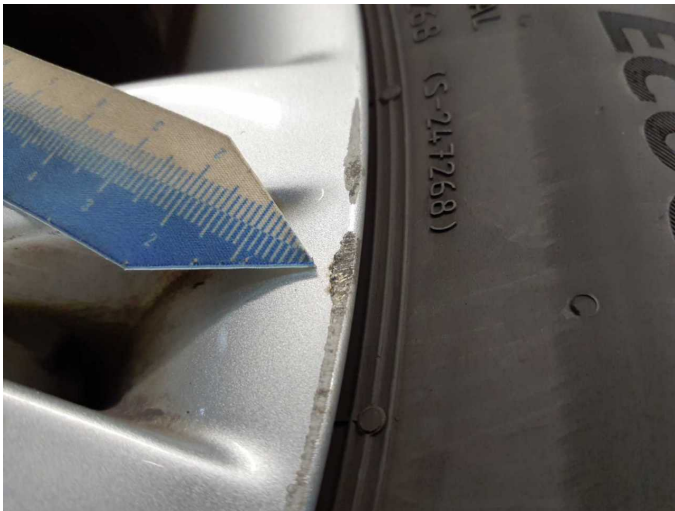
Damage 5: Wheel / tyres: Alloy rim - rear right side (Materialabtrag) - Damaged - Loss in value

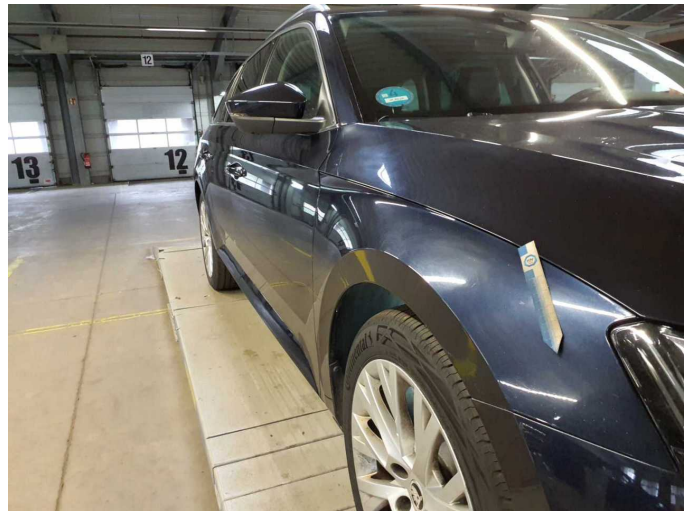
Damage 6: Mudguard - right side: Mudguard - right side (Sandstrahleffekt) - Stone chips - Paint

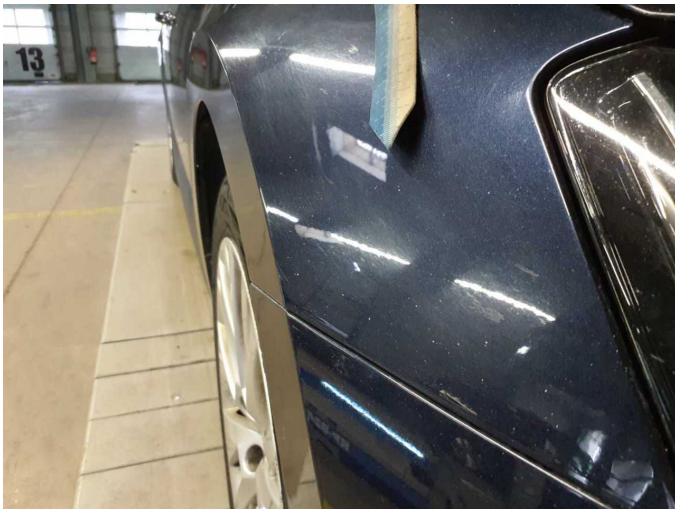
Damage 6: Mudguard - right side: Mudguard - right side (Sandstrahleffekt) - Stone chips - Paint

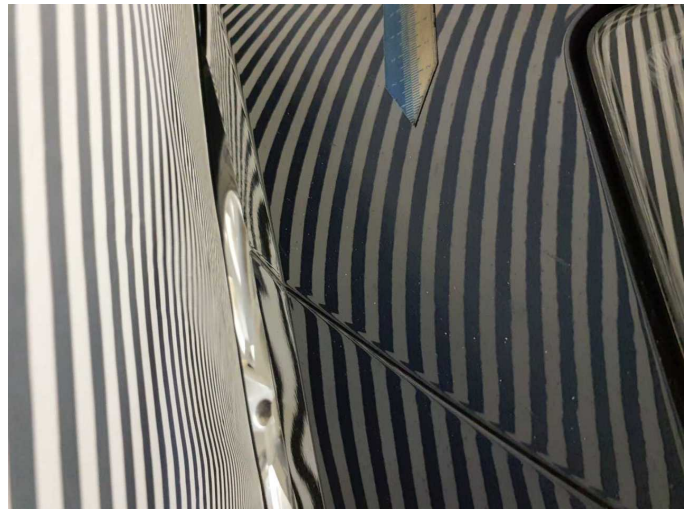
Damage 6: Mudguard - right side: Mudguard - right side (Sandstrahleffekt) - Stone chips - Paint

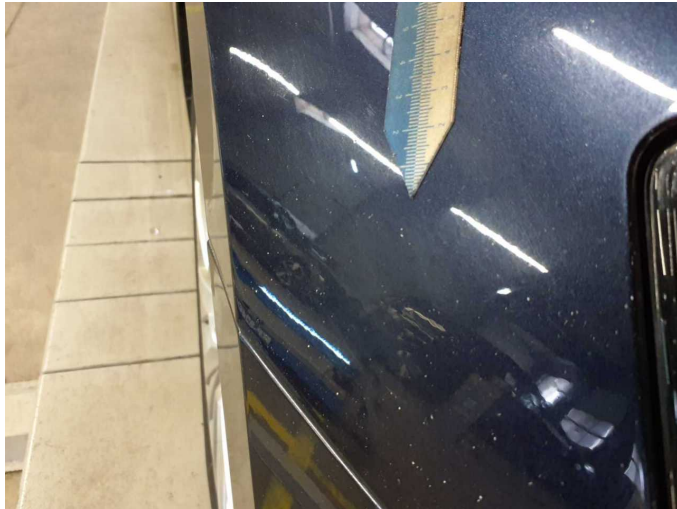
Damage 6: Mudguard - right side: Mudguard - right side
(Sandstrahleffekt) - Stone chips - Paint

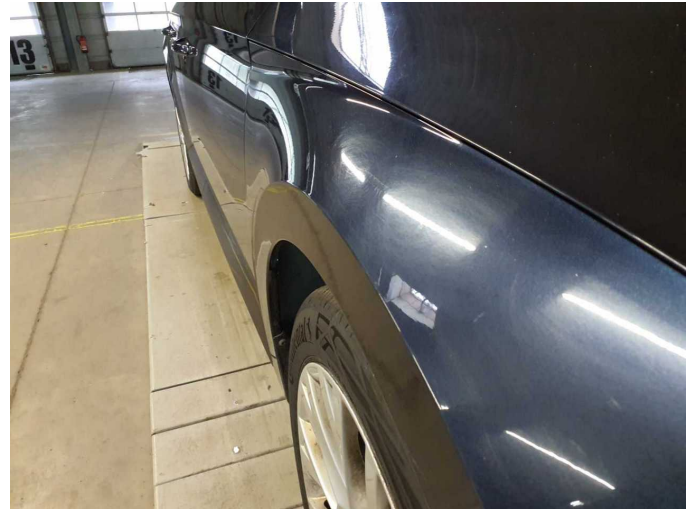
Damage 6: Mudguard - right side: Mudguard - right side
(Sandstrahleffekt) - Stone chips - Paint

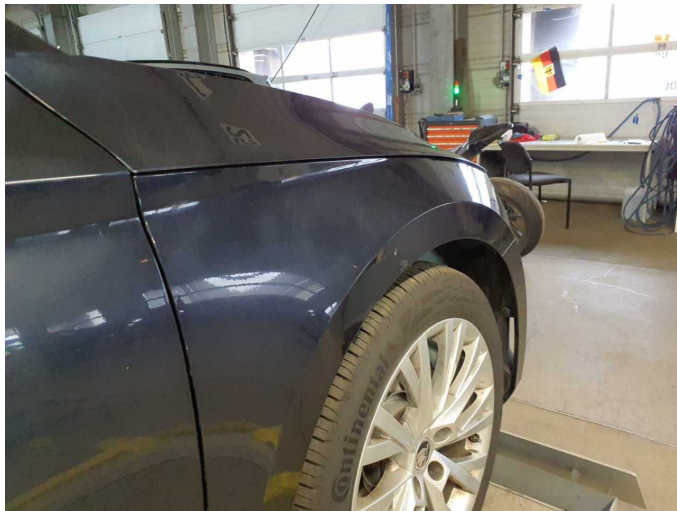
Damage 6: Mudguard - right side: Mudguard - right side
(Sandstrahleffekt) - Stone chips - Paint

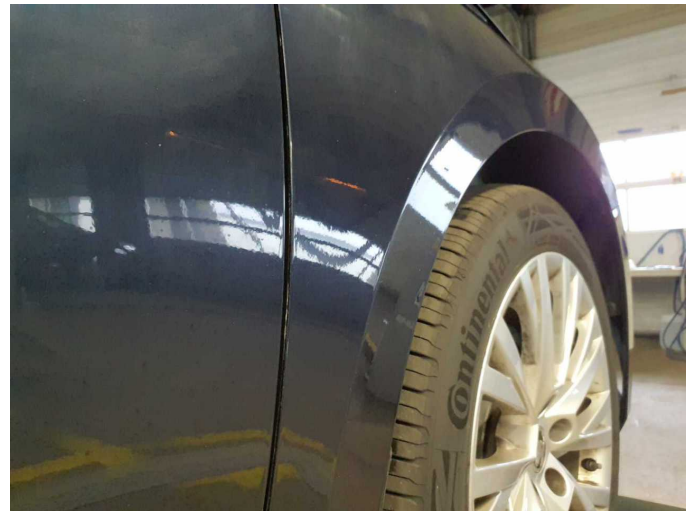
Damage 6: Mudguard - right side: Mudguard - right side
(Sandstrahleffekt) - Stone chips - Paint

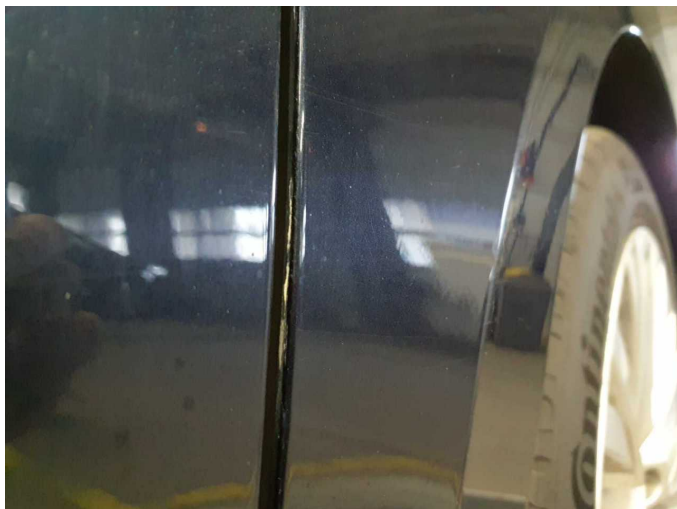
Damage 6: Mudguard - right side: Mudguard - right side
(Sandstrahleffekt) - Stone chips - Paint

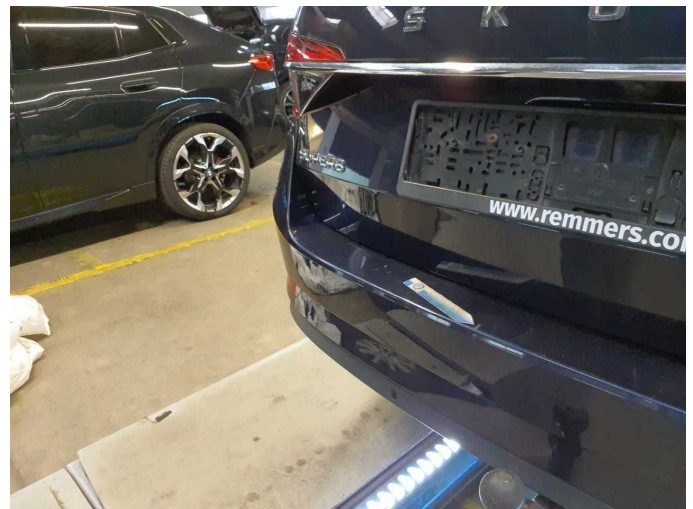
Damage 7: Rear bumper: Rear bumper - Scratched - Paint

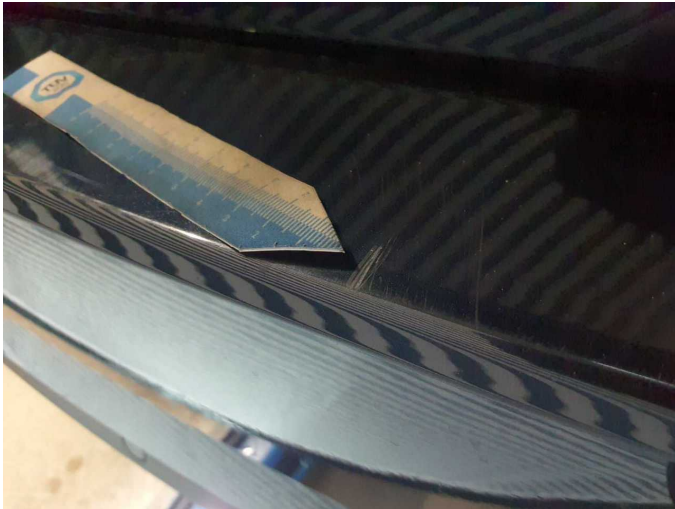
Damage 7: Rear bumper: Rear bumper - Scratched - Paint

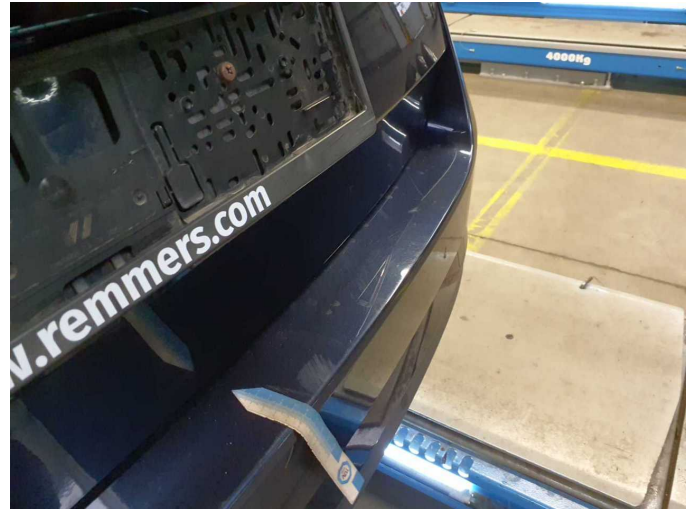
Damage 7: Rear bumper: Rear bumper - Scratched - Paint

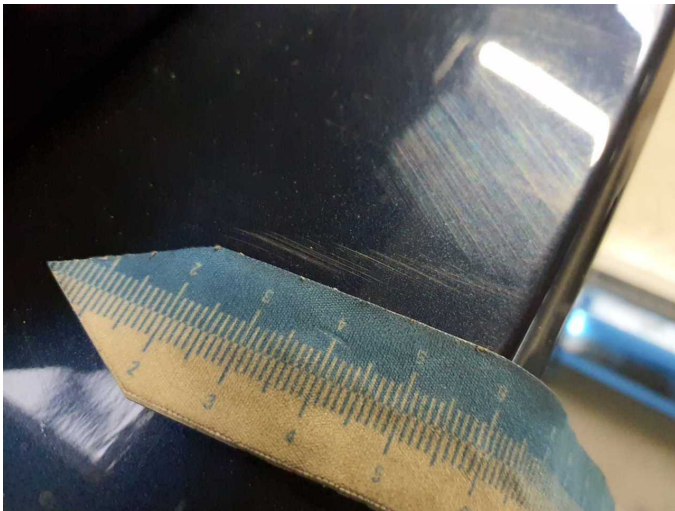
Damage 7: Rear bumper: Rear bumper - Scratched - Paint

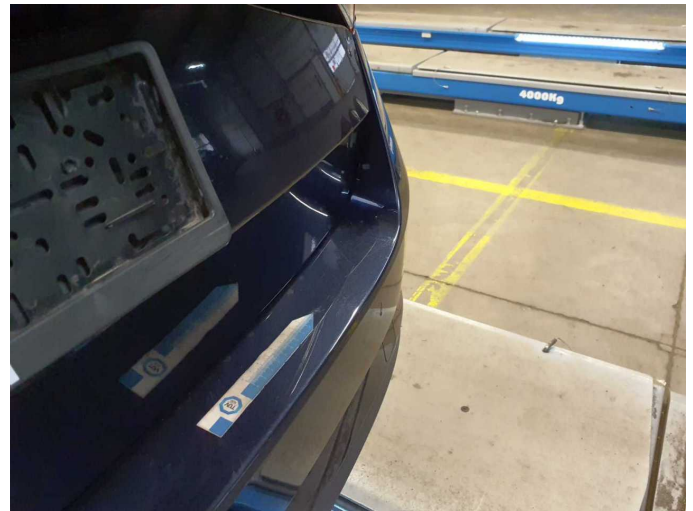
Damage 7: Rear bumper: Rear bumper - Scratched - Paint

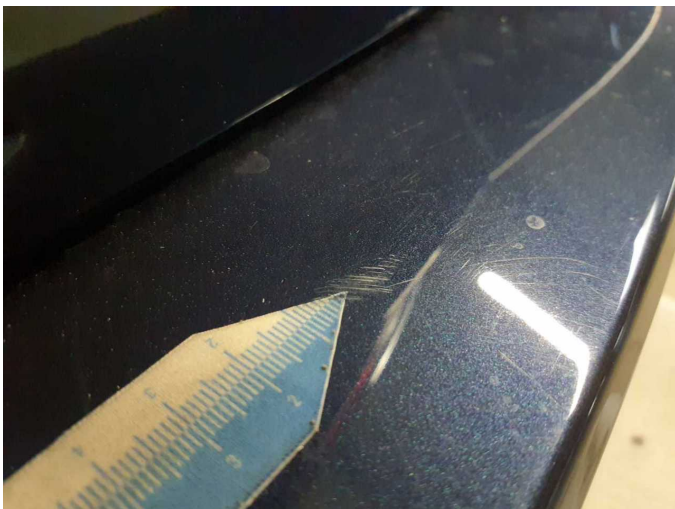
Damage 7: Rear bumper: Rear bumper - Scratched - Paint

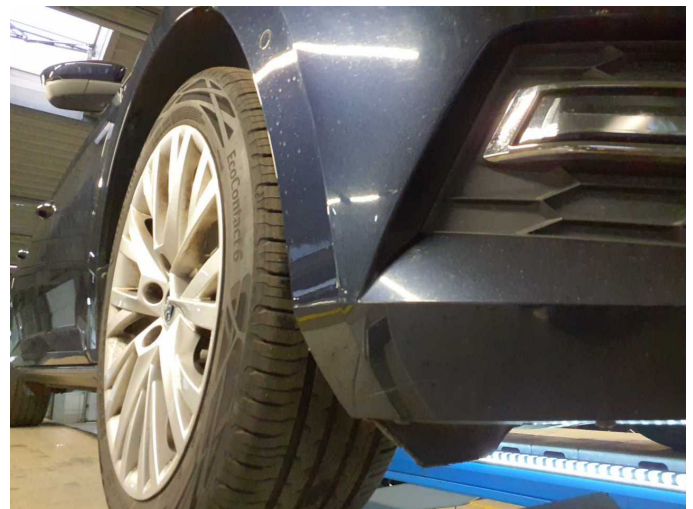
Damage 8: Front bumper: Front bumper (Steinschlag) - Scratched - Paint

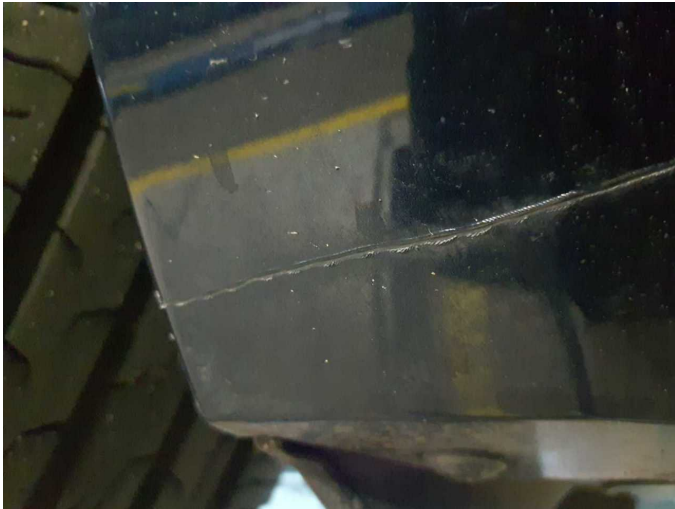
Damage 8: Front bumper: Front bumper (Steinschlag) - Scratched - Paint

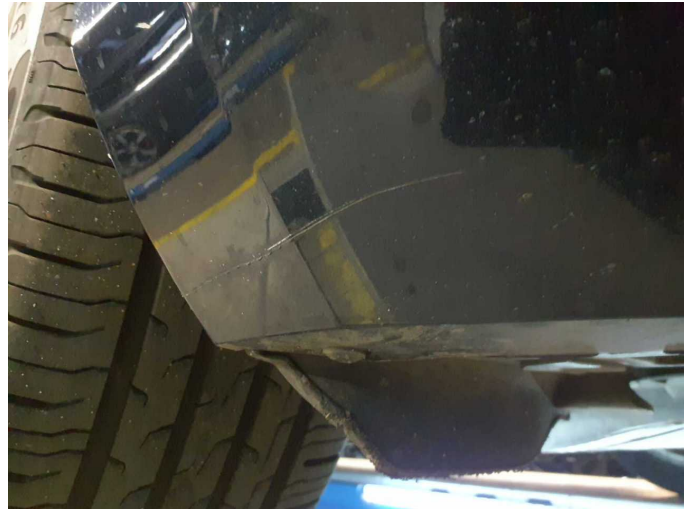
Damage 8: Front bumper: Front bumper (Steinschlag) - Scratched - Paint

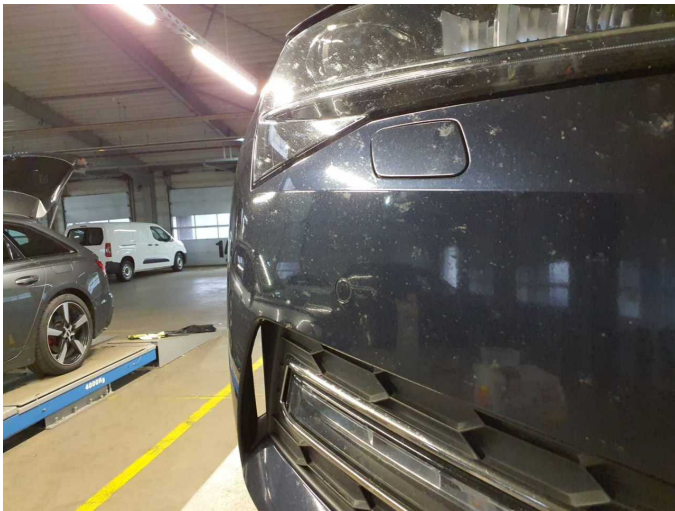
Damage 8: Front bumper: Front bumper (Steinschlag) - Scratched - Paint

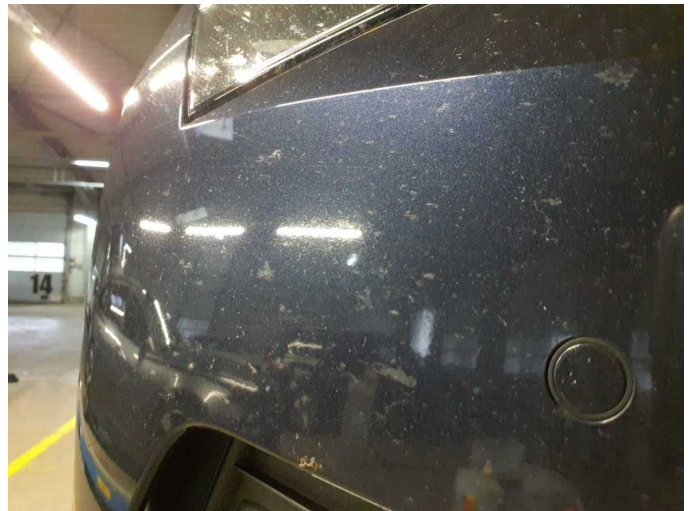
Damage 8: Front bumper: Front bumper (Steinschlag) - Scratched - Paint

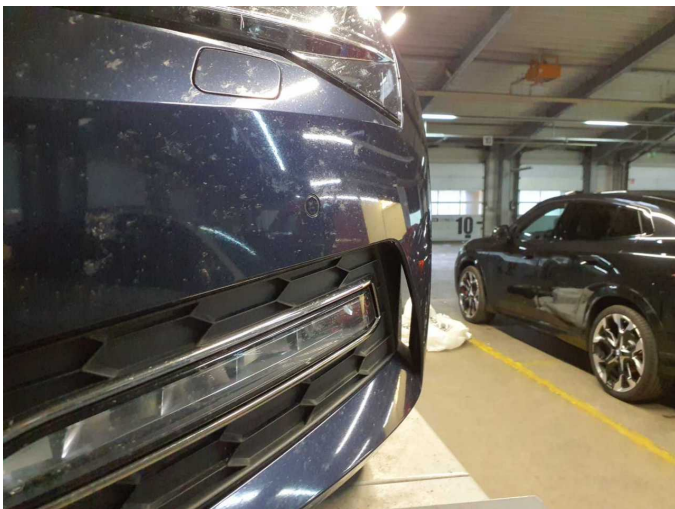
Damage 8: Front bumper: Front bumper (Steinschlag) - Scratched - Paint

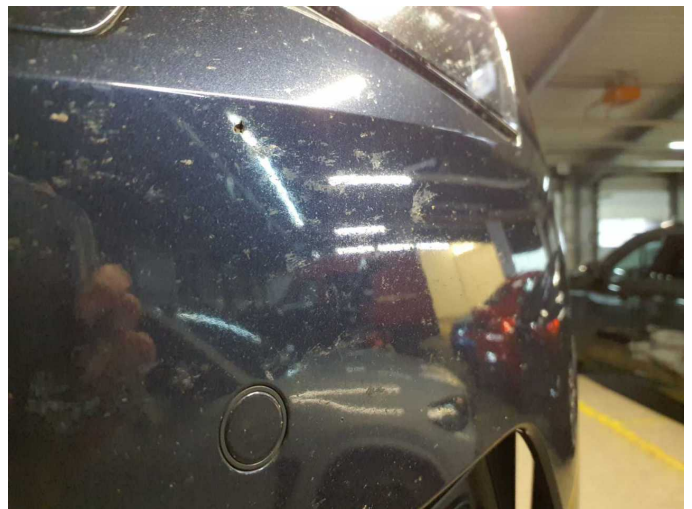
Damage 8: Front bumper: Front bumper (Steinschlag) - Scratched - Paint

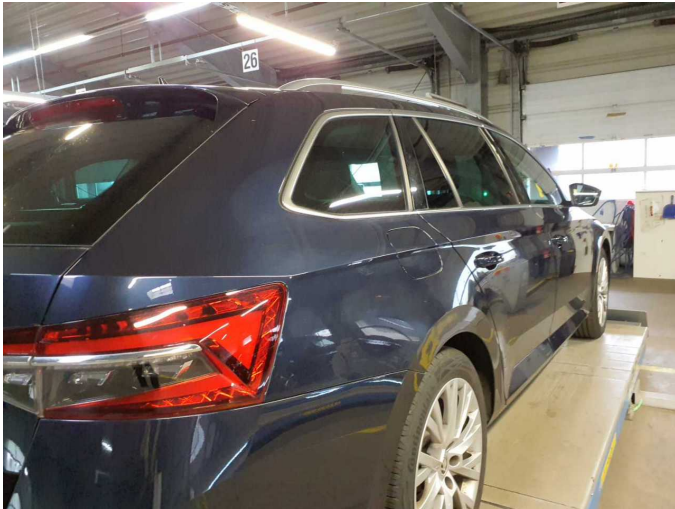
Damage 9: Side panel - rear right side: Side panel - Scratched - Paint

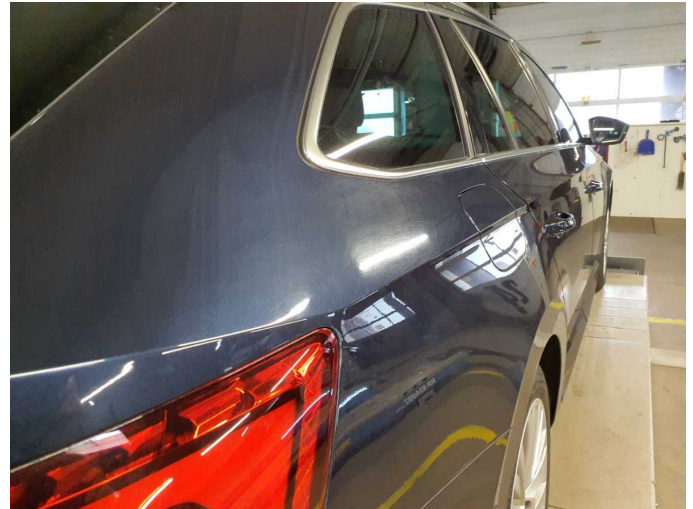
Damage 9: Side panel - rear right side: Side panel - Scratched - Paint

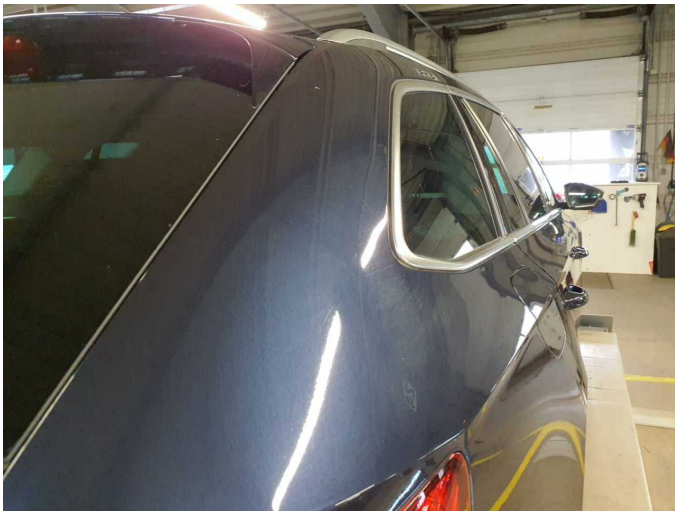
Damage 9: Side panel - rear right side: Side panel - Scratched - Paint

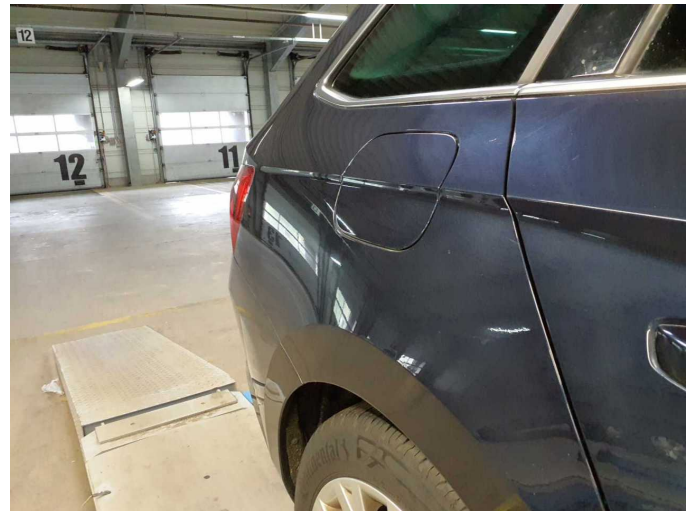
Damage 9: Side panel - rear right side: Side panel - Scratched - Paint

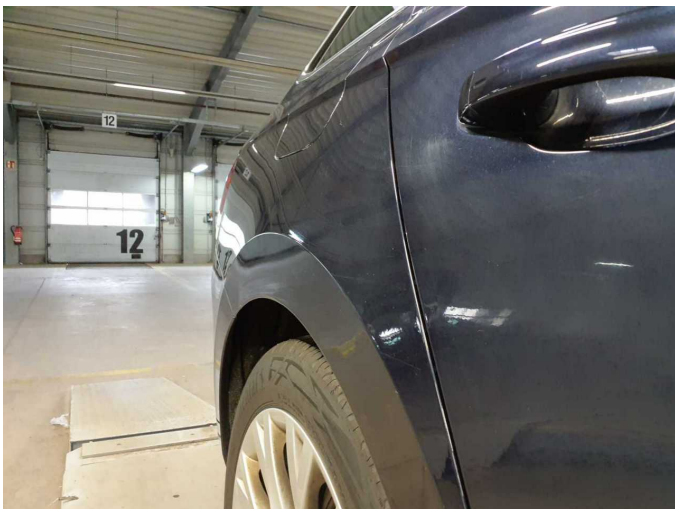
Damage 9: Side panel - rear right side: Side panel - Scratched - Paint

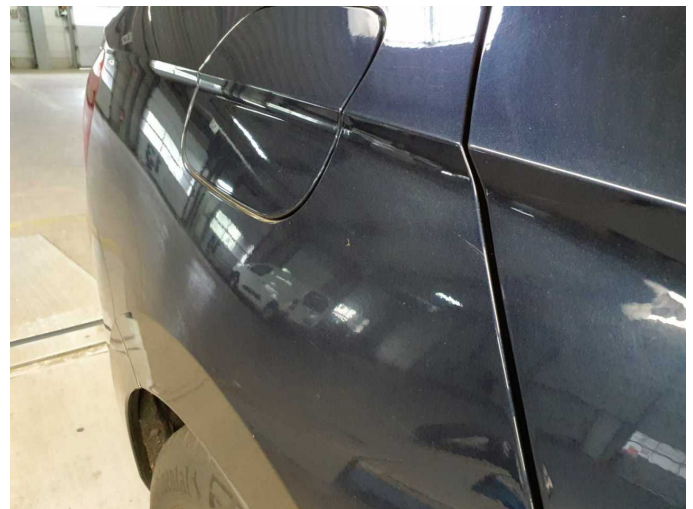
Damage 9: Side panel - rear right side: Side panel - Scratched - Paint

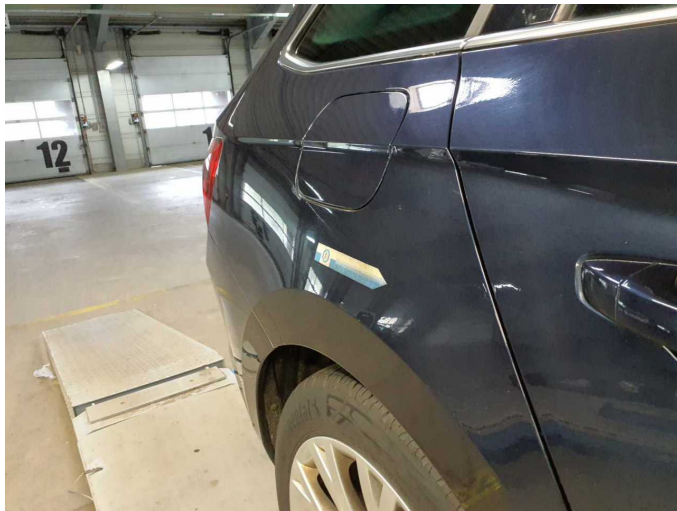
Damage 9: Side panel - rear right side: Side panel - Scratched - Paint

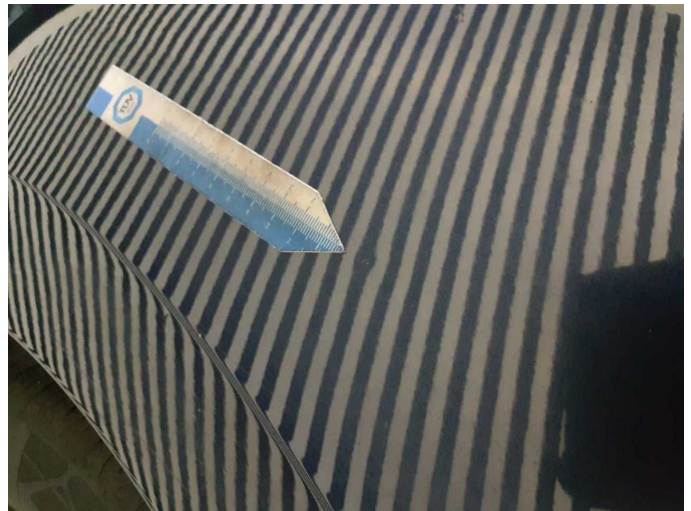
Damage 9: Side panel - rear right side: Side panel - Scratched - Paint

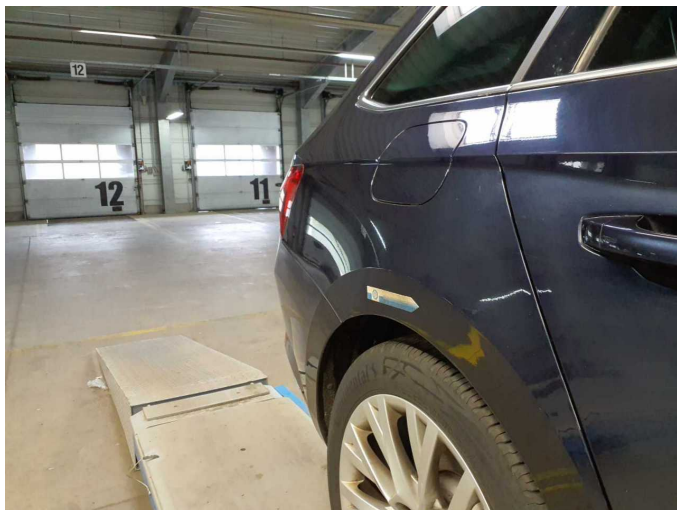
Damage 9: Side panel - rear right side: Side panel - Scratched - Paint

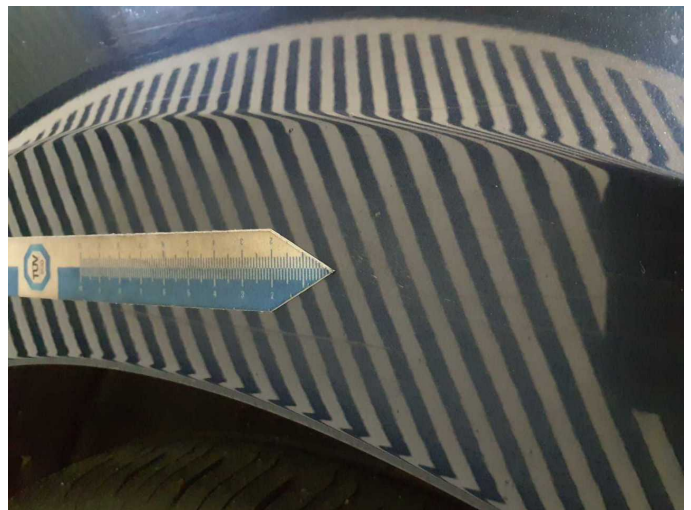
Damage 9: Side panel - rear right side: Side panel - Scratched - Paint

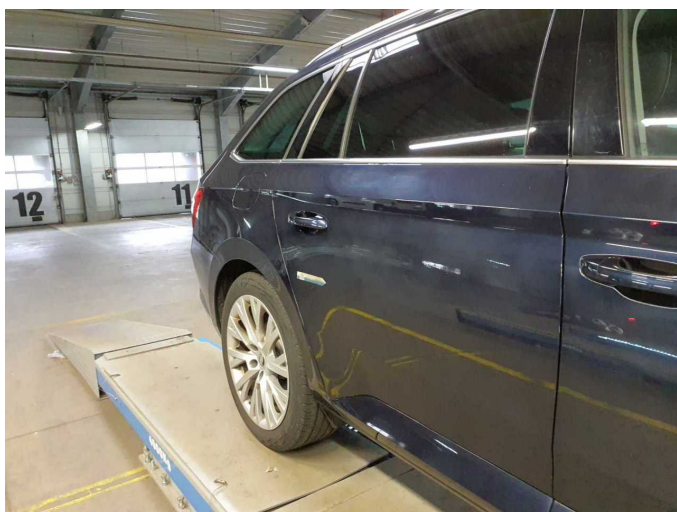
Damage 10: Door - rear right side: Door (teilweise matt) - Scratched - Paint

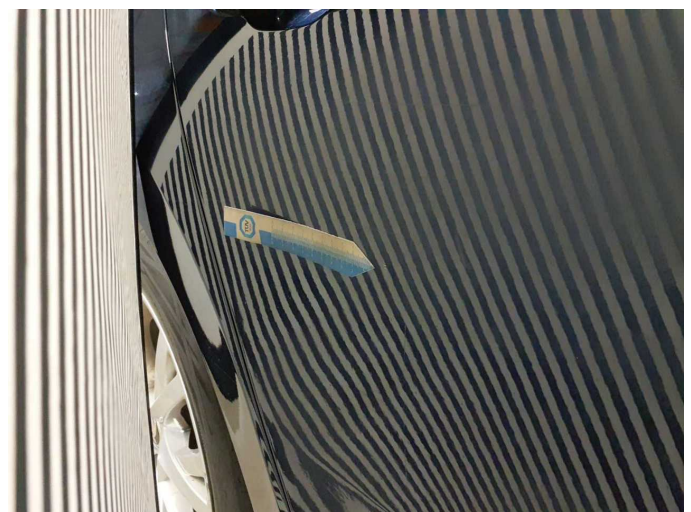
Damage 10: Door - rear right side: Door (teilweise matt) - Scratched - Paint

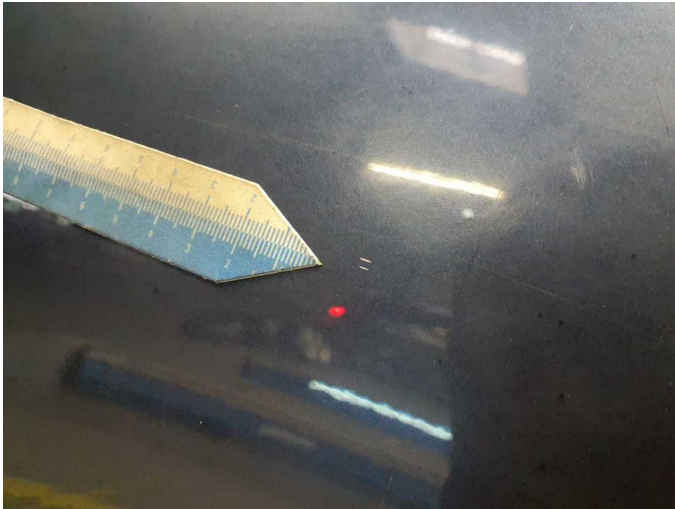
Damage 10: Door - rear right side: Door (teilweise matt) - Scratched - Paint

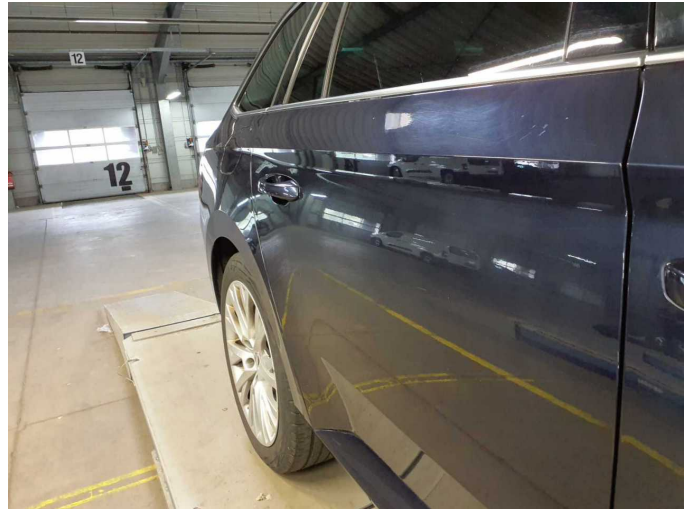
Damage 10: Door - rear right side: Door (teilweise matt) - Scratched - Paint

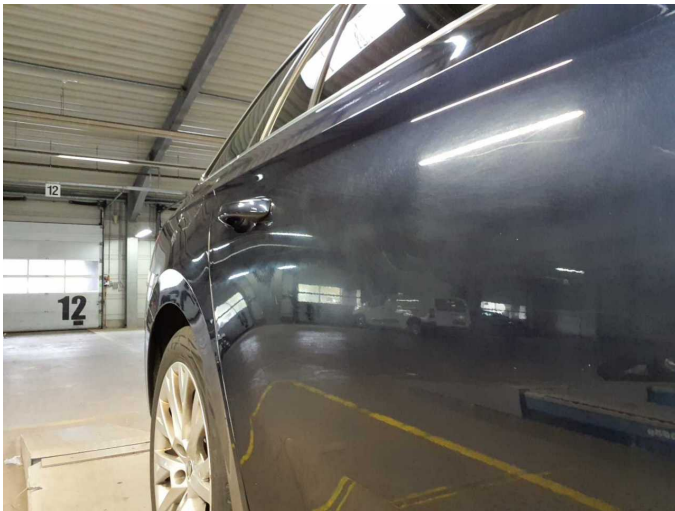
Damage 10: Door - rear right side: Door (teilweise matt) - Scratched - Paint

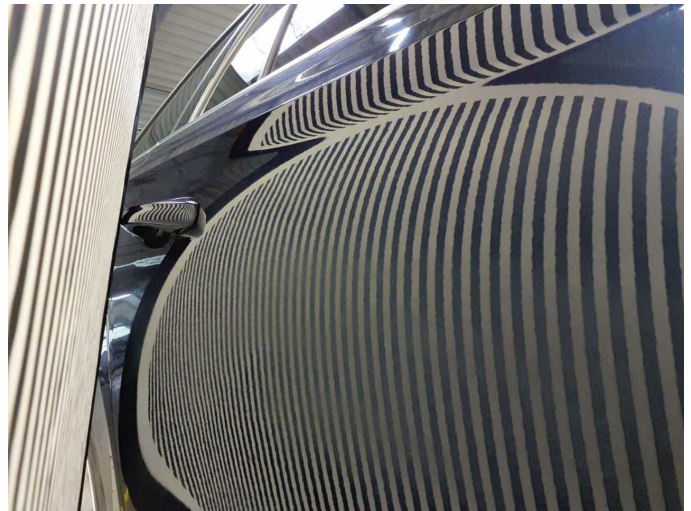
Damage 10: Door - rear right side: Door (teilweise matt) - Scratched - Paint

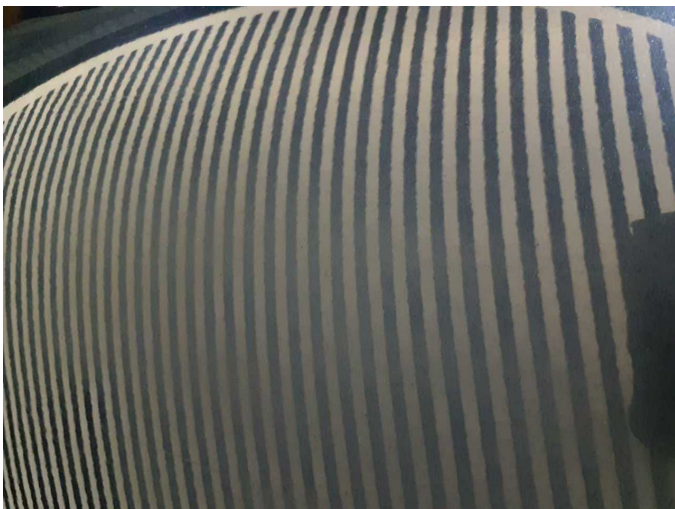
Damage 10: Door - rear right side: Door (teilweise matt) - Scratched - Paint

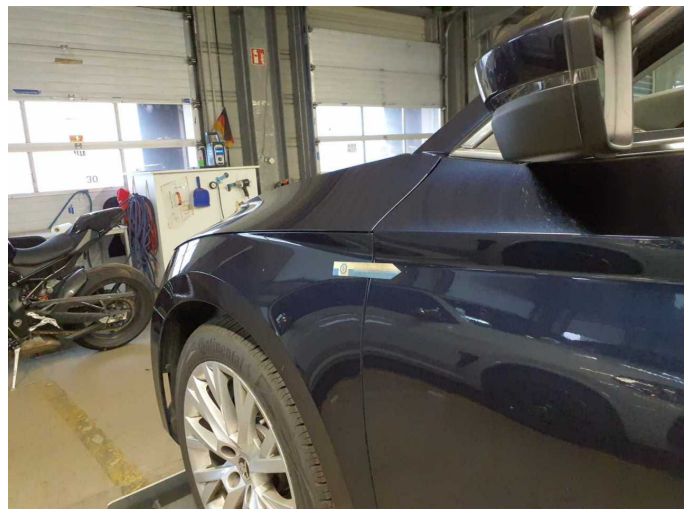
Damage 11: Door - front left side: Door (Kratzer) - Stone chips - Paint

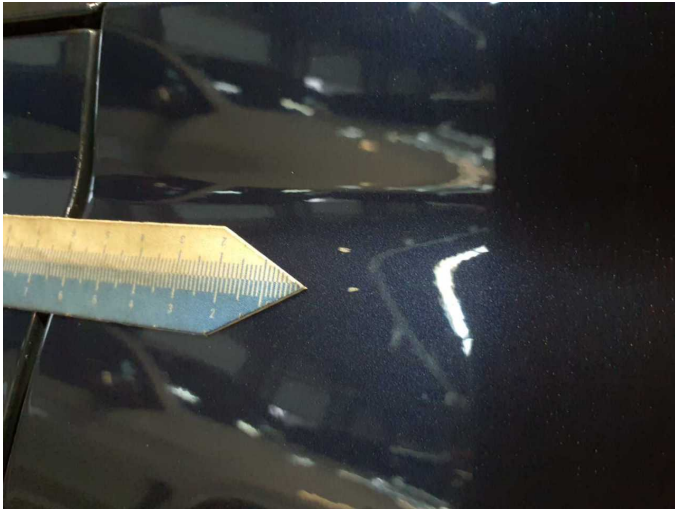
Damage 11: Door - front left side: Door (Kratzer) - Stone chips - Paint

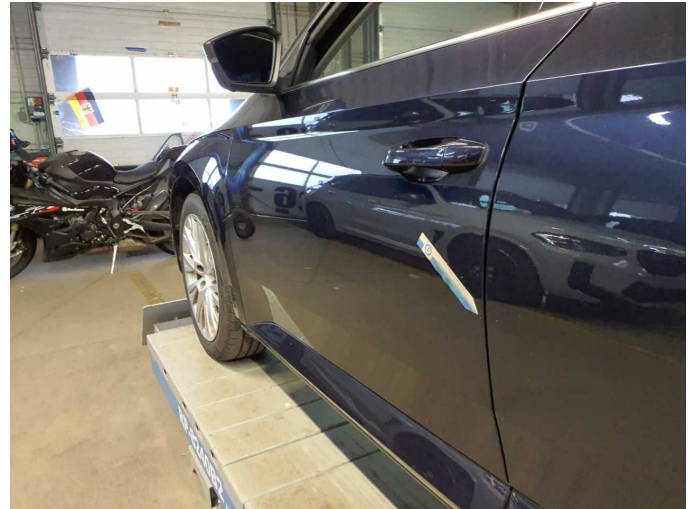
Damage 11: Door - front left side: Door (Kratzer) - Stone chips - Paint

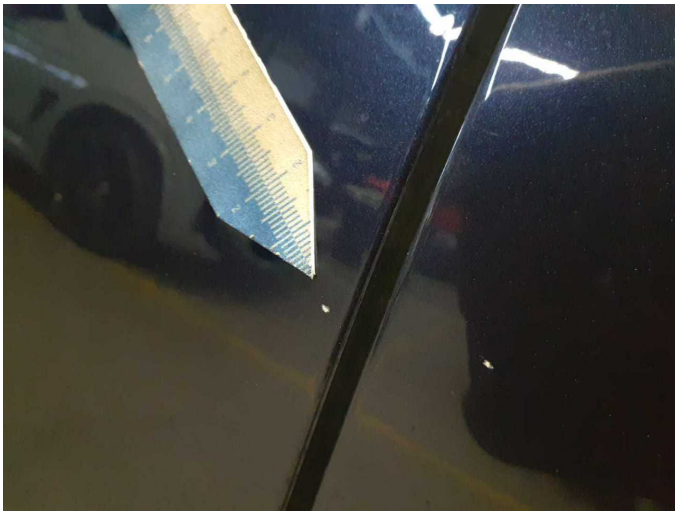
Damage 11: Door - front left side: Door (Kratzer) - Stone chips - Paint

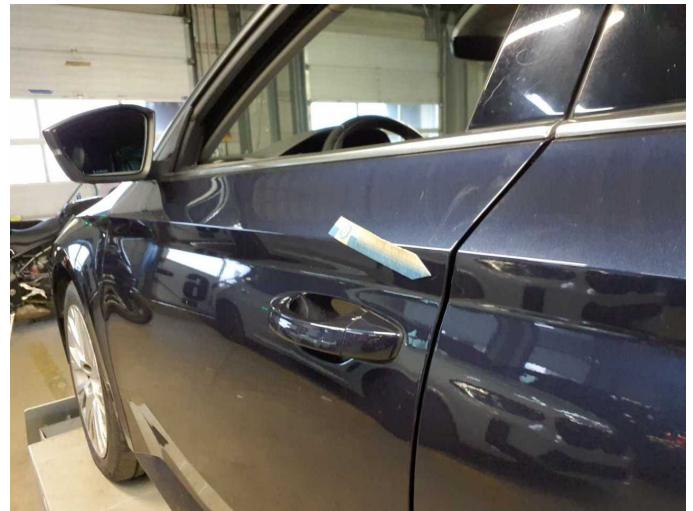
Damage 11: Door - front left side: Door (Kratzer) - Stone chips - Paint

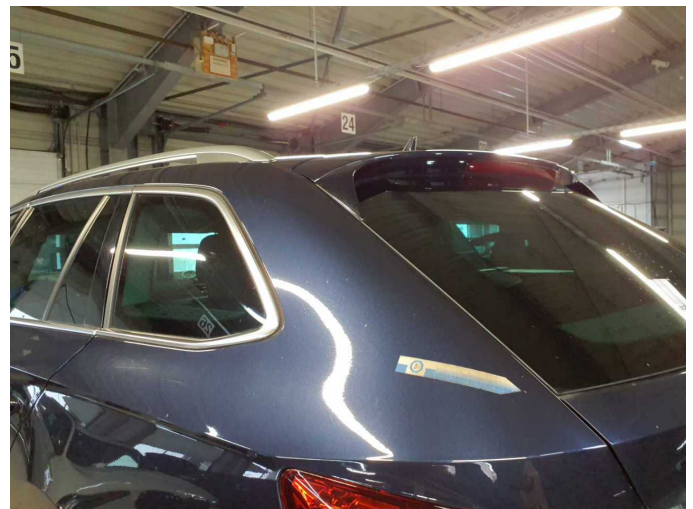
Damage 12: Side panel - rear left side: Side panel - Corrosion - Repair and paint

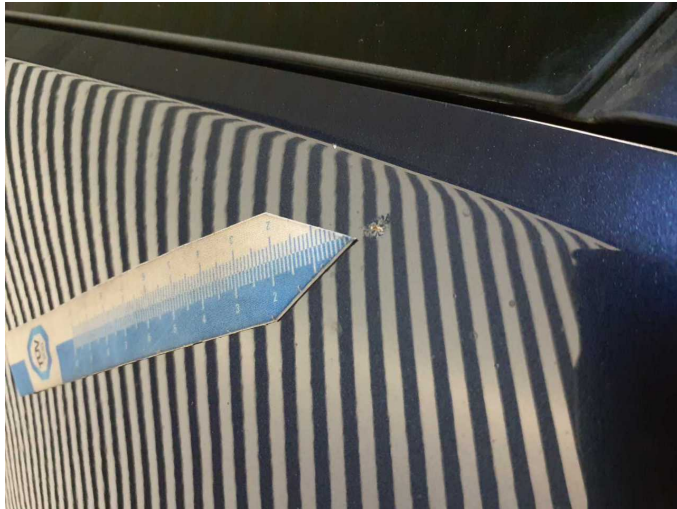
Damage 12: Side panel - rear left side: Side panel - Corrosion - Repair and paint

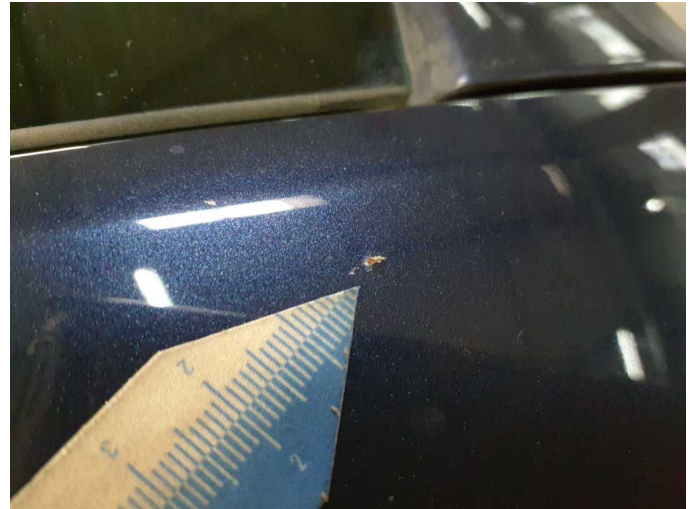
Damage 12: Side panel - rear left side: Side panel - Corrosion - Repair and paint

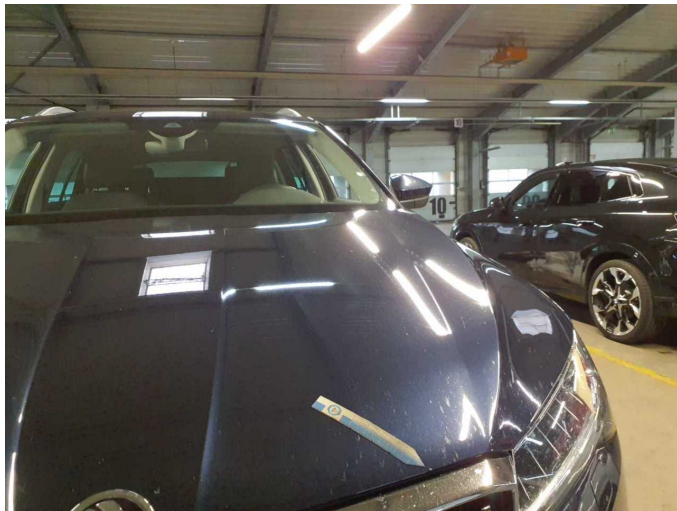
Damage 13: Bonnet: Bonnet - Scratched - Paint

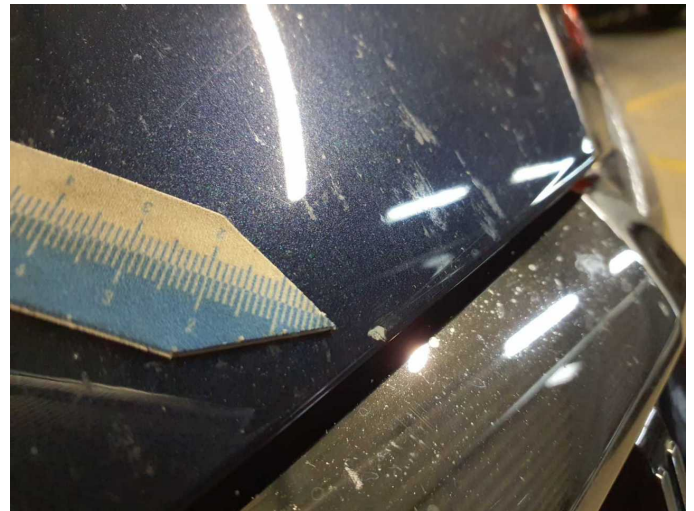
Damage 13: Bonnet: Bonnet - Scratched - Paint

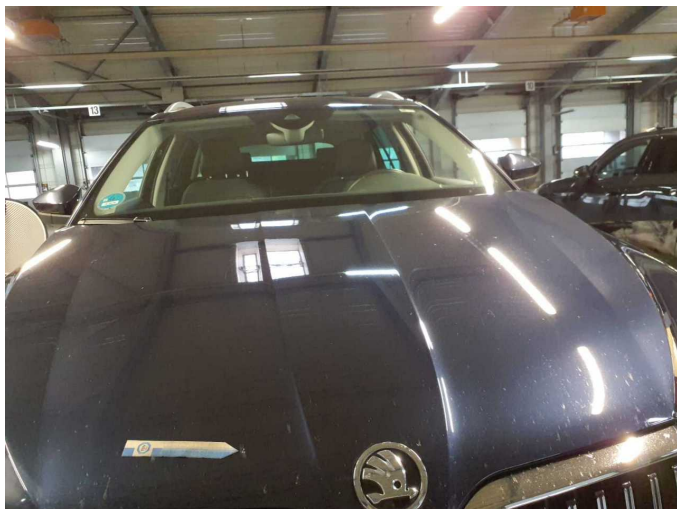
Damage 13: Bonnet: Bonnet - Scratched - Paint

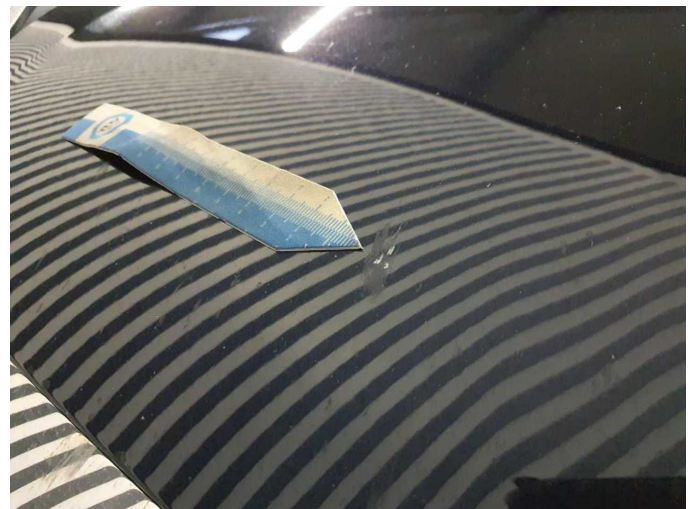
Damage 13: Bonnet: Bonnet - Scratched - Paint

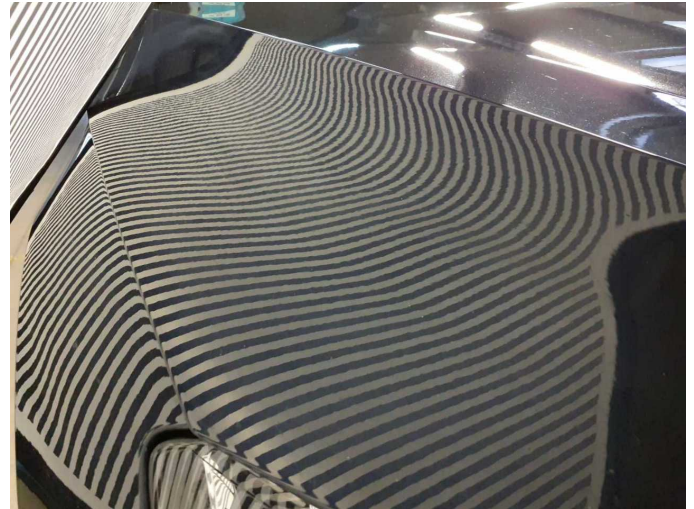
Damage 13: Bonnet: Bonnet - Scratched - Paint
