Expertise

Protocol number: 41553571
Order No. / Reference: 25113544
Inspection date: 15 Sept 2025

Manufacturer: Skoda
VIN: TMBJH7NP4P7062689

Model: Superb Combi 2.0 TDI DSG Style

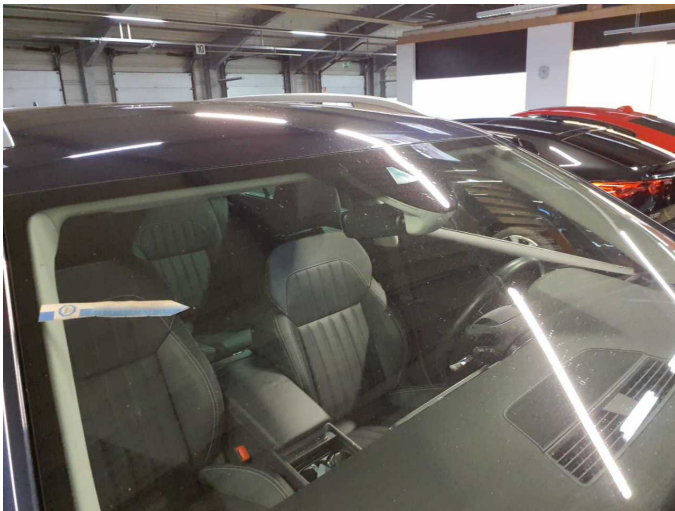
Damage 14: Vehicle glazing: Windscreen (Rissbildung) - Stone chips - repair according to calculation

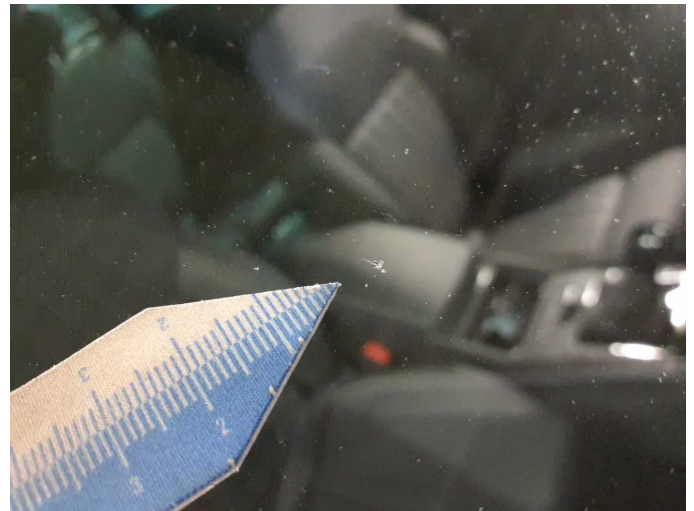
Damage 14: Vehicle glazing: Windscreen (Rissbildung) - Stone chips - repair according to calculation

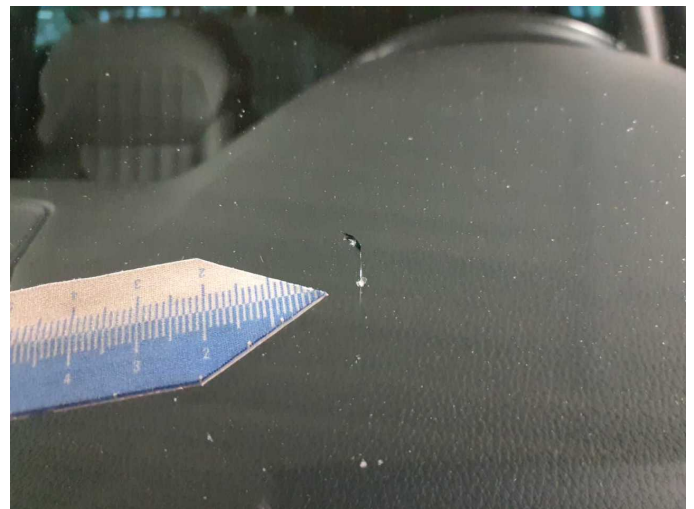
Damage 14: Vehicle glazing: Windscreen (Rissbildung) - Stone chips - repair according to calculation

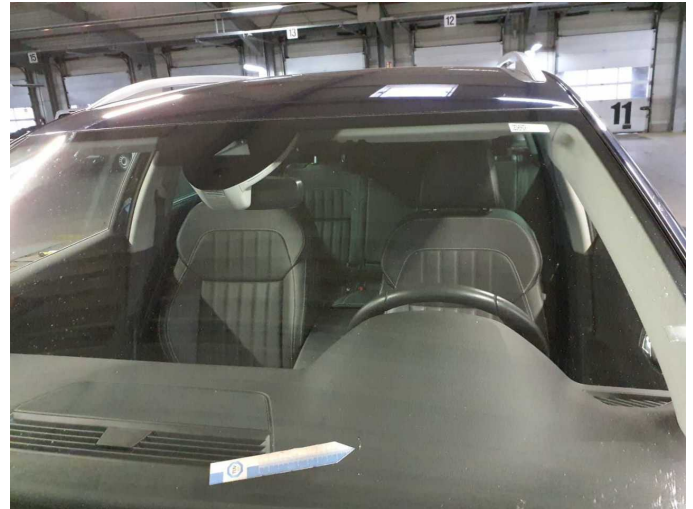
Damage 14: Vehicle glazing: Windscreen (Rissbildung) - Stone chips - repair according to calculation

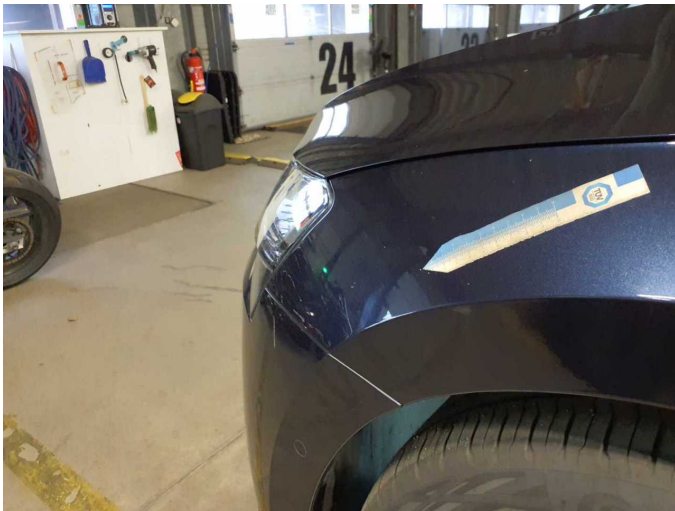
Wear and tear 3: Mudguard - left side: Mudguard - left side - Stone chips - No deduction

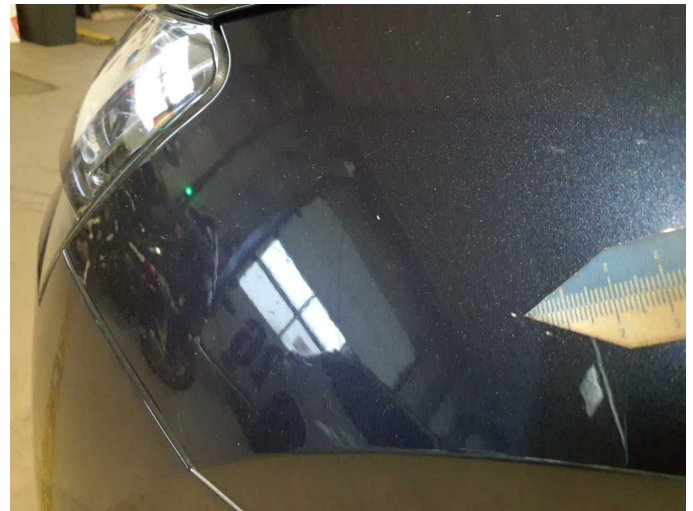
Wear and tear 3: Mudguard - left side: Mudguard - left side - Stone chips - No deduction

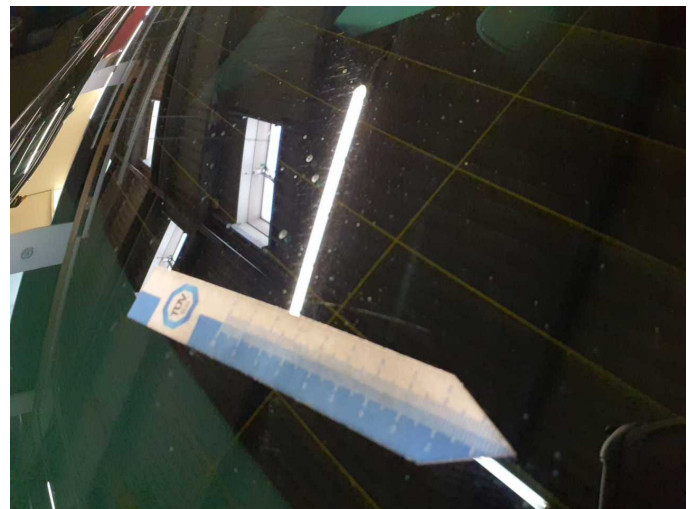
Wear and tear 5: Vehicle glazing: Rear window - Scratched - No deduction
