Expertise

Protocol number: 41224199  
Order No. / Reference: 25110557  
Inspection date: 26 Aug 2025

Manufacturer: Skoda	Model: Superb Combi 2.0 TDI DSG Ambition
VIN: TMBJH7NP7M7068773

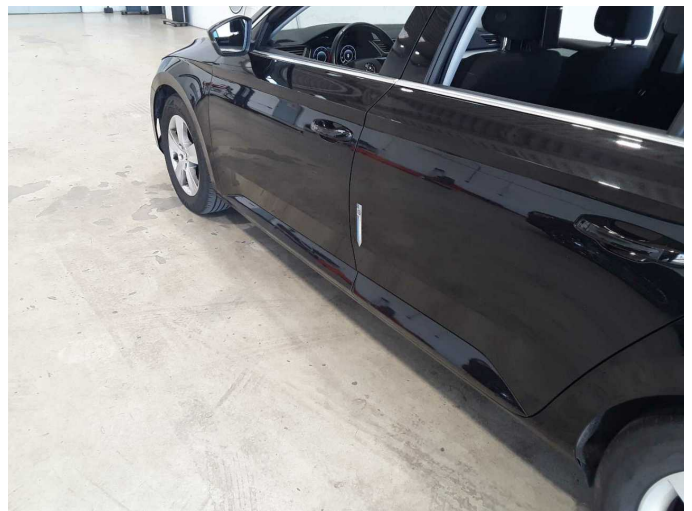
Damage 1: Door - rear left side: Door - dent(s) - Smart repair

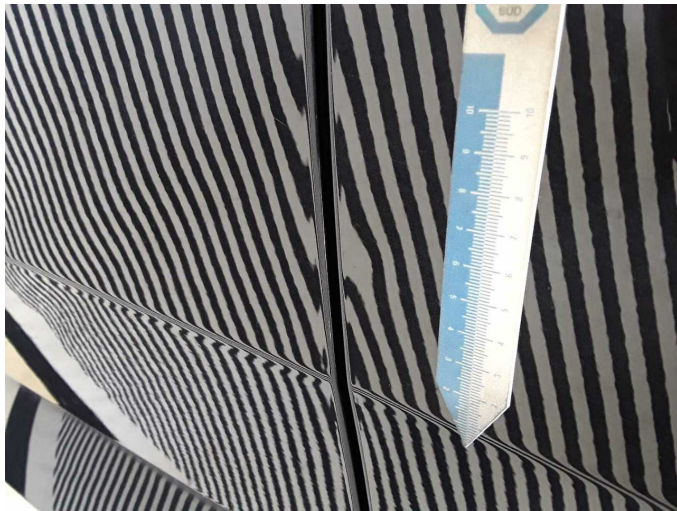
**Damage 1:** Door - rear left side: Door - dent(s) - Smart repair

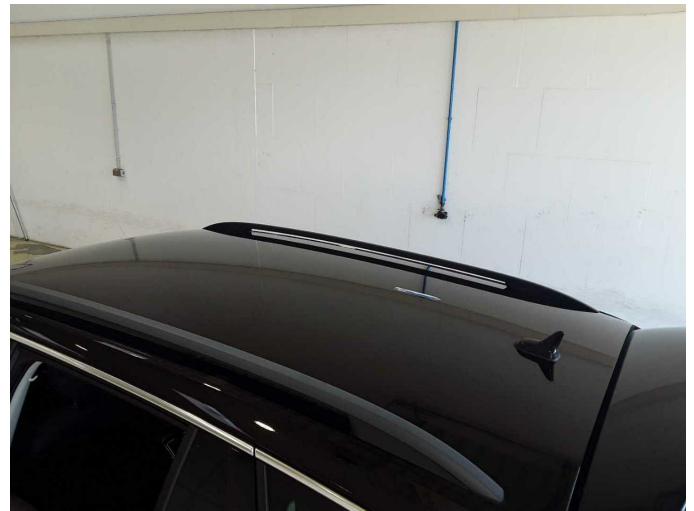
**Damage 2:** Roof: Roof - dent(s) - Smooth repair work

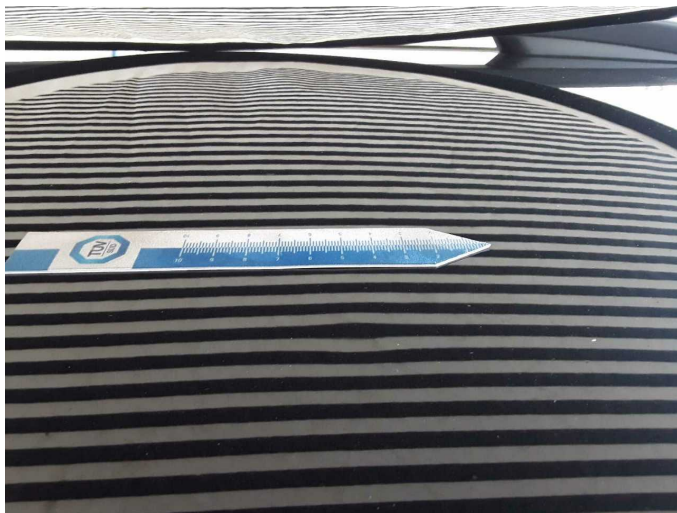
**Damage 2:** Roof: Roof - dent(s) - Smooth repair work

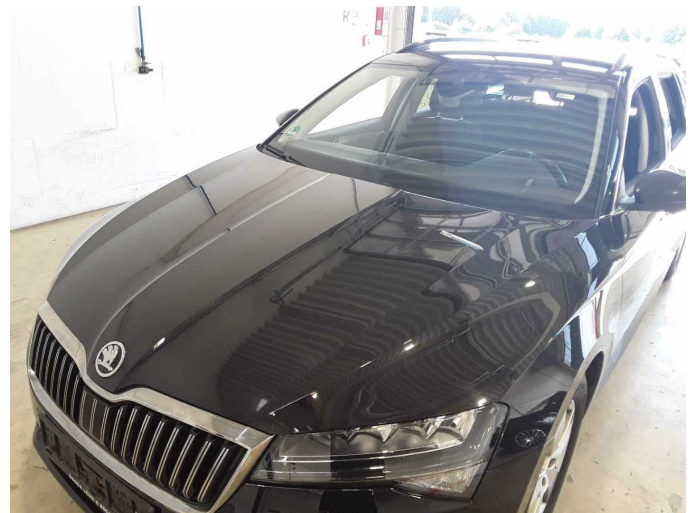
**Damage 3:** Bonnet: Bonnet - dent(s) - Smooth repair work

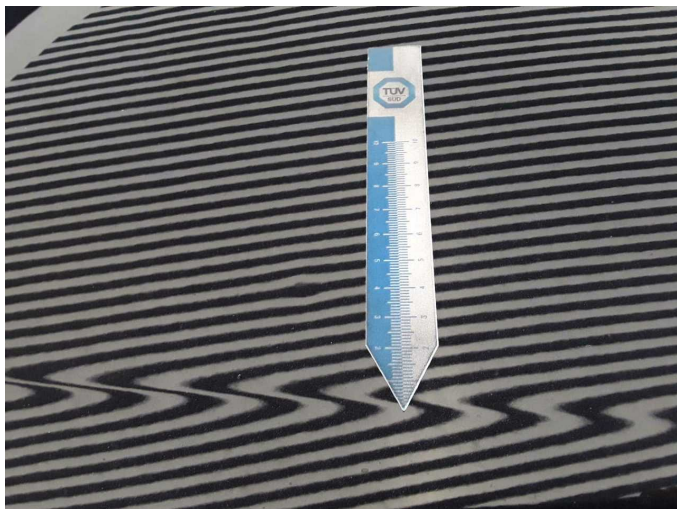
**Damage 3:** Bonnet: Bonnet - dent(s) - Smooth repair work

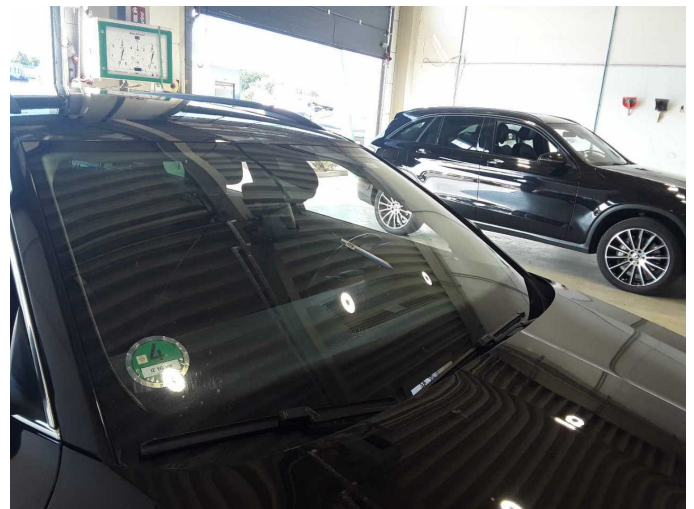
**Damage 4:** Vehicle glazing: Windscreen - Broken / torn - Replace

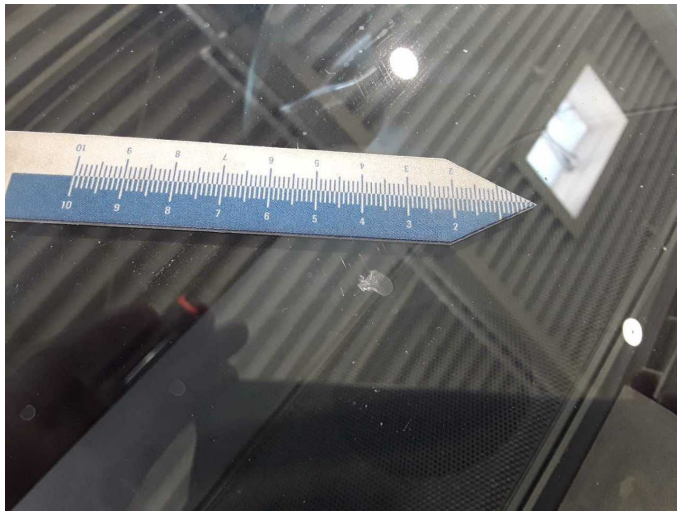
**Damage 4:** Vehicle glazing: Windscreen - Broken / torn - Replace

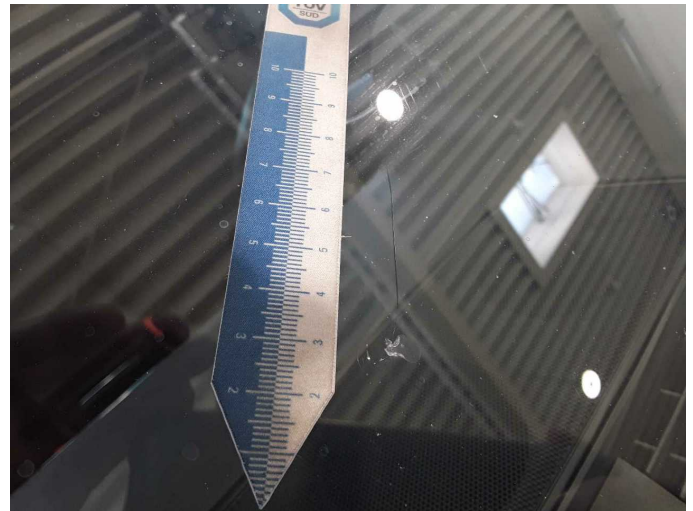
**Damage 4:** Vehicle glazing: Windscreen - Broken / torn - Replace

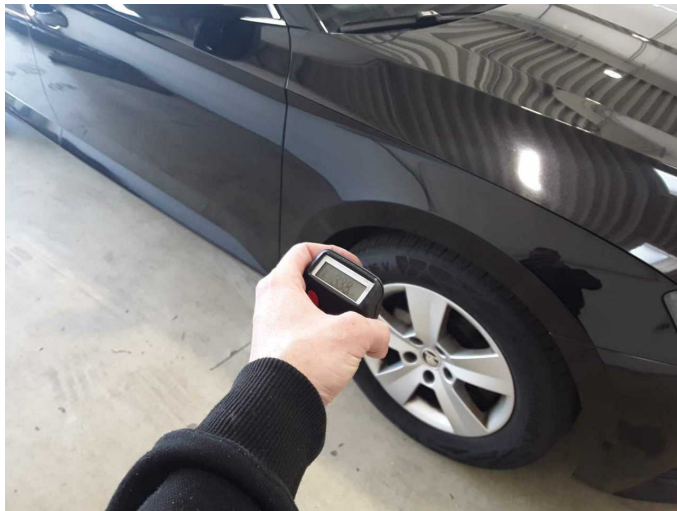
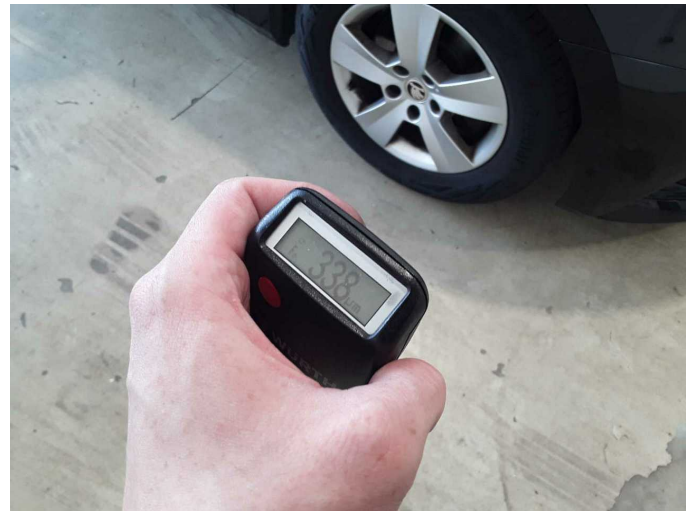
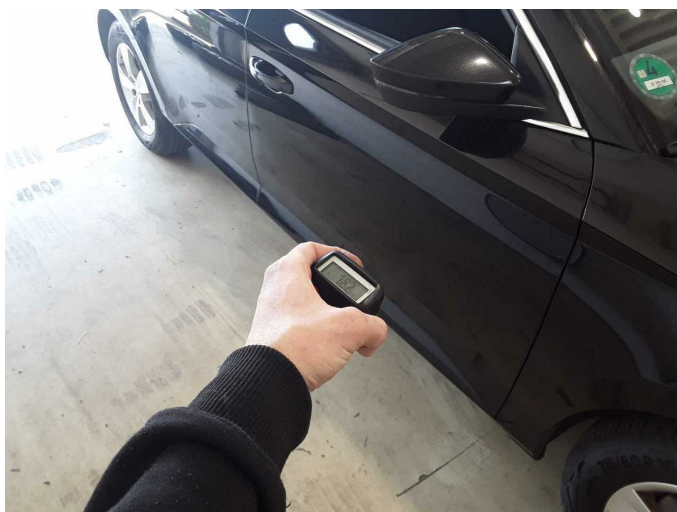
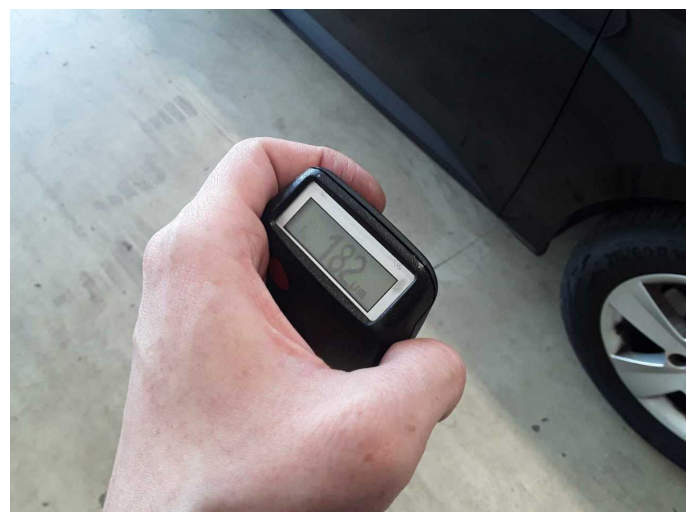
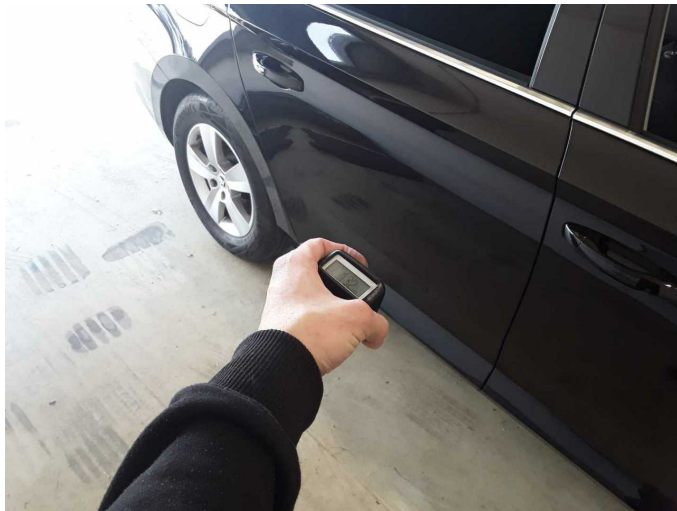
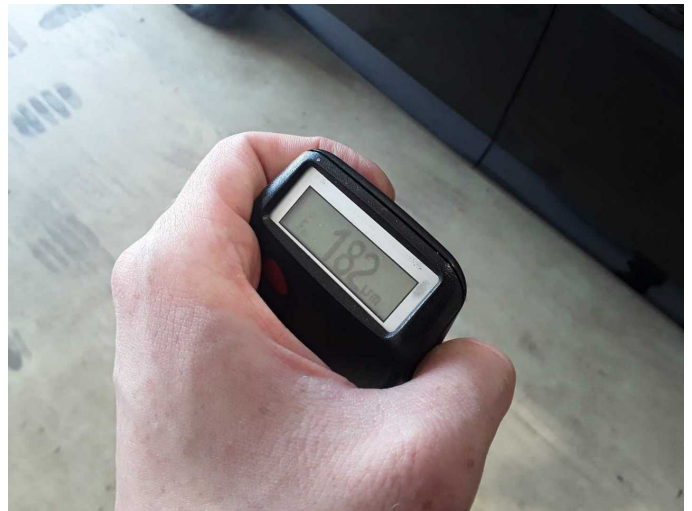
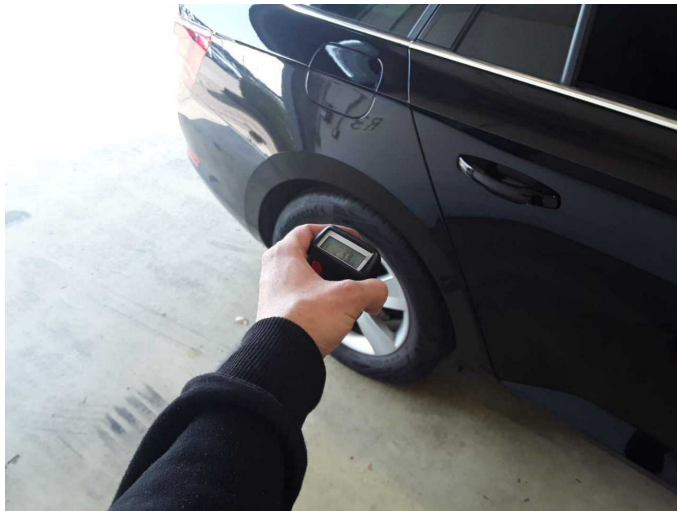
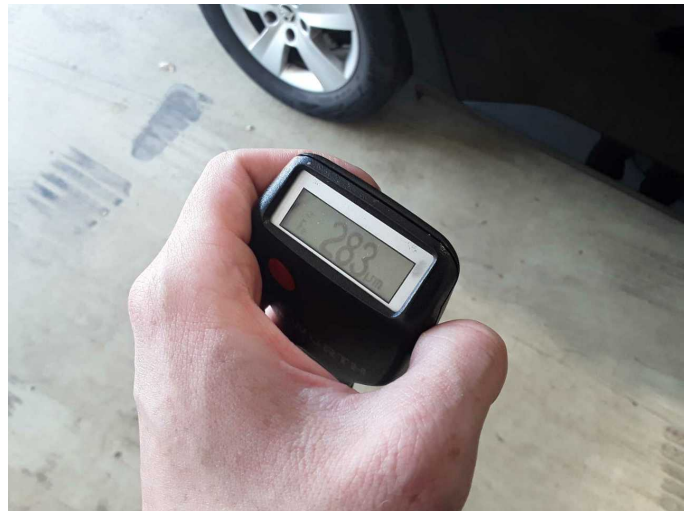
- 1 Mudguard - right side, Side panel - rear right side, Door - rear right side, Door - front right side, Professionally carried out, Invoice of repair done  
Non-existent

Mudguard - right side	338 µm	Side panel - rear right side	283 µm
Door - rear right side	182 µm	Door - front right side	182 µm

**Repainting 1:** Mudguard - right side, Side panel - rear right side, Door - rear right side, Door - front right side
