Expertise

Protocol number: 41667837  
Order No. / Reference: 25150159  
Inspection date: 22 Sept 2025

Manufacturer: Skoda  
VIN: TMBJH7NP8M7067647

Model: Superb Combi 2.0 TDI Ambition

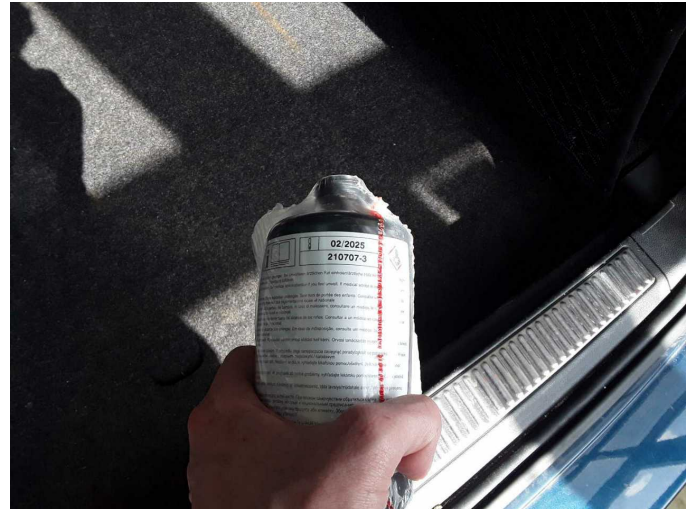
| No. | Component group | Description |
|---|---|---|
| 1 | Equipment | Tirefit filler - Expired - Replace |

**Damage 1:** Equipment: Tirefit filler - Expired - Replace

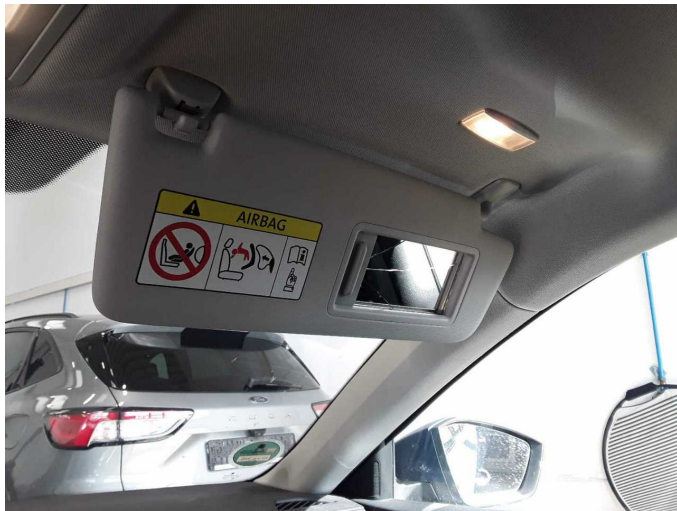
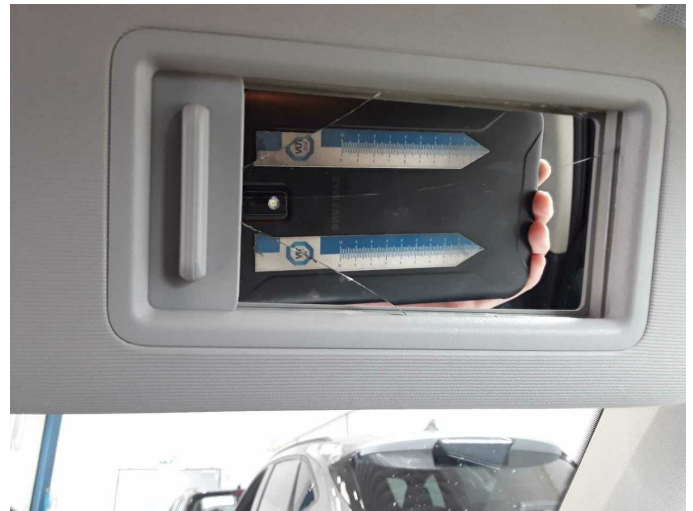
| No. | Component group | Description |
|---|---|---|
| 2 | Interior | Sun visor - right side - Damaged - Replace |

**Damage 2:** Interior: Sun visor - right side - Damaged - Replace

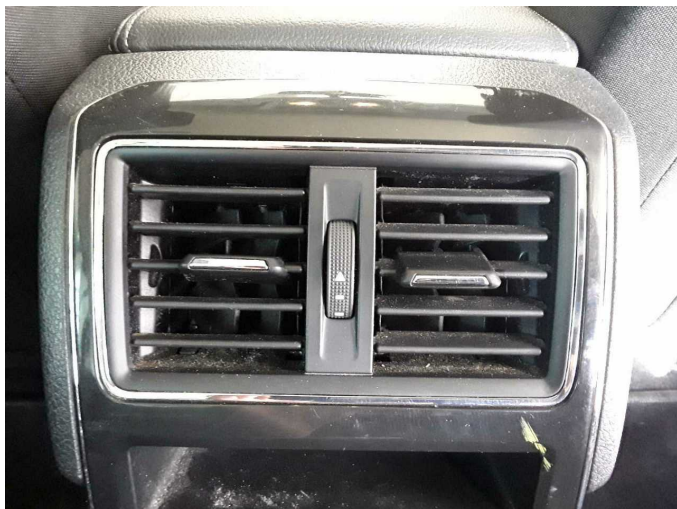
| No. | Component group | Description |
|---|---|---|
| 3 | Instrument panel | Air nozzle - centre - Damaged - Replace |

**Damage 3:** Instrument panel: Air nozzle - centre - Damaged - Replace

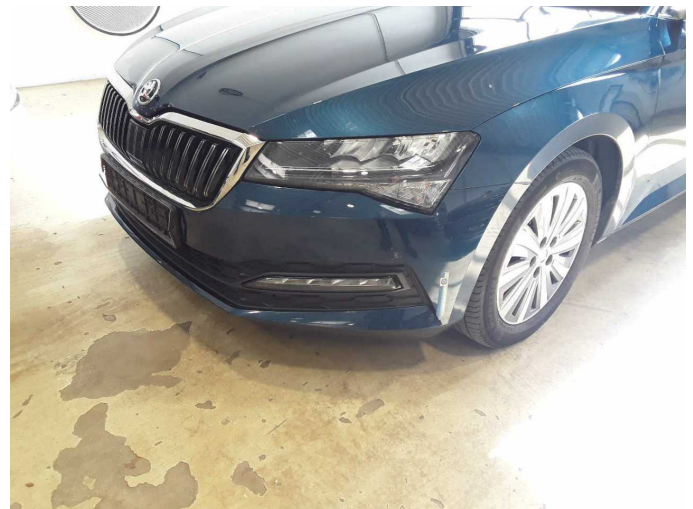
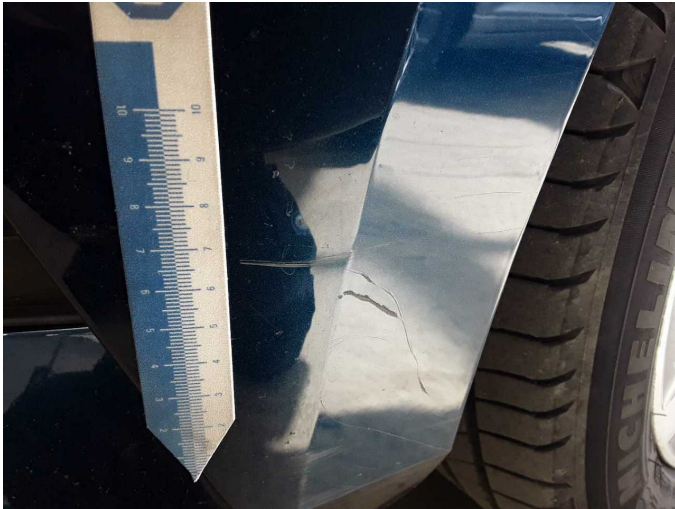
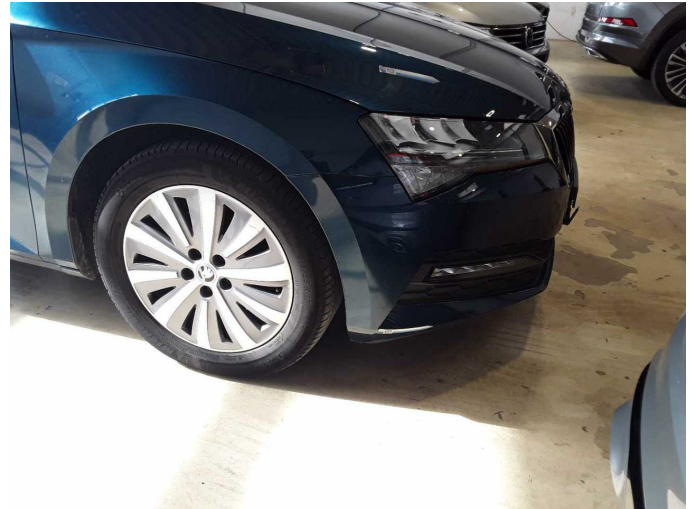
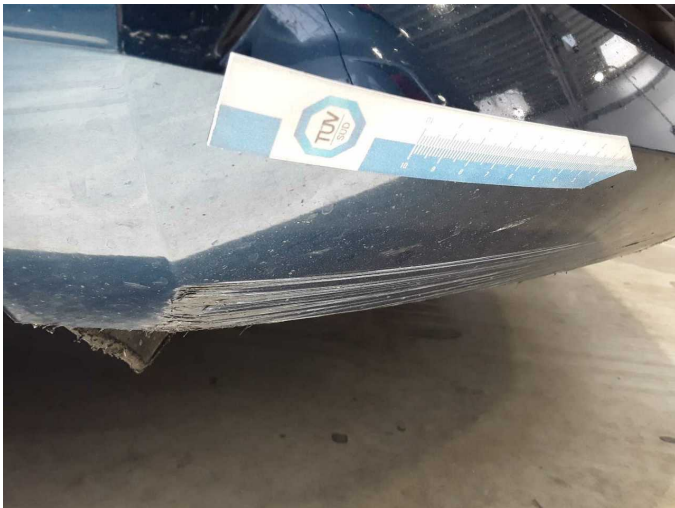
| No. | Component group | Description |
|---|---|---|
| 4 | Front bumper | Front bumper - Scratched - Repair and paint |

**Damage 4:** Front bumper: Front bumper - Scratched - Repair and paint

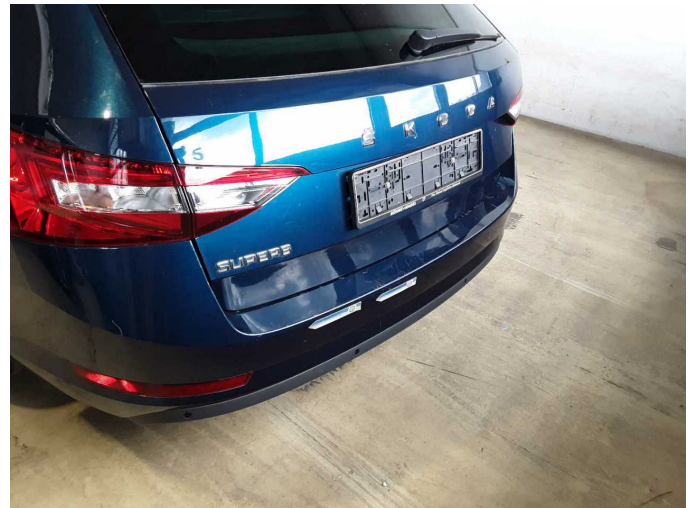
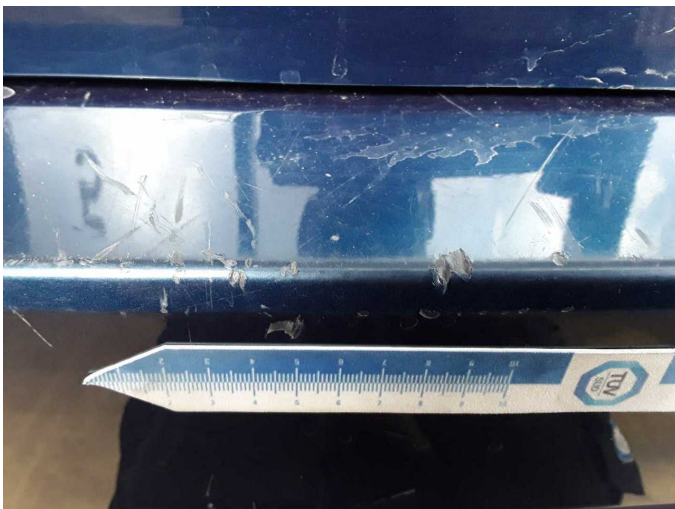
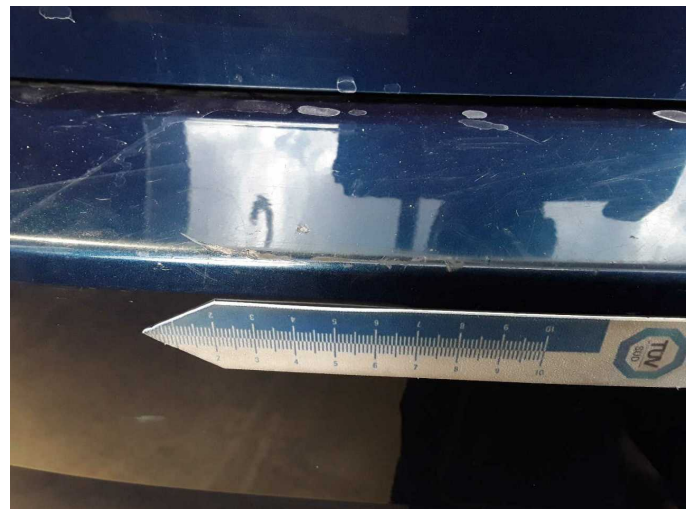
| No. | Component group | Description |
|---|---|---|
| 5 | Rear bumper | Rear bumper - Scratched - Repair and paint |

**Damage 5:** Rear bumper: Rear bumper - Scratched - Repair and paint

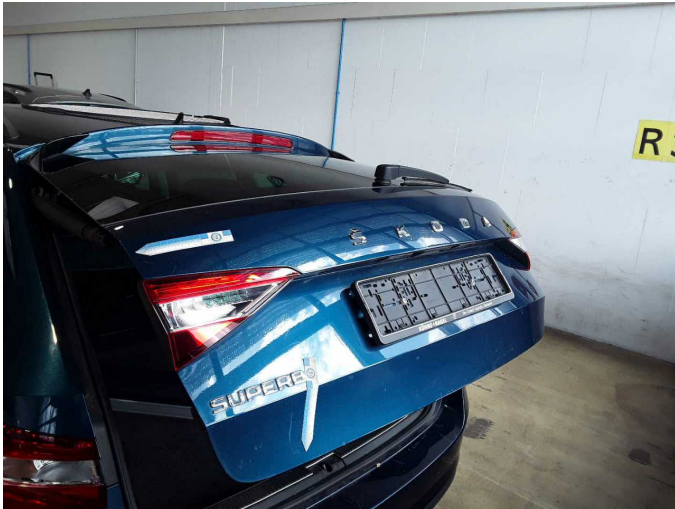
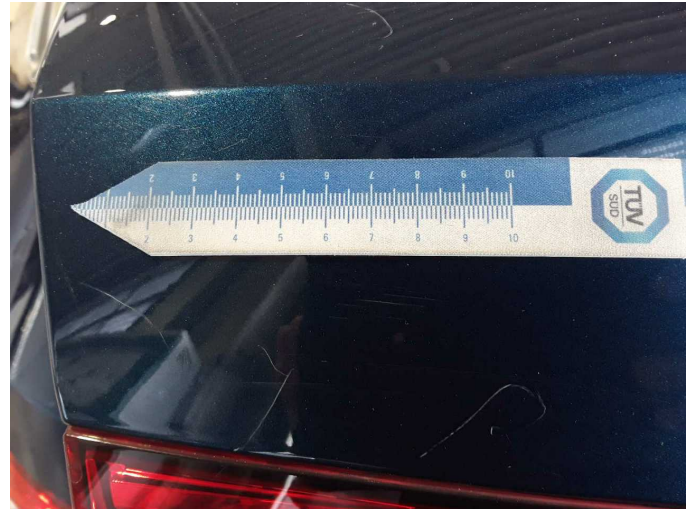
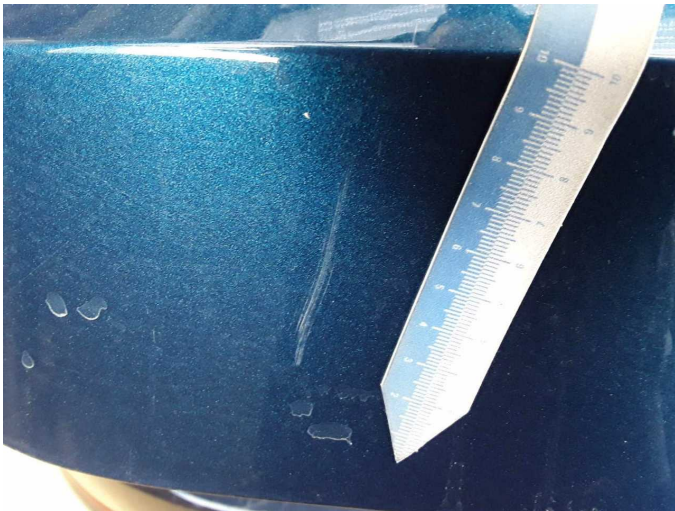
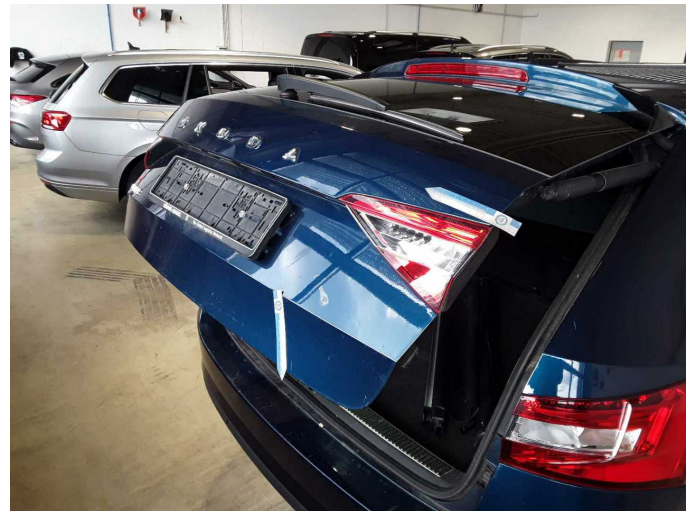
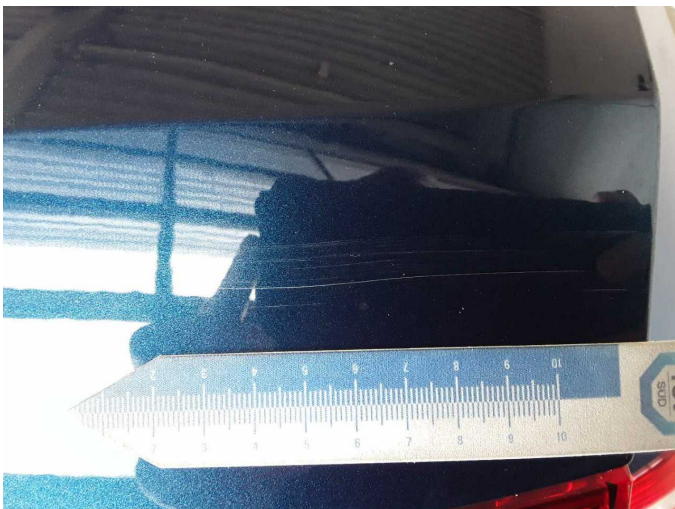
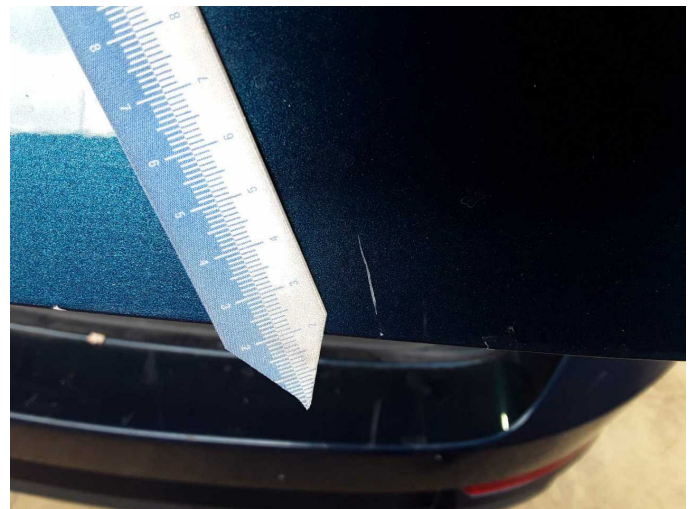
| No. | Component group | Description |
|---|---|---|
| 6 | Boot lid / rear door | Boot lid - Scratch(es) - Paint |

**Damage 6:** Boot lid / rear door: Boot lid - Scratch(es) - Paint

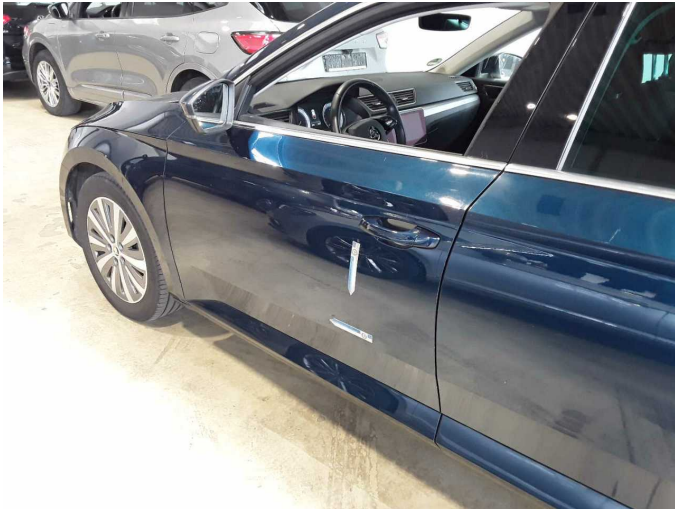
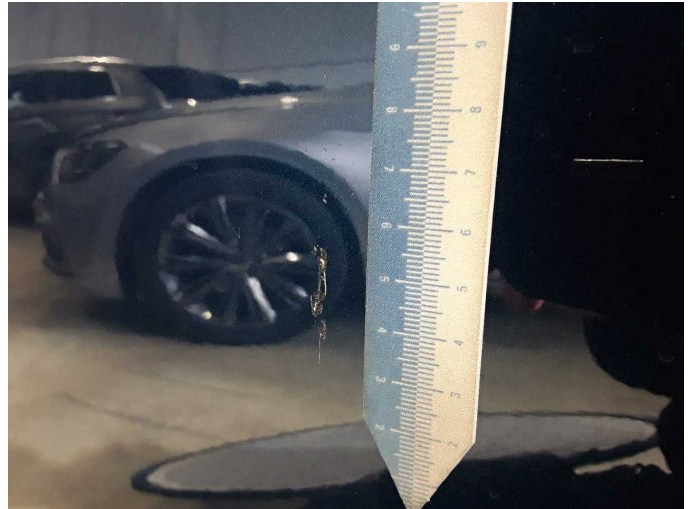
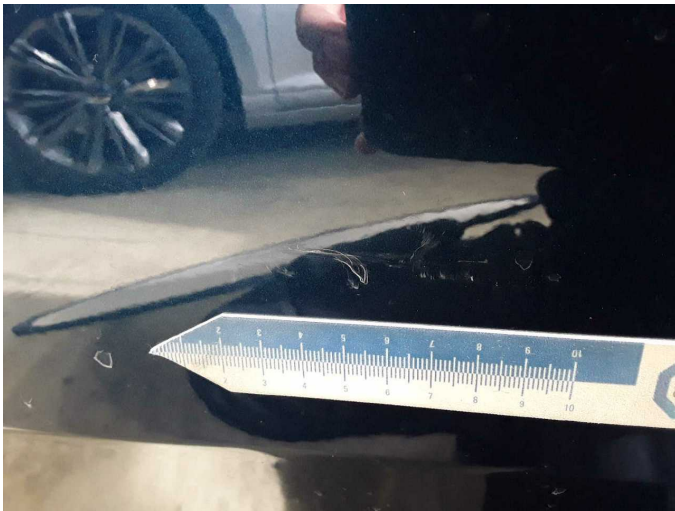
| No. | Component group | Description |
|---|---|---|
| 7 | Door - front left side | Door - Scratch(es) - Paint |

**Damage 7:** Door - front left side: Door - Scratch(es) - Paint

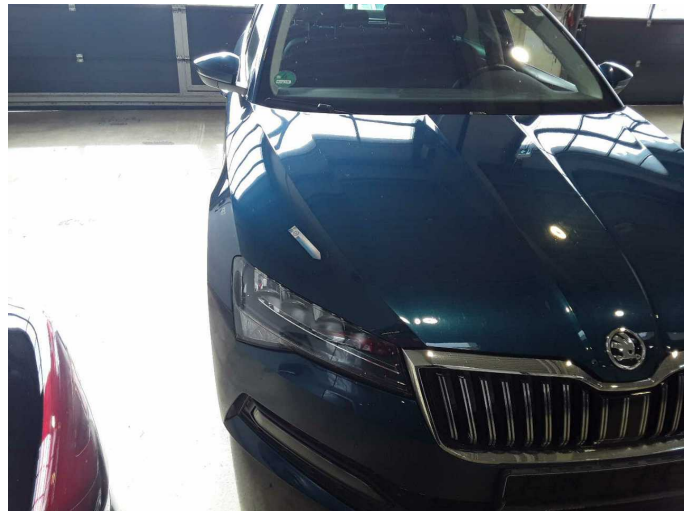
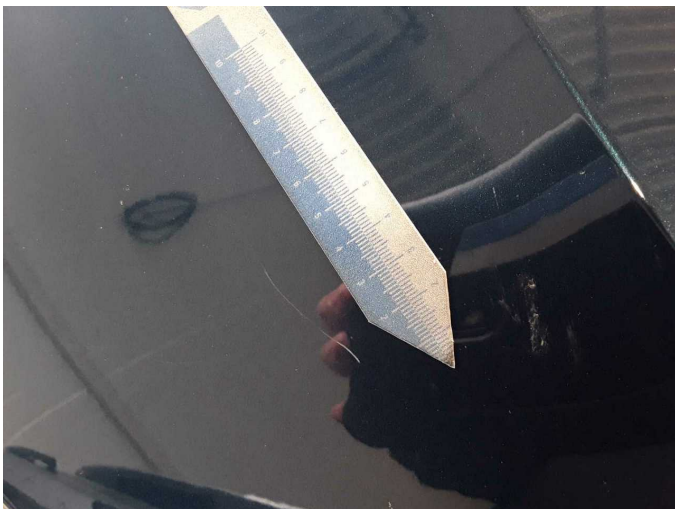
| No. | Component group | Description |
|---|---|---|
| 8 | Bonnet | Bonnet - Scratch(es) - Paint |

**Damage 8:** Bonnet: Bonnet - Scratch(es) - Paint

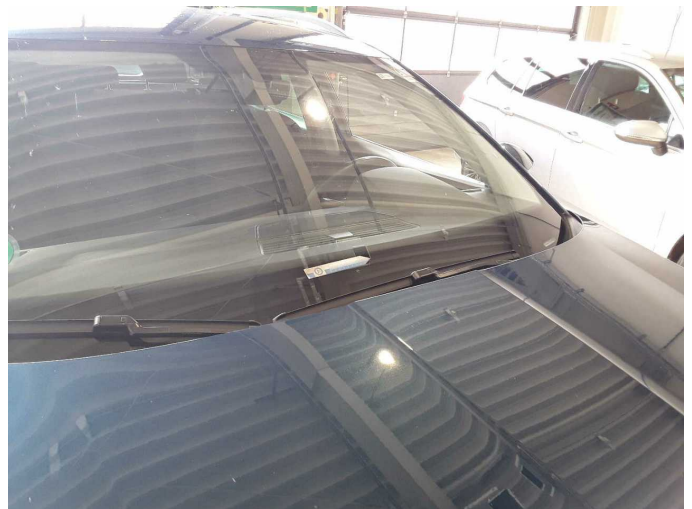
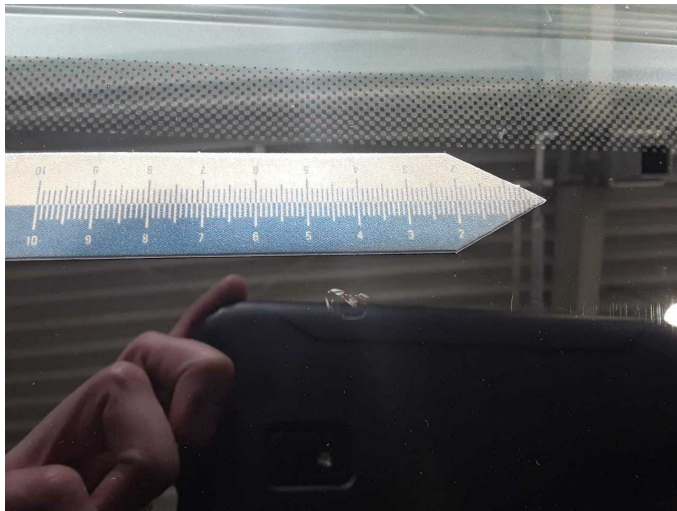
| No. | Component group | Description |
|---|---|---|
| 9 | Vehicle glazing | Windscreen - Damaged - Replace |

**Damage 9:** Vehicle glazing: Windscreen - Damaged - Replace

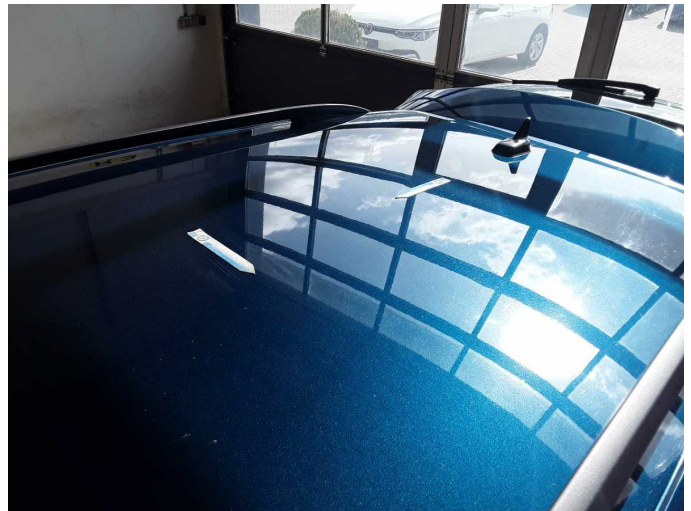
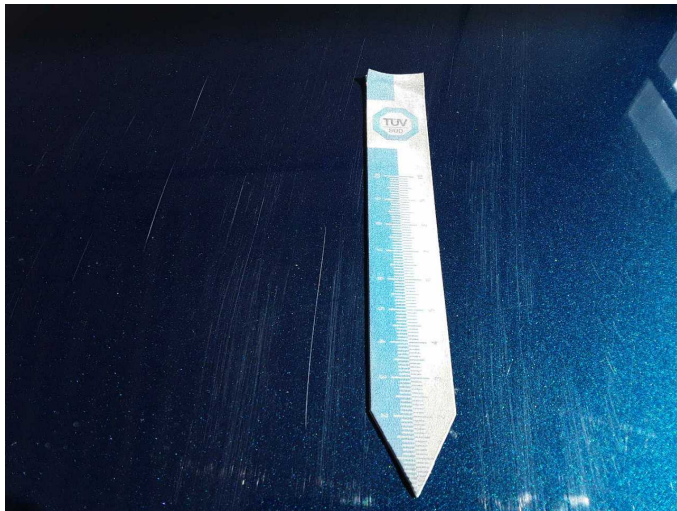
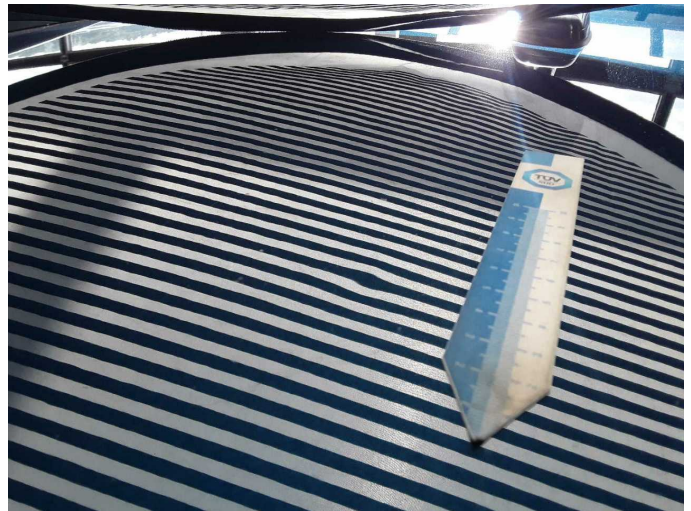
| No. | Component group | Description |
|---|---|---|
| 10 | Roof | Roof (+ Kratzer) - dent(s) - Repair and paint |

**Damage 10:** Roof: Roof (+ Kratzer) - dent(s) - Repair and paint

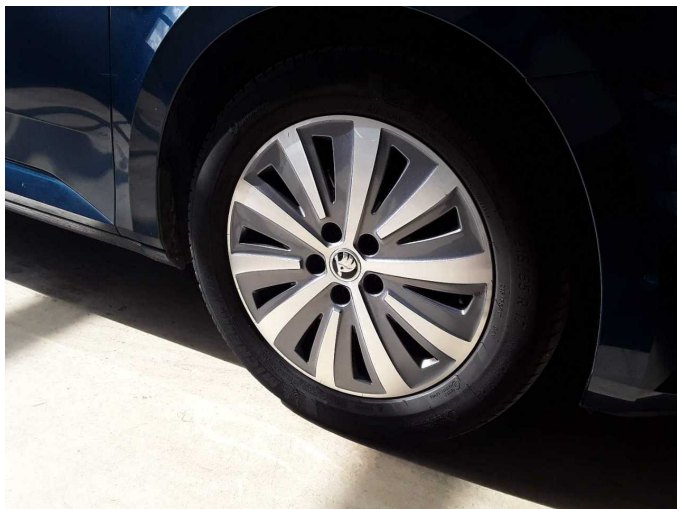
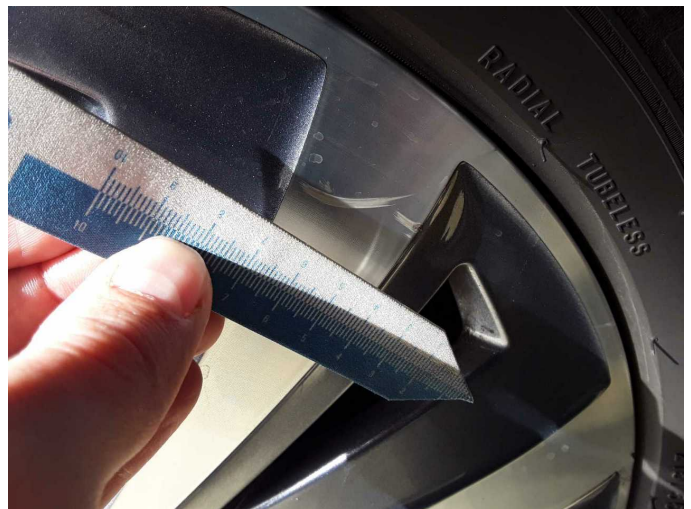
| No. | Component group | Description |
|---|---|---|
| 4 | Wheel / tyres | Alloy rim - front right side - Scratch(es) - No deduction |

**Wear and tear 4:** Wheel / tyres: Alloy rim - front right side - Scratch(es) - No deduction

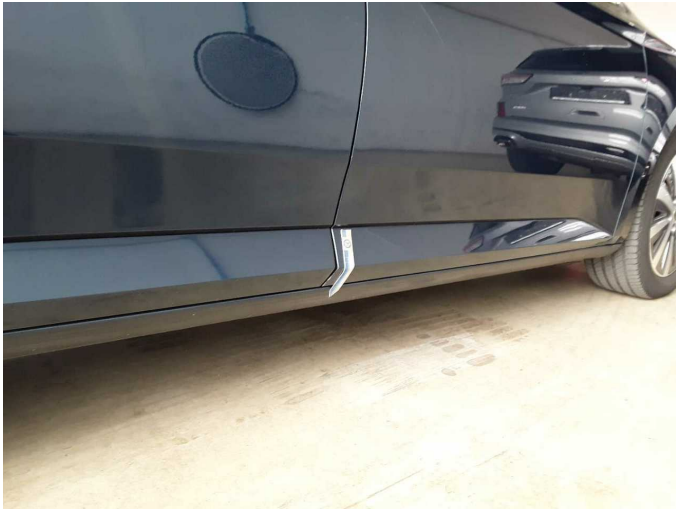
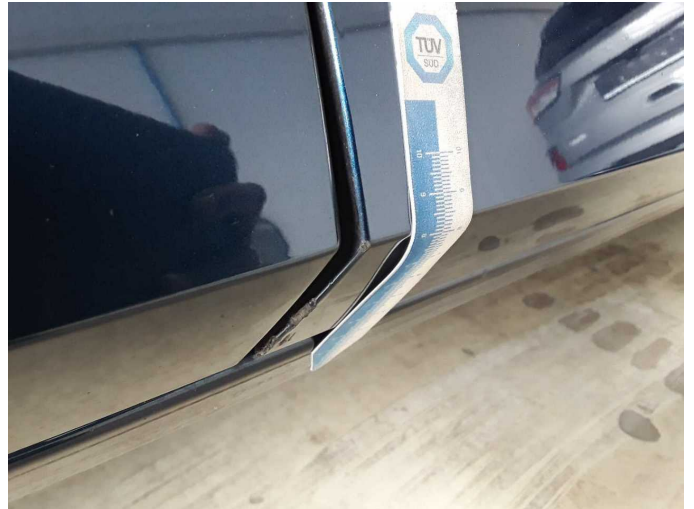
| No. | Component group | Description |
|---|---|---|
| 5 | Door - front right side | Brightware - lower - Scratch(es) - No deduction |

**Wear and tear 5:** Door - front right side: Brightware - lower - Scratch(es) - No deduction

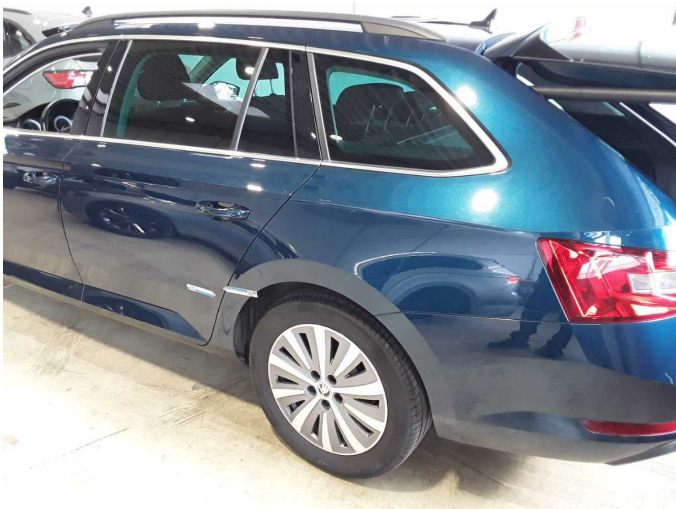
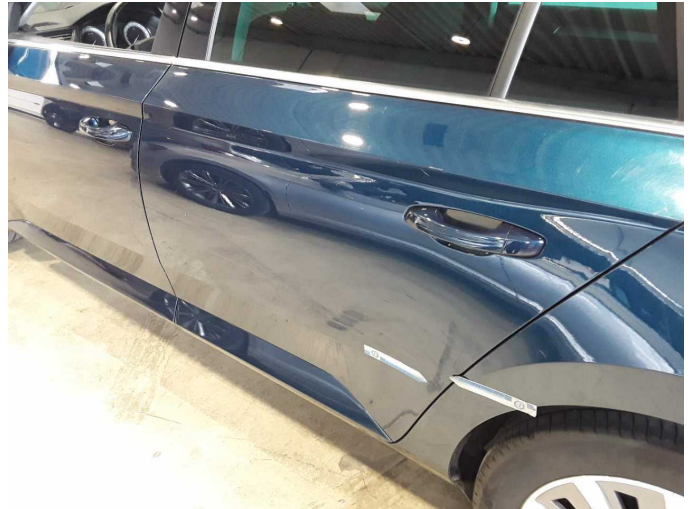
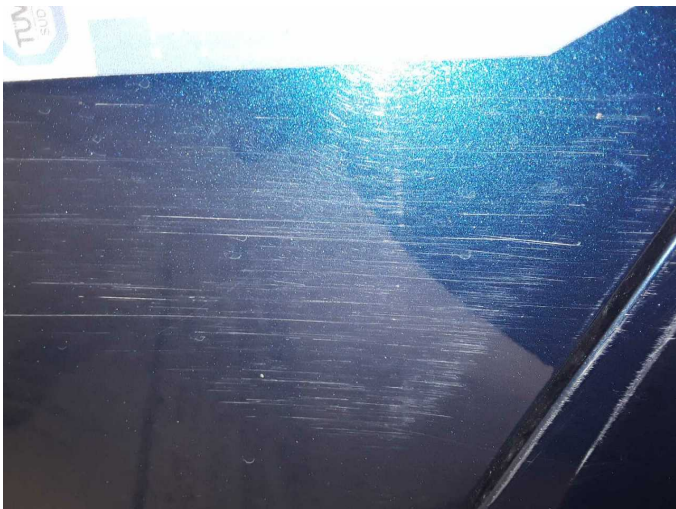
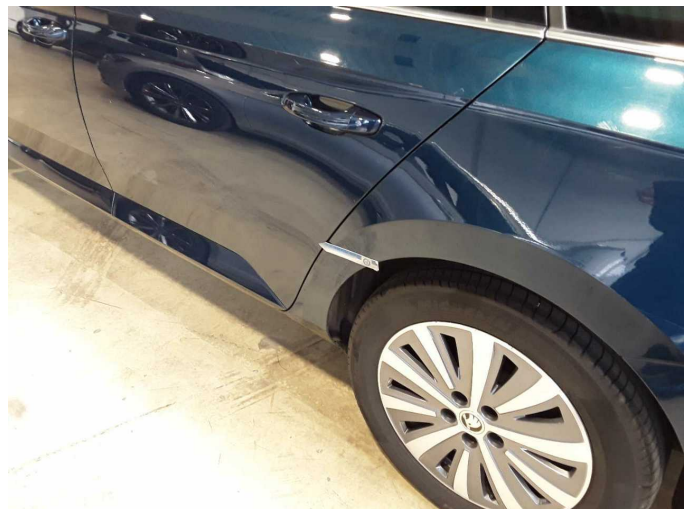
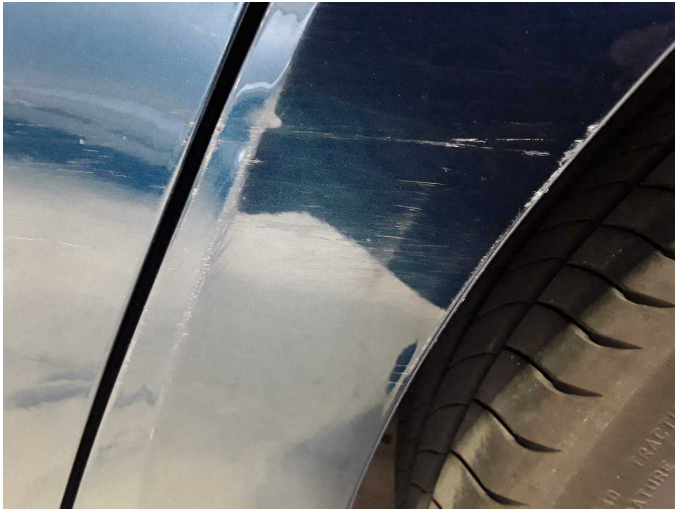
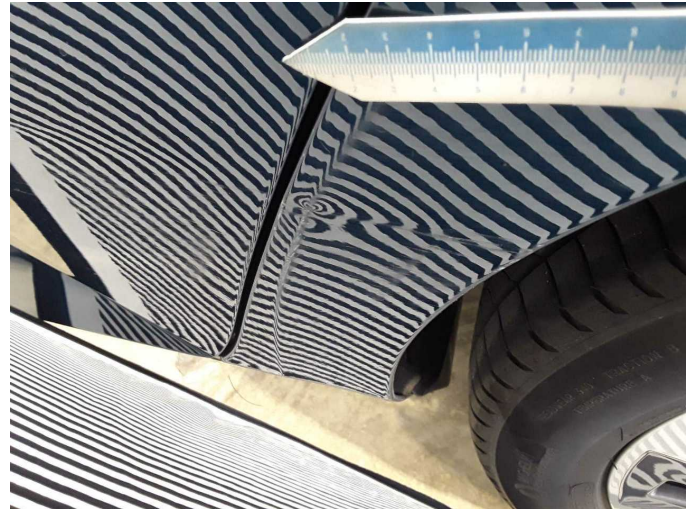
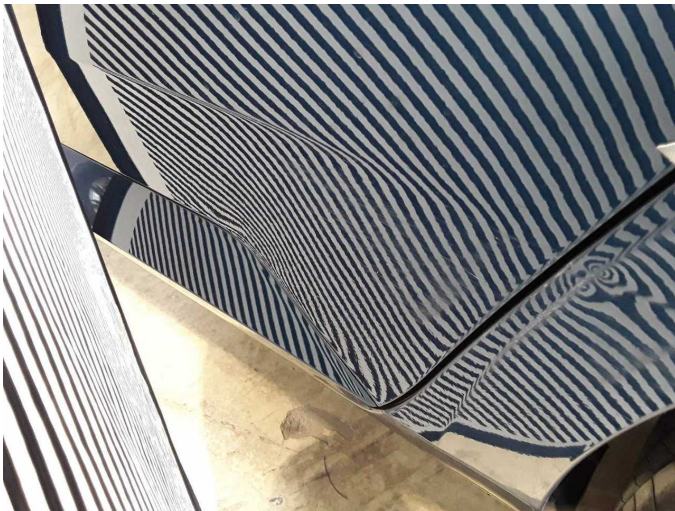
**Accident 1:** Side - left

**Accident 1: Side - left**

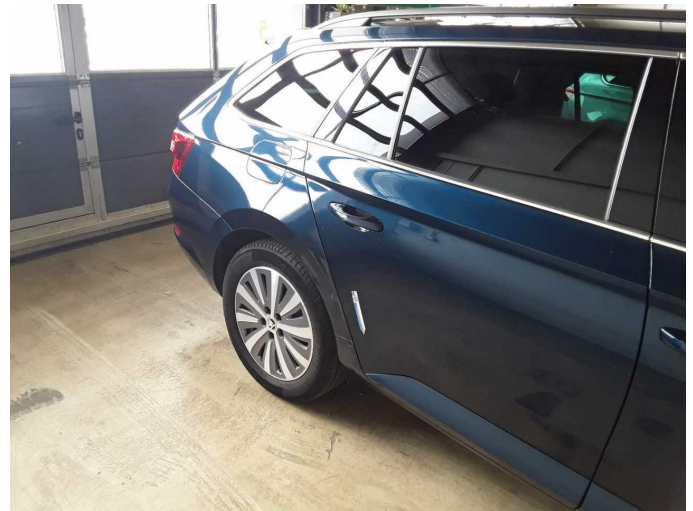
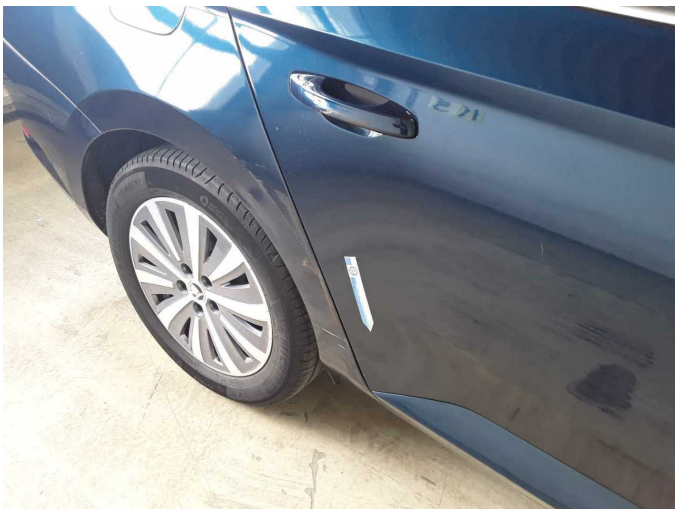
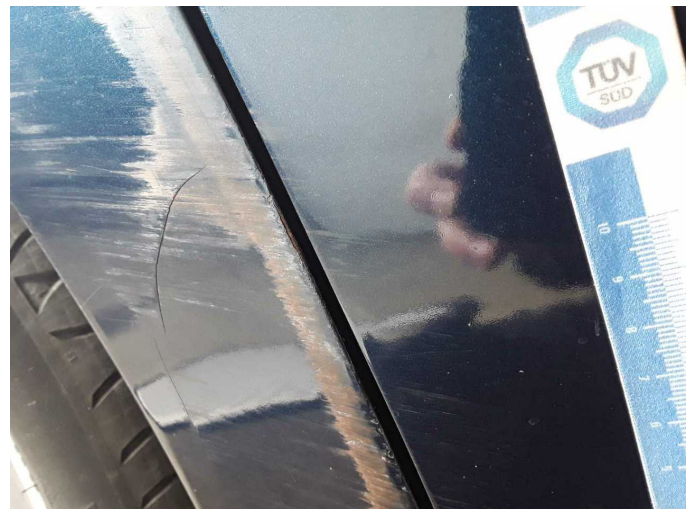
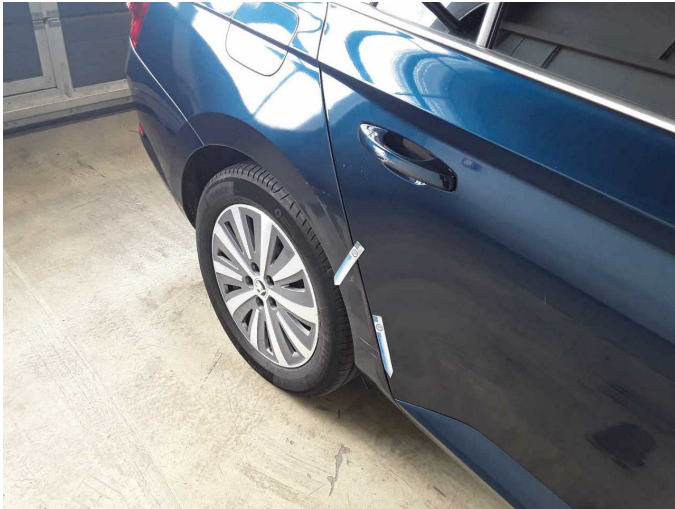
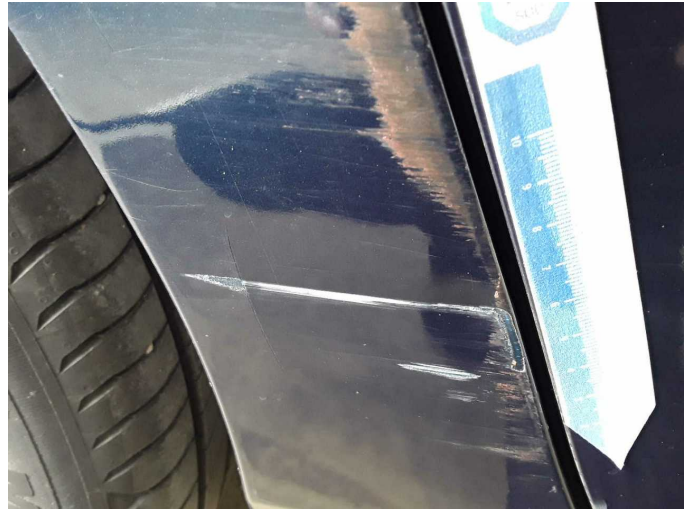
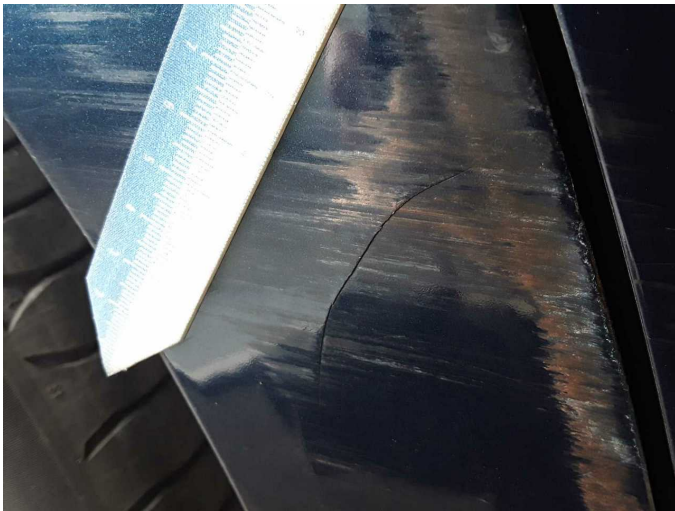
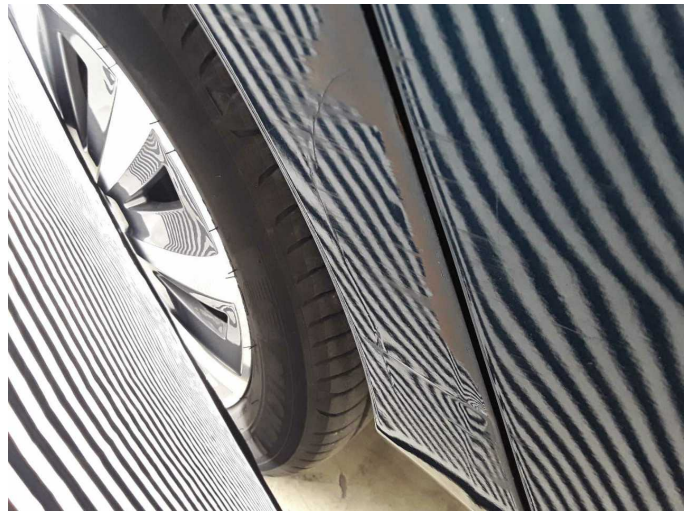
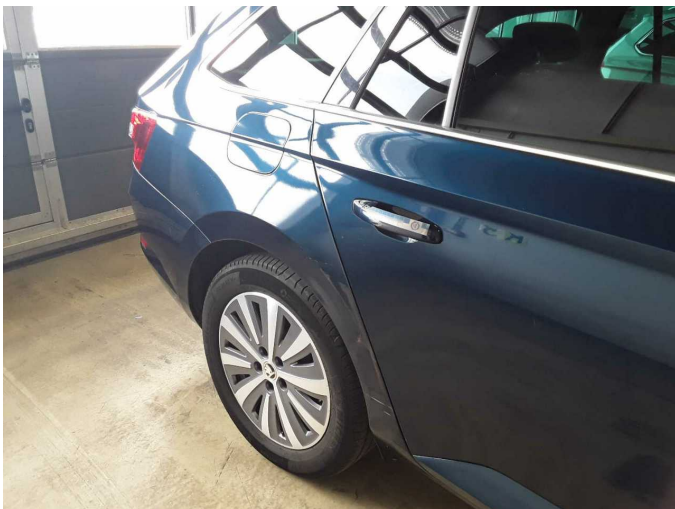
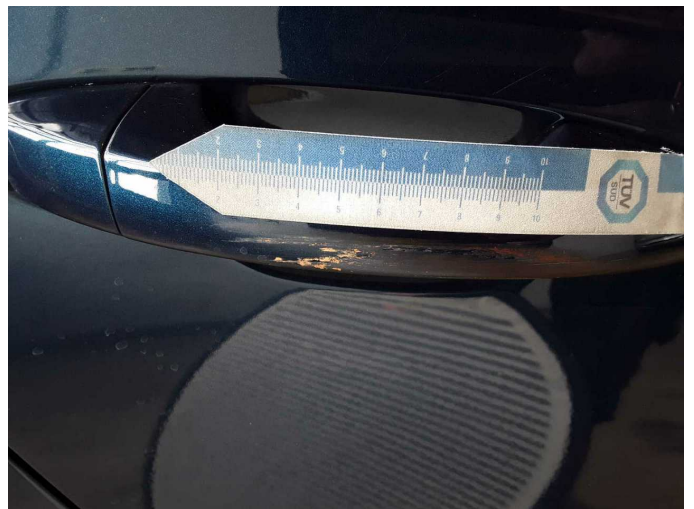
| No. | Previous damage | Extent of damage (Net) |
|---|---|---|
| 1 | Side right, Provided by user / customer, from 29 Oct 2023 | 1.585,77 € |

**Accident 2: Side right**

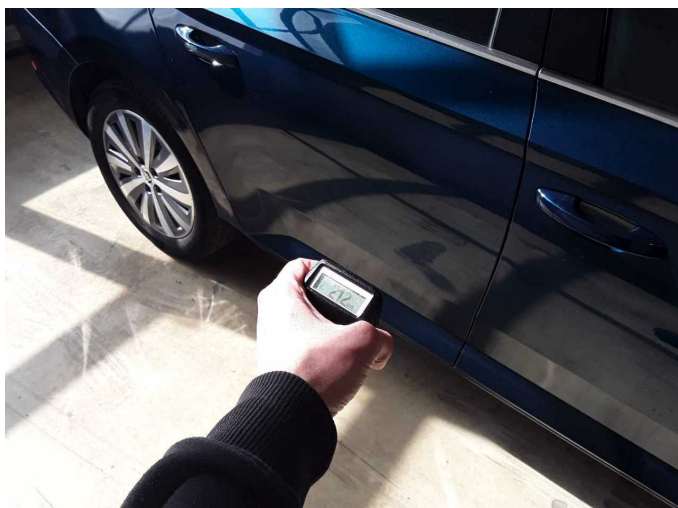
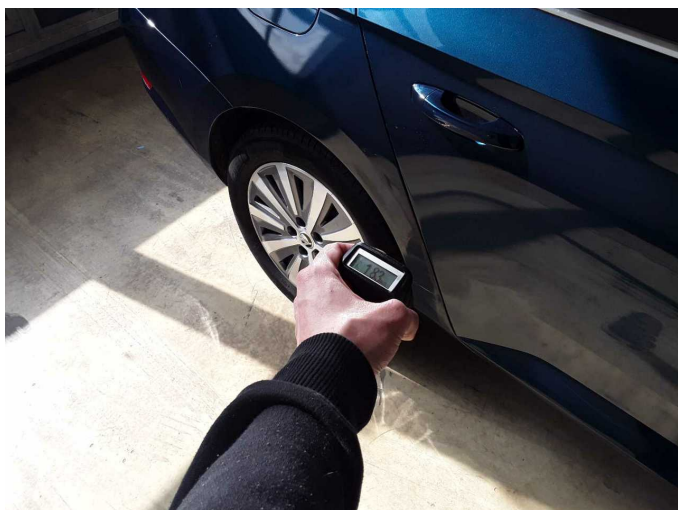
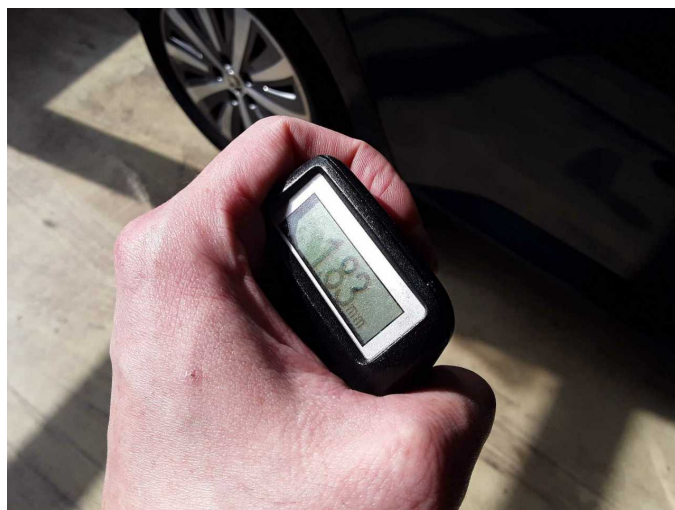
- 1 Side panel - rear right side, Door - rear right side, Professionally carried out, Invoice of repair done Non-existent

| Side panel - rear right side | 1,830<br>µm | Door - rear right side | 212 µm |

**Repainting 1:** Side panel - rear right side, Door - rear right side
