Expertise

Protocol number: 41186826  
Order No. / Reference: 25036588  
Inspection date: 20 Aug 2025

Manufacturer: Skoda  
VIN: TMBJH7NP8N7029322

Model: Superb Combi 2.0 TDI DSG Ambition

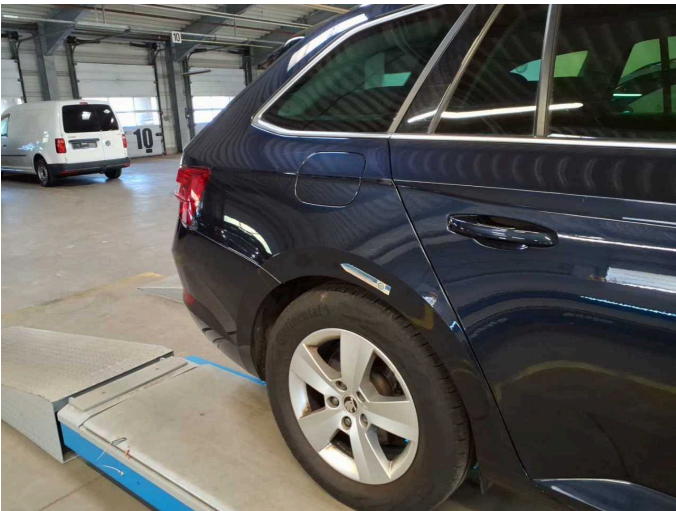
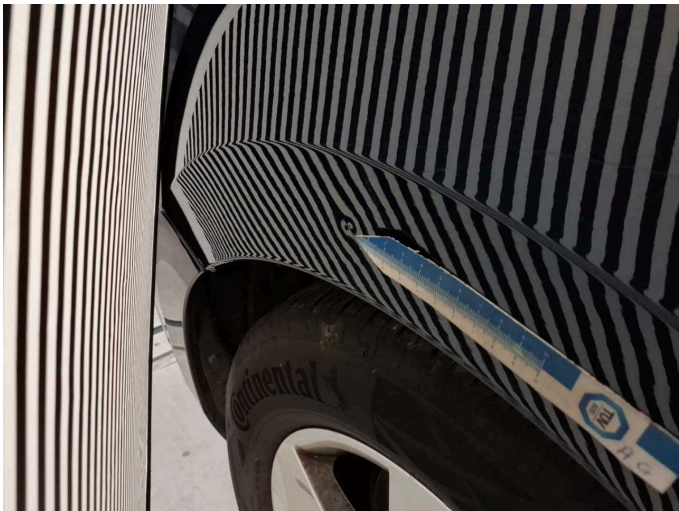
Damage 1: Side panel - rear right side: Side panel - dent(s) - Smooth repair work

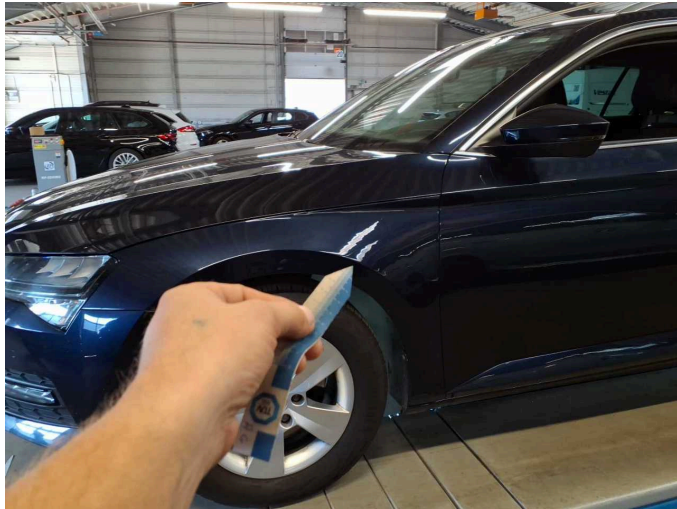
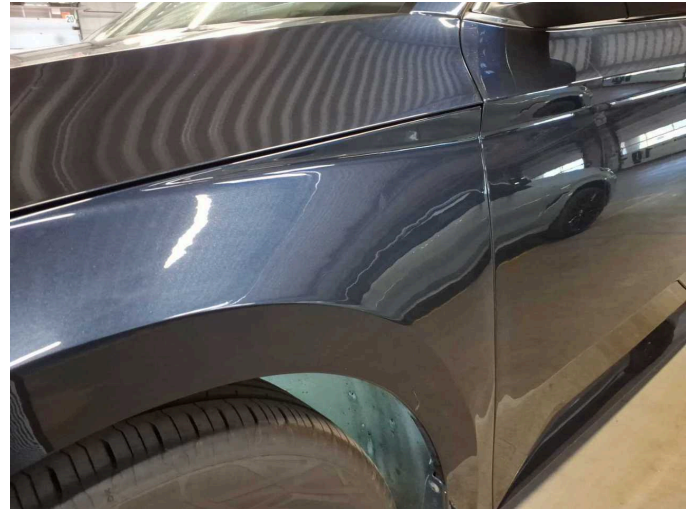
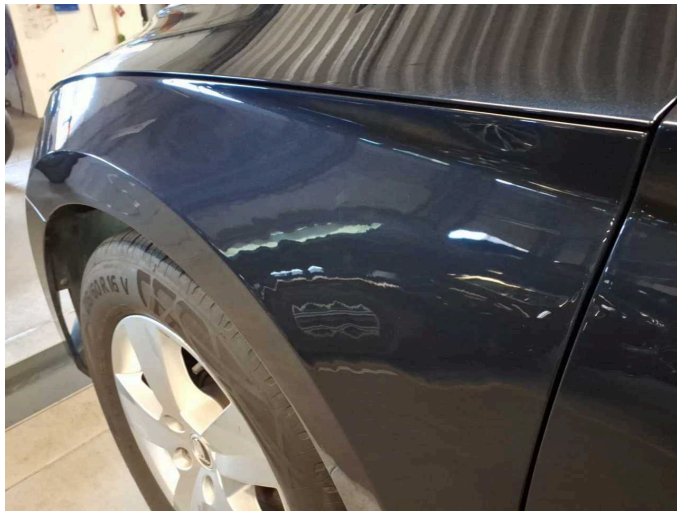
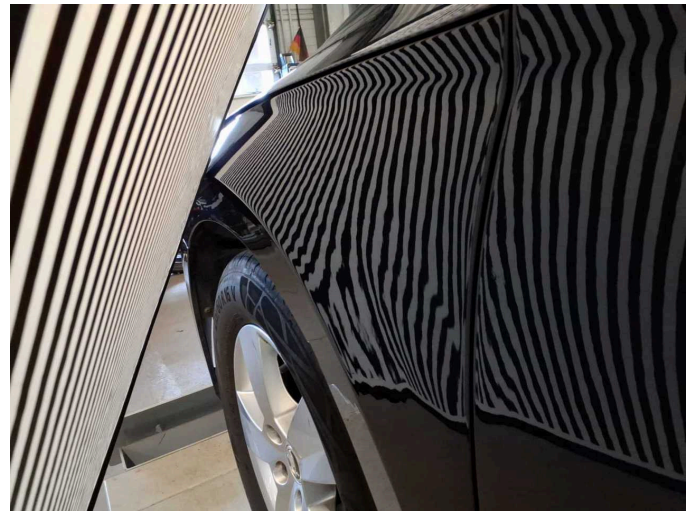
Mudguard - left side	2,063 µm	Door - front left side	448 µm
----------------------	-------------	------------------------	--------

**Damage 2:** Mudguard - left side: Mudguard - left side (Schleifspuren, wellig) - Unprofessionally repaired - Repair and paint

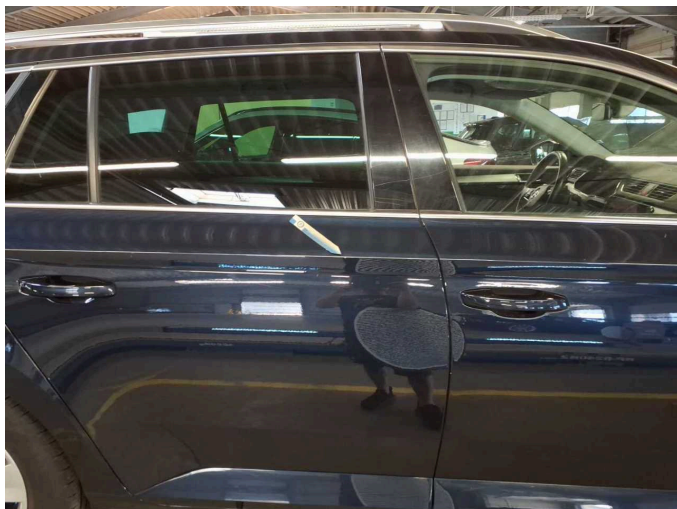
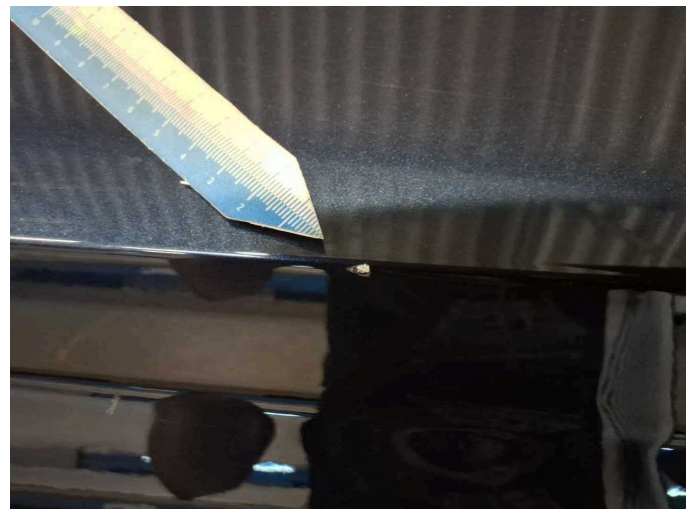
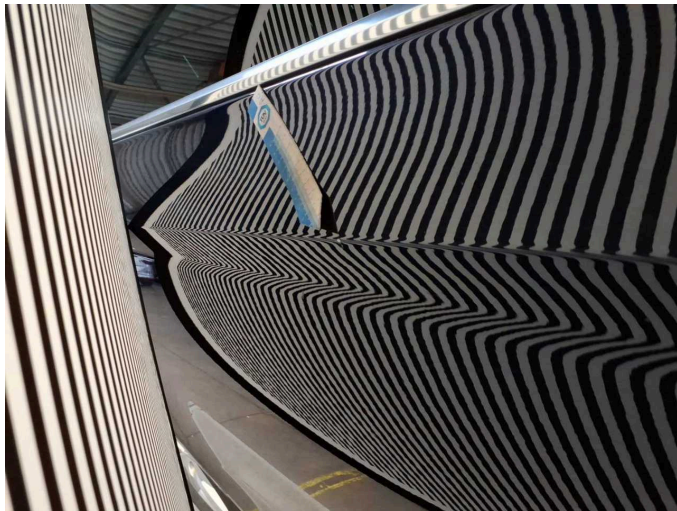
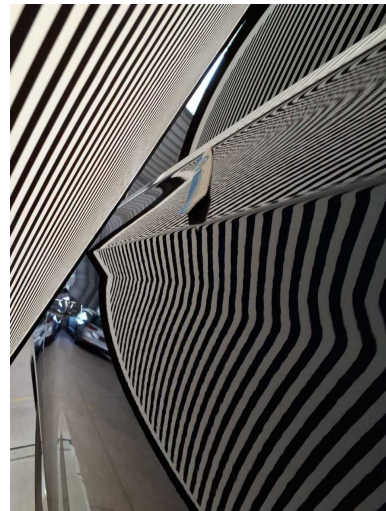
**Damage 3:** Door - rear right side: Door (Delle geht über die Kante) - Dent / paintcoat damage - Repair and paint

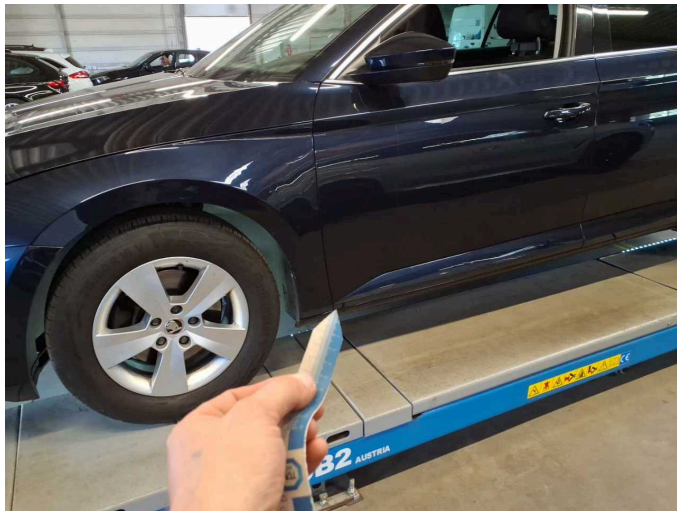
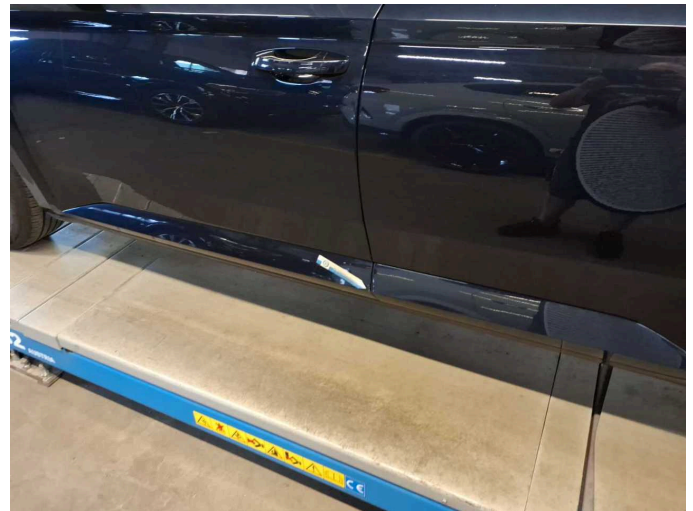
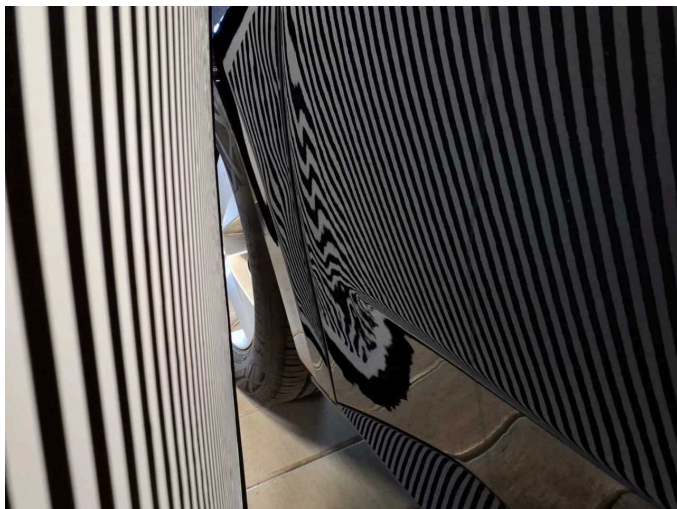
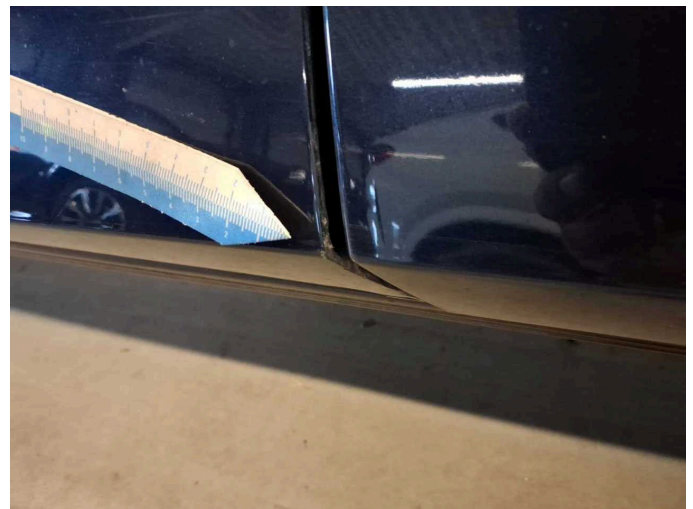
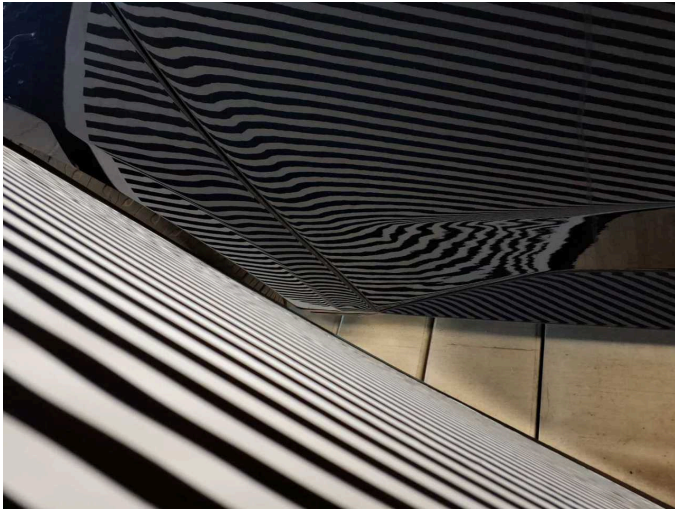
**Damage 4:** Door - front left side: Door (Wellig) - Unprofessionally repaired - Repair and paint

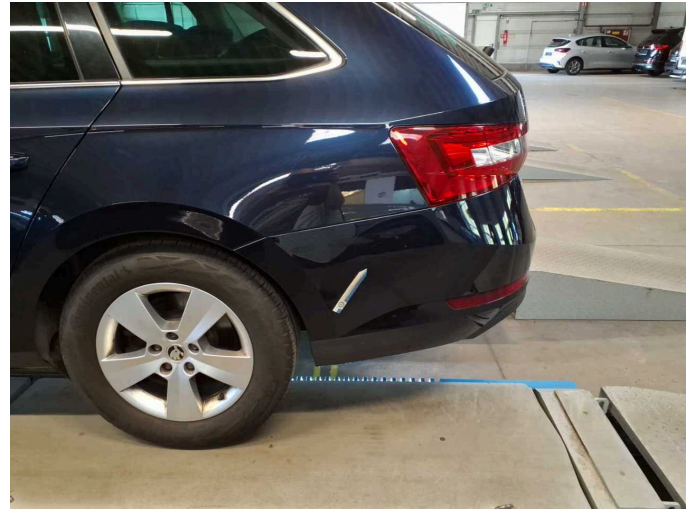
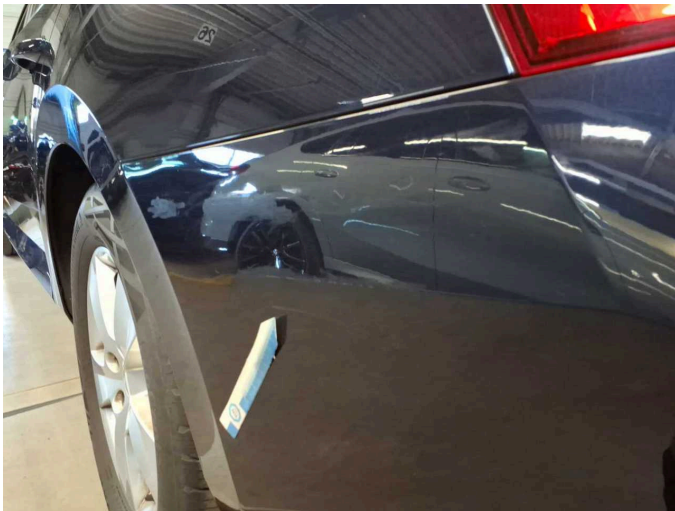
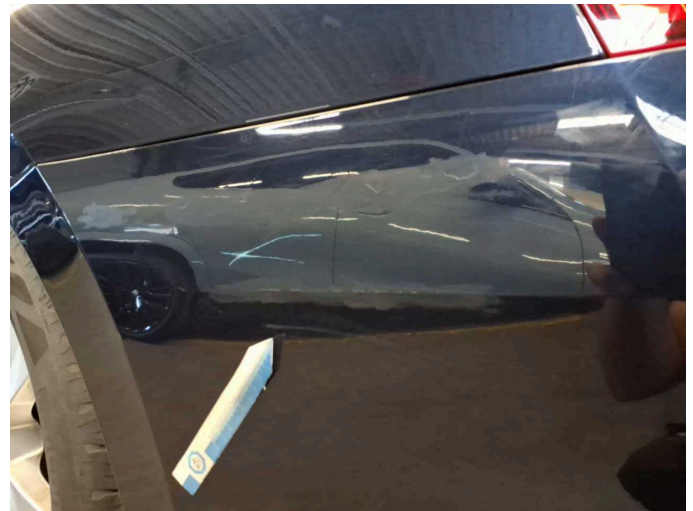
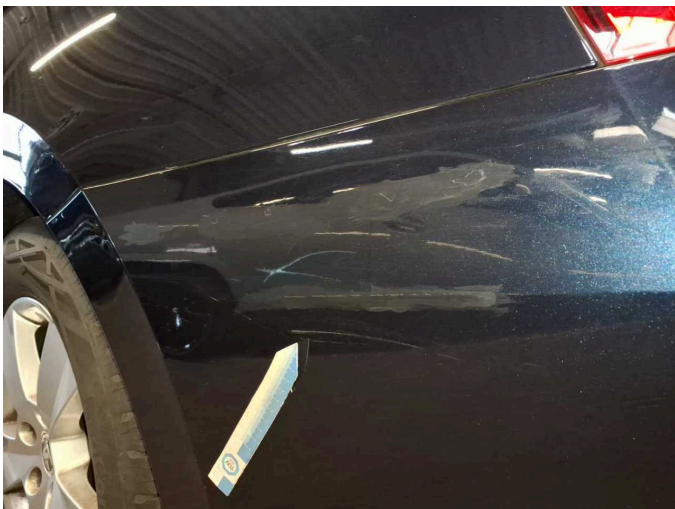
**Damage 5:** Rear bumper: Rear bumper - Scratched - Paint

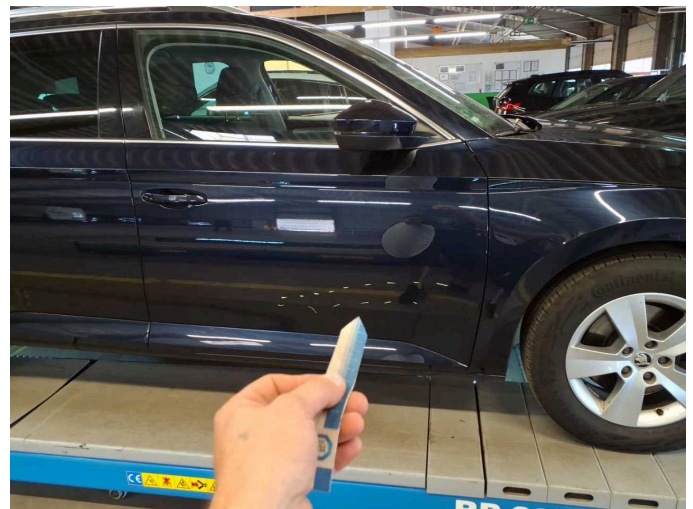
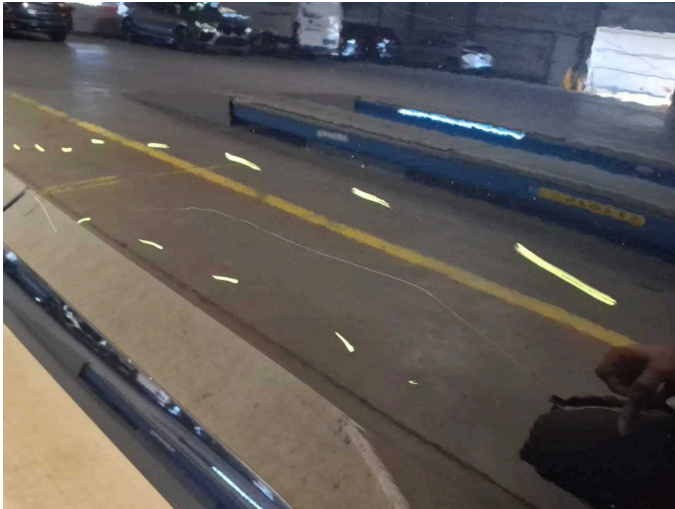
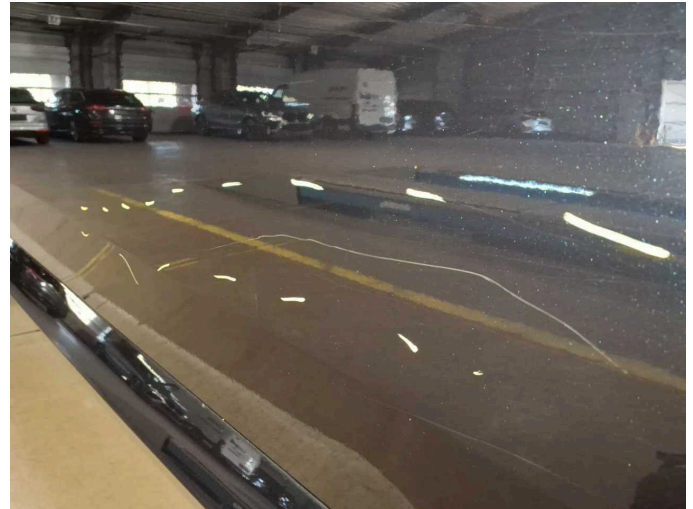
**Damage 6:** Door - front right side: Door - Scratch(es) - Paint

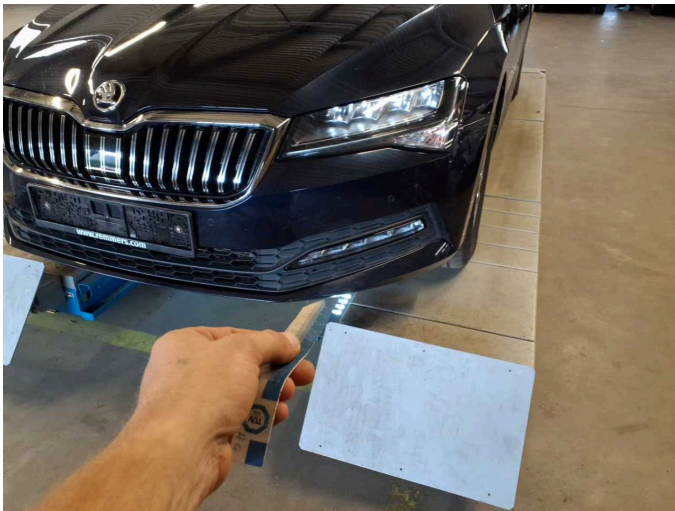
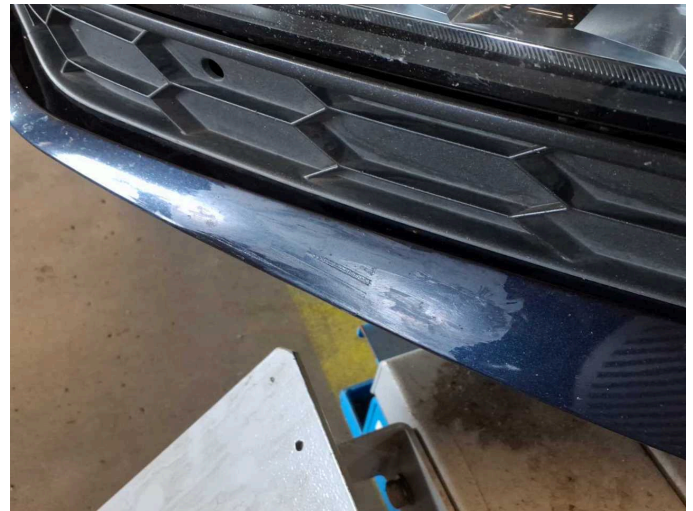
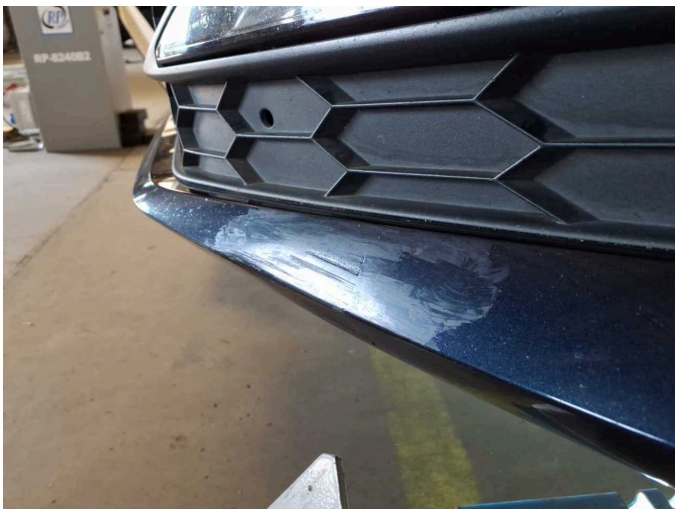
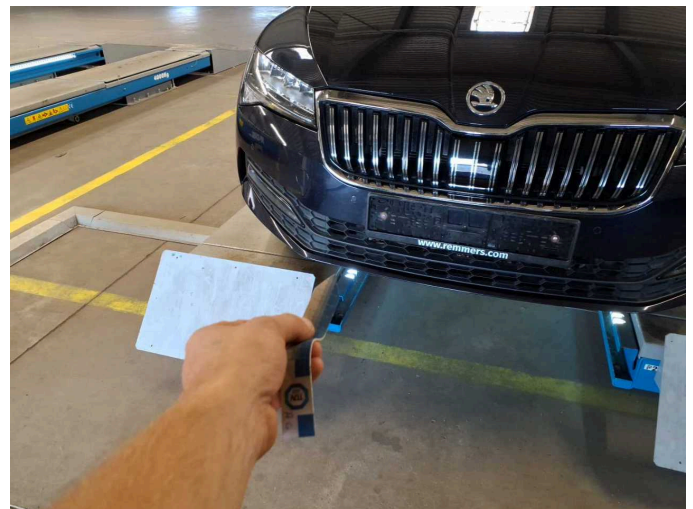
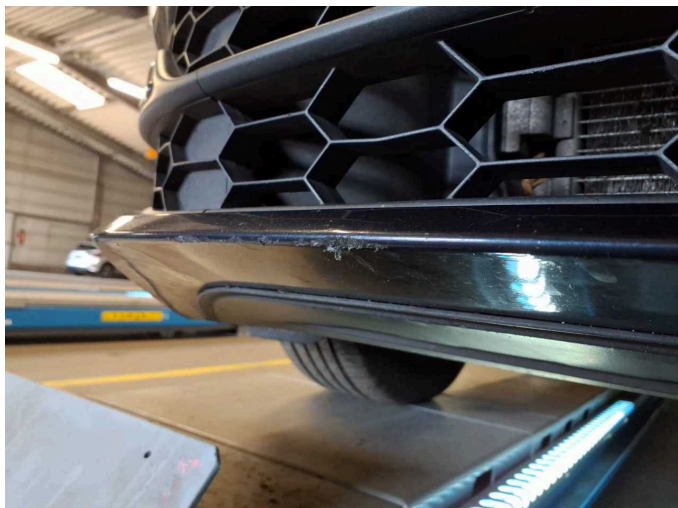
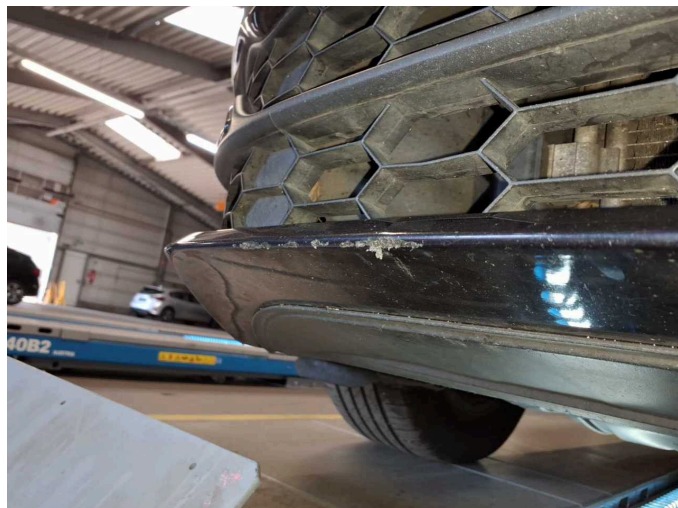
**Damage 7:** Front bumper: Front bumper - Scratched - Repair and paint

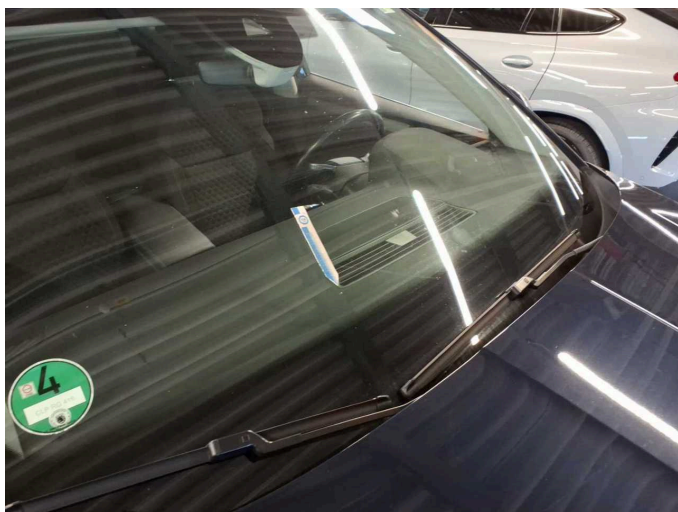
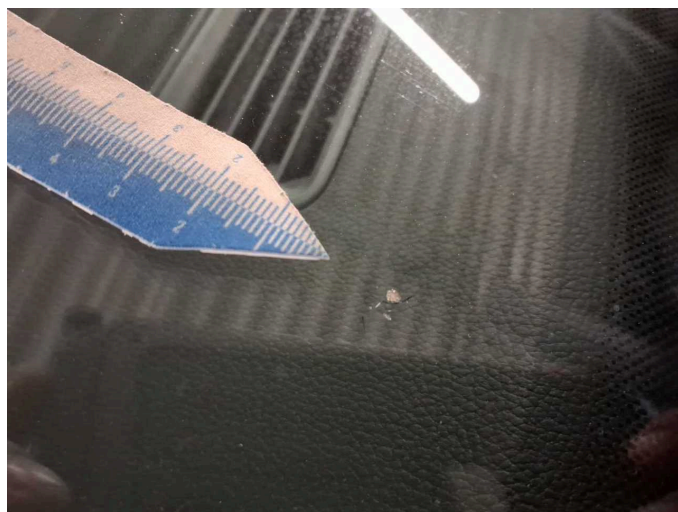
**Damage 8:** Vehicle glazing: Windscreen (Rissbildung) - Stone chips - Replace
