Expertise

Protocol number: 41544875
Order No. / Reference: 25189453
Inspection date: 16 Sept 2025

Manufacturer: Skoda
VIN: TMBJH9NP2L7078718

Model: Superb Combi 2.0 TDI DSG Ambition

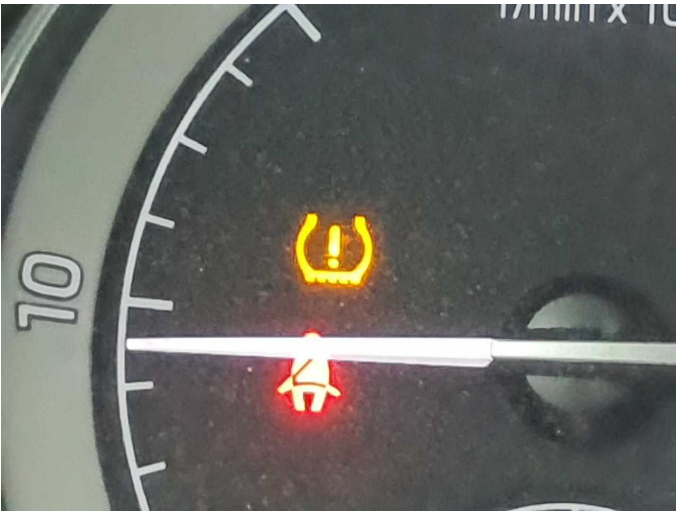
Damage 1: Instrument panel: Indicator light (RDK) - on - Perform diagnosis

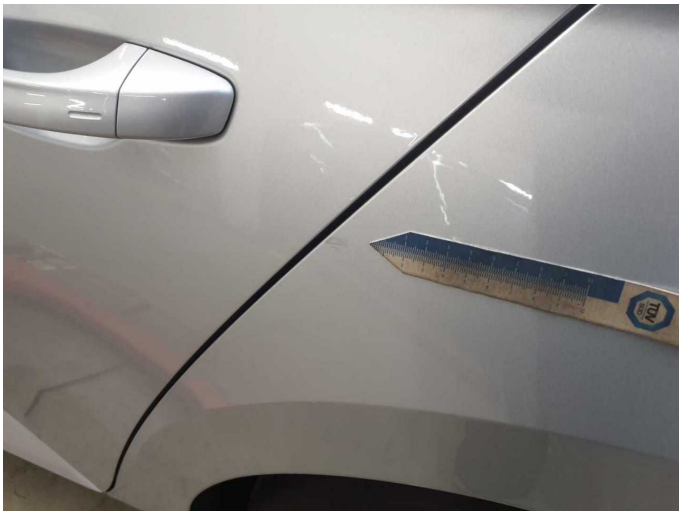
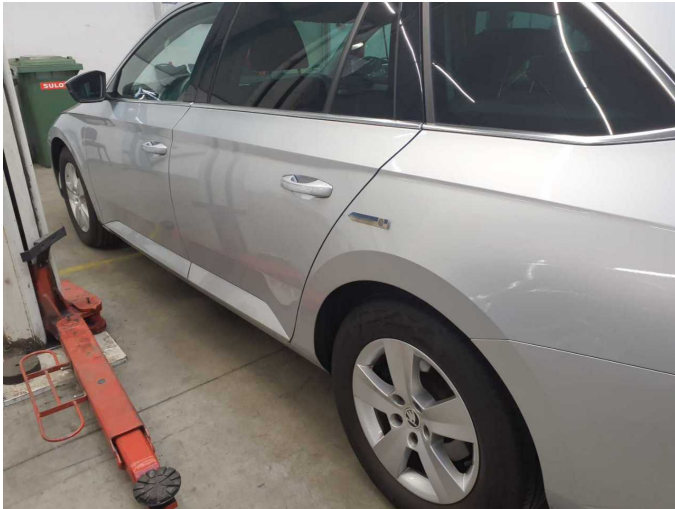
Damage 2: Side panel - rear left side: Side panel - Scratch(es) - Smart repair

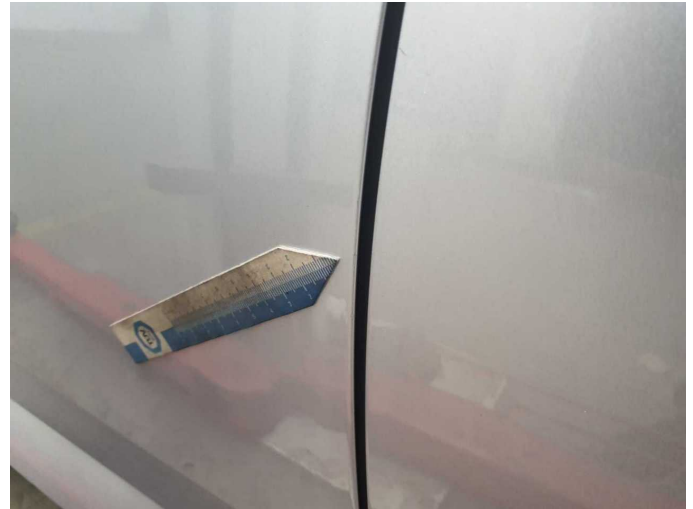
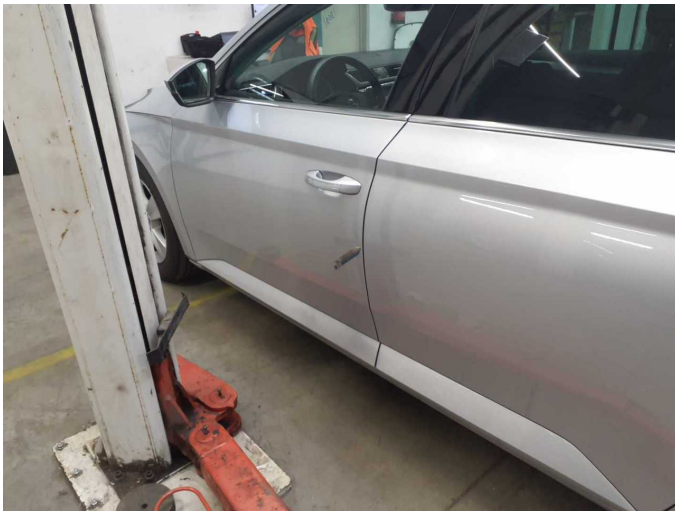
Damage 3: Door - front left side: Door edge - Scratch(es) - Smart repair

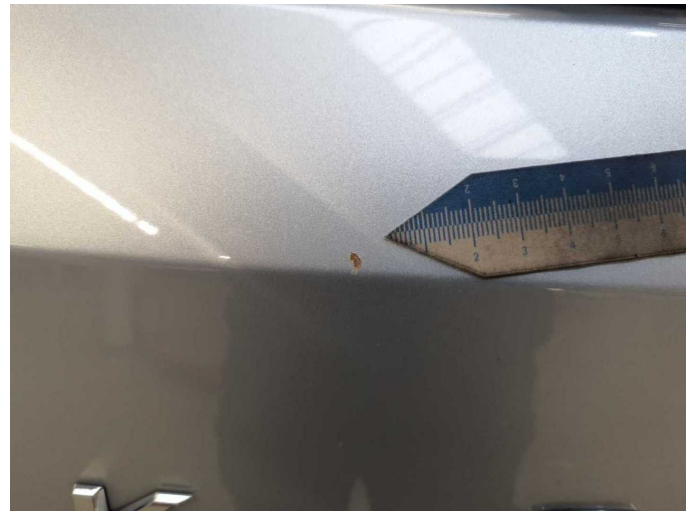
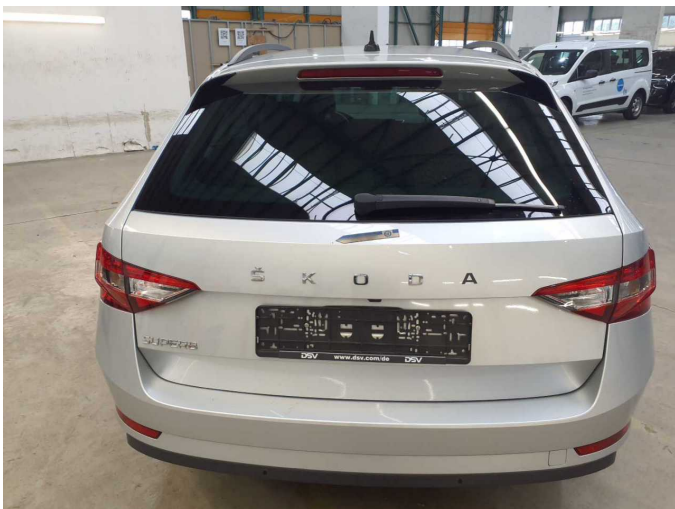
Damage 4: Boot lid / rear door: Boot lid - Scratch(es) - Smart repair

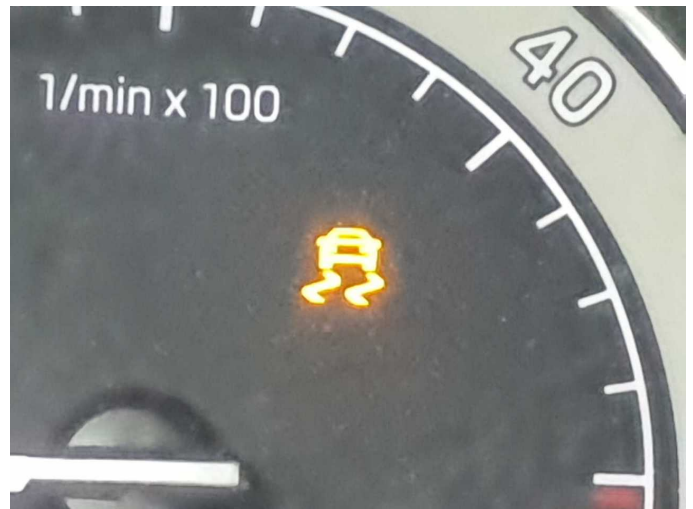
Damage 5: Instrument panel: Indicator light (ESP) - on - Perform diagnosis

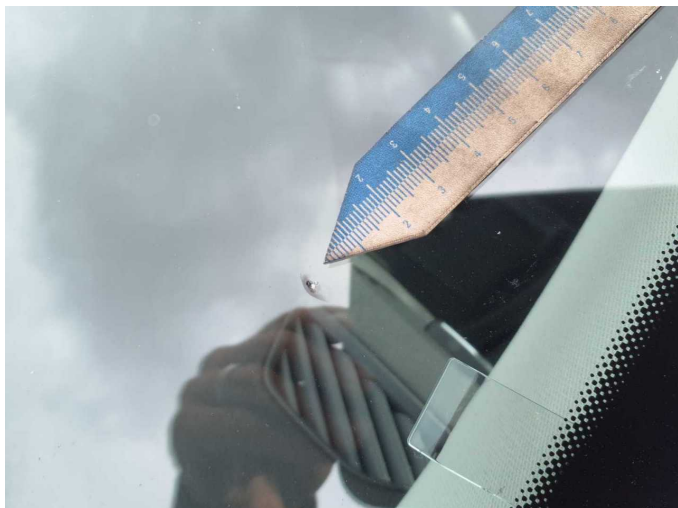
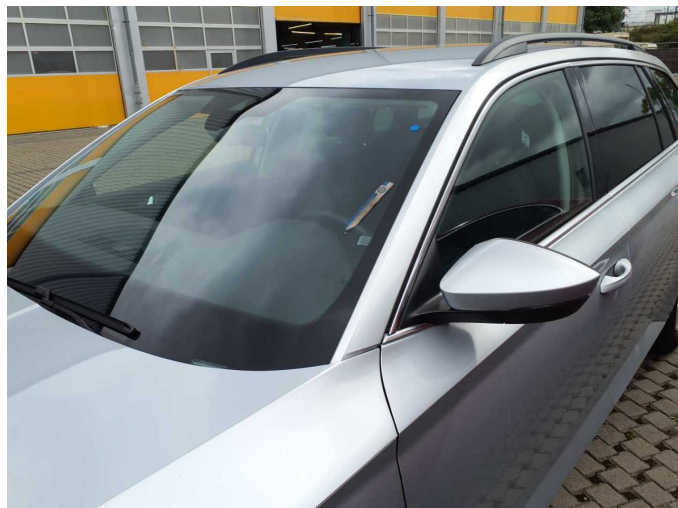
Damage 6: Vehicle glazing: Windscreen - Stone chips - Replace

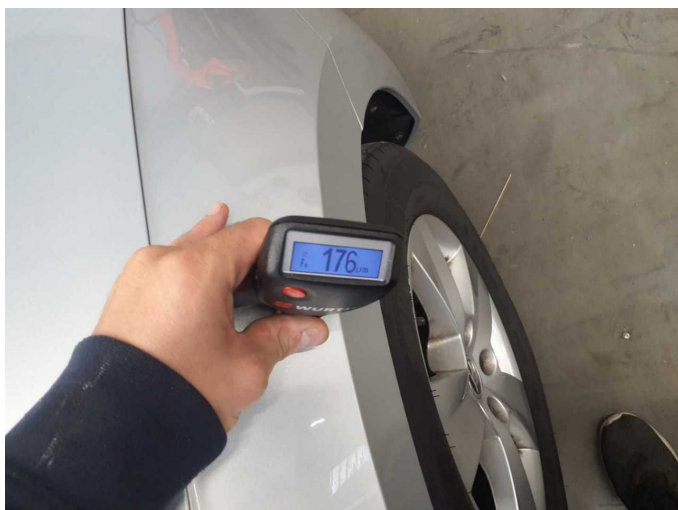
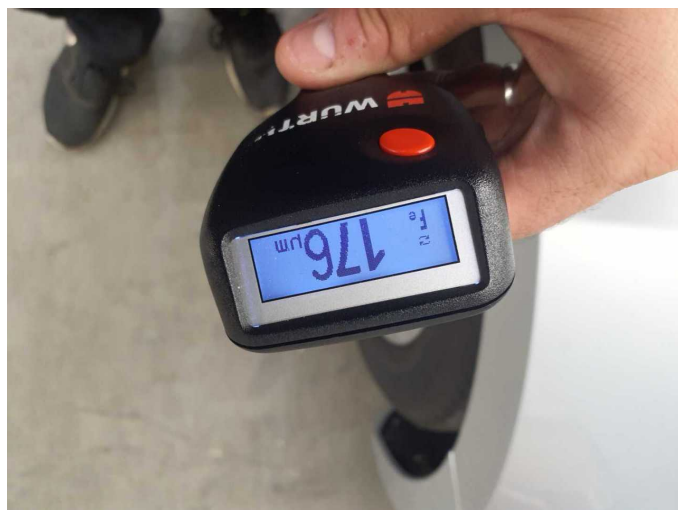
No.	Repainting
1	Mudguard - right side, Professionally carried out, Invoice of repair done Non-existent

176 µm

Repainting 1: Mudguard - right side
