SKODA Octavia Octavia Combi 2.0 TDI DSG

VIN NO TMBJJ7NE3J0356040 Registration Number E3J0356040

Inspection Report Summary

Customer	BCA Online	Report Number	P20250924111518
Inspection Date / Place	2025-09-24 / BCA Oberndorf	Cosmetic Grade	3

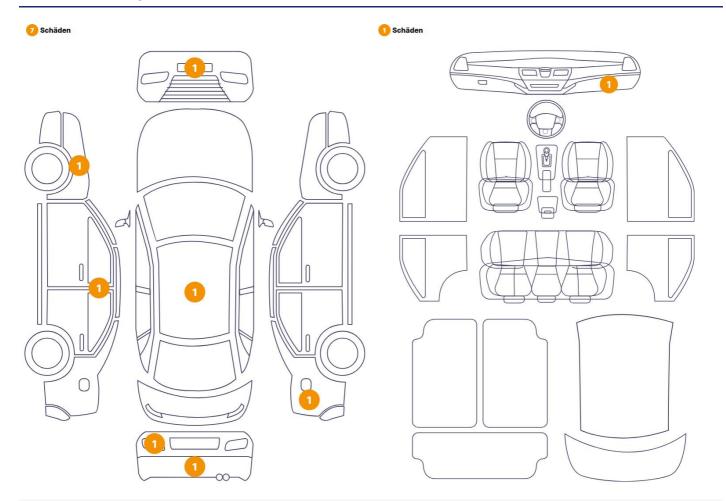
Component	Damage	Comments
1	Bumper / Front	Paint / Scratch / Scuff	
2	Roof	Bodywork / Dent / Dent	
3	Center Console	Interior / Ripped	
4	B Pillar / Center Left	Paint / Scratch / Line	
5	Fender / Front Left	Bodywork / Dent / Dent	
6	Reflector / Back Left	Bodywork / Breakage / Crack	
7	Bumper / Back	Paint / Scratch / Scuff	
8	Fender / Back Right	Bodywork / Dent / Dent

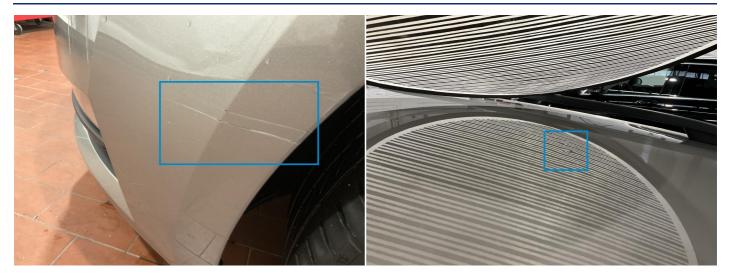
1. Bumper / Front Paint / Scratch / Scuff -

2. Roof Bodywork / Dent / Dent -

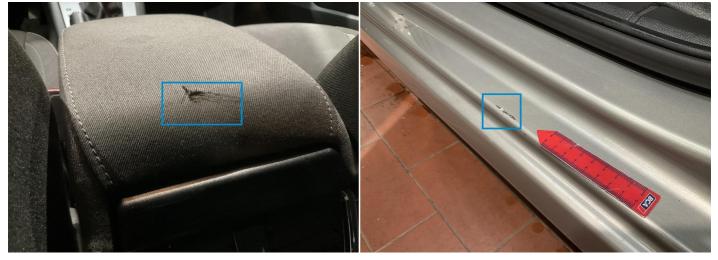
3. Center Console Interior / Ripped -

4. B Pillar / Center Left Paint / Scratch / Line -

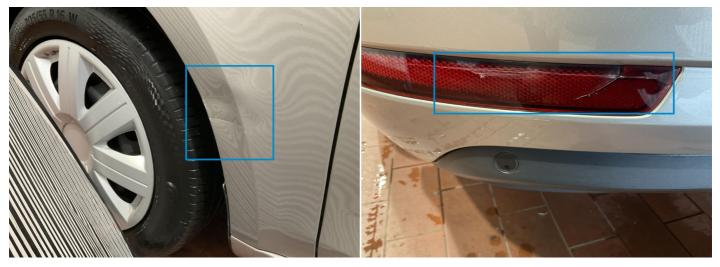
5. Fender / Front Left Bodywork / Dent / Dent -

6. Reflector / Back Left Bodywork / Breakage / Crack -

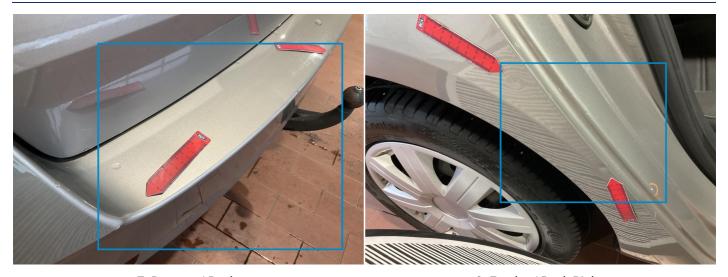
7. Bumper / Back Paint / Scratch / Scuff -

8. Fender / Back Right Bodywork / Dent / Dent -
