Expertise

Protocol number: 41514884  
Order No. / Reference: 25225490  
Inspection date: 12 Sept 2025

Manufacturer: Skoda  
VIN: TMBJJ7NP5L7076356

Model: Superb Combi 2.0 TDI DSG Style

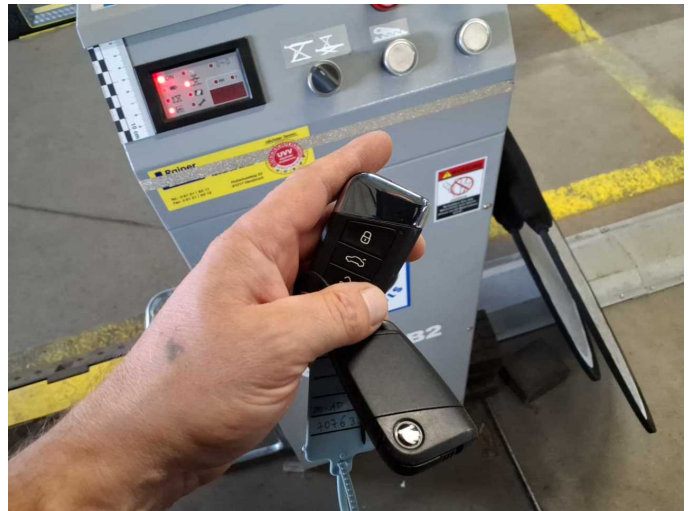
Damage 2: Equipment: Vehicle key (Batterie) - Empty - Replace

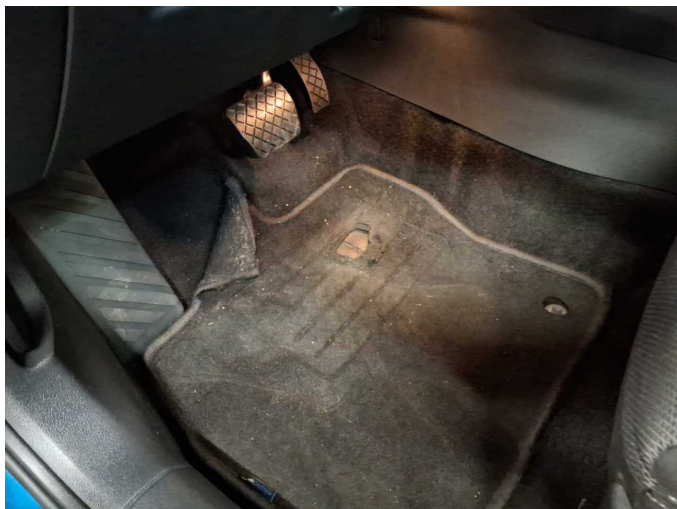
Damage 3: Trim / covers: Floor mats - Broken / torn - Replace

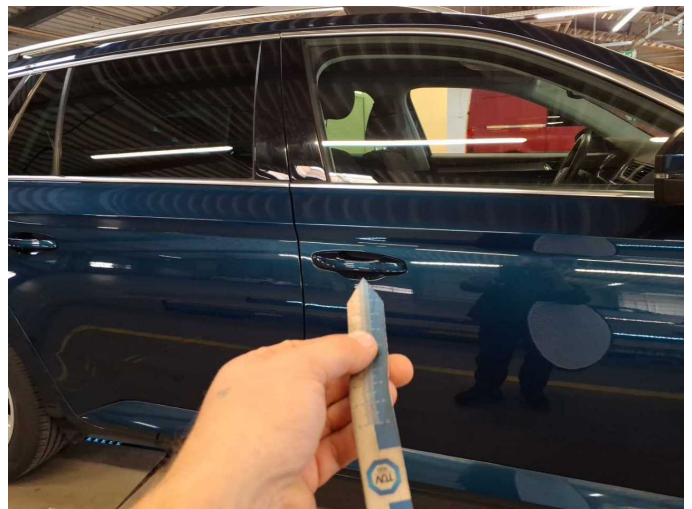
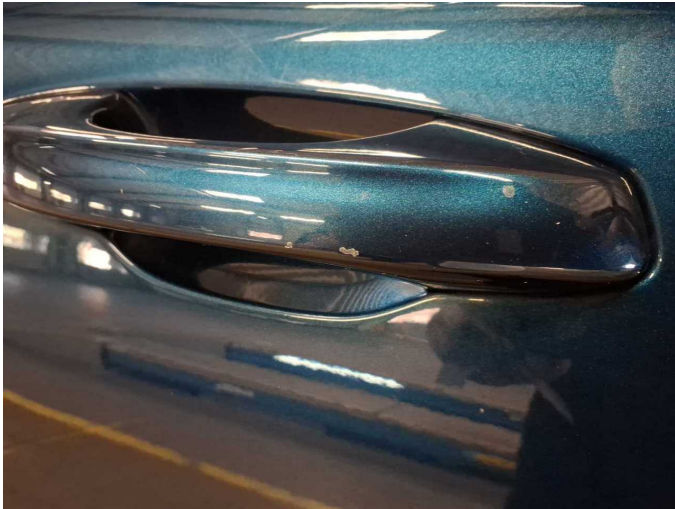
Damage 4: Door - front right side: Door handle - outside - Scratch(es) - Smart repair

**Damage 4:** Door - front right side: Door handle - outside - Scratch(es) - Smart repair

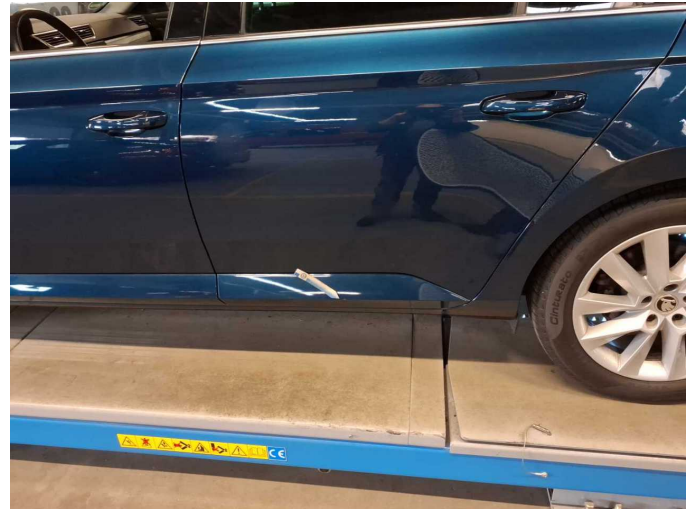
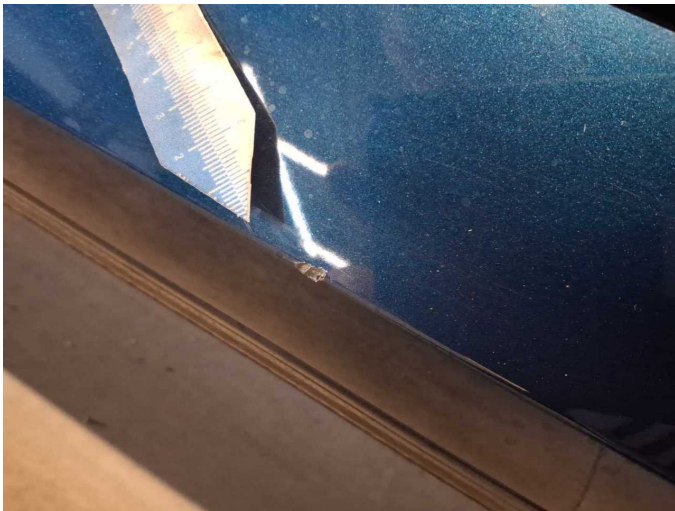
**Damage 5:** Door - rear left side: Brightware - lower - Scratch(es) - Smart repair

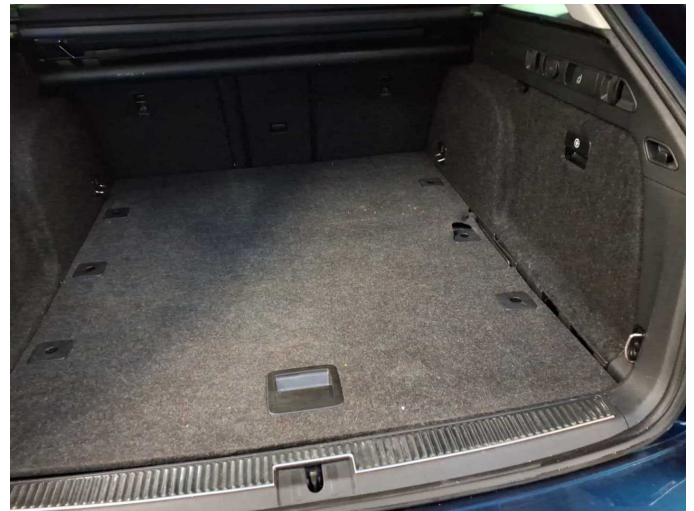
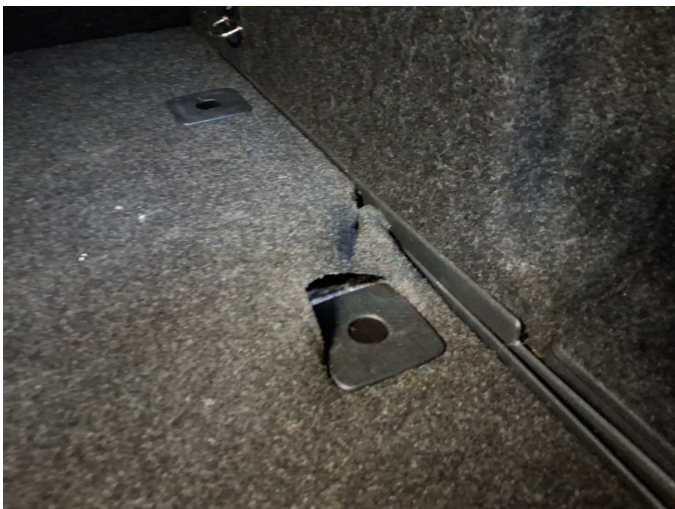
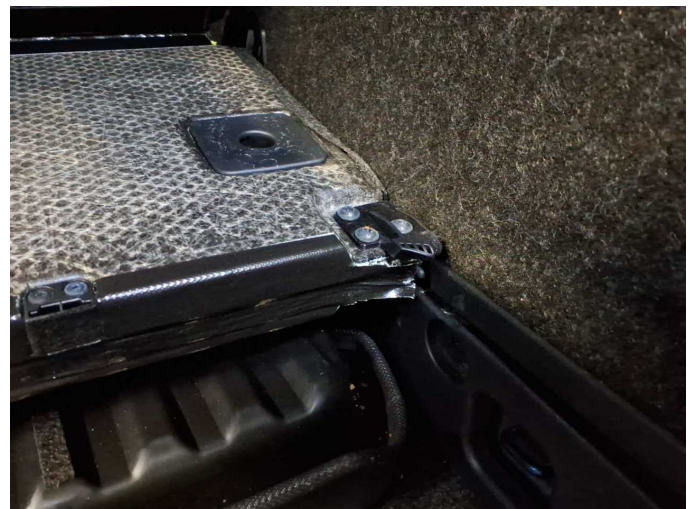
**Damage 6:** Interior: Cargo area floor - Broken / torn - Replace

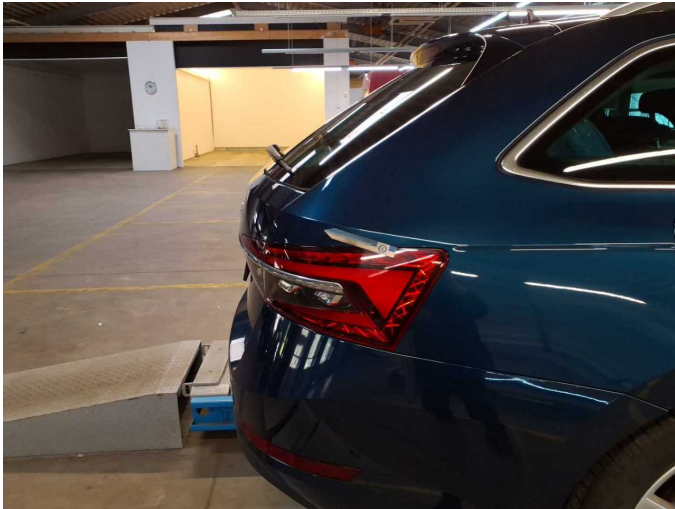
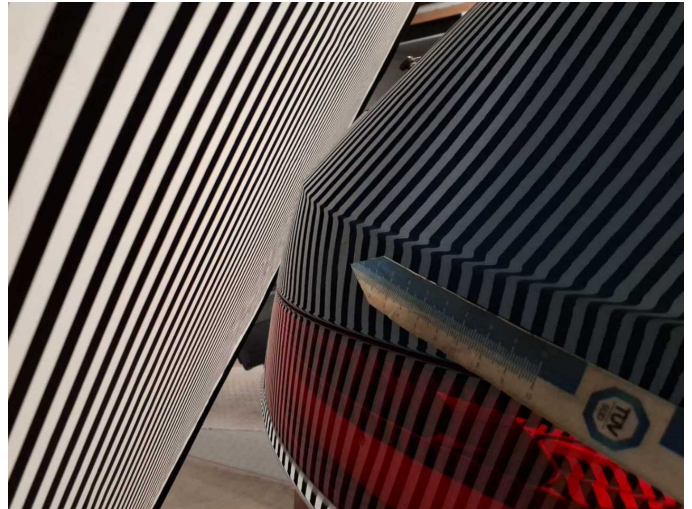
**Wear and tear 2:** Side panel - rear right side: Side panel - dent(s) - Smooth repair work

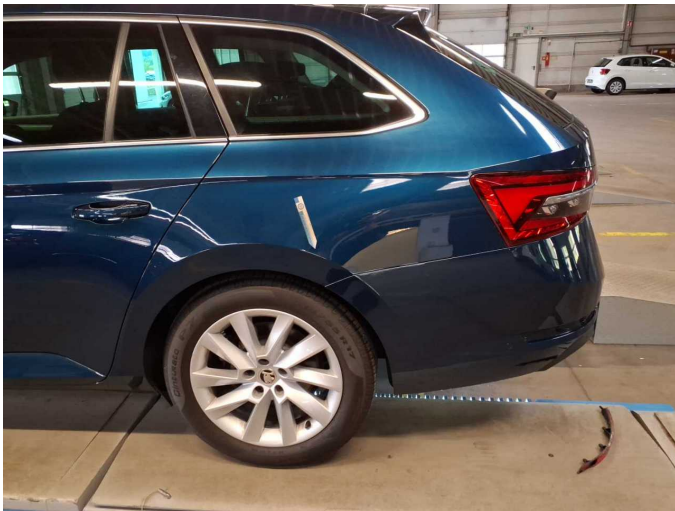
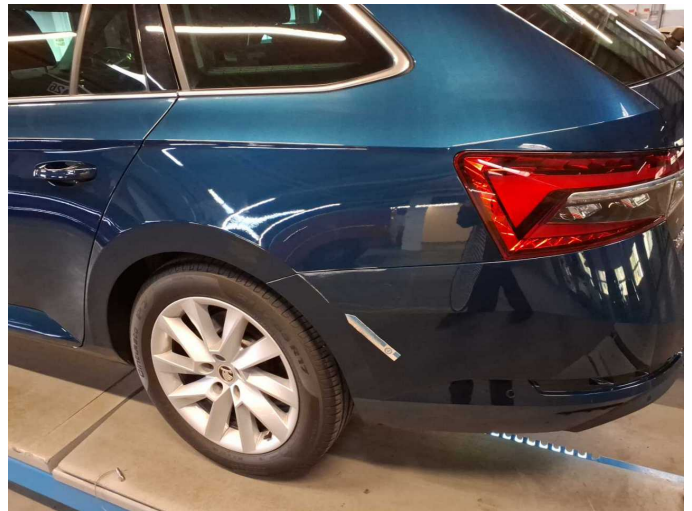
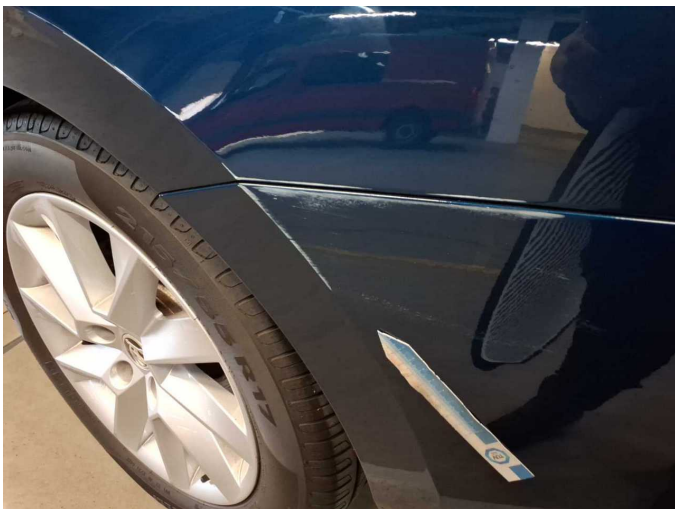
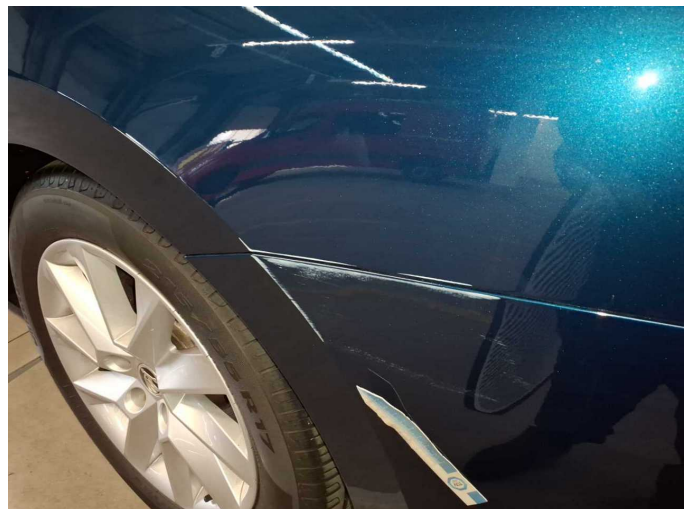
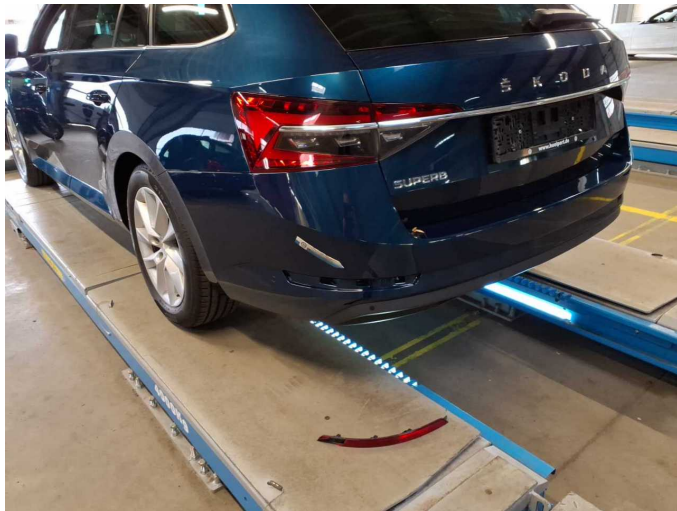
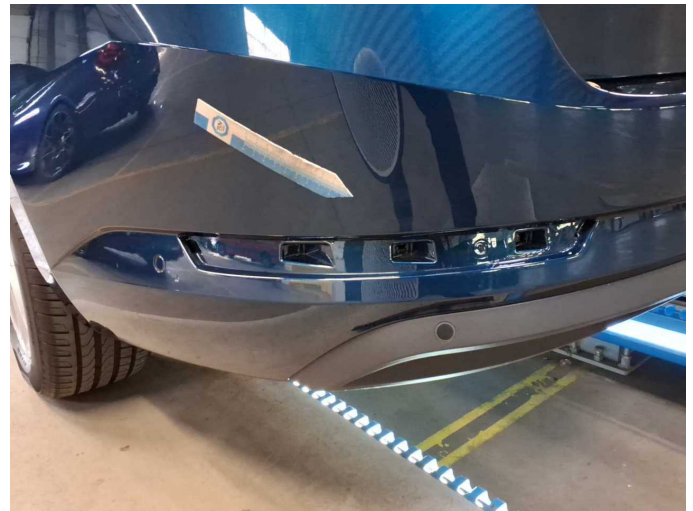
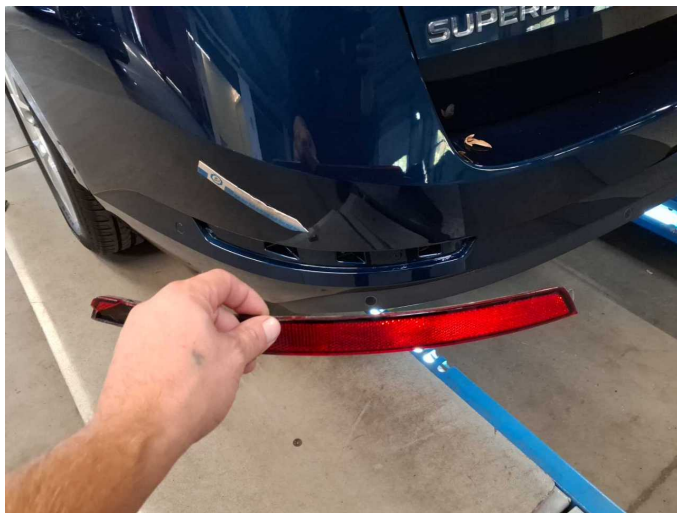
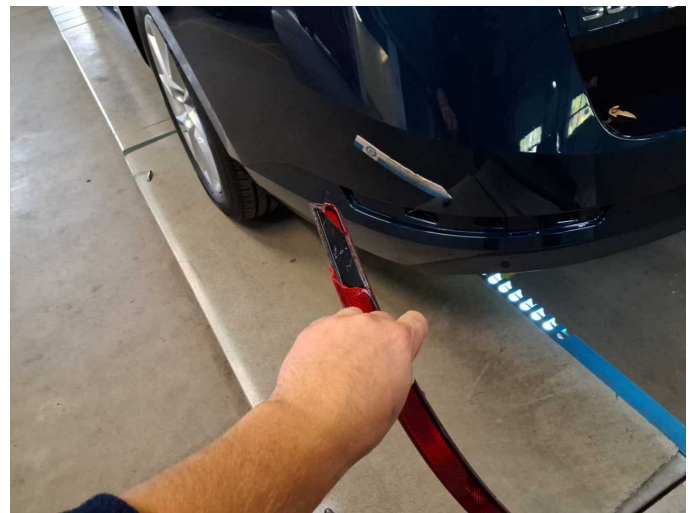
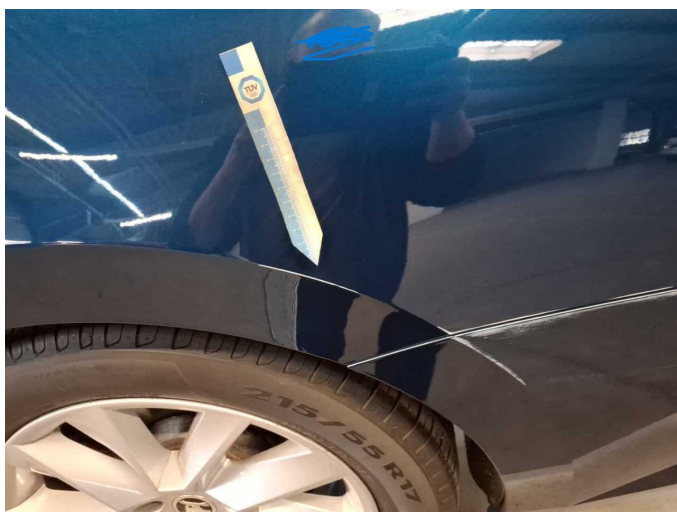
**Accident 1:** Rear, Side - left

**Accident 1: Rear, Side - left**

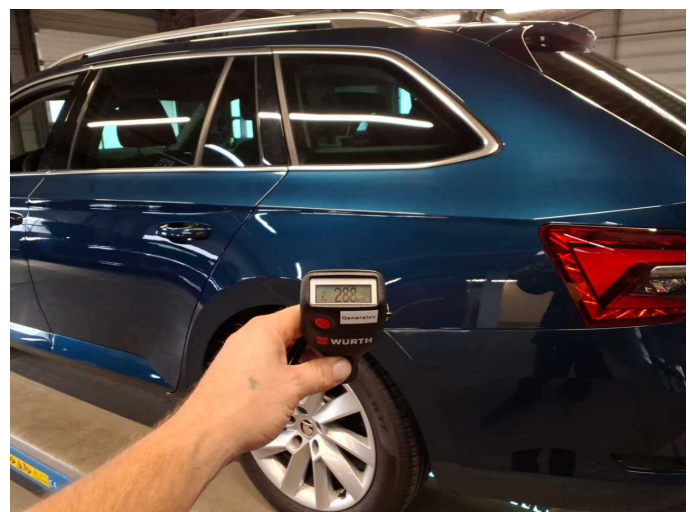
No.	Repainting
1	Side panel - rear left side, Professionally carried out, Invoice of repair done Non-existent
2	Door - rear left side, Professionally carried out, Invoice of repair done Non-existent

288 µm

**Repainting 1: Side panel - rear left side**

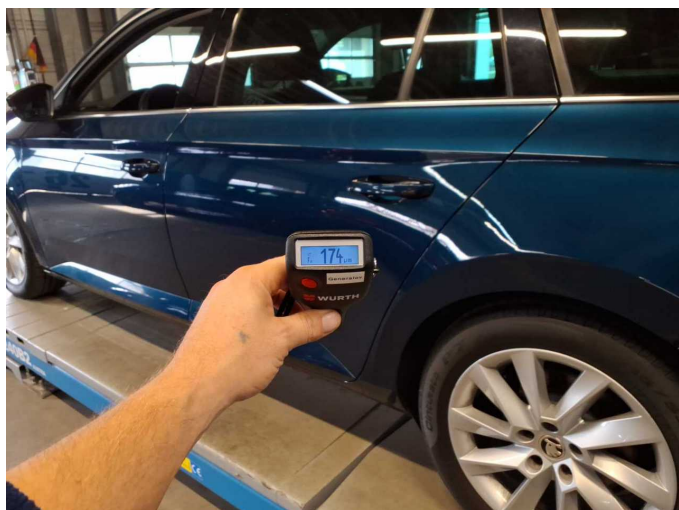
174 µm

**Repainting 2:** Door - rear left side
