Expertise

Protocol number: 41611053  
Order No. / Reference: 25142117  
Inspection date: 19 Sept 2025

Manufacturer: Skoda  
VIN: TMBJJ7NS6P8022634

Model: Kodiaq 2.0 TDI DSG L&K

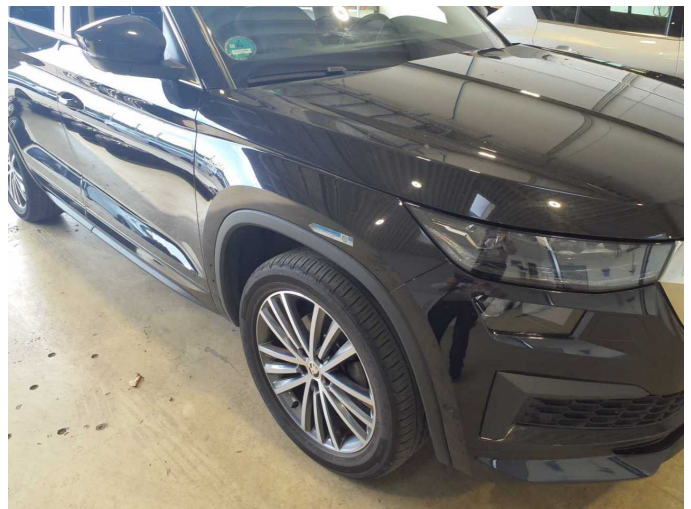
**Damage 1:** Mudguard - right side: Mudguard - right side - Dent / paintcoat damage - Smart repair

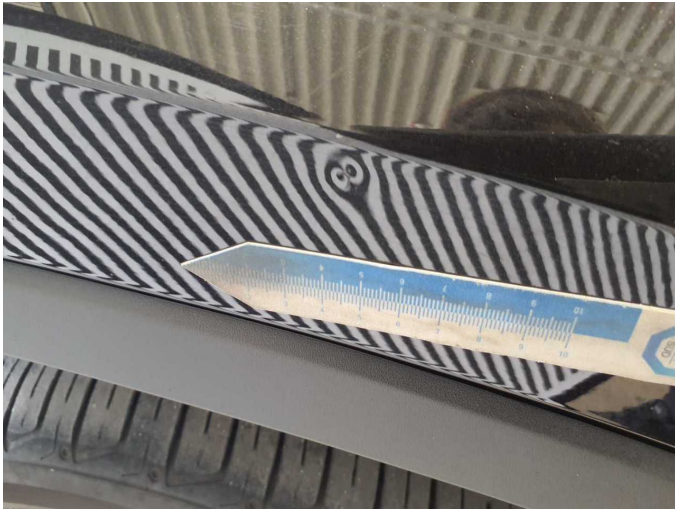
**Damage 1:** Mudguard - right side: Mudguard - right side - Dent / paintcoat damage - Smart repair

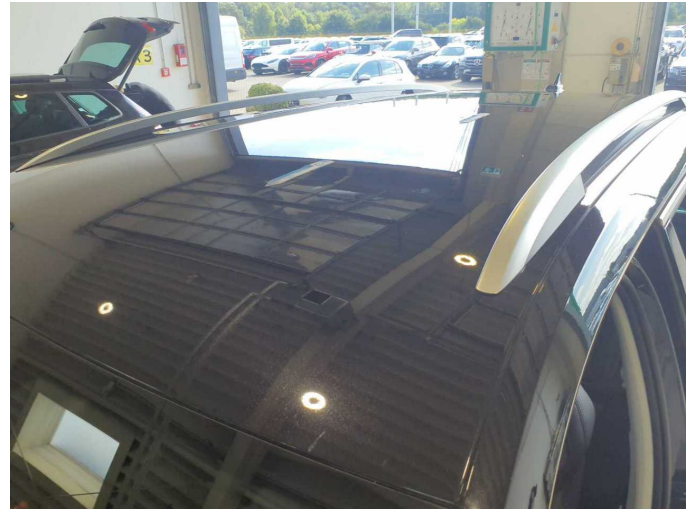
**Damage 2:** Roof: Roof (+Harz) - dent(s) - Smart repair

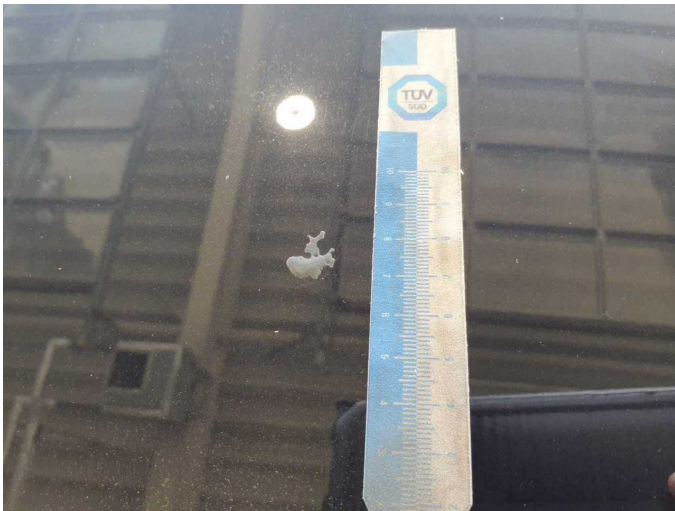
**Damage 2:** Roof: Roof (+Harz) - dent(s) - Smart repair

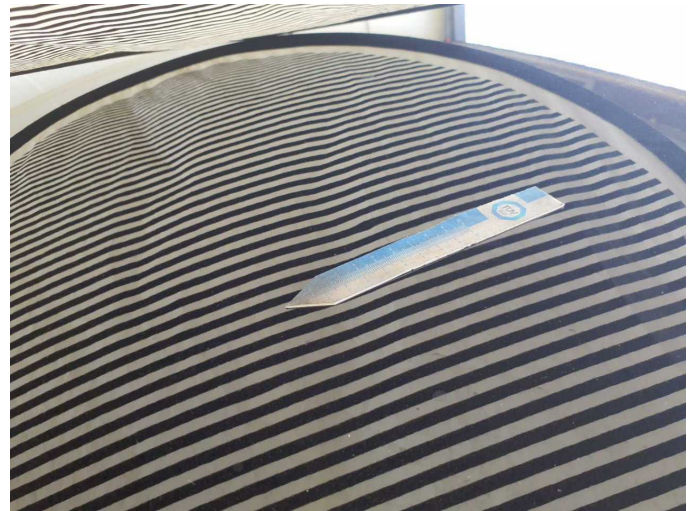
**Damage 2:** Roof: Roof (+Harz) - dent(s) - Smart repair

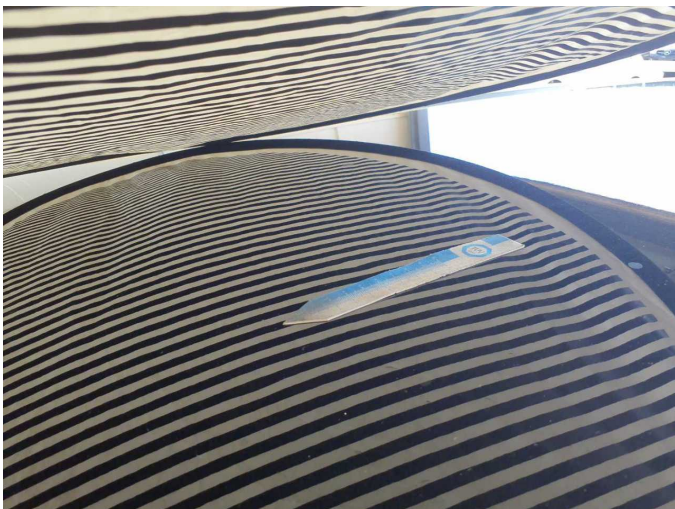
**Damage 2:** Roof: Roof (+Harz) - dent(s) - Smart repair

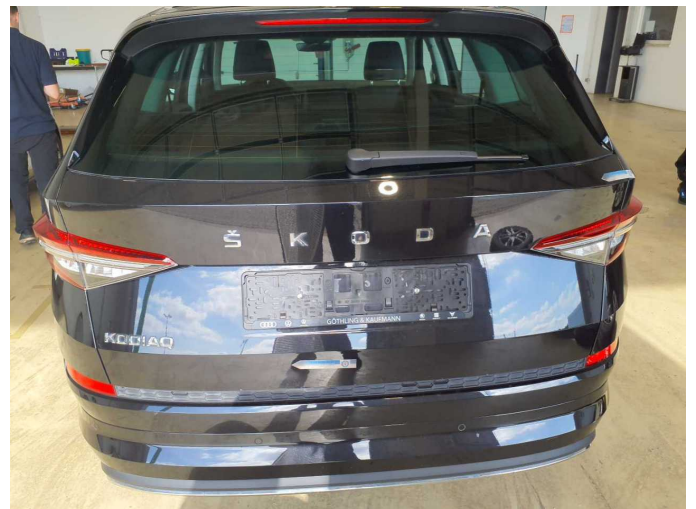
**Damage 3:** Boot lid / rear door: Boot lid - dent(s) - Smooth repair work

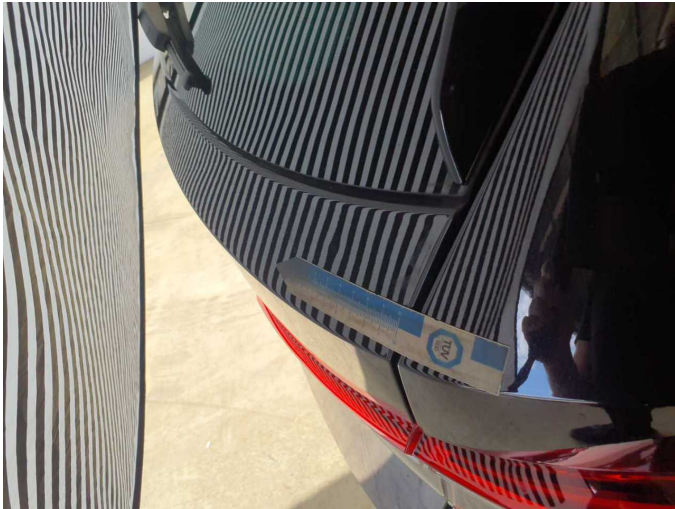
**Damage 3:** Boot lid / rear door: Boot lid - dent(s) - Smooth repair work

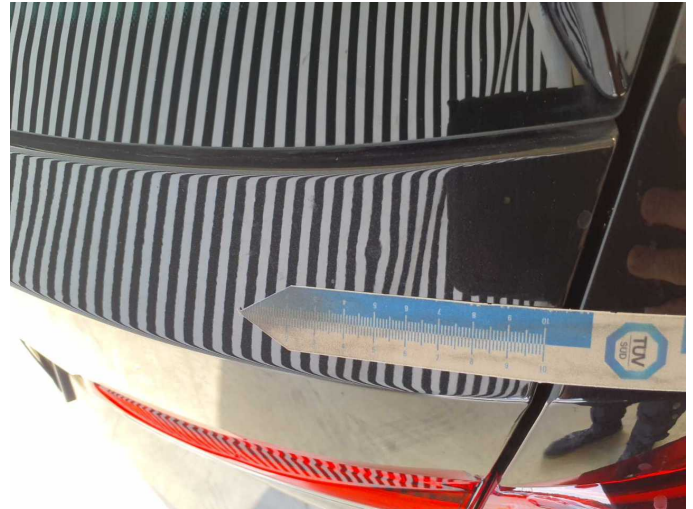
**Damage 3:** Boot lid / rear door: Boot lid - dent(s) - Smooth repair work

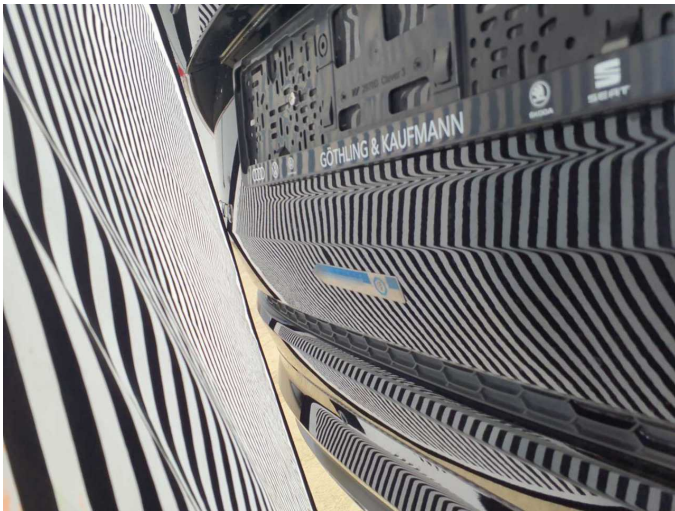
**Damage 3:** Boot lid / rear door: Boot lid - dent(s) - Smooth repair work

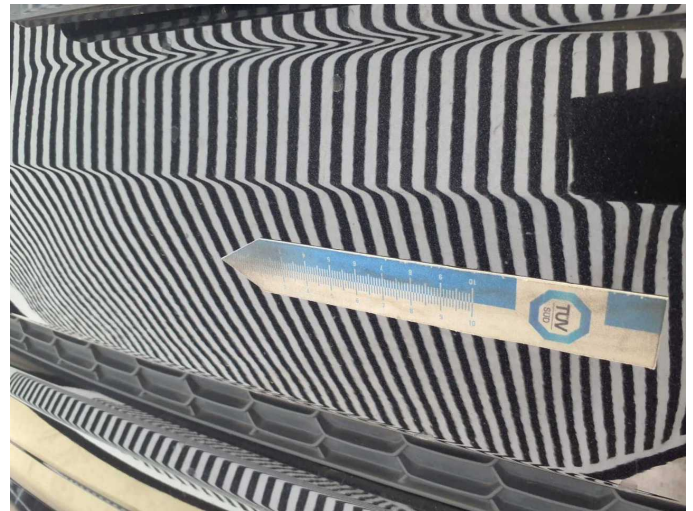
**Damage 3:** Boot lid / rear door: Boot lid - dent(s) - Smooth repair work

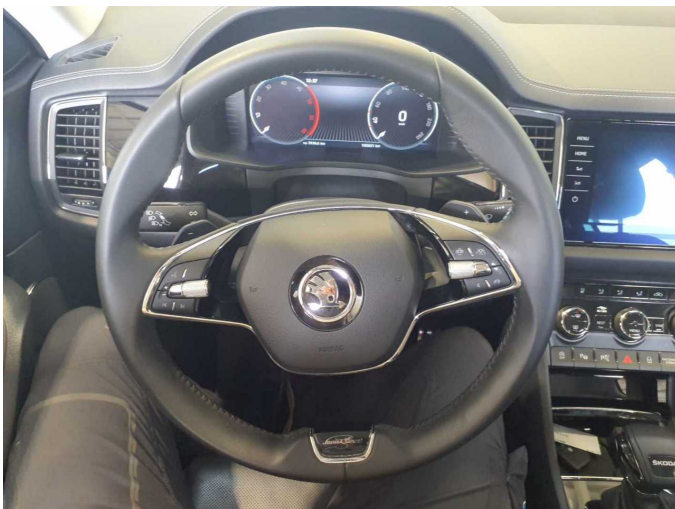
**Damage 4:** Steering system: Steering wheel sheath - Scratch(es) - Loss in value

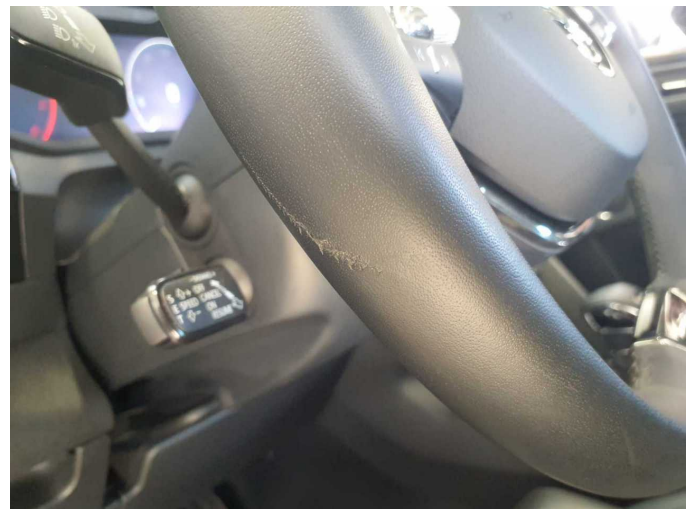
**Damage 4:** Steering system: Steering wheel sheath - Scratch(es) - Loss in value

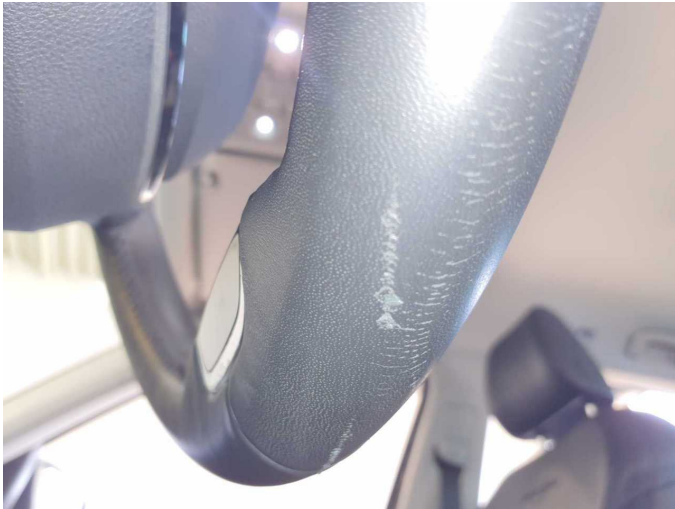
**Damage 4:** Steering system: Steering wheel sheath - Scratch(es) - Loss in value

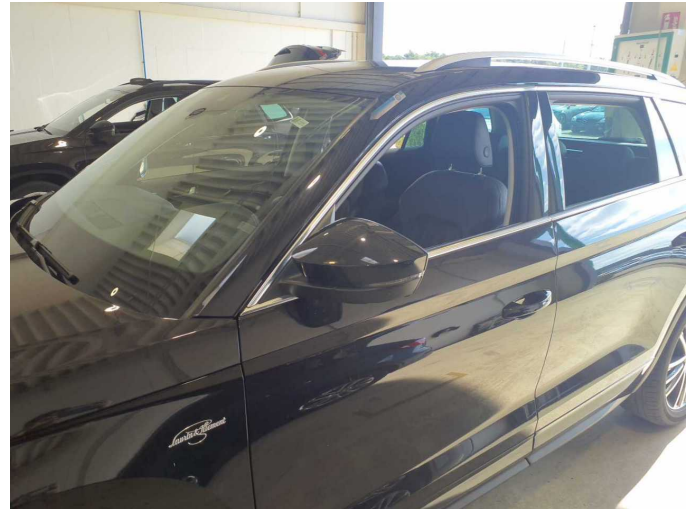
**Damage 5:** Body: A-pillar - left side - Scratch(es) - Paint

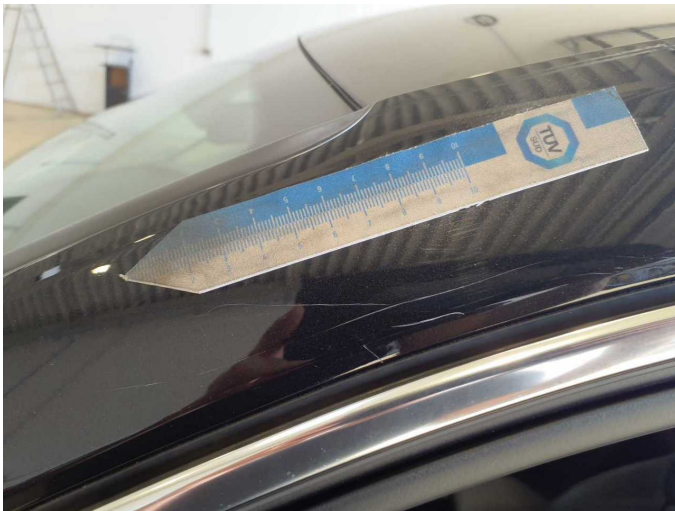
**Damage 5:** Body: A-pillar - left side - Scratch(es) - Paint

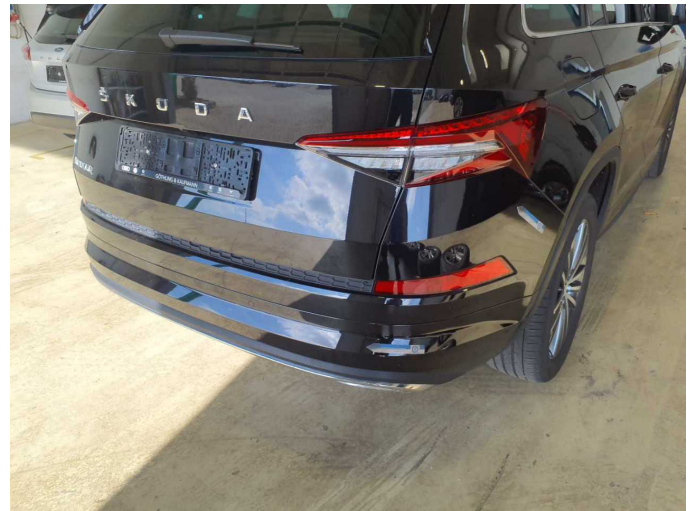
**Damage 6:** Rear bumper: Rear bumper - Dent / paintcoat damage - Repair and paint

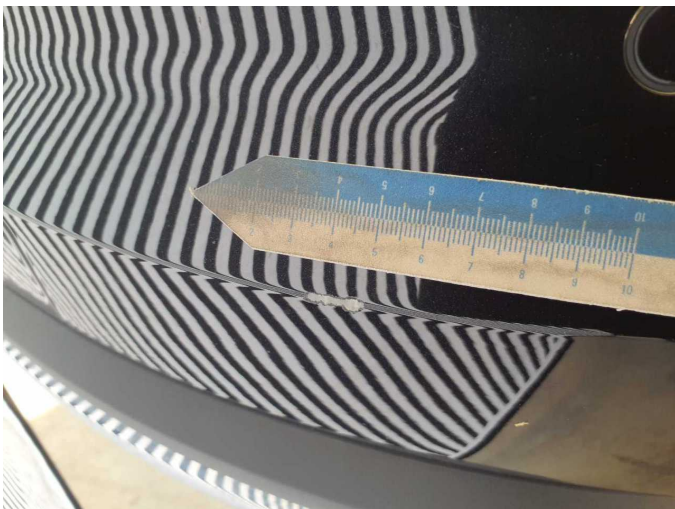
**Damage 6:** Rear bumper: Rear bumper - Dent / paintcoat damage - Repair and paint

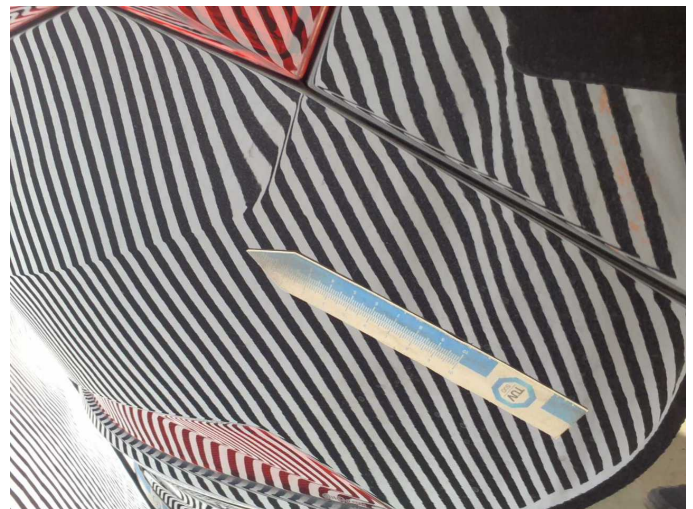
**Damage 6:** Rear bumper: Rear bumper - Dent / paintcoat damage - Repair and paint

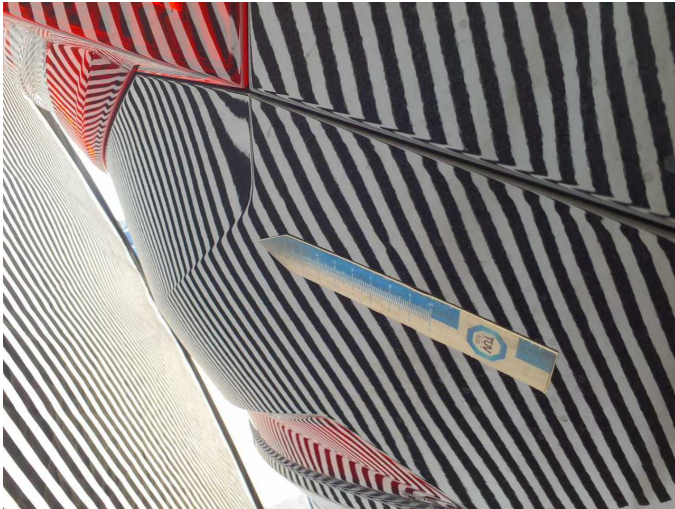
**Damage 6:** Rear bumper: Rear bumper - Dent / paintcoat damage - Repair and paint

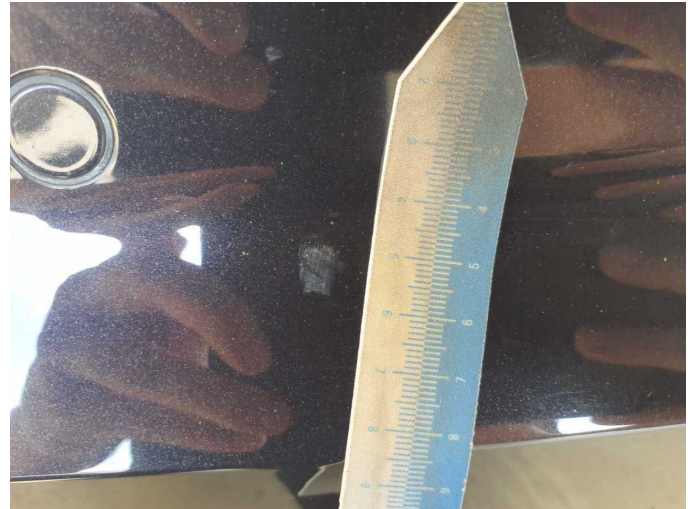
**Damage 6:** Rear bumper: Rear bumper - Dent / paintcoat damage - Repair and paint

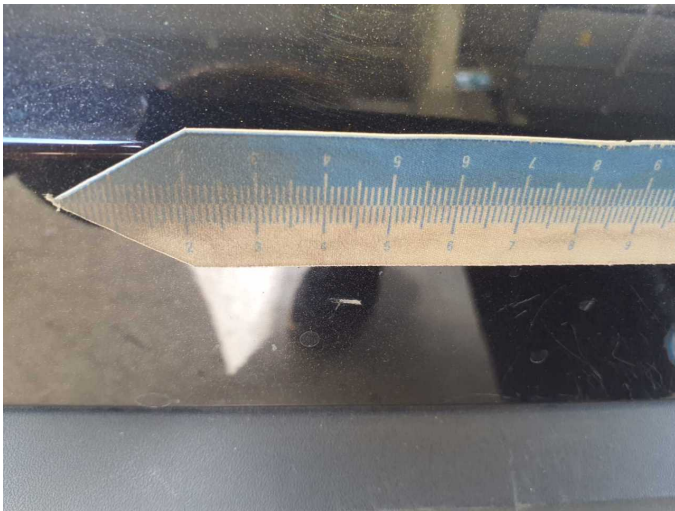
**Damage 6:** Rear bumper: Rear bumper - Dent / paintcoat damage - Repair and paint

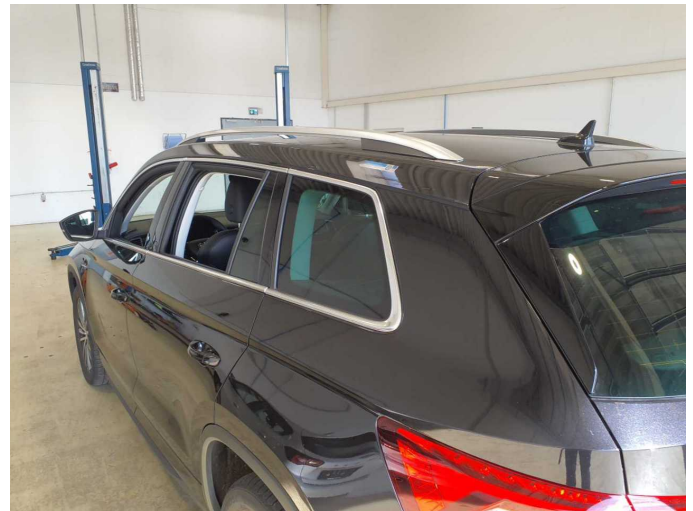
**Wear and tear 5:** Roof: Roof rail - left side - dent(s) - No deduction

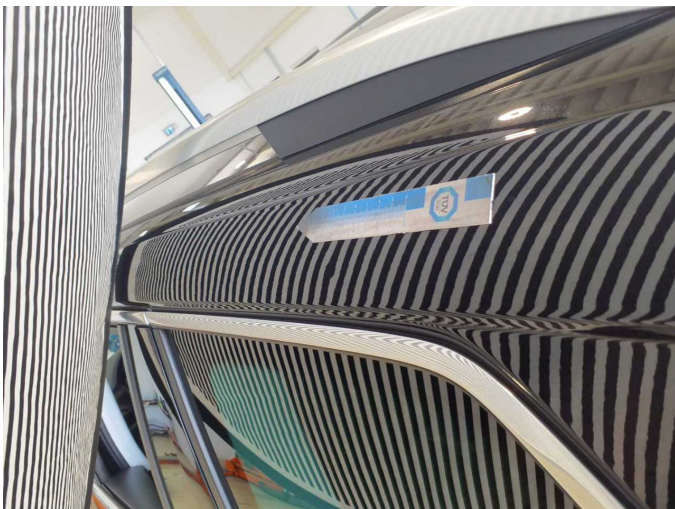
**Wear and tear 5:** Roof: Roof rail - left side - dent(s) - No deduction

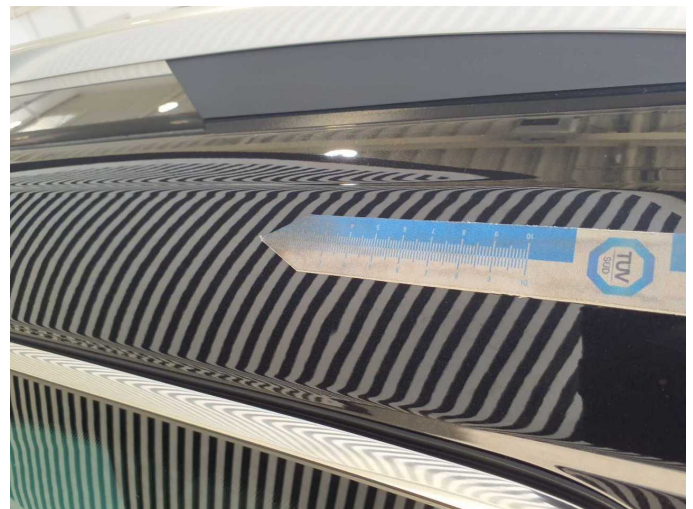
**Wear and tear 5:** Roof: Roof rail - left side - dent(s) - No deduction

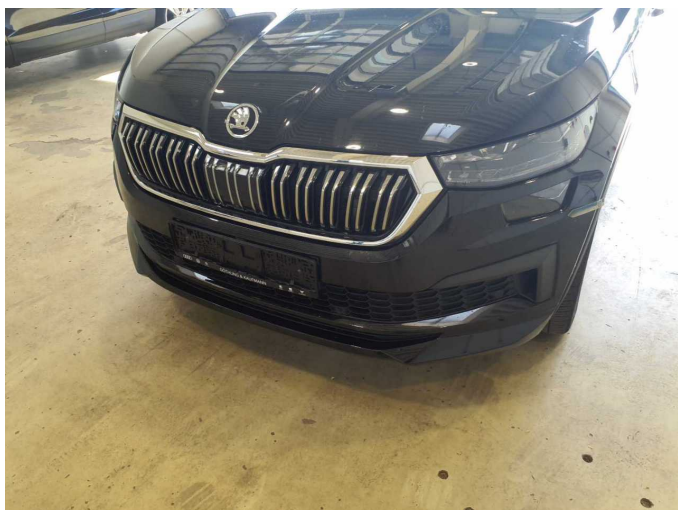
**Wear and tear 6:** Front bumper: Front bumper - Stone chips - No deduction

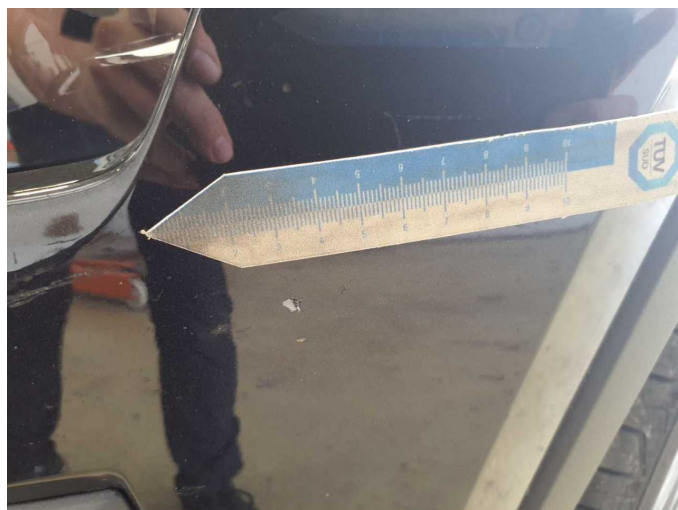
**Wear and tear 6:** Front bumper: Front bumper - Stone chips - No deduction
