Expertise

Protocol number: 39967748
Order No. / Reference: 24798987
Inspection date: 30 May 2025

Manufacturer: Skoda	Model: Octavia Combi 2.0 TDI DSG Style
VIN: TMBJJ7NX0MY141190

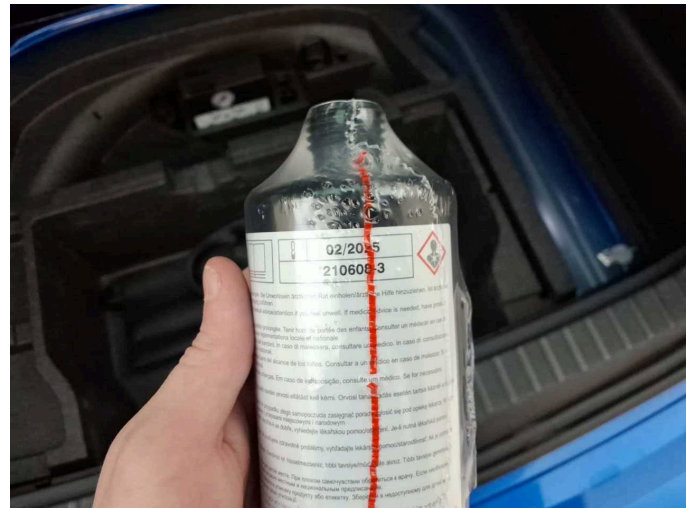
Damage 1: Equipment: Tirefit filler - Expired - Replace

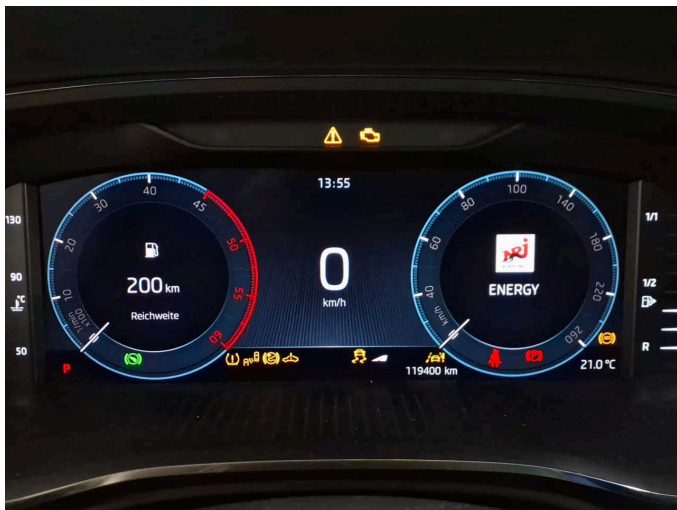
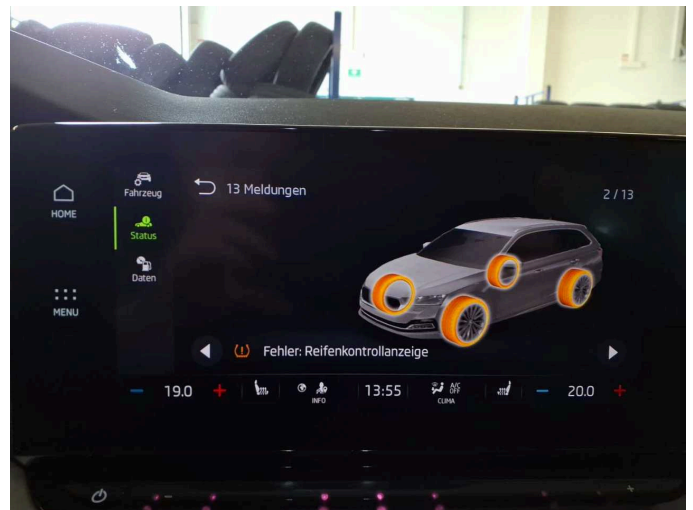
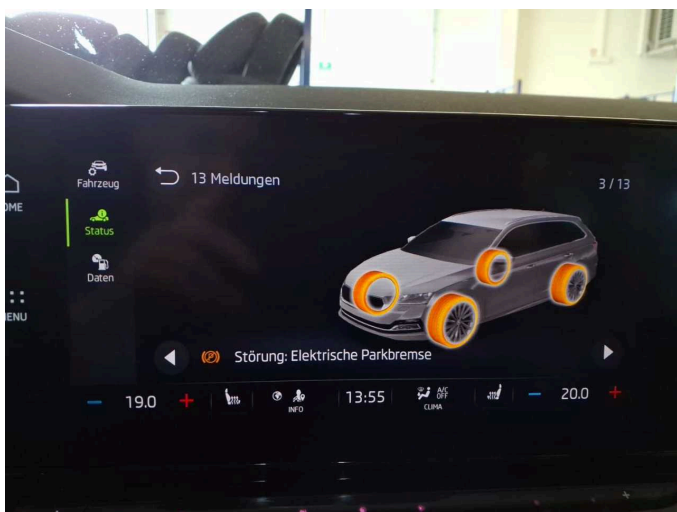
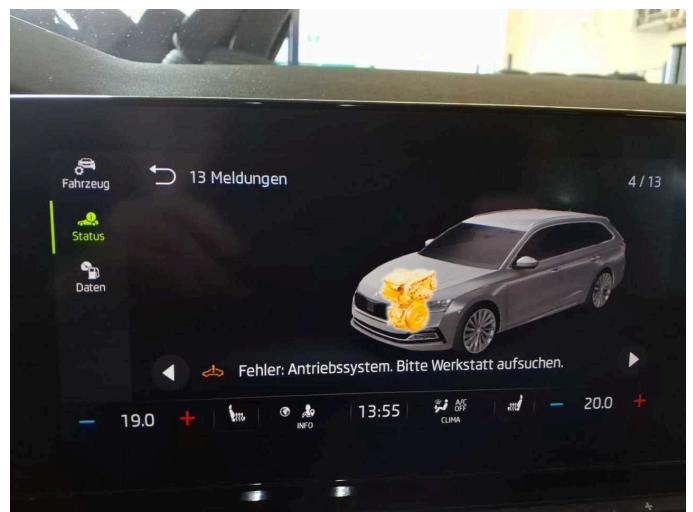
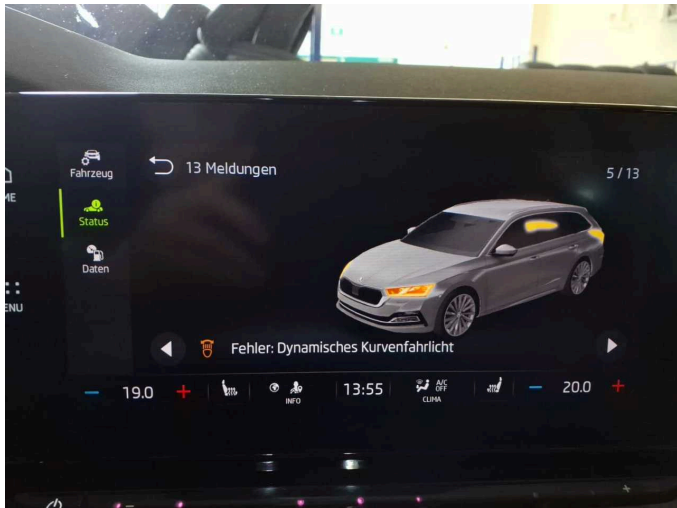
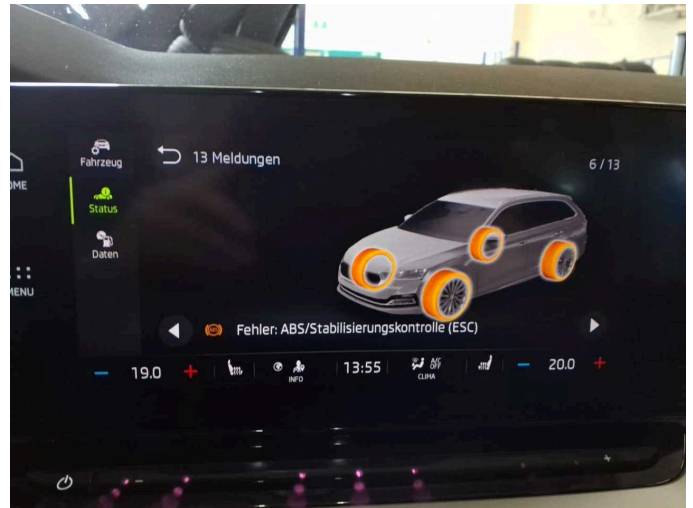
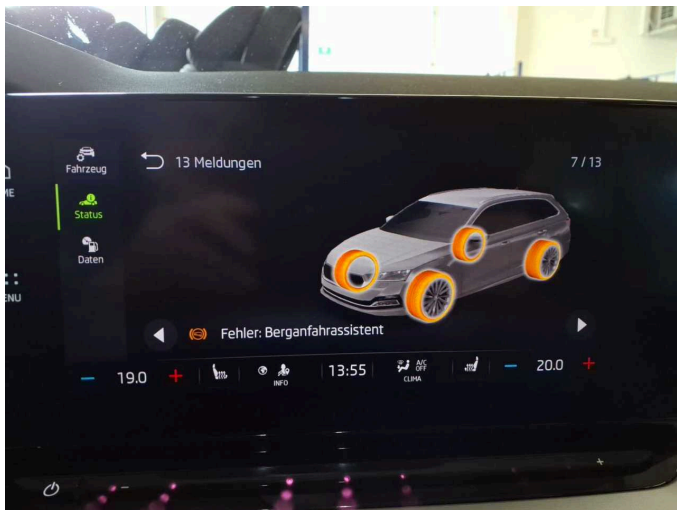
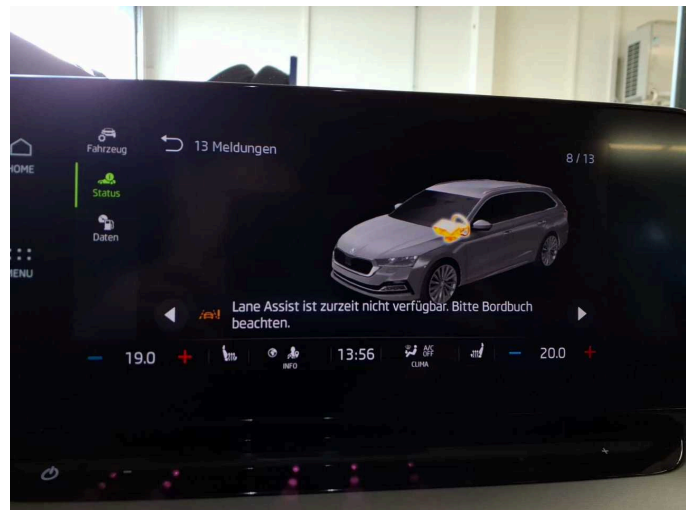
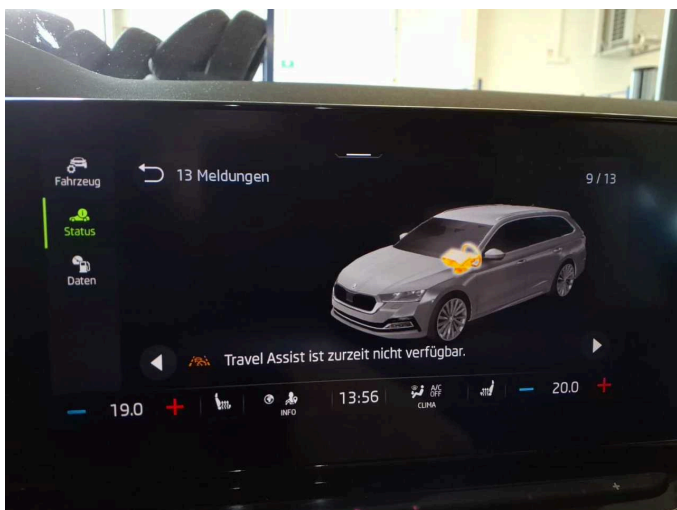
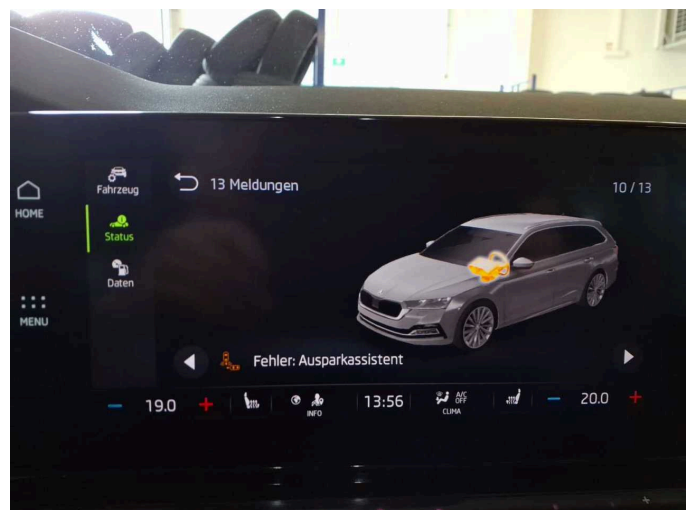
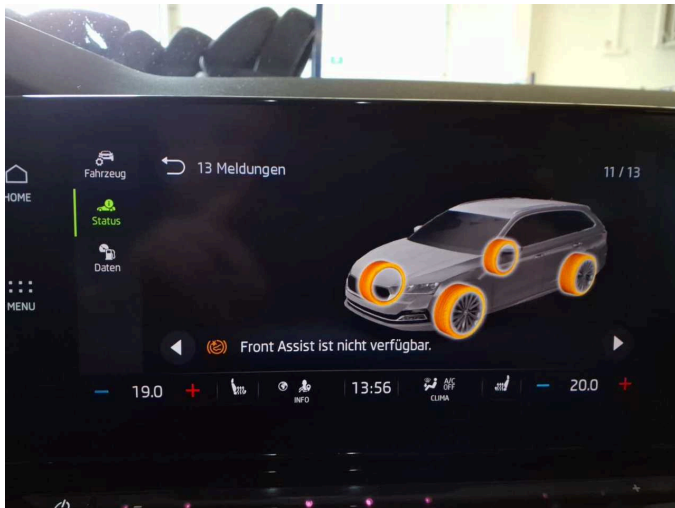
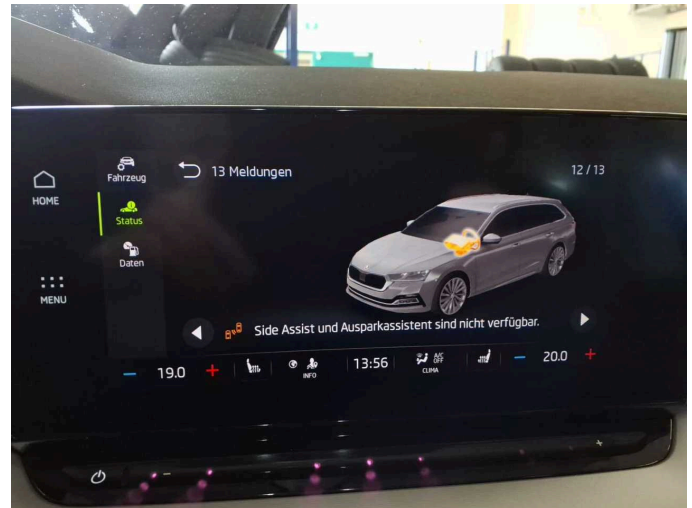
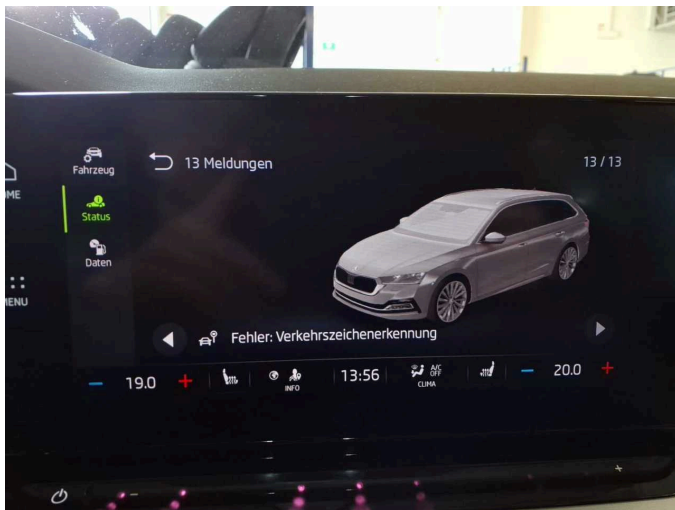
Damage 2: Instrument panel: Indicator light (Mehrkosten können entstehen) - on - Perform diagnosis

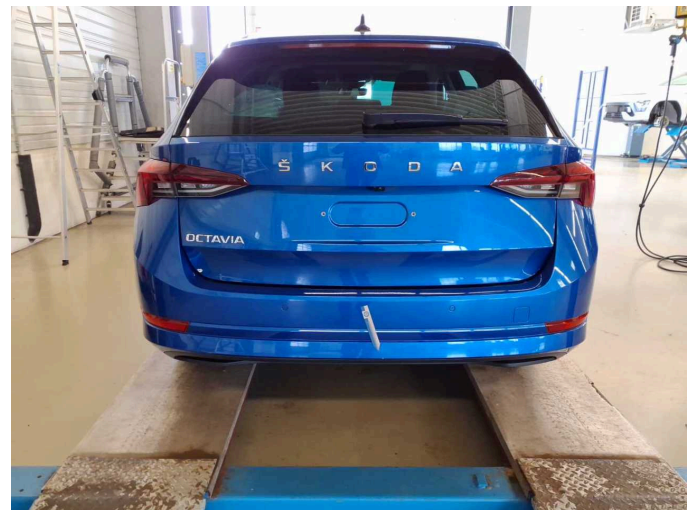
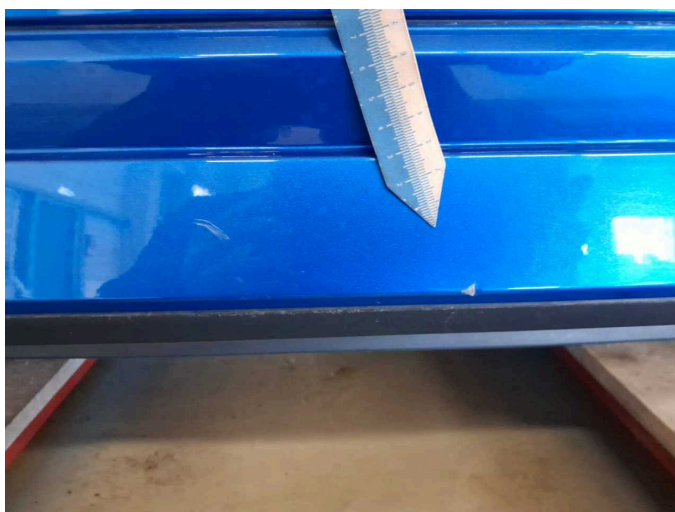
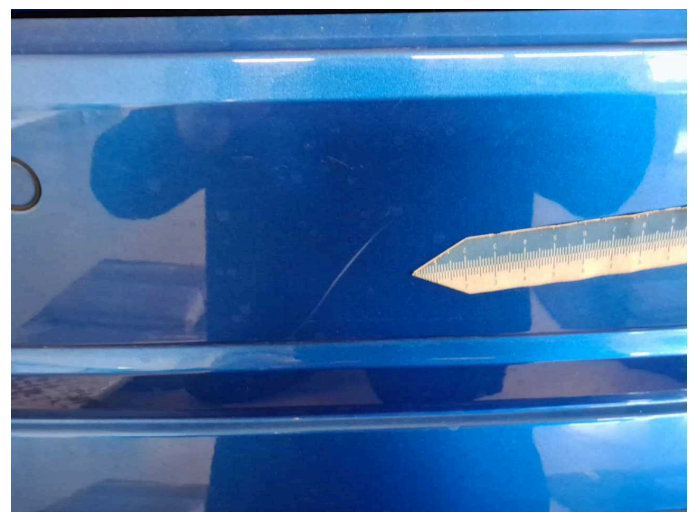
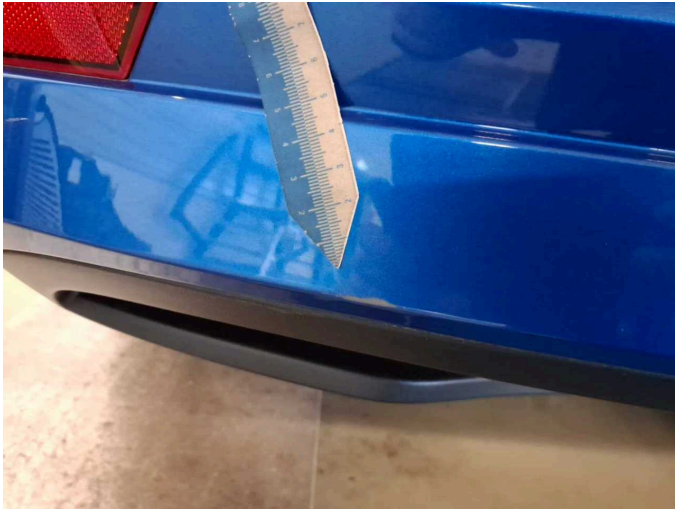
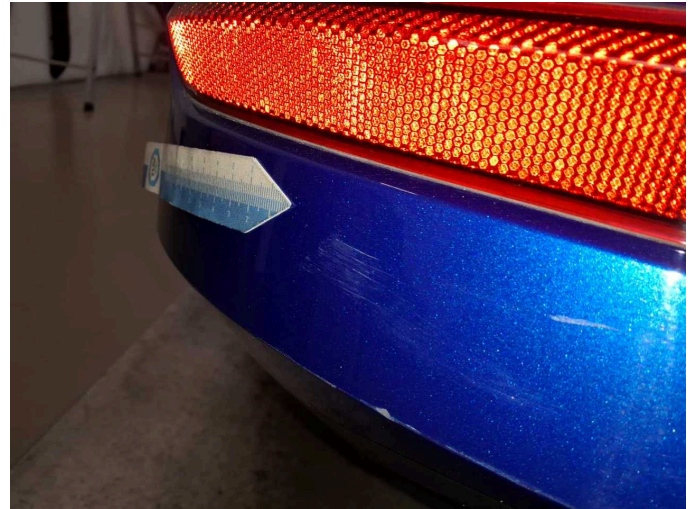
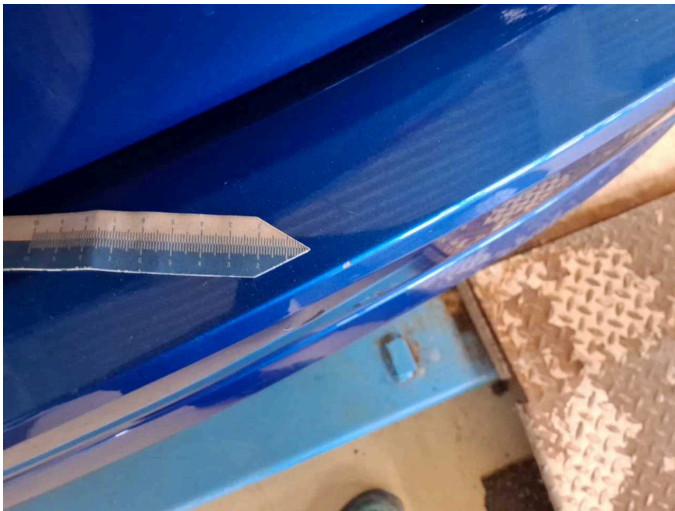
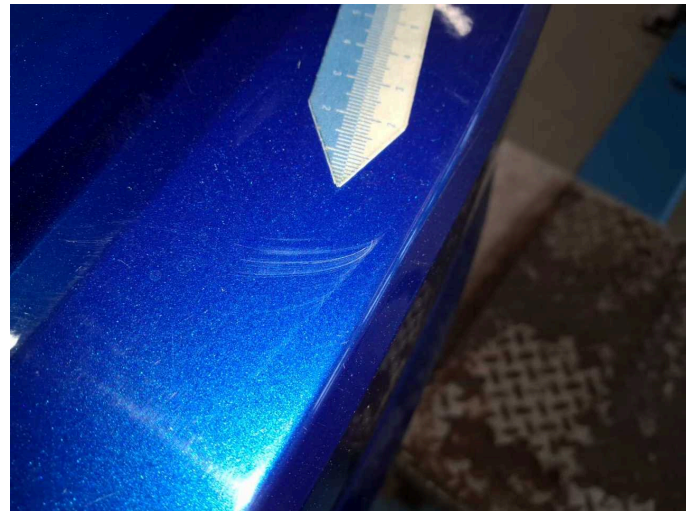
Damage 3: Rear bumper: Rear bumper - Scratch(es) - Paint

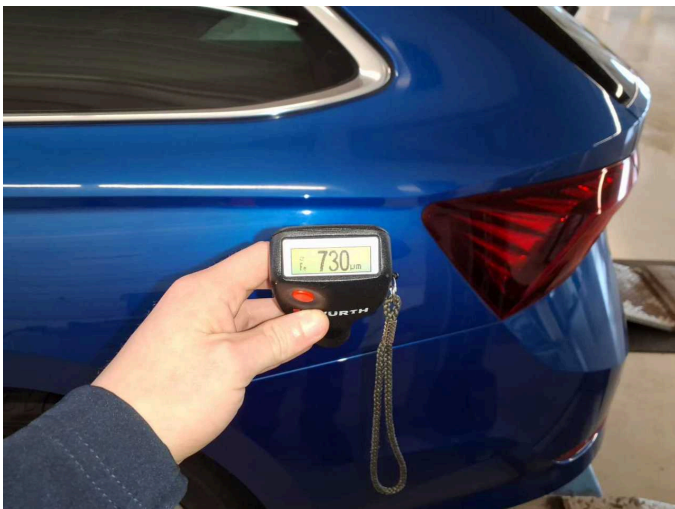
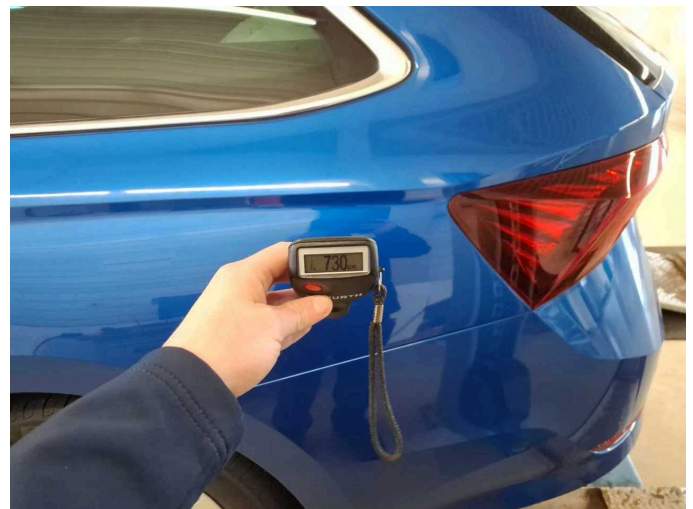
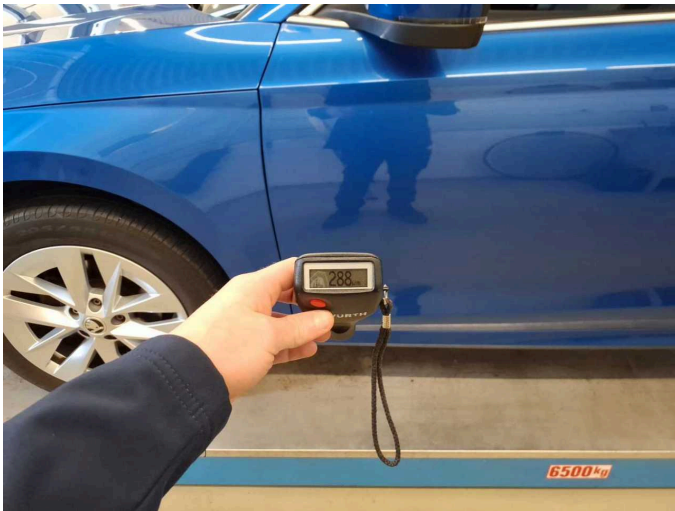
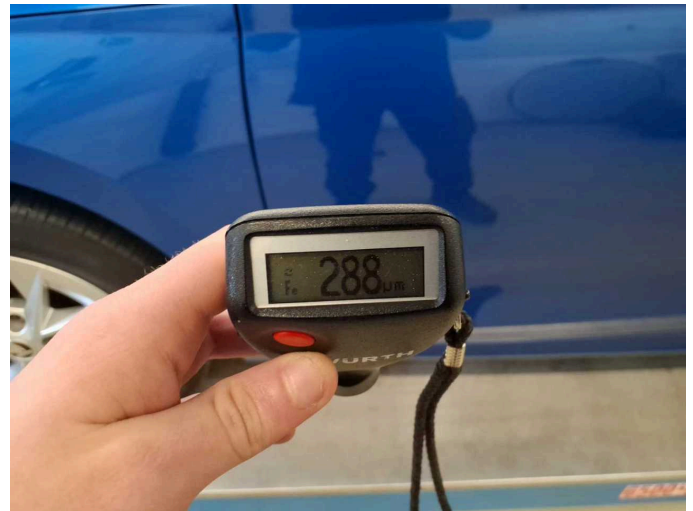
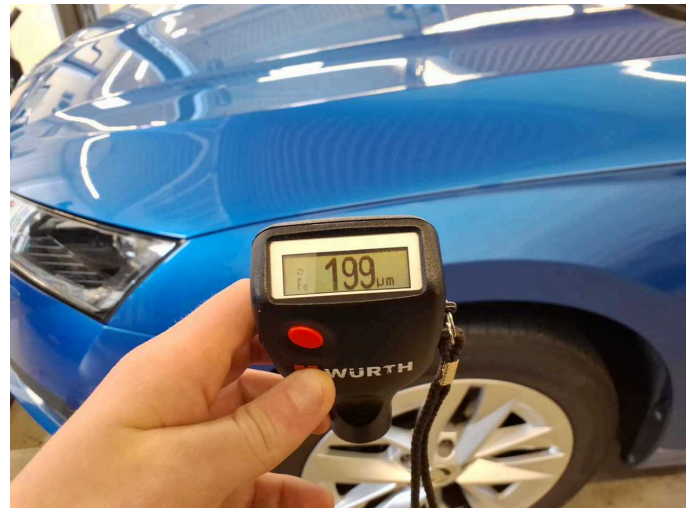
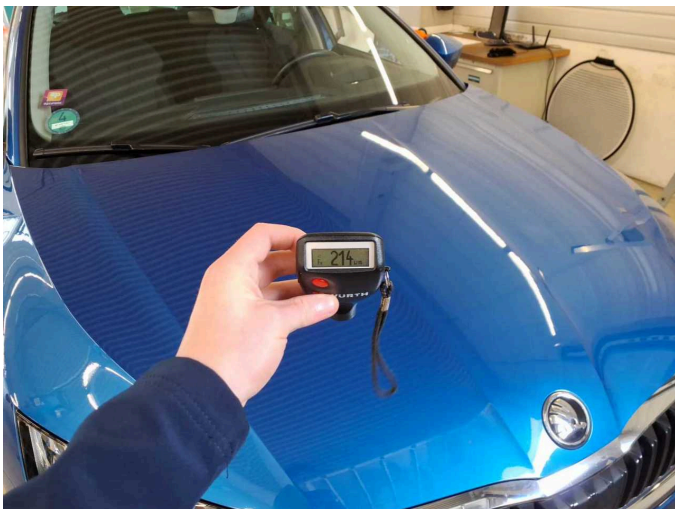
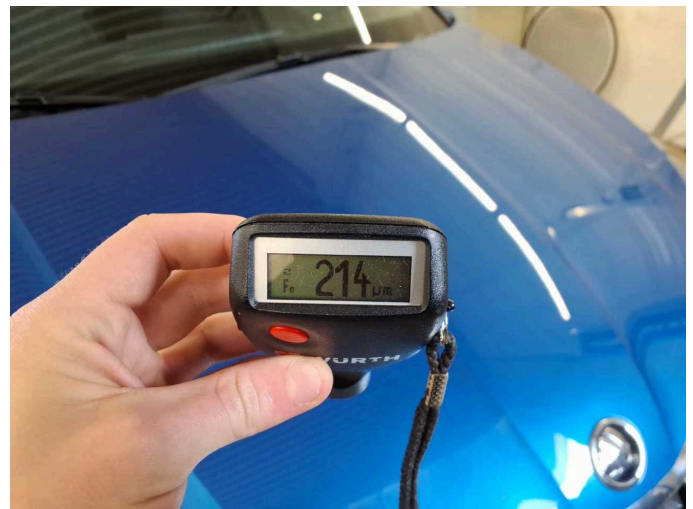
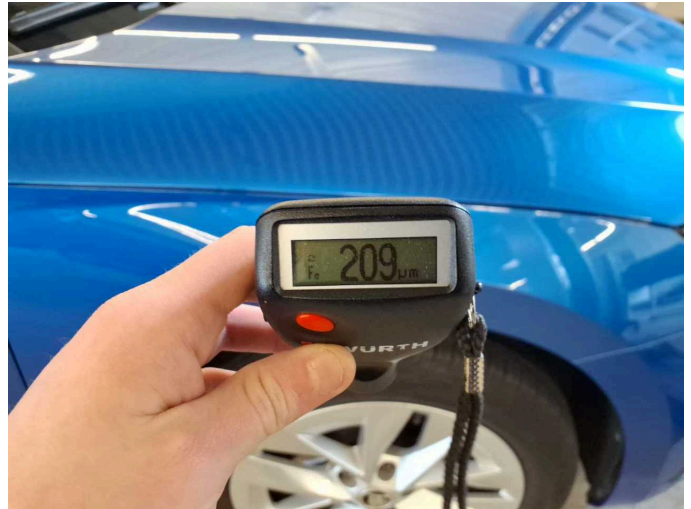
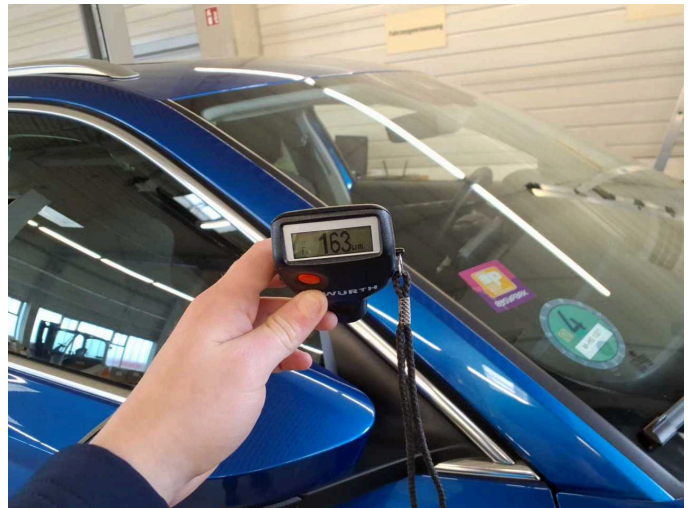
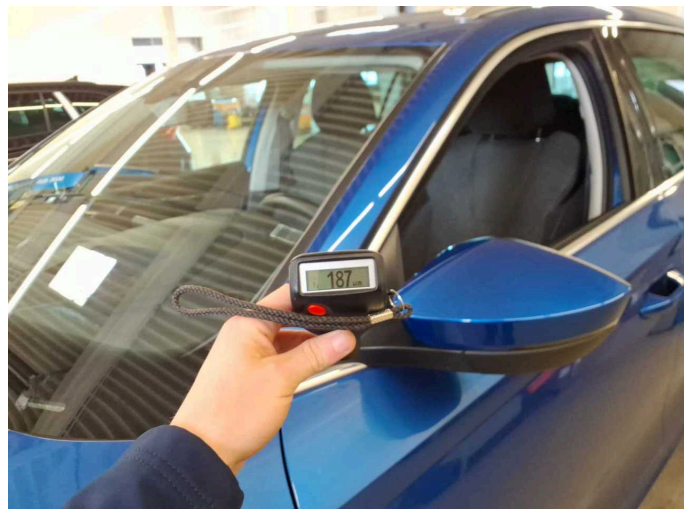
No.	Repainting
1	Roof rail - left side, Roof rail - right side, Mudguard - left side, Mudguard - right side, Bonnet, Side panel - rear left side, Door - front left side, Professionally carried out

Repainting 1: Roof rail - left side, Roof rail - right side, Mudguard - left side, Mudguard - right side, Bonnet, Side panel - rear left side, Door - front left side

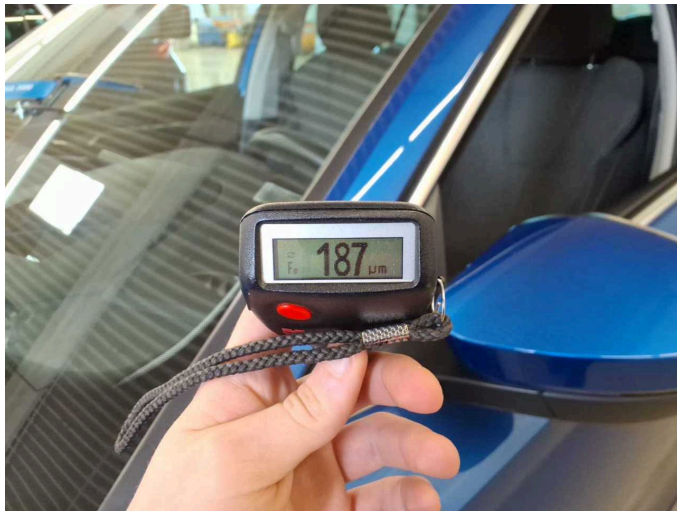
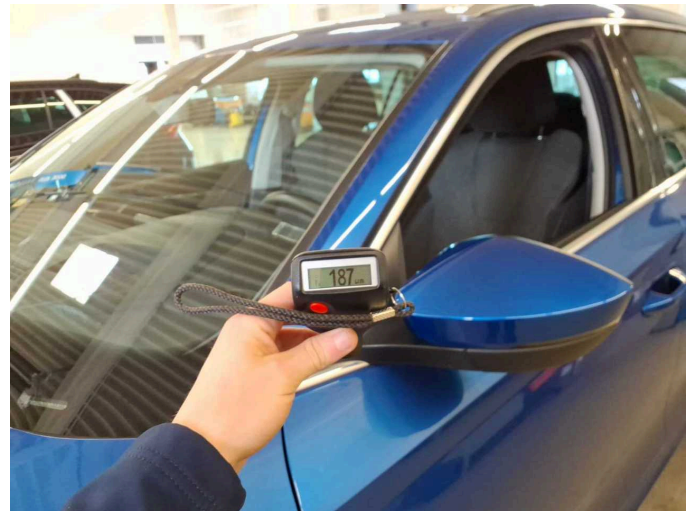
Roof rail - left side: 187 µm

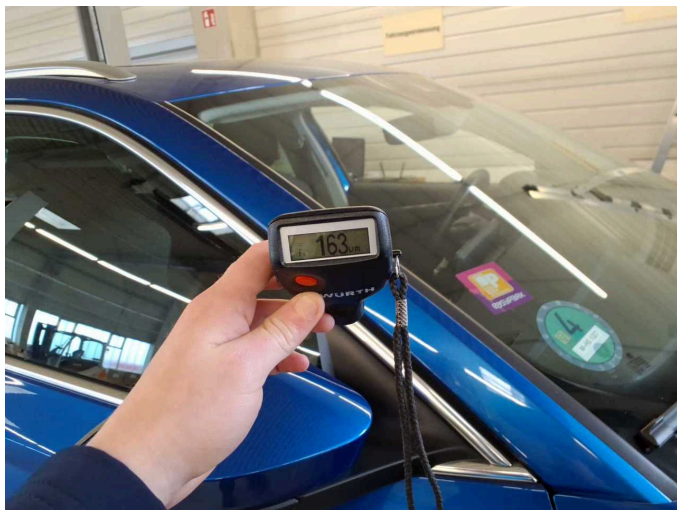
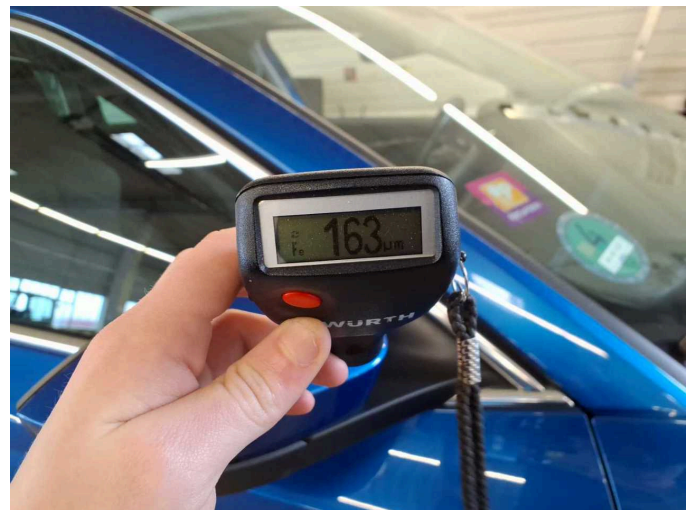
Roof rail - right side: 163 µm

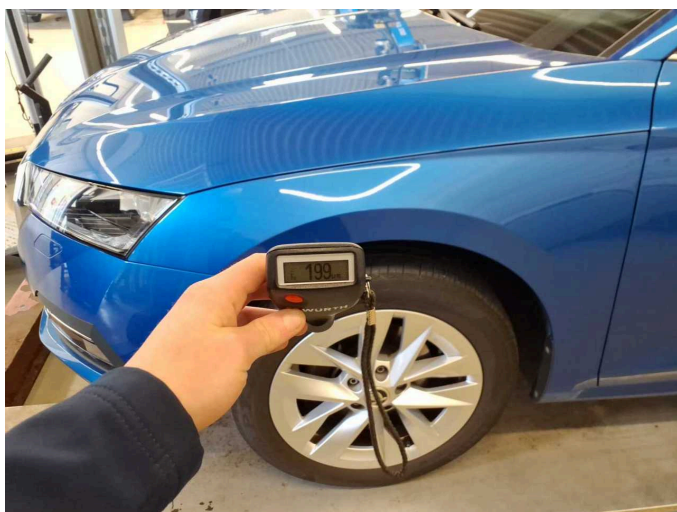
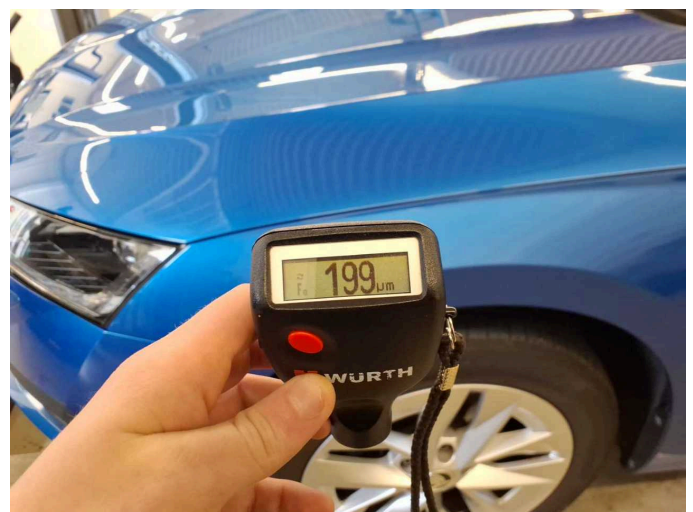
Mudguard - left side: 199 µm

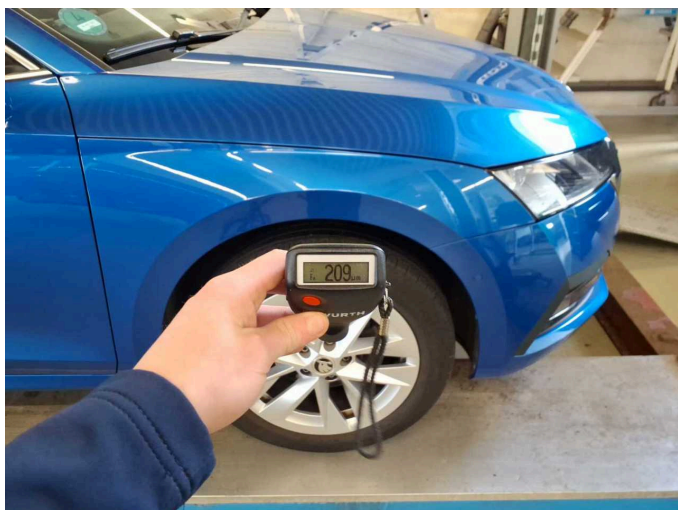
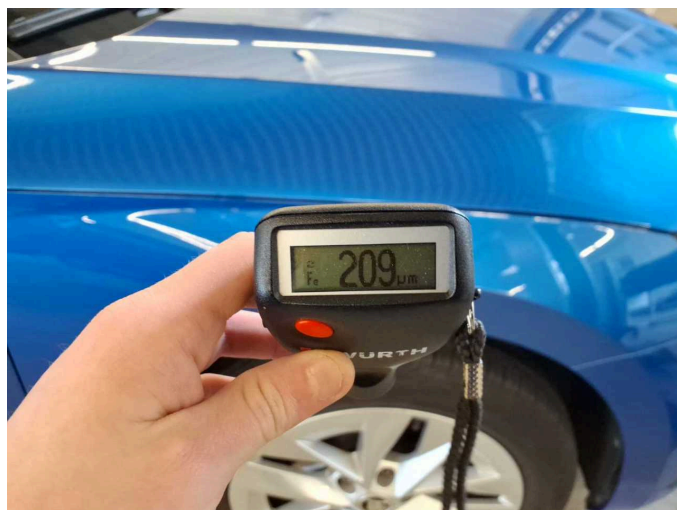
Mudguard - right side: 209 µm

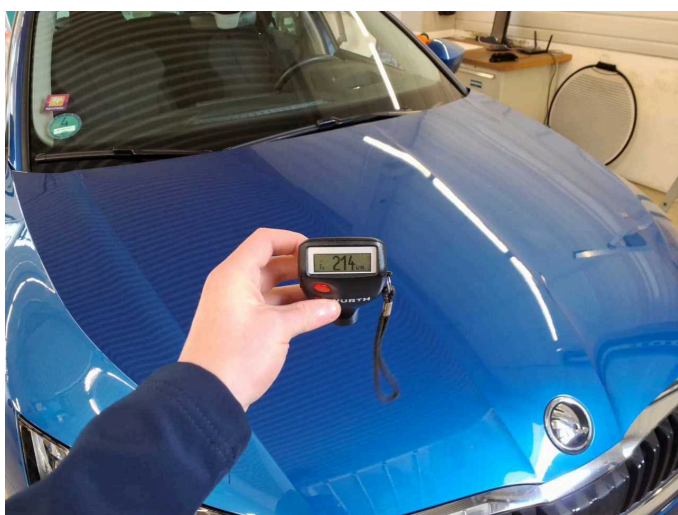
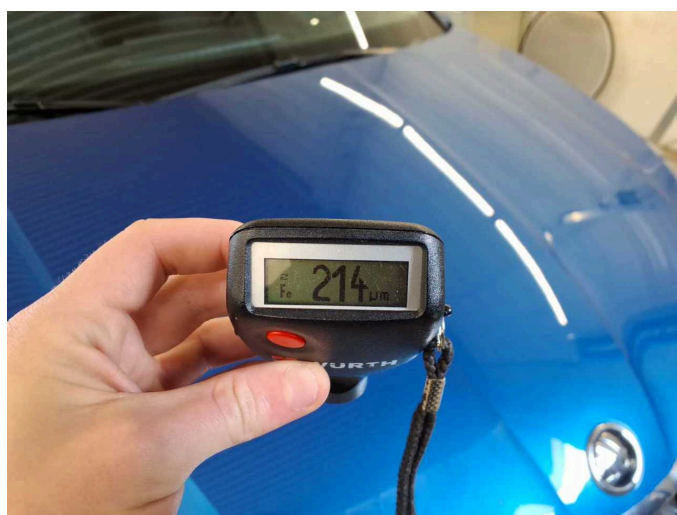
Bonnet: 214 µm

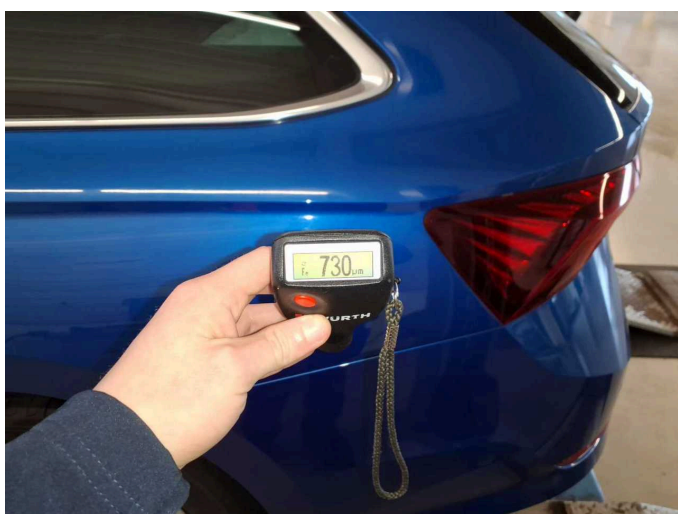
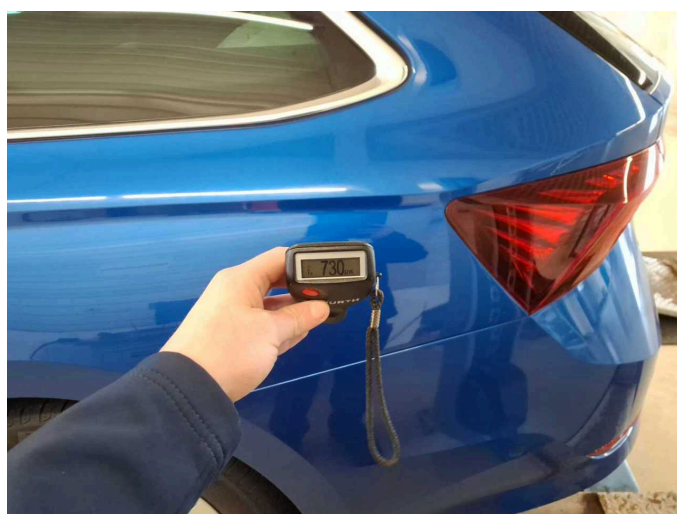
Side panel - rear left side: 730 µm

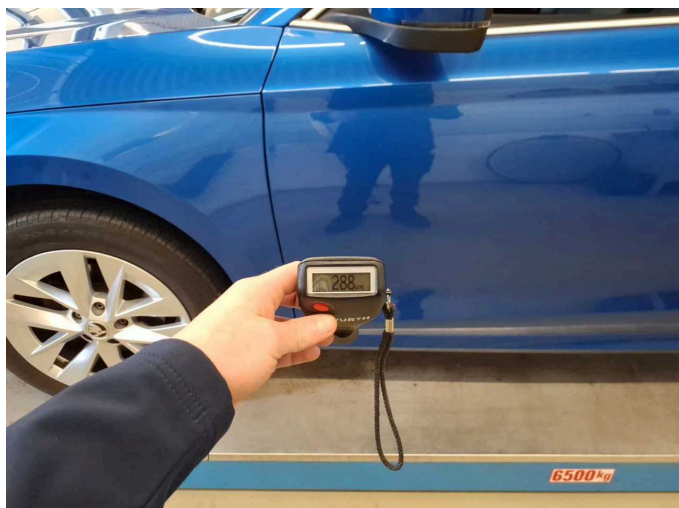
Door - front left side: 288 μm
