Expertise

Protocol number: 41478468
Order No. / Reference: 25199754
Inspection date: 10 Sept 2025

Manufacturer: Skoda
VIN: TMBJJ7NX4NY065460

Model: Octavia Combi 2.0 TDI DSG Style

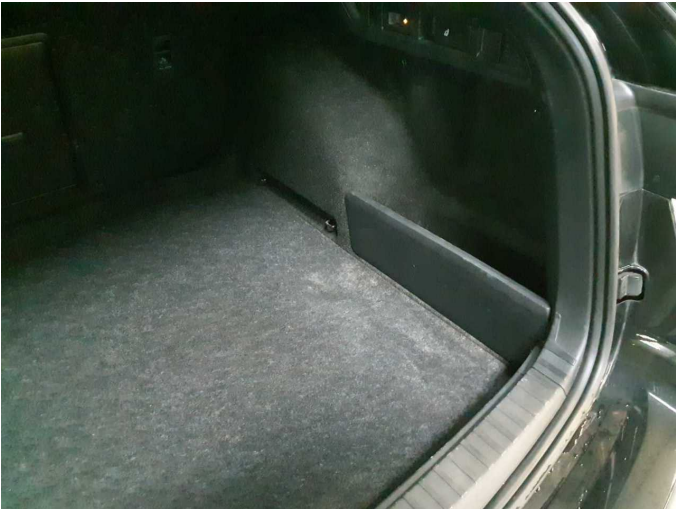
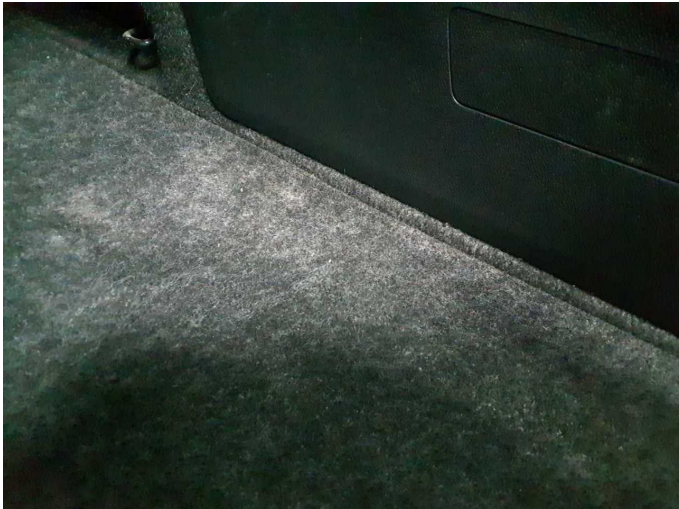
Damage 1: Interior: Cargo area floor - Soiled - Clean

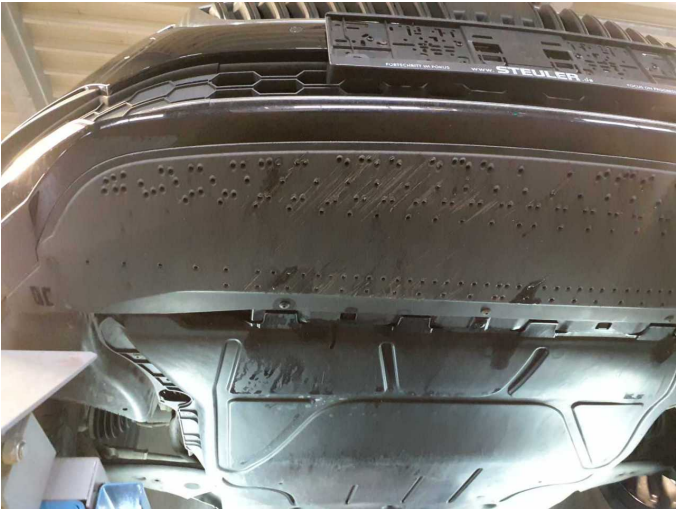
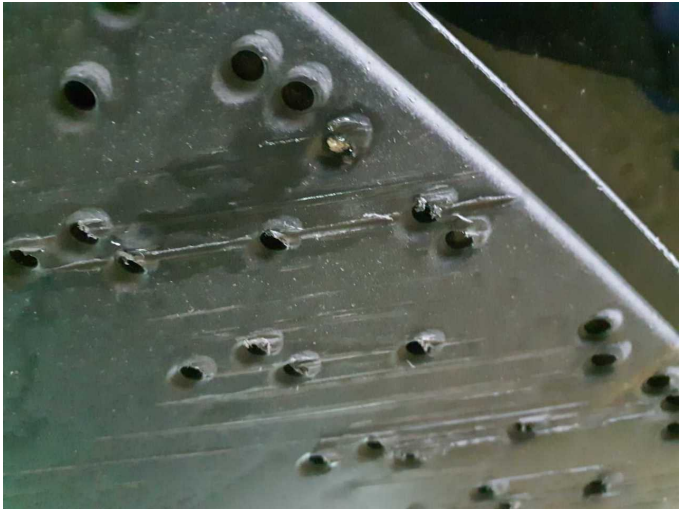
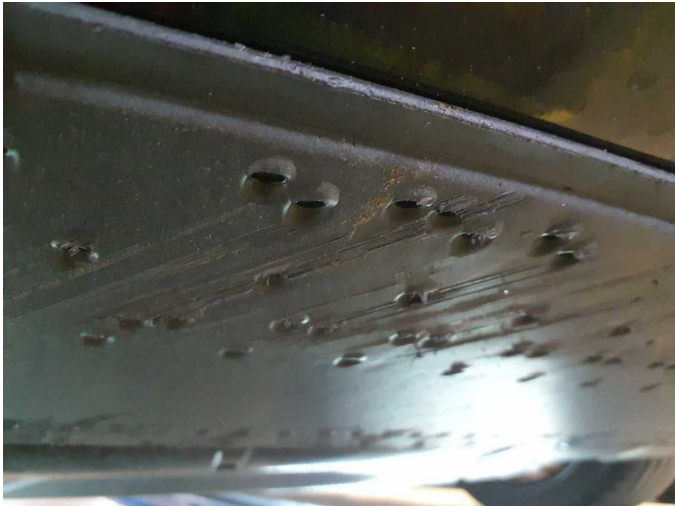
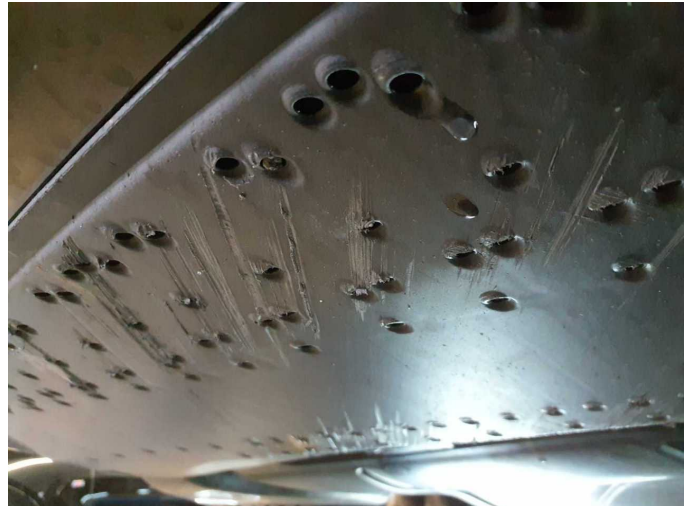
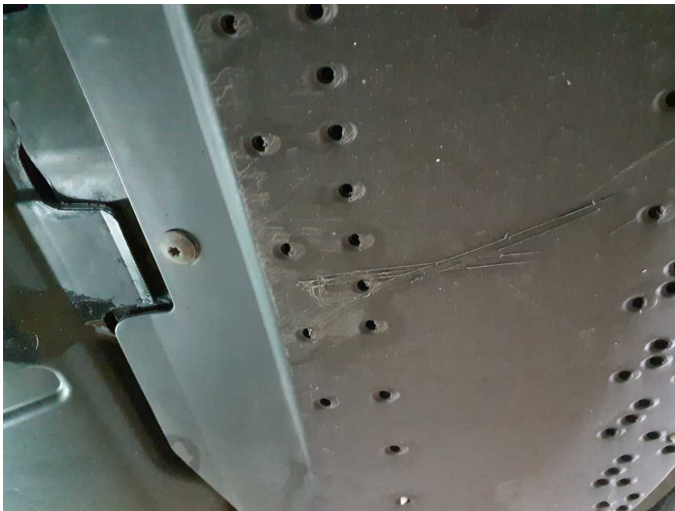
Damage 2: Body: Underbody panelling - Scratched - Replace

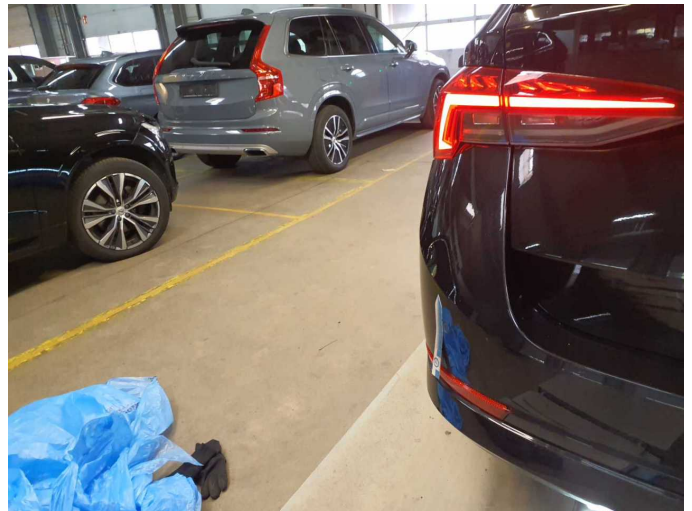
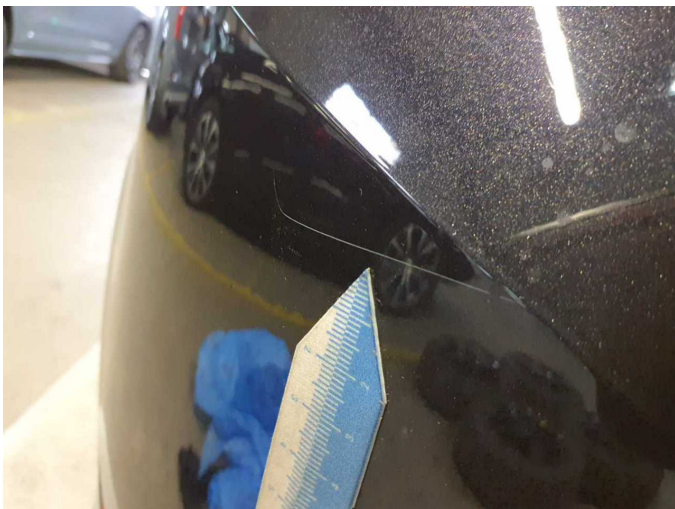
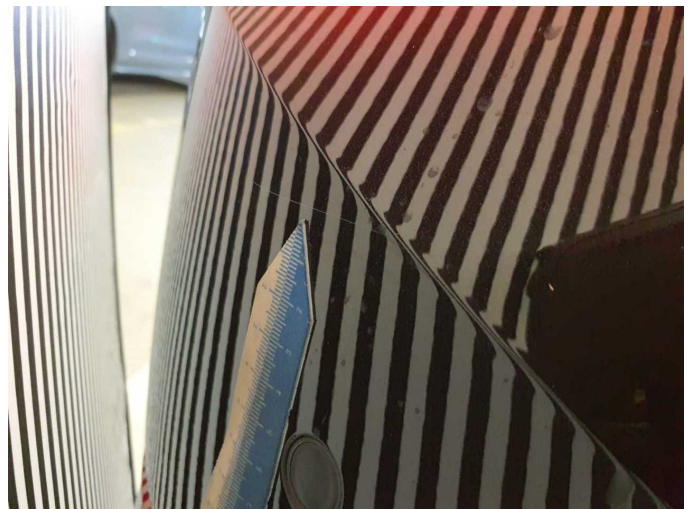
Damage 3: Rear bumper: Rear bumper - Scratched - Smart repair

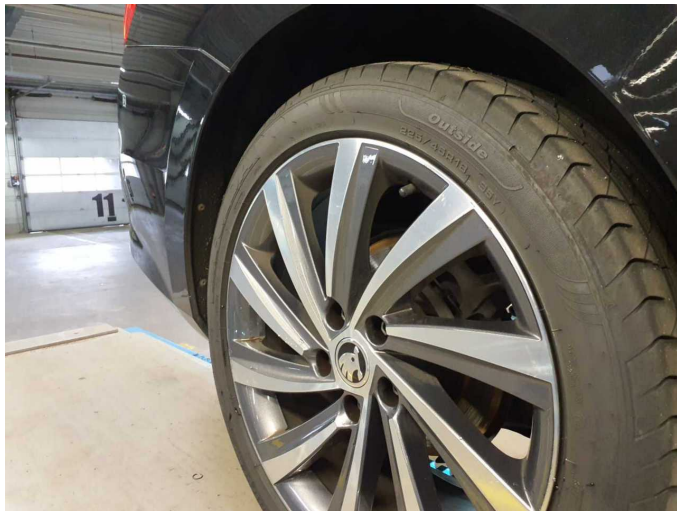
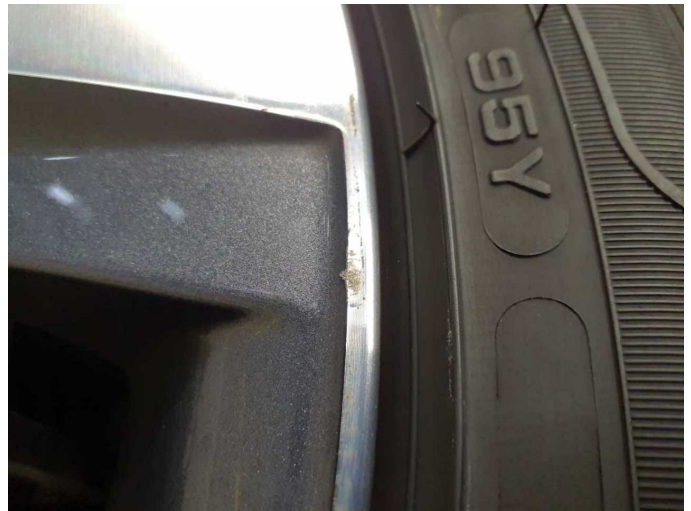
Wear and tear 11: Wheel / tyres: Alloy rim - rear right side - Scratched - No deduction

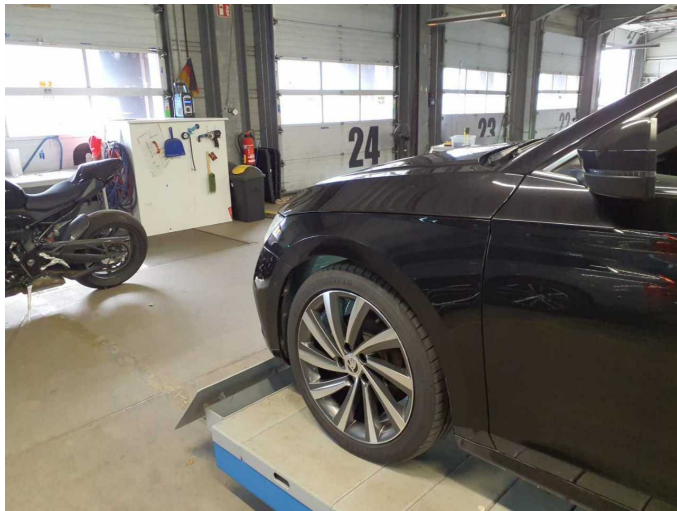
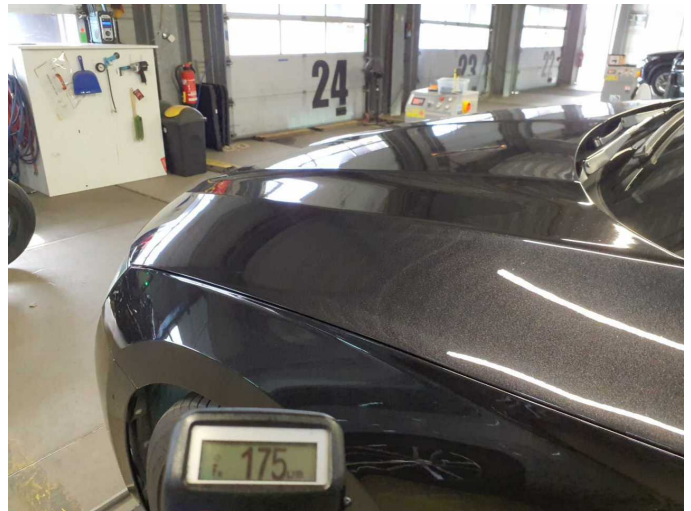
Repainting 1: Mudguard - left side

No.	Repainting
1	Mudguard - left side, Professionally carried out, Invoice of repair done Non-existent

Mudguard - left side	175 µm	Bonnet	199 µm
----------------------	--------	--------	--------

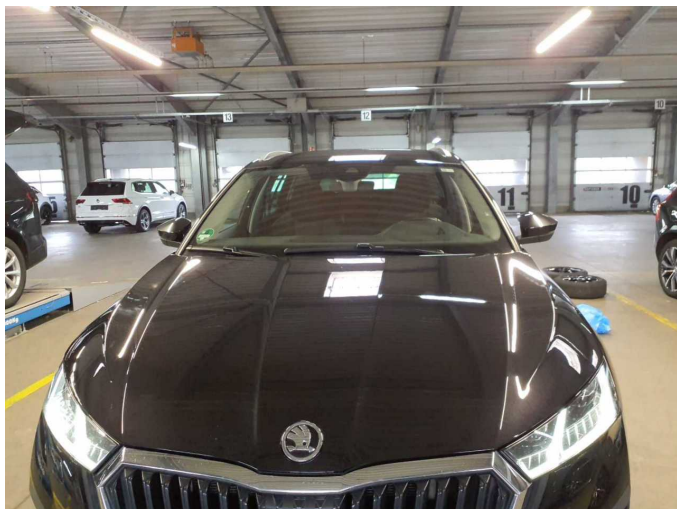
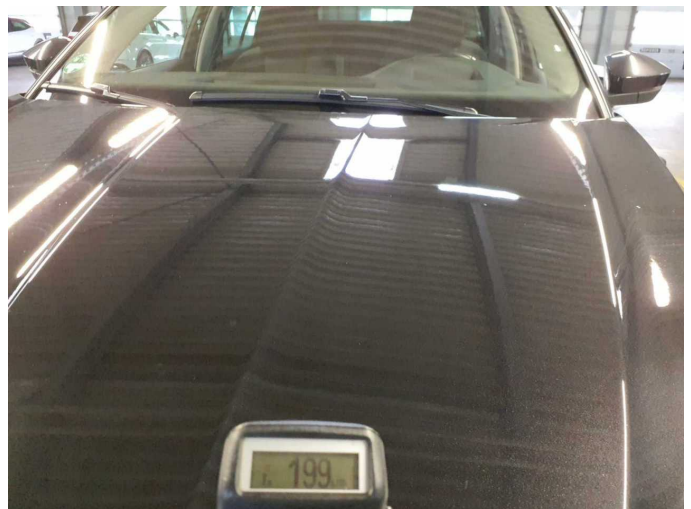
Repainting 2: Bonnet

2 Bonnet, Professionally carried out, Invoice of repair done Non-existent
