Expertise

Protocol number: 41225940
Order No. / Reference: 25019138
Inspection date: 25 Aug 2025

Manufacturer: Skoda	Model: Octavia Combi 2.0 TDI DSG First Edition
VIN: TMBJJ7NX5LY026034

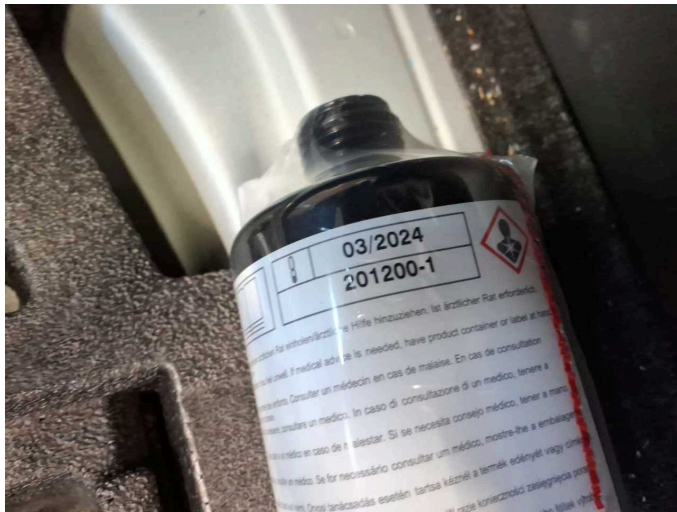
Damage 1: Equipment: Tirefit filler - Expired - Replace

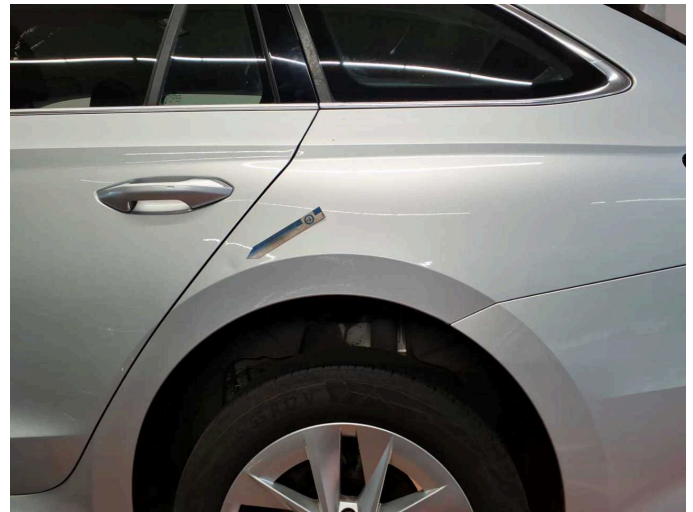
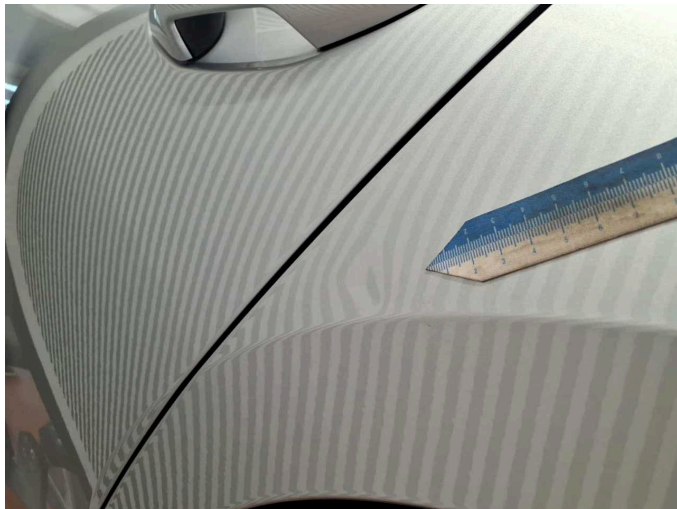
Damage 2: Side panel - rear left side: Side panel - dent(s) - Smart repair

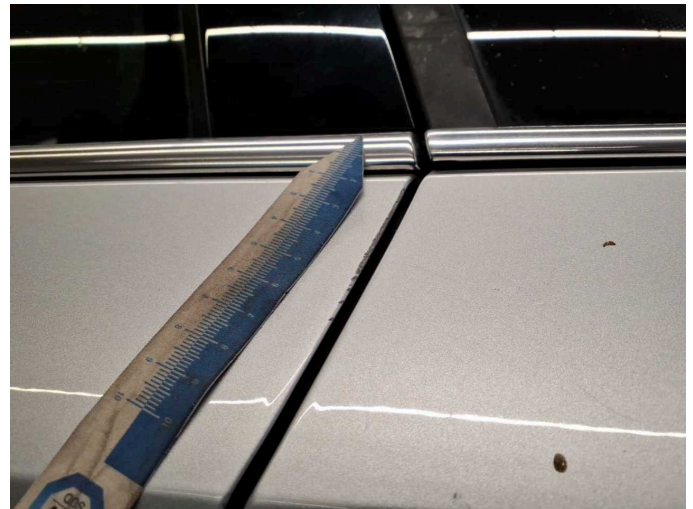
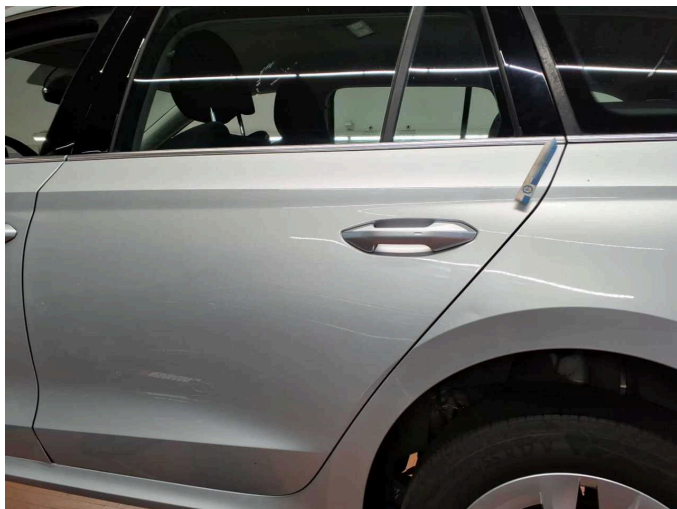
Damage 3: Door - rear left side: Door edge - Scratch(es) - Smart repair

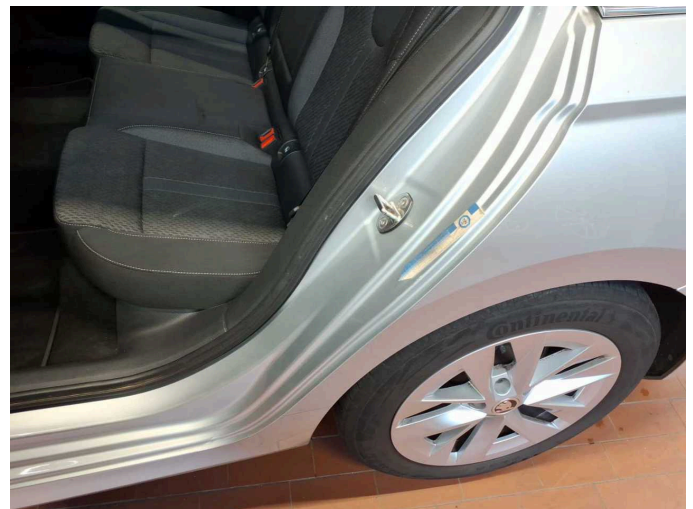
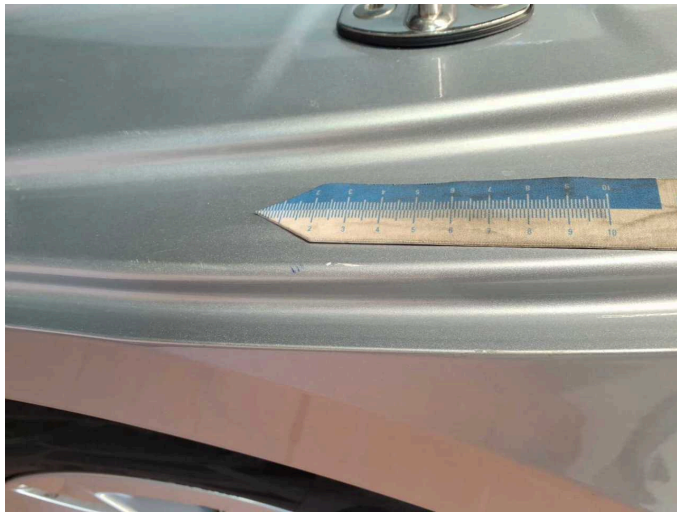
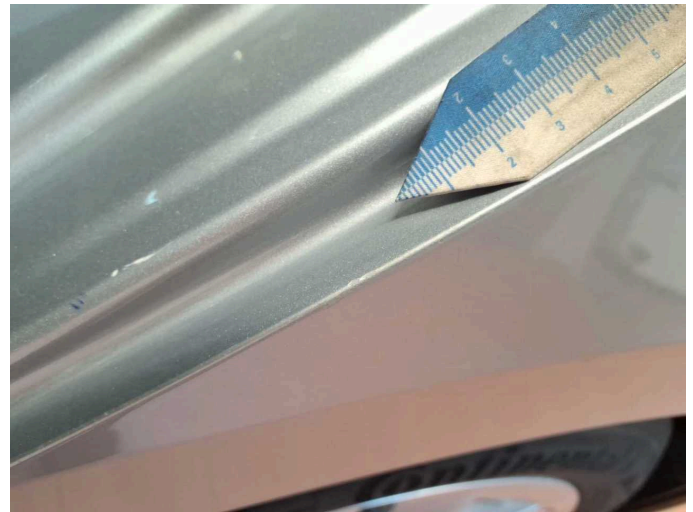
Damage 4: Side panel - rear left side: Sill - Scratch(es) - Smart repair

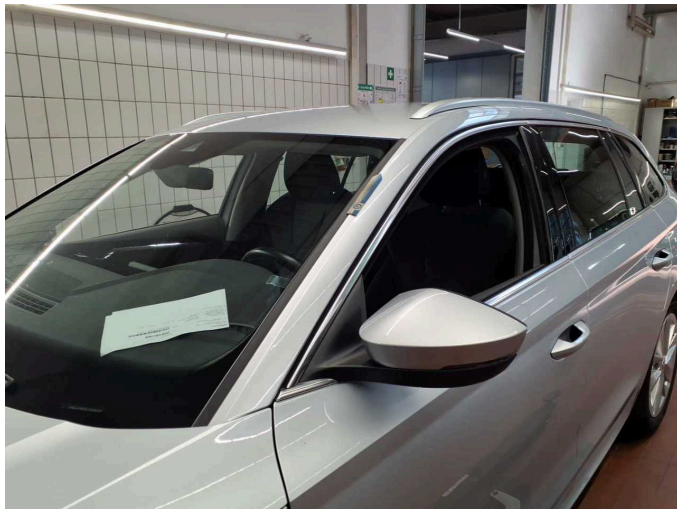
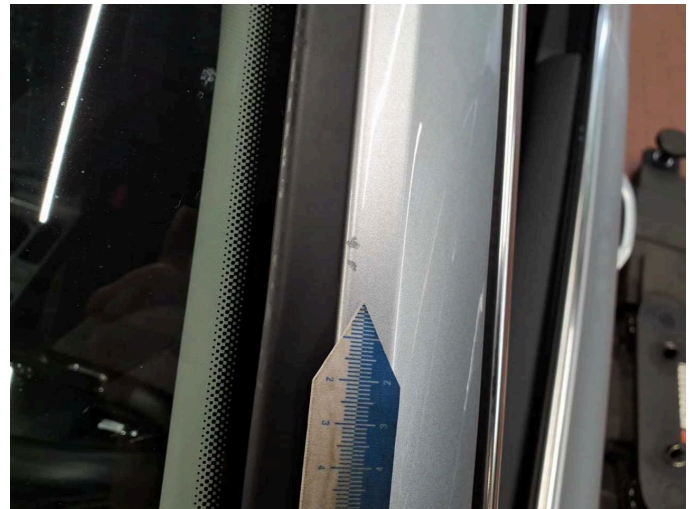
Damage 6: Roof: Roof rail - left side - Stone chips - Smart repair

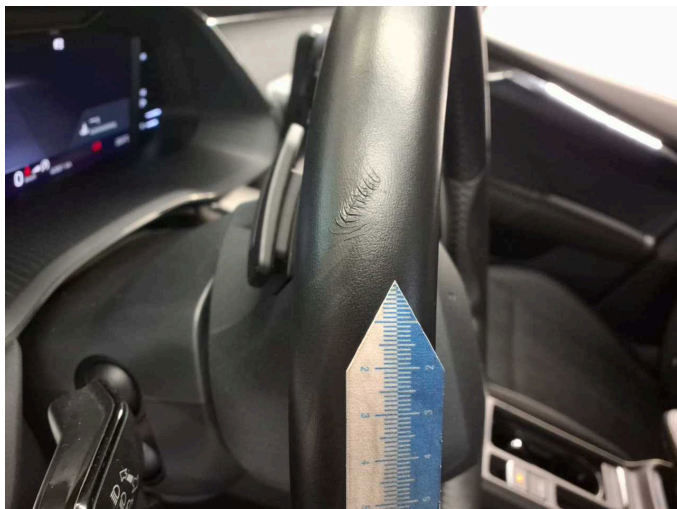
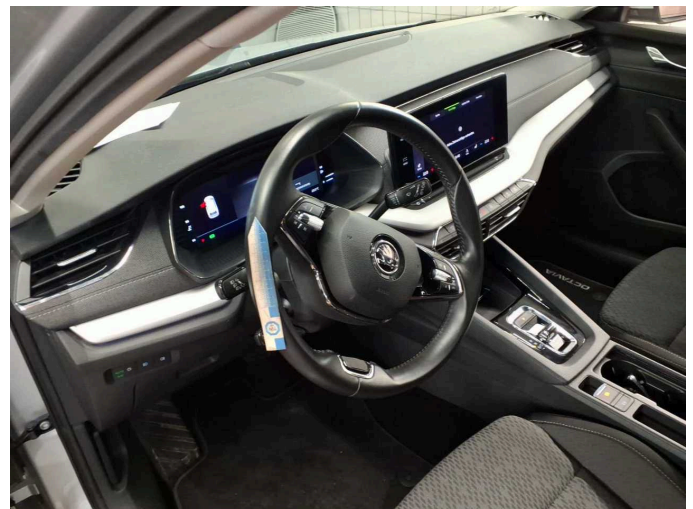
Damage 7: Steering system: Steering wheel - Scratch(es) - Smart repair

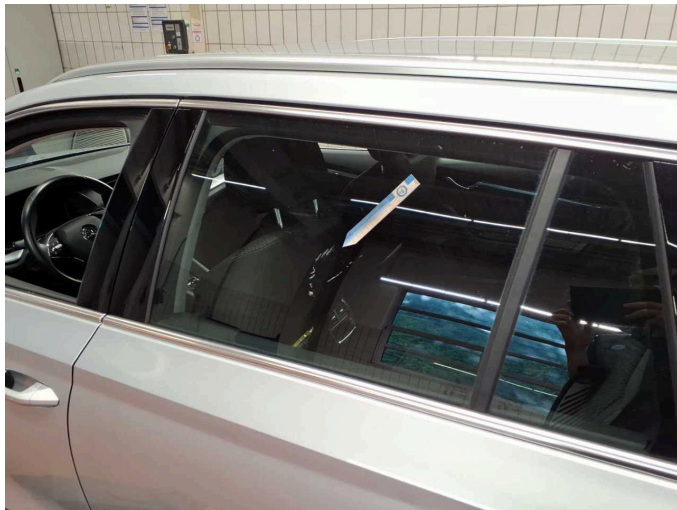
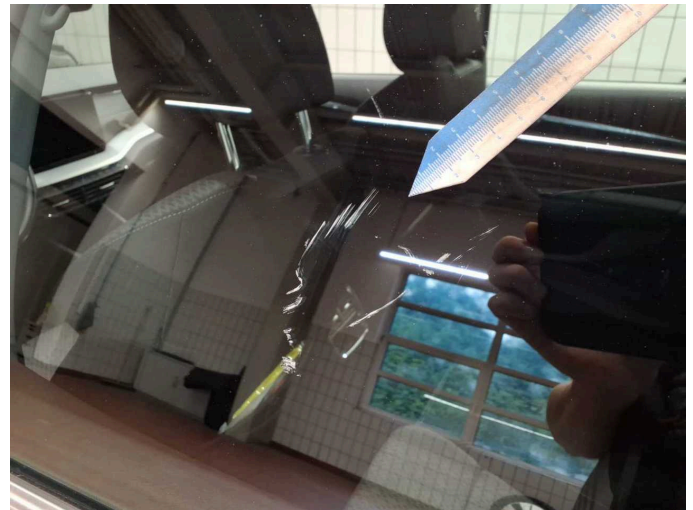
Damage 8: Vehicle glazing: Door glass - rear left side - Scratch(es) - Replace

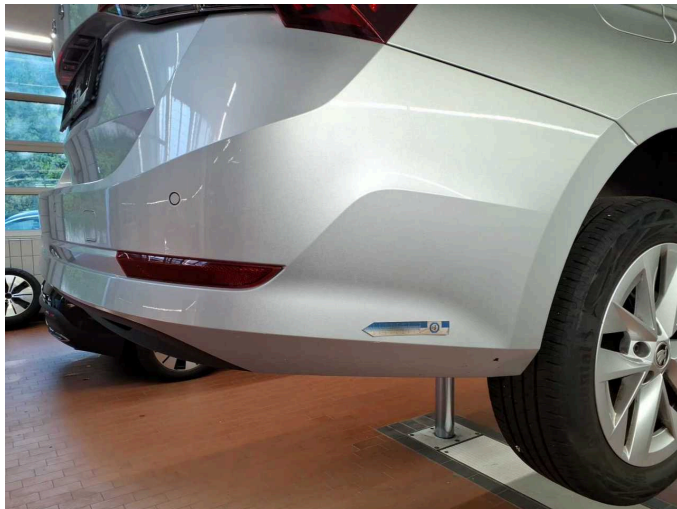
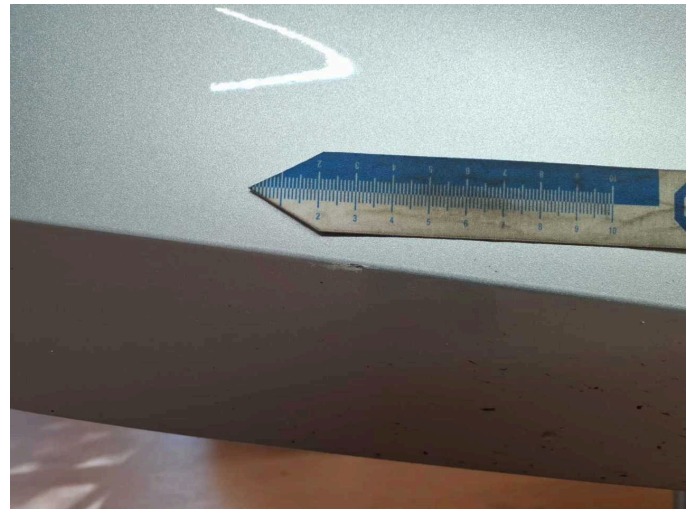
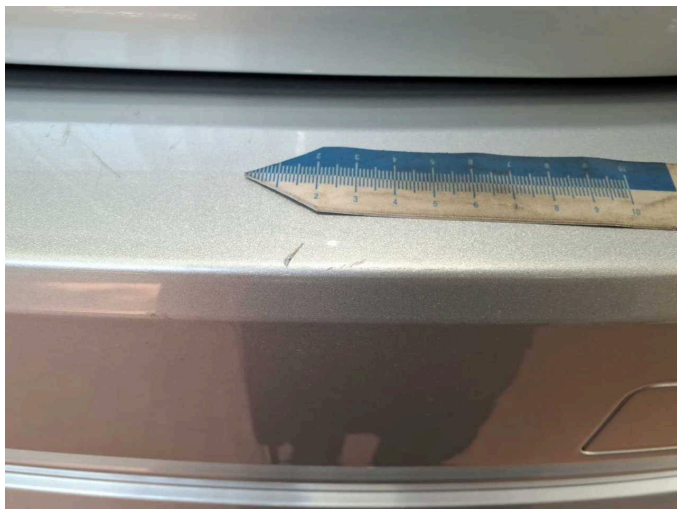
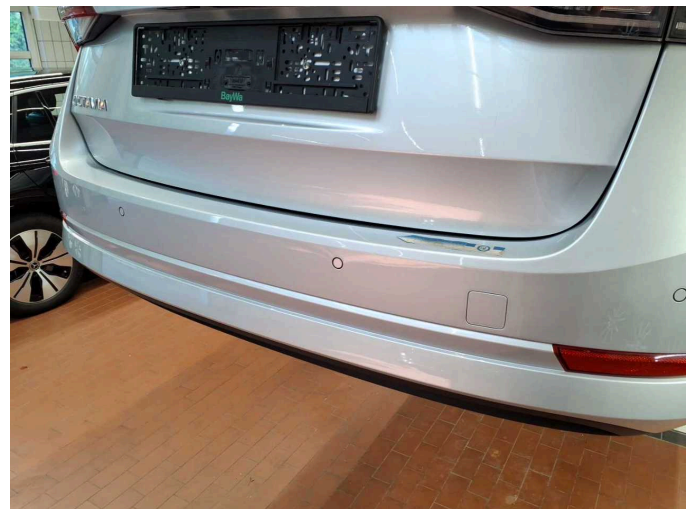
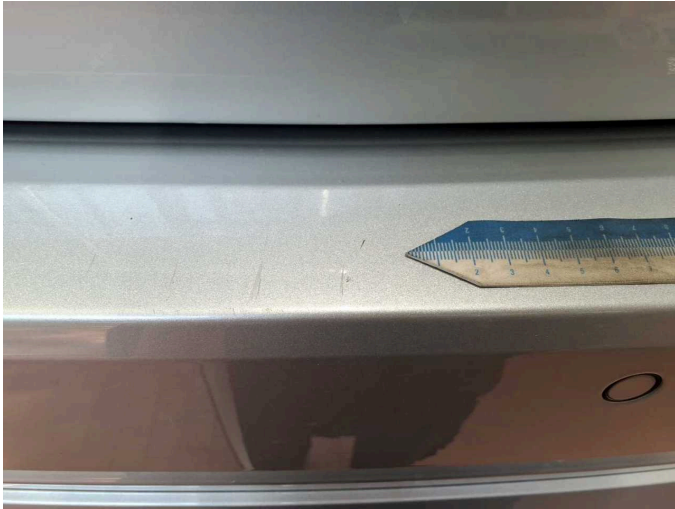
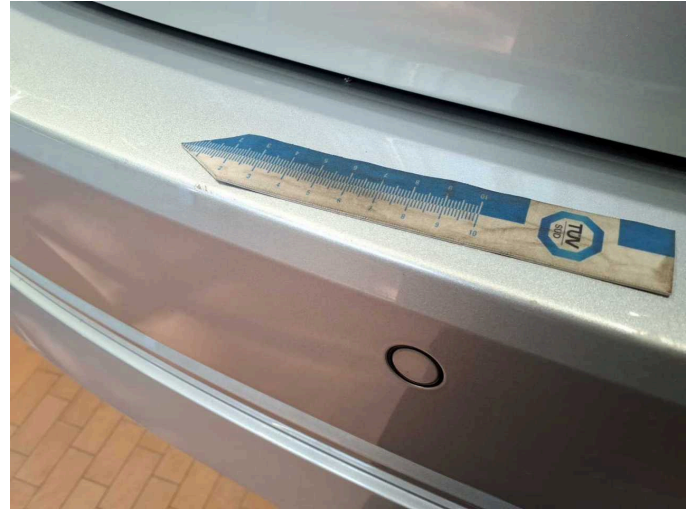
Damage 9: Rear bumper: Rear bumper - Scratch(es) - Paint

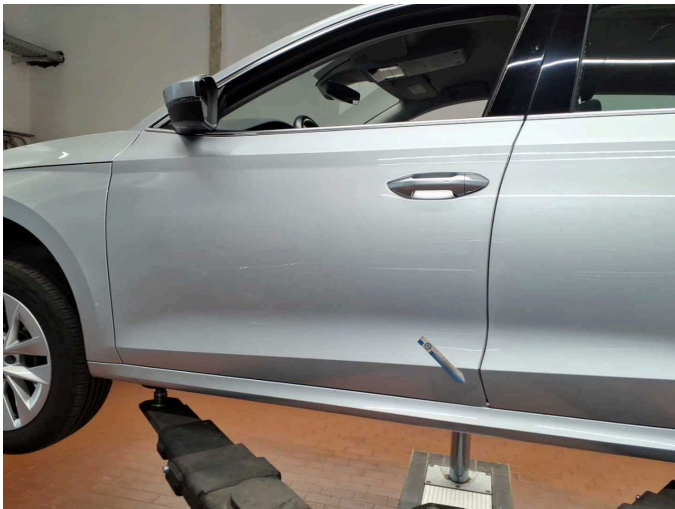
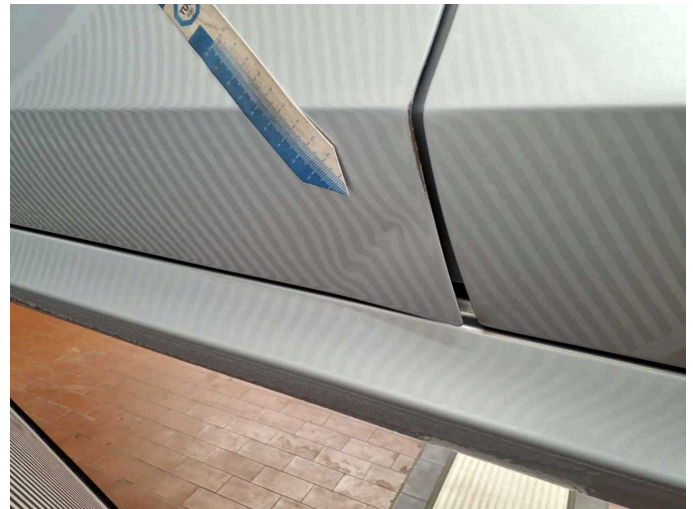
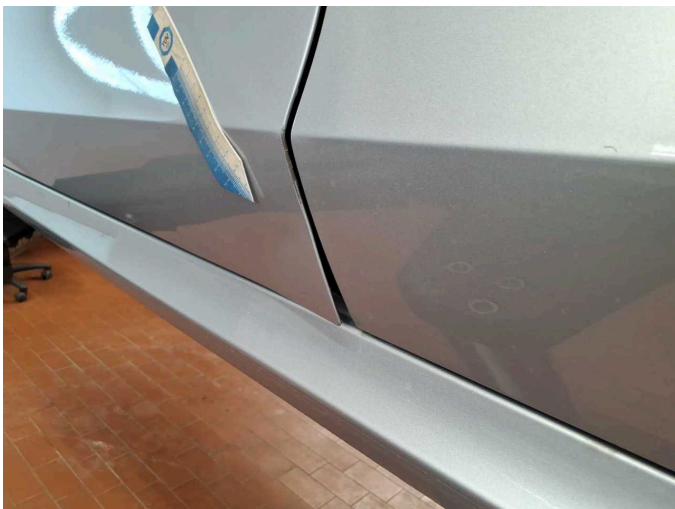
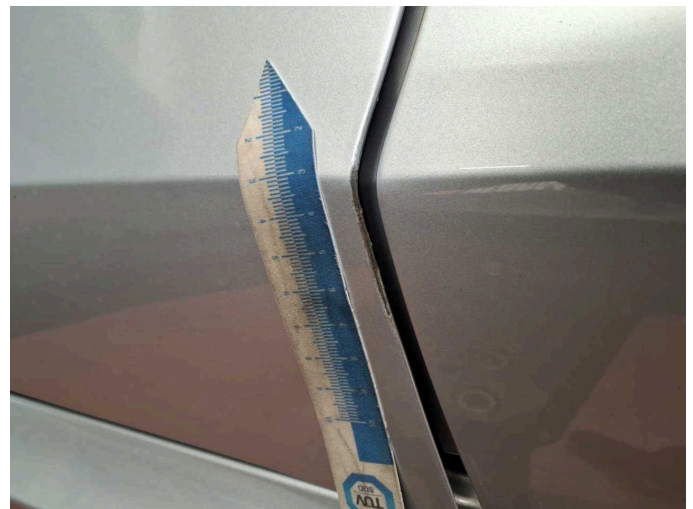
Damage 10: Door - front left side: Door - Deformed - Repair and paint

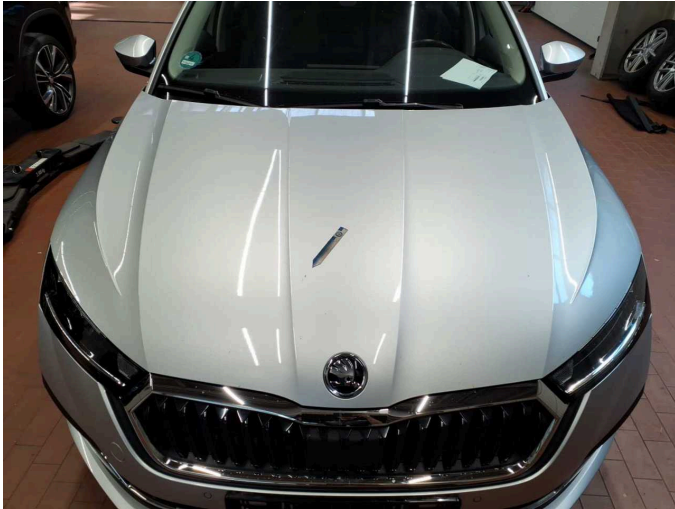
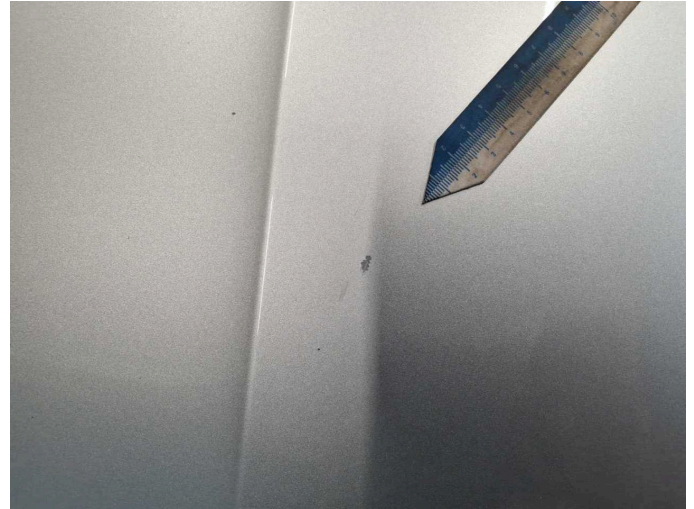
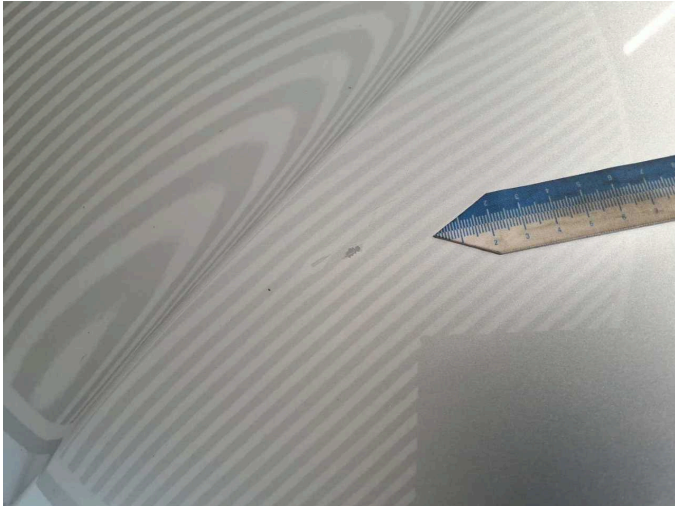
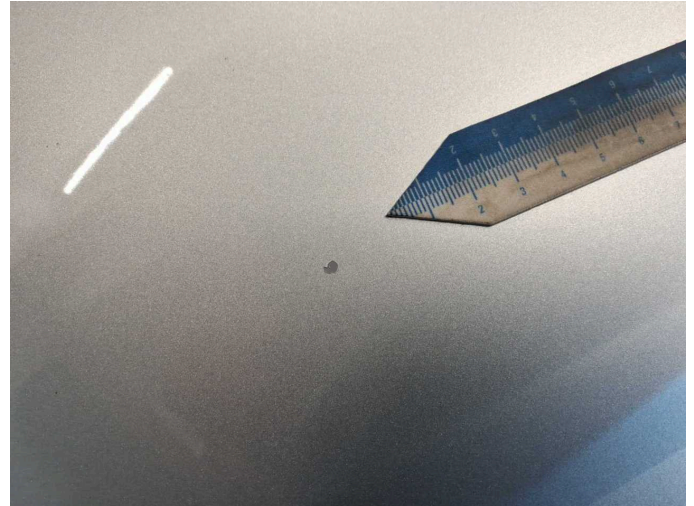
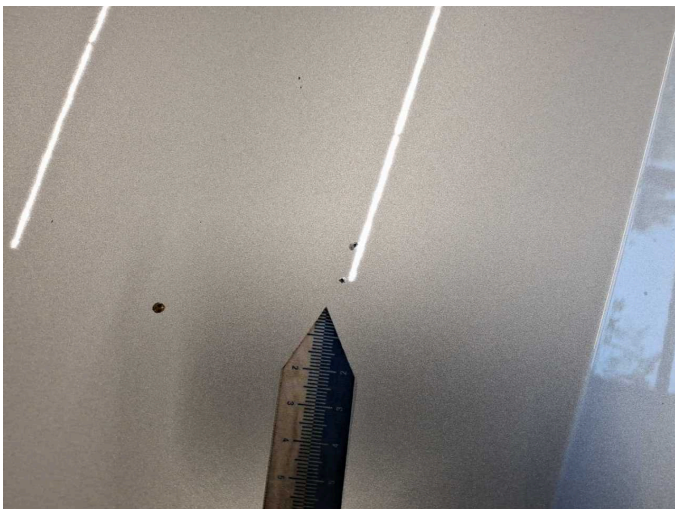
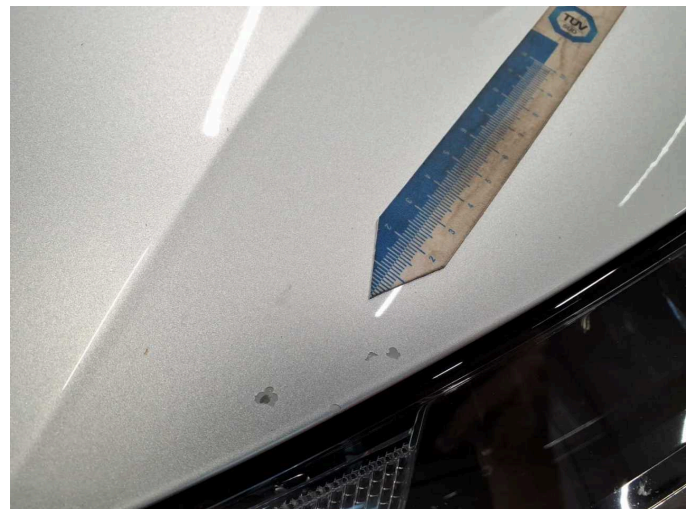
Damage 11: Bonnet: Bonnet - Dent / paintcoat damage - Repair and paint

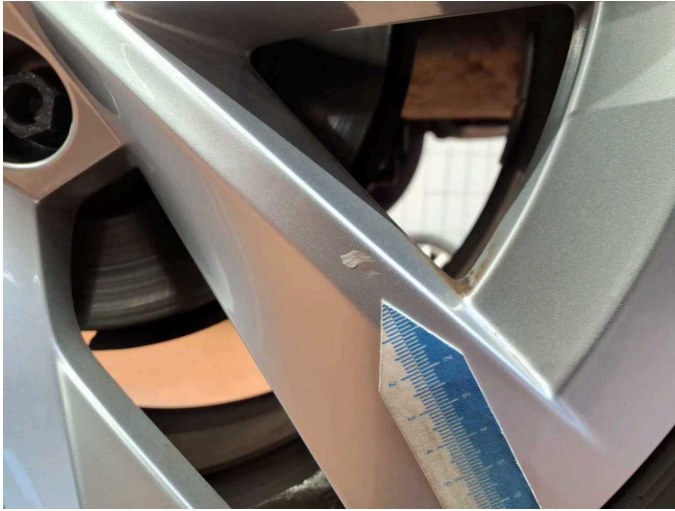
Wear and tear 7: Wheel / tyres: Alloy rim - rear left side - Scratch(es) - Smart repair

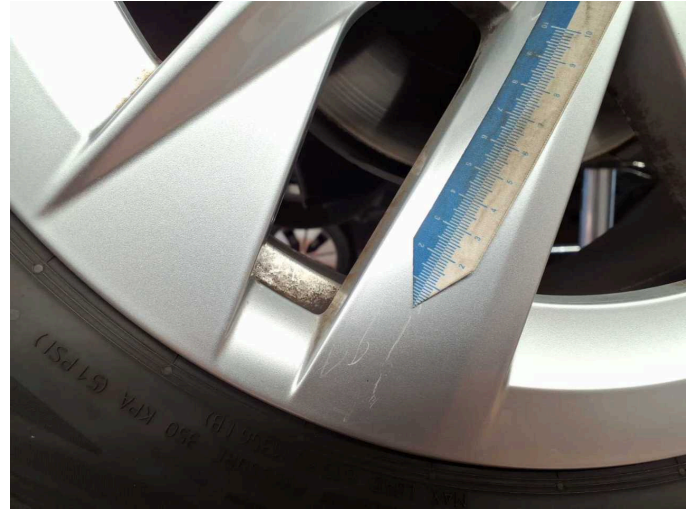
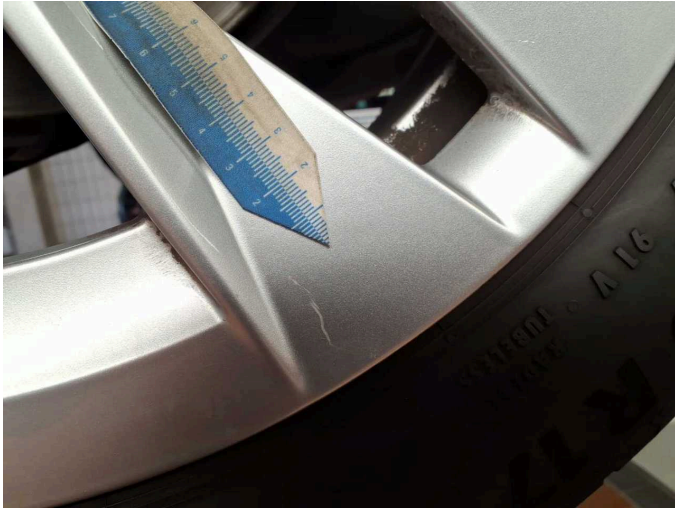
Wear and tear 8: Wheel / tyres: Alloy rim - rear right side - Scratch(es) - Smart repair

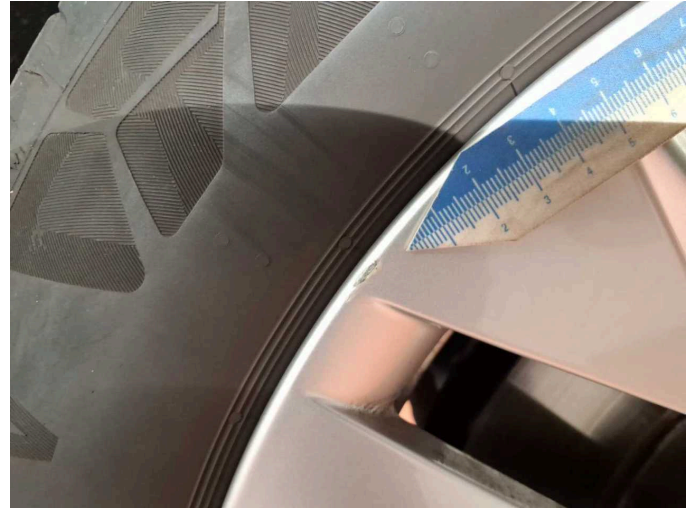
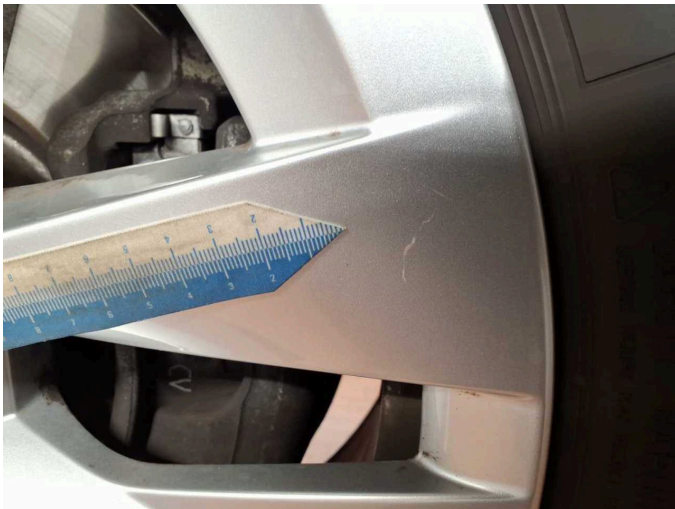
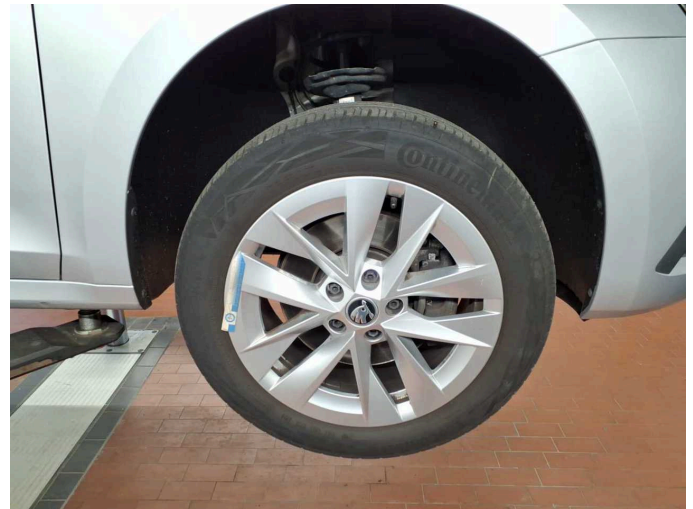
Wear and tear 9: Wheel / tyres: Alloy rim - front right side - Scratch(es) - Smart repair

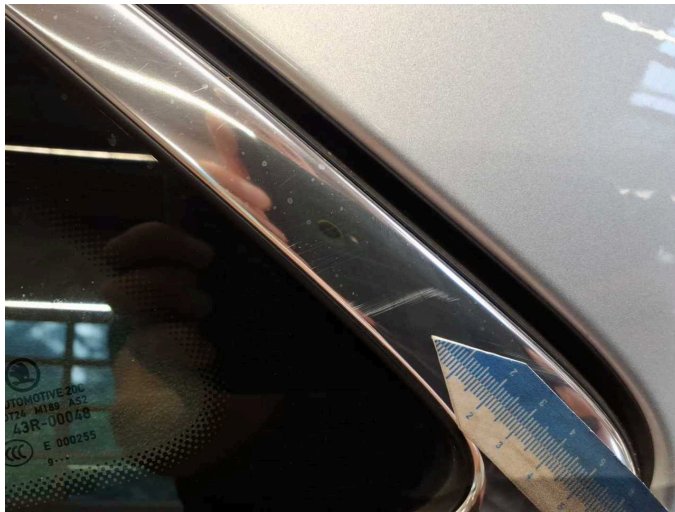
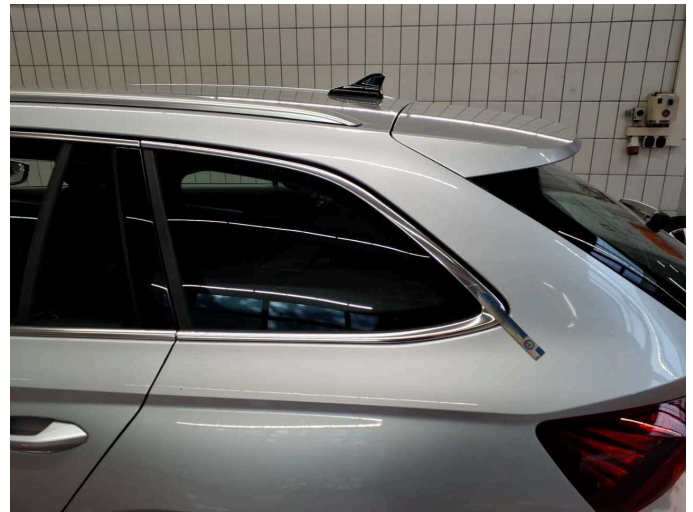
Wear and tear 10: Vehicle glazing: Side window - rear left side (Zierleiste) - Scratch(es) - No deduction
