Expertise

Protocol number: 41551879
Order No. / Reference: 25227074
Inspection date: 15 Sept 2025

Manufacturer: Skoda

Model: Octavia Combi 2.0 TDI DSG Style

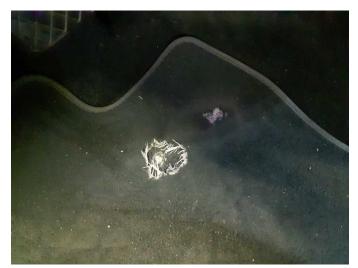
Damage 1: Trim / covers: Floor mats - Holes - Replace

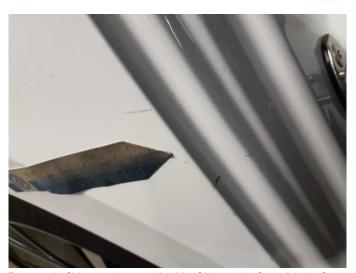
Damage 3: Side panel - rear right side: Side panel - Scratch(es) - Smart repair

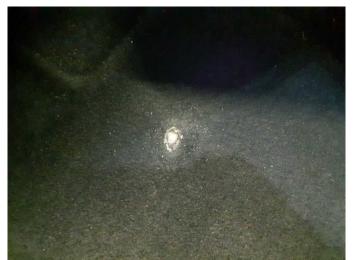
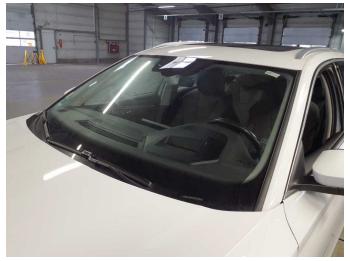
Damage 5: Trim / covers: Carpet - front left side - Holes - Loss in value

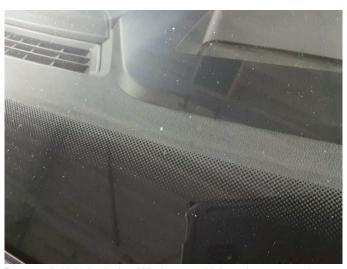
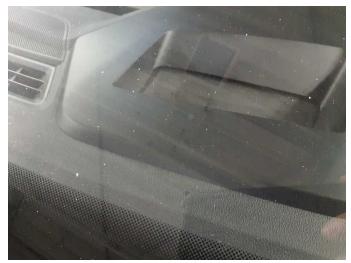
Damage 6: Vehicle glazing: Windscreen with lane departure assistant - Stone chips - Paint
