Expertise

Protocol number: 41556538  
Order No. / Reference: 25213914  
Inspection date: 16 Sept 2025

Manufacturer: Skoda	Model: Octavia Combi 2.0 TDI Style
VIN: TMBJJ7NX8MY169769

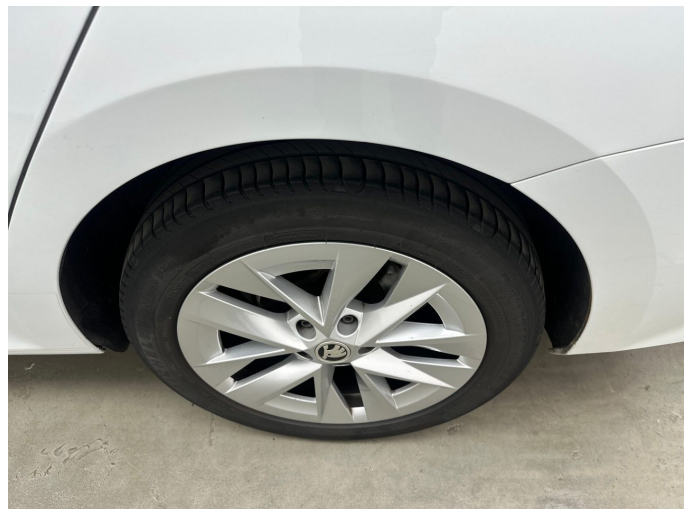
Figure 12: Mounted tyres

#	Tyre size	Type of tyre	Manufacturer	Tread depth
1)	205/55 R17 91V	Summer tyres on Light alloy	Michelin	2mm / 2mm
2)	205/55 R17 91V	Summer tyres on Light alloy	Michelin	6mm / 6mm

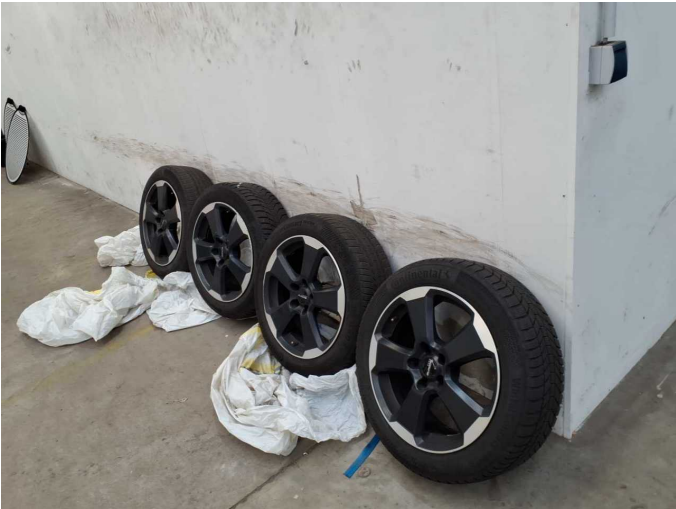
Figure 15: Additional tyres

#	Tyre size	Type of tyre	Manufacturer	Tread depth
1)	205/55 R17 97H	Winter tyres on Light alloy	Continental	2mm / 2mm
2)	205/55 R17 97H	Winter tyres on Light alloy	Continental	5mm / 5mm

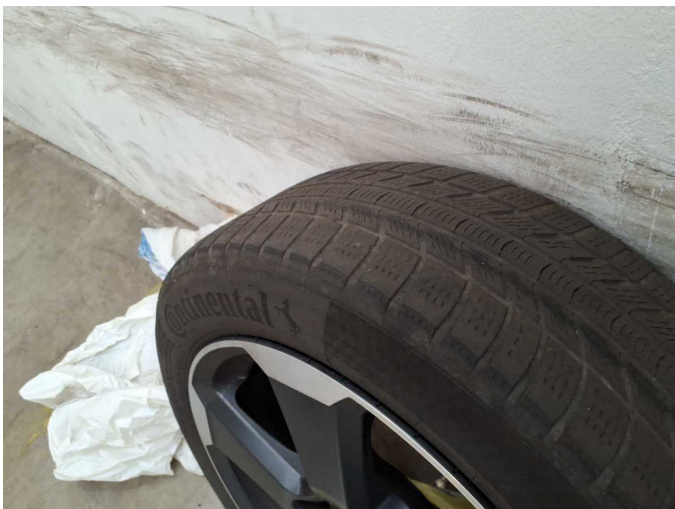
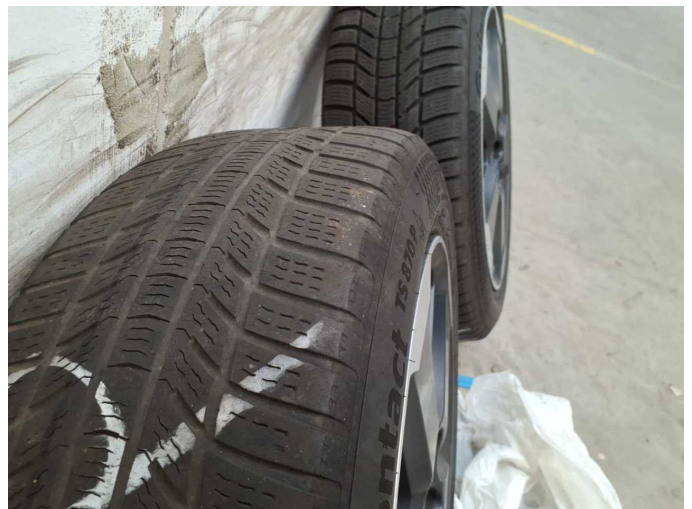
**Damage 1:** 2nd wheel set: 2 tyres (Zubehör) - Does not meet the leasing specifications - No deduction

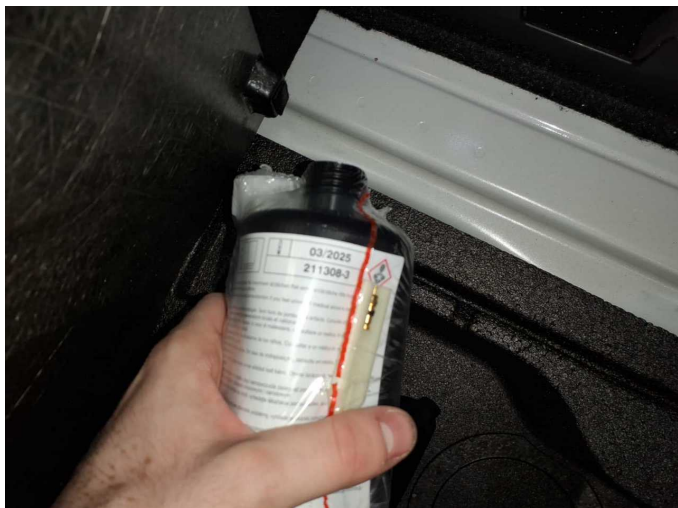
**Damage 2:** Equipment: Tirefit filler - Expired - Replace

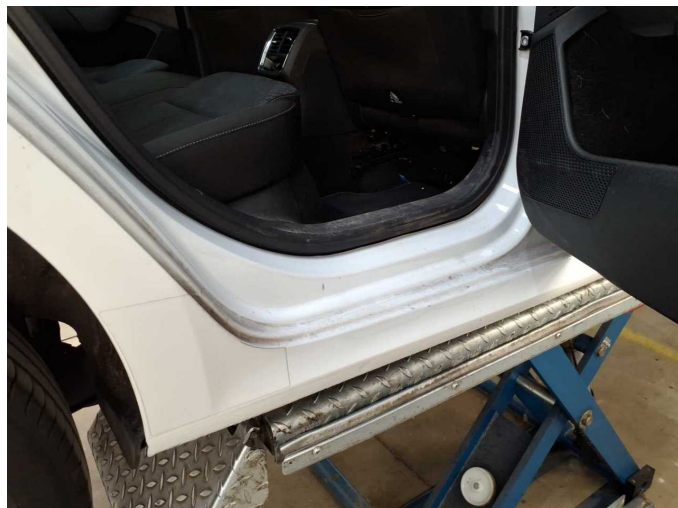
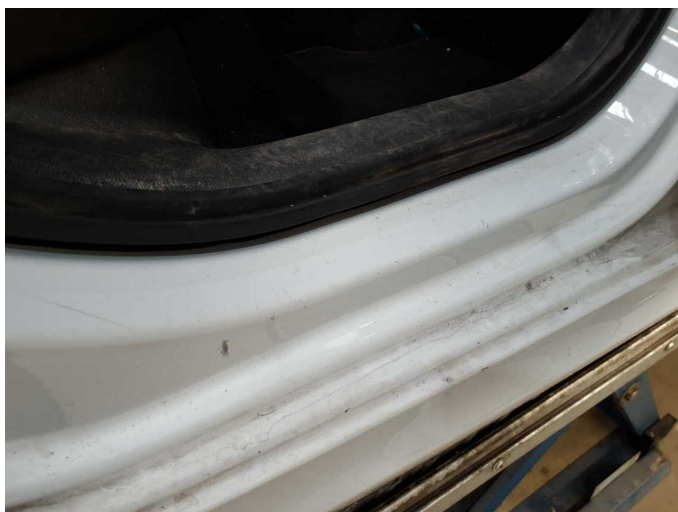
**Damage 3:** Side panel - rear right side: Sill - Scratch(es) - Cover / polish

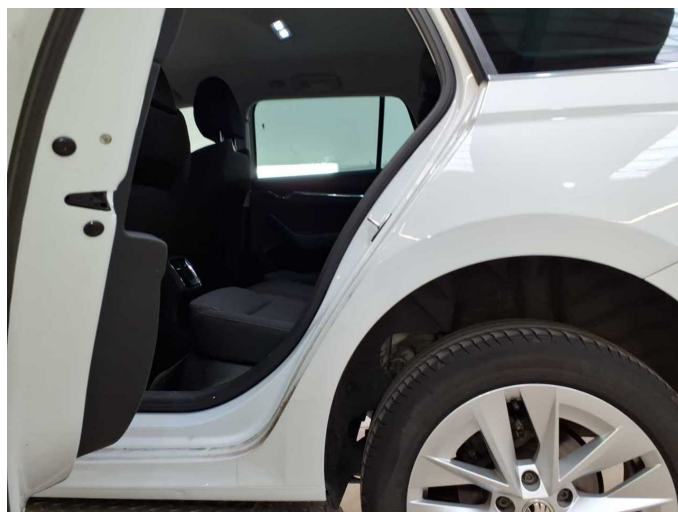
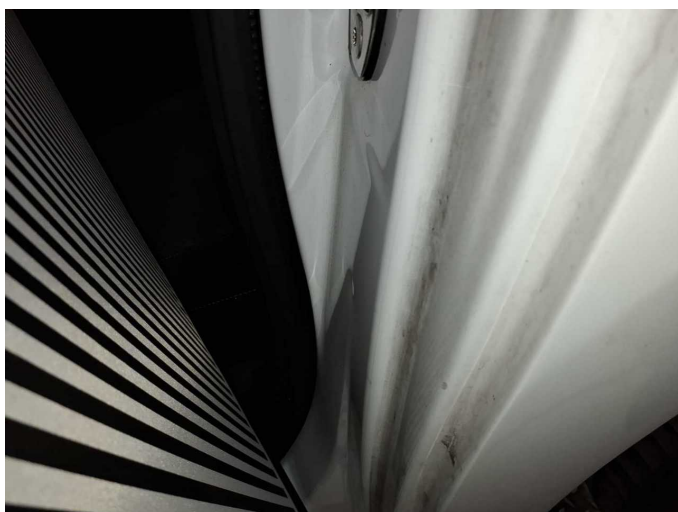
**Damage 4:** Side panel - rear left side: Sill - dent(s) - Smooth repair work

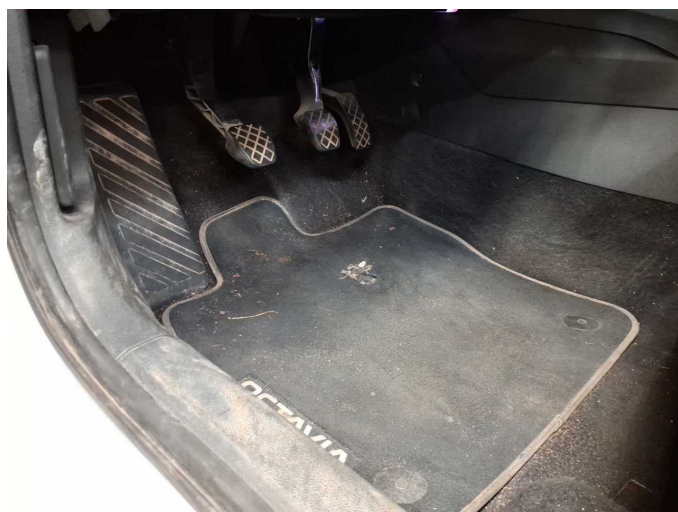
**Damage 5:** Trim / covers: Floor mats - Broken / torn - Replace

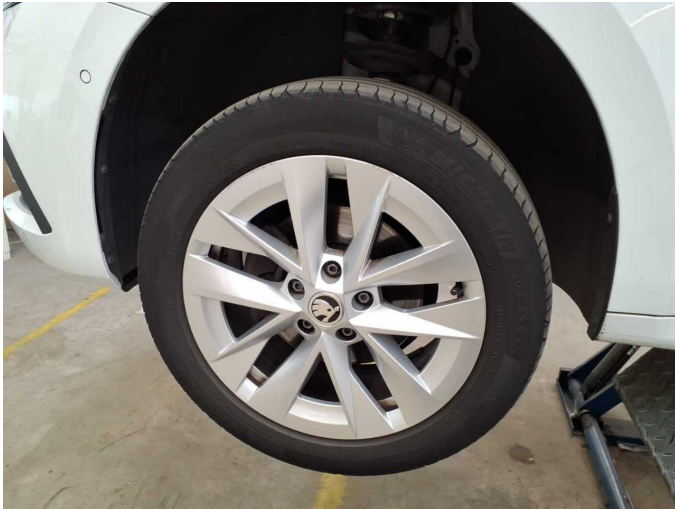
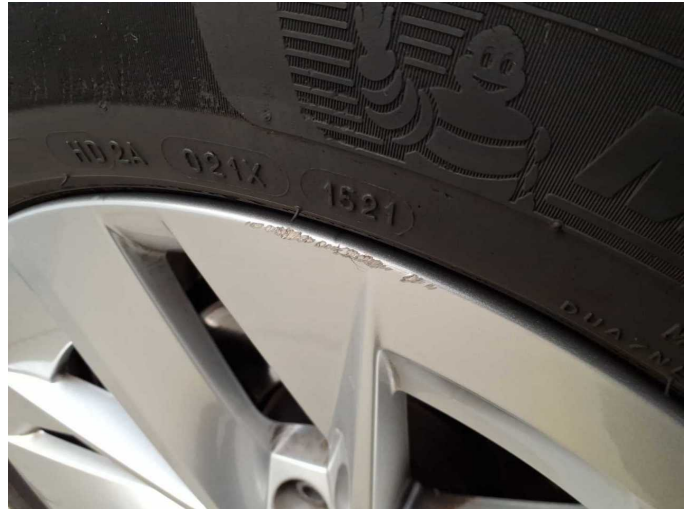
**Damage 6:** Wheel / tyres: Alloy rim - front left side - Scratch(es) - Loss in value

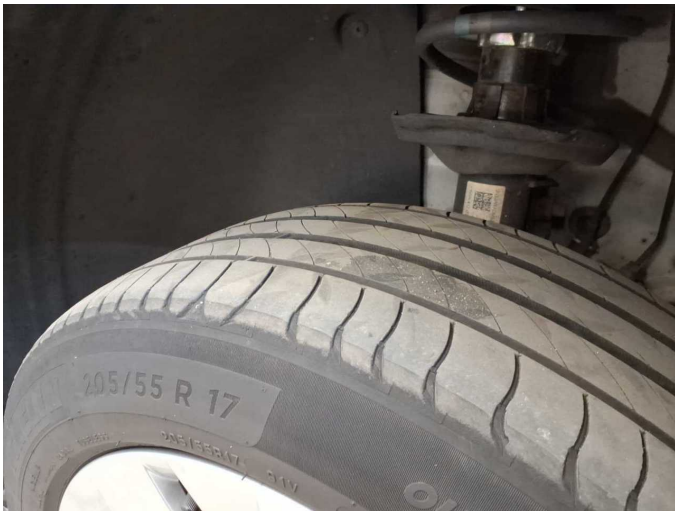
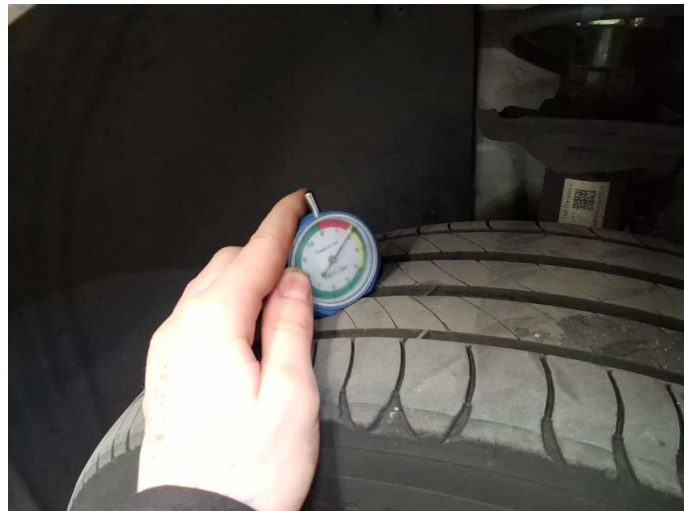
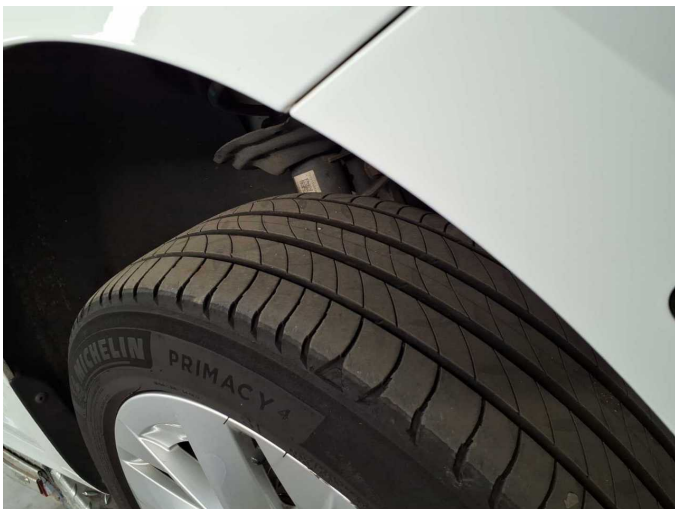
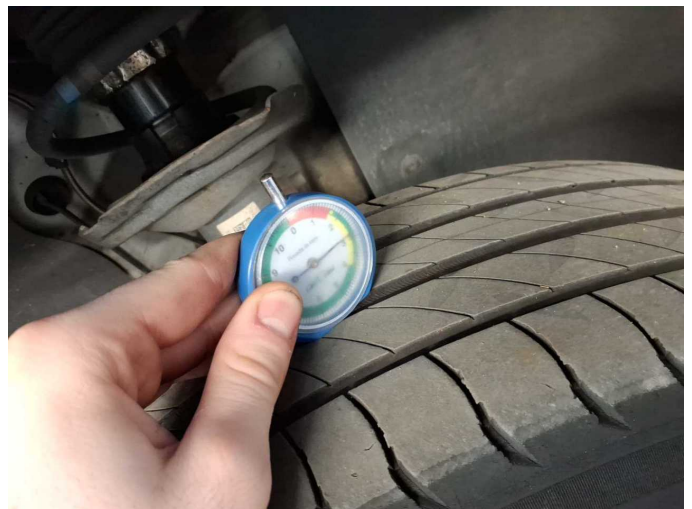
**Damage 8:** Wheel / tyres: Tyre - front - Does not meet the leasing specifications - Replace

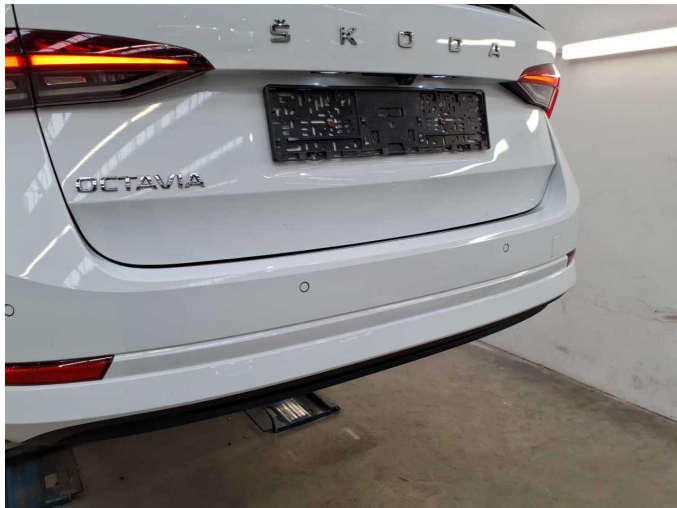
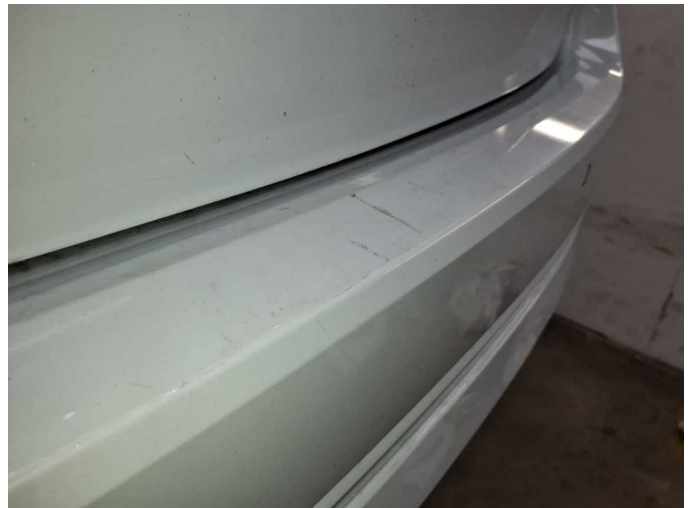
**Damage 9:** Rear bumper: Rear bumper - Scratch(es) - Paint

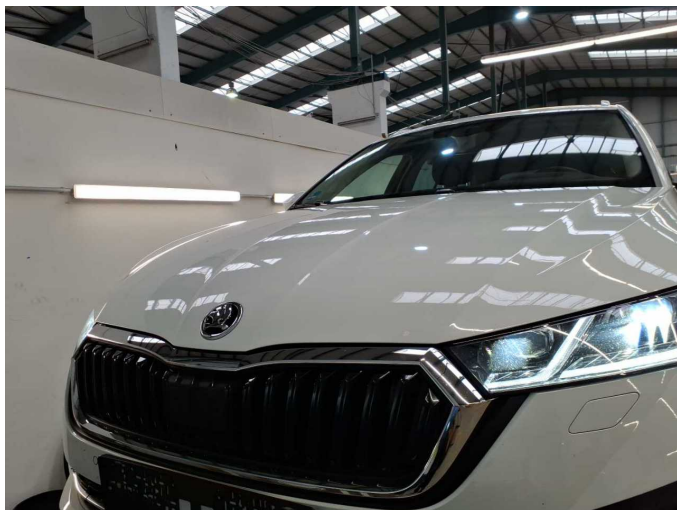
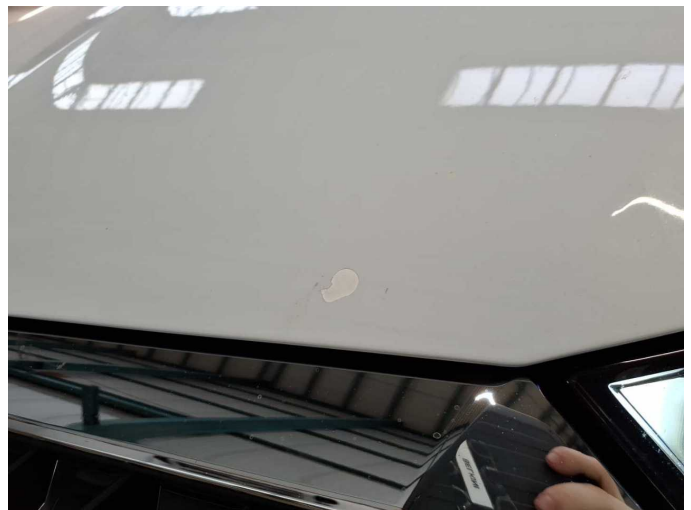
**Damage 10:** Bonnet: Bonnet - Unprofessionally repaired - Paint

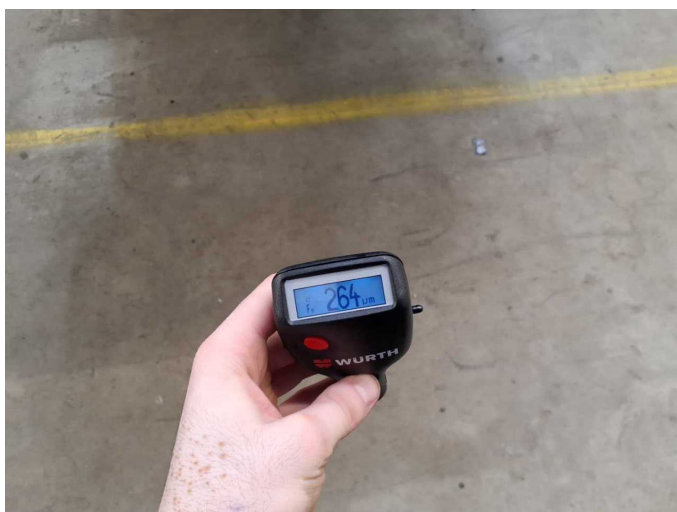
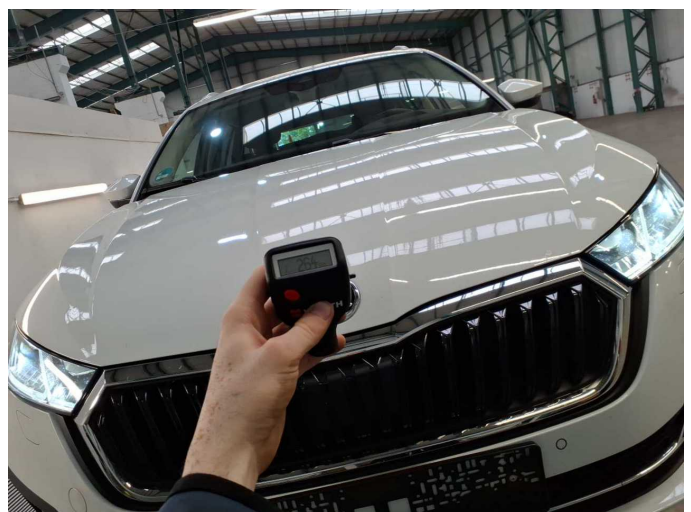
Bonnet	264 µm	Side panel - rear right side	239 µm
--------	--------	------------------------------	--------

**Repainting 1:** Bonnet

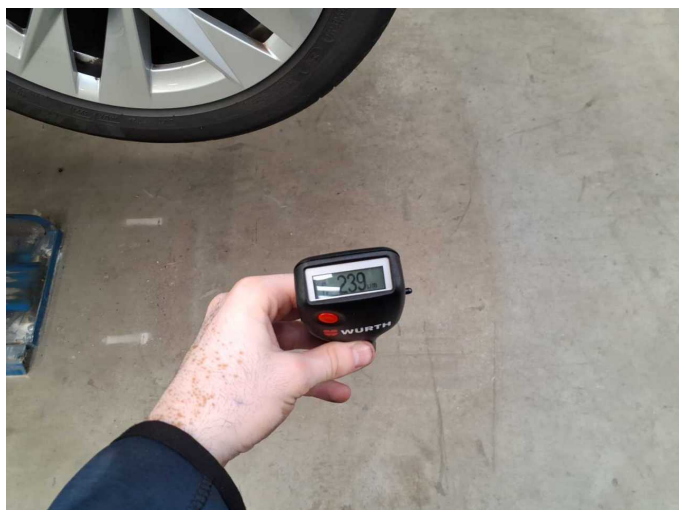
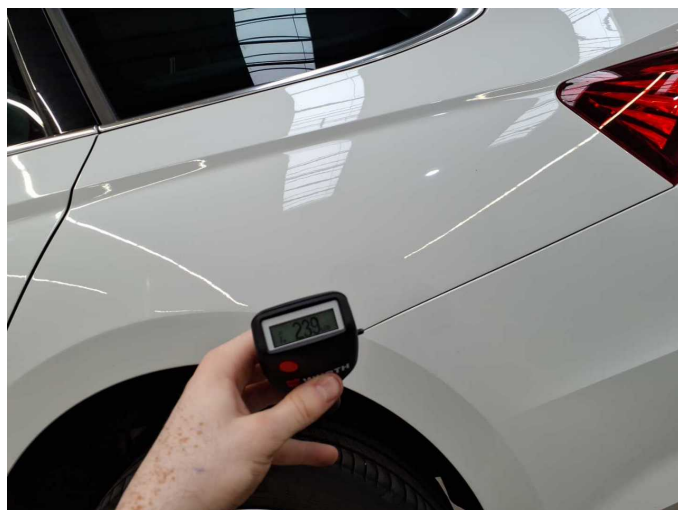
**Repainting 2:** Side panel - rear right side
