Expertise

Protocol number: 41662199
Order No. / Reference: 25188050
Inspection date: 18 Sept 2025

Manufacturer: Skoda
VIN: TMBJJ7NX9MY184099

Model: Octavia Combi 2.0 TDI DSG Ambition

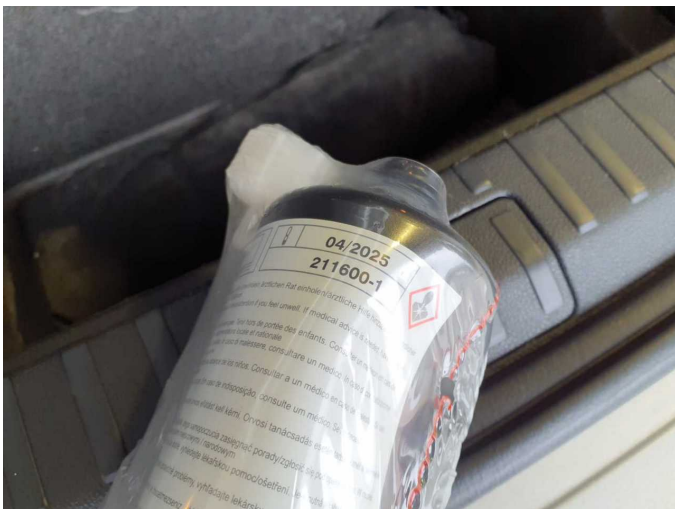
Damage 2: Equipment: Tirefit filler - Expired - Replace

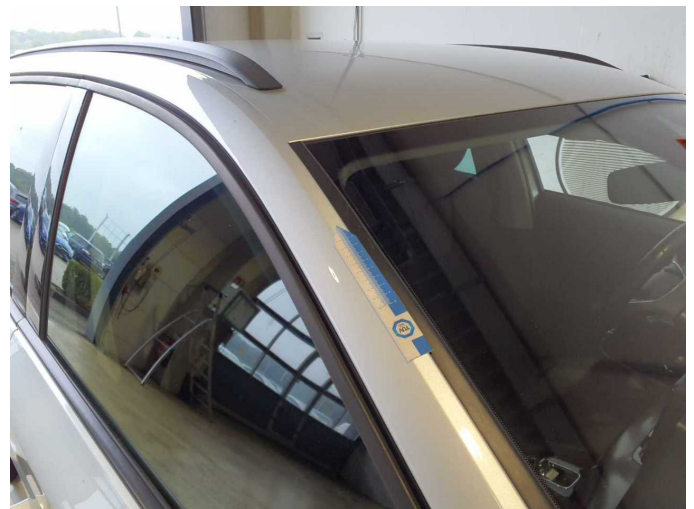
Damage 3: Trim / covers: Brightware / decorative strip (Frontscheibe rechts) - Scratched - Replace

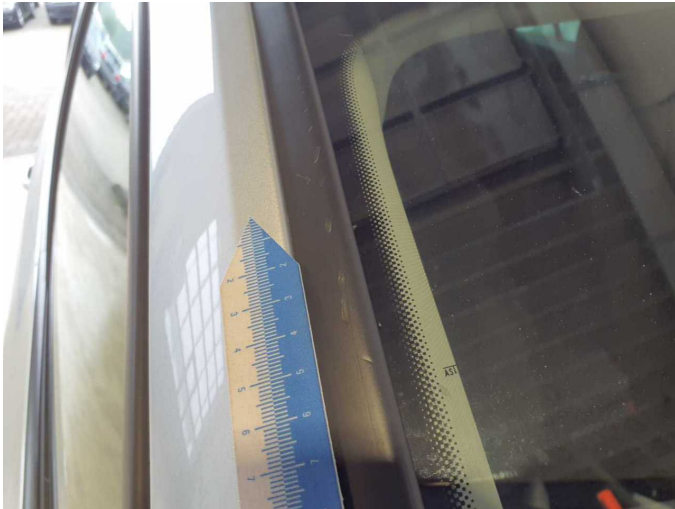
Damage 3: Trim / covers: Brightware / decorative strip (Frontscheibe rechts) - Scratched - Replace

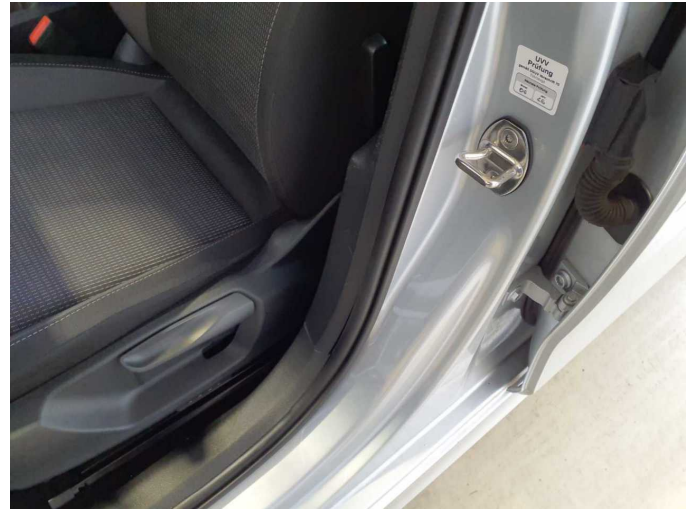
Damage 4: Trim / covers: B-pillar - trim - interior, left side - Malposition - Set / adjust

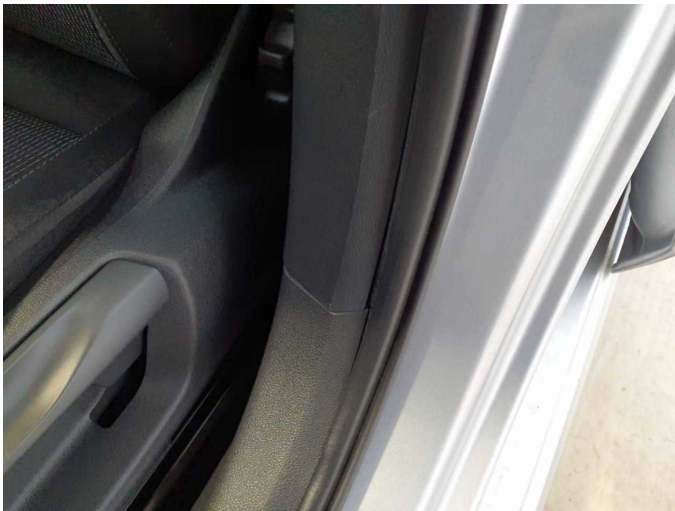
Damage 4: Trim / covers: B-pillar - trim - interior, left side - Malposition - Set / adjust

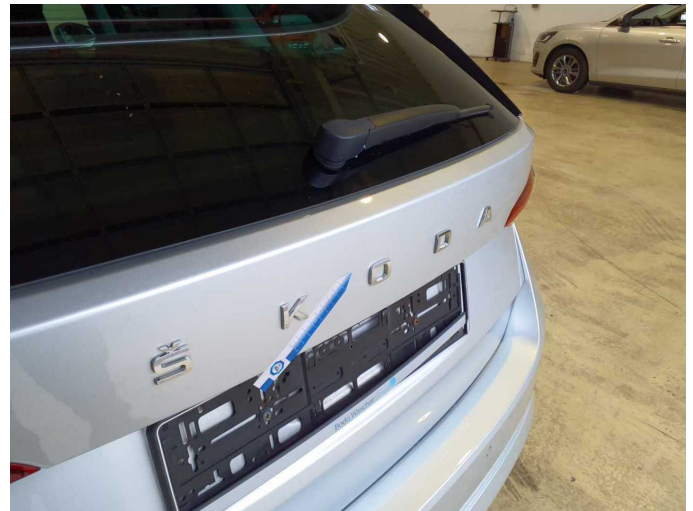
Damage 5: Boot lid / rear door: Boot lid - Scratch(es) - Smart repair

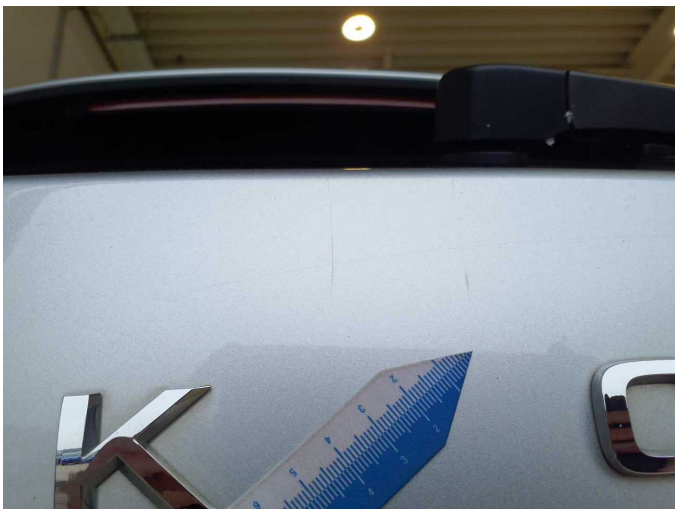
Damage 5: Boot lid / rear door: Boot lid - Scratch(es) - Smart repair

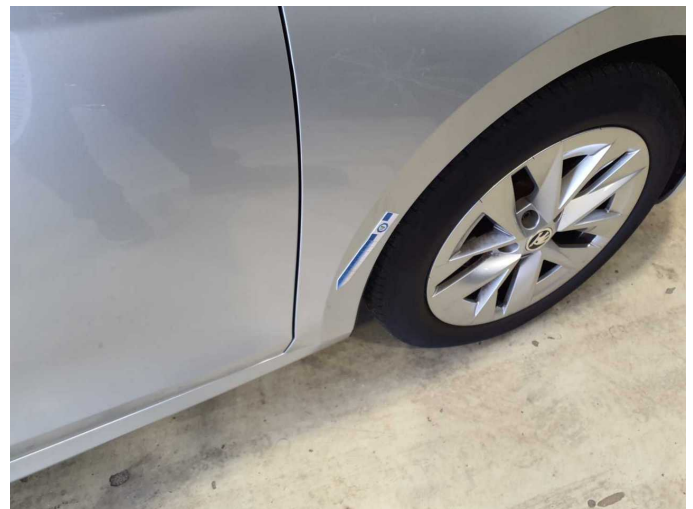
Damage 6: Mudguard - right side: Mudguard - right side - Dent / paintcoat damage - Smart repair

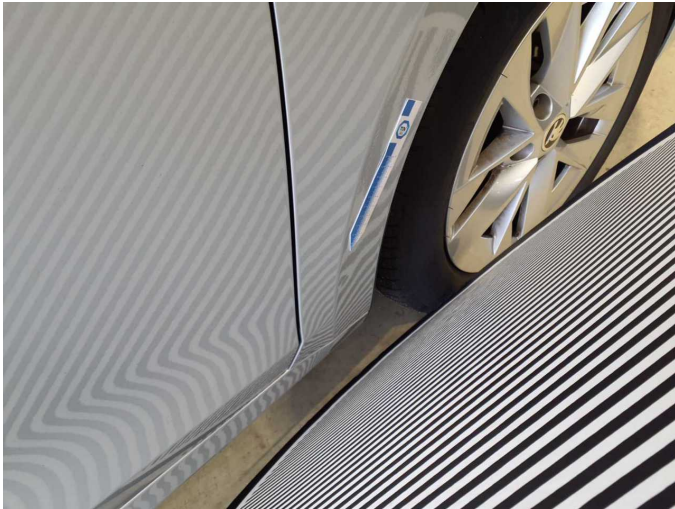
Damage 6: Mudguard - right side: Mudguard - right side - Dent / paintcoat damage - Smart repair

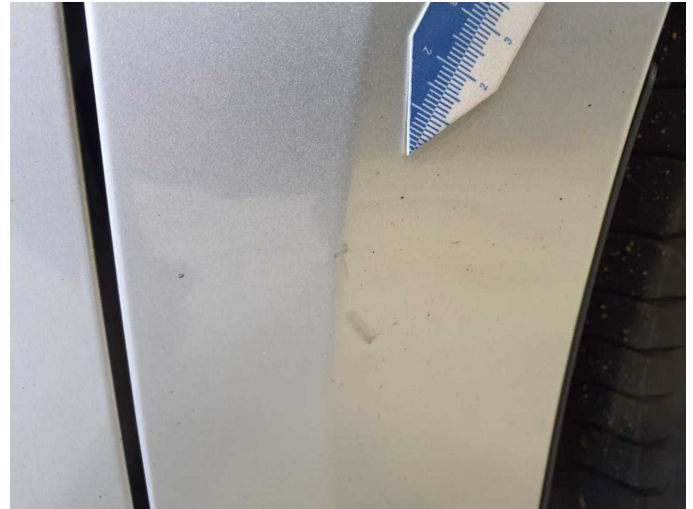
Damage 6: Mudguard - right side: Mudguard - right side - Dent / paintcoat damage - Smart repair

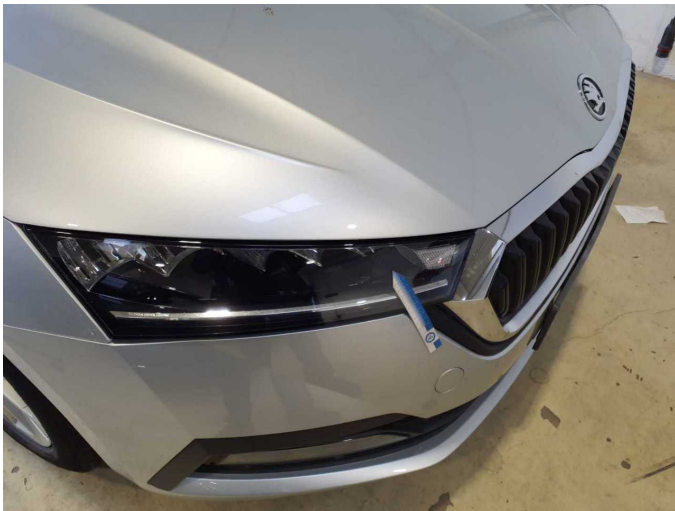
Damage 7: Headlight: Headlight - right side - Stone chips - Loss in value

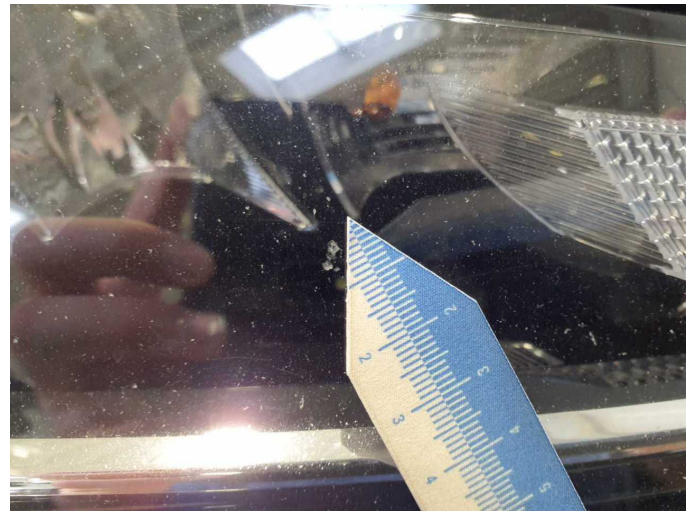
Damage 7: Headlight: Headlight - right side - Stone chips - Loss in value

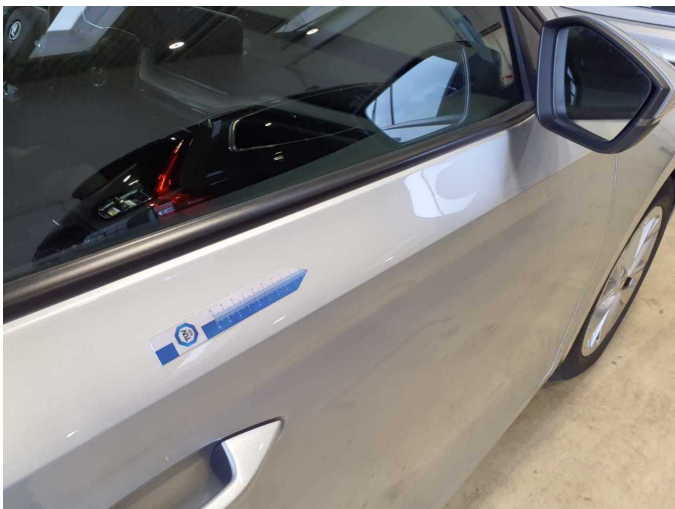
Damage 8: Door - front right side: Door - Dent / paintcoat damage - Repair and paint

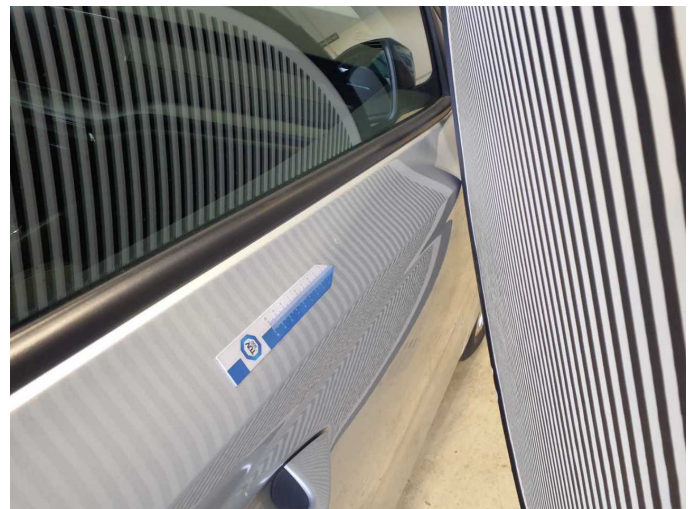
Damage 8: Door - front right side: Door - Dent / paintcoat damage - Repair and paint

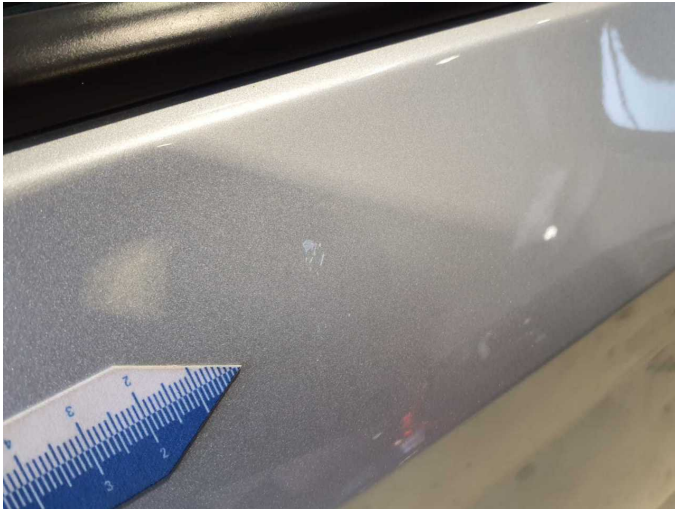
Damage 8: Door - front right side: Door - Dent / paintcoat damage - Repair and paint

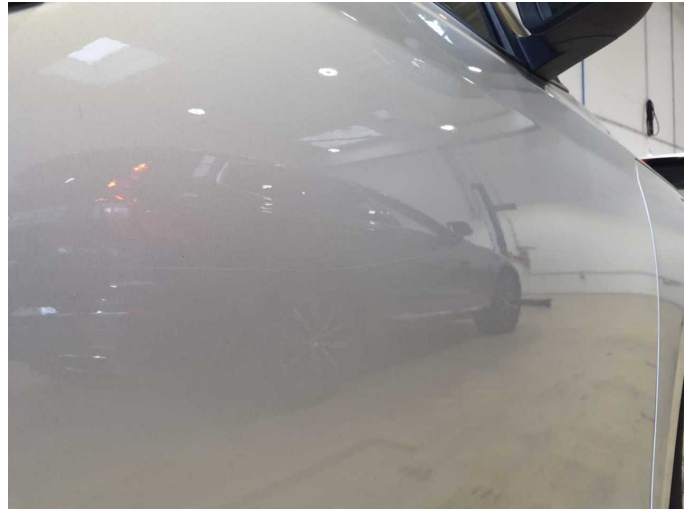
Damage 8: Door - front right side: Door - Dent / paintcoat damage - Repair and paint

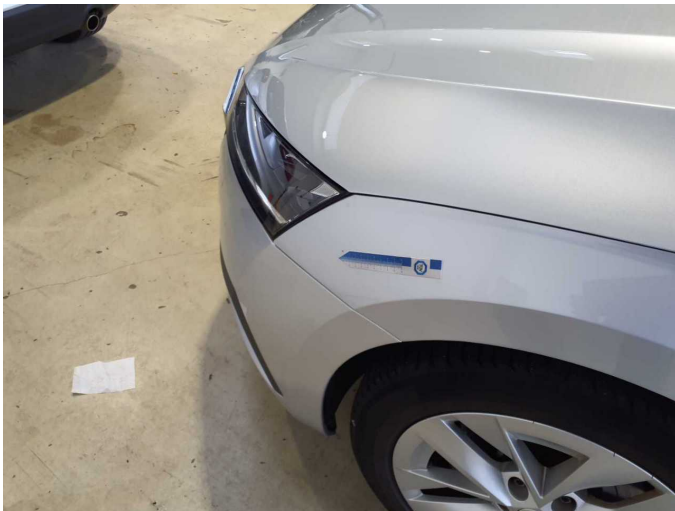
Damage 9: Mudguard - left side: Mudguard - left side - Scratch(es) - Paint

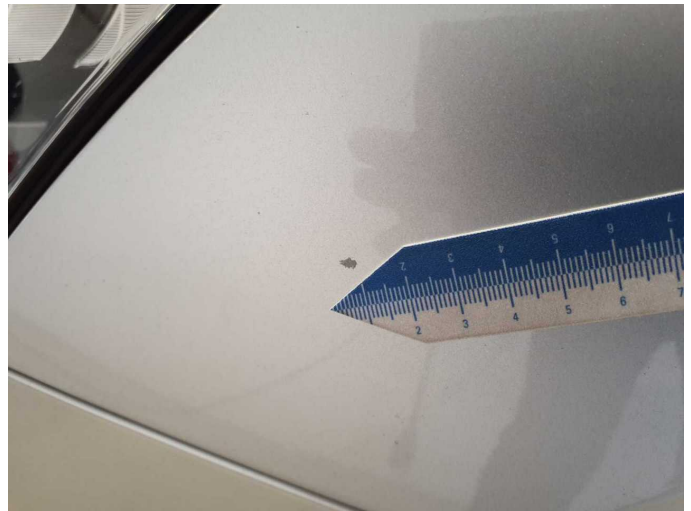
Damage 9: Mudguard - left side: Mudguard - left side - Scratch(es) - Paint

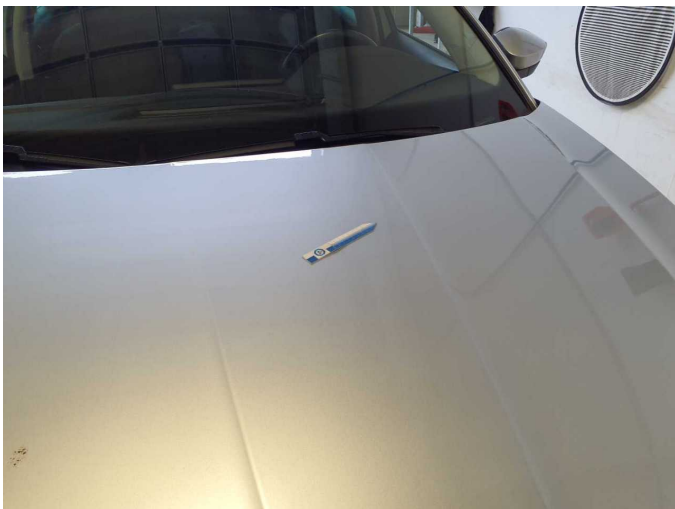
Bonnet 387 µm |

Damage 10: Bonnet: Bonnet (Einschlüsse) - Unprofessionally repaired - Paint

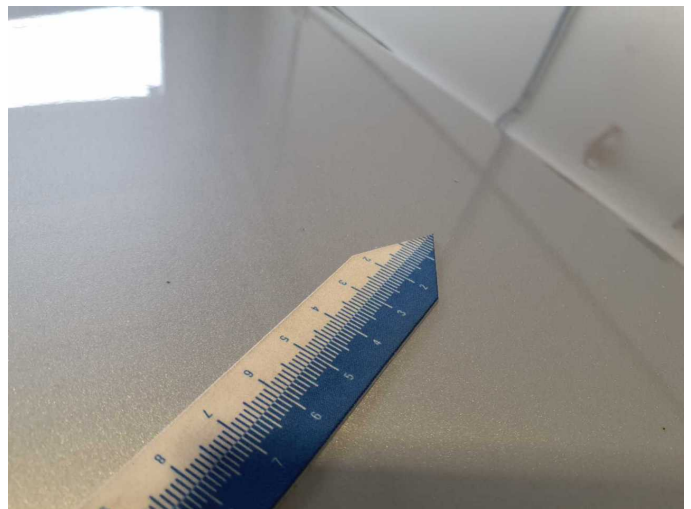
Damage 10: Bonnet: Bonnet (Einschlüsse) - Unprofessionally repaired - Paint

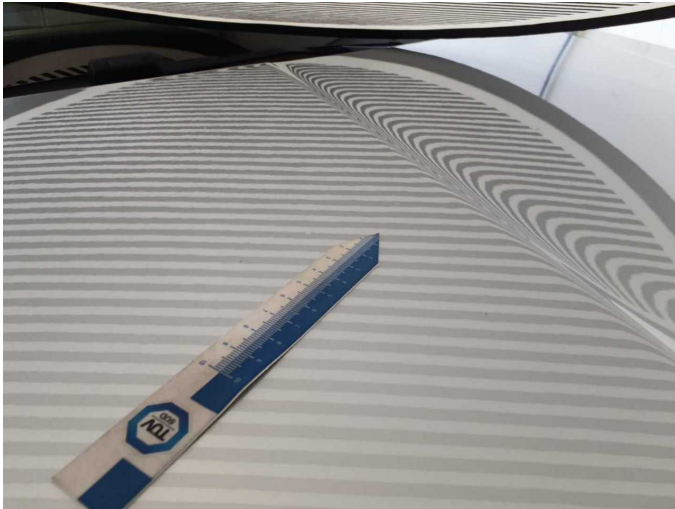
Damage 10: Bonnet: Bonnet (Einschlüsse) - Unprofessionally repaired - Paint

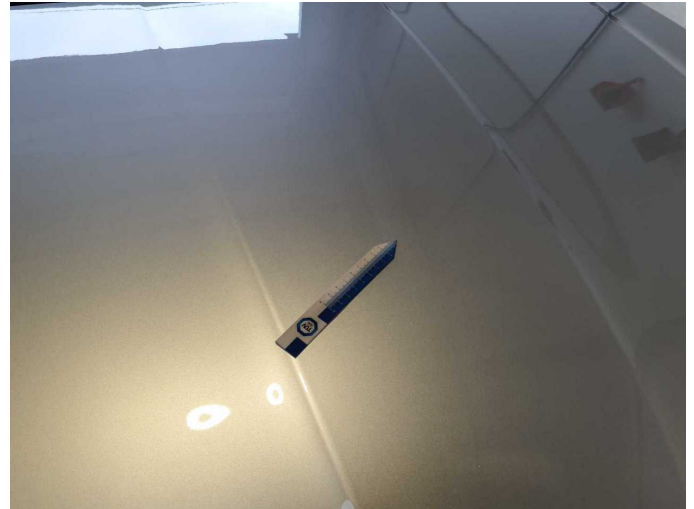
Damage 10: Bonnet: Bonnet (Einschlüsse) - Unprofessionally repaired - Paint

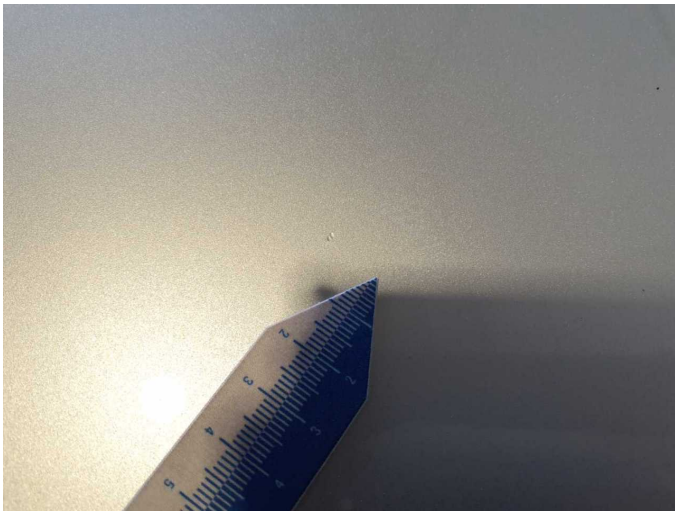
Damage 10: Bonnet: Bonnet (Einschlüsse) - Unprofessionally repaired - Paint

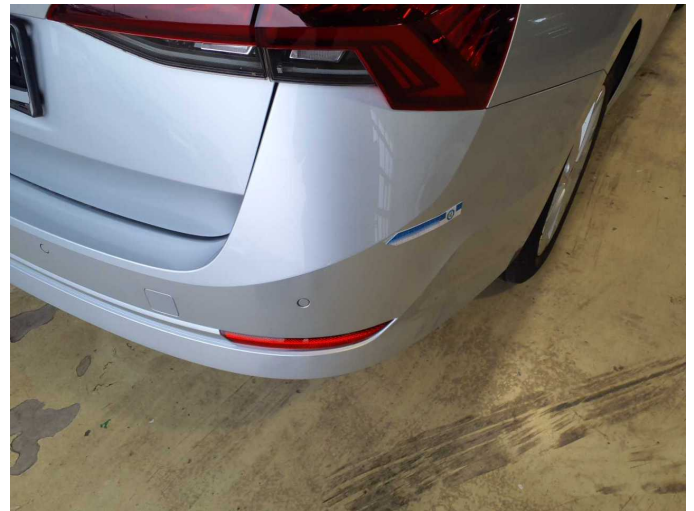
Damage 11: Rear bumper: Rear bumper (Stellenweise Matt, Einschlüsse) - Unprofessionally repaired - Paint

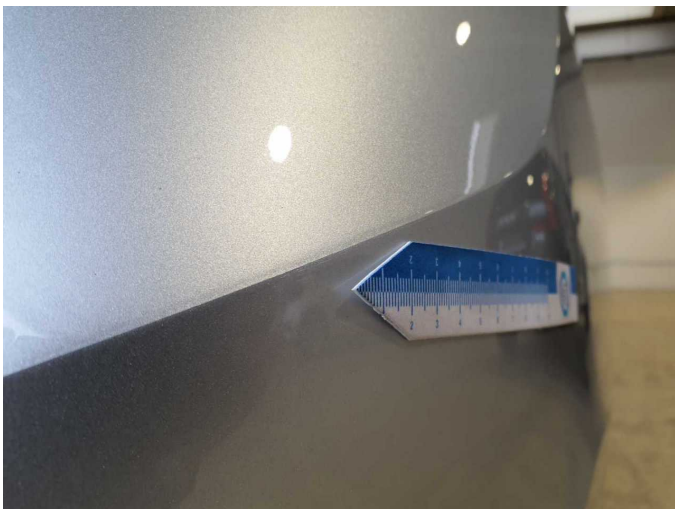
Damage 11: Rear bumper: Rear bumper (Stellenweise Matt, Einschlüsse) - Unprofessionally repaired - Paint

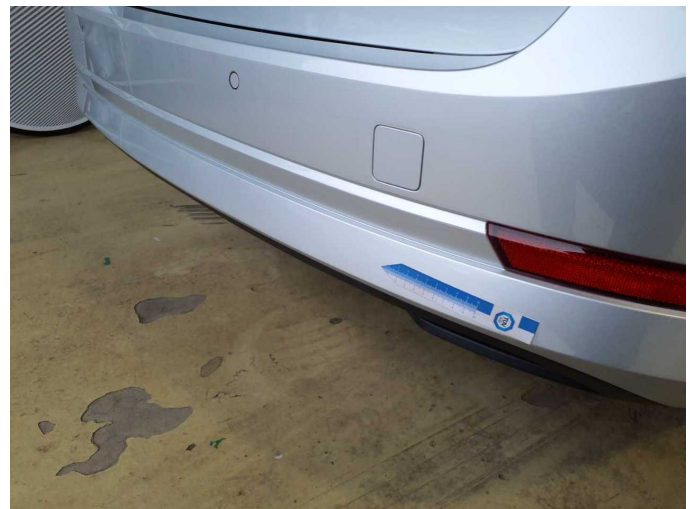
Damage 11: Rear bumper: Rear bumper (Stellenweise Matt, Einschlüsse) - Unprofessionally repaired - Paint

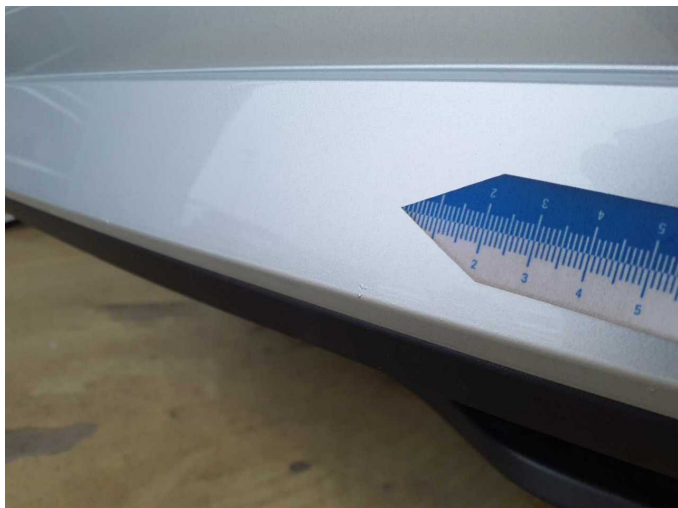
Damage 11: Rear bumper: Rear bumper (Stellenweise Matt, Einschlüsse) - Unprofessionally repaired - Paint

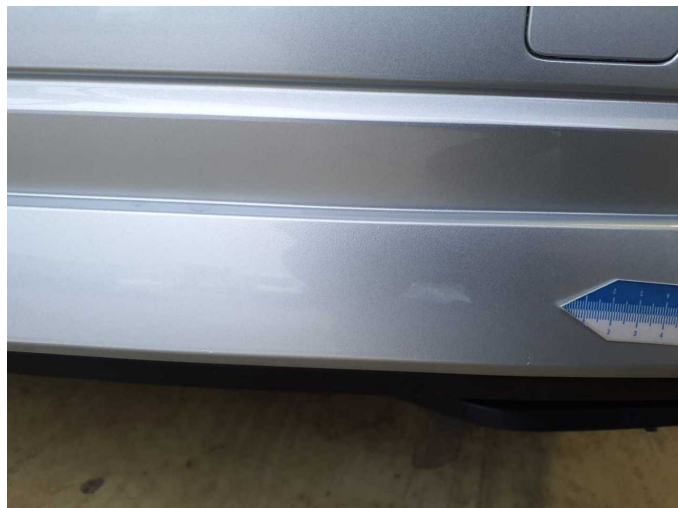
Damage 11: Rear bumper: Rear bumper (Stellenweise Matt, Einschlüsse) - Unprofessionally repaired - Paint

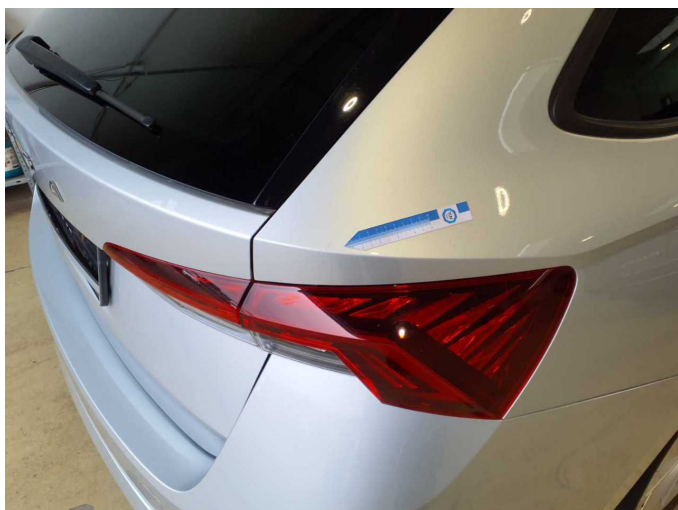
Damage 12: Side panel - rear right side: Side panel - Scratched - Paint

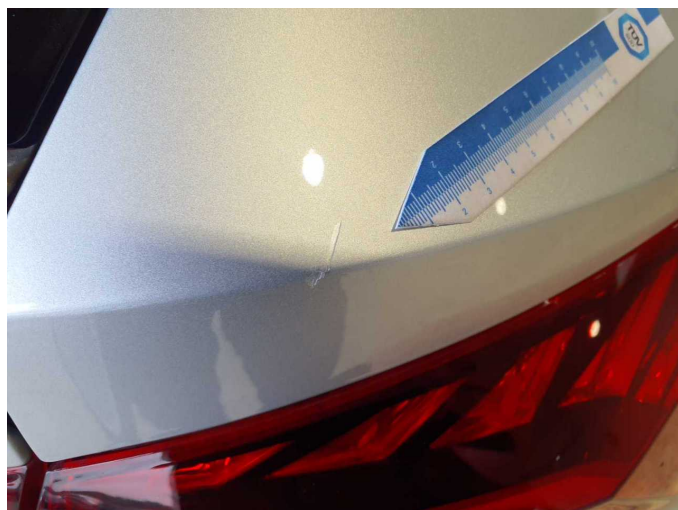
Damage 12: Side panel - rear right side: Side panel - Scratched - Paint

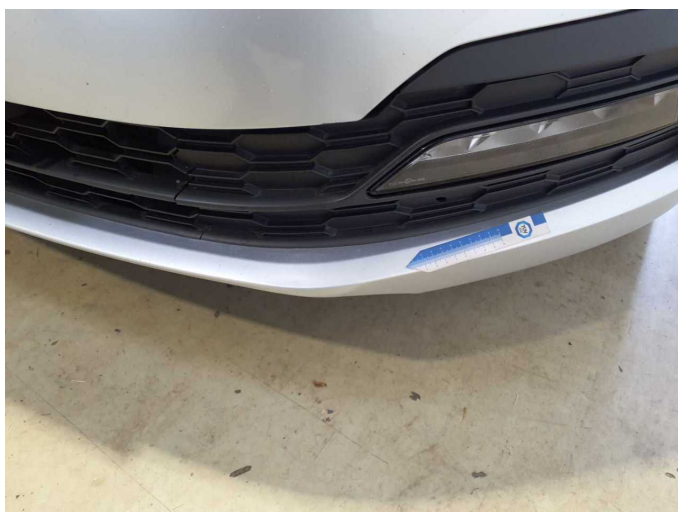
Damage 13: Front bumper: Front bumper (Schleifspuren) - Unprofessionally repaired - Paint

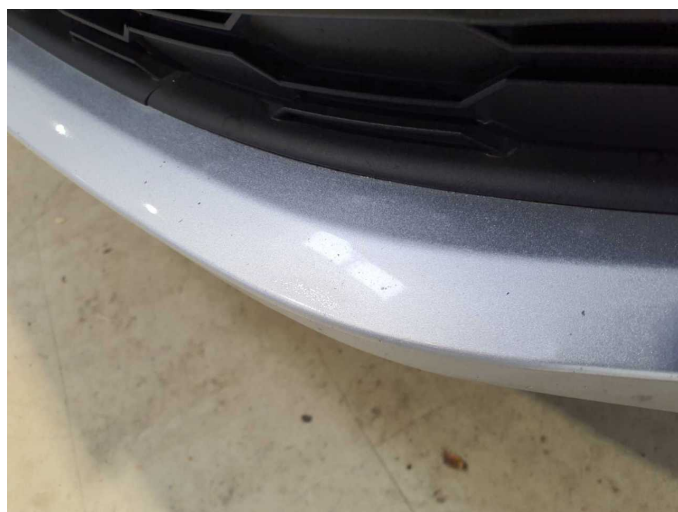
Damage 13: Front bumper: Front bumper (Schleifspuren) - Unprofessionally repaired - Paint

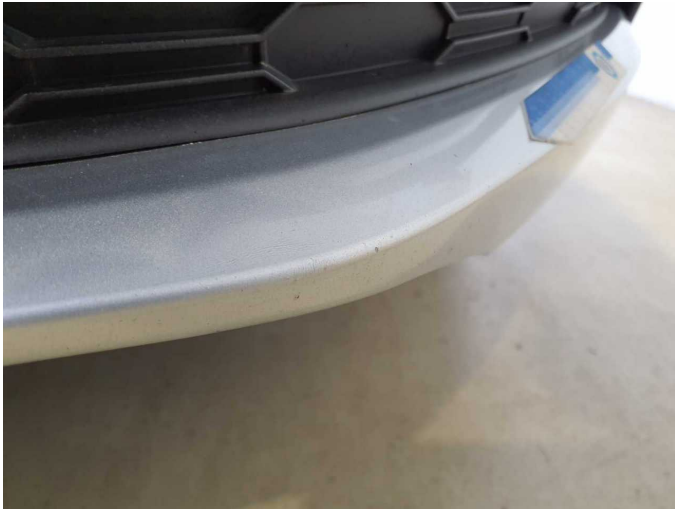
Damage 13: Front bumper: Front bumper (Schleifspuren) - Unprofessionally repaired - Paint

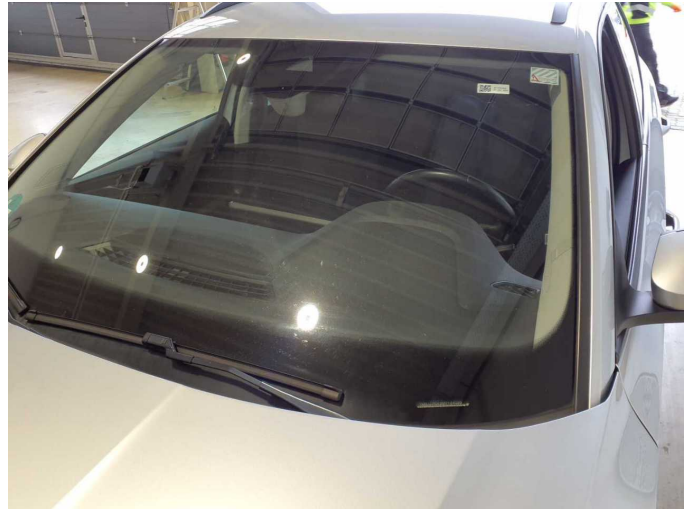
Damage 14: Vehicle glazing: Windscreen with lane departure assistant (Sandstrahleffekt) - Stone chips - Replace

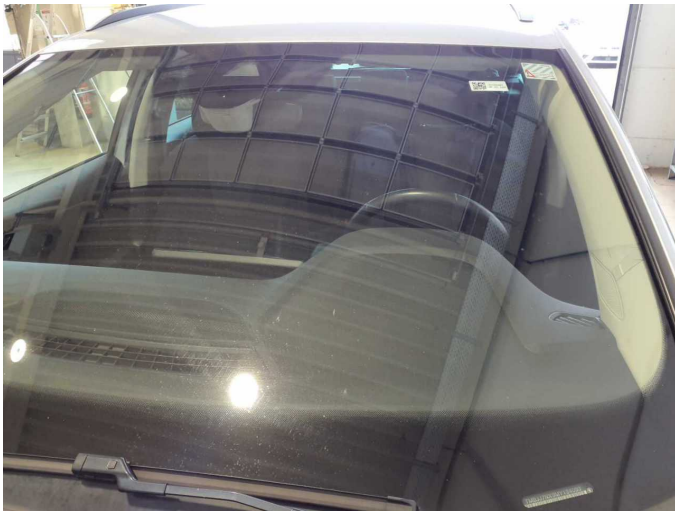
Damage 14: Vehicle glazing: Windscreen with lane departure assistant (Sandstrahleffekt) - Stone chips - Replace

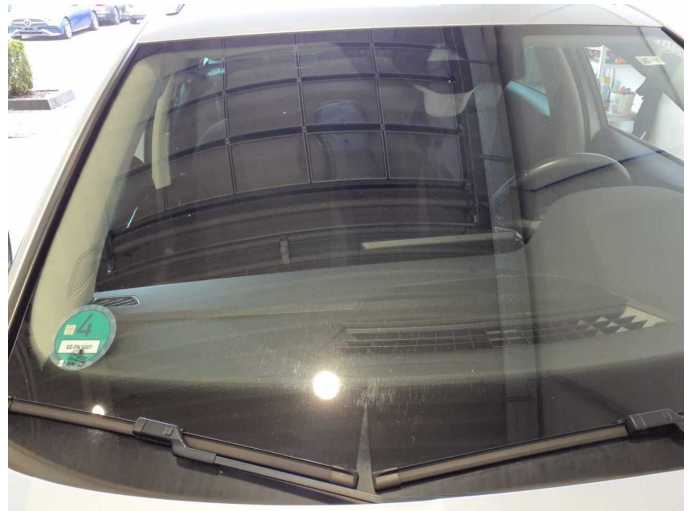
Damage 14: Vehicle glazing: Windscreen with lane departure assistant (Sandstrahleffekt) - Stone chips - Replace

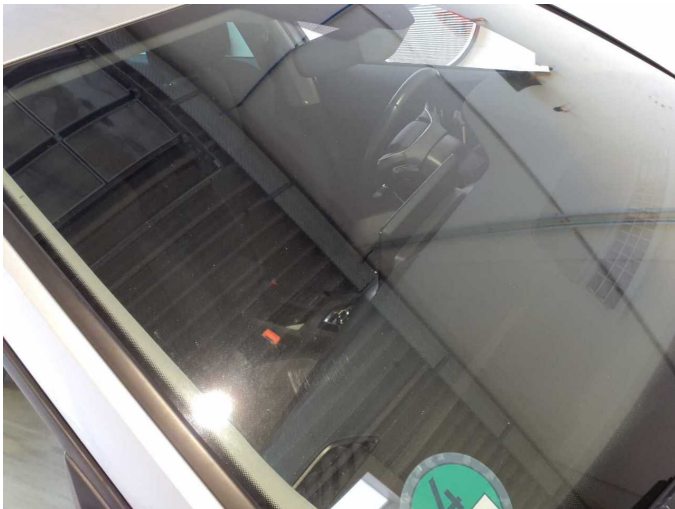
Damage 14: Vehicle glazing: Windscreen with lane departure assistant (Sandstrahleffekt) - Stone chips - Replace

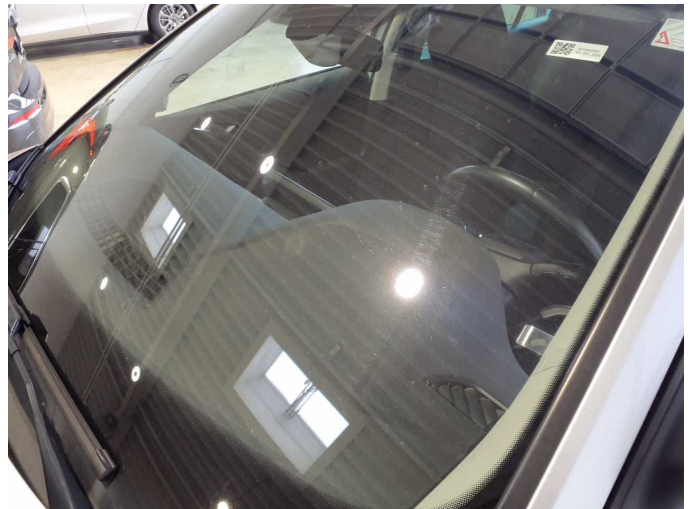
Damage 14: Vehicle glazing: Windscreen with lane departure assistant (Sandstrahleffekt) - Stone chips - Replace

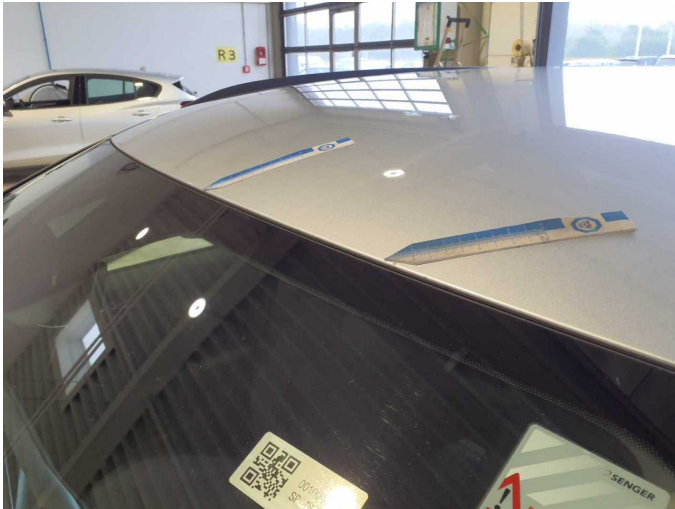
Damage 15: Roof: Roof - Stone chips - Paint

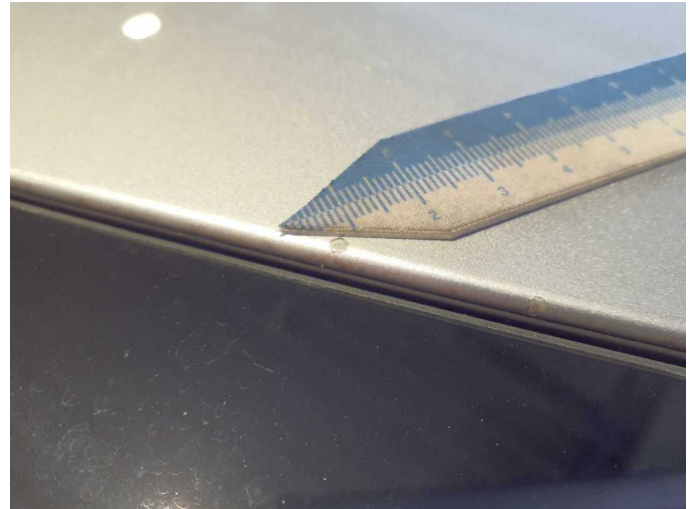
Damage 15: Roof: Roof - Stone chips - Paint

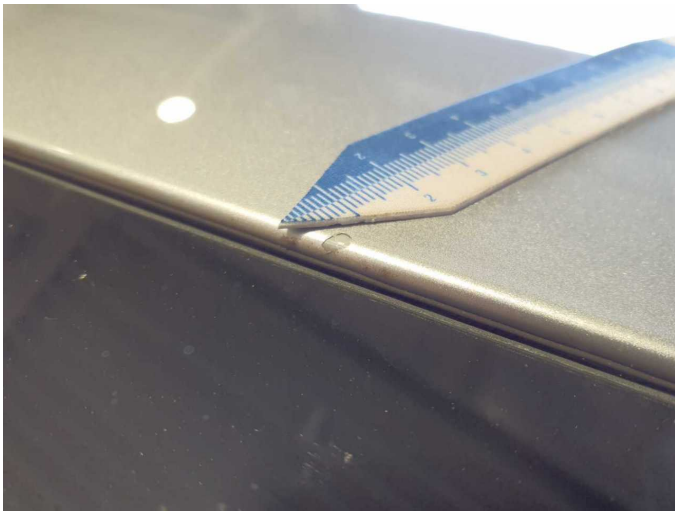
Damage 15: Roof: Roof - Stone chips - Paint

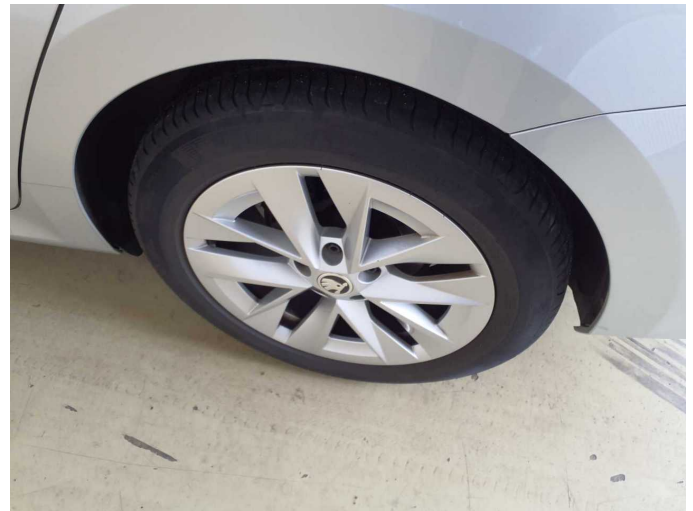
Wear and tear 1: Wheel / tyres: Alloy rim - rear left side - Stone chips - No deduction

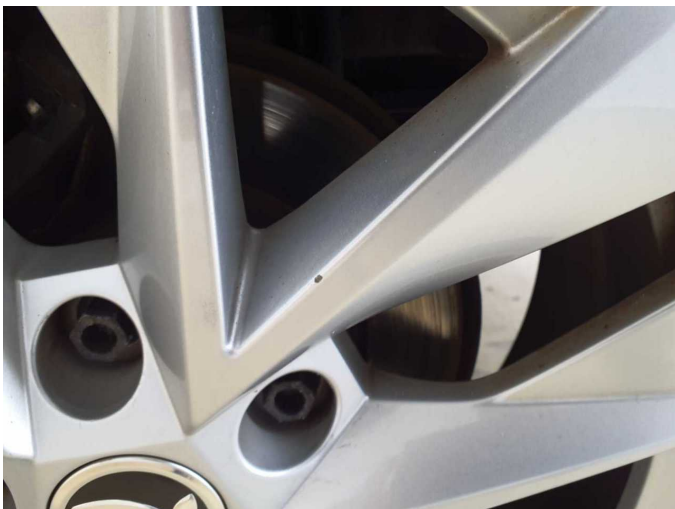
Wear and tear 1: Wheel / tyres: Alloy rim - rear left side - Stone chips - No deduction

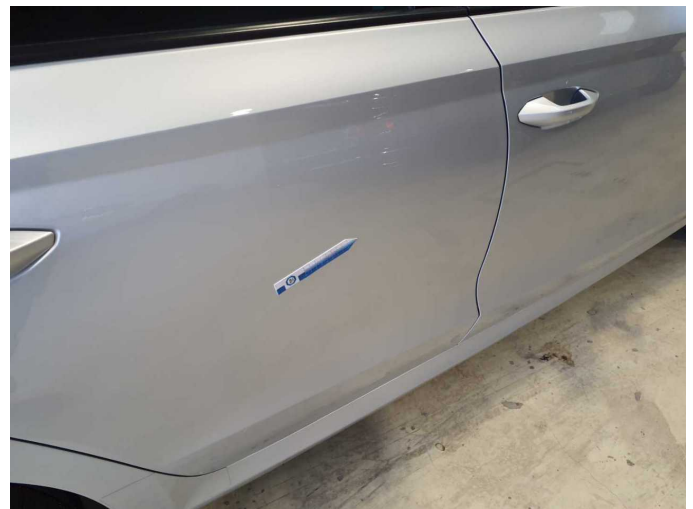
Wear and tear 2: Door - rear right side: Door - Scratch(es) - No deduction

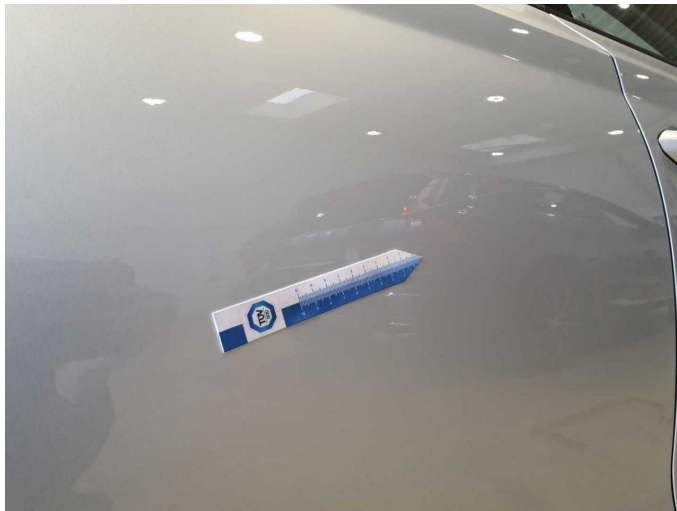
Wear and tear 2: Door - rear right side: Door - Scratch(es) - No deduction

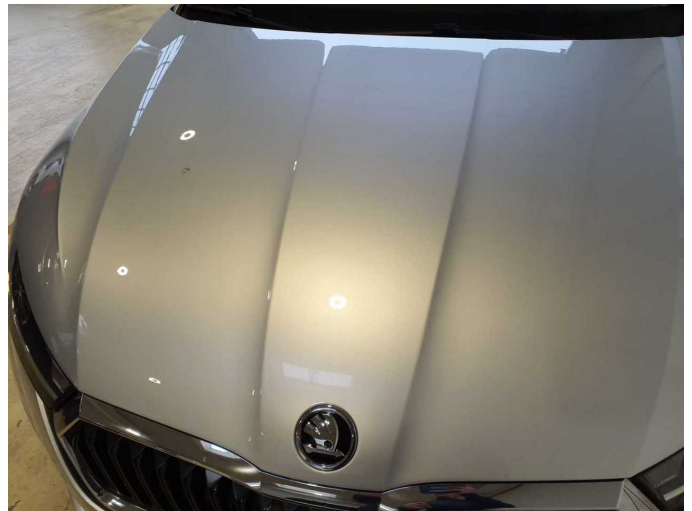
1 Bonnet, Bumper rear, Bumper front, Unprofessionally carried out, Invoice of repair done Non-existent

Repainting 1: Bonnet, Bumper rear, Bumper front

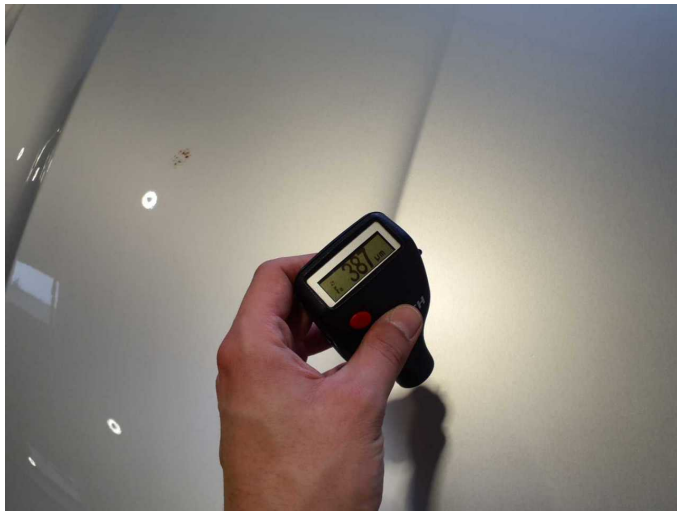
Repainting 1: Bonnet, Bumper rear, Bumper front

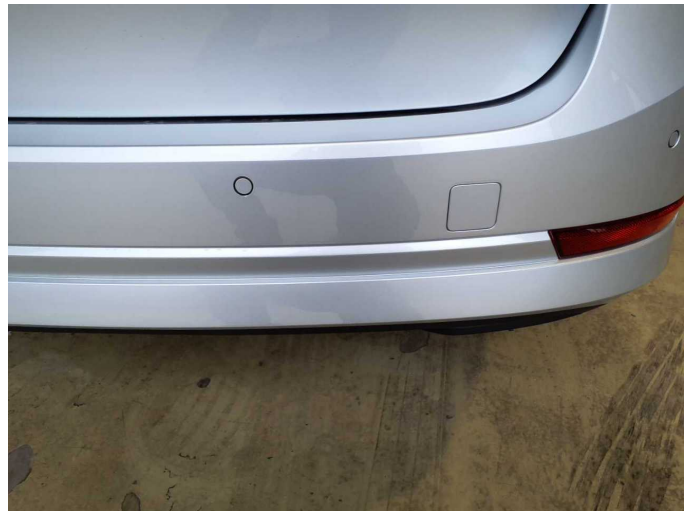
Repainting 1: Bonnet, Bumper rear, Bumper front

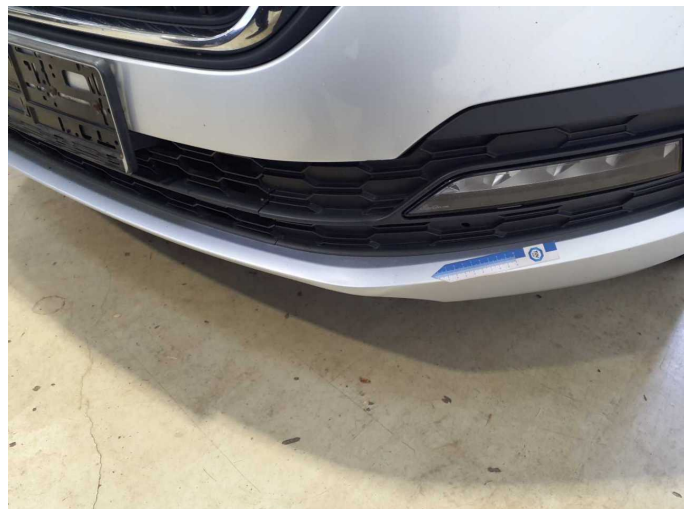
Repainting 1: Bonnet, Bumper rear, Bumper front
