Expertise

Protocol number: 41592779
Order No. / Reference: 25137423
Inspection date: 16 Sept 2025

Manufacturer: Skoda

Model: Octavia Combi 2.0 TDI DSG First Edition

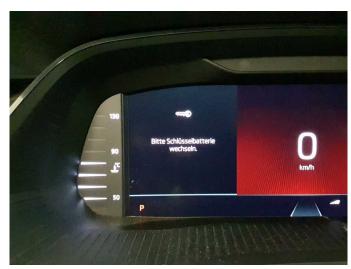
Damage 2: Equipment: Vehicle key (Batterie) - Empty - Replace

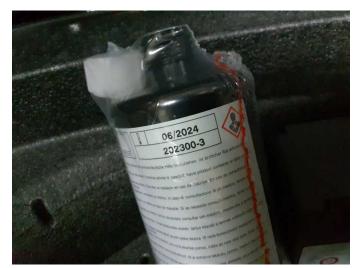
Damage 3: Equipment: Tirefit filler - Expired - Replace

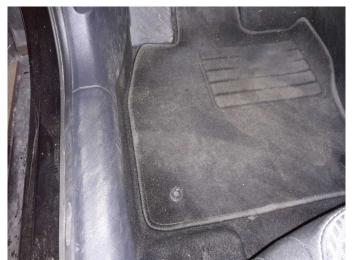
Damage 4: Trim / covers: Floor mats - Damaged - Replace

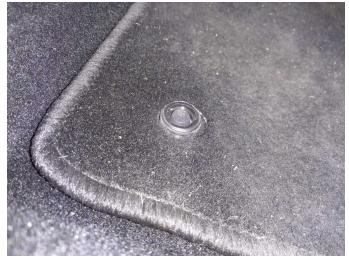
Damage 4: Trim / covers: Floor mats - Damaged - Replace

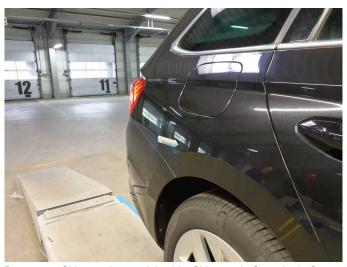
Damage 5: Side panel - rear right side: Side panel - Scratched - Smart repair

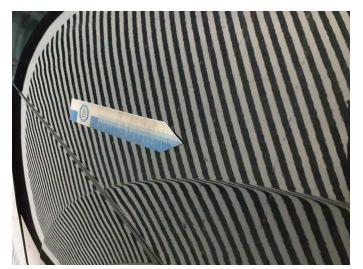
Damage 5: Side panel - rear right side: Side panel - Scratched - Smart repair

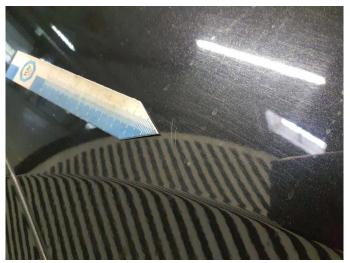
Damage 5: Side panel - rear right side: Side panel - Scratched - Smart repair

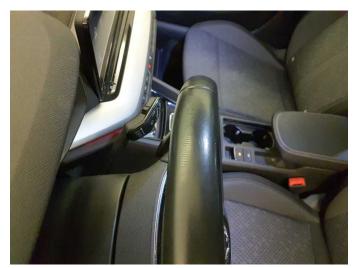
Damage 6: Steering system: Steering wheel - Scratched - Smart repair

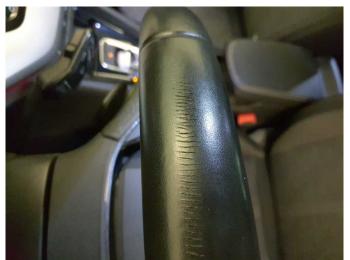
Damage 6: Steering system: Steering wheel - Scratched - Smart repair

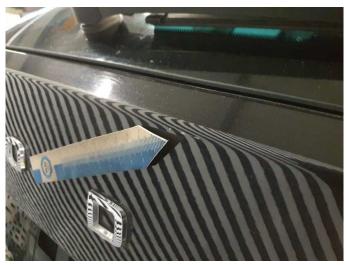
Damage 7: Boot lid / rear door: Boot lid - Scratched - Smart repair

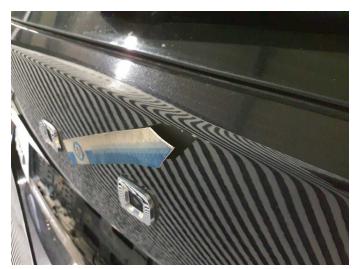
Damage 7: Boot lid / rear door: Boot lid - Scratched - Smart repair

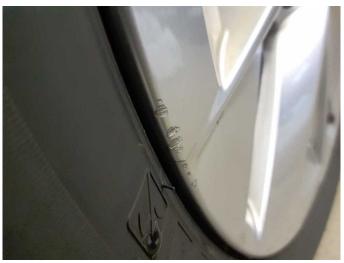
Damage 9: Wheel / tyres: Wheel rim - rear left side - Scratched - Loss in value

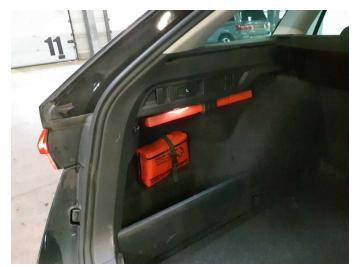
Damage 10: Trim / covers: Cargo area - lining -left side - Scratched - Replace

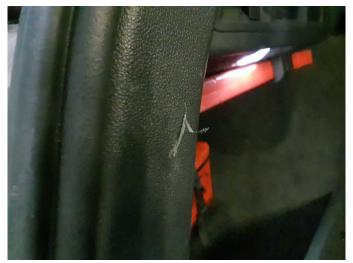
Damage 10: Trim / covers: Cargo area - lining -left side - Scratched - Replace

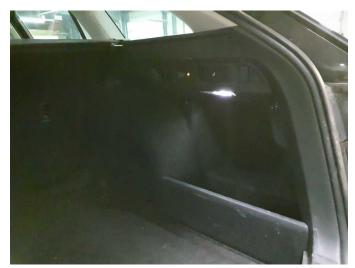
Damage 11: Trim / covers: Cargo area - lining - right side - Scratched - Replace

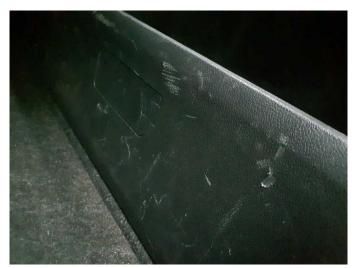
Damage 11: Trim / covers: Cargo area - lining - right side - Scratched - Replace

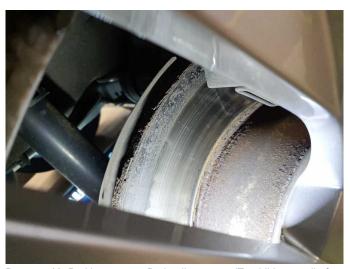
Damage 12: Braking system: Brake discs - rear (Tragbild mangelhaft, Rostrand) - Corrosion - Replace

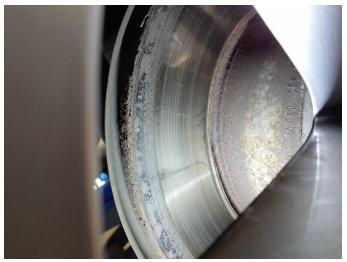
Damage 12: Braking system: Brake discs - rear (Tragbild mangelhaft, Rostrand) - Corrosion - Replace

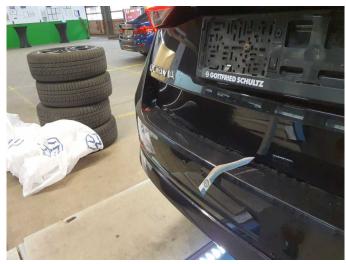
Damage 13: Rear bumper: Rear bumper - Scratched - Paint

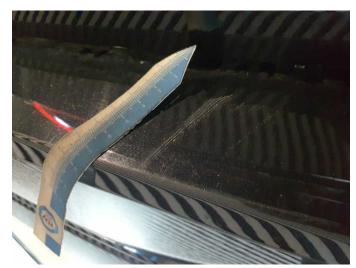
Damage 13: Rear bumper: Rear bumper - Scratched - Paint

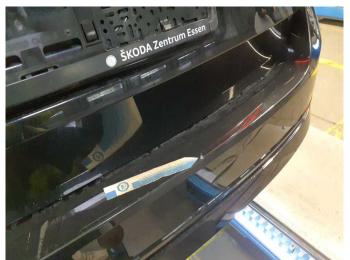
Damage 13: Rear bumper: Rear bumper - Scratched - Paint

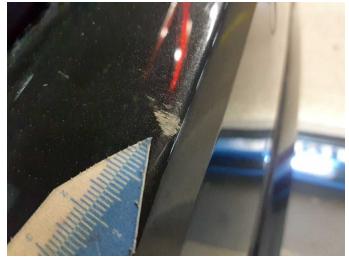
Damage 13: Rear bumper: Rear bumper - Scratched - Paint

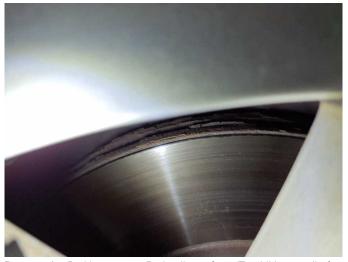
Damage 14: Braking system: Brake discs - front (Tragbild mangelhaft, Rostrand) - Corrosion - Replace

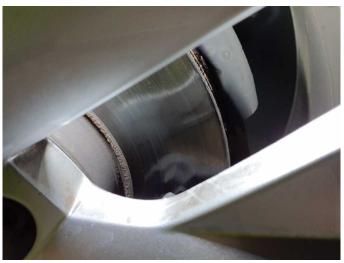
Damage 14: Braking system: Brake discs - front (Tragbild mangelhaft, Rostrand) - Corrosion - Replace

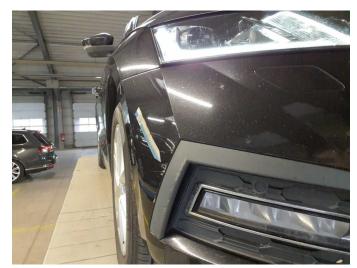
Damage 15: Front bumper: Front bumper (Steinschlag, und Blende) - Scratched - Repair and paint

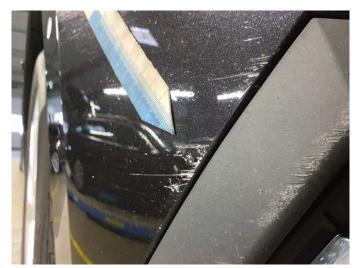
Damage 15: Front bumper: Front bumper (Steinschlag, und Blende) - Scratched - Repair and paint

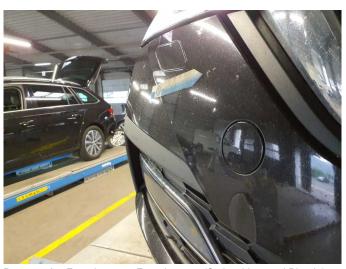
Damage 15: Front bumper: Front bumper (Steinschlag, und Blende) - Scratched - Repair and paint

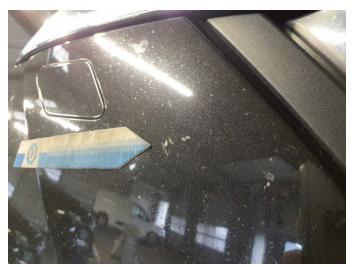
Damage 15: Front bumper: Front bumper (Steinschlag, und Blende) - Scratched - Repair and paint

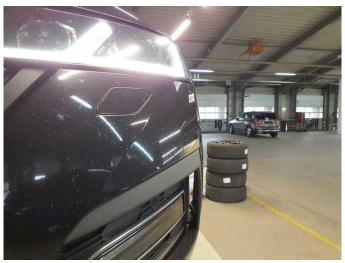
Damage 15: Front bumper: Front bumper (Steinschlag, und Blende) - Scratched - Repair and paint

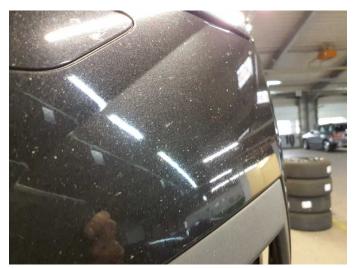
Damage 15: Front bumper: Front bumper (Steinschlag, und Blende) - Scratched - Repair and paint

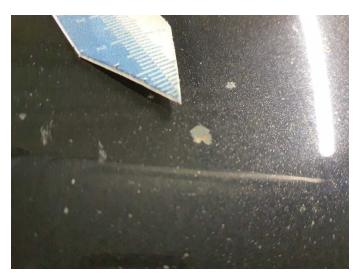
Damage 16: Bonnet: Bonnet (Korrosion) - Stone chips - Repair and paint Damage 16: Bonnet: Bonnet (Korrosion) - Stone chips - Repair and paint

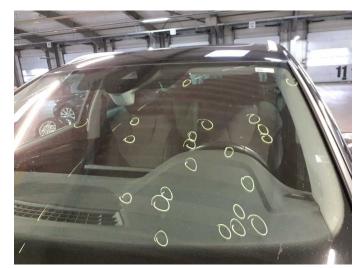
Damage 17: Vehicle glazing: Windscreen (Sandstrahleffekt, Blendwirkung) - Stone chips - repair according to calculation

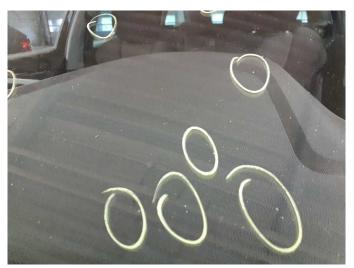
Damage 17: Vehicle glazing: Windscreen (Sandstrahleffekt, Blendwirkung) - Stone chips - repair according to calculation

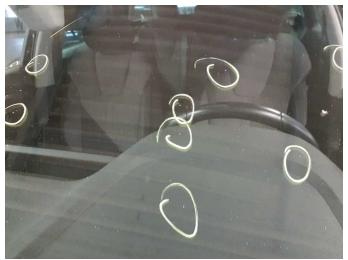
Damage 17: Vehicle glazing: Windscreen (Sandstrahleffekt, Blendwirkung) - Stone chips - repair according to calculation

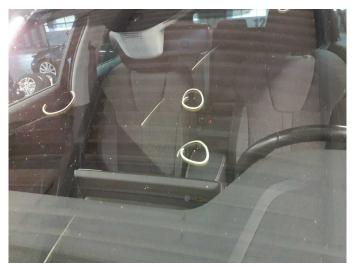
Damage 17: Vehicle glazing: Windscreen (Sandstrahleffekt, Blendwirkung) - Stone chips - repair according to calculation
