Expertise

Protocol number: 41321961
Order No. / Reference: 25139365
Inspection date: 2 Sept 2025

Manufacturer: Skoda
VIN: TMBJK0NX4PY007100

Model: Octavia Combi 2.0 TDI DSG RS Plus

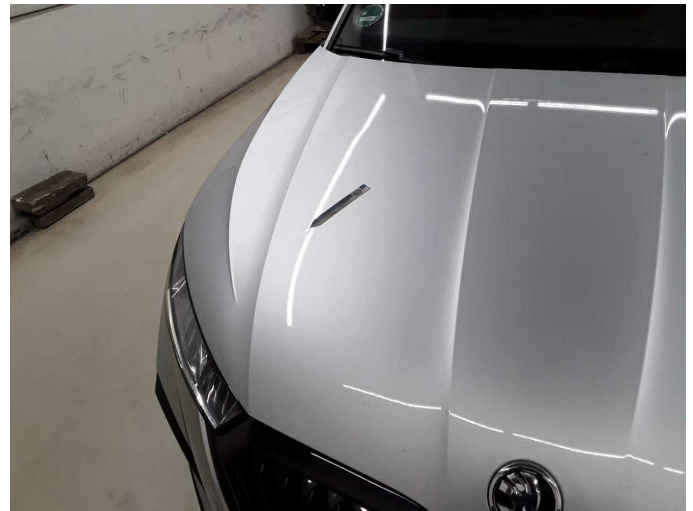
Damage 1: Bonnet: Bonnet - dent(s) - Smooth repair work

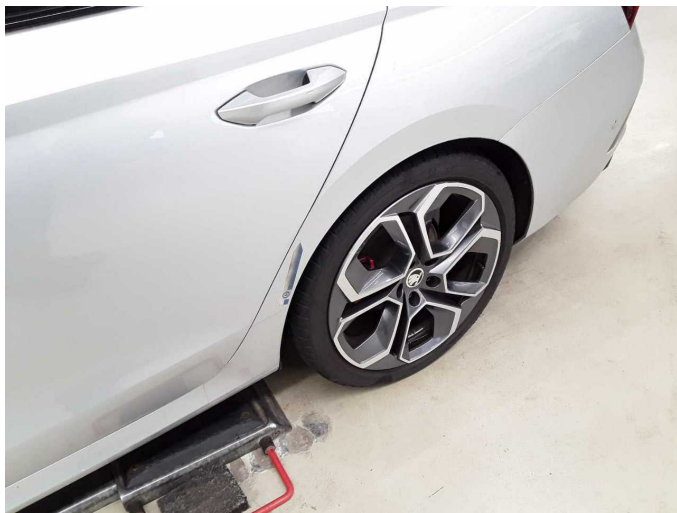
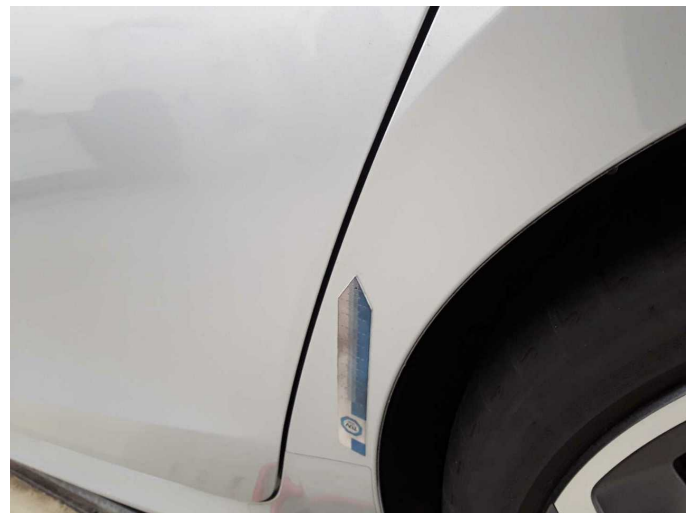
Damage 2: Side panel - rear left side: Wheel arch - dent(s) - Smooth repair work

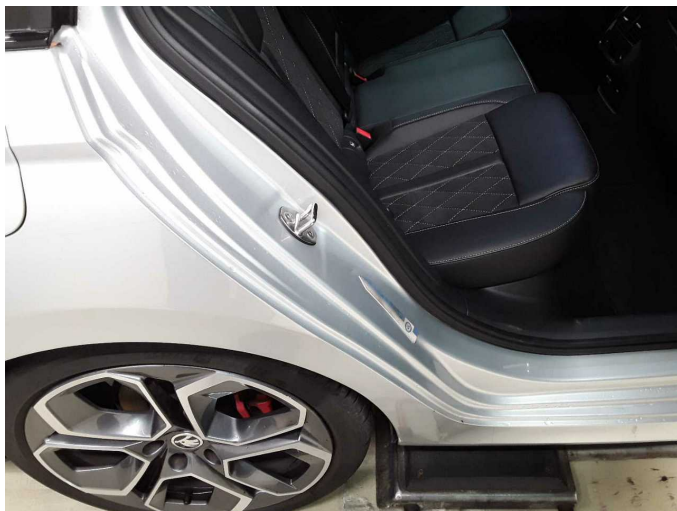
Damage 3: Side panel - rear right side: Sill - Dent / paintcoat damage - Smart repair

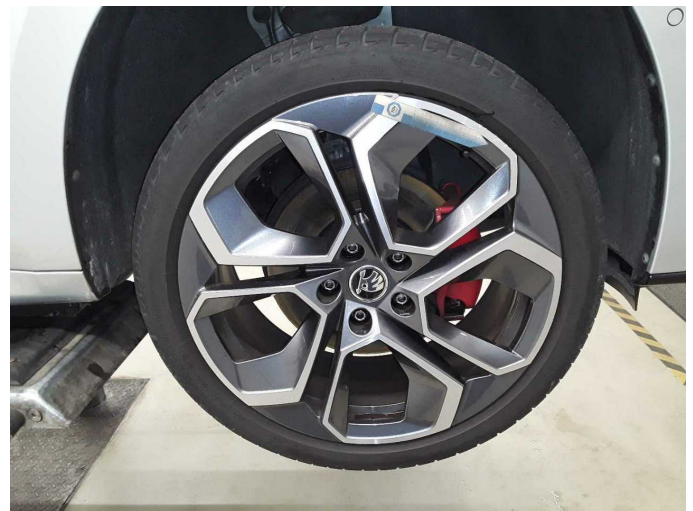
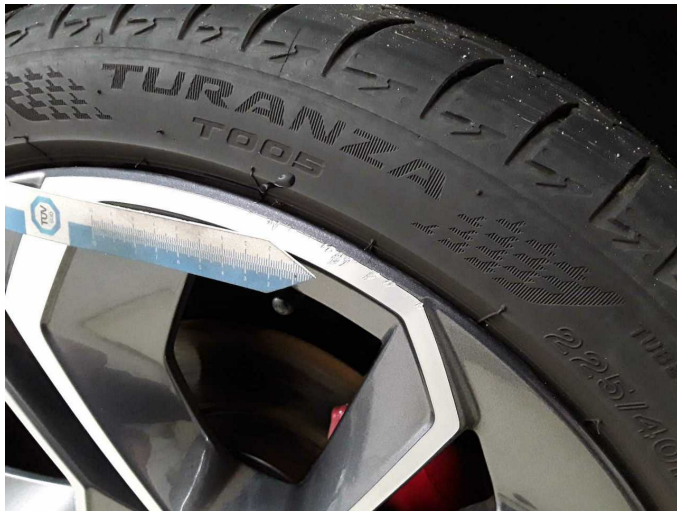
Damage 4: Wheel / tyres: Alloy rim - front right side - Damaged - Loss in value

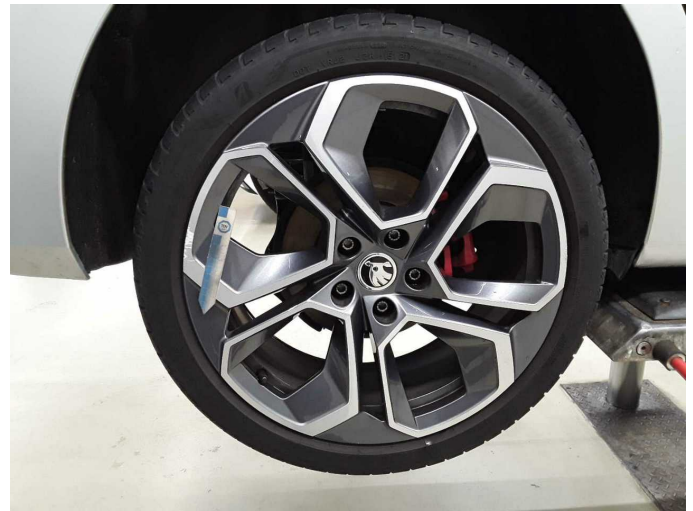
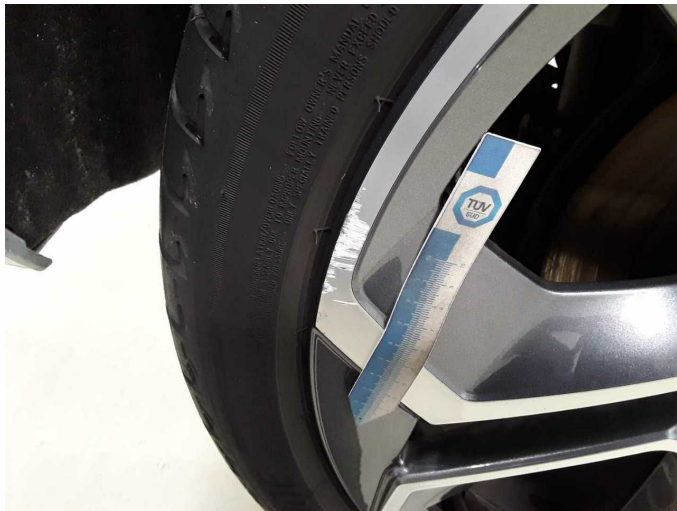
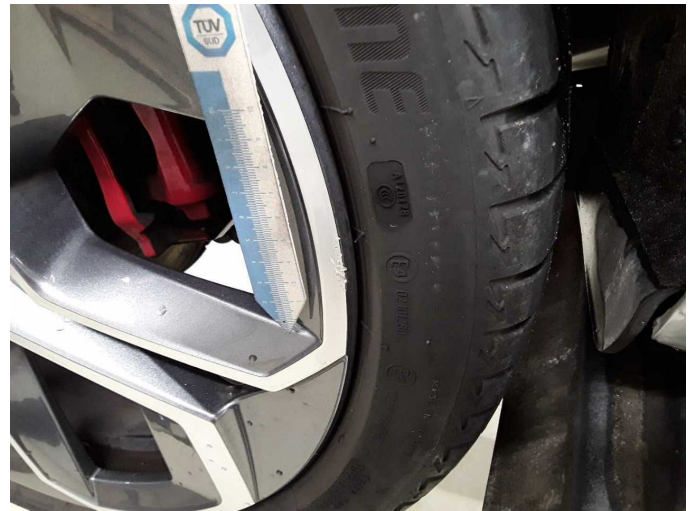
Damage 5: Wheel / tyres: Alloy rim - rear right side - Damaged - Loss in value

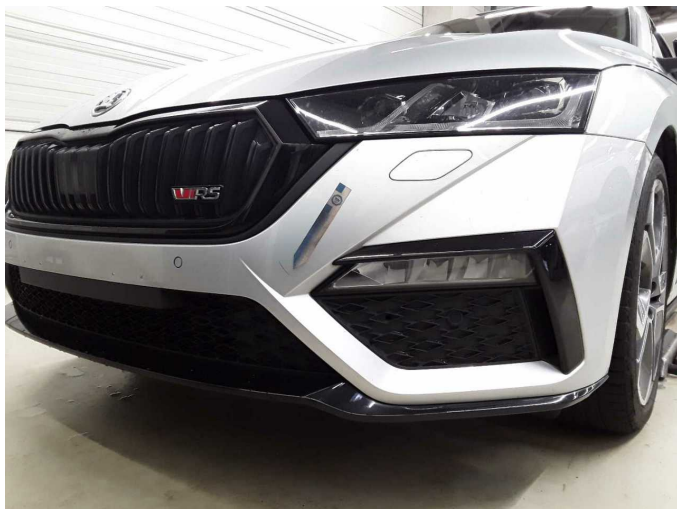
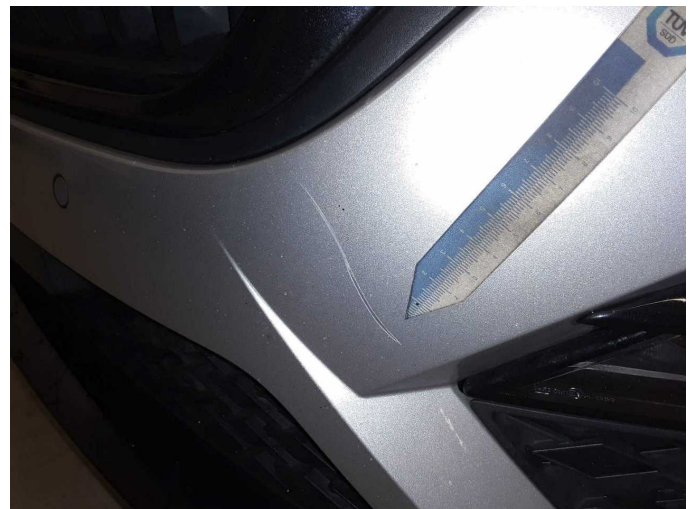
Damage 6: Front bumper: Front bumper - Scratch(es) - Smart repair

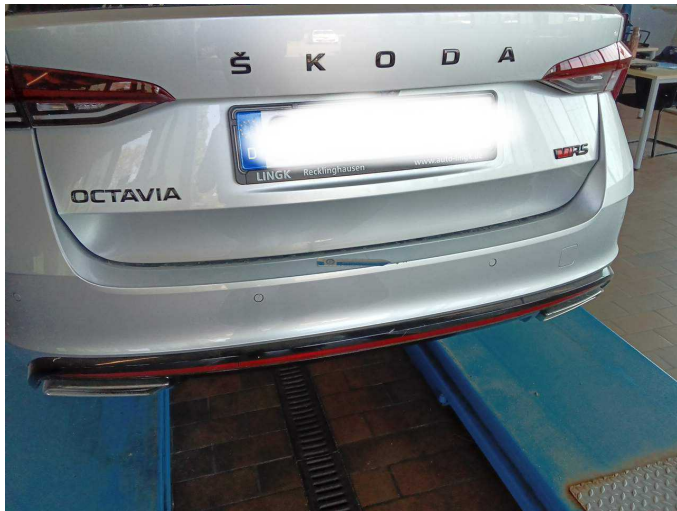
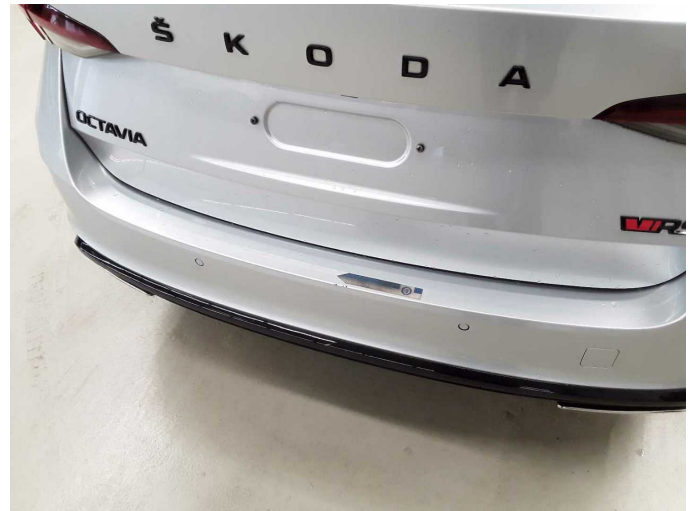
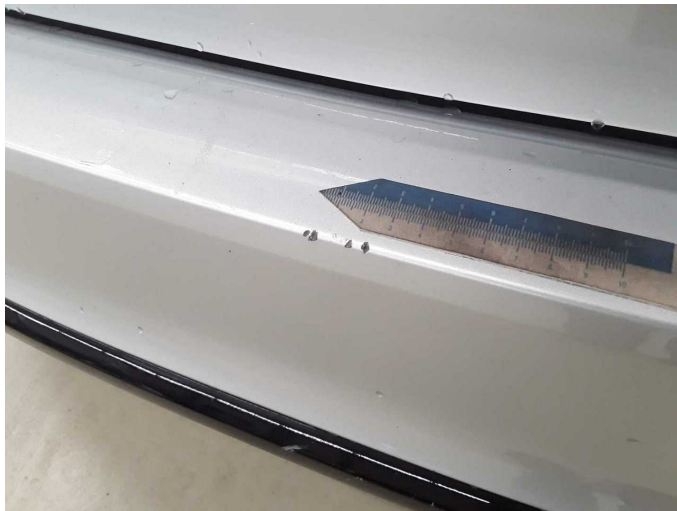
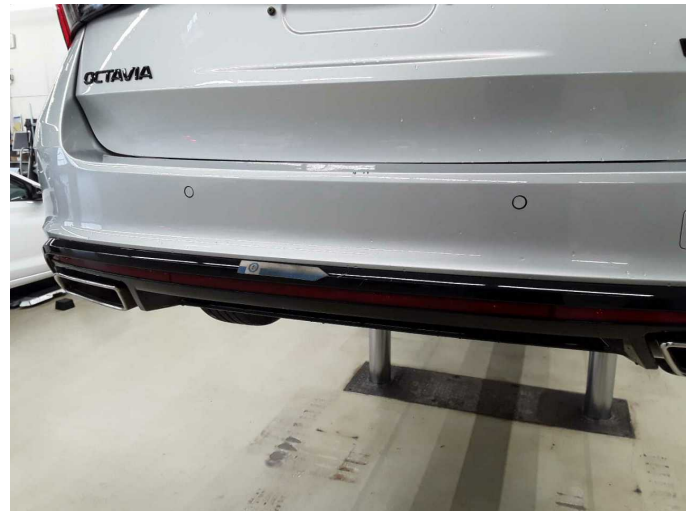
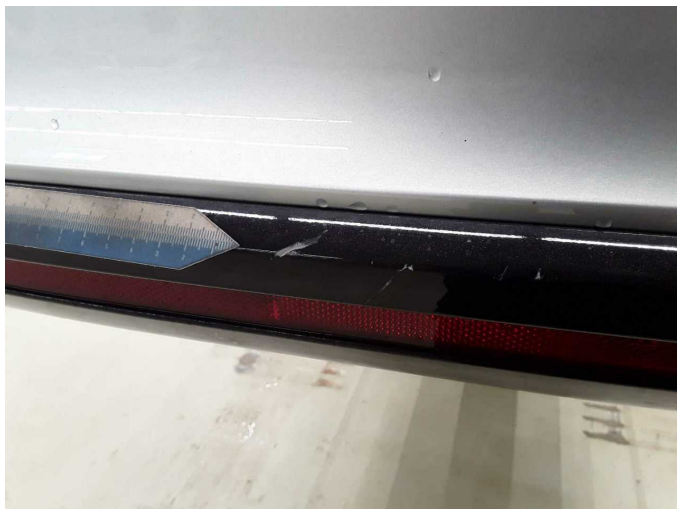
Damage 7: Rear bumper: Rear bumper (Incl. Schwarzer Zierleiste) - Damaged - Smart repair

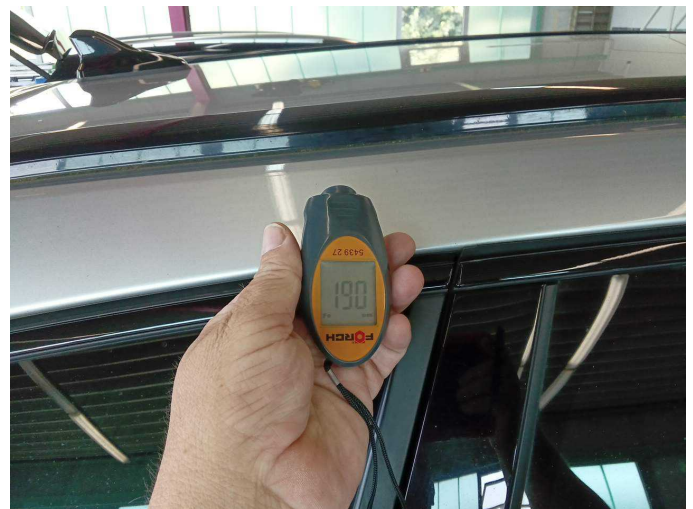
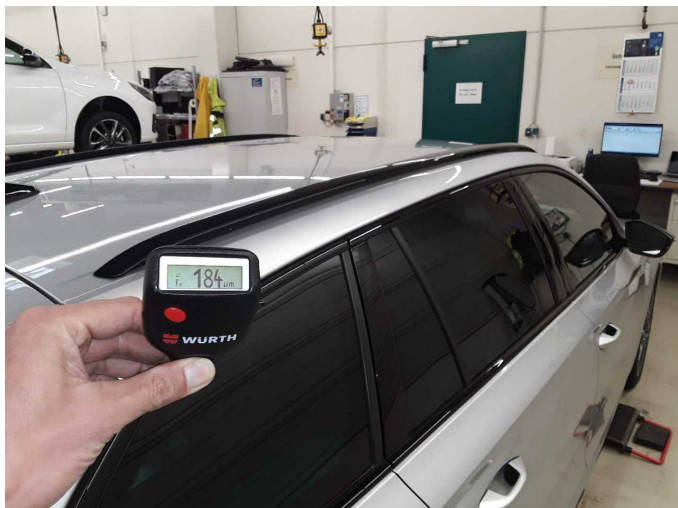
| 1 | Roof rail - right side, Side panel - rear right side, Professionally carried out, Invoice of repair done Non-existent |

Roof rail - right side: 184 µm

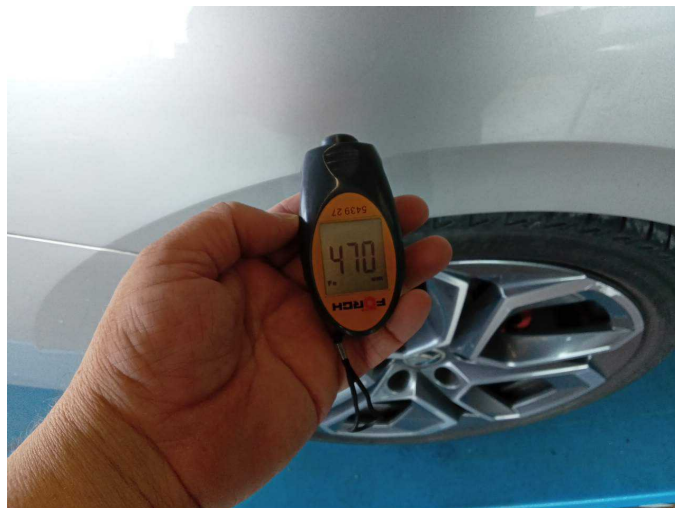
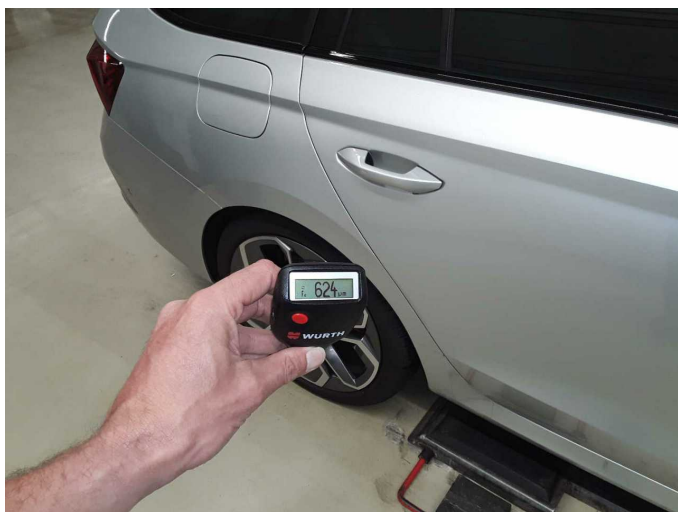
Side panel - rear right side: 624 µm
