## status report

#### Skoda Octavia Combi Ambition

Vehicle identification number	<b>TMBJP7NXXMY039541</b>	mileage read:	<b>96218 km</b>
First Registration / construction year:	<b>19.04.2021 / 2020</b>	Visit Date / place of birth:	<b>18.09.2025 Riedstadt-Goddelau</b>
Bodywork:	<b>cars</b>	Re - import:	<b>no</b>
Body type:	<b>station wagon</b>	KBA no. :	<b>8004//AVO</b>
Fuel / emission class:	<b>gasoline / € 6</b>	transmission type:	<b>automatic</b>
Displacement / power:	<b>999 ccm / 81 kW (110 PS)</b>	Engine:	<b>front-wheel drive</b>
paint:	<b>Quarz-Grau Metallic</b>	Number of previous owners:	<b>2</b>
Doors / seats:	<b>5 / 5</b>	number keys:	<b>2</b>
Next HU / AU:	<b>- / -</b>	cushion type:	<b>substance</b>
Service book available:	<b>digital</b>	Interior Color:	<b>black</b>
smoking vehicle:	<b>no</b>	Last service km / on the:	<b>19375 / 06.05.2022</b>
Vehicle roadworthy:	<b>yes</b>	Vehicle roadworthy:	<b>yes</b>
Submitted vehicle	<b>-</b>	state outside:	<b>3 - Average</b>

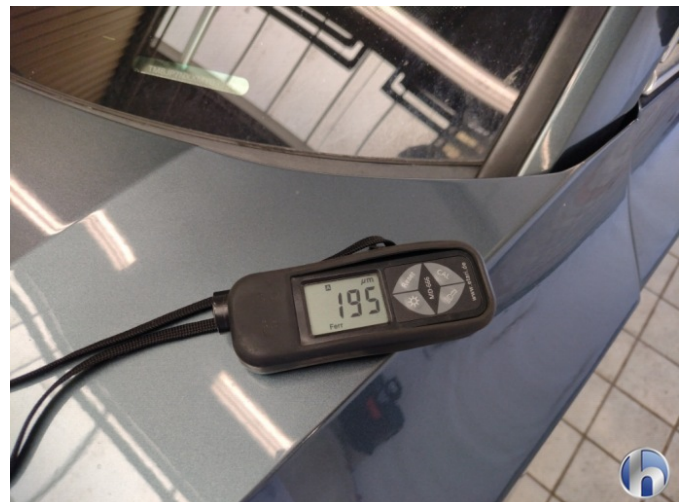
component	Damage	Rep kind
1. hood	Subsequently painted	acceptable
2. A-pillar Front - Left	Subsequently painted	acceptable
3. Roof frame - left	Subsequently painted	acceptable
4. Sidewall - Rear - Left	Subsequently painted	acceptable
5. maintenance	Due	Replace
6. Cargo cover	Missing	Replace
7. hood	Deformed	Refurbish and paint
8. Front door - left	Scratch(es)	Smart repair
9. Sitzreihe Hinten	Dirty	
10. Sidewall - Rear - Left	Deformed	Refurbish and paint
11. tailgate	Damaged	Refurbish and paint
12. Door Rear - right	Damaged	Refurbish and paint
13. Türeinstieg Hinten - Rechts	Scratch(es)	Paint
14. Front fender - right	Scratch(es)	
15. Mittelkonsole	Dirty
