Expertise

Protocol number: 41662080
Order No. / Reference: 25216281
Inspection date: 23 Sept 2025

Manufacturer: Skoda
VIN: TMBJR7NP0N7024709

Model: Superb Combi 2.0 TDI DSG Ambition

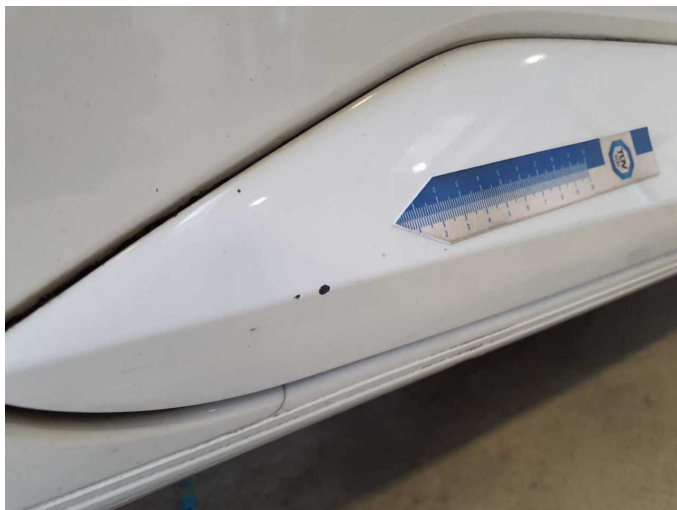
No.	Component group	Description
1	Door - rear right side	Brightware - lower - Scratched - Smart repair
2	Door - front left side	Brightware - lower - Scratched - Smart repair
3	Boot lid / rear door	Seal - Broken / torn - Replace
4	Front bumper	Front bumper - Scratched - Smart repair
5	Instrument panel	Air nozzle - centre - Broken / torn - Replace
6	Steering system	Steering wheel - Scratched - Loss in value
7	Rear bumper	Rear bumper - Dent / paintcoat damage - Repair and paint
8	Side panel - rear left side	Side panel - Scratched - Paint
9	Side panel - rear right side	Side panel - Dent / paintcoat damage - Repair and paint
10	Bonnet	Bonnet - Dent / paintcoat damage - Repair and paint
11	Vehicle glazing	Windscreen (Rissbildung/ Kratzer) - Stone chips - Replace
12	Roof	Roof - Corrosion - Repair and paint

Damage 1: Door - rear right side: Brightware - lower - Scratched - Smart repair

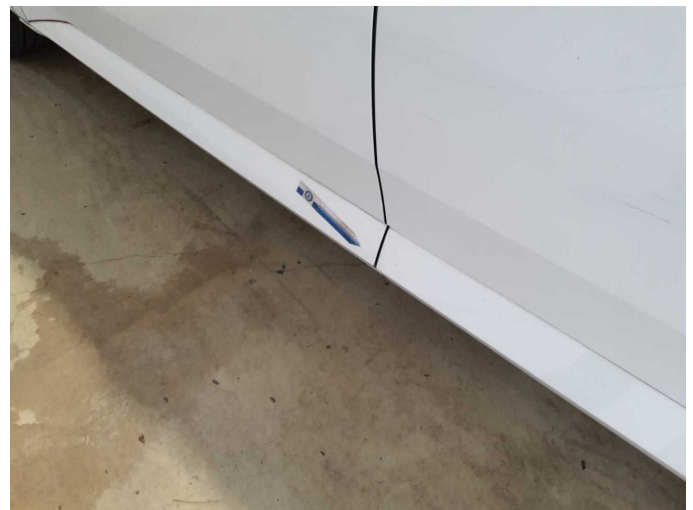
Damage 1: Door - rear right side: Brightware - lower - Scratched - Smart repair

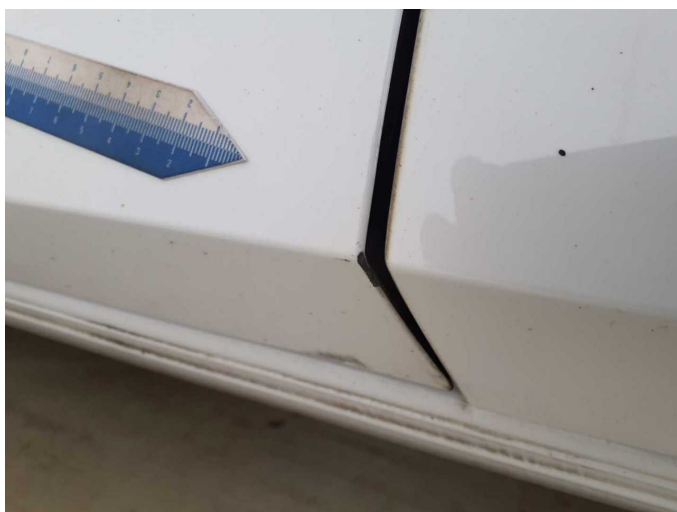
Damage 2: Door - front left side: Brightware - lower - Scratched - Smart repair

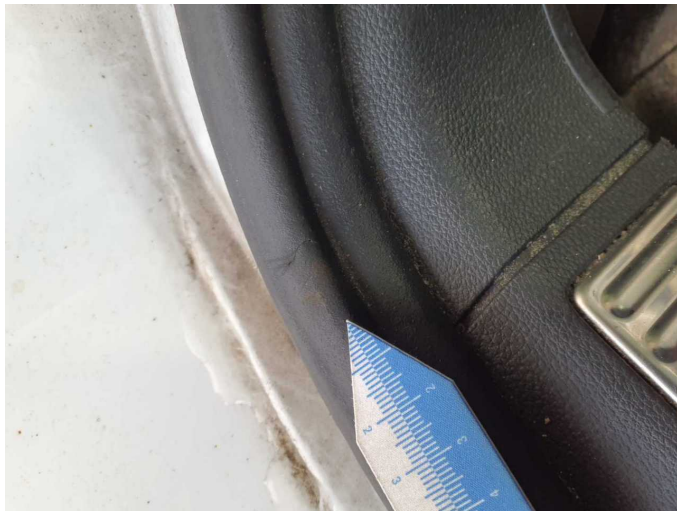
Damage 3: Boot lid / rear door: Seal - Broken / torn - Replace

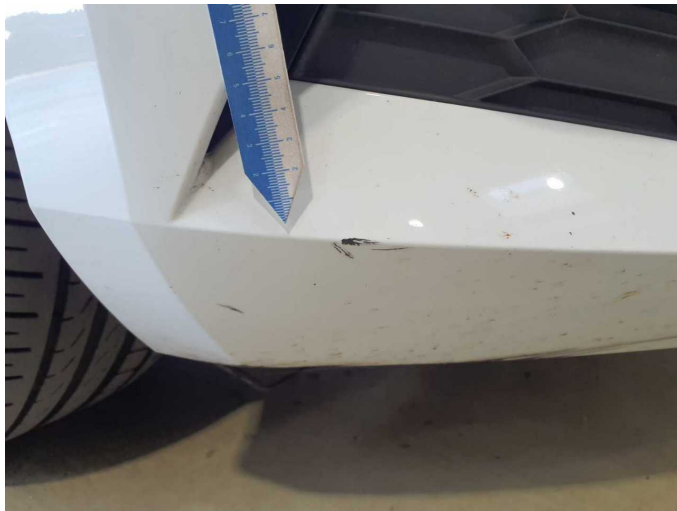
Damage 4: Front bumper: Front bumper - Scratched - Smart repair

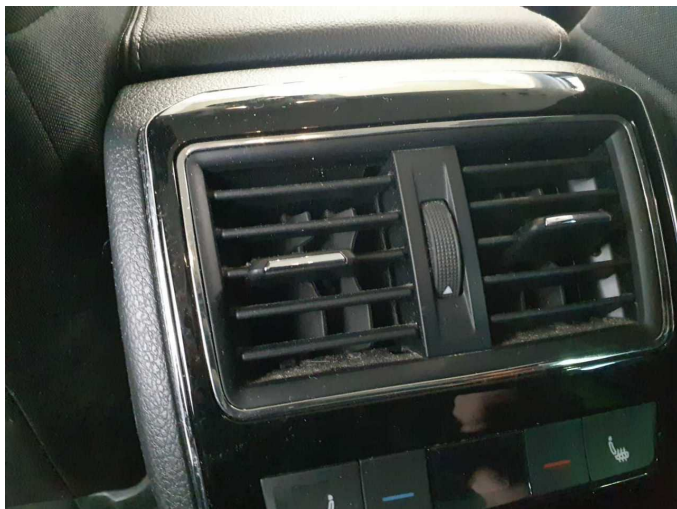
Damage 5: Instrument panel: Air nozzle - centre - Broken / torn - Replace

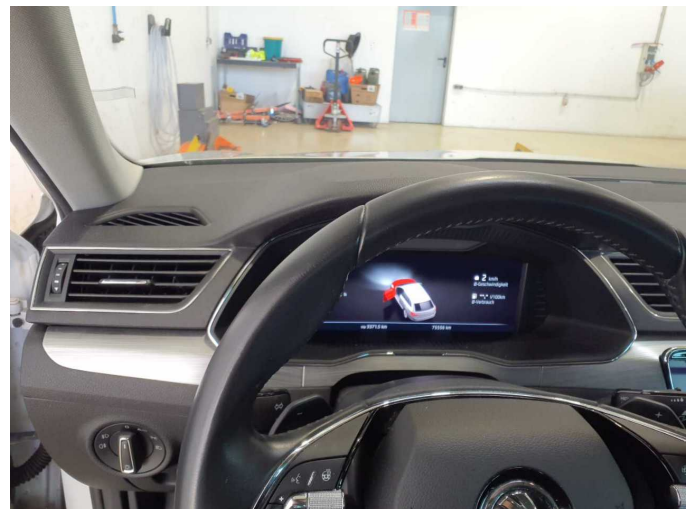
Damage 5: Instrument panel: Air nozzle - centre - Broken / torn - Replace

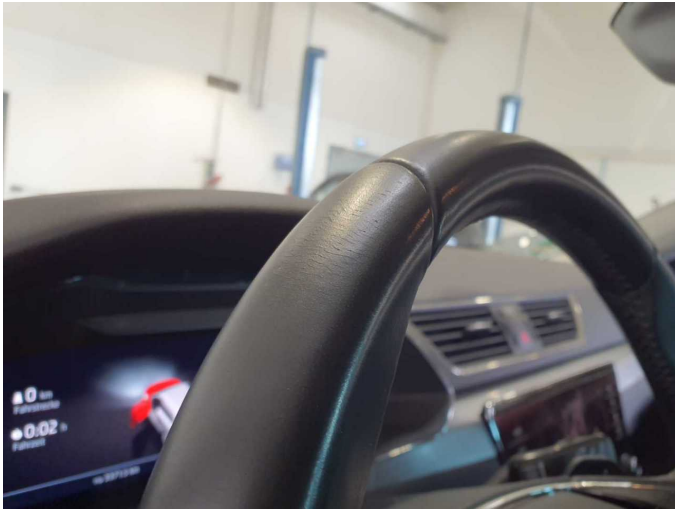
Damage 6: Steering system: Steering wheel - Scratched - Loss in value

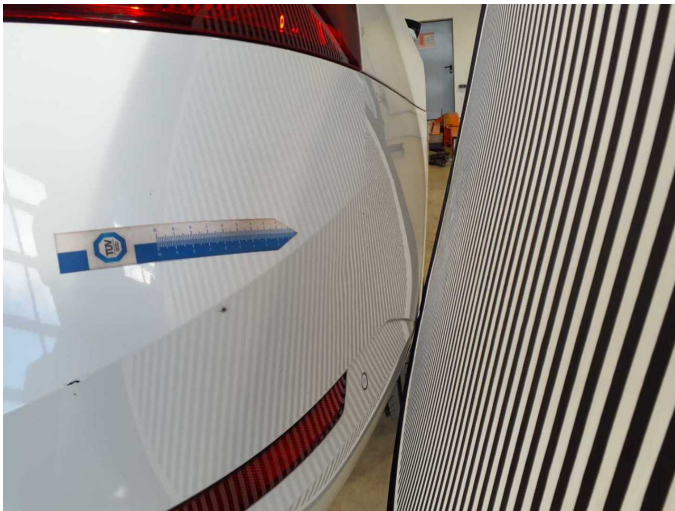
Damage 7: Rear bumper: Rear bumper - Dent / paintcoat damage - Repair and paint

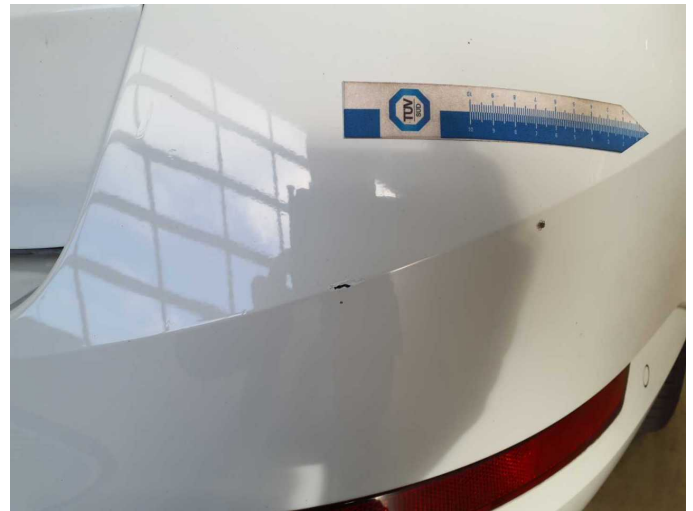
Damage 7: Rear bumper: Rear bumper - Dent / paintcoat damage - Repair and paint

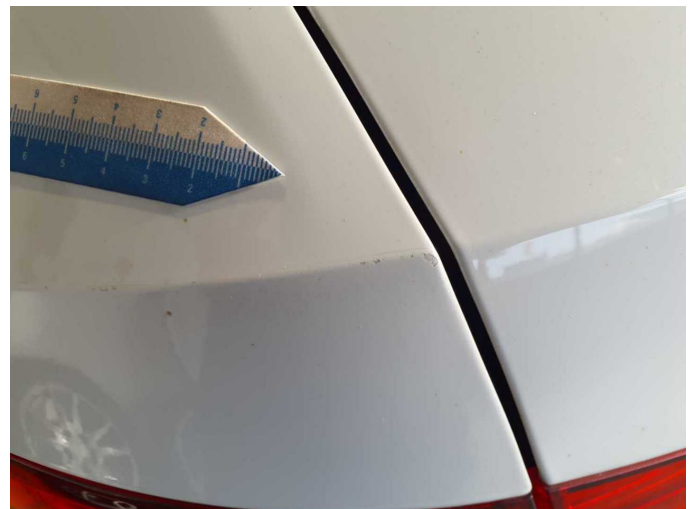
Damage 8: Side panel - rear left side: Side panel - Scratched - Paint

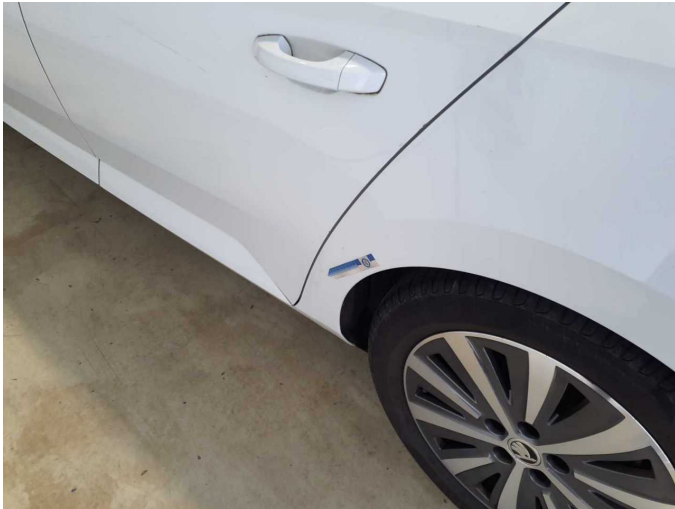
Damage 8: Side panel - rear left side: Side panel - Scratched - Paint

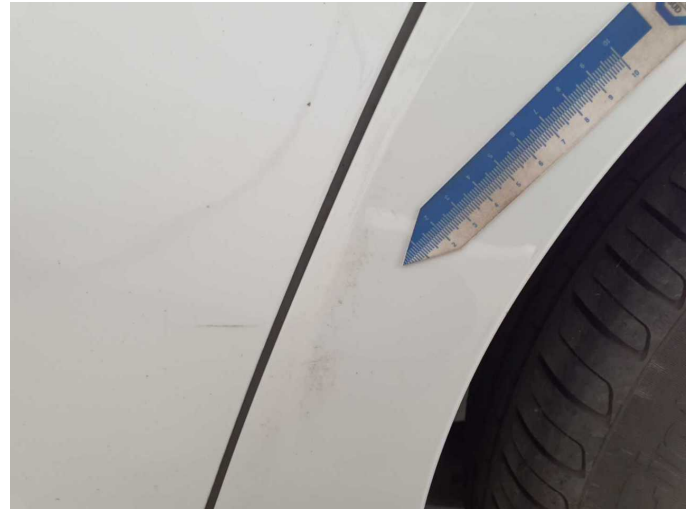
Damage 8: Side panel - rear left side: Side panel - Scratched - Paint

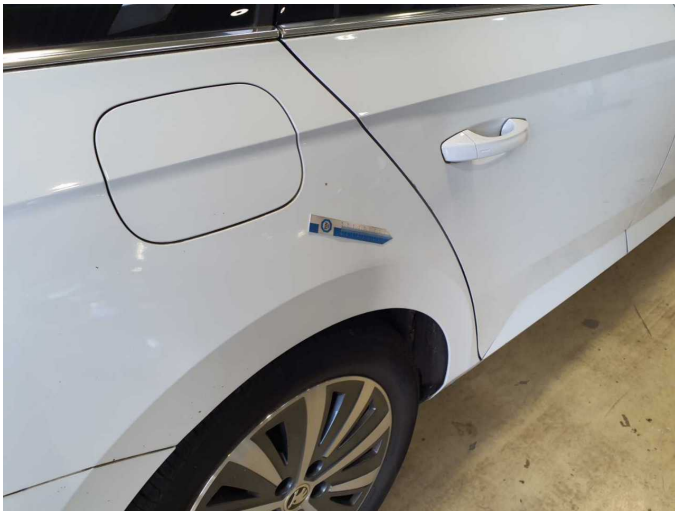
Damage 8: Side panel - rear left side: Side panel - Scratched - Paint

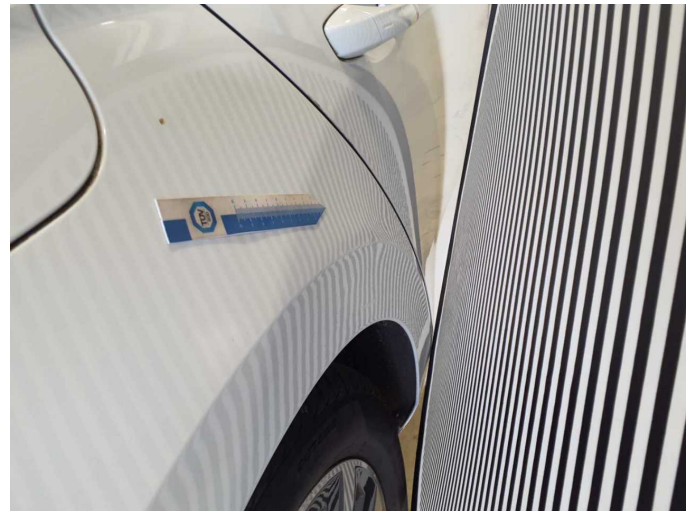
Damage 9: Side panel - rear right side: Side panel - Dent / paintcoat damage - Repair and paint

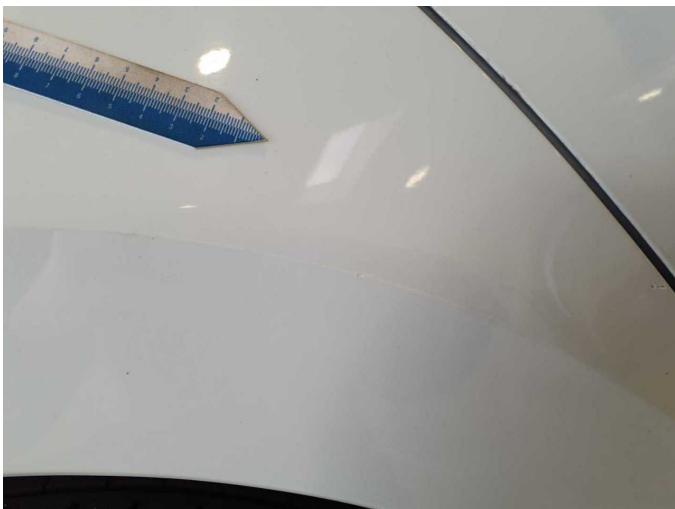
Damage 9: Side panel - rear right side: Side panel - Dent / paintcoat damage - Repair and paint

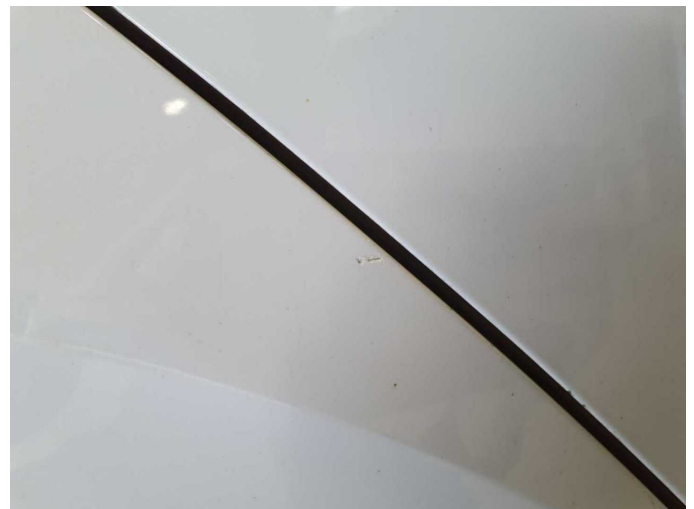
Damage 9: Side panel - rear right side: Side panel - Dent / paintcoat damage - Repair and paint

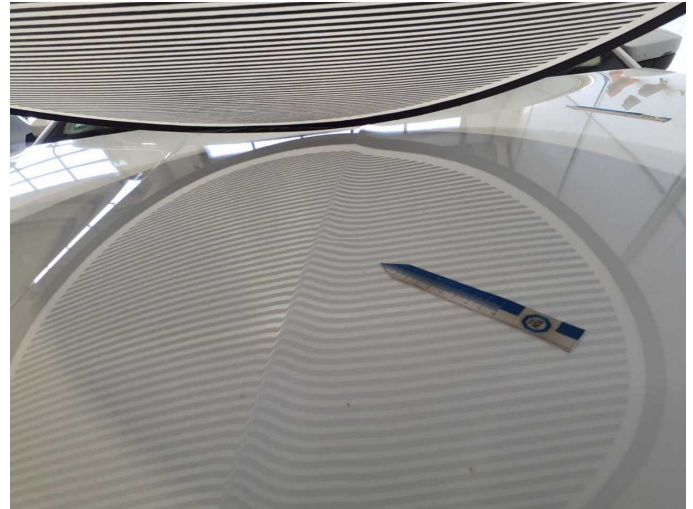
Damage 10: Bonnet: Bonnet - Dent / paintcoat damage - Repair and paint

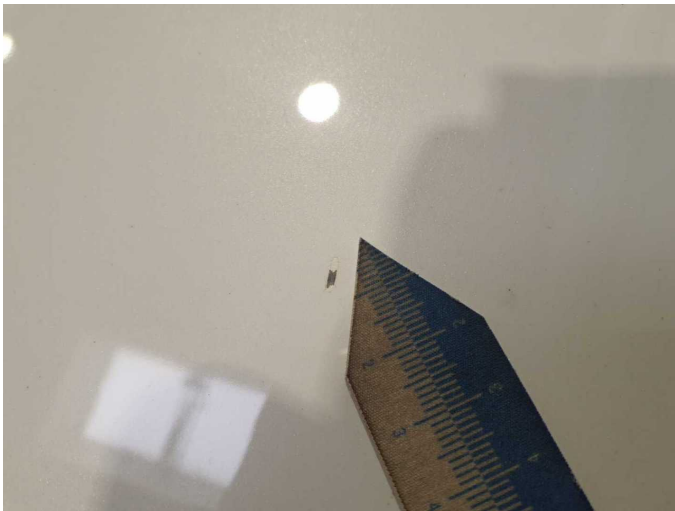
Damage 10: Bonnet: Bonnet - Dent / paintcoat damage - Repair and paint

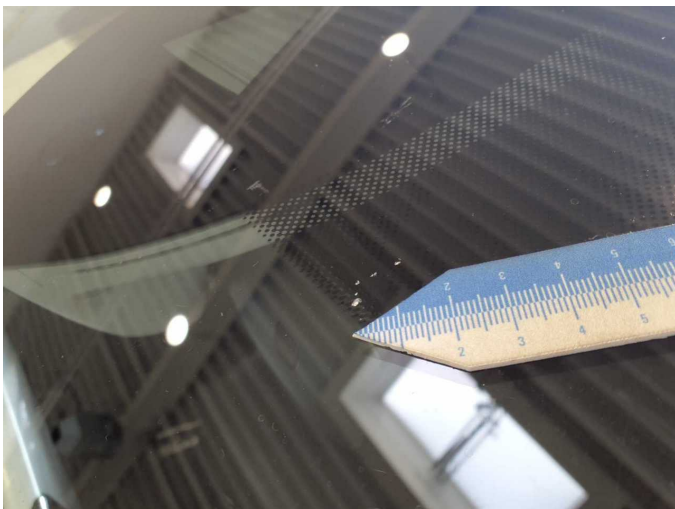
Damage 11: Vehicle glazing: Windscreen (Rissbildung/ Kratzer) - Stone chips - Replace

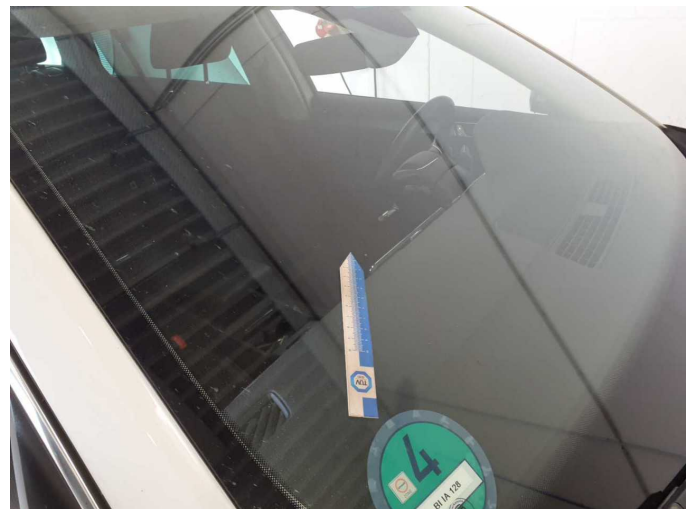
Damage 11: Vehicle glazing: Windscreen (Rissbildung/ Kratzer) - Stone chips - Replace

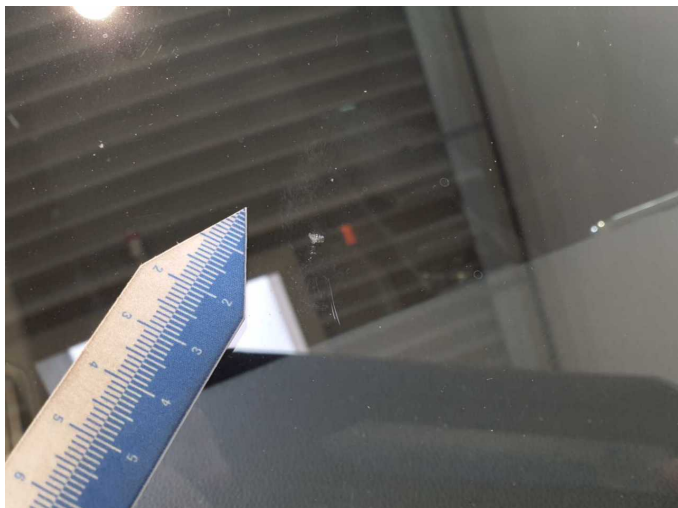
Damage 11: Vehicle glazing: Windscreen (Rissbildung/ Kratzer) - Stone chips - Replace

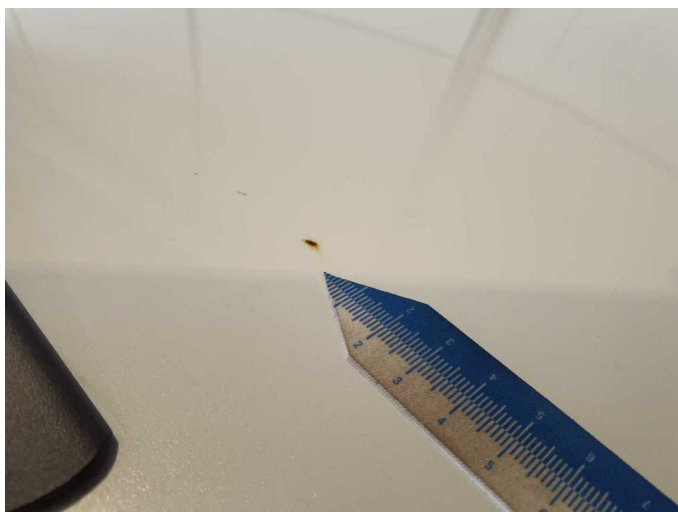
Damage 12: Roof: Roof - Corrosion - Repair and paint

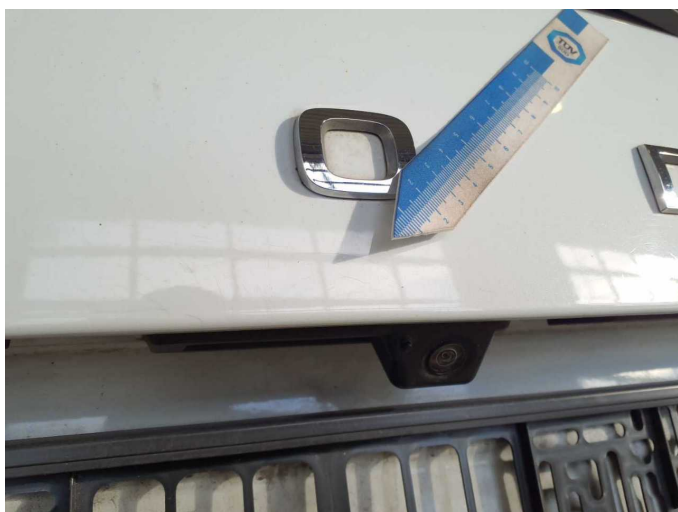
Wear and tear 1: Boot lid / rear door: Boot lid - Scratch(es) - No deduction

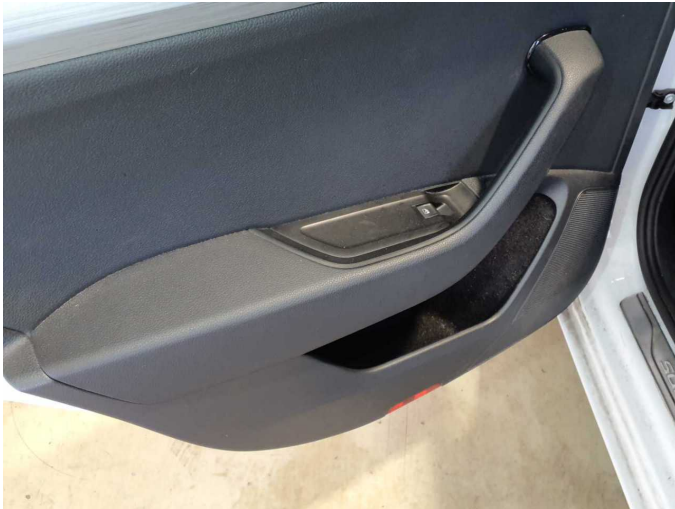
Wear and tear 2: Interior: Interior - Soiled - No deduction

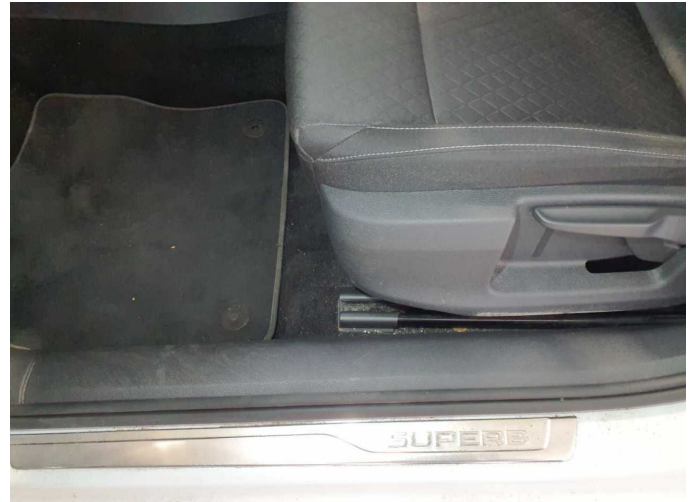
Wear and tear 2: Interior: Interior - Soiled - No deduction

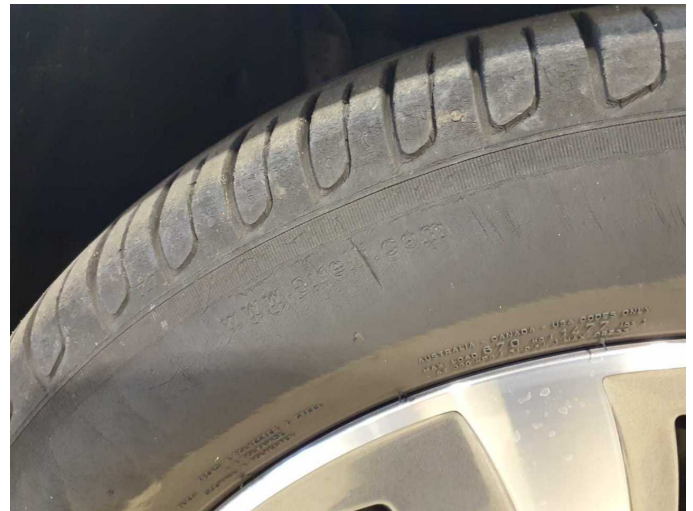
Wear and tear 3: Wheel / tyres: Tyre - front right side - Abrasion - No deduction

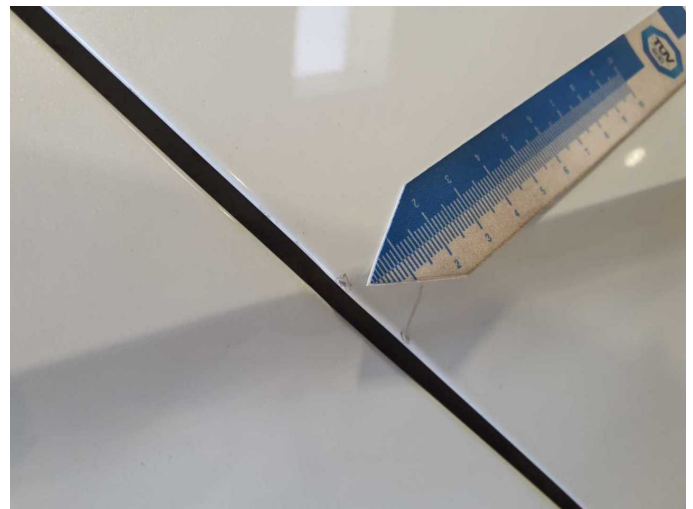
Wear and tear 4: Door - rear right side: Door - Scratch(es) - No deduction

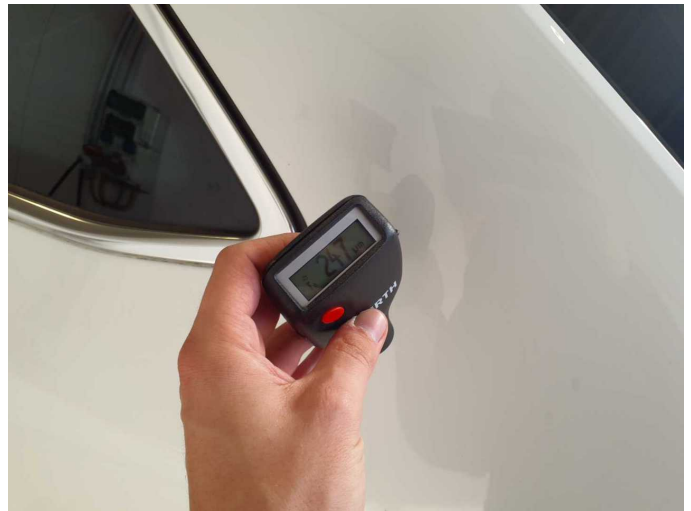
Repainting 1: Roof rail - left side, Side panel - rear left side

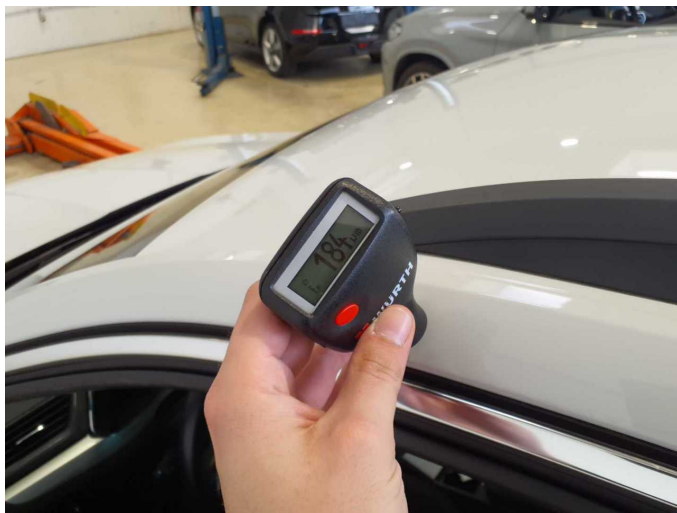
Repainting 1: Roof rail - left side, Side panel - rear left side

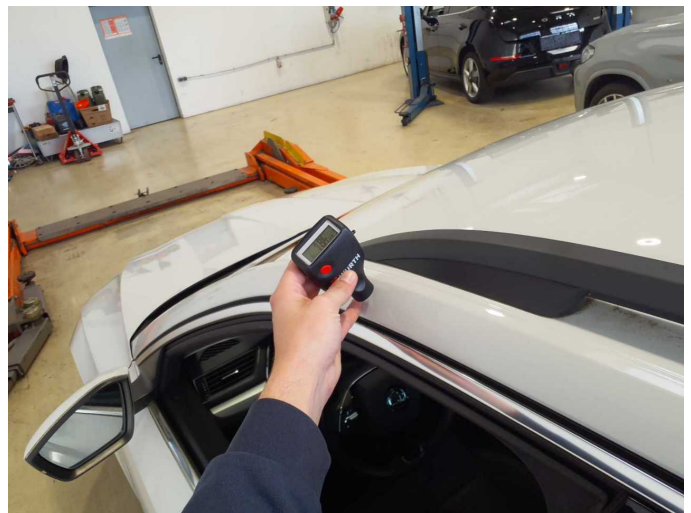
Repainting 1: Roof rail - left side, Side panel - rear left side

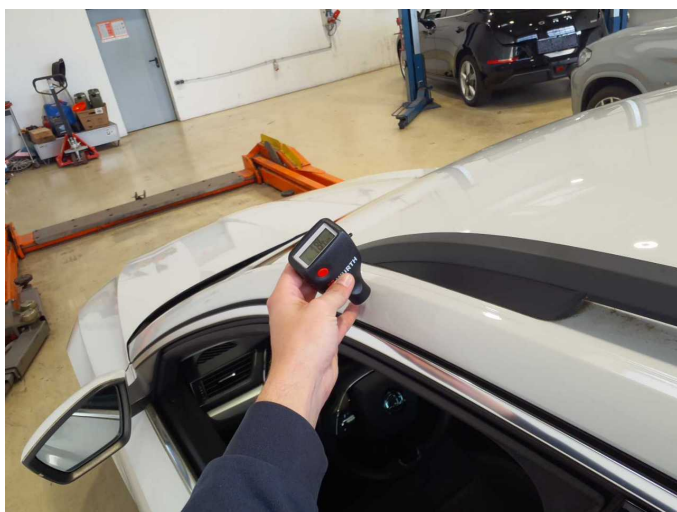
Repainting 1: Roof rail - left side, Side panel - rear left side

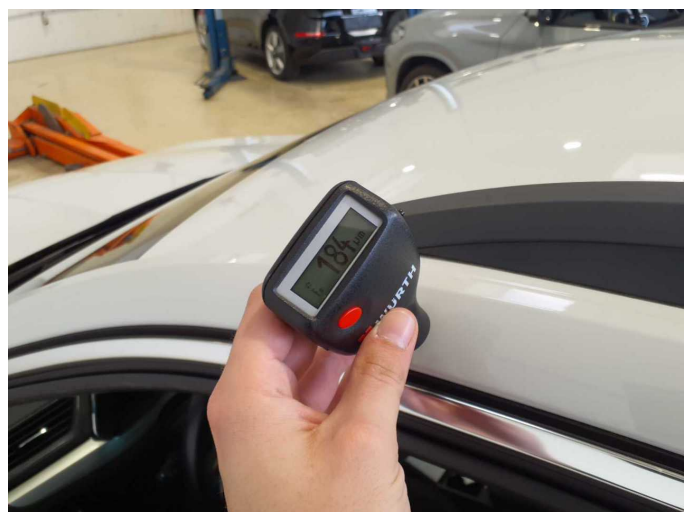
Roof rail - left side: 184 µm
