Expertise

Protocol number: 39556940
Order No. / Reference: 24652184
Inspection date: 23 Apr 2025

Manufacturer: Skoda
VIN: TMBJR7NP7M7035835

Model: Superb Combi 2.0 TDI DSG Ambition

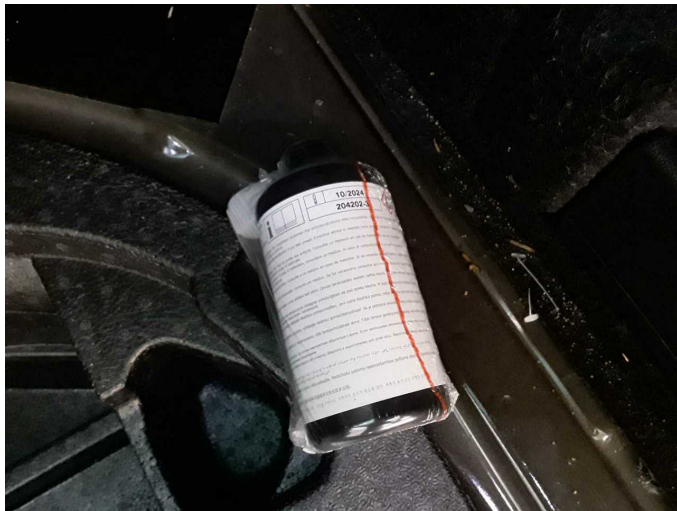
Damage 1: Equipment: Tirefit filler - Due - Replace

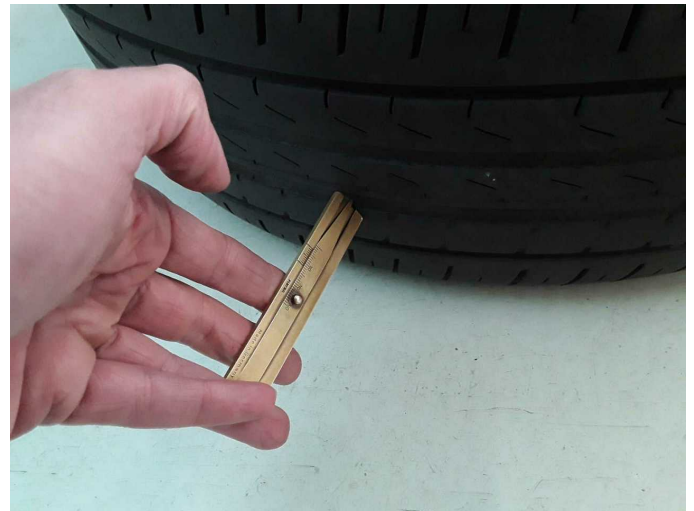
Damage 2: 2nd wheel set: 1 tyre - Does not meet the leasing specifications - Replace

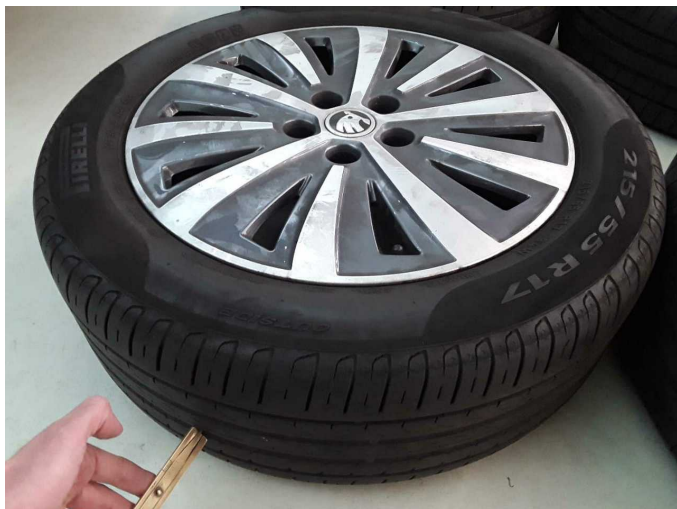
Damage 2: 2nd wheel set: 1 tyre - Does not meet the leasing specifications - Replace

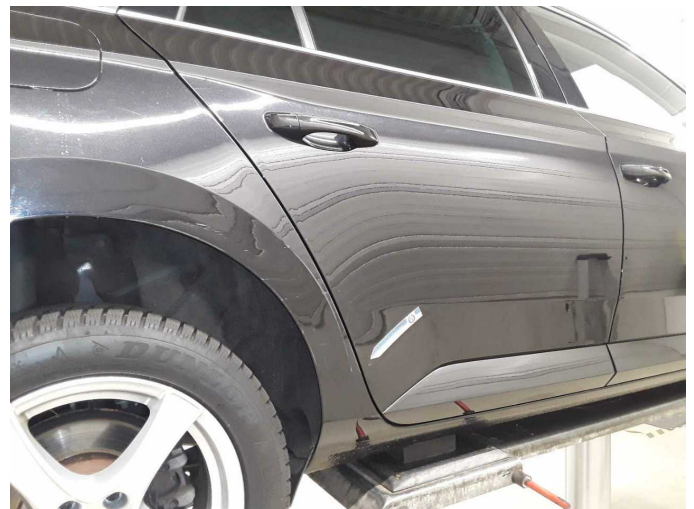
Damage 3: Door - rear right side: Door - Scratch(es) - Smart repair

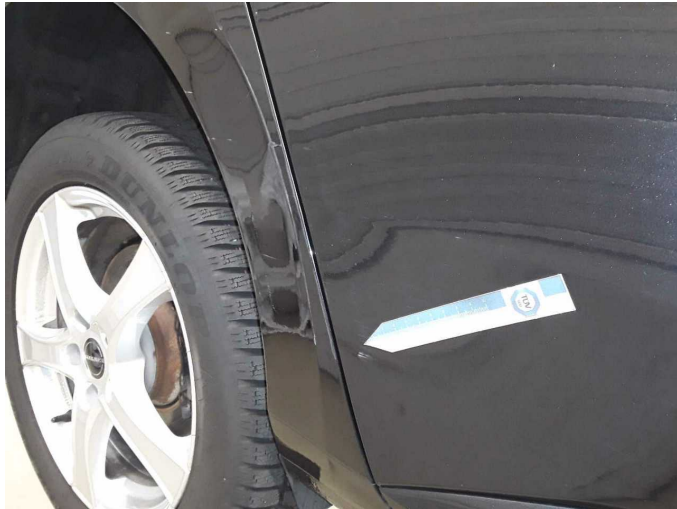
Damage 3: Door - rear right side: Door - Scratch(es) - Smart repair

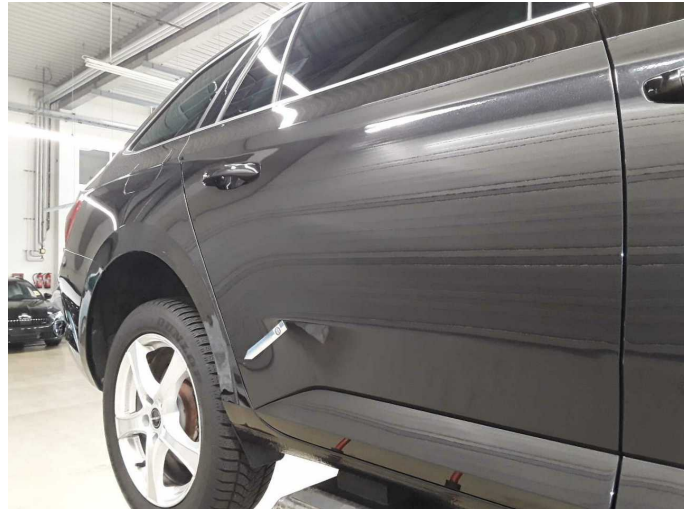
Damage 3: Door - rear right side: Door - Scratch(es) - Smart repair

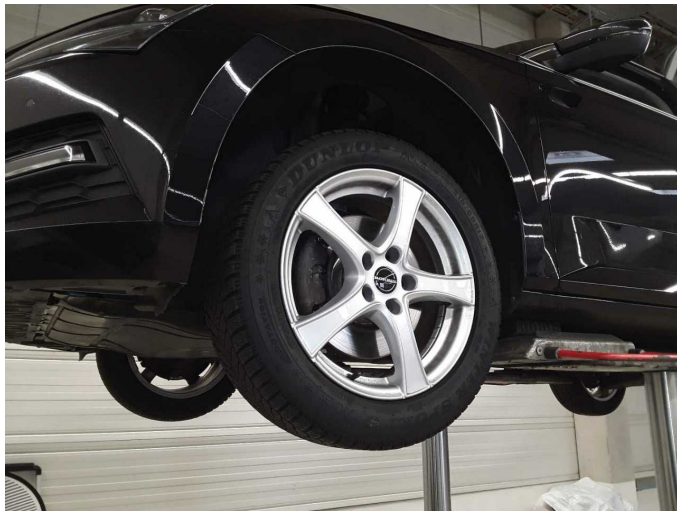
Damage 4: Body: Wheel well - front left side - Broken / torn - Replace

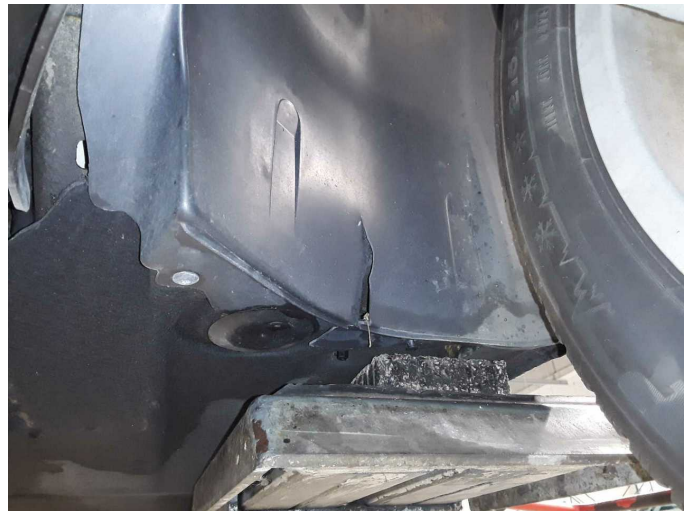
Damage 4: Body: Wheel well - front left side - Broken / torn - Replace

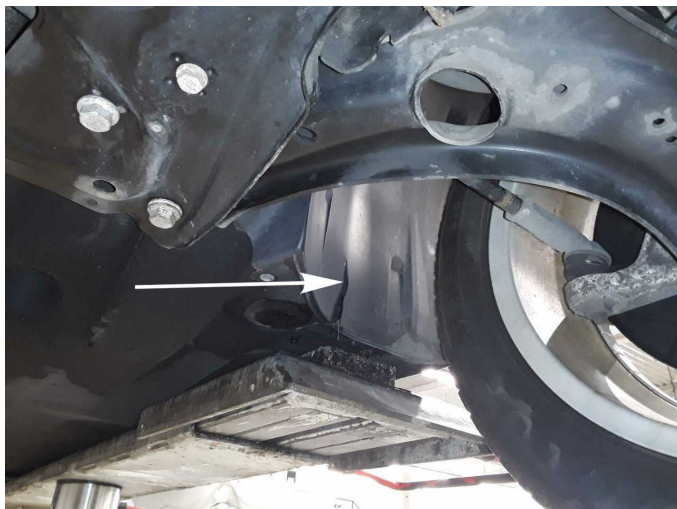
Damage 4: Body: Wheel well - front left side - Broken / torn - Replace

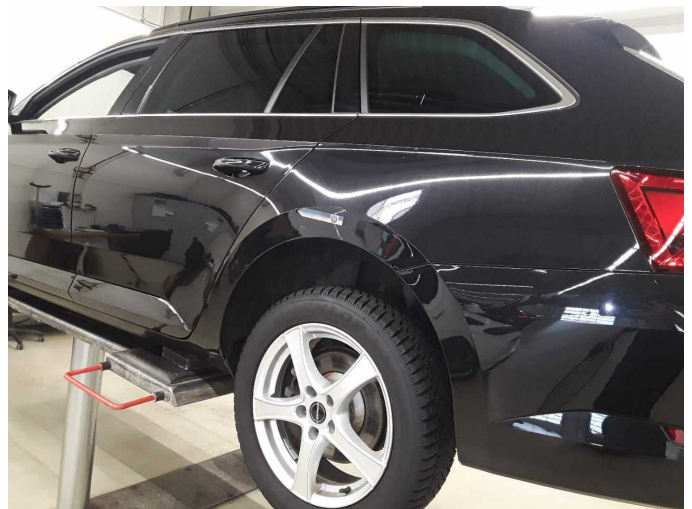
Damage 5: Side panel - rear left side: Side panel - Dent / paintcoat damage - Smart repair

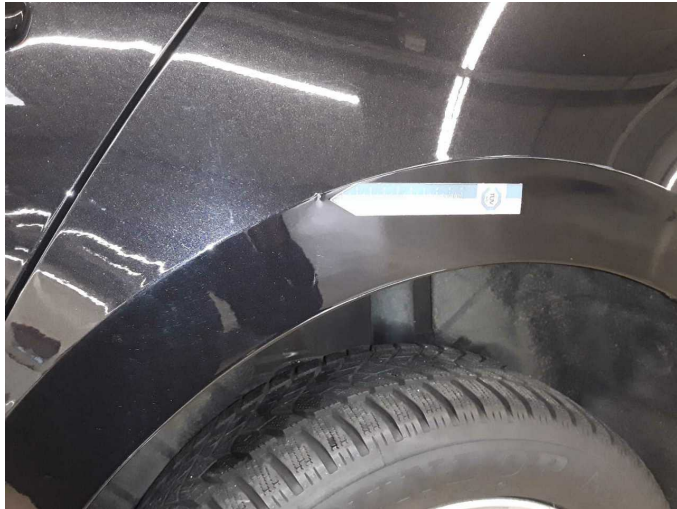
Damage 5: Side panel - rear left side: Side panel - Dent / paintcoat damage - Smart repair

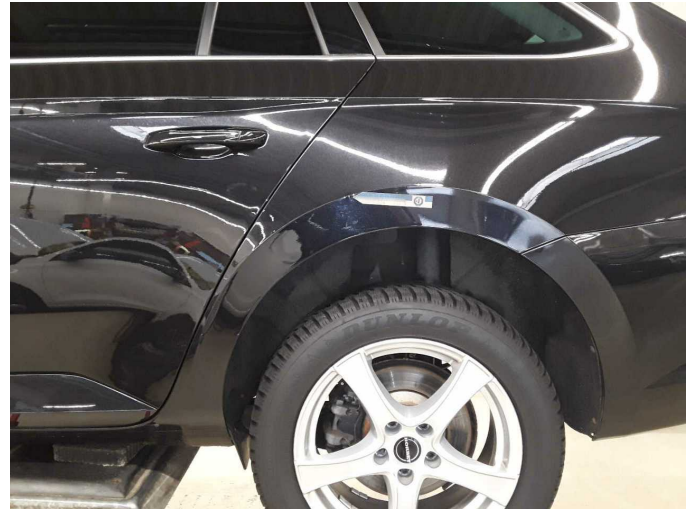
Damage 5: Side panel - rear left side: Side panel - Dent / paintcoat damage - Smart repair

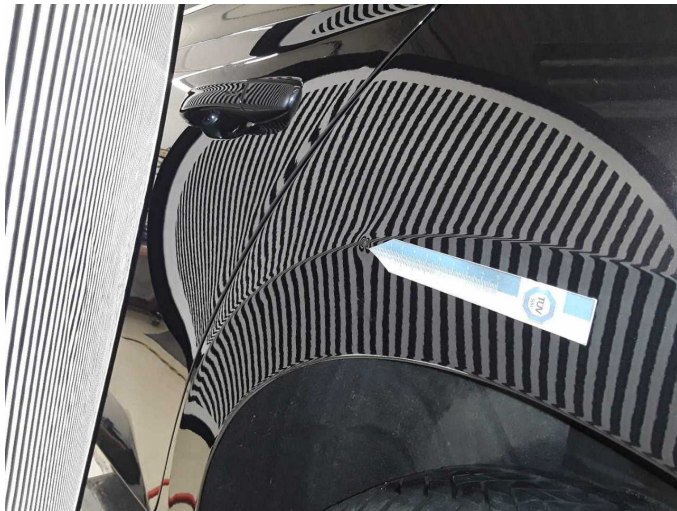
Damage 5: Side panel - rear left side: Side panel - Dent / paintcoat damage - Smart repair

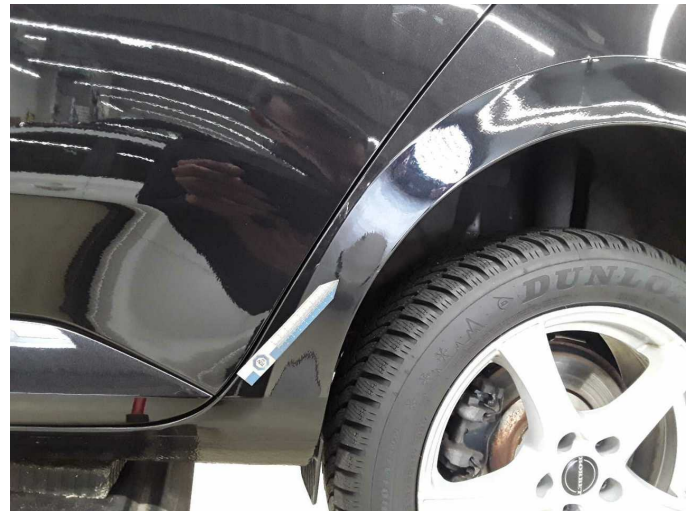
Damage 5: Side panel - rear left side: Side panel - Dent / paintcoat damage - Smart repair

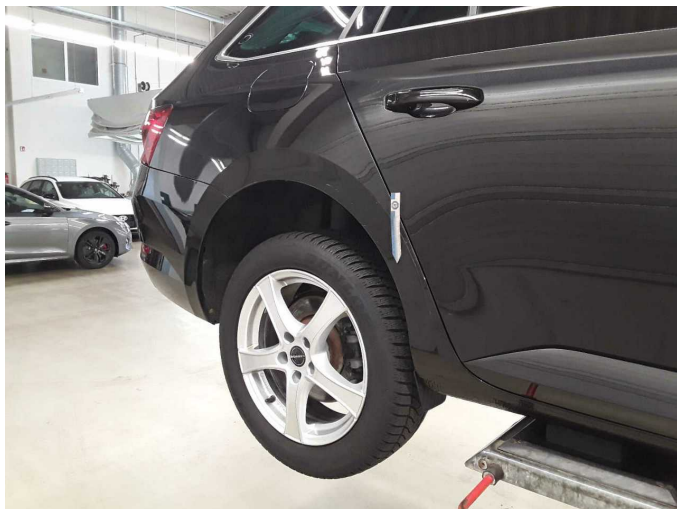
Damage 6: Side panel - rear right side: Side panel - Scratched - Repair and paint

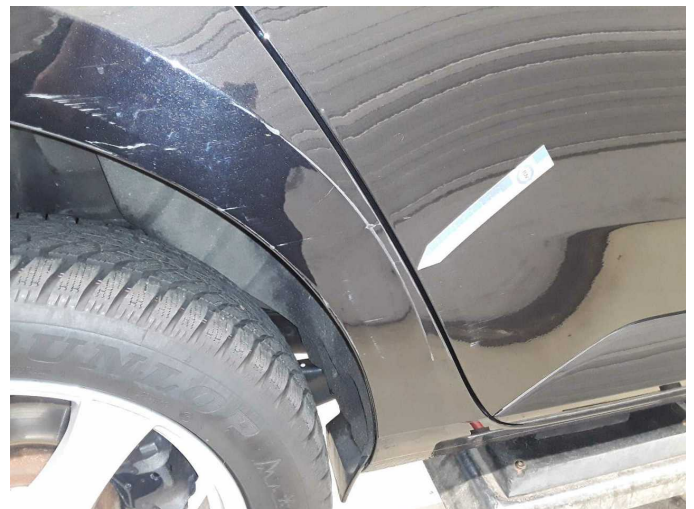
Damage 6: Side panel - rear right side: Side panel - Scratched - Repair and paint

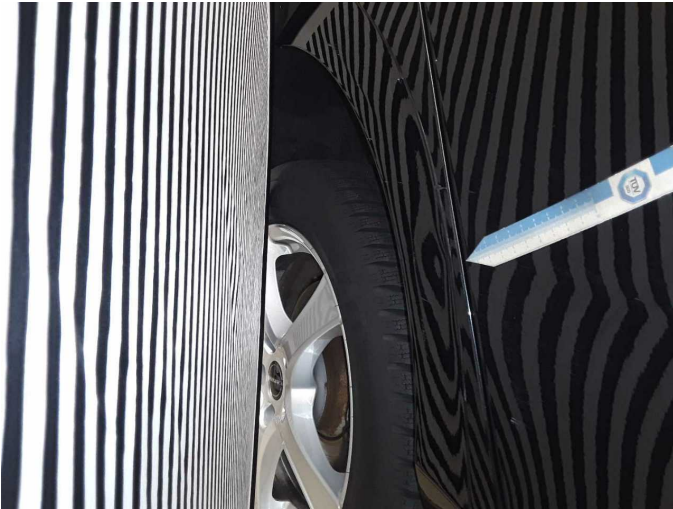
Damage 6: Side panel - rear right side: Side panel - Scratched - Repair and paint

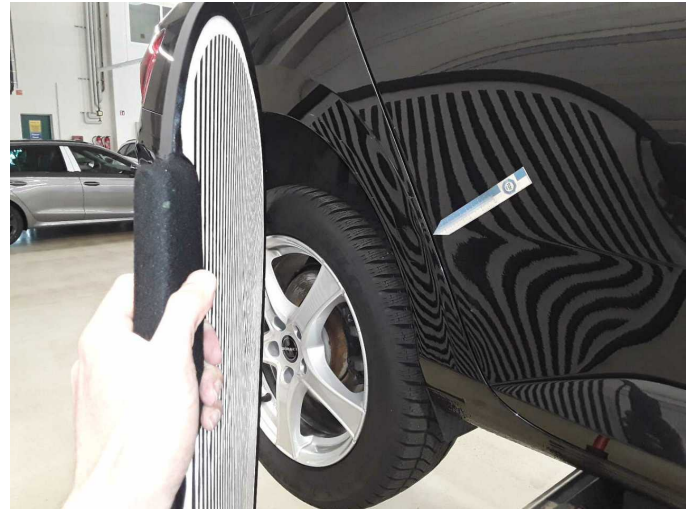
Damage 6: Side panel - rear right side: Side panel - Scratched - Repair and paint

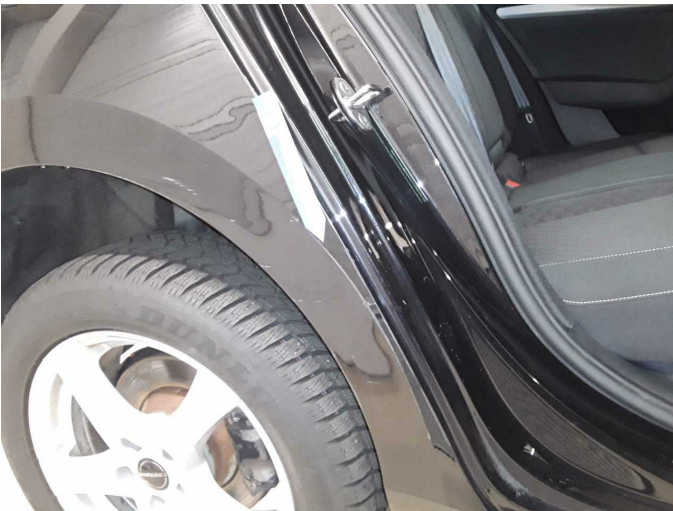
Damage 6: Side panel - rear right side: Side panel - Scratched - Repair and paint

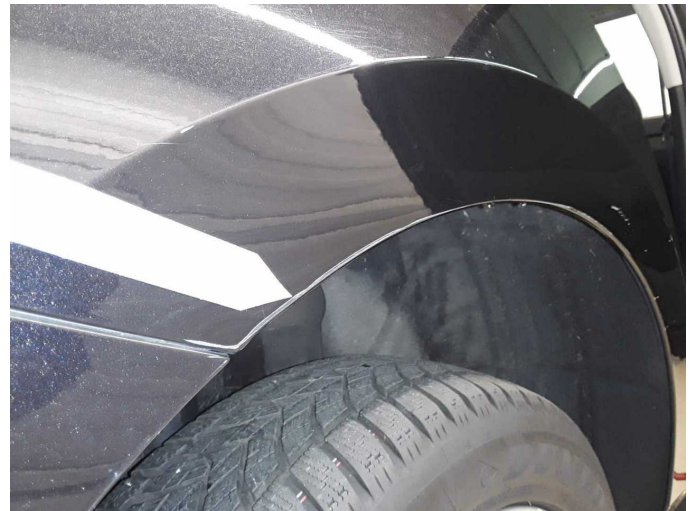
Damage 6: Side panel - rear right side: Side panel - Scratched - Repair and paint
