Expertise

Protocol number: 39455293
Order No. / Reference: 24633938
Inspection date: 4 Apr 2025

Manufacturer: Skoda
VIN: TMBJR7NXXMY112028

Model: Octavia Combi 1.5 TSI First Edition

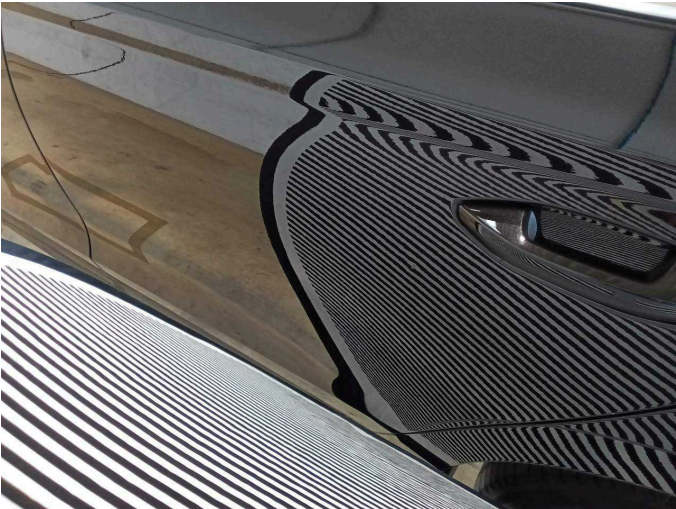
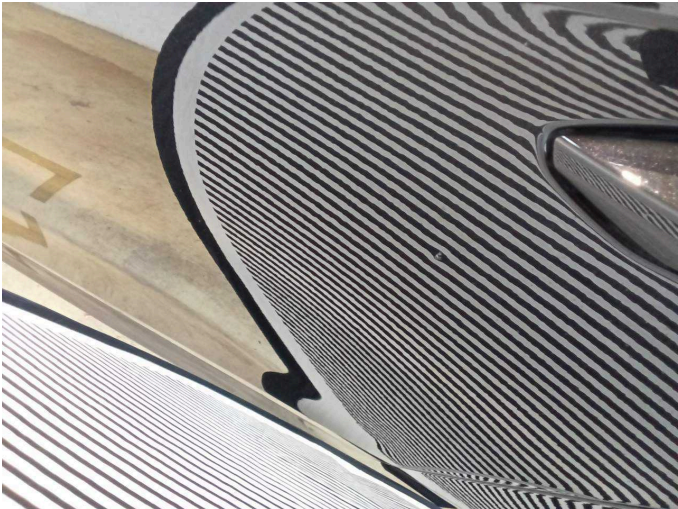
Damage 2: Door - rear left side: Door - Dent / paintcoat damage - Smart repair

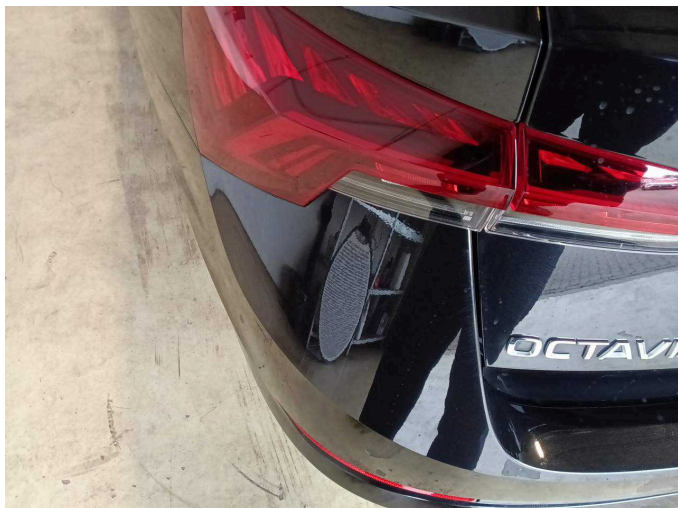
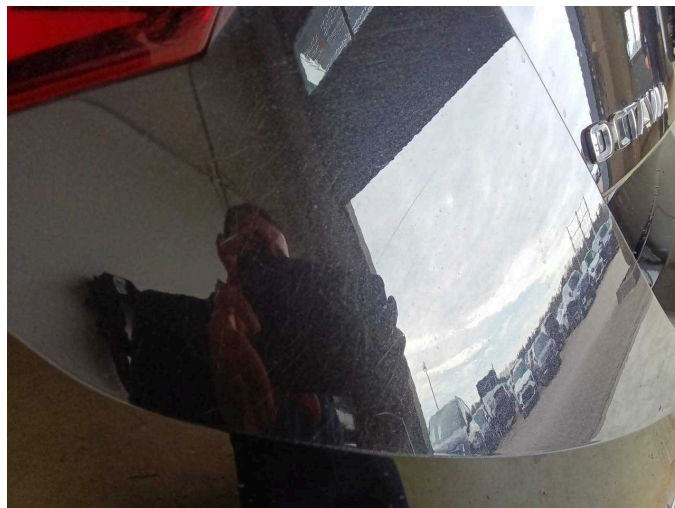
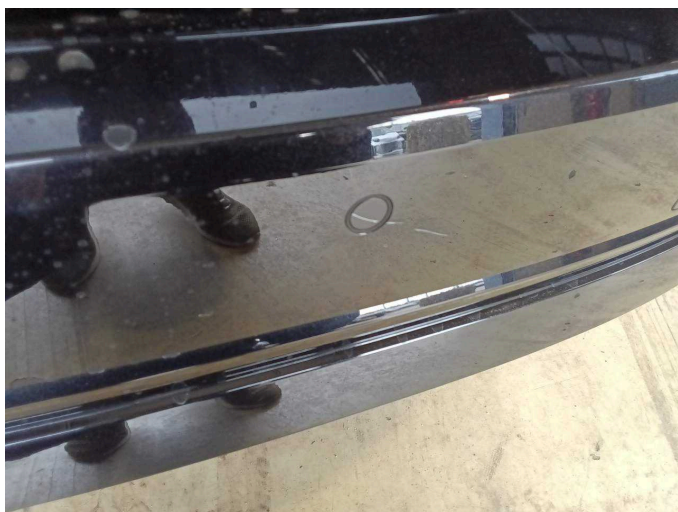
Damage 3: Rear bumper: Rear bumper - Scratch(es) - Paint

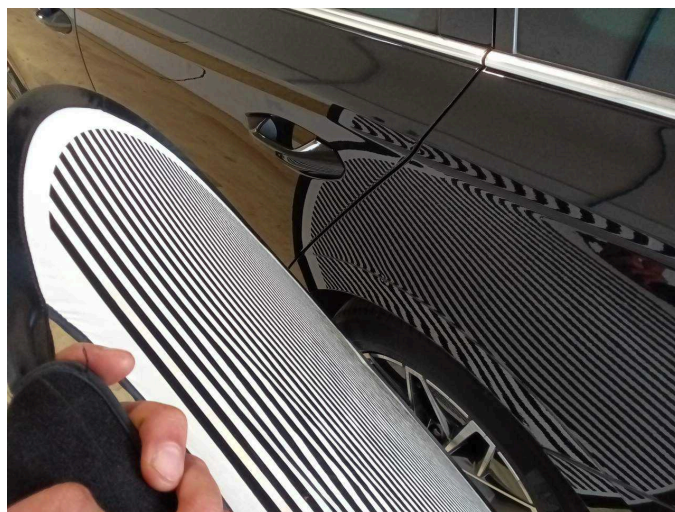
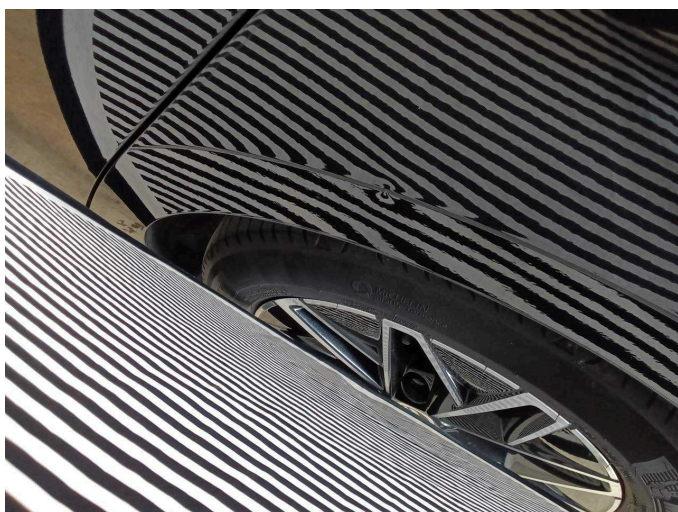
Damage 4: Side panel - rear left side: Side panel (Delle geht über die Kante) - Dent / paintcoat damage - Repair and paint

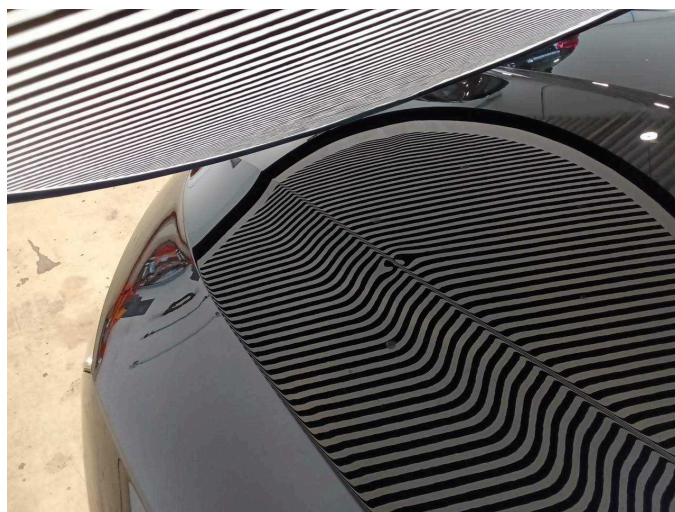
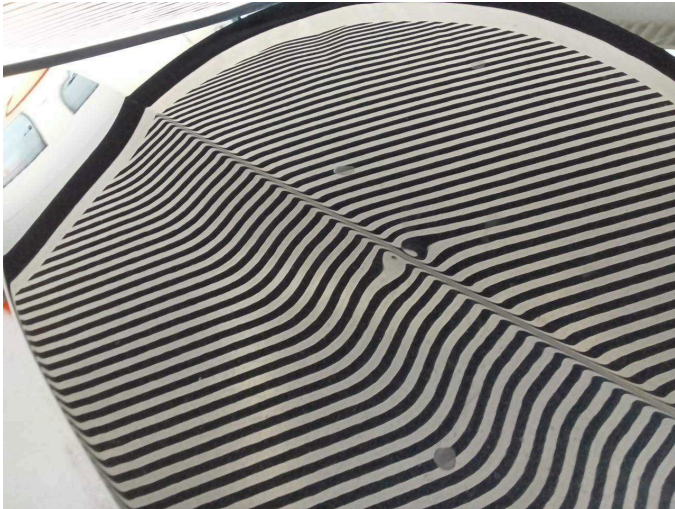
Damage 5: Bonnet: Bonnet - dent(s) - Repair and paint
