Expertise

Protocol number: 41606988  
Order No. / Reference: 25210189  
Inspection date: 17 Sept 2025

| Manufacturer: Skoda | Model: Octavia Combi 1.5 TSI e-TEC DSG Tour |
| VIN: TMBJR8NX6NY105861 | |

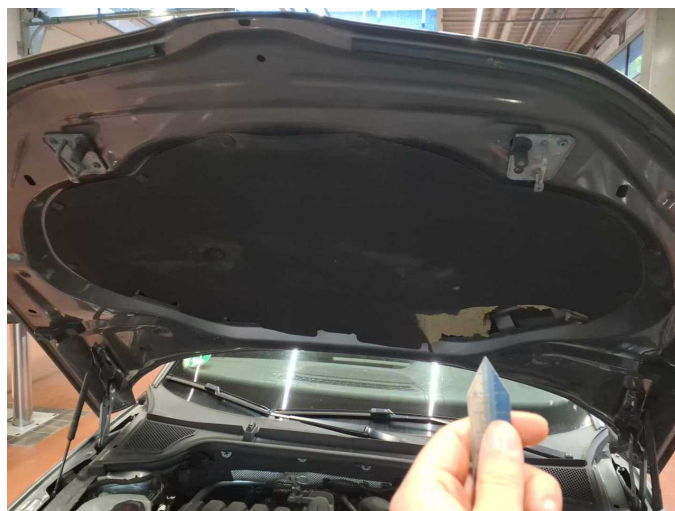
| No. | Component group | Description |
|---|---|---|
| 1 | Bonnet | Insulation lining - Damage caused by marten / rodent - Replace |

**Damage 1:** Bonnet: Insulation lining - Damage caused by marten / rodent  
- Replace

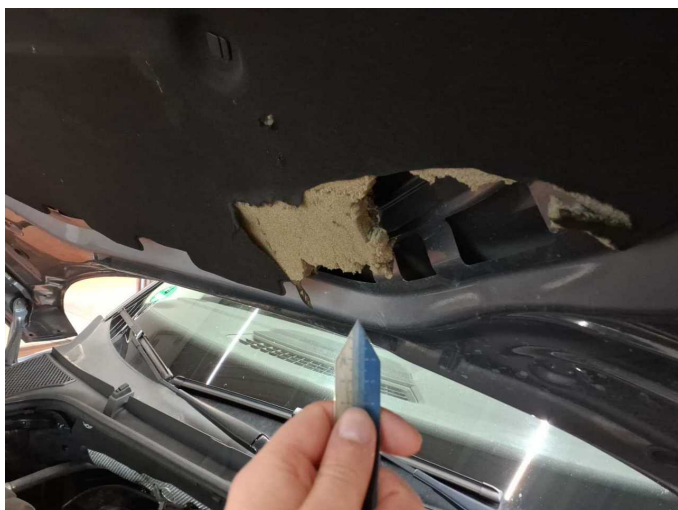
**Damage 1:** Bonnet: Insulation lining - Damage caused by marten / rodent - Replace

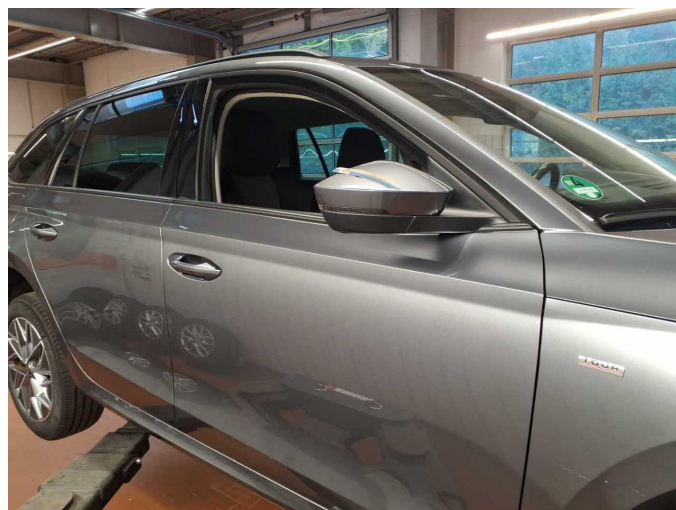
| No. | Component group | Description |
|---|---|---|
| 2 | Wing mirror - right side | Cap - Scratch(es) - Smart repair |

**Damage 2:** Wing mirror - right side: Cap - Scratch(es) - Smart repair

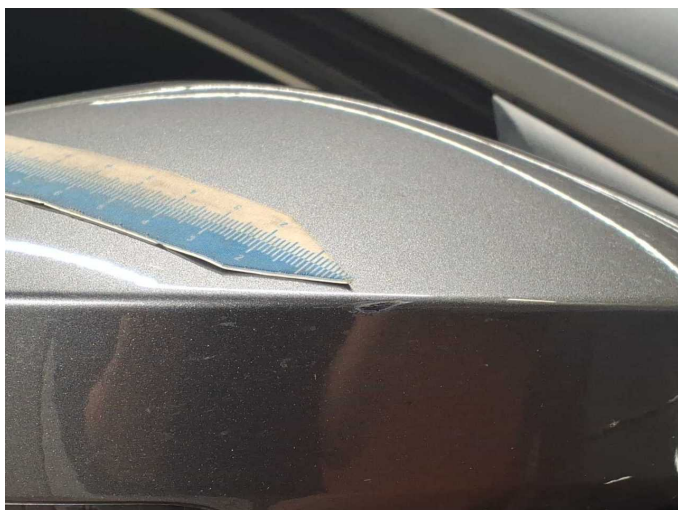
**Damage 2:** Wing mirror - right side: Cap - Scratch(es) - Smart repair

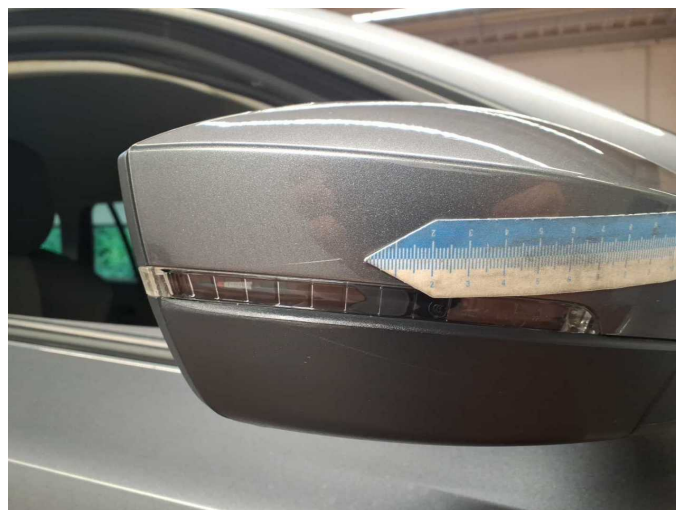
**Damage 2:** Wing mirror - right side: Cap - Scratch(es) - Smart repair

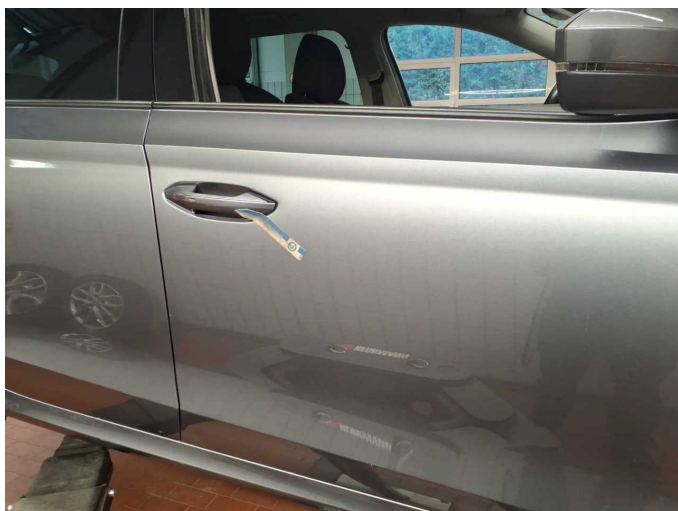
| No. | Component group | Description |
|---|---|---|
| 3 | Door - front right side | Door handle - outside - Scratch(es) - Smart repair |

**Damage 3:** Door - front right side: Door handle - outside - Scratch(es) - Smart repair

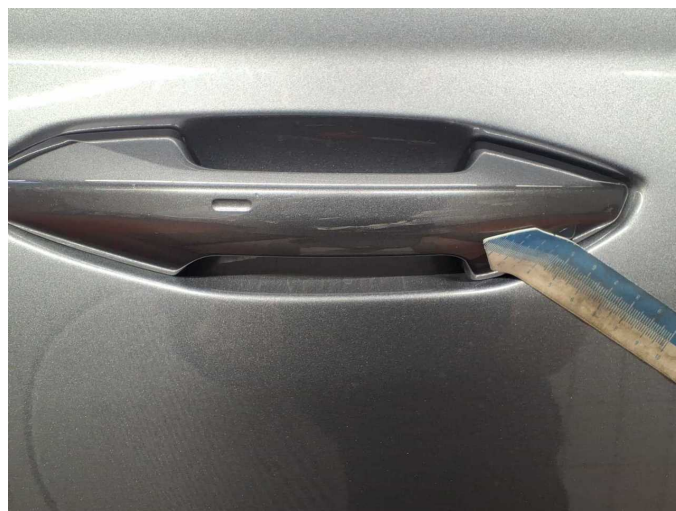
**Damage 3:** Door - front right side: Door handle - outside - Scratch(es) - Smart repair

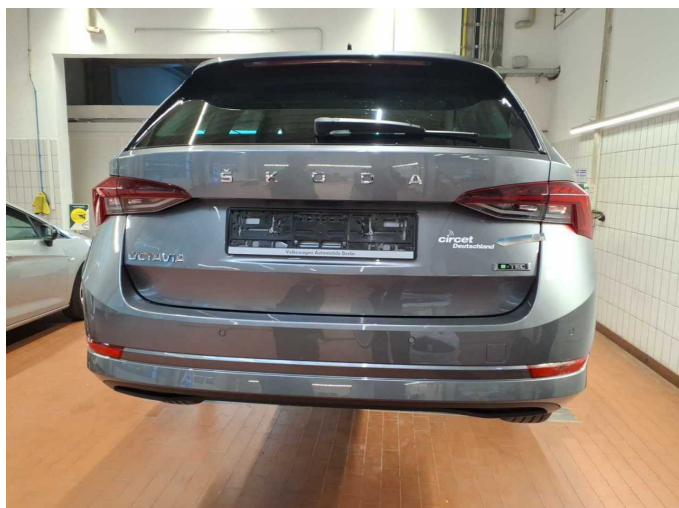
| No. | Component group | Description |
|---|---|---|
| 4 | Boot lid / rear door | Boot lid - Glued / labelled - Remove |

**Damage 4:** Boot lid / rear door: Boot lid - Glued / labelled - Remove

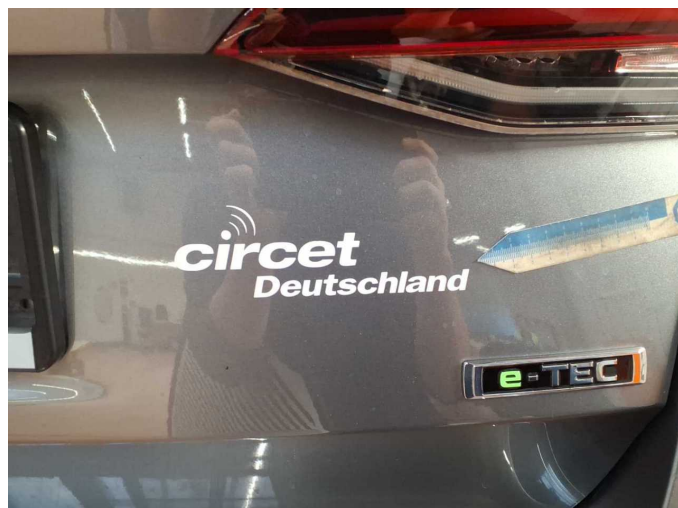
**Damage 4:** Boot lid / rear door: Boot lid - Glued / labelled - Remove

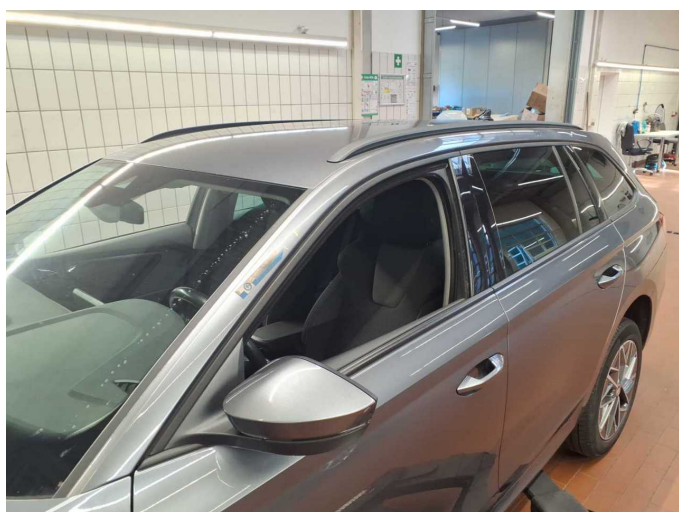
| No. | Component group | Description |
|---|---|---|
| 5 | Roof | Roof rail - left side - dent(s) - Smart repair |

**Damage 5:** Roof: Roof rail - left side - dent(s) - Smart repair

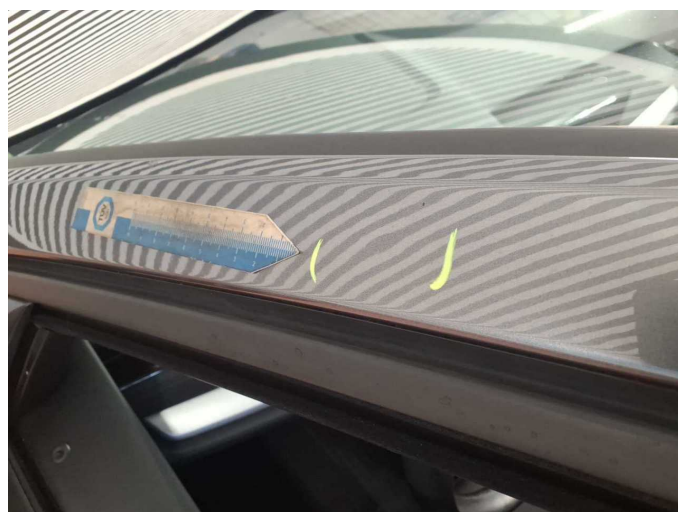
**Damage 5:** Roof: Roof rail - left side - dent(s) - Smart repair

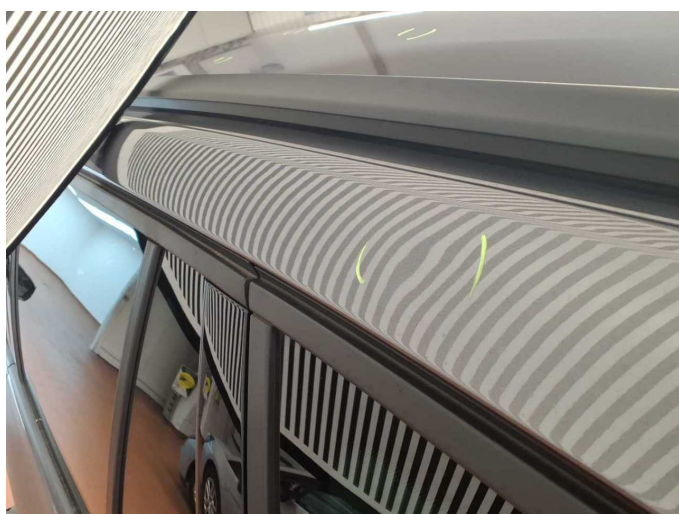
**Damage 5:** Roof: Roof rail - left side - dent(s) - Smart repair

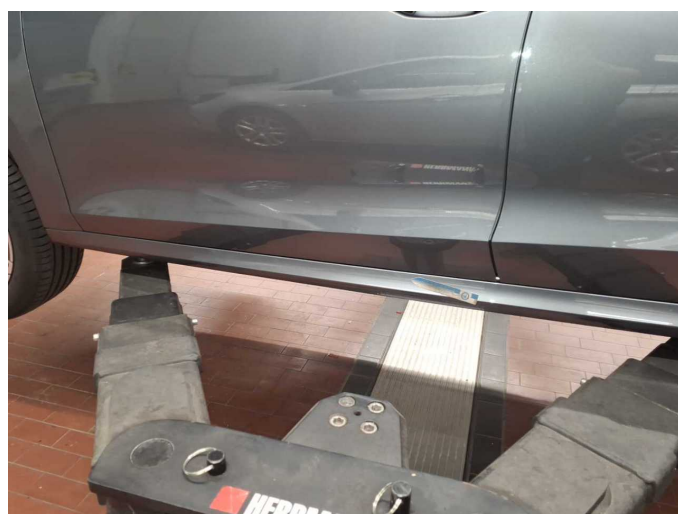
| No. | Component group | Description |
|---|---|---|
| 6 | Sill - left side | Sill - Scratch(es) - Smart repair |

**Damage 6:** Sill - left side: Sill - Scratch(es) - Smart repair

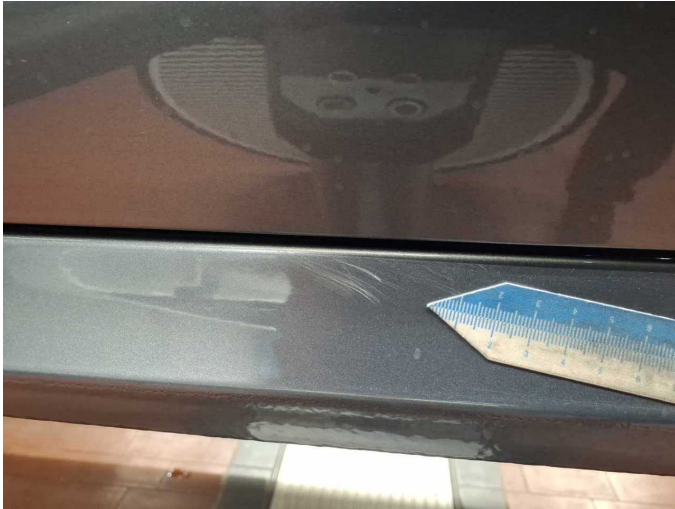
**Damage 6:** Sill - left side: Sill - Scratch(es) - Smart repair

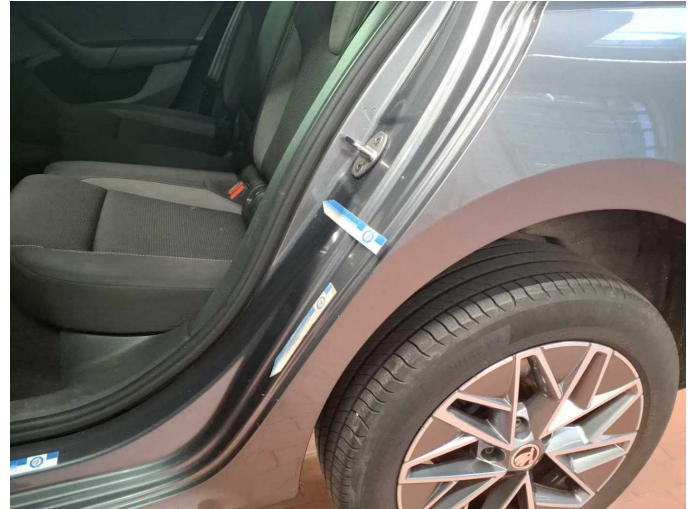
| No. | Component group | Description |
|---|---|---|
| 7 | Side panel - rear left side | Sill - Scratch(es) - Smart repair |

**Damage 7:** Side panel - rear left side: Sill - Scratch(es) - Smart repair

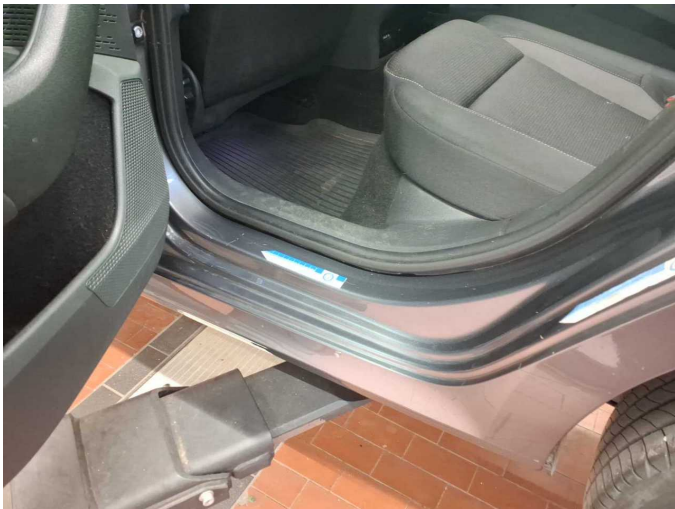
**Damage 7:** Side panel - rear left side: Sill - Scratch(es) - Smart repair

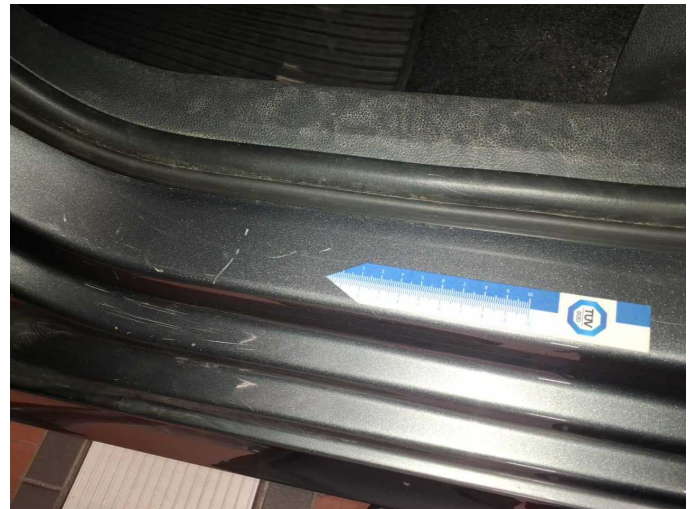
**Damage 7:** Side panel - rear left side: Sill - Scratch(es) - Smart repair

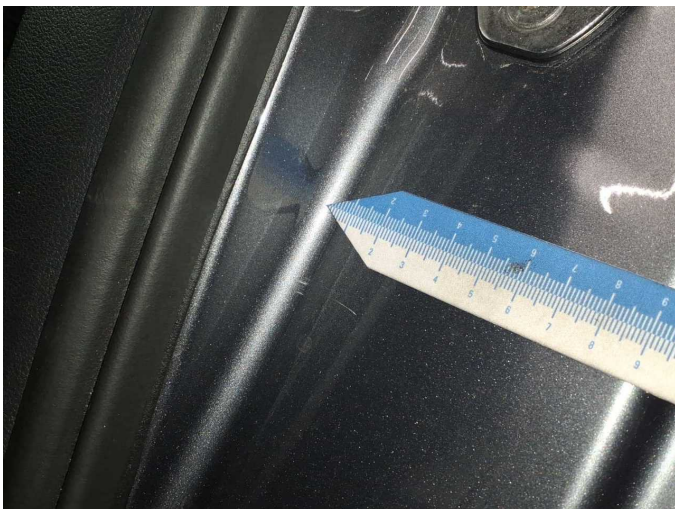
**Damage 7:** Side panel - rear left side: Sill - Scratch(es) - Smart repair

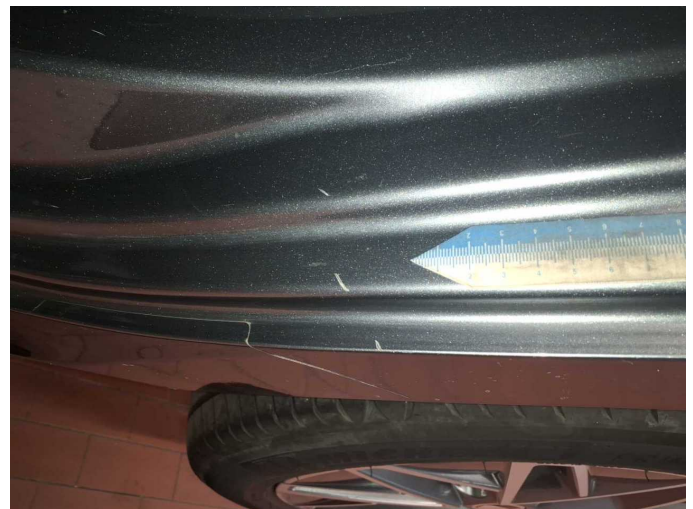
**Damage 7:** Side panel - rear left side: Sill - Scratch(es) - Smart repair

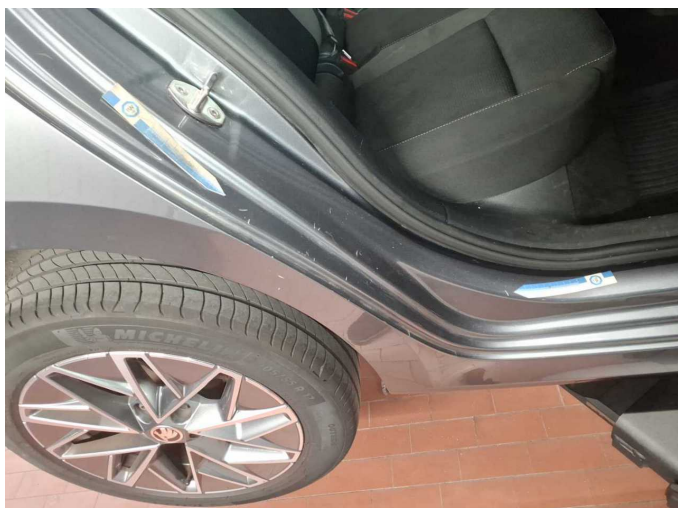
| No. | Component group | Description |
|---|---|---|
| 8 | Side panel - rear right side | Sill - Scratch(es) - Smart repair |

**Damage 8:** Side panel - rear right side: Sill - Scratch(es) - Smart repair

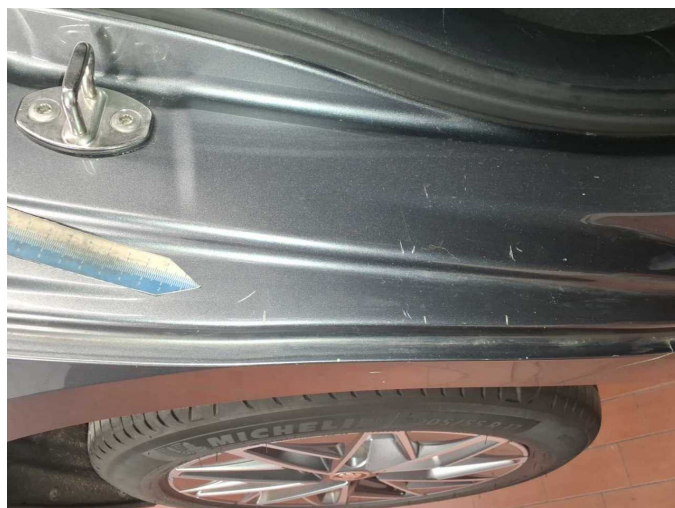
**Damage 8:** Side panel - rear right side: Sill - Scratch(es) - Smart repair

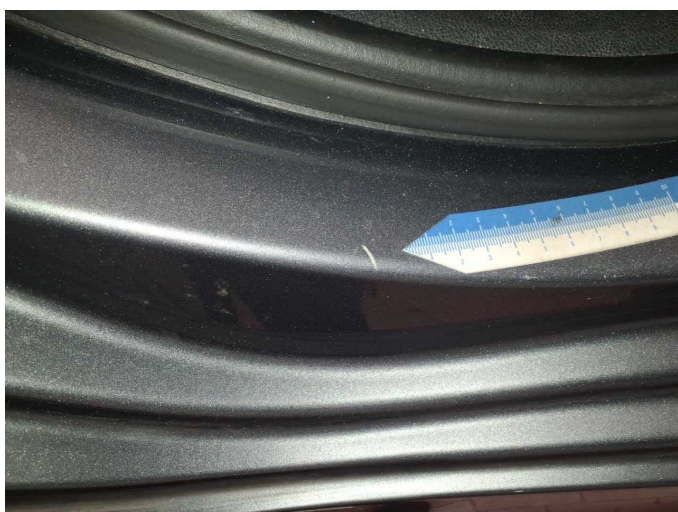
**Damage 8:** Side panel - rear right side: Sill - Scratch(es) - Smart repair

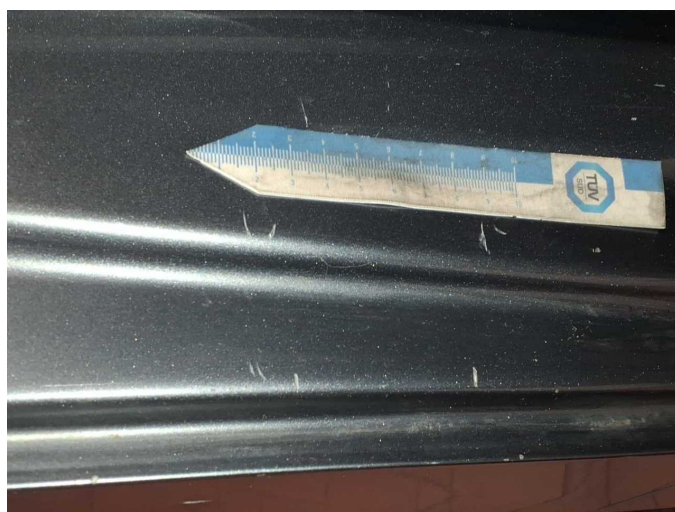
**Damage 8:** Side panel - rear right side: Sill - Scratch(es) - Smart repair

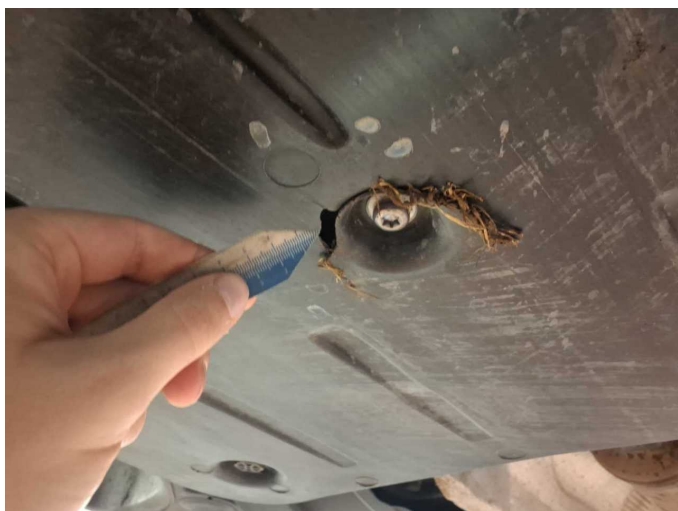
| No. | Component group | Description |
|---|---|---|
| 9 | Body | Underbody panelling - Broken / torn - Replace |

**Damage 9:** Body: Underbody panelling - Broken / torn - Replace

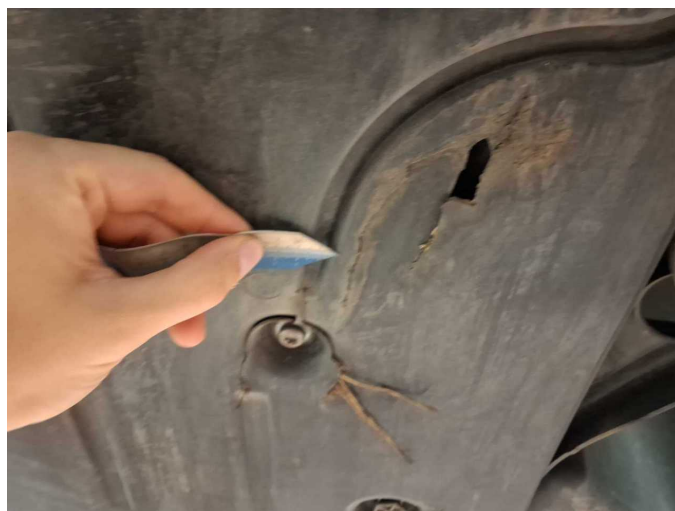
**Damage 9:** Body: Underbody panelling - Broken / torn - Replace

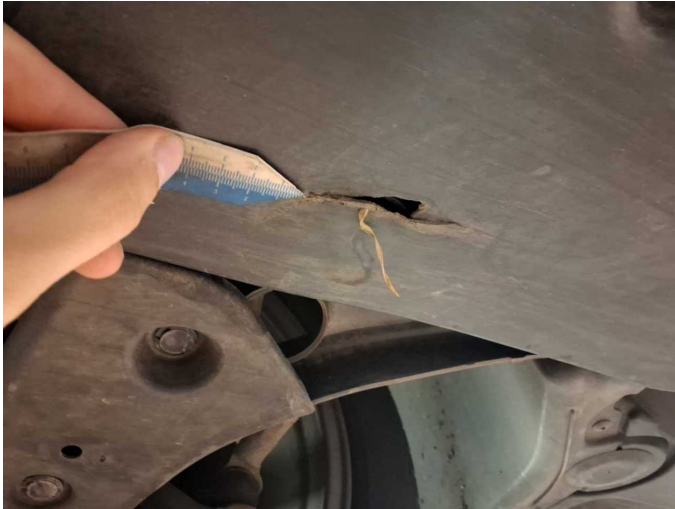
**Damage 9:** Body: Underbody panelling - Broken / torn - Replace

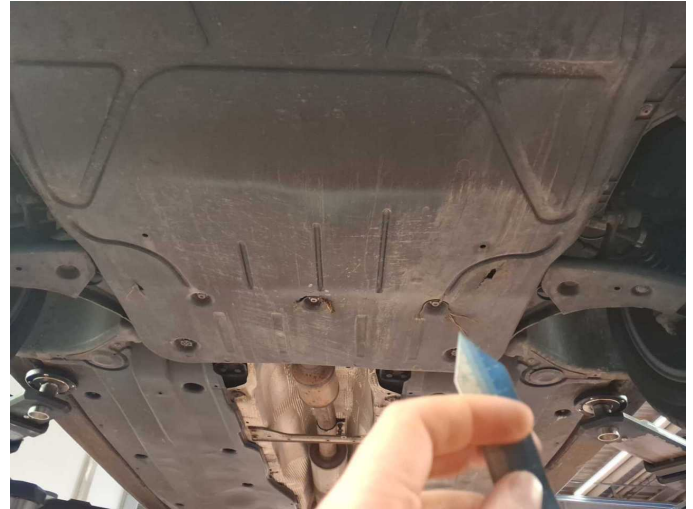
**Damage 9:** Body: Underbody panelling - Broken / torn - Replace

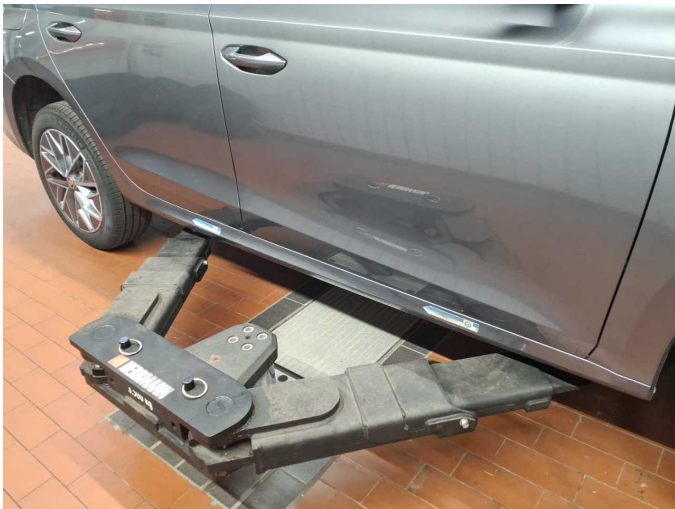
| No. | Component group | Description |
|---|---|---|
| 10 | Sill - right side | Sill - Scratch(es) - Paint |

**Damage 10:** Sill - right side: Sill - Scratch(es) - Paint

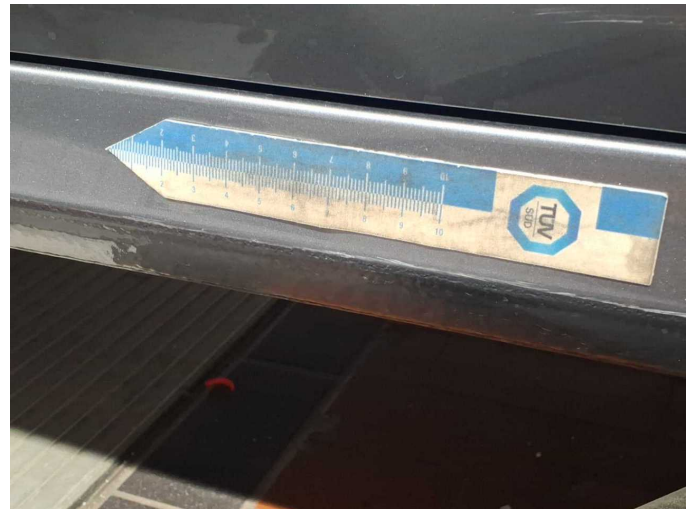
**Damage 10:** Sill - right side: Sill - Scratch(es) - Paint

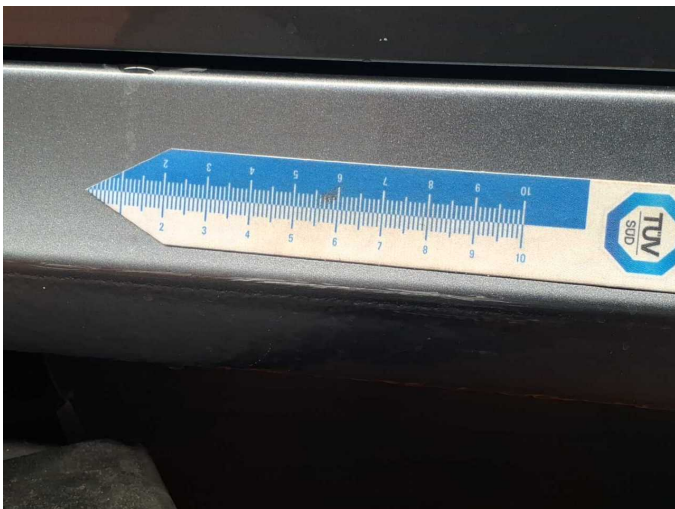
**Damage 10:** Sill - right side: Sill - Scratch(es) - Paint

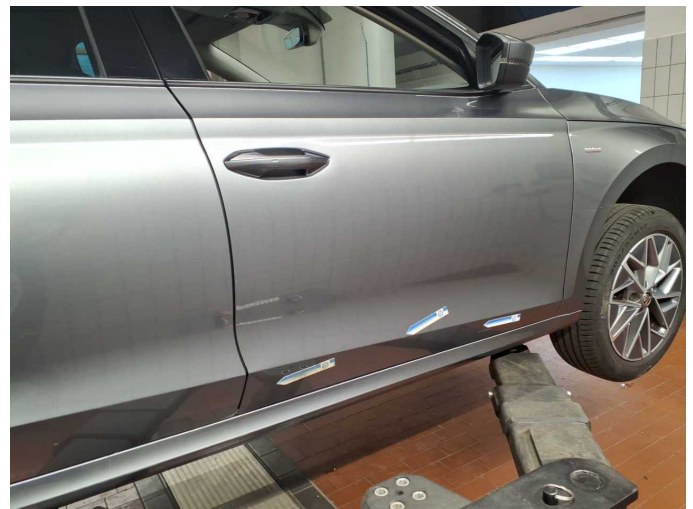
| No. | Component group | Description |
|---|---|---|
| 11 | Door - front right side | Door - Dent / paintcoat damage - Repair and paint |

**Damage 11:** Door - front right side: Door - Dent / paintcoat damage - Repair and paint

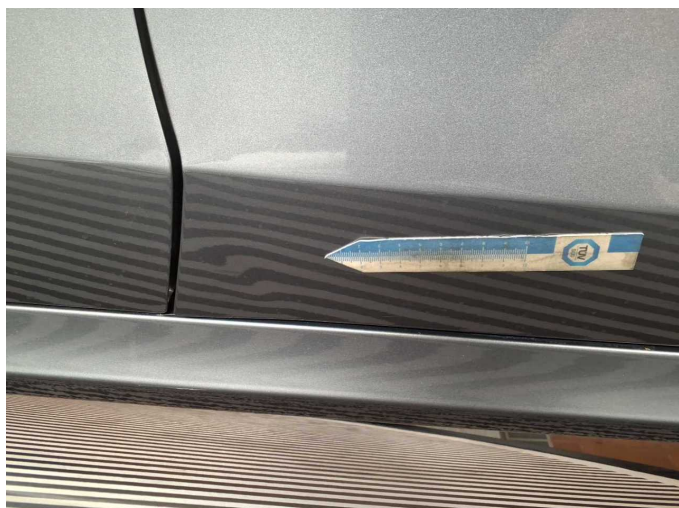
**Damage 11:** Door - front right side: Door - Dent / paintcoat damage - Repair and paint

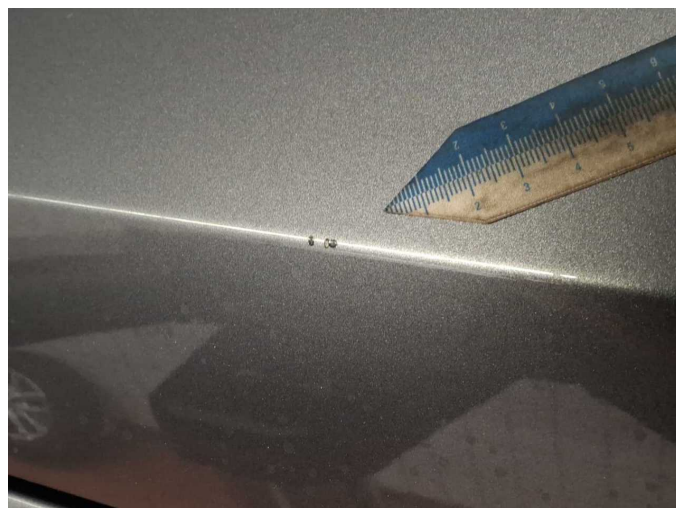
**Damage 11:** Door - front right side: Door - Dent / paintcoat damage - Repair and paint

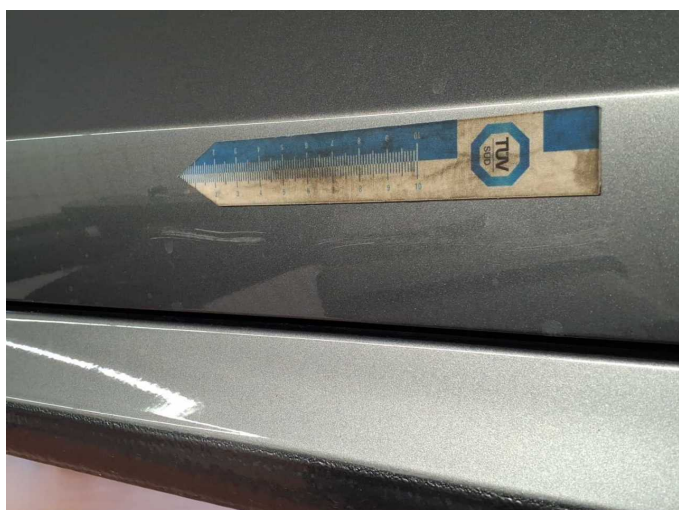
**Damage 11:** Door - front right side: Door - Dent / paintcoat damage - Repair and paint

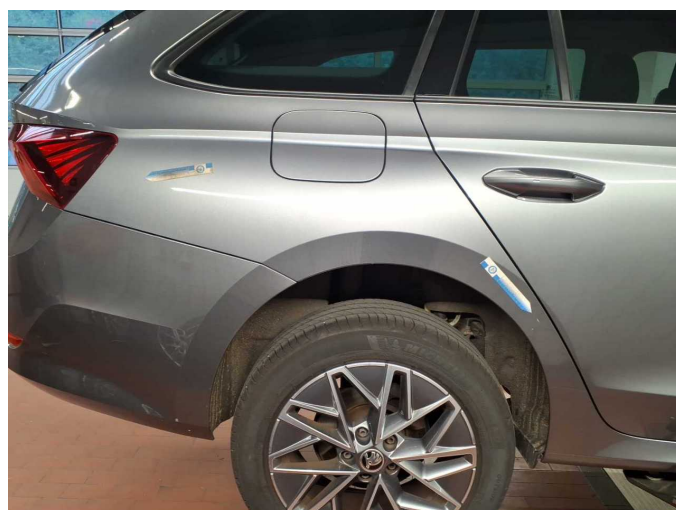
| No. | Component group | Description |
|---|---|---|
| 12 | Side panel - rear right side | Side panel - Dent / paintcoat damage - Repair and paint |

**Damage 12:** Side panel - rear right side: Side panel - Dent / paintcoat damage - Repair and paint

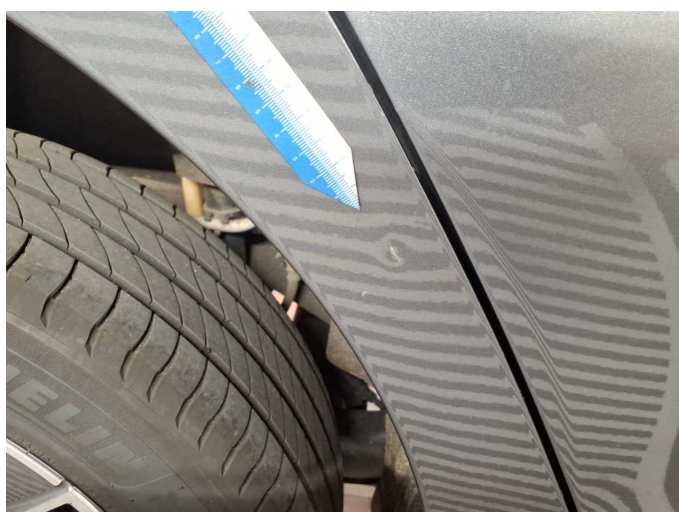
**Damage 12:** Side panel - rear right side: Side panel - Dent / paintcoat damage - Repair and paint

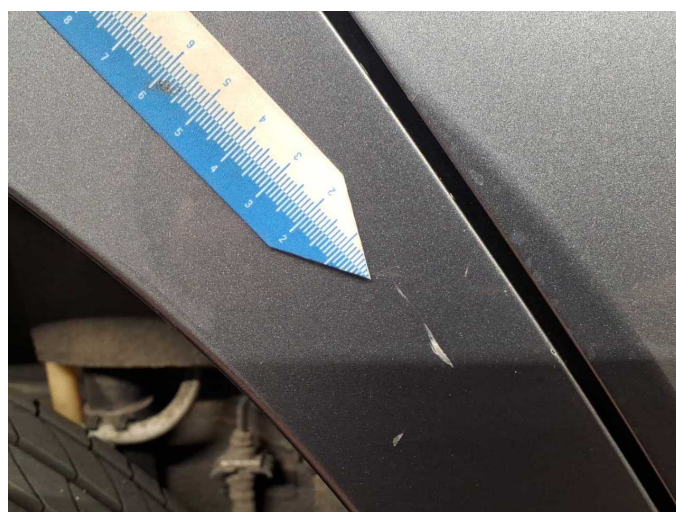
**Damage 12:** Side panel - rear right side: Side panel - Dent / paintcoat damage - Repair and paint

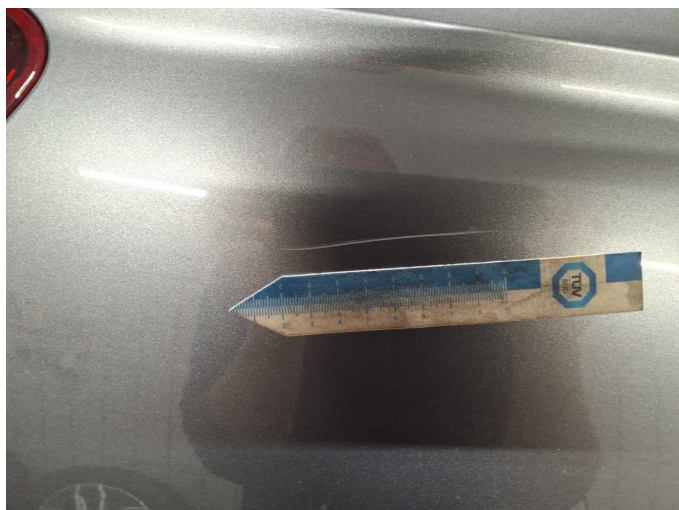
**Damage 12:** Side panel - rear right side: Side panel - Dent / paintcoat damage - Repair and paint

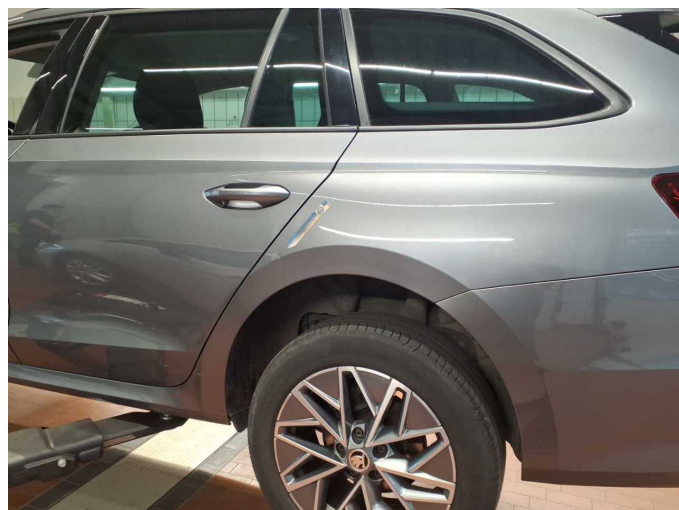
| No. | Component group | Description |
|---|---|---|
| 13 | Side panel - rear left side | Side panel (An Kante) - dent(s) - Repair and paint |

**Damage 13:** Side panel - rear left side: Side panel (An Kante) - dent(s) - Repair and paint

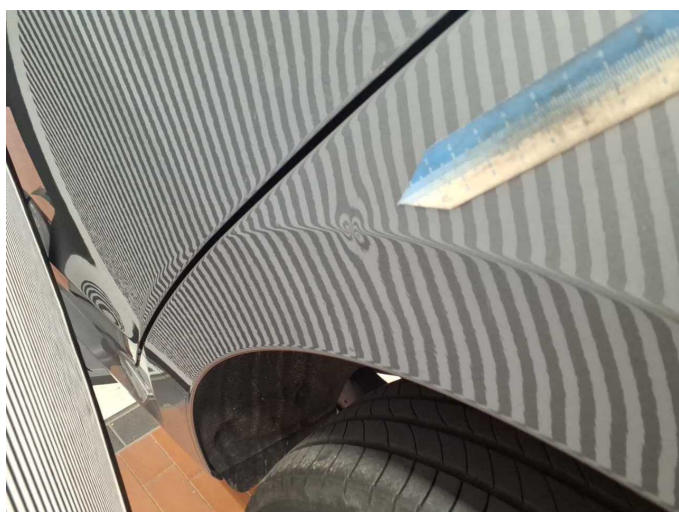
**Damage 13:** Side panel - rear left side: Side panel (An Kante) - dent(s) - Repair and paint

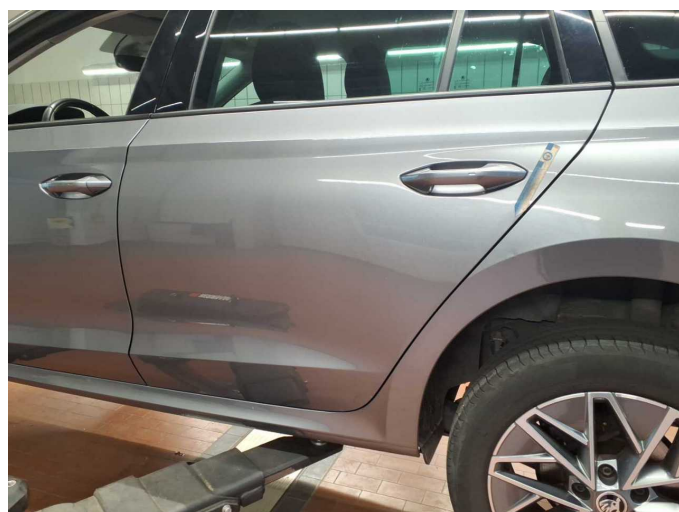
| No. | Component group | Description |
|---|---|---|
| 14 | Door - rear left side | Door - Dent / paintcoat damage - Repair and paint |

**Damage 14:** Door - rear left side: Door - Dent / paintcoat damage - Repair and paint

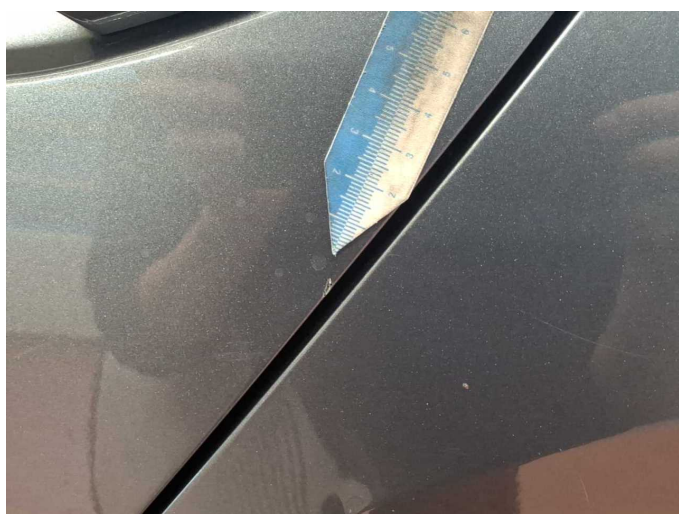
**Damage 14:** Door - rear left side: Door - Dent / paintcoat damage - Repair and paint

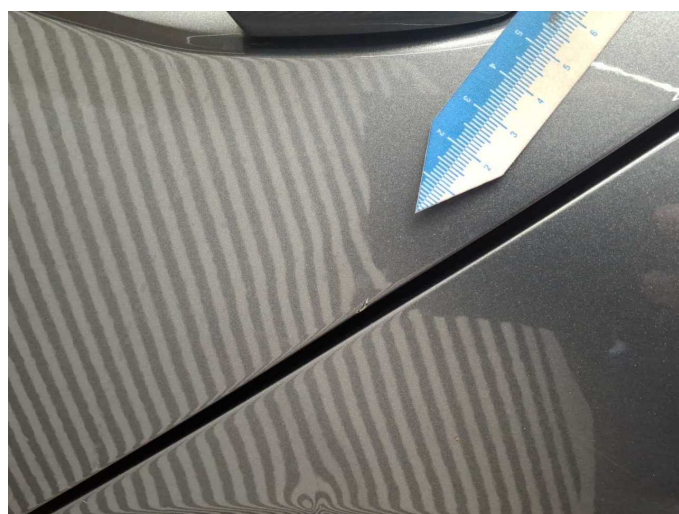
**Damage 14:** Door - rear left side: Door - Dent / paintcoat damage - Repair and paint

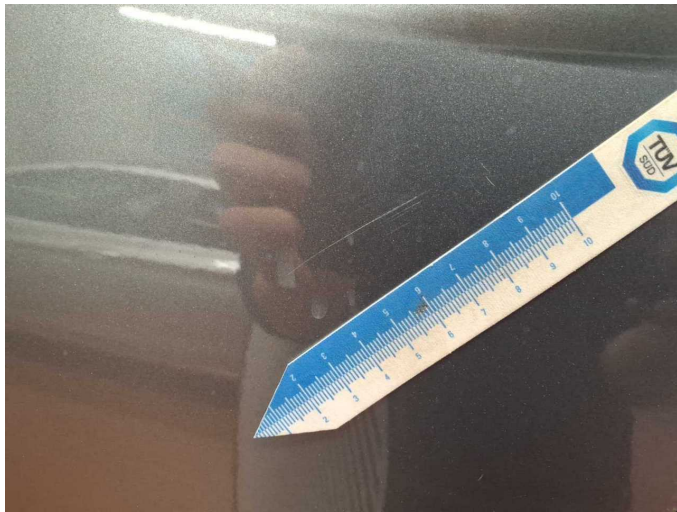
**Damage 14:** Door - rear left side: Door - Dent / paintcoat damage - Repair and paint

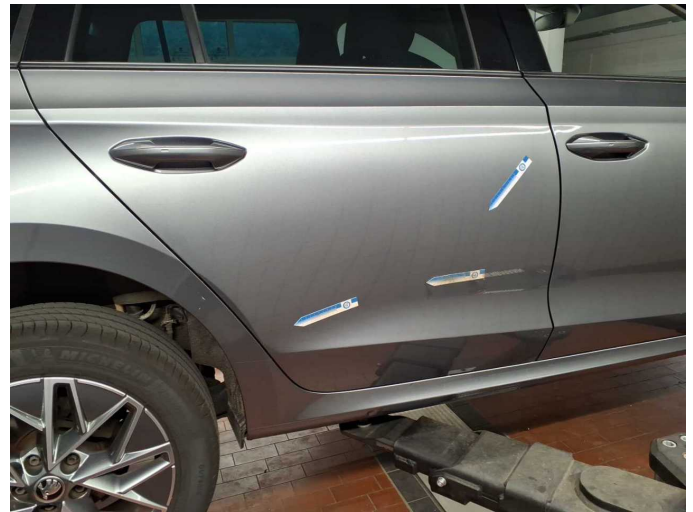
| No. | Component group | Description |
|---|---|---|
| 15 | Door - rear right side | Door (Folgekosten möglich) - Scratch(es) - Paint |

**Damage 15:** Door - rear right side: Door (Folgekosten möglich) - Scratch(es) - Paint

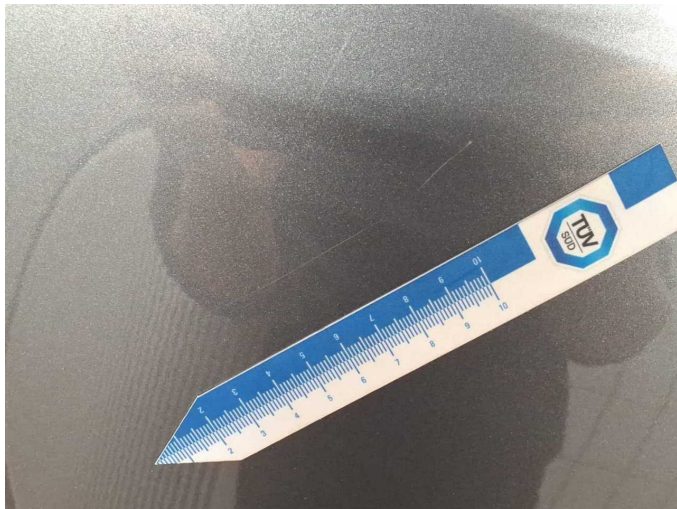
**Damage 15:** Door - rear right side: Door (Folgekosten möglich) - Scratch(es) - Paint

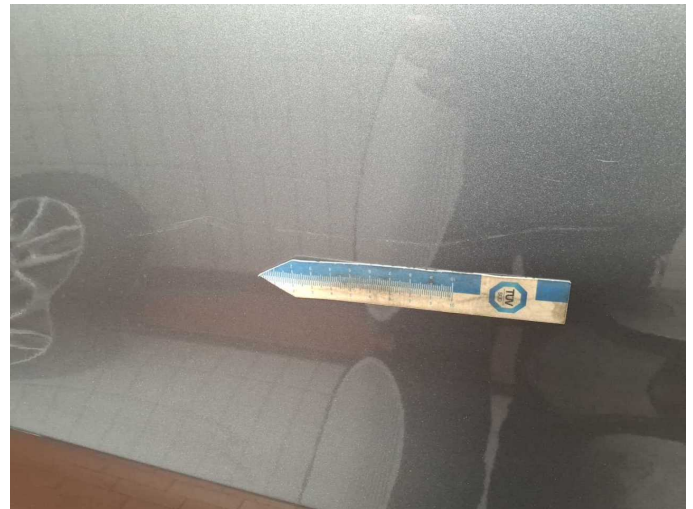
**Damage 15:** Door - rear right side: Door (Folgekosten möglich) - Scratch(es) - Paint

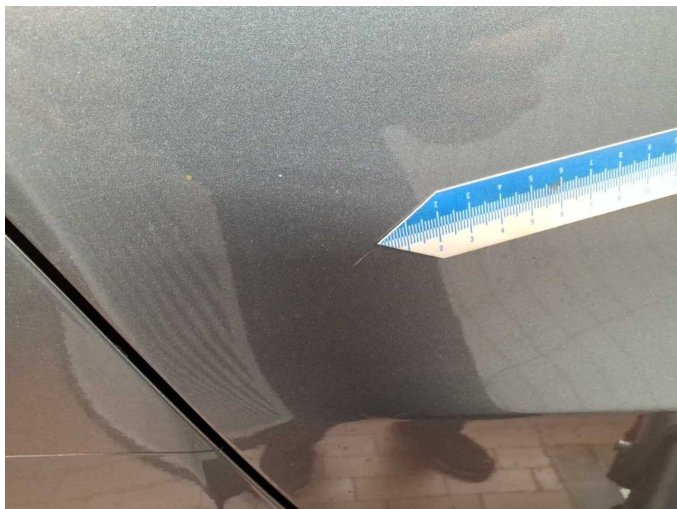
**Damage 15:** Door - rear right side: Door (Folgekosten möglich) - Scratch(es) - Paint

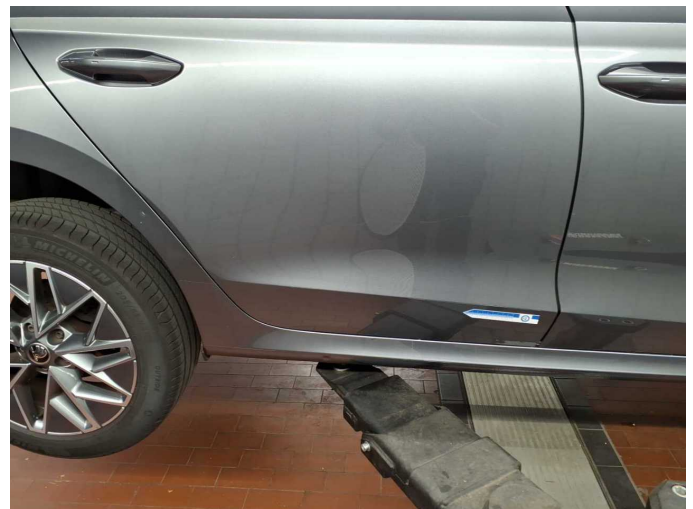
**Damage 15:** Door - rear right side: Door (Folgekosten möglich) - Scratch(es) - Paint

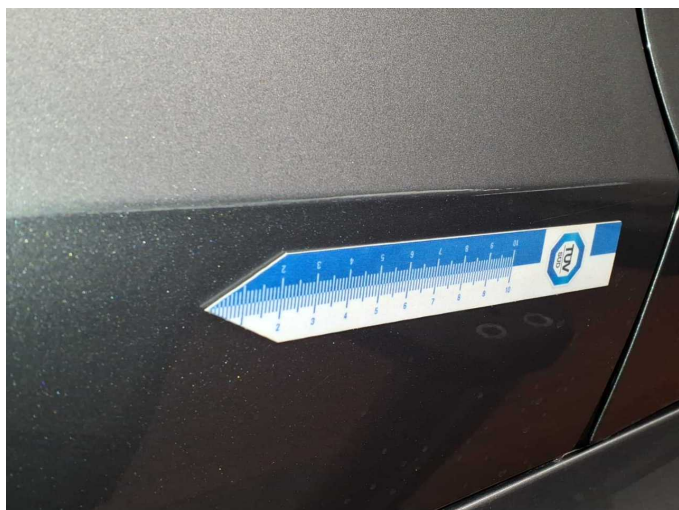
**Damage 15:** Door - rear right side: Door (Folgekosten möglich) - Scratch(es) - Paint

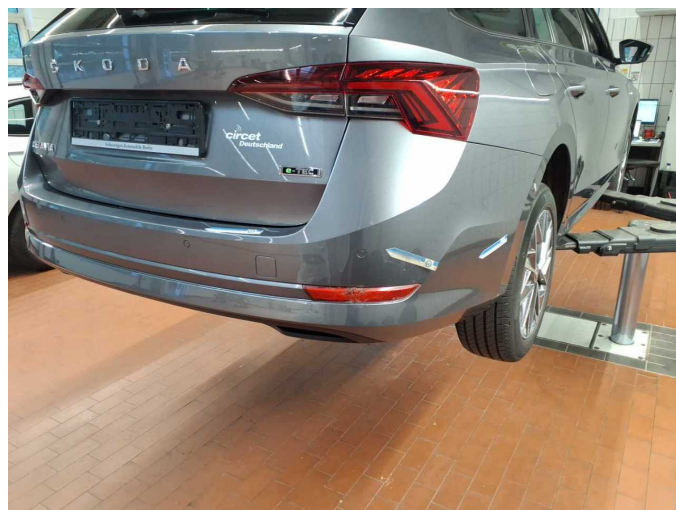
| No. | Component group | Description |
|---|---|---|
| 16 | Rear bumper | Rear bumper (inkl. Rückstrahler rechts ersetzen) - Scratch(es) - Repair |

**Damage 16:** Rear bumper: Rear bumper (inkl. Rückstrahler rechts ersetzen) - Scratch(es) - Repair

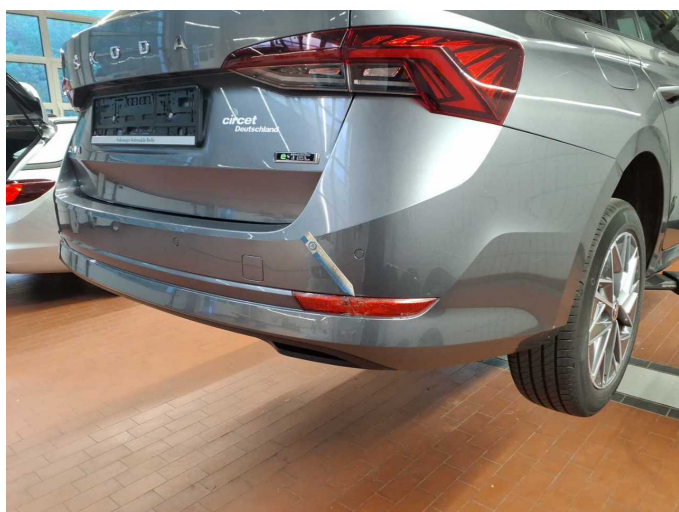
**Damage 16:** Rear bumper: Rear bumper (inkl. Rückstrahler rechts ersetzen) - Scratch(es) - Repair

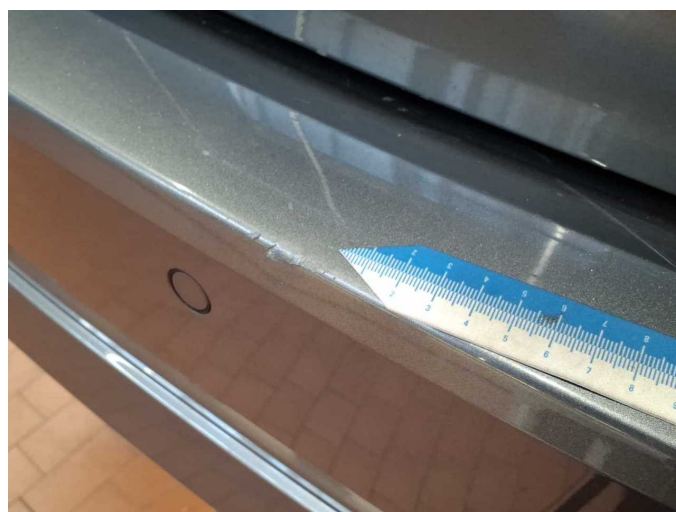
**Damage 16:** Rear bumper: Rear bumper (inkl. Rückstrahler rechts ersetzen) - Scratch(es) - Repair

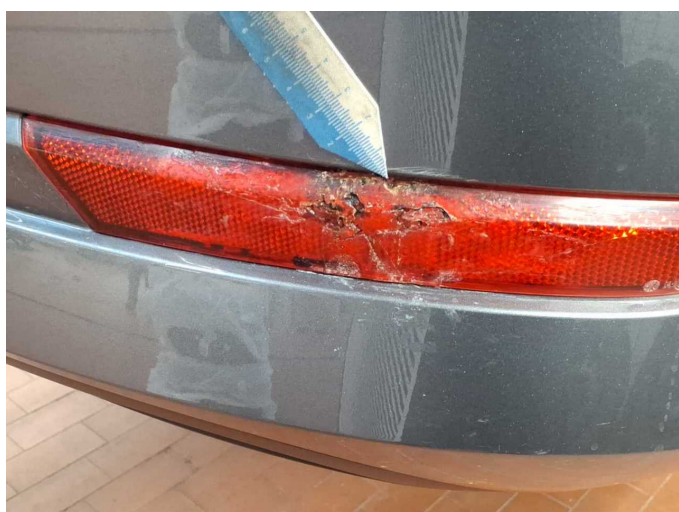
**Damage 16:** Rear bumper: Rear bumper (inkl. Rückstrahler rechts ersetzen) - Scratch(es) - Repair

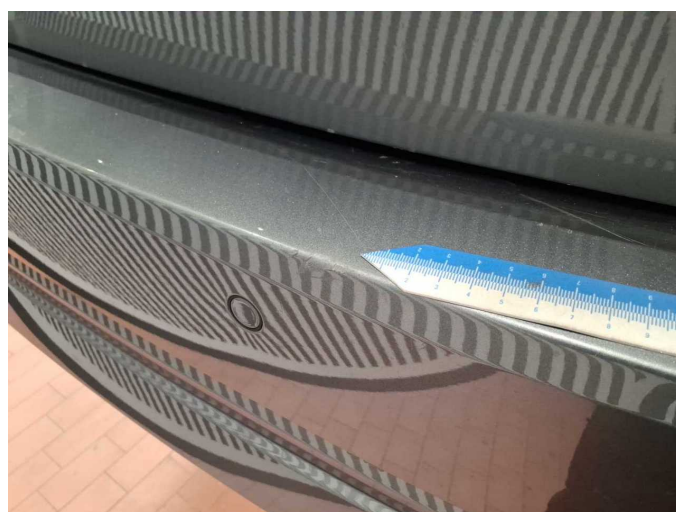
**Damage 16:** Rear bumper: Rear bumper (inkl. Rückstrahler rechts ersetzen) - Scratch(es) - Repair

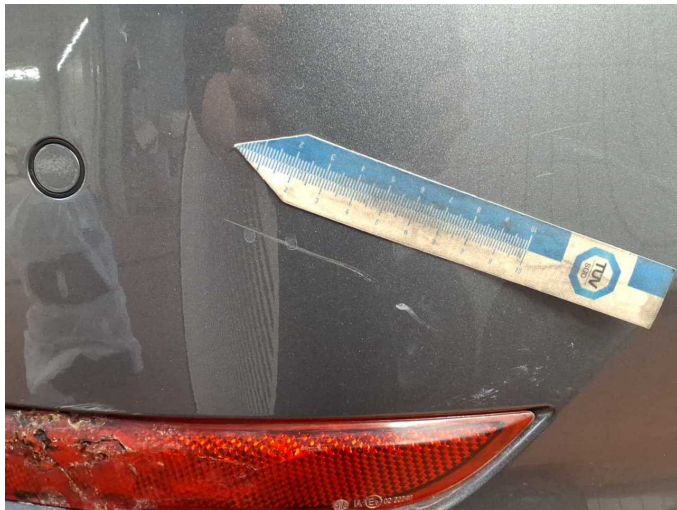
**Damage 16:** Rear bumper: Rear bumper (inkl. Rückstrahler rechts ersetzen) - Scratch(es) - Repair

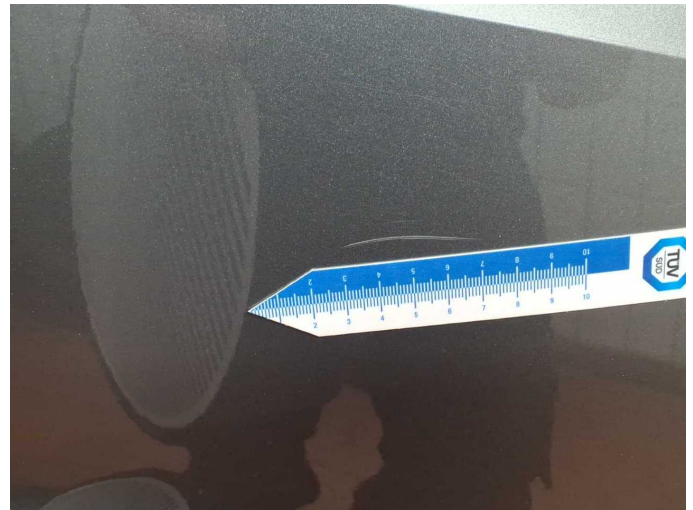
**Damage 16:** Rear bumper: Rear bumper (inkl. Rückstrahler rechts ersetzen) - Scratch(es) - Repair

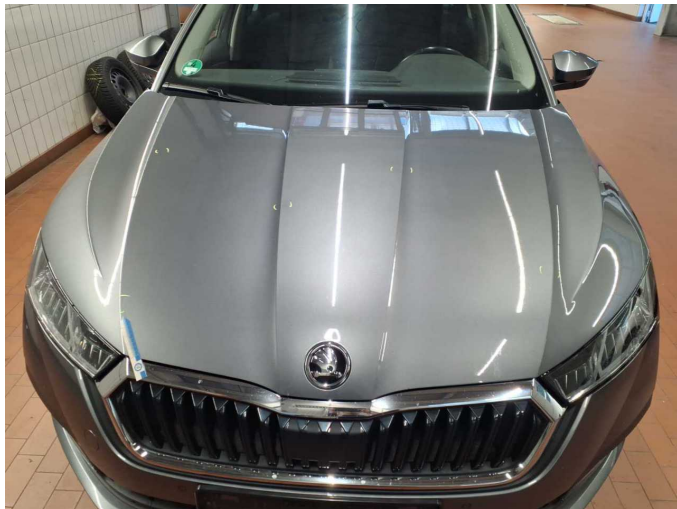
| No. | Component group | Description |
|---|---|---|
| 17 | Bonnet | Bonnet - Dent / paintcoat damage - Repair and paint |

**Damage 17:** Bonnet: Bonnet - Dent / paintcoat damage - Repair and paint

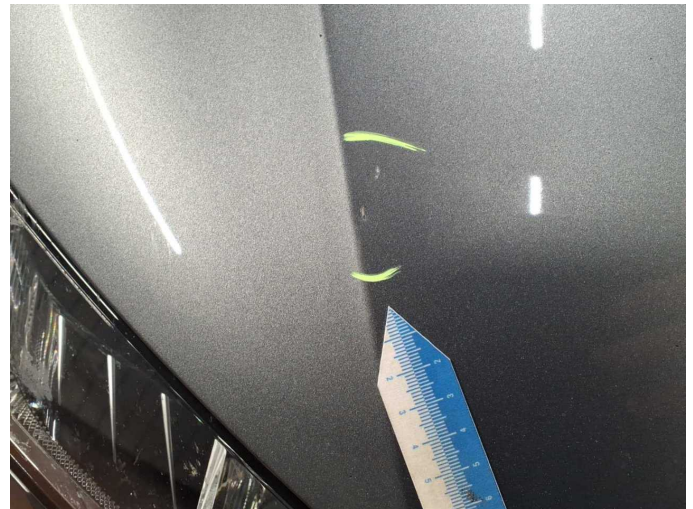
**Damage 17:** Bonnet: Bonnet - Dent / paintcoat damage - Repair and paint

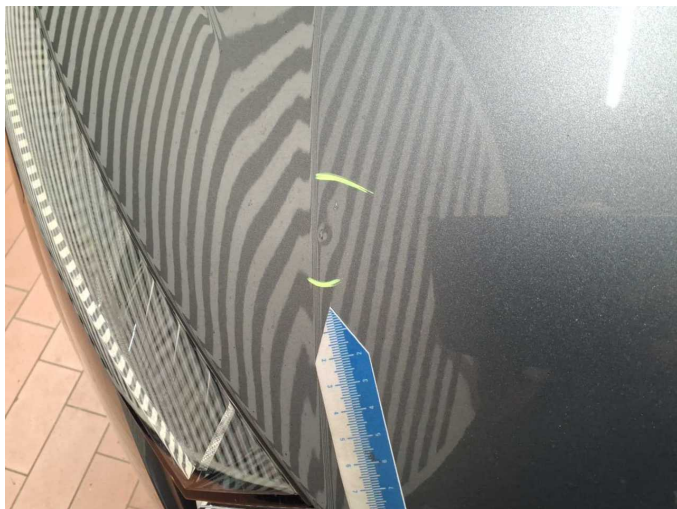
**Damage 17:** Bonnet: Bonnet - Dent / paintcoat damage - Repair and paint
