Expertise

Protocol number: 41606988  
Order No. / Reference: 25210189  
Inspection date: 17 Sept 2025

| Manufacturer: Skoda | Model: Octavia Combi 1.5 TSI e-TEC DSG Tour |
| VIN: TMBJR8NX6NY105861 | |

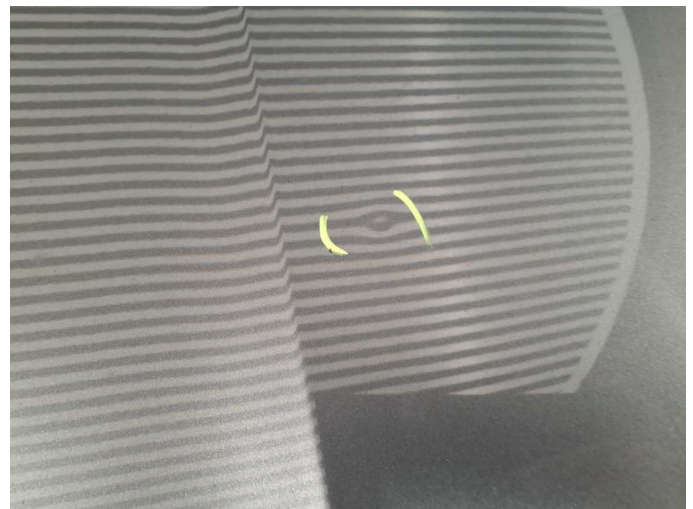
| No. | Component group | Description |
|---|---|---|
| 17 | Bonnet | Bonnet - Dent / paintcoat damage - Repair and paint |

**Damage 17:** Bonnet: Bonnet - Dent / paintcoat damage - Repair and paint

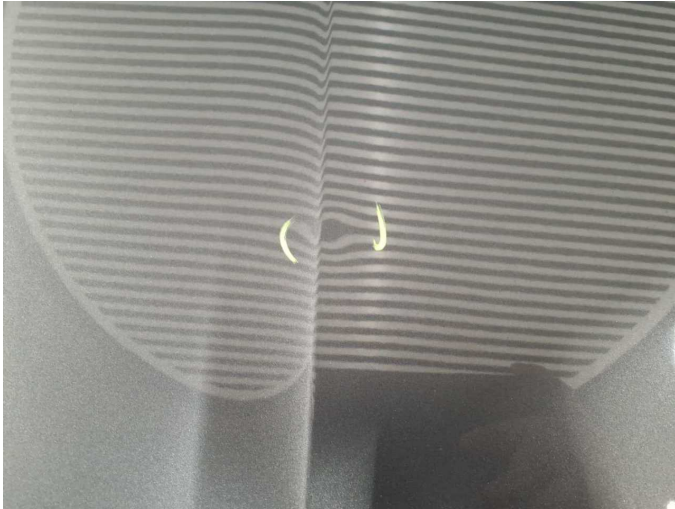
**Damage 17:** Bonnet: Bonnet - Dent / paintcoat damage - Repair and paint

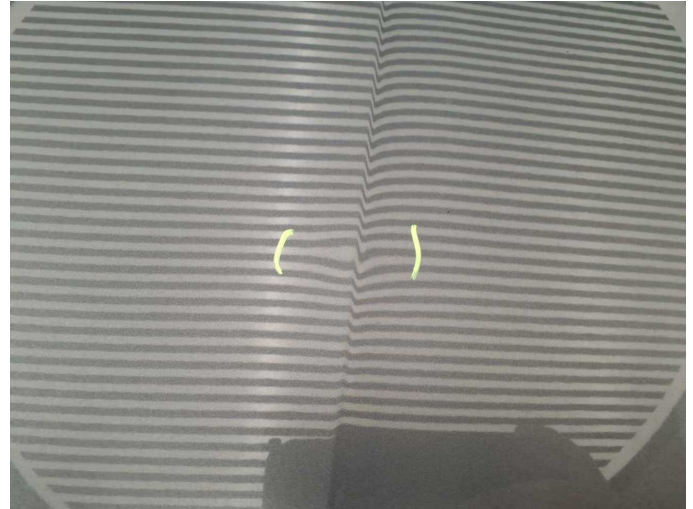
**Damage 17:** Bonnet: Bonnet - Dent / paintcoat damage - Repair and paint

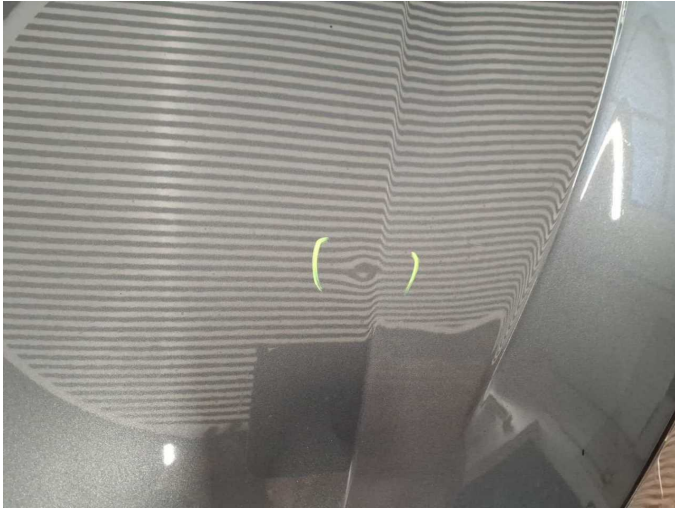
**Damage 17:** Bonnet: Bonnet - Dent / paintcoat damage - Repair and paint

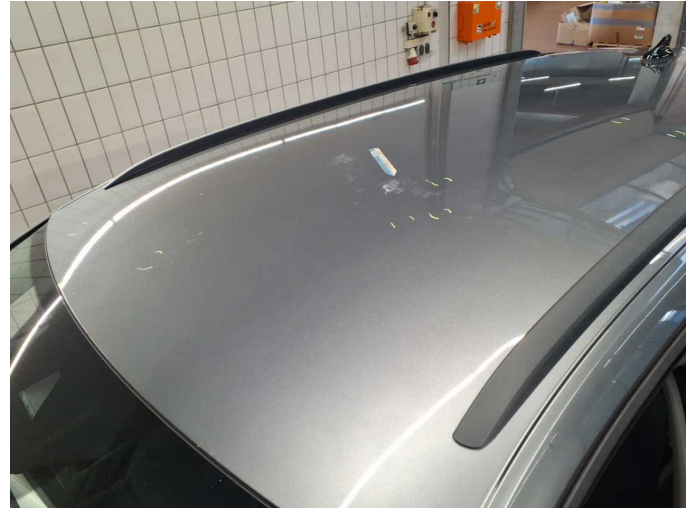
| No. | Component group | Description |
|---|---|---|
| 18 | Roof | Roof (Verätzungen + ca 10 Dellen) - Dent / paintcoat damage - Repair and paint |

**Damage 18:** Roof: Roof (Verätzungen + ca 10 Dellen) - Dent / paintcoat damage - Repair and paint

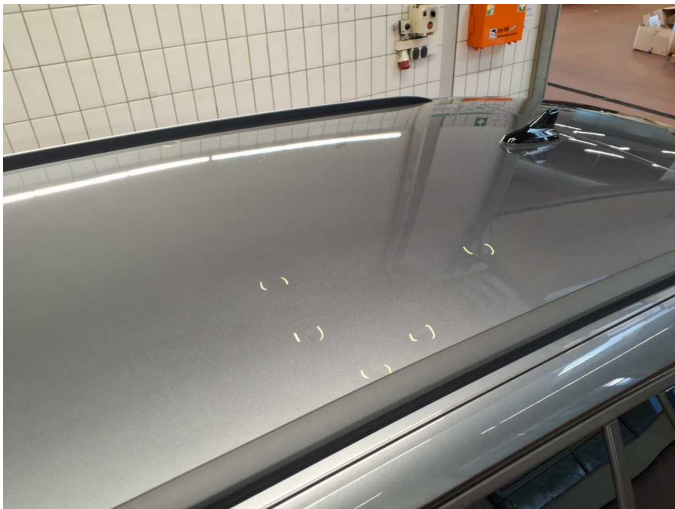
**Damage 18:** Roof: Roof (Verätzungen + ca 10 Dellen) - Dent / paintcoat damage - Repair and paint

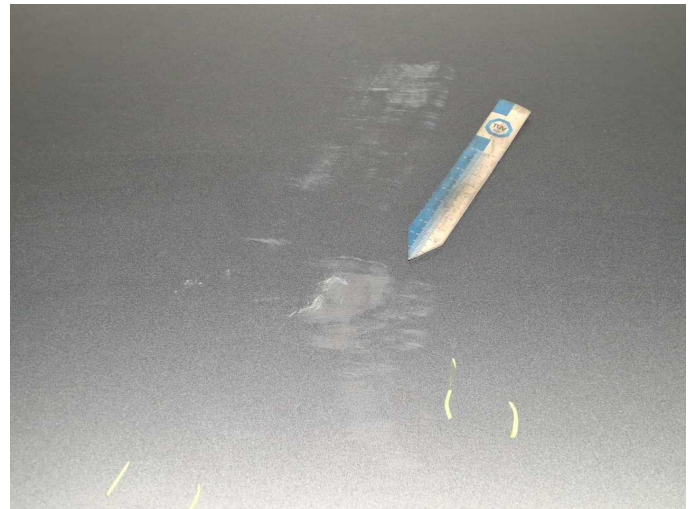
**Damage 18:** Roof: Roof (Verätzungen + ca 10 Dellen) - Dent / paintcoat damage - Repair and paint

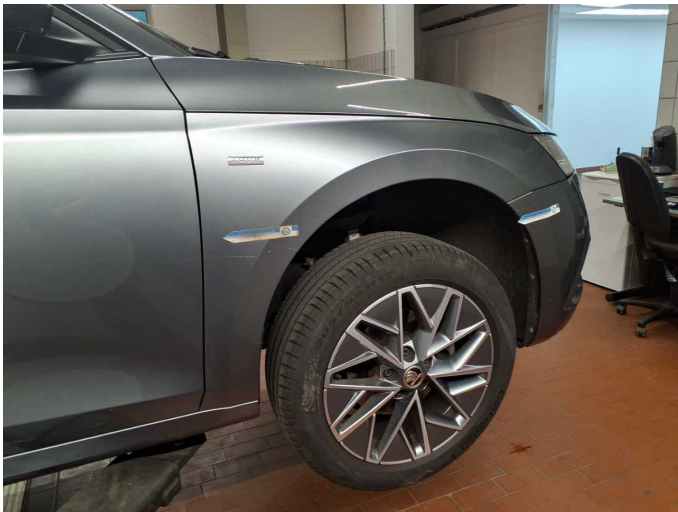
1 Side right

Accident 1: Side right
